Building and Timber Pest Inspection Report

Inspection Date: Tue, 31 Mar 2026

Property Address: 1/14 Milton Ave, Clayton South VIC 3169,
Australia

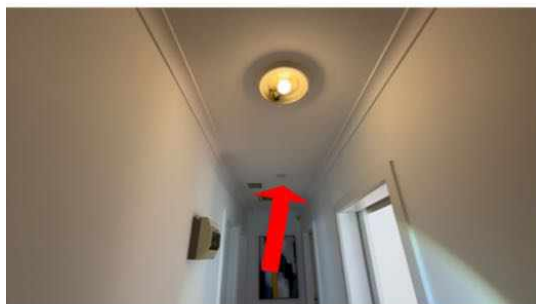
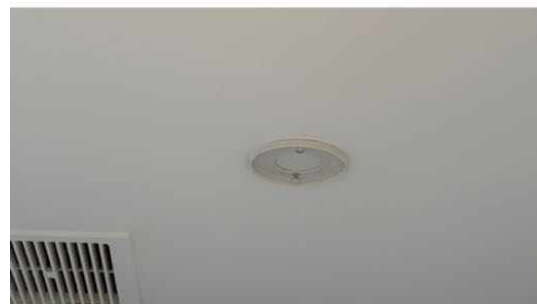
Please note that this defect is highlighted as a caution only. We suspect, based on our experience in the building industry, that the absence of smoke detectors, or their poor condition, should be addressed as a matter of urgency to improve occupant safety.

Always ensure sufficient working and suitable smoke detectors are installed prior to occupying any building. Additionally, it is advised that all smoke detectors be tested by the homeowner on a monthly basis.

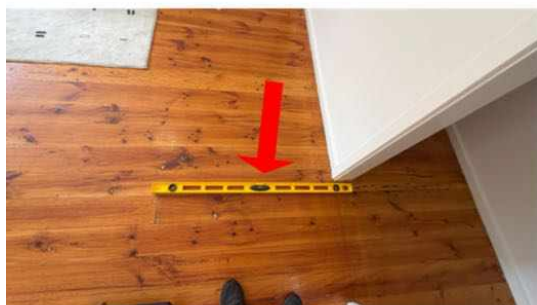
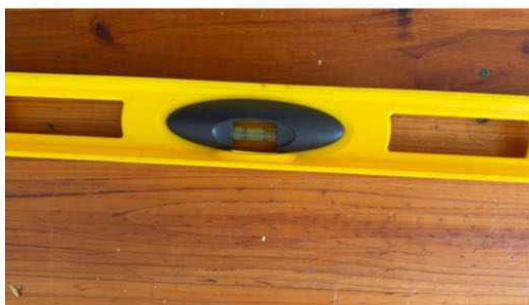
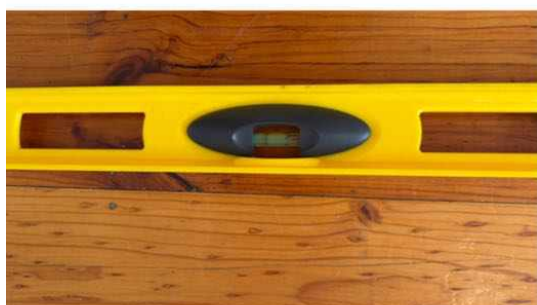
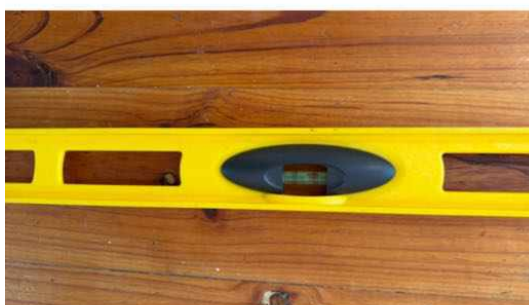
Finding 2.01

Information: Floor levels were found to be significantly uneven across multiple sections of the dwelling, indicating potential structural movement. The subfloor area was not accessible at the time of inspection, therefore the condition of structural supports, stumps, and footings could not be assessed.

Significant unevenness is commonly associated with issues such as footing movement, failed or deteriorated stumps, or subfloor structural defects. This may lead to ongoing movement, cracking of walls and finishes, misalignment of doors and windows, and potential safety risks if not addressed.

Given the severity of the defect, it is strongly recommended that a registered builder or structural engineer be engaged as a matter of priority to undertake a detailed and invasive assessment of the subfloor and structural elements, and to provide appropriate rectification measures.

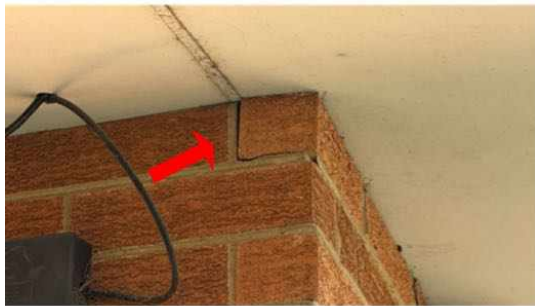
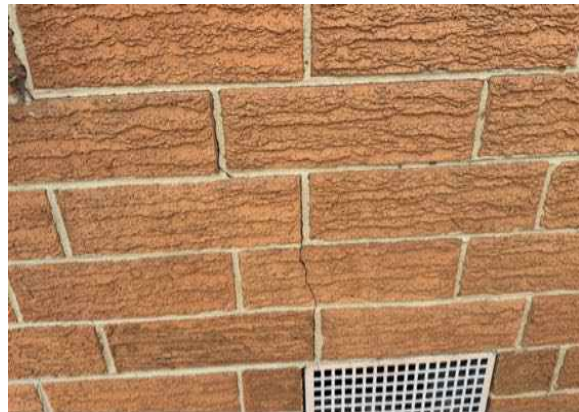
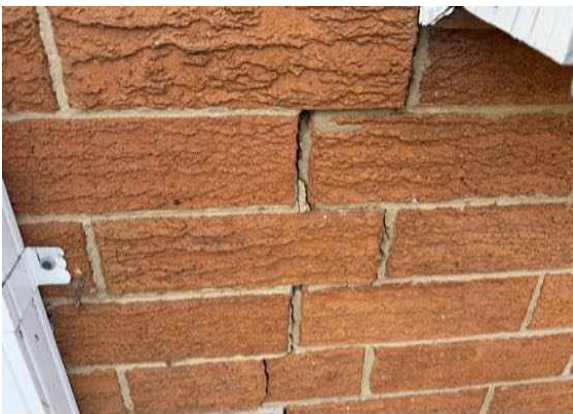
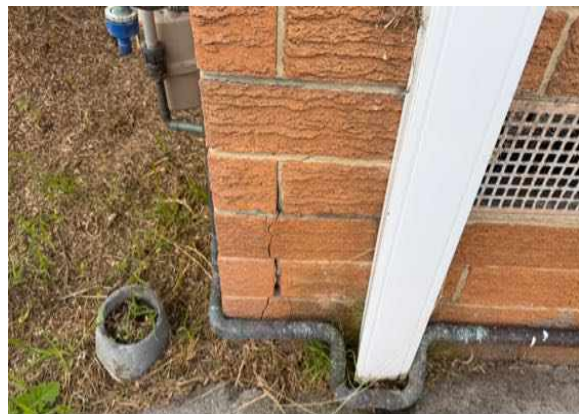
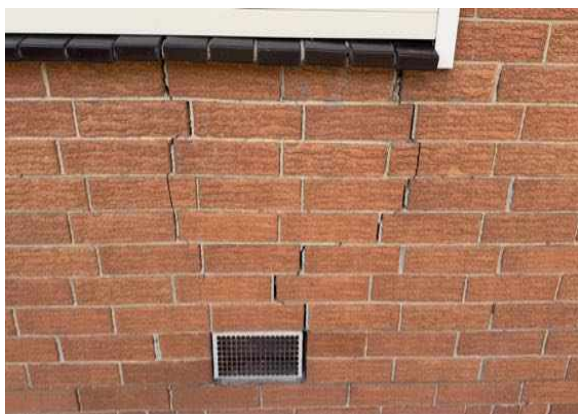
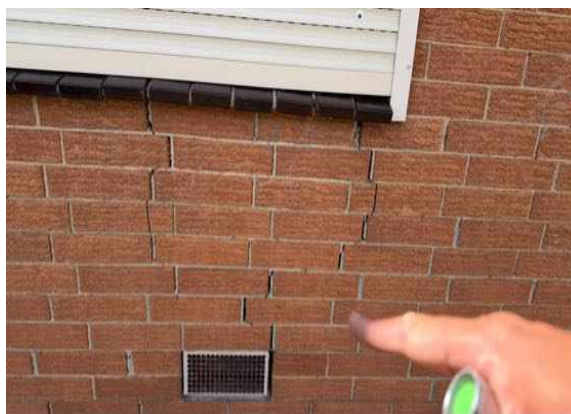
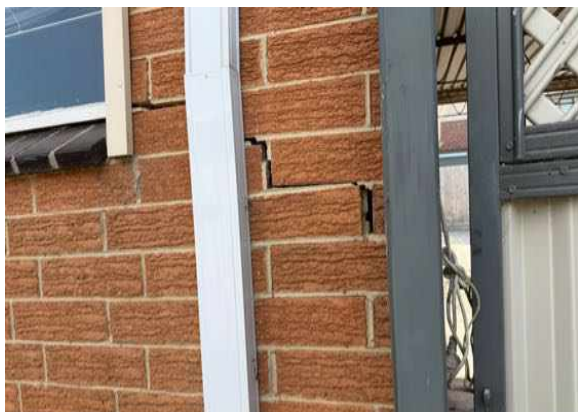
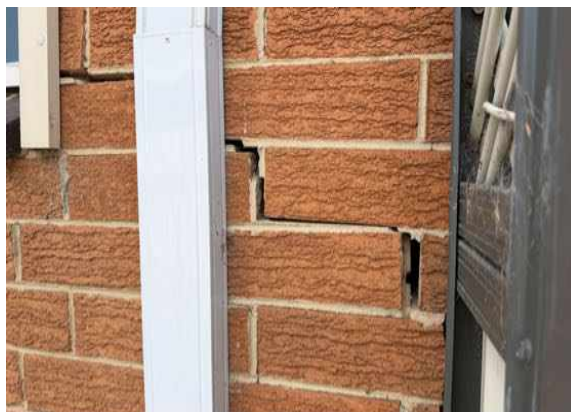
Finding 2.02

Finding: Cracked Brickwork

Information: Several cracks of varying sizes were observed in the brickwork, with more significant cracks noted predominantly on the left side of the property. The presence of a tree in

close proximity to the external walls may be contributing to this condition, potentially due to root influence or moisture variation in the soil. Structural movement is also considered a likely contributing factor.

Cracking of this nature may indicate movement in the footing or foundation system. If progressive, it can lead to further structural instability, moisture ingress, and deterioration of the masonry. The extent of cracking observed suggests a heightened risk if the underlying cause is not addressed.

It is strongly recommended that a structural engineer be engaged to assess the cause and extent of movement. A registered builder should also be consulted to carry out necessary rectification works. Consideration should be given to managing or removing the nearby tree, subject to professional advice, to mitigate ongoing impact on the structure.

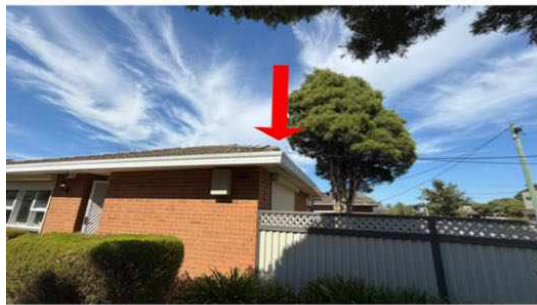
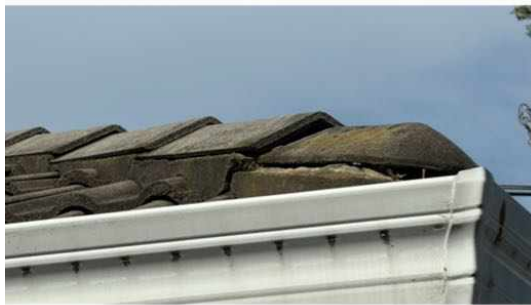
Finding 3.01

Building:	Main Building
Location:	Roof Exterior
Finding:	Deteriorated Roof Mortar
Information:	The mortar bedding and pointing to the roof tiles were found to be deteriorated in sections. This is typically caused by prolonged exposure to weathering, age-related wear, and thermal movement, leading to cracking and loss of bonding between tiles.

Deteriorated mortar can result in loosening or displacement of roof tiles, increasing the risk of water ingress during rainfall and potential damage to underlying roof structures. If left unaddressed, this may lead to further deterioration and internal moisture-related issues.

It is recommended that a licensed roofing contractor be engaged to assess the affected areas and carry out necessary re-bedding and re-pointing works to restore the integrity of the roof system.

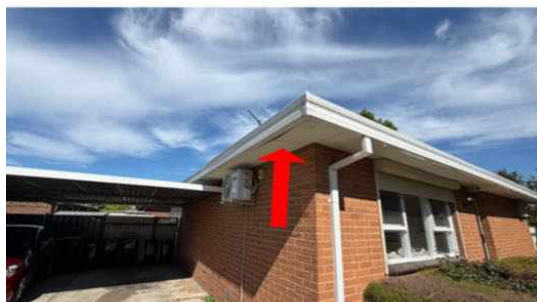
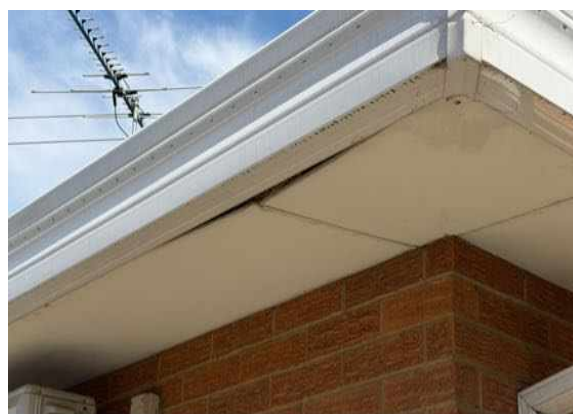
Finding 3.02

Finding: Loose Eaves

Information: The eaves lining was observed to be loose in sections. This is typically caused by deterioration of fixings, moisture exposure, or general ageing of materials leading to reduced structural support.

Loose eaves can pose a safety hazard due to the risk of detachment and may also allow entry points for moisture, pests, and vermin into the roof cavity. If left unattended, further deterioration of surrounding materials may occur.

It is recommended that a registered builder or qualified tradesperson be engaged to secure or replace the affected eaves lining and inspect the area for any underlying moisture damage or structural concerns.

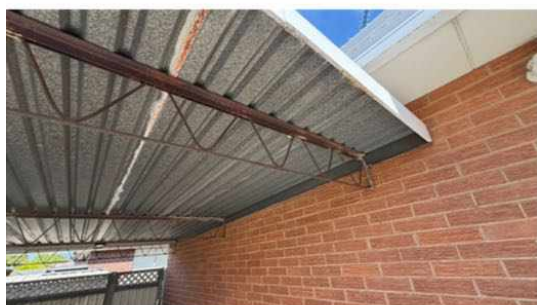
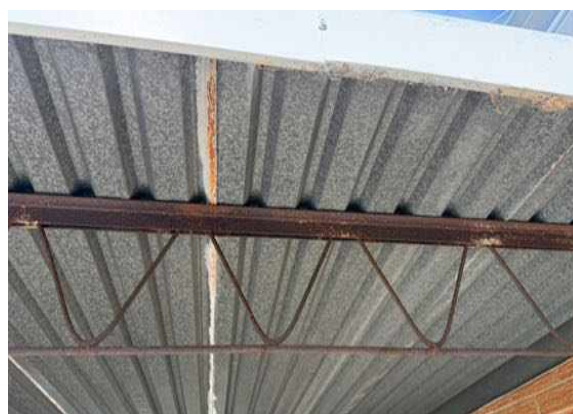
Finding 3.03

Finding: Rusting to Carport Roof and Structure

Information: Rusting was observed to the carport roof sheeting and structural members. This is

typically due to prolonged exposure to weather conditions and ageing of protective coatings, leading to corrosion of metal components.

Ongoing corrosion can reduce the structural integrity of the carport over time and may result in weakening of connections, potential leaks through roof sheeting, and eventual failure of affected elements if left unaddressed.

It is recommended that a registered builder or qualified metal roofing contractor be engaged to assess the extent of corrosion. Remedial works may include treatment of rusted areas, protective coating application, or replacement of severely affected components as required.

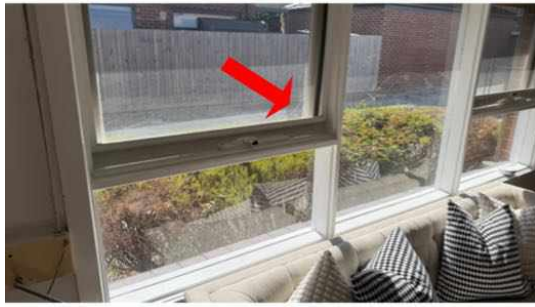
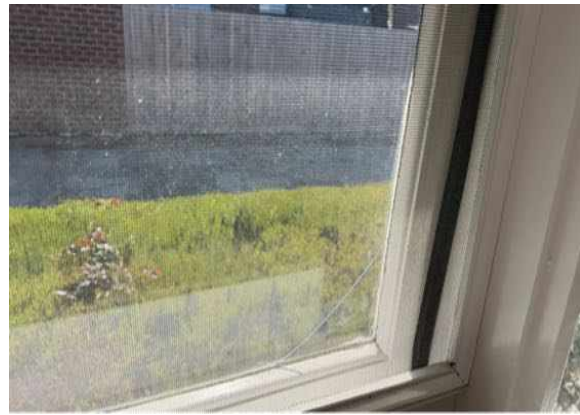
Finding 3.04

Building:	Main Building
Location:	Living Room
Finding:	Window - Cracked
Information:	Cracks were identified in the window in this area. Cracking in windows is generally the result of impact damage, and is likely to develop further when left unmanaged.

The likelihood of this windowpane further cracking and shattering is increased exponentially, providing a safety hazard in the area. The cracked window also impairs the weather tightness of the building, creating potential for minor water leaks.

A qualified glazier is required to repair the window as soon as possible. Depending on the extent of the cracking, replacement of the window may be required. Please be advised that any persons coming into contact with the cracked window should do so with due caution to avoid any personal injury that may ensue.

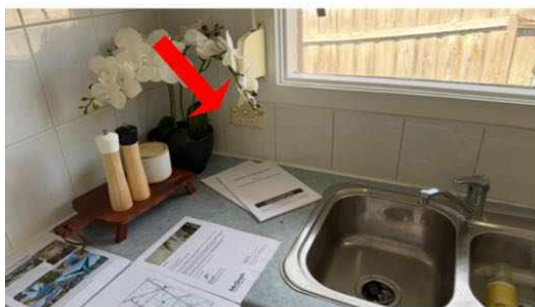
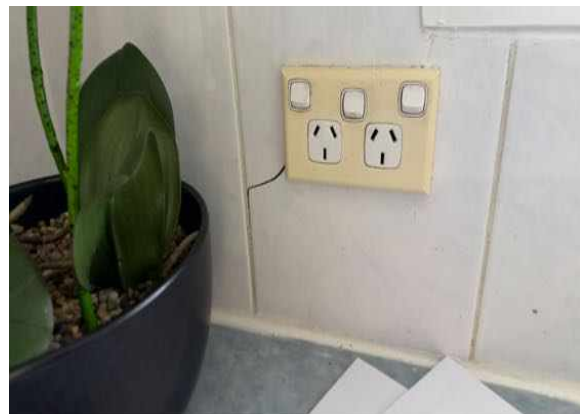
Finding 3.05

Building: Main Building
 Location: Kitchen
 Finding: Cracked Wall Tile – Kitchen
 Information: A wall tile in the kitchen area was found to be cracked. This is typically caused by minor impact, material stress, or normal wear and tear over time.

Cracked tiles are generally cosmetic in nature but may worsen if subjected to further impact or movement. In wet or splash-prone areas, cracks can allow minor moisture ingress behind the tile.

It is recommended that the affected tile be replaced or repaired by a suitable tradesperson to maintain the finish and prevent further deterioration.

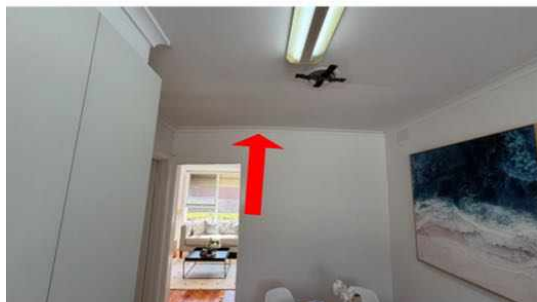
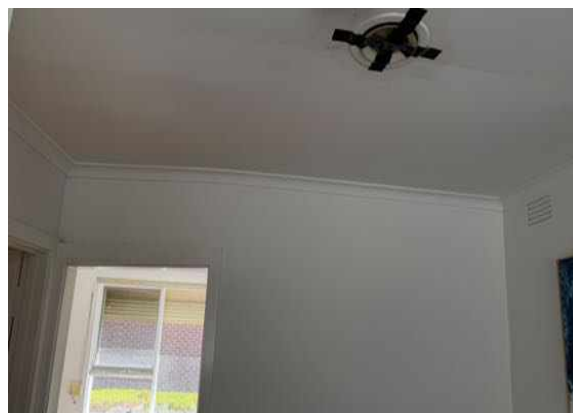
Finding 3.06

Building: Main Building
 Location: Dining Room
 Finding: Sagging Ceiling
 Information: Minor sagging was observed to the ceiling lining. This is commonly associated with ageing of materials, slight loosening of fixings, or minor settlement over time.

At the time of inspection, the condition appeared to be minor; however, if the sagging

progresses, it may lead to further deterioration or aesthetic concerns.

It is recommended that the area be monitored and, if the condition worsens, a suitable tradesperson be engaged to assess and carry out minor repairs as required.

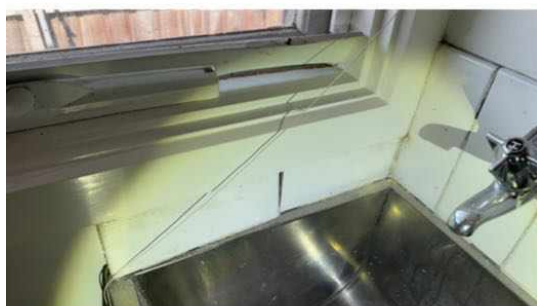
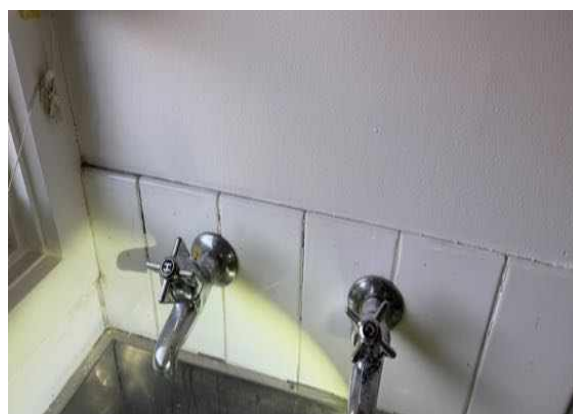
Finding 3.07

Building:	Main Building
Location:	Laundry
Finding:	Grout - Deteriorated
Information:	Grout was found deteriorated in this area. Grout is used to protect gaps and crevices in building materials to ensure that they are water-tight and prevent water penetration to the associated structures.

Where grout is missing or deteriorated, a tiling contractor should be appointed immediately to apply grout and re-apply any silicone where necessary. Failure to do so is likely to lead to water damage to the surrounding area.

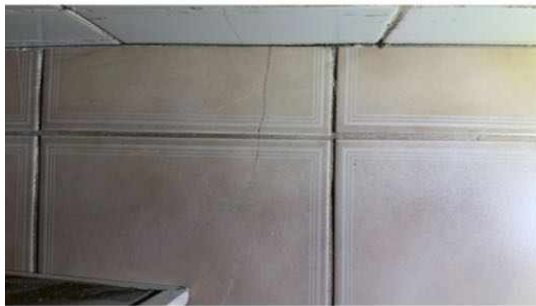
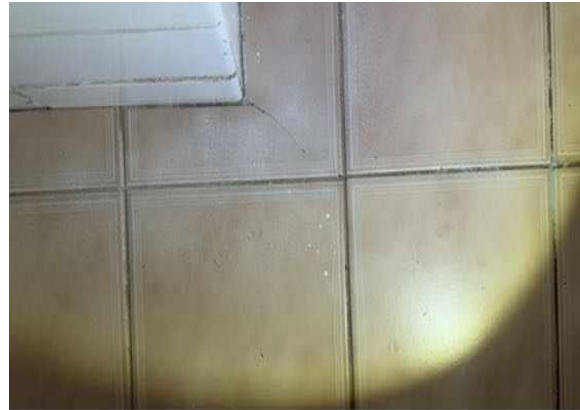
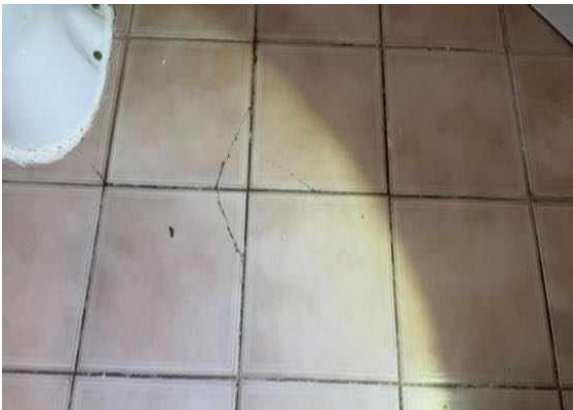
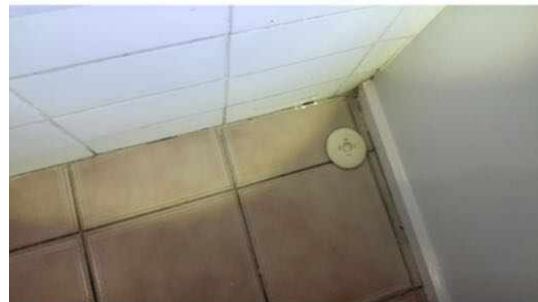
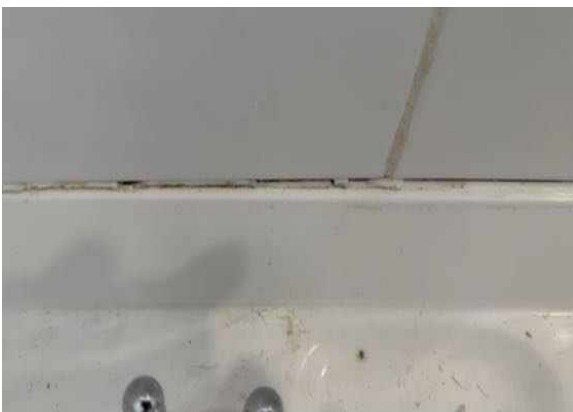
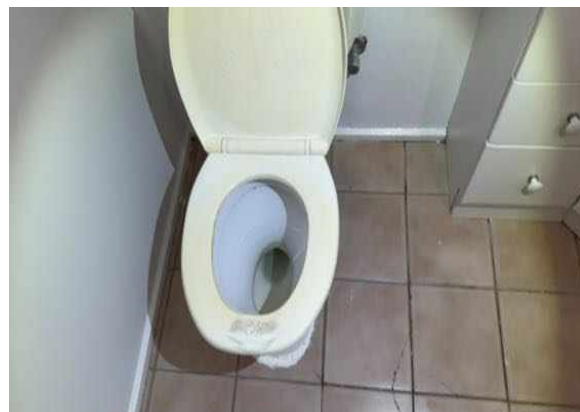
Finding 3.08

Building:	Main Building
Location:	Bathroom
Finding:	Cracked Bathroom Tiles and Deteriorated Grout

Information: Multiple tiles in the bathroom were found to be cracked, and grout joints were observed to be deteriorated. This is typically caused by minor impact, ageing of materials, and general wear and tear over time.

Cracked tiles and deteriorated grout can allow moisture to penetrate behind the tiled surface, which may affect the underlying substrate if left unattended. While the condition appears minor, it may lead to further deterioration if not addressed.

It is recommended that the affected tiles be replaced and grout joints re-grouted or sealed by a suitable tradesperson to maintain the integrity of the bathroom finishes.

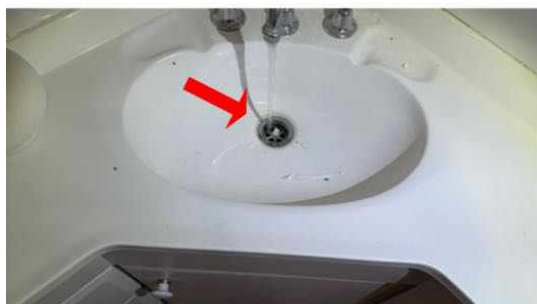
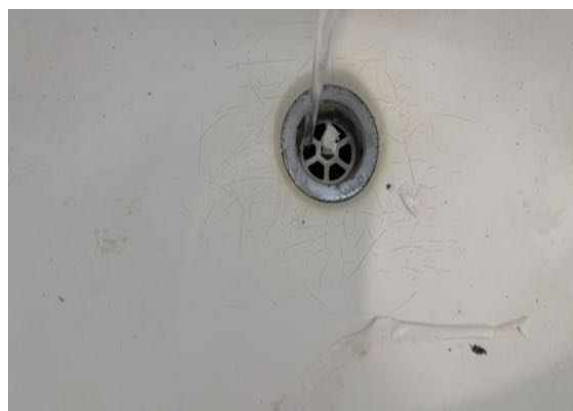
Finding 3.09

Building:	Main Building
Location:	Bathroom
Finding:	Basin Cracking
Information:	Cracking was observed on the surface of the basin during the inspection. Cracking typically appears as fine hairline cracks in the glazed finish and commonly occurs due to age, thermal stress, manufacturing defects, or prolonged use of harsh cleaning products.

While crazing is generally a cosmetic defect, it can trap dirt and moisture within the cracks, making the surface difficult to clean and potentially leading to staining or hygiene concerns over time. In some cases, continued deterioration may eventually compromise the glazed surface.

No immediate action is required if the basin remains functional and watertight. However, it is recommended that the basin be monitored for any signs of cracking progression or leakage. Replacement of the basin may be considered if the crazing worsens or if hygiene or aesthetic concerns become unacceptable.

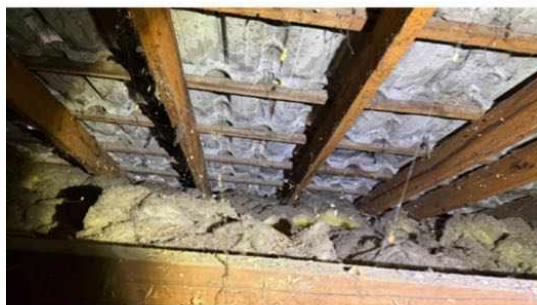
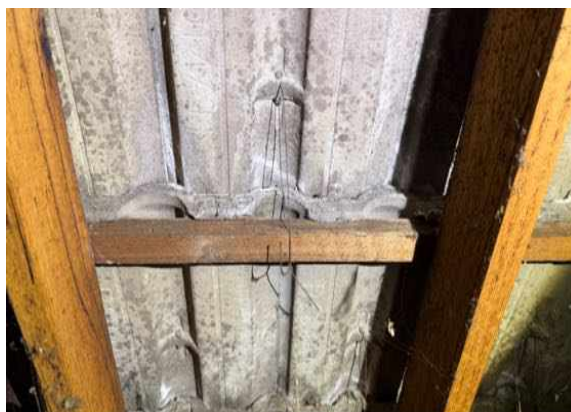
Finding 3.10

Building:	Main Building
Location:	Roof Void
Finding:	Roof tiles - deterioration
Information:	Edge deterioration and surface wear were observed in the roof tiles during the inspection of the roof void. These defects may have occurred due to natural aging, prolonged exposure to weather conditions, or general wear and tear over time.

If left unaddressed, this deterioration could compromise the roof's ability to provide a watertight barrier, potentially leading to water ingress and damage to the interior structure. Additionally, weakened edges may further degrade, increasing the risk of tiles becoming dislodged during strong winds or storms.

It is recommended to engage a licensed roof plumber to assess the extent of the deterioration and undertake necessary replacement or restoration work. Prompt

action will help ensure the roof remains weatherproof and structurally sound.

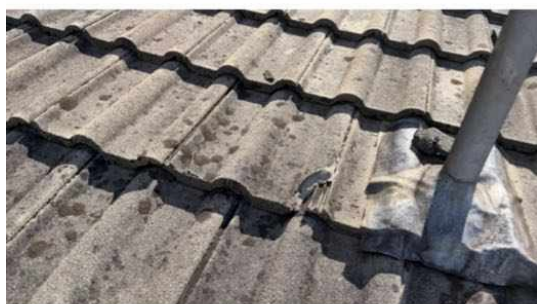
Finding 3.11

Finding: Roof tile - Broken

Information: Upon inspection of the exterior roof covering, broken roofing tile was identified. Broken and friable roof tiles are generally the result of ageing and weathering of what is essentially a porous material.

If left to further deteriorate, broken and brittle roof tiles are likely to lead to water penetration via the roof into the ceiling space, causing secondary damage to ceiling linings, insulation and roof structures. Broken roof tiles are also likely to detract from the effectiveness of the roof drainage system, creating potential for secondary damage to the exterior roof covering and roof plumbing.

Replacement of broken tiles is required and should be performed by a roofing contractor as soon as possible.

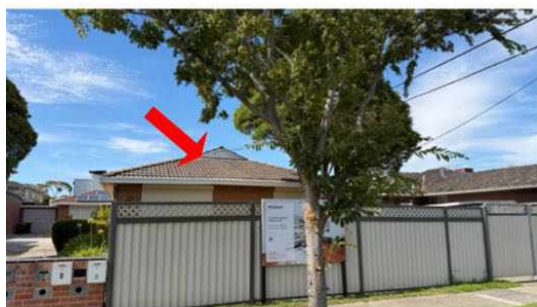
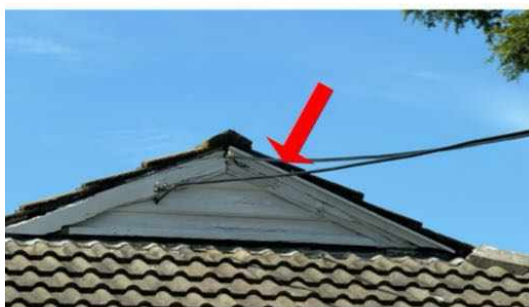
Finding 3.12

Location:	Roof Exterior
Finding:	Deteriorated Barge Boards and Gable End Timber
Information:	The barge boards and gable end timber elements were observed to be deteriorated, with visible weathering, cracking, and paint breakdown. This condition is typically caused by prolonged exposure to weather without adequate maintenance or protective coating.

Deterioration of these external timber elements can allow moisture ingress, leading to further decay and potential impact on adjacent roof components. If left unmanaged, the condition may worsen and increase the risk of timber rot and pest activity.

It is recommended that a registered builder or qualified tradesperson be engaged to repair or replace the affected timber elements and apply appropriate protective coatings to prevent further deterioration.

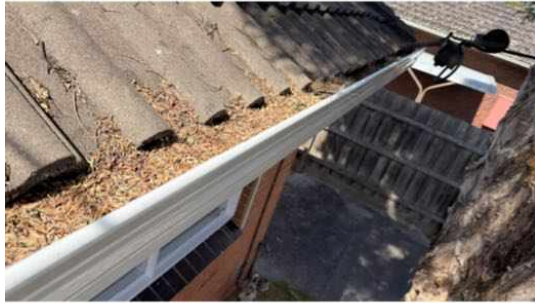
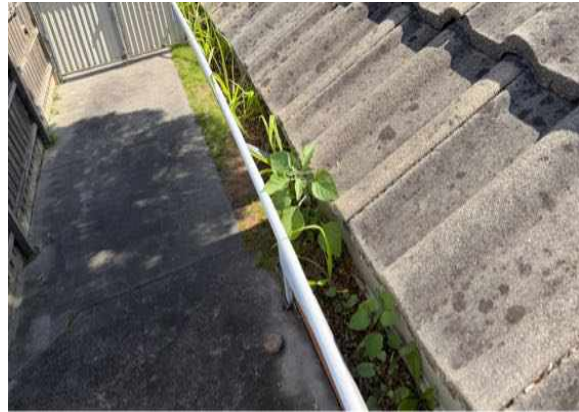
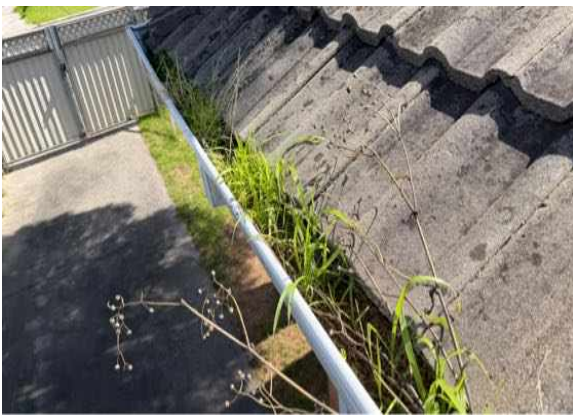
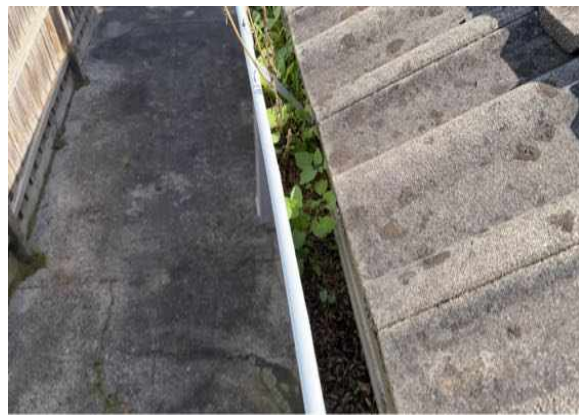
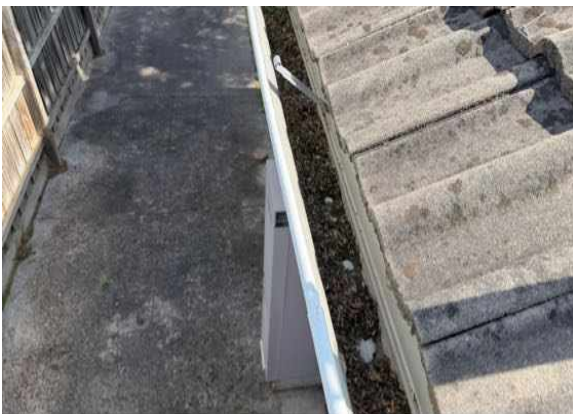
Finding 3.13

Building:	Main Building
Location:	Roof Exterior
Finding:	Gutters - Partially Blocked
Information:	Roof plumbing structures, such as guttering and downpipes, should be free of all debris to prevent blockages. Blockages of the guttering and downpipes will lead to pooling and accumulated water overflows, which is likely to subsequently flood eaves and exterior walls.

Blocked gutters are likely to lead to high levels of moisture in the affected areas. Such moisture will not only cause rust and decay of the associated building materials, but can also provide conditions that are conducive to termite and timber pest activity. Blockages in gutters should therefore be removed immediately to ensure dry conditions are maintained.

required. In the interim, it is highly advised that blocked gutters be removed by the homeowner or a general handyperson as a matter of urgency.

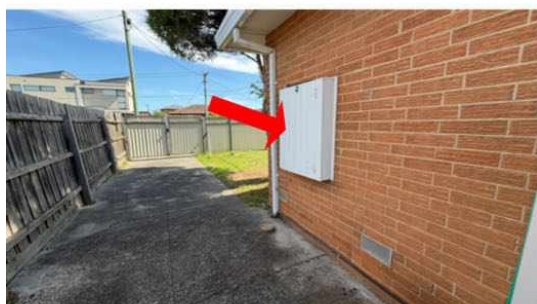
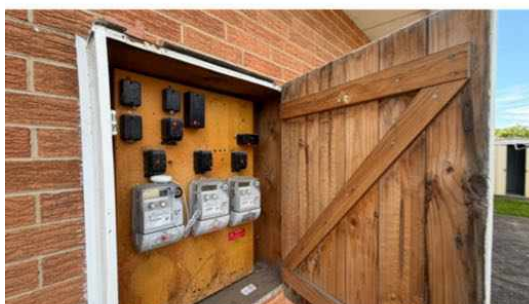
Building:	Main Building
Location:	Meter Box
Finding:	Termite Management System - no evidence of a chemical installation
Information:	The application of a post-construction chemical termite barrier is highly recommended for all properties, particularly if live termite activity has been found on the site previously. Such barriers are highly effective in preventing termite attack on any timber building elements throughout the property.

The client may consider gaining further advice from a pest controller as to the costs and procedures involved with this application. It is recommended that obtaining such advice be a short-term priority.

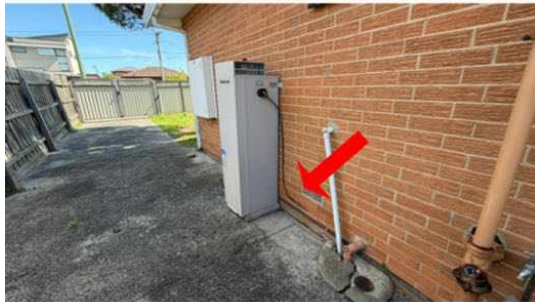
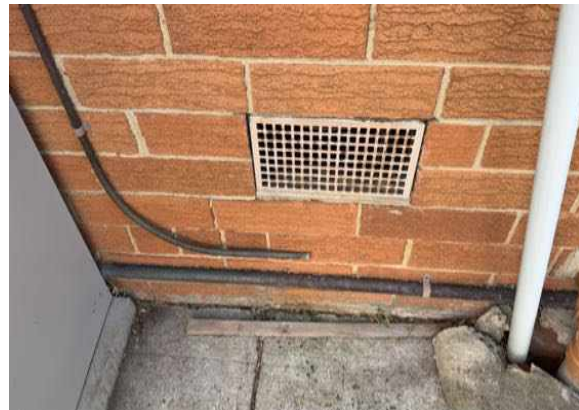
Finding 6.02

Building:	Main Building
Location:	All External Areas
Finding:	HWS Overflow - Not Connected
Information:	The Hot Water System (HWS) overflow was found to be disconnected from storm water drainage and is creating excessive moisture in the surrounding area.

These damp conditions can lead to secondary defects such as rot, rust or corrosion of associated building elements, the formation of fungal decay, or even the creation of potential slip hazards. When coupled with poor site drainage, pooling of water may also attract termite activity to this area.

It is highly recommended that a licensed plumber be appointed to connect the HWS overflow in order to prevent such an environment from being created. These minor works should be carried out as soon as possible.

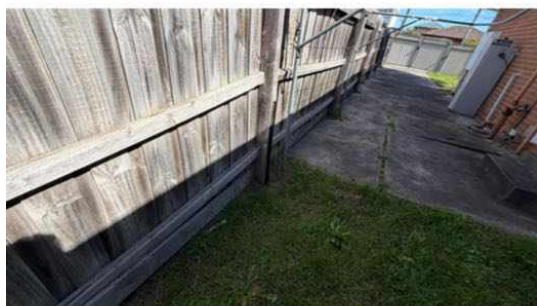
Finding:	Building materials in direct ground contact - conducive to termites
Information:	<p>Where timber elements are in direct contact with the ground and consequently moisture or dampness they become conducive to termite activity. Whether timber is used as a building element part of a fencing structure or stored as an unused item they can provide an environment that is attractive to termite infestation.</p> <p>When met with excessive moisture timber begins to decay and develop wood rot. Any timbers that are in direct contact with external grounds especially if left untreated or non-durable also provide ingress for subterranean termites into that particular element.</p> <p>The removal of any such materials that may be conducive to termite activity should be removed as soon as possible to minimise the risk of termite attack.</p>

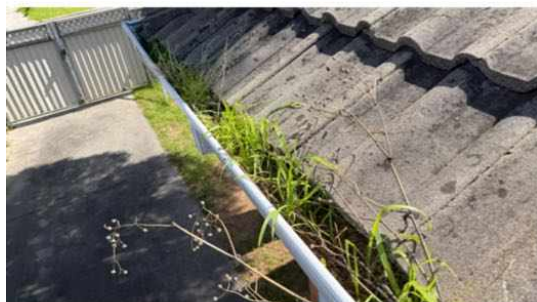
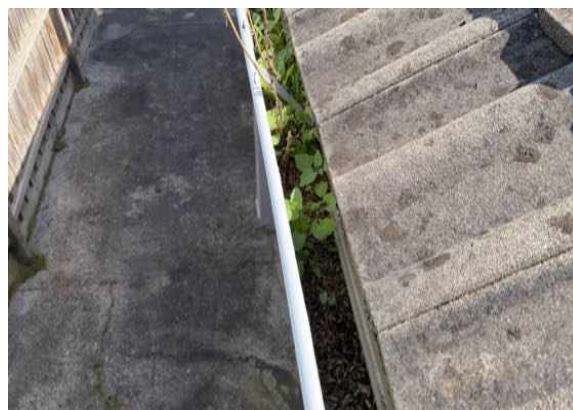
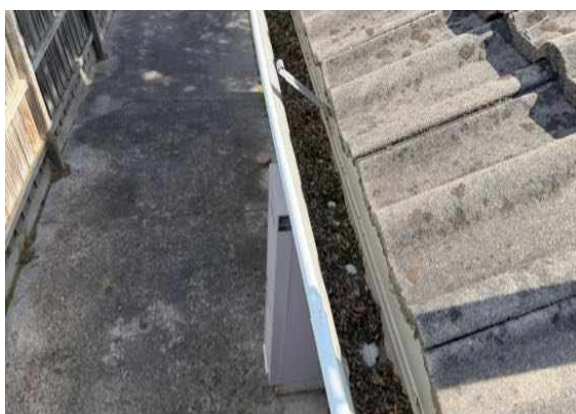
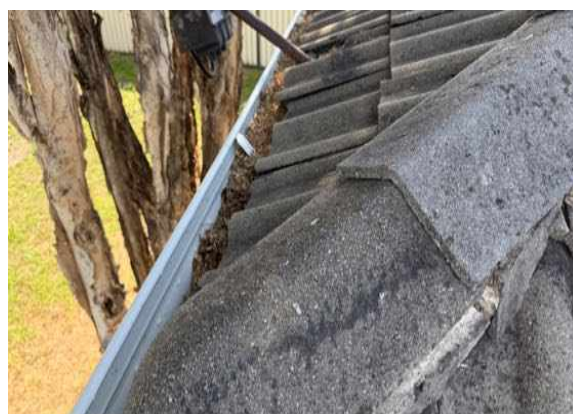
Finding 6.05

Building:	Main Building
Location:	Roof Exterior
Finding:	Gutters - Partially Blocked - Timber Pest Risk
Information:	<p>During the inspection, debris accumulation was noted in the guttering and downpipes. Blocked gutters can cause water to pool and overflow, leading to excessive moisture around eaves, fascia boards, and exterior walls. Where gutter guards are installed, regular maintenance is essential to remove any debris that may settle on top or filter through. Prolonged exposure to moisture in these areas creates conditions conducive to timber decay and potential termite or timber pest activity.</p> <p>Excess moisture resulting from blocked gutters can accelerate timber deterioration, increasing the risk of fungal decay and attracting timber pests such as termites. Moisture-damaged timber is highly susceptible to infestation, as pests are drawn to damp and softened wood. If left unaddressed, this issue can lead to structural weakening and costly remediation work.</p> <p>It is strongly recommended that all blockages in the gutters and downpipes be cleared immediately to maintain dry conditions and reduce the risk of timber pest activity. Homeowners or a general handyperson can perform routine cleaning; however, a</p>

licensed plumber should be consulted for further assessment and any necessary remedial work. Ongoing gutter maintenance is crucial in preventing future moisture-related timber issues.

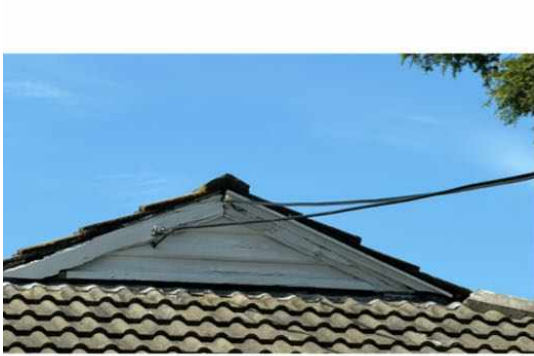
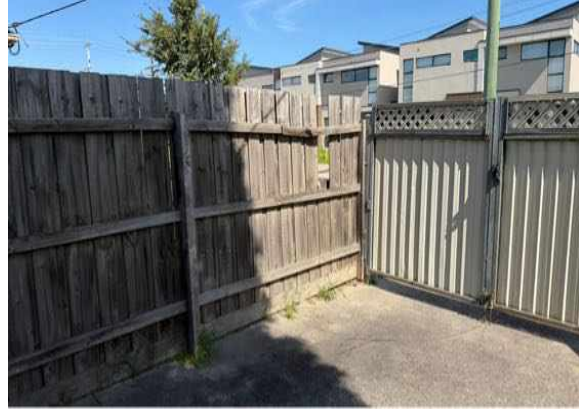
Finding 7.01

Building:	Main Building
Location:	All Areas
Finding:	Wood Rot to Fence and Barge Boards
Information:	The fence and barge board timbers show evidence of wood rot. Wood rot, also known as fungal decay, occurs when timber elements are exposed to prolonged damp conditions. This is typically the result of ongoing weather exposure, moisture retention, or inadequate protective coatings, with contributing factors including poor ventilation and lack of maintenance.

Wood rot is commonly associated with damp conditions and may be accompanied by surface deterioration, softness in timber, and potential mould or mildew growth. If left unmanaged, the decay will continue to progress, compromising the durability and integrity of the affected elements and potentially leading to failure of sections of the fence or roof edge components.

Early intervention and regular maintenance, particularly of exposed exterior timbers, will help prolong their service life. It is recommended that the source of moisture contributing to the decay be identified and addressed. A qualified carpenter or registered builder should be engaged to repair or replace the affected fence and barge board timbers, and to apply appropriate protective treatments to prevent recurrence.
