Building and Timber Pest Inspection Report

Inspection Date: Mon, 30 Mar 2026

Property Address: 120/144 Dorville Rd, Carseldine QLD 4034,
Australia

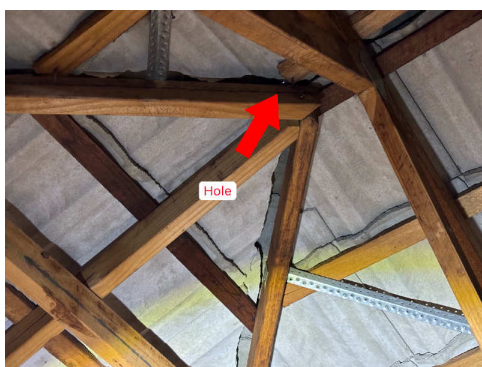
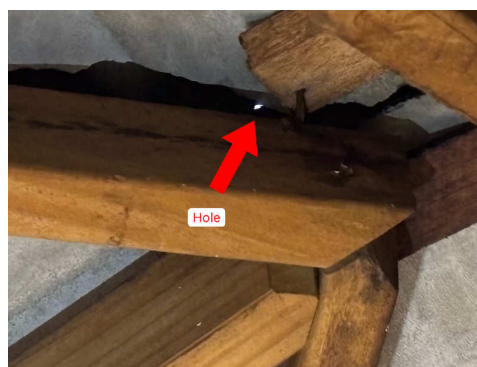
Finding 3.01

Location: Roof Void

Finding: Roof covering - hole

Information: At the time of the inspection, it was noted that there was a small hole in the tiled roof covering. This is on the ridge capping at the front of the dwelling. The client should inform the body corporate of this finding as maintenance and repairs to the tiled roof covering may be the responsibility of the body corporate.

A roofing contractor should be engaged to assess the roof covering and make any necessary repairs. This should be done as a short term priority.

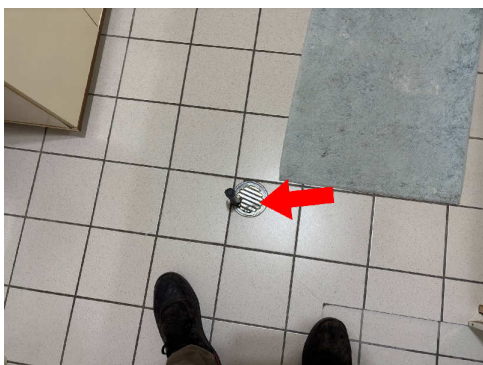
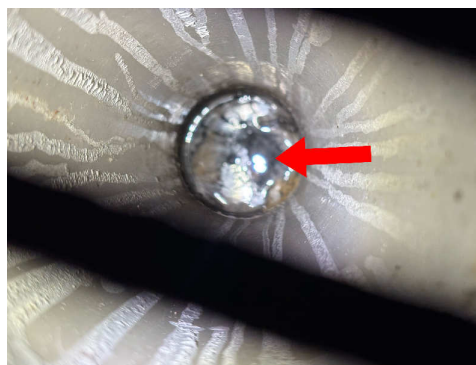
Finding 3.02

Location: Bathroom

Finding: Bathroom - floor drain build up

Information: At the time of the inspection, it was noted that there was a build up of waste in the floor drain trap in the bathroom. Currently, water is flowing freely, however, if left unaddressed, this build up may cause a blockage in the floor waste trap. The shower and vanity drains flow into this trap.

A licensed plumber should be engaged to clear the build up of waste from the floor drain trap. This should be done as a short term priority.

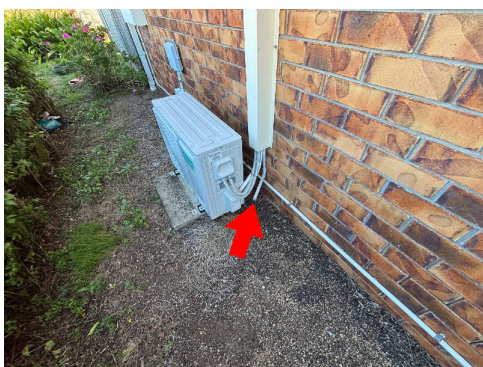
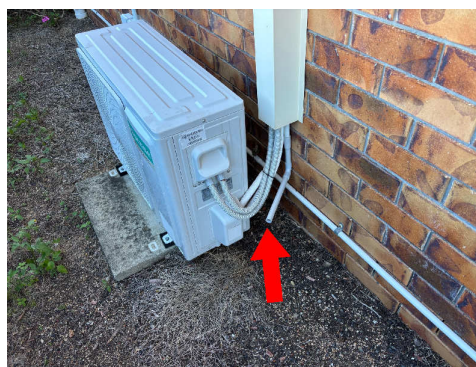
Finding 6.01

Building: Main Building
Location: All External Areas
Finding: Air conditioner - Disconnected overflow

Information: At the time of the inspection, it was noted that the air conditioner drain overflow to the unit at the side of the dwelling was not connected to the storm water drainage and as a result are draining next to the foundations of the dwelling.

Air conditioning overflows that are not connected to the storm water drainage and are draining near the foundation can create excessive moisture in the surrounding area.

Such leaking creates an environment which is conducive to an array of defects, including water damage to associated building elements and the attraction of termite or timber pest infestation.

It is highly recommended that a licensed plumber be appointed to connect the A/C overflow in order to prevent such an environment from being created. These minor works should be carried out as soon as possible.

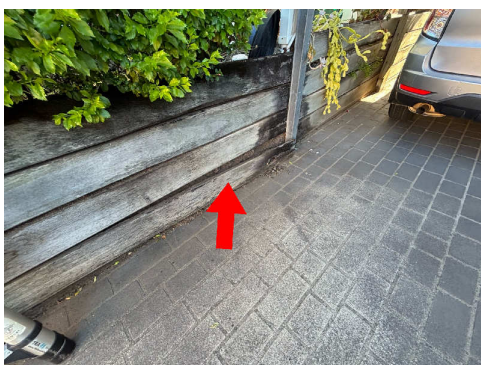
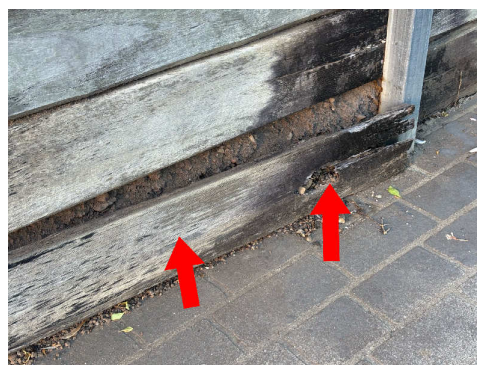
Finding 7.01

Location: Carport

Finding: Wood rot - timber retaining wall

Information: At the time of the inspection, it was noted that there was evidence of wood rot to the timber retaining wall in the carport. This may be due to the age of the timber building elements and general weathering.

This building element shows evidence of wood rot.

The client should inform the body corporate of this finding as maintenance and repairs may be the responsibility of the body corporate.

Early intervention and regular maintenance, particularly of exterior timbers, will prolong the useful life of these building elements. Prior to any works being performed, the cause of the moisture that has created the visible wood rot should be identified and addressed in a suitable manner. Replacement of affected timbers may then be a necessary step in protecting surrounding building elements from such deterioration.

A qualified carpenter or registered builder may also be required to replace affected building materials.

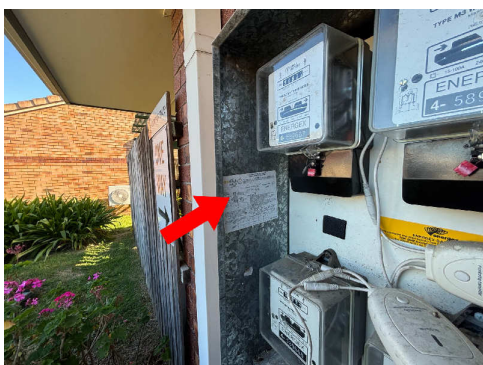
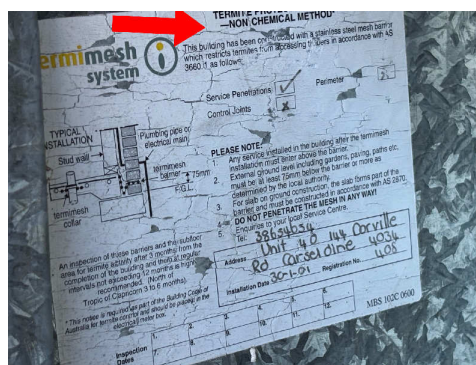
Finding 9.01

Location: All External Areas

Finding: Evidence of a previous physical termite management system was identified.

At the time of the inspection, evidence of a previous physical termite management system was found by way of a durable notice in the meter box.

A physical termite barrier was applied to the slab penetrations and perimeter during construction. The durable notice is dated the 30/01/2001. The product used was Termimesh.

The client may wish to enquire of the body corporate as to the nature of the termite management plan for the complex and the individual villas. Also, are annual termite inspections being carried out and up to date.

A termite and timber pest technician should be engaged to carry out annual termite inspections as per AS 3660 in order to further protect the dwelling. Annual termite inspections must be carried out in partnership with termite treatment systems, physical or chemical, as no termite treatment system can be expected to be 100% effective.

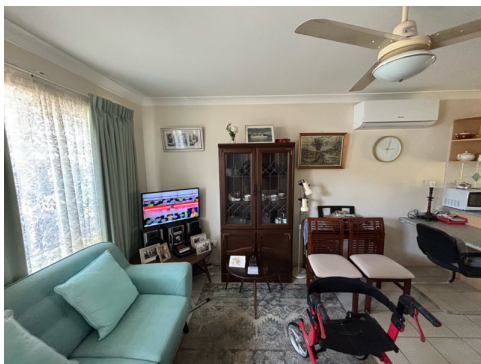
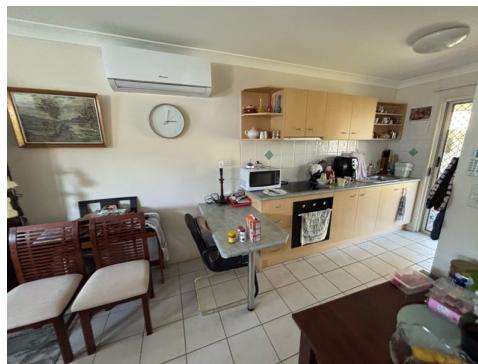
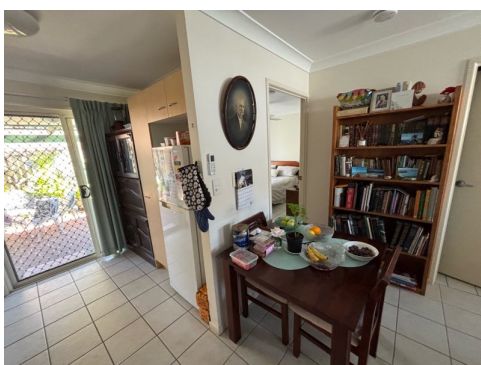
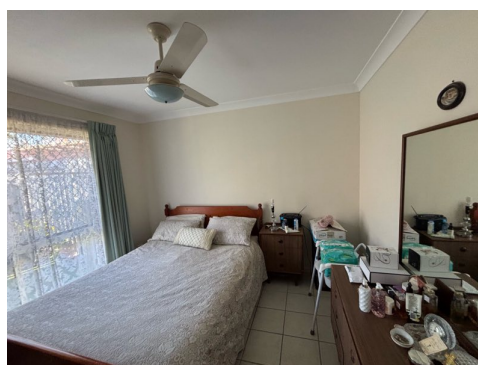
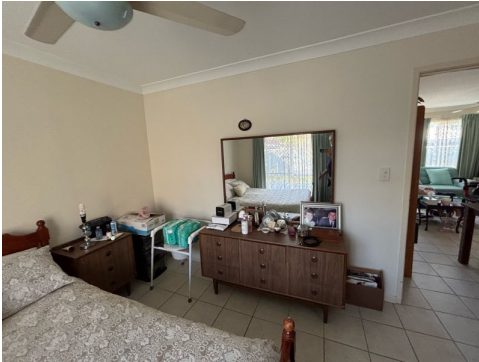
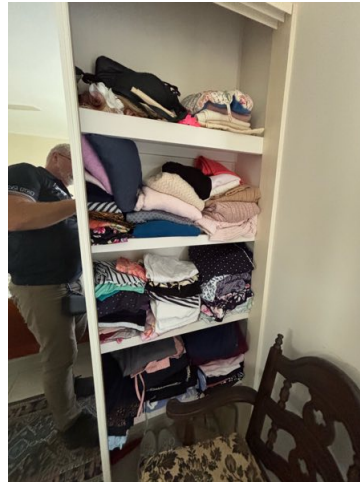
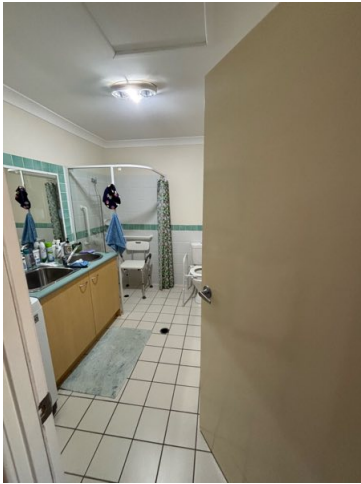
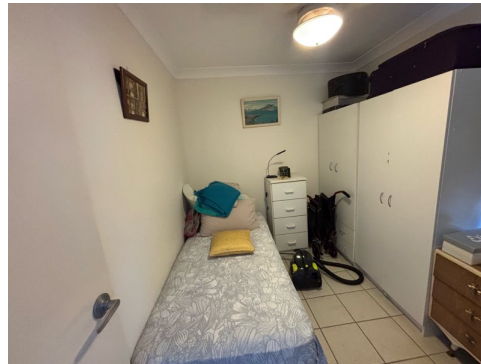
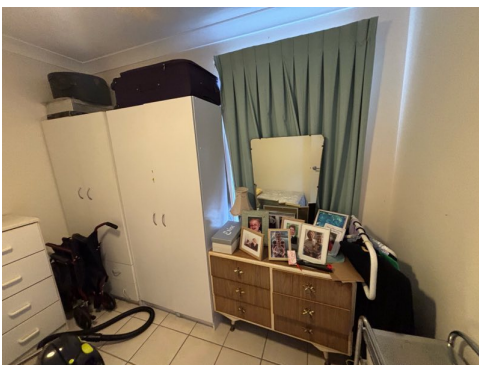
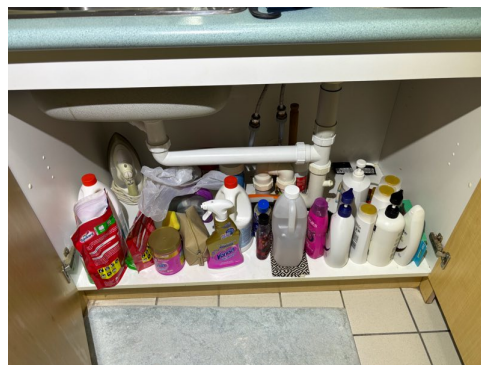
Location: All Internal Areas

Finding: Obstructions and Limitations - Internal areas

Information: These photographs are an indication of the obstructions and limitations which impeded full inspection of the property of the internal areas at the time of inspection. These obstructions can hide an array of defects and should be removed to allow full inspection to be carried out. A re-inspection is recommended once the areas are made accessible.

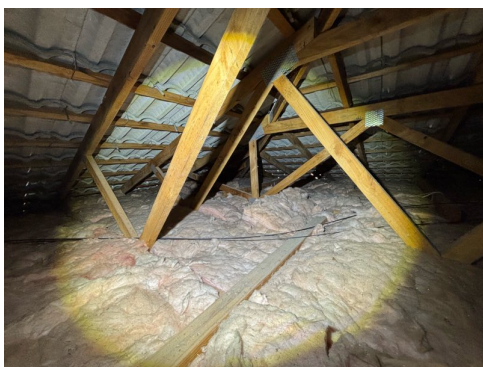
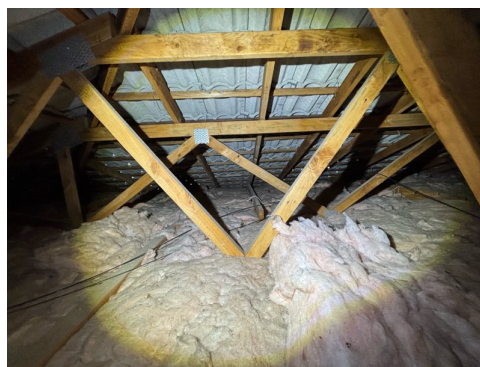
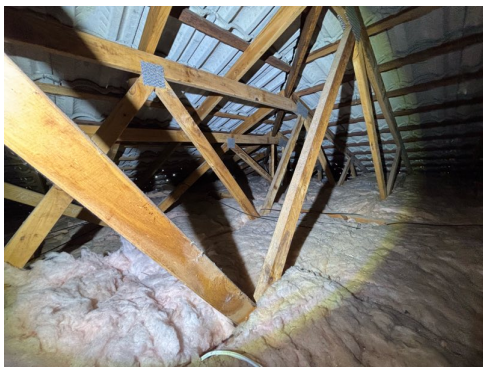
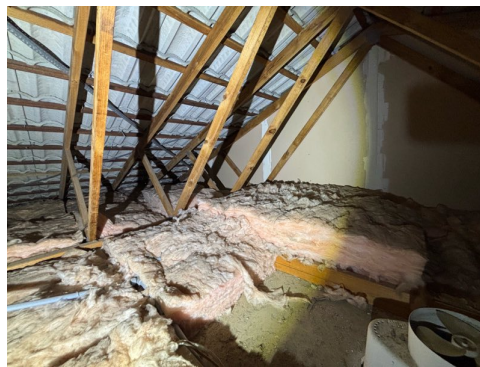
Location: Roof Void

Finding: Obstructions and Limitations - Roof cavity

Information: These photographs are an indication of the obstructions and limitations which impeded full inspection of the property of the roof cavity at the time of inspection. These obstructions can hide an array of defects and should be removed to allow full inspection to be carried out. A re-inspection is recommended once the areas are made accessible.
