# Building and Timber Pest Inspection Report

Inspection Date: Tue, 24 Feb 2026

Property Address: 25 Senna Ave, Denham Court NSW 2565,  
Australia

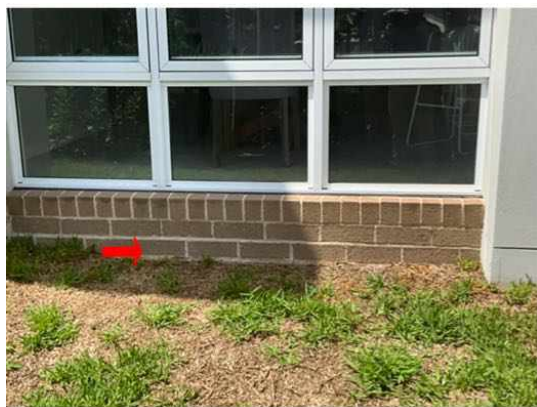
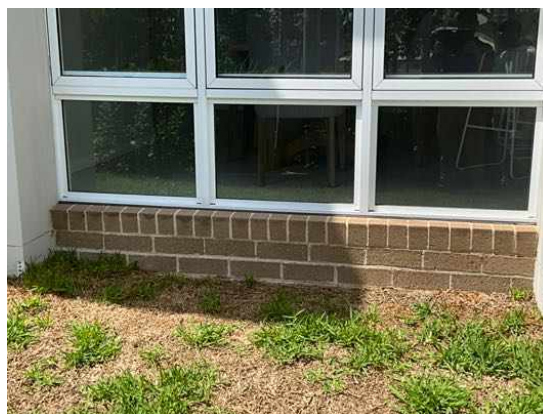
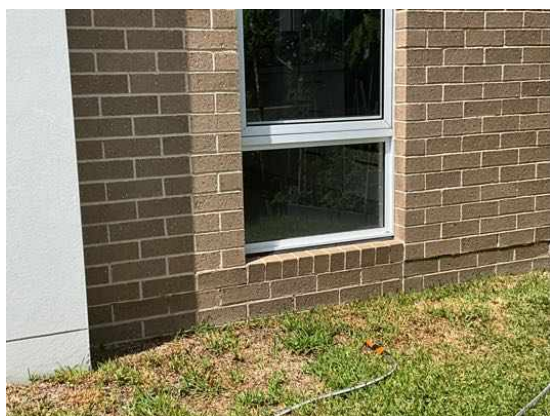
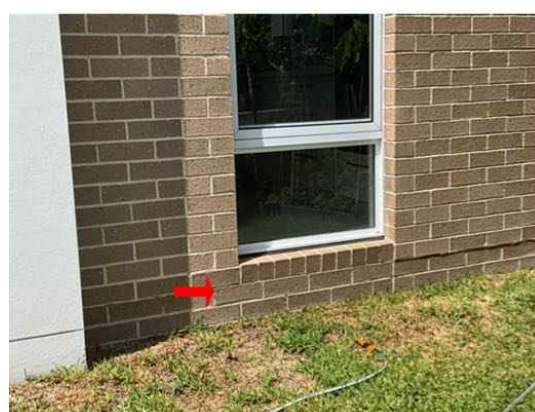
Building: Main Building  
Location: Exterior walls - rear  
Finding: Weep holes - Missing  
Information: The external masonry wall of the building lacks the necessary weepholes, which are crucial for the drainage and ventilation of the wall cavity.

1. Moisture Accumulation: Without weepholes, moisture can accumulate within the wall cavity, leading to dampness and potential water damage to the building structure.
2. Mold and Mildew Growth: The trapped moisture creates an ideal environment for mold and mildew, which can cause health issues for occupants and degrade building materials.
3. Structural Damage: Prolonged exposure to moisture can weaken the structural integrity of the wall, causing deterioration of bricks, mortar, and internal framing.
4. Efflorescence: The absence of proper drainage can lead to the formation of efflorescence (white salt deposits) on the surface of the masonry, which can be unsightly and indicative of moisture problems.
5. Pest Infestation: Inadequate ventilation and moisture control can attract pests such as termites, leading to further damage and potential infestation.

A qualified bricklayer or masonry contractor should be contacted to assess and install the missing weepholes. They will:

- Drill or create gaps in the appropriate locations of the masonry wall to ensure effective drainage and ventilation.

- Ensure compliance with the Australian Standard AS 3700 (Masonry Structures) and the National Construction Code (NCC) requirements for weephole placement and spacing.
- Inspect the wall cavity for any existing moisture damage and recommend additional repairs if necessary.

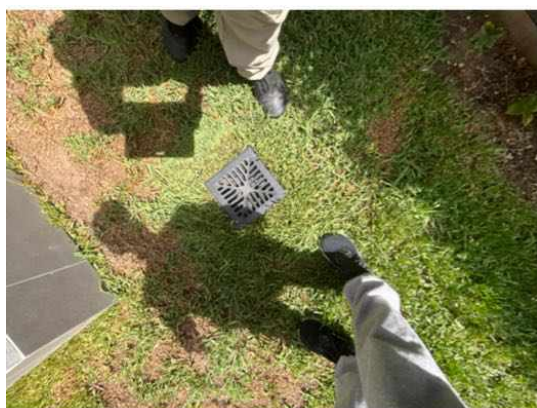
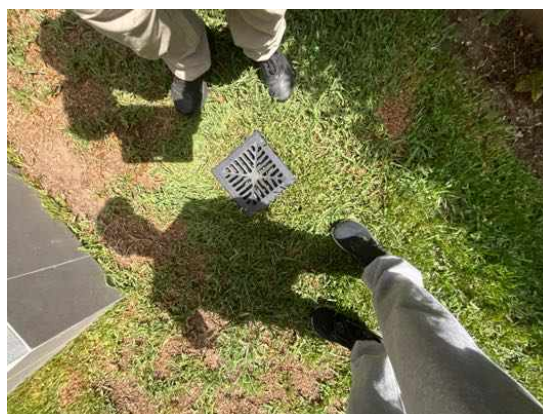
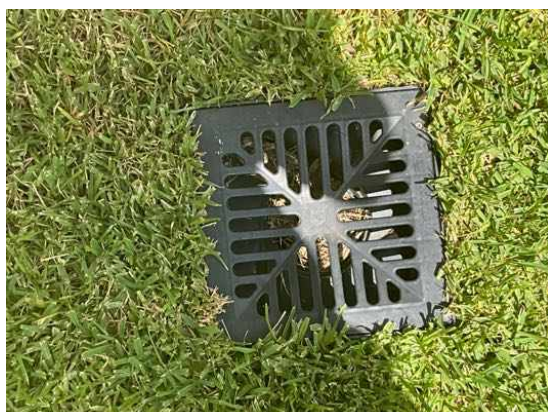
### Finding 3.02

Building: Main Building  
 Location: All Areas  
 Finding: Blocked - Drains  
 Information: The drains are blocked, causing standing water and potential flooding during rain. This impedes proper drainage, posing a risk of property damage, waterlogging, and potential health hazards due to stagnant water.”

- Property damage from flooding.
- Waterlogging leading to potential structural damage.
- Health hazards due to stagnant water, such as breeding grounds for mosquitoes and other pests.

A licensed plumber or drainage specialist can fix the blocked drains by inspecting and clearing the blockage, repairing any damaged pipes, and ensuring proper drainage functionality. Regular maintenance and inspection of the drainage system may also help prevent future blockages and associated risks.

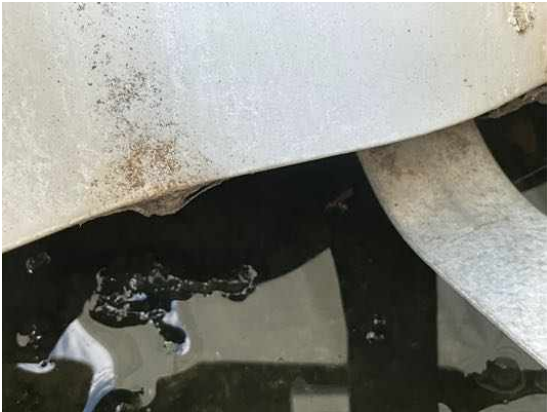
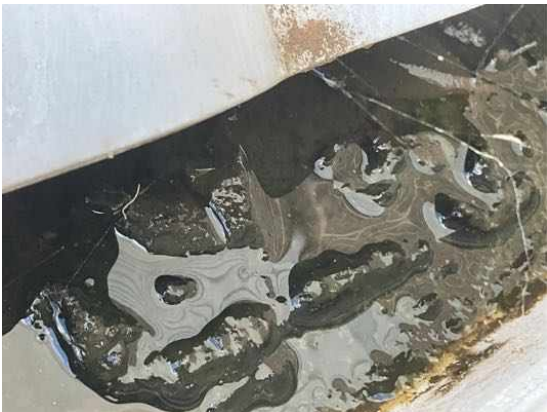
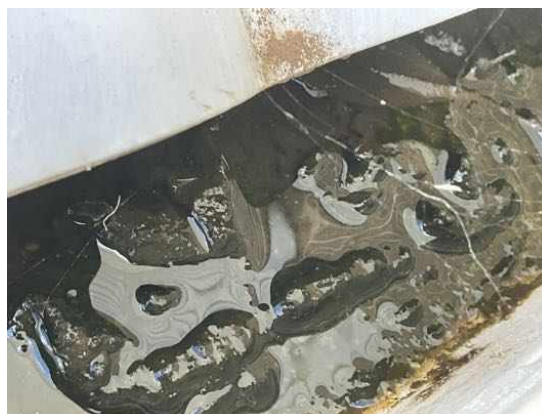
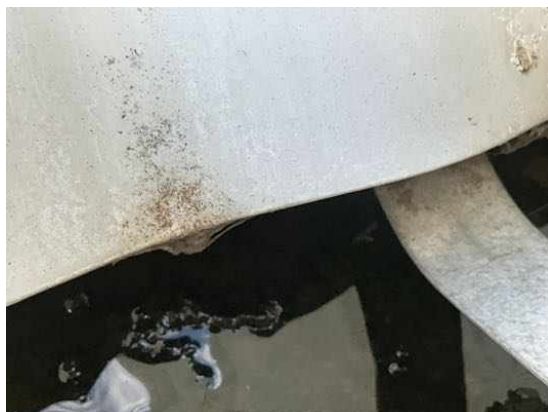
### Finding 3.03

Building:	Main Building
Location:	All Areas
Finding:	Gutters - Water pooling
Information:	Water was found to be pooling in sections of the roof guttering. This is generally a secondary defect caused by blocked or partially blocked gutters. Such blockages and subsequent water pooling are likely to lead to rust and water damage to associated structures if left unattended.

Any areas of guttering that shows evidence of water pooling should be checked for partial or full blockages and any secondary damage that may have occurred as a result. Depending on the extent of the damage, building elements may require repair and/or replacement to ensure adequate roof drainage and function of exterior

A roofing plumber should be appointed as soon as possible to rectify this issue. It is highly advised that all gutters be maintained on a frequent basis to ensure the condition of roof plumbing.

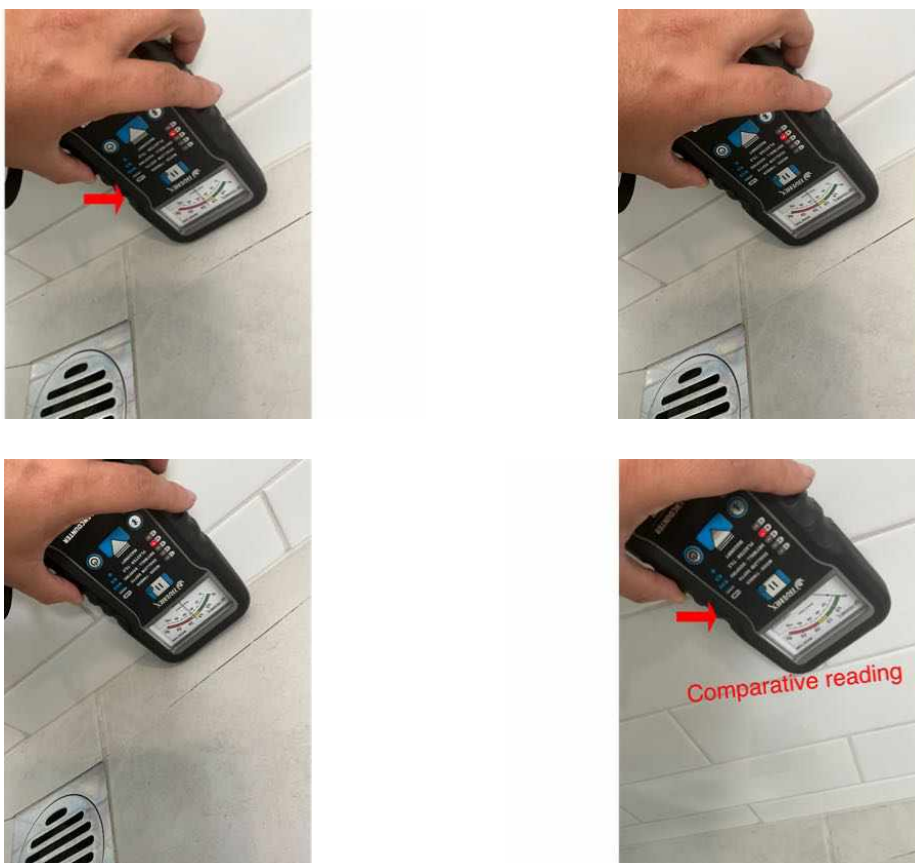
### Finding 3.04

Building:	Main Building
Location:	Ensuite
Finding:	Shower - Damp
Information:	Damp is evident to the lower 300mm of wall to the shower alcove. This defect is quite common, and is suspected to have been caused by moisture permeating through the grouting in this area, which shows evidence of deterioration. Leaking pipes within the adjoining wall is also a possible cause.

Unmanaged damp in the shower recess is likely to facilitate the formation and development of mould and fungi growth, decaying associated building materials and compromising their structural integrity. It is important to address damp conditions, as the World Health Organisation notes that excess moisture leads - on almost all indoor materials - to growth of microbes such as moulds, fungi and bacteria, which subsequently emit spores and other matter into the indoor air. Exposure to these contaminants is associated with a wide range of respiratory and other health-related problems.

Consultation with a qualified plumber or bathroom specialist is advised immediately to identify the cause of damp and to perform remedial works as required. Where excessive mould growth is present, further inspection by a specialist environmental health inspector should also be considered.

Always ensure that sealant and grout is in good condition to prevent any moisture issues occurring in the future.

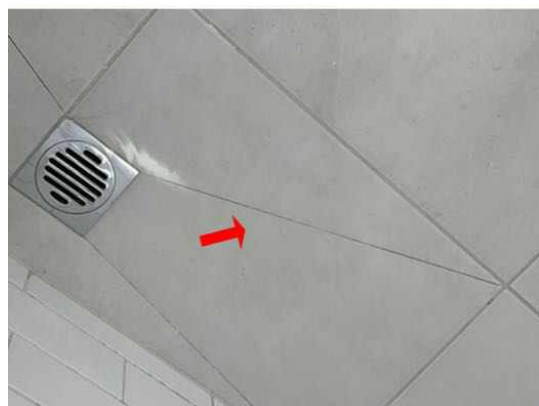
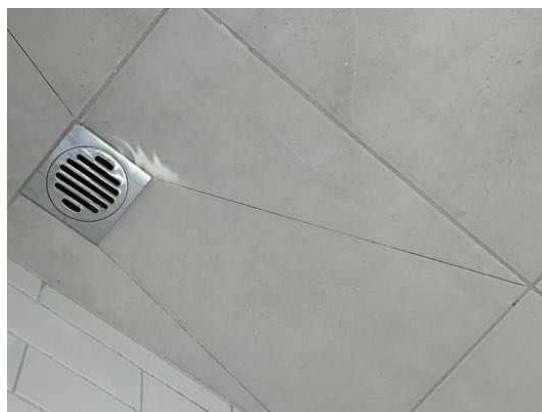
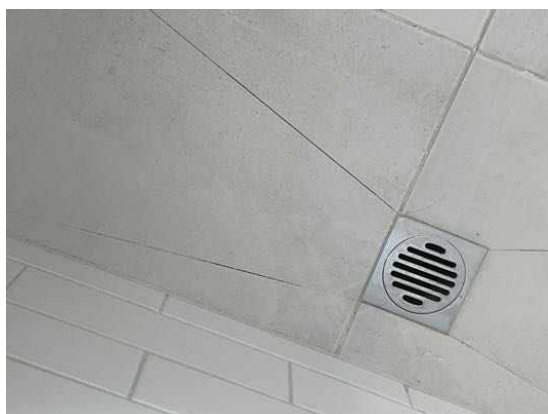
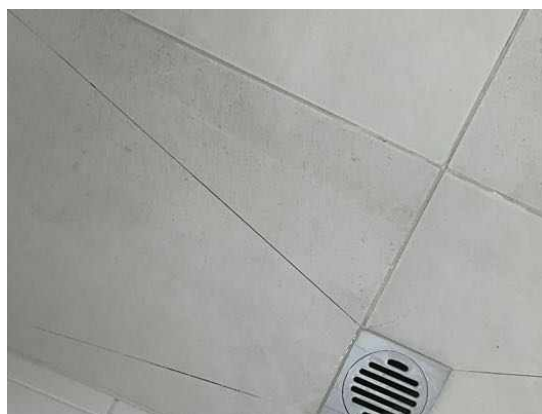
### Finding 3.05

Building:	Main Building
Location:	Ensuite
Finding:	Sealant and grouting - Missing or damaged
Information:	It was noted on inspection that sealant or grout is degraded to the tiled shower alcove and or other areas of the bathroom.

Different materials and floor areas move at different rates, generally causing cracking to grout or sealant at this point. A flexible sealant is required to allow for expected expansion and contraction, while keeping the joint water tight and protective of all associated building materials.

There appears to be excessive mould to the sealant and grout which will likely require scraping out and replacement.

Flexible and mould resistant materials should be applied to affected areas to prevent any subsequent water damage that is likely to occur. Regular maintenance and replacement of damage or missing or damaged sealant and grout is highly recommended to the wet areas, as this is a regular wear and tear defect. Sealant and grouting in areas that come into regular contact with water should be maintained for the long term care of your property.

A sealant specialist or tiling contractor should be appointed to complete these works as soon as possible

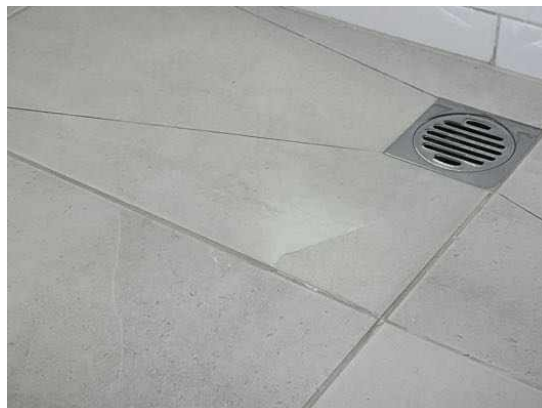
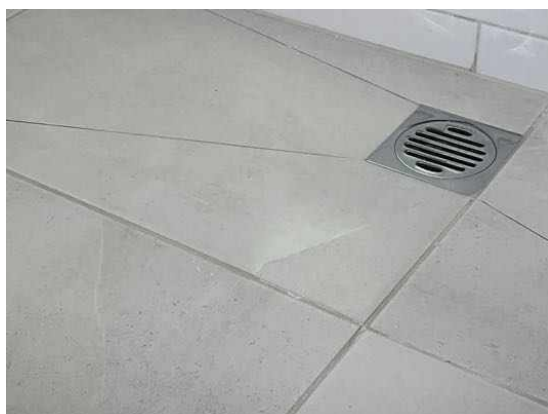
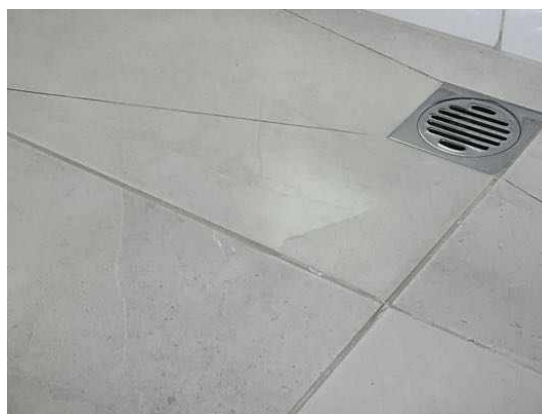
### Finding 3.06

Building: Main Building  
 Location: Ensuite  
 Finding: Shower base - Water pooling  
 Information: Evidence of water pooling around the floor waste in the shower recess was noticed at the time of inspection. It is suspected that this excessive moisture is attributed to insufficient fall in the shower floor tiles.

This pooling is minor overall but is still considered unsatisfactory, as standard tiling practices would not permit this situation to occur. Pooling water around floor wastes can create a slip hazard in extreme cases and create conditions that are conducive to mould growth over time. Where left unmanaged, the degradation of sealant and

Remedial works may involve some sections of tiling and flooring repair and replacement. A tiling contractor or bathroom specialist should be appointed to provide further advice on reparation options and to perform works as necessary.

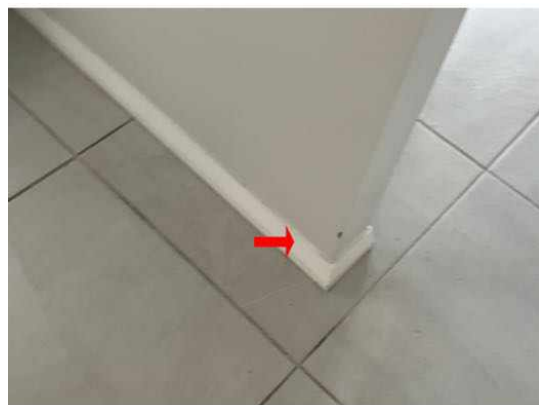
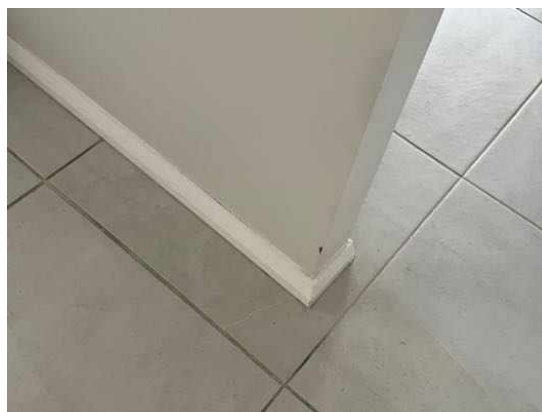
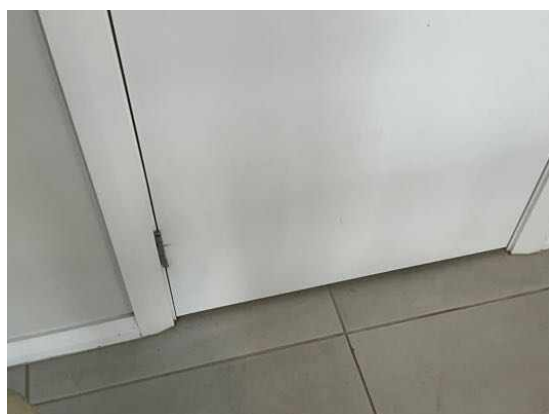
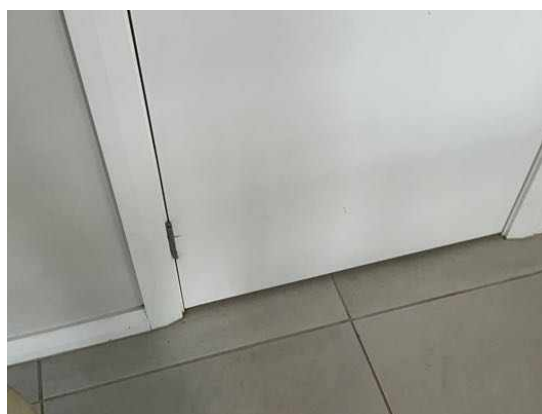
### Finding 3.07

Building:	Main Building
Location:	All Areas
Finding:	Paint surface - Scratches
Information:	Scratches have been identified on the paint surface, detracting from the overall appearance and quality of the painted surface.

1. Aesthetic Degradation: Scratches mar the appearance of the painted surface, diminishing its visual appeal and potentially lowering property value.
2. Corrosion Vulnerability: Exposed areas of bare metal due to scratched paint are susceptible to corrosion, leading to structural damage and compromised durability.

A qualified painter should address the issue promptly to repair the scratched paint. Depending on the severity of the scratches, repair options may include sanding, priming, and repainting the affected area to restore the integrity and appearance of the paint surface.

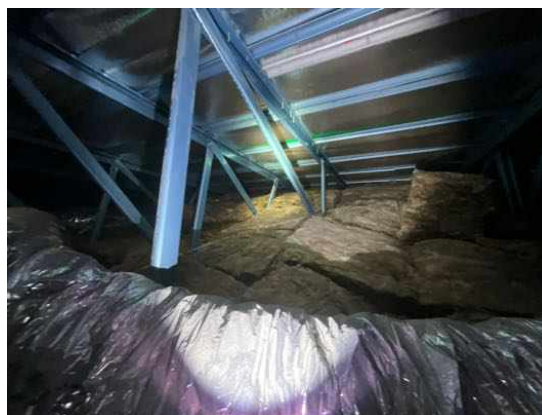
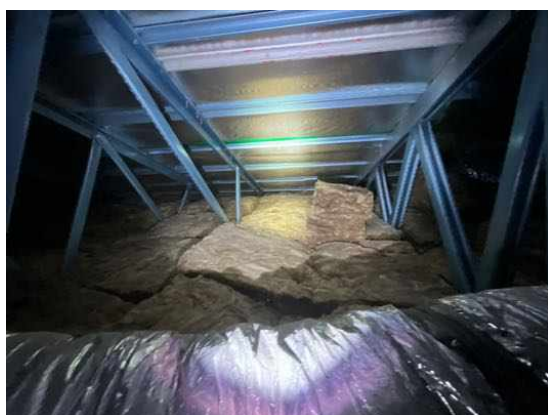
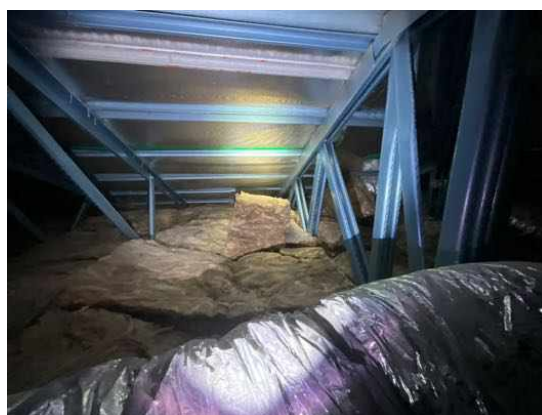
### Finding 3.08

Building: Main Building  
 Location: Roof Void  
 Finding: Insulation - Covering downlights  
 Information: Sections of insulation in the roof void have been poorly installed or moved from their original position and are covering down light fittings. While the down lights have been fitted with appropriate protective covers, the presence of this insulation creates a potential fire hazard.

Any insulation within the vicinity of down light fixtures should be moved and re-applied to more appropriate sections of the roof void, thus ensuring the area is fire-safe. An insulation contractor should be appointed as soon as possible to perform any

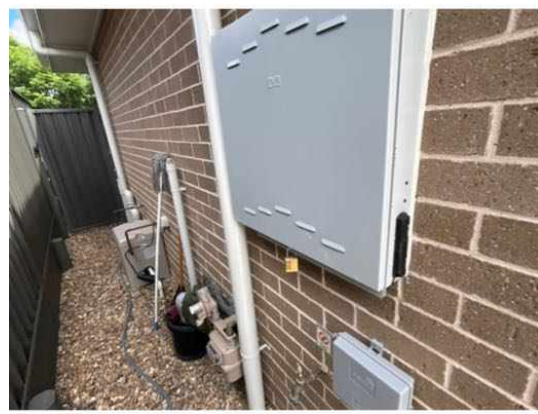
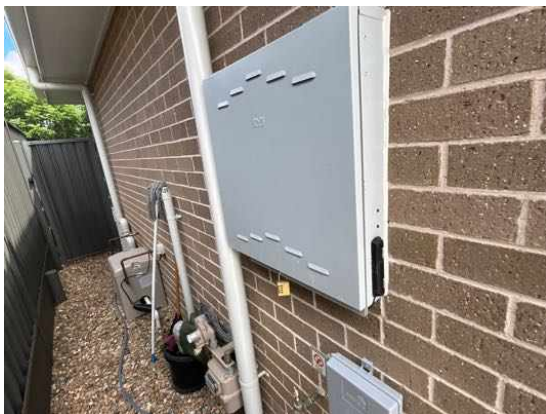
Building:	Main Building
Location:	Exterior walls - left side
Finding:	No Evidence of Termite Management System - Durable notice / Legible Sticker
Information:	The application of a pre & post-construction chemical termite barrier is highly recommended for all properties. Such barriers are highly effective in preventing termite attack on any timber building elements throughout the property.

Client must seek further information from the vendor or real estate agent if the conditions of termite management systems were maintained.

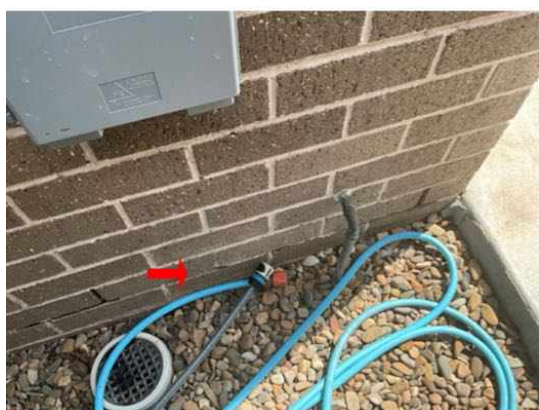
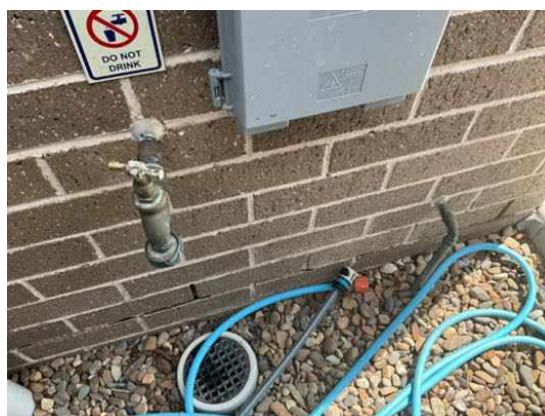
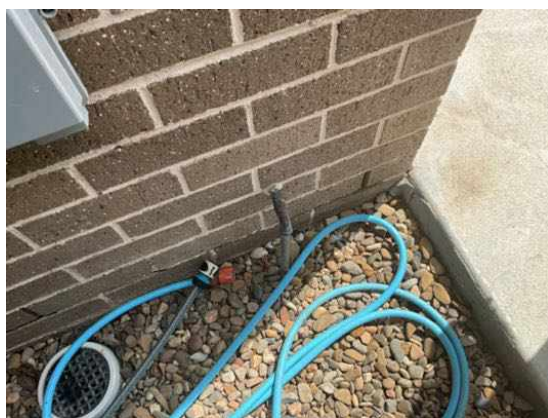
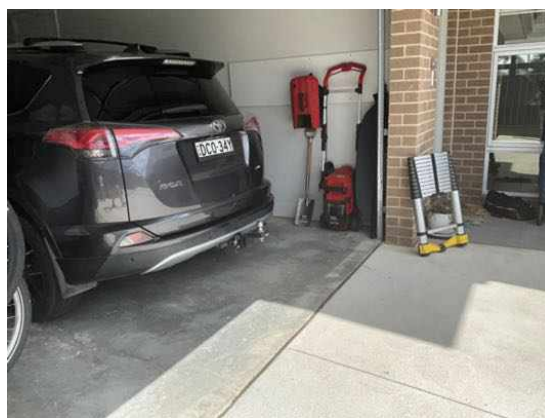
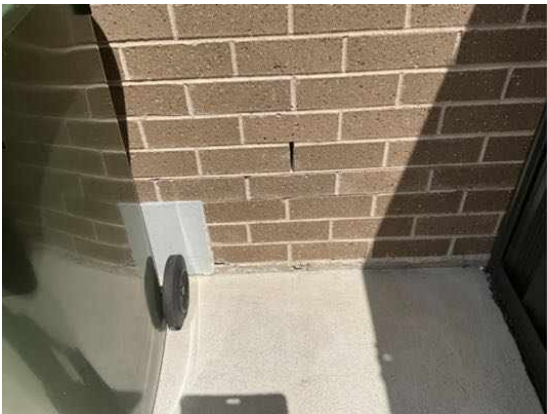
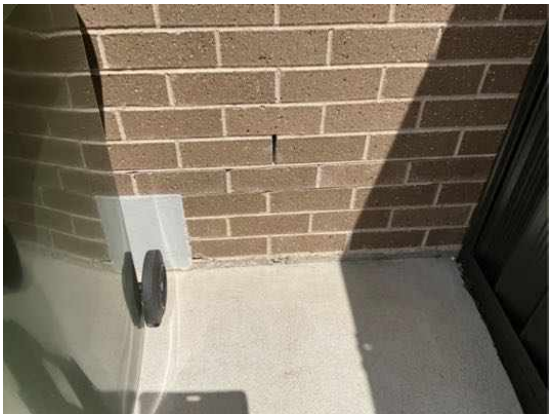
### Finding 6.02

Building:	Main Building
Location:	All Areas
Finding:	Slab Edge - Exposure
Information:	An inspection zone of at least 75mm in relation to the exposed slab edge, between the bottom brick and the perimeter pavement, is required. This inspection zone

If the slab edge is not properly exposed there is a high risk of termite attack. Sometimes, in order to determine the type of slab, a suitably qualified person such as an architect or builder may be required to consult the construction plans.

Where the slab edge cannot be properly inspected, it is highly recommended that termite or timber pest inspections be carried out every 6-12 months to aid protection of the property against infestation.

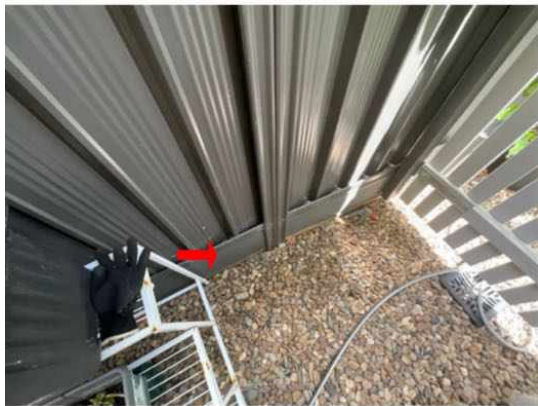
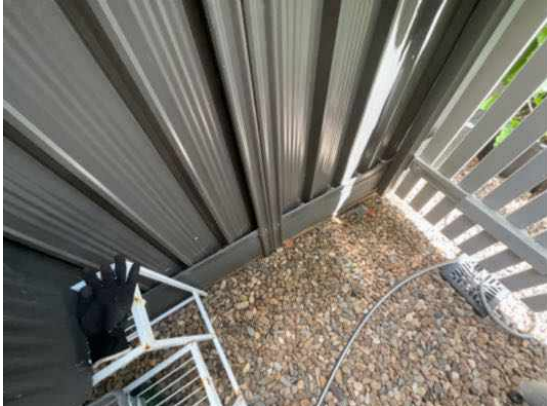
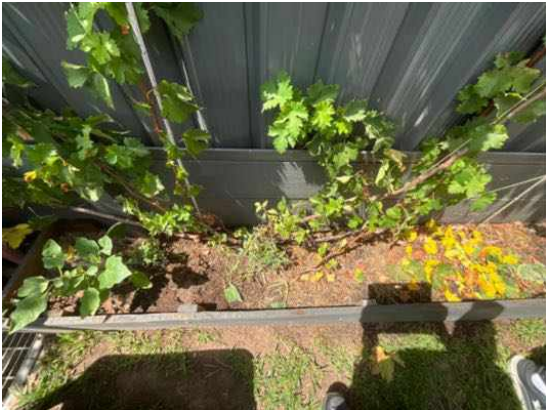
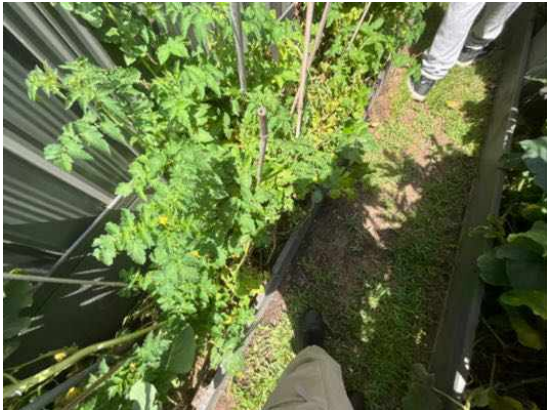
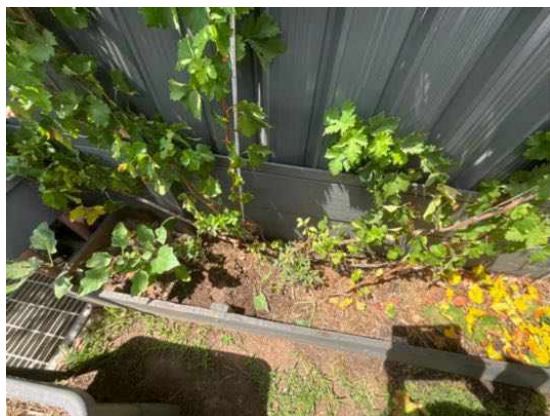
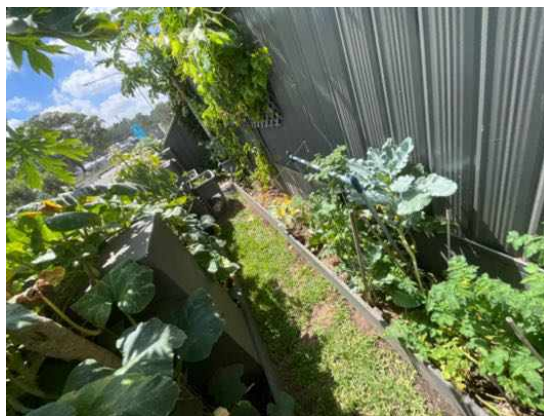
Building: Main Building  
 Location: All Areas  
 Finding: Timber on ground / conducive conditions to termite damage  
 Information: Timber on the ground is indeed conducive to termite damage. Termites are known to thrive in moist environments, and wood in contact with soil or moisture is more susceptible to infestation.

To prevent this, it's important to keep timber elevated and away from direct ground contact. Regular inspections and proper termite control measures are also essential to protect your wooden structures from termite damage.

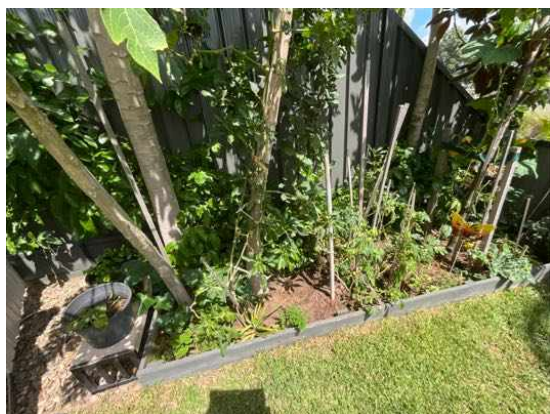
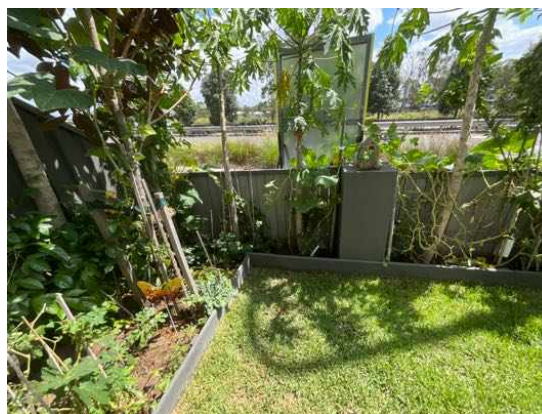
### Finding 6.05

Building:	Main Building
Location:	All Areas
Finding:	Dense vegetation around a property can increase the risk of termite infestation
Information:	The presence of dense vegetation around a property can increase the risk of termite infestation, as it provides a conducive environment for them. To address this, consider maintaining a clear space between the vegetation and your home. If you suspect a termite issue, it's advisable to consult with a licensed pest control professional for inspection and treatment.

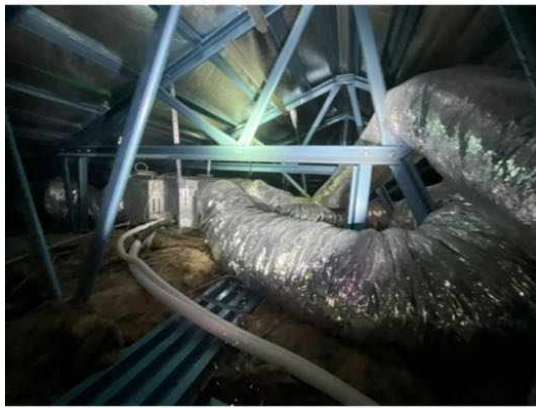
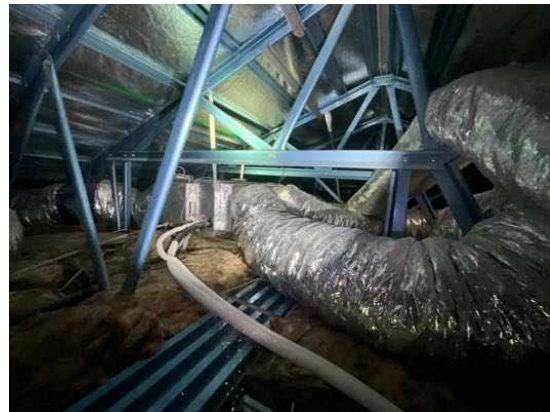
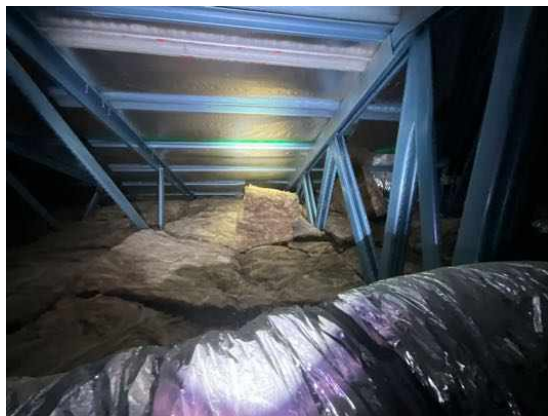
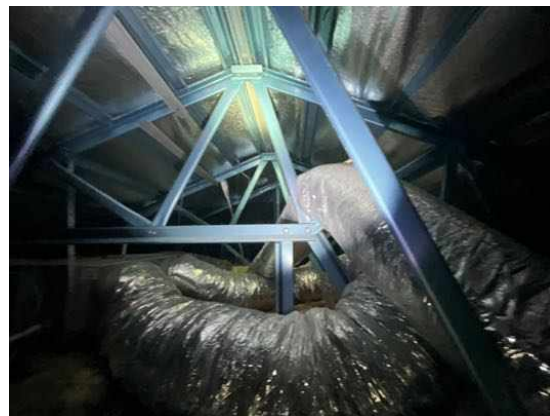
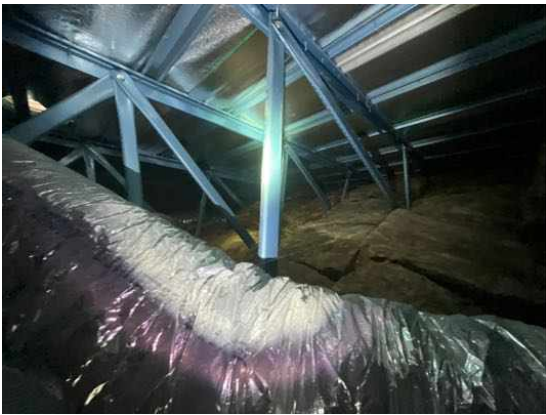
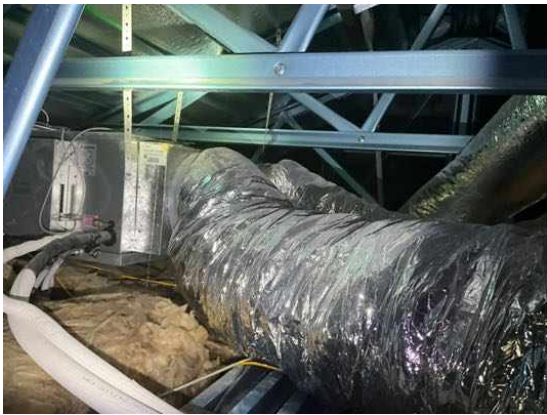
Building: Main Building  
Location: All Areas  
Finding: Additional Photos - Obstructions and Limitations  
Information: These photographs are an indication of the obstructions and limitations which impeded full inspection of the property at the time of inspection. These obstructions can hide an array of defects and should be removed to allow full inspection to be carried out. A re-inspection is recommended once the areas are made accessible.
