## Building Inspection Report

Inspection Date: Sat, 21 Feb 2026

Property Address: 4/48-50 Ann St, Dandenong VIC 3175,  
Australia

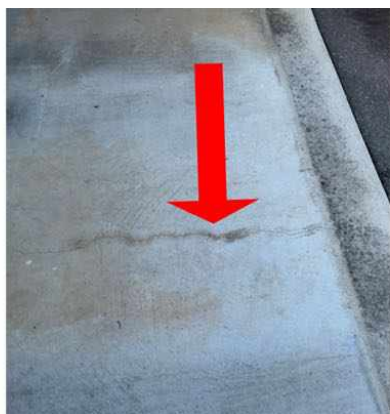
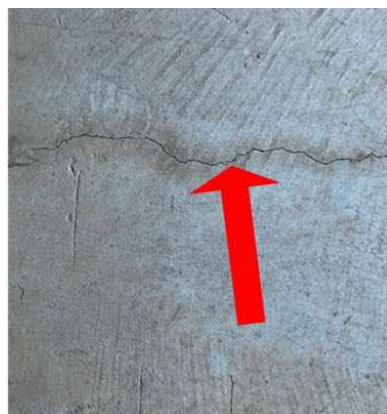
#### Defects 3.01

Building:	Main Building
Location:	Garage
Finding:	Noticeable cracks in concrete slab of the the garage floor
Information:	During the inspection, multiple noticeable cracks were identified in the concrete slab of the garage floor. These cracks vary in size and location, which may indicate underlying movement or stress within the slab. While they do not currently appear to significantly impact the structural integrity, their presence suggests potential early-stage deterioration.

It is recommended that the cracks be monitored closely over the next 12 months. If any of the cracks widen or worsen during this period, it is critical to engage a structural engineer immediately to assess the situation and recommend appropriate rectification measures to prevent further damage and ensure the long-term stability of the structure.

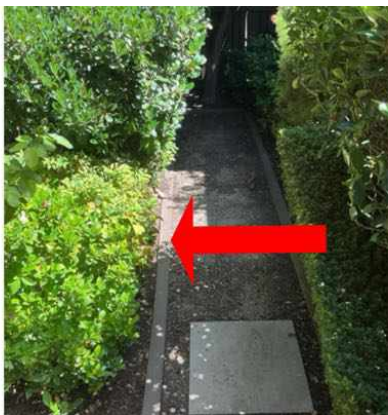
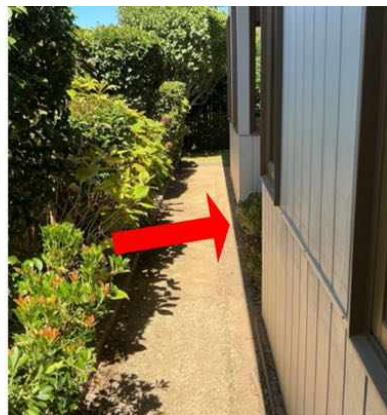
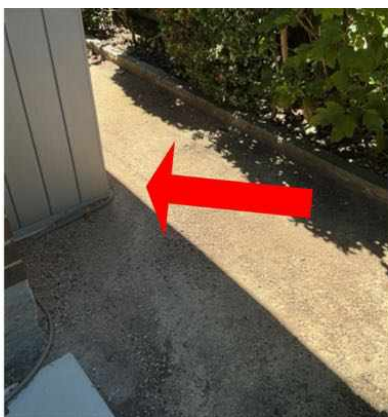
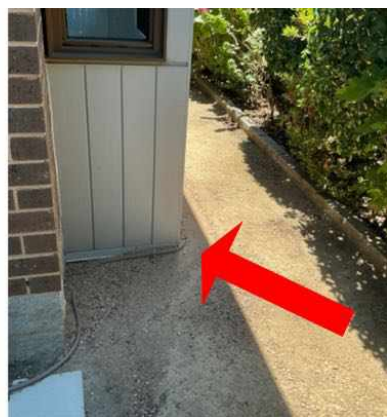
#### Defects 3.02

Building:	Main Building
Location:	All External Areas
Finding:	Site drainage - Inadequate

Information: The site drainage in sections of the side yards and the backyard was found to be inadequate at the time of inspection, creating potential for subsequent water damage to associated building elements.

It is important that water does not lie against the base of walls; surrounding paths and ground levels should be sloped to drain water away from walls. Downpipes should not discharge stormwater onto lower walls or plinths. Stormwater should be carried away by large, regularly cleaned drains. Ground levels may need to be lowered to expose a buried DPC.

Where site drainage is inadequate, installation of an Agricultural (Aggie) Drain may be required. A qualified plumber should be appointed to further inspect the property and perform any remedial works as necessary. Water damage and secondary defects are likely to occur if left unmanaged.

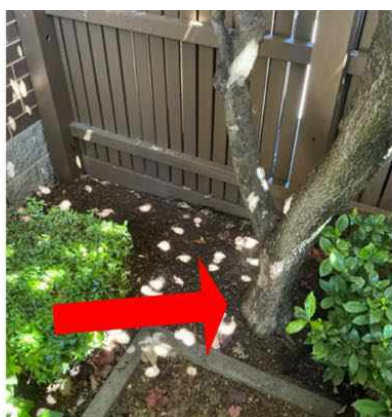
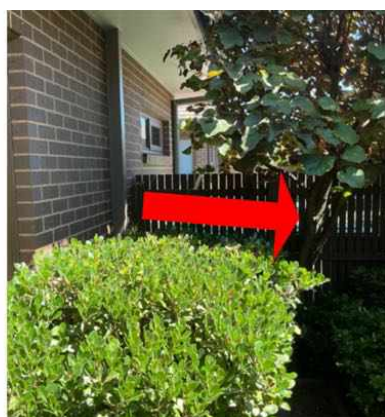
### Defects 3.03

Building: Main Building  
 Location: Sideyard  
 Finding: Tree Located in Close Proximity to Building – Side Yard  
 Information: A mature tree was identified on the left-hand side yard located very close to the exterior walls of the house and adjacent building elements, including downpipes. The proximity of the tree raises concern regarding potential root interaction with footings,

Tree roots can exert pressure on foundations, drainage systems, and surface elements, and may contribute to movement, cracking, or damage over time. Due to the non-invasive nature of the inspection, the extent of any root impact could not be determined at the time of inspection.

It is recommended that a qualified arborist assess the tree and its root system to determine whether it poses a risk to the structure or adjacent building elements. This assessment should be carried out without delay, and any recommended management or removal actions should be implemented as required.

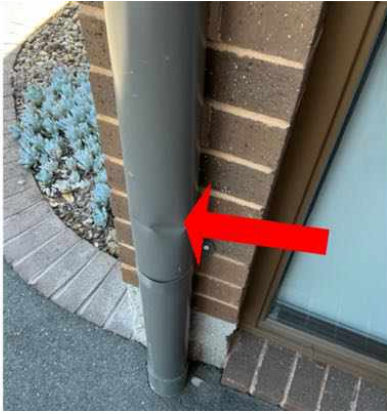
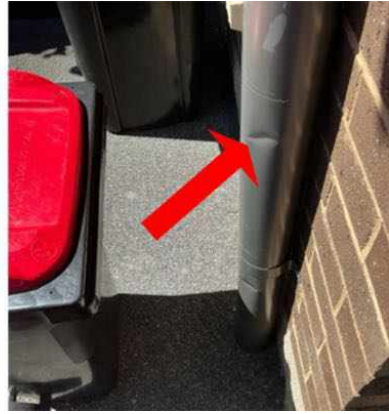
### Defects 3.04

Building: Main Building  
 Location: All External Areas  
 Finding: Dented Downpipes – Front Elevation  
 Information:

Two downpipes located at the front elevation were observed to be dented. The deformation appears to be minor in nature and is likely the result of impact damage.

While the downpipes were not observed to be actively leaking at the time of inspection, denting can potentially restrict water flow or weaken the pipe material over time, particularly during heavy rainfall events. Damage to stormwater components may also affect the overall presentation of the façade.

It is recommended that a licensed plumber assess the extent of the deformation and, if necessary, repair or replace the affected sections to ensure proper stormwater discharge and maintain the integrity of the drainage system.

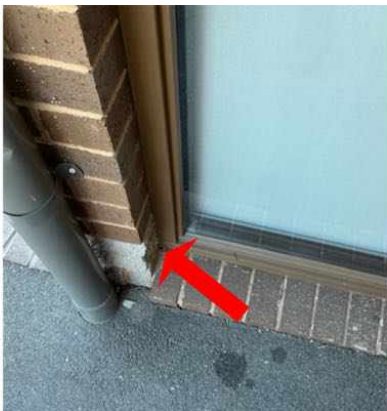
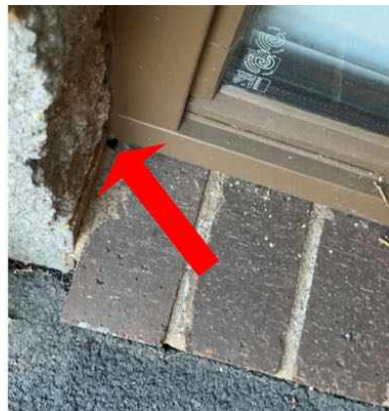
### Defects 3.05

Building: Main Building  
 Location: Front Elevation  
 Finding: Window seals - deteriorated  
 Information: The window seal to the window in the front elevation is in a generally poor condition. Due to frequent exposure to weather conditions and subsequent moisture, deterioration of window seals is expected in a property of this condition and age.

Where window seals have deteriorated, the window is no longer weather-tight; rain penetration and subsequent water damage is therefore likely to ensue. Insulation of the area against external weather conditions will also be compromised.

It is recommended that all deteriorated window seals be replaced by a general handyman or sealant expert to prevent any further damage and to restore the window to a fully functional level.

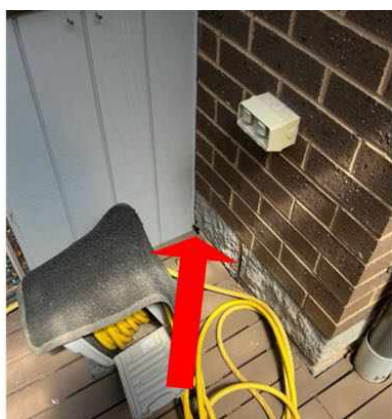
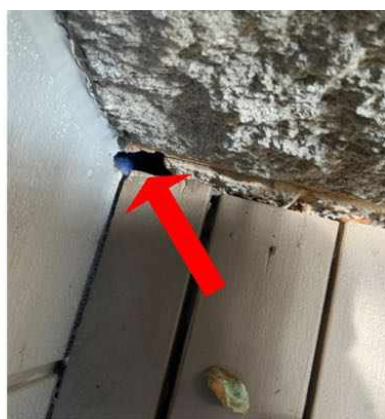
### Defects 3.06

Building: Main Building  
 Location: Exterior walls - rear  
 Finding: Open Gap at Base of Rear External Wall – Brickwork/Cladding Junction  
 Information: An open gap was observed at the base of the rear external wall where the

Unsealed gaps at external wall junctions may allow the entry of moisture, vermin, insects, and debris into the wall cavity. Over time, this may contribute to moisture-related deterioration of internal building elements or create conducive conditions for timber pest activity. Proper sealing and detailing at such junctions are essential to maintain the integrity of the external building envelope.

It is recommended that a qualified builder assess the affected area and install appropriate closure detailing, backing material, and external-grade sealant or flashing as required to properly close the gap while maintaining any necessary drainage provisions in accordance with acceptable building practice.

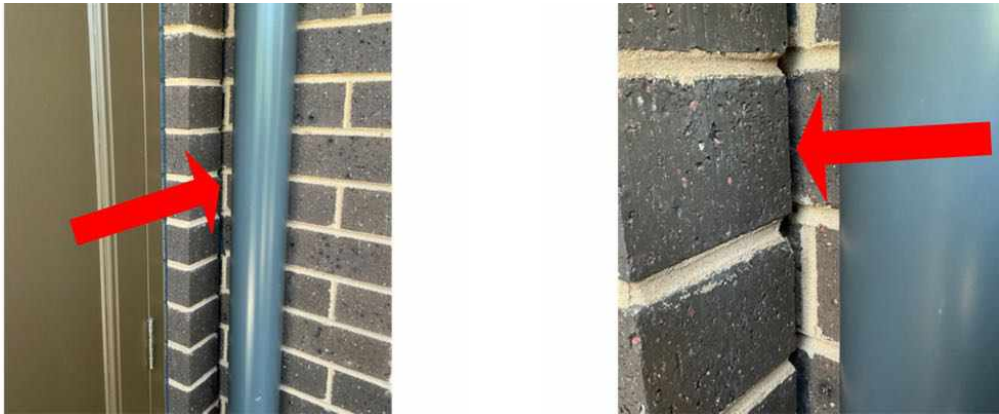
### Defects 3.07

Building:	Main Building
Location:	Exterior walls - rear
Finding:	Brickwork expansion joint - Seal missing.
Information:	During the inspection, it was noted that the seal for the brickwork expansion joint is missing on the rear exterior walls. Expansion joints in brickwork are critical as they accommodate the natural movement of building materials caused by thermal expansion, contraction, and other environmental factors. The absence of a proper seal in these joints can lead to several issues:

- Water Penetration: Without a seal, water can penetrate the expansion joint, potentially leading to water damage within the wall cavity and interior spaces. This can result in dampness, mold growth, and deterioration of building materials.

To address this issue, it is recommended that a qualified handyman, caulking specialist, or bricklayer be engaged to inspect and reseal the expansion joint. This will help maintain the integrity, durability, and appearance of the brickwork, as well as

prevent potential water ingress and structural problems.

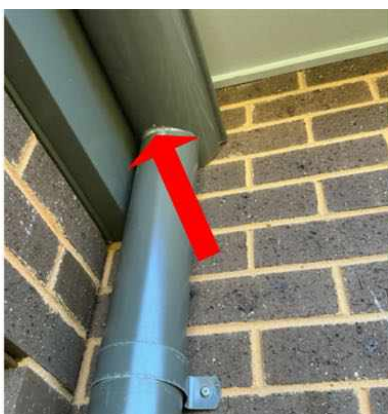
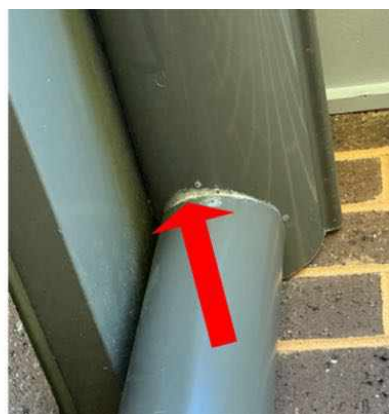
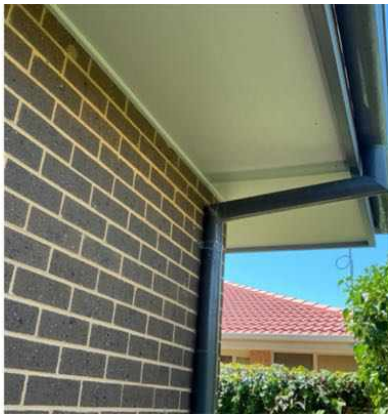
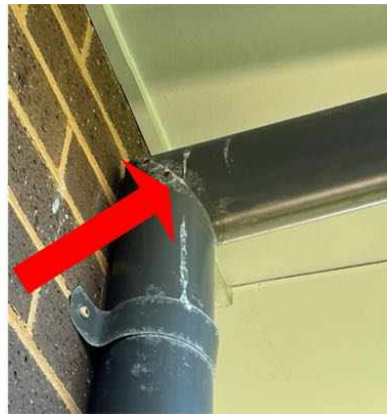
### Defects 3.08

Building: Main Building  
 Location: Exterior walls - rear  
 Finding: Water Staining to Rear Downpipe Joints  
 Information:

Water staining was observed to two downpipes located at the rear of the property, specifically at the joint junctions. Visible residue and discolouration around the connection points suggest that minor leakage may be occurring during rainfall events.

Leakage at downpipe joints can allow uncontrolled discharge of stormwater at the base of the wall, which may contribute to moisture accumulation near footings and adjacent building elements over time.

It is recommended that a licensed plumber inspect the affected downpipe joints and reseal, refit, or replace the connections as necessary to ensure they are watertight and functioning correctly.

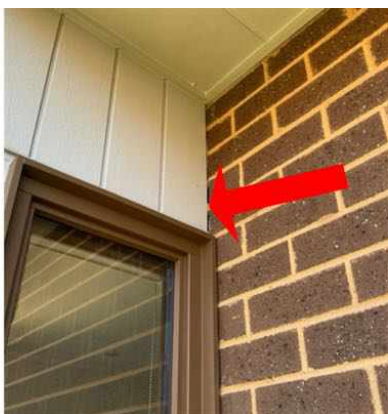
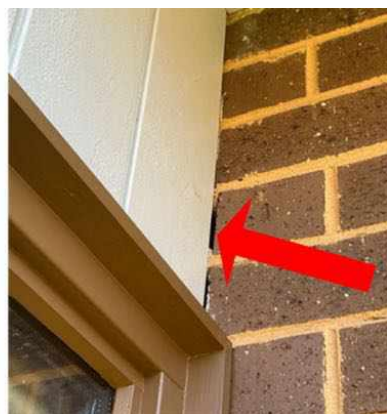
### Defects 3.09

Building:	Main Building
Location:	Exterior walls - rear
Finding:	Unsealed Junction – Rear External Wall (Cladding to Brickwork Interface)
Information:

The junction between the external cladding and adjacent brickwork at the rear elevation was observed to be unsealed. A visible gap is present along the interface, and no appropriate flexible sealant or weatherproof detailing was noted at the time of inspection.

Unsealed wall junctions may permit moisture ingress, draughts, and pest entry into the wall cavity. Over time, this can contribute to deterioration of internal building elements and compromise the weather-tightness of the external envelope.

It is recommended that a qualified caulking specialist apply an appropriate flexible, exterior-grade sealant to the junction to ensure the area is properly weatherproofed and waterproofed while allowing for normal building movement.

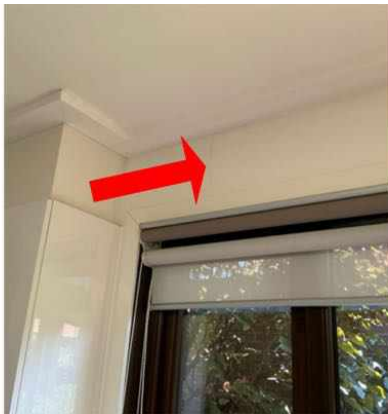
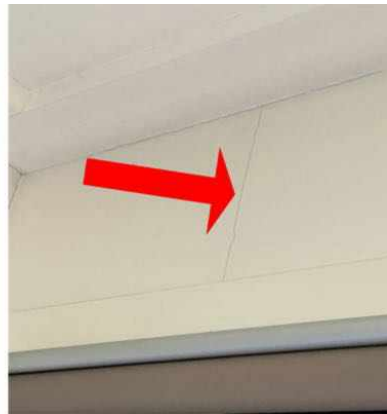
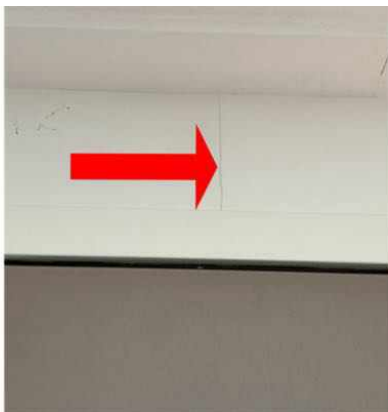
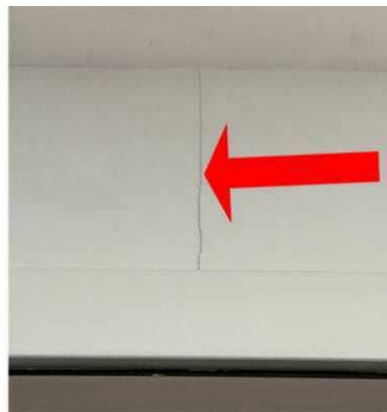
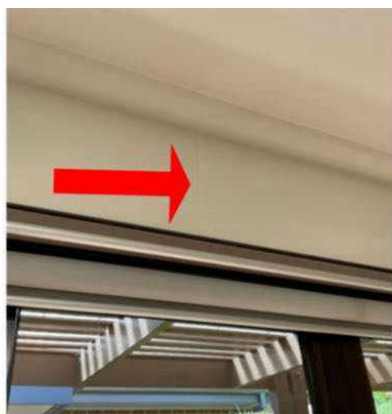
### Defects 3.10

Building:	Main Building
Location:	All Internal Areas
Finding:	Vertical Cracking Above Windows and Sliding Doors – Living Area

Multiple vertical cracks were observed to internal wall surfaces in the living area, predominantly above windows and sliding door openings. The cracks were measured to be approximately 1 mm to 2 mm in width and appear consistent with movement-related stress concentrations commonly occurring at openings.

Cracking in these locations is typically associated with minor settlement, thermal expansion and contraction, or normal building movement around structural openings. While the cracks are not considered structurally significant at the time of inspection, their width places them within a range that warrants monitoring to ensure they are not progressive.

It is recommended that the cracks be monitored for further movement. If no progression is noted, cosmetic repairs may be undertaken by a qualified plasterer or painter, including filling, sanding, and repainting. Should the cracking widen, continue to develop, or show signs of structural movement, further assessment by a registered builder or structural engineer would be advised.

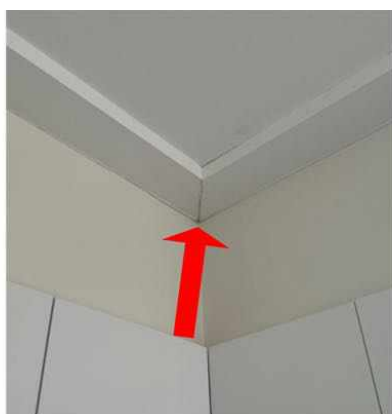
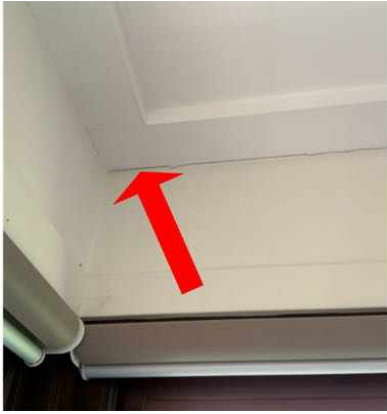
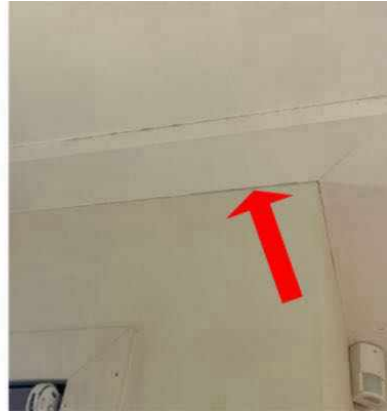
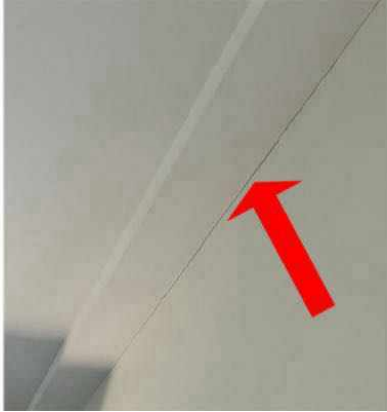
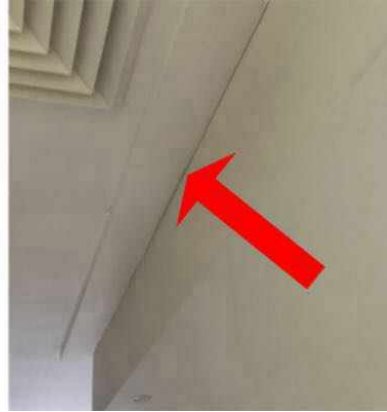
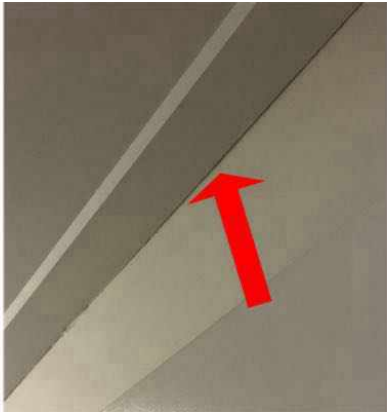
### Defects 3.11

Building:	Main Building
Location:	All Internal Areas
Finding:	Minor Gaps at Ceiling-to-Wall Junctions – Internal Areas
Information:

Minor separations and small gaps were observed at various ceiling-to-wall junctions throughout the dwelling. The gaps are generally fine and localised, consistent with typical shrinkage and minor settlement movement that commonly occurs as building materials adjust over time.

Such gaps are generally cosmetic in nature and are often attributable to normal structural movement, seasonal expansion and contraction, or minor settlement. No evidence was observed at the time of inspection to suggest structural failure associated with these junctions.

If considered unsightly, a qualified painter or handyman can undertake cosmetic rectification works including filling, re-sealing, sanding, and repainting to achieve a uniform and consistent finish. Ongoing monitoring is recommended to ensure the gaps do not progressively widen.

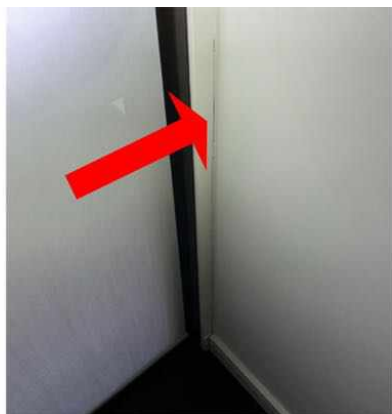
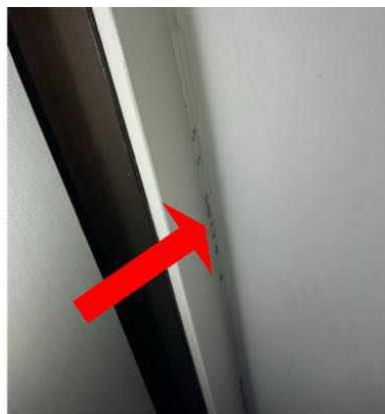
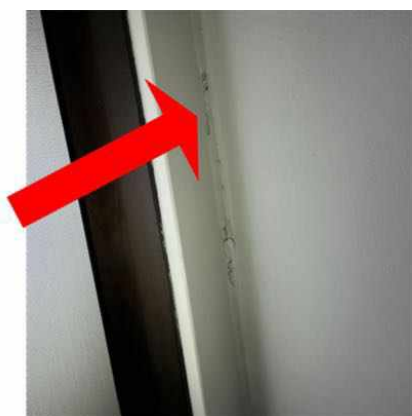
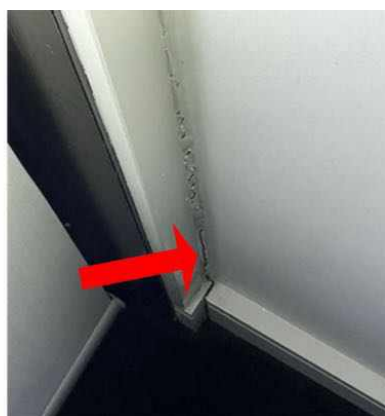
### Defects 3.12

Building: Main Building  
 Location: Bedroom 1  
 Finding: Damaged Plaster Finish – Corner Junction, Bedroom 1  
 Information:

Damage and deterioration were observed to the internal plaster finish at the corner junction in Bedroom 1, extending vertically from approximately skirting level upward. The plaster surface shows signs of cracking, separation, and localised delamination of joint compound along the corner bead.

The condition appears consistent with minor building movement and/or inadequate joint preparation or finishing at the time of construction. While the defect is not

considered structural in nature, it affects the finish quality and presentation of the room and may worsen if left unaddressed.

It is recommended that a qualified plasterer attend to remove any loose material, resecure or reinstate the corner bead if required, reapply joint compound, sand smooth, and repaint to achieve a uniform and professional finish consistent with surrounding wall surfaces.

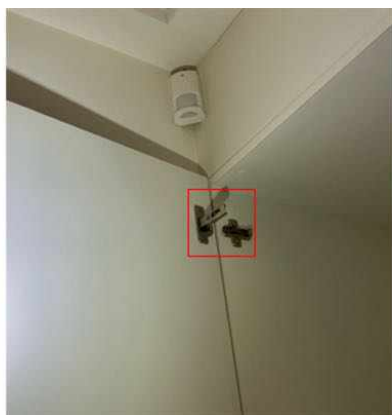
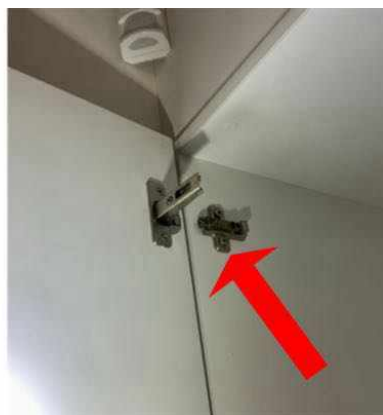
### Defects 3.13

Building: Main Building  
 Location: Laundry  
 Finding: Failed Upper Cabinet Hinge – Laundry Cupboard  
 Information:

The upper hinge to the laundry cupboard door was observed to have separated from its fixing point and is no longer securely attached. The hinge is defective and does not properly support the door in its current condition.

A failed hinge may cause misalignment of the cupboard door, difficulty in operation, and additional stress on the remaining hinges, potentially leading to further hardware damage if not addressed.

It is recommended that a qualified handyman or cabinetmaker replace the defective hinge and ensure the cupboard door is correctly aligned and securely fixed to allow

smooth and safe operation.

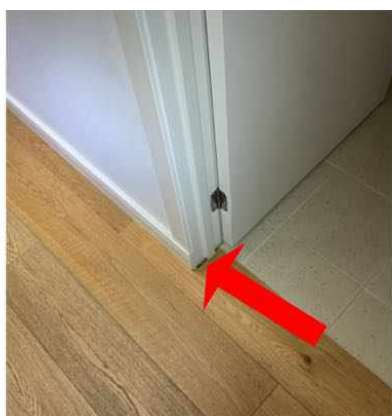
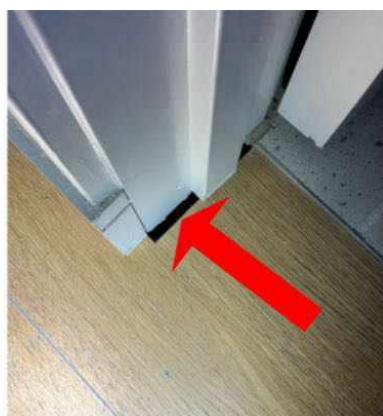
### Defects 3.14

Building: Main Building  
 Location: Toilet (WC)  
 Finding: Minor Gap – Floorboard to Door Frame Junction (WC Entrance)  
 Information:

A minor gap was observed between the floorboards and the adjacent door frame at the entrance to the WC room. The separation appears to be the result of initial installation detailing rather than structural movement.

While the condition is cosmetic in nature, open gaps at floor junctions may allow dust accumulation and detract from the overall finish quality of the area.

Rectification can be undertaken by a qualified flooring specialist or carpenter, either by applying an appropriate flexible sealant or installing a suitable trim/scotia to achieve a neat and uniform finish.

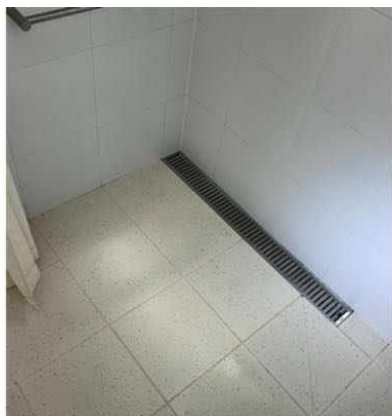
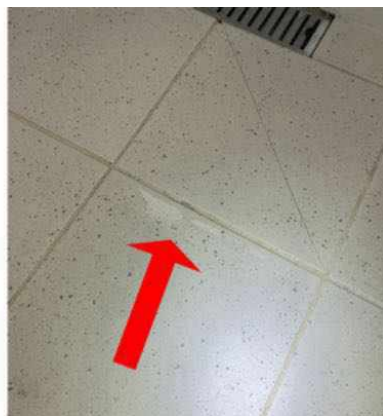
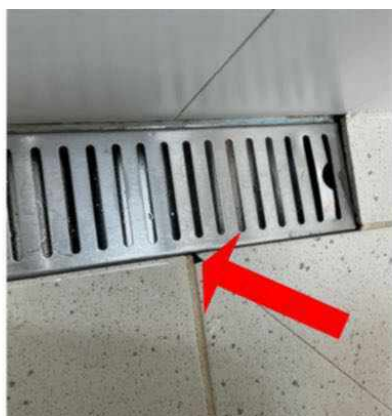
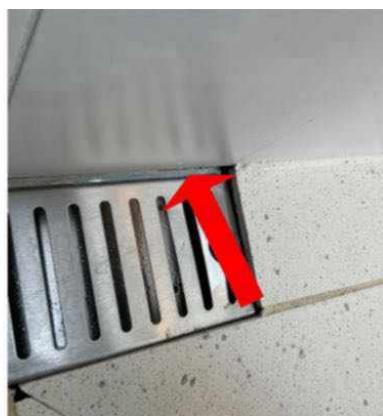
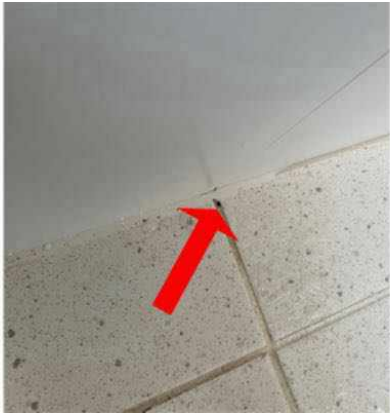
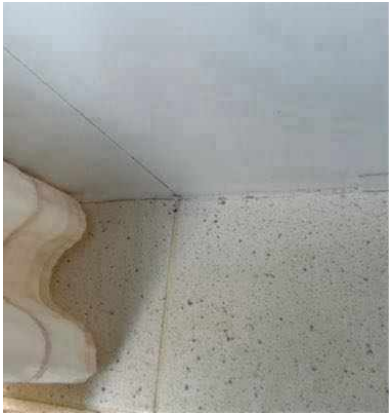
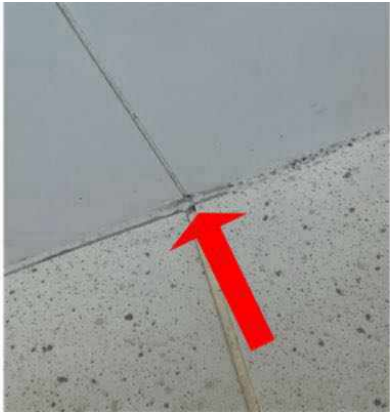
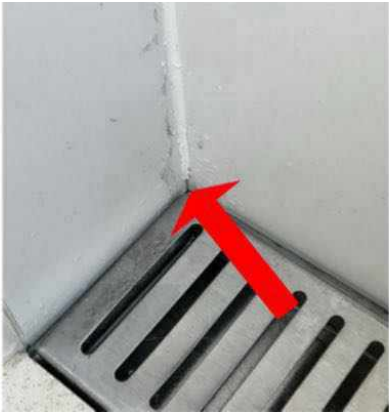
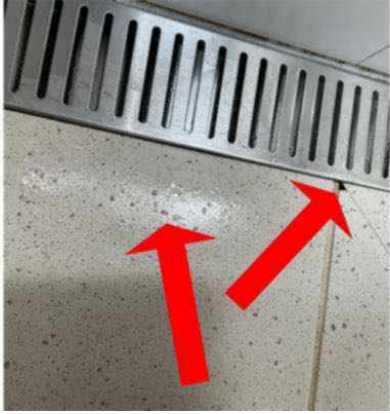
### Defects 3.15

Building: Main Building  
 Location: Bathroom

Finding: Shower Floor Grout, Sealant Deterioration and Inadequate Falls

Sections of the grout to the shower floor tiles and wall tiles were observed to contain minor gaps and localised deterioration. Small separations were also noted in the silicone sealant at the wall-to-floor junction, with minor mould growth visible along the base sealant line. Additionally, after operating the shower continuously for approximately 25 minutes, residual water was observed pooling in sections of the tiled floor, indicating that the falls to the waste in some areas may be insufficient to achieve effective drainage.

Deteriorated grout and sealant may allow water penetration beneath tiles, potentially leading to concealed moisture damage over time. Inadequate floor falls can result in ongoing water ponding, increasing the risk of mould growth, surface deterioration, and moisture impact to adjacent finishes. Given that this is an open (disability-access) shower without screens or a shower enclosure, the potential for water migration to surrounding areas is increased.

It is recommended that a qualified tiler or bathroom specialist attend to rake out and regROUT affected areas, remove and replace deteriorated silicone with mould-resistant sanitary-grade sealant, and assess the adequacy of tile falls toward the waste. While rectification of falls can be complex, professional advice should be sought. In the interim, it is strongly advised that the shower area be thoroughly dried after each use to minimise moisture impact to surrounding finishes

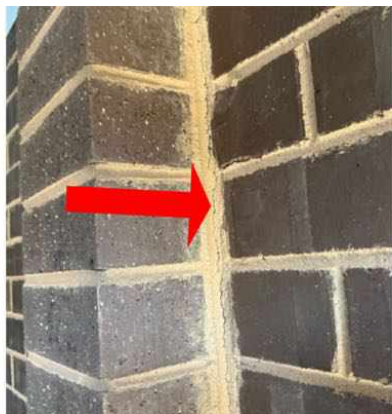
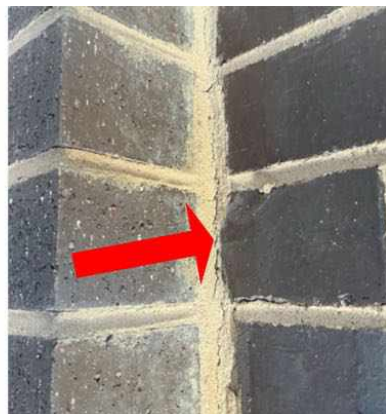
**Defects 3.16**

Building: Main Building  
Location: Garage  
Finding: Hairline Cracking – Mortar Joints, Garage Internal Brickwork  
Information: Hairline cracking was observed to mortar joints within the internal brickwork walls of the garage. The cracking is minor in width and appears consistent with normal building and ground movement commonly experienced in residential structures over time.

At the time of inspection, the cracking does not appear structurally significant and is

considered typical settlement-related movement. Such minor mortar cracking is relatively common and may remain stable without further progression.

The condition may be left as is; however, if considered unsightly, a qualified bricklayer can undertake localised repointing of affected mortar joints for cosmetic improvement.

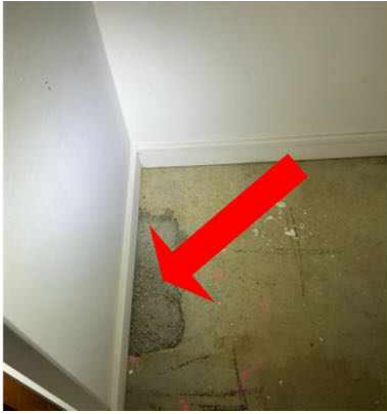
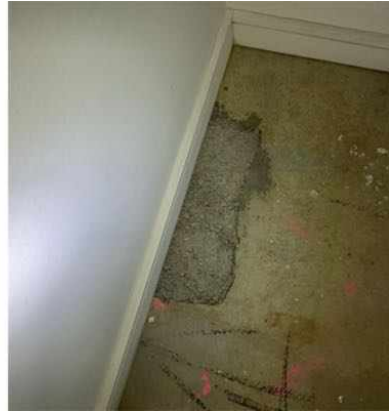
### Defects 3.17

Building:	Main Building
Location:	Garage
Finding:	Localised Damage – Concrete Slab, Storage Area within Garage
Information:

Localised damage and irregularity were observed to the concrete slab surface within the storage area of the garage. The affected section appears to have been cut, chipped, or shaved during initial construction, possibly to accommodate service penetrations or plumbing installations.

Based on visual assessment, the condition appears historic and does not currently indicate active structural distress. The slab remains generally serviceable; however, the surface finish is uneven in the affected area.

If desired for appearance or surface uniformity, a qualified concreter can assess the area and undertake patching or resurfacing works as appropriate.

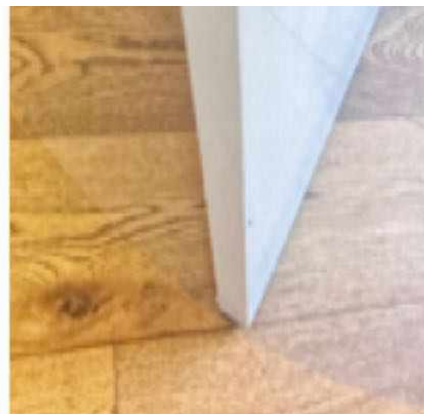
### Defects 3.18

Building: Main Building  
 Location: Entry  
 Finding: Entry Door Rubbing Against Floor Finish  
 Information:

The main entry door was observed to be rubbing against the adjacent floorboards during operation. Evidence of friction is visible, including localised removal of floorboard polish at the contact point. A weather strip/seal is installed to the underside of the door, which may be contributing to the reduced clearance.

Continued friction may cause further damage to the floor finish and place unnecessary stress on the door hinges and hardware. The condition affects both functionality and presentation.

It is recommended that a qualified carpenter assess the door assembly. The weather strip may be temporarily removed to determine whether it is the cause of the interference. If friction persists, the door should be realigned, adjusted at the hinges, or carefully shaved at the bottom to provide adequate clearance without compromising weatherproofing performance.

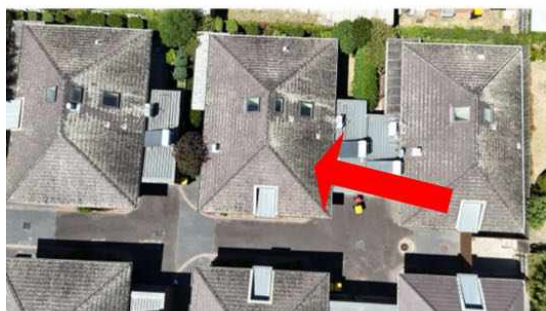
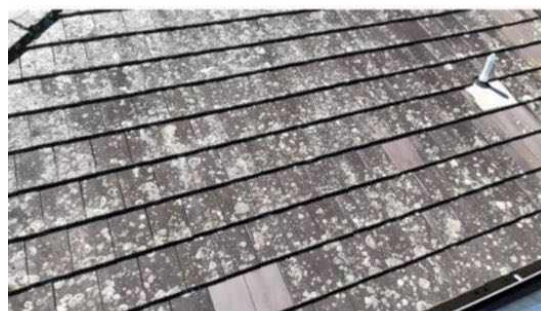
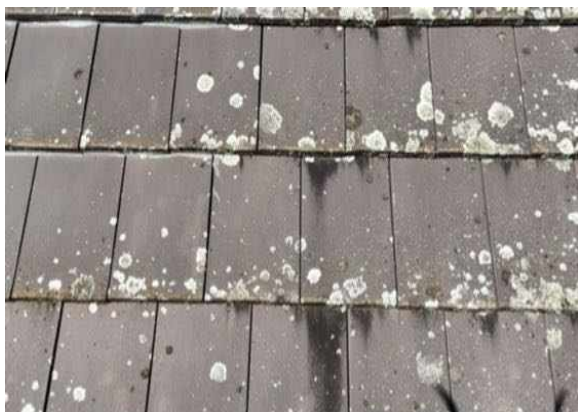
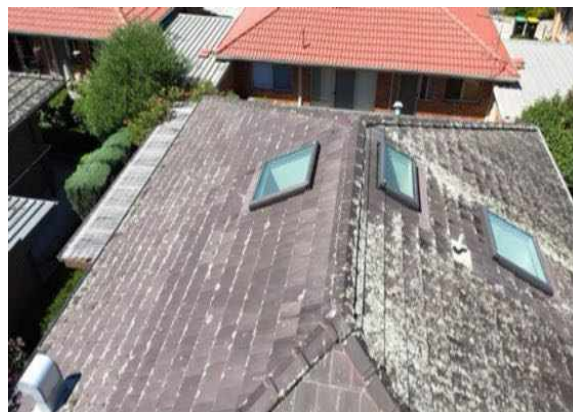
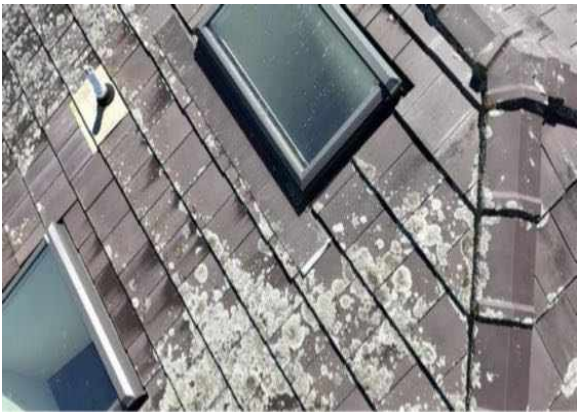
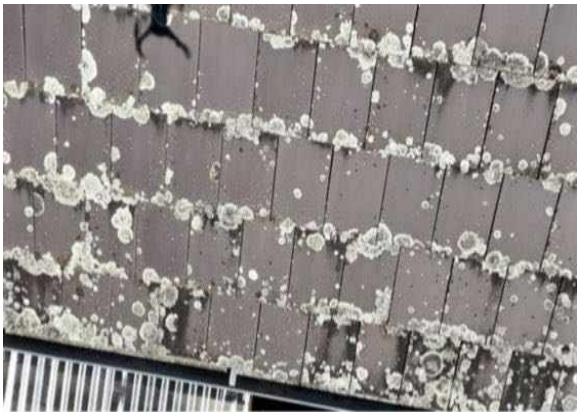
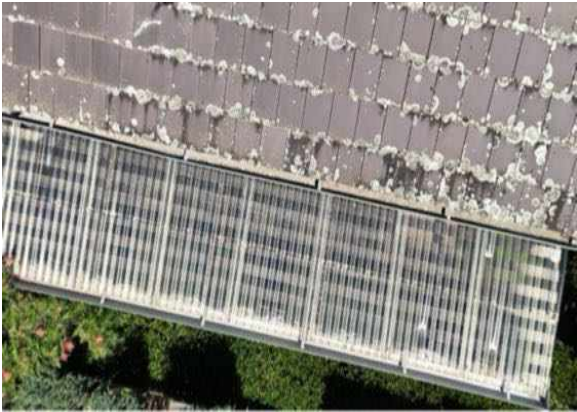
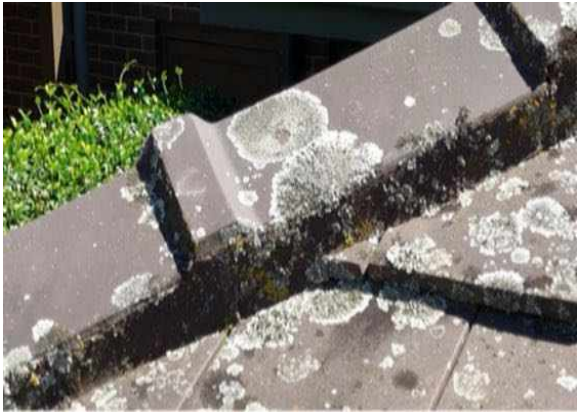
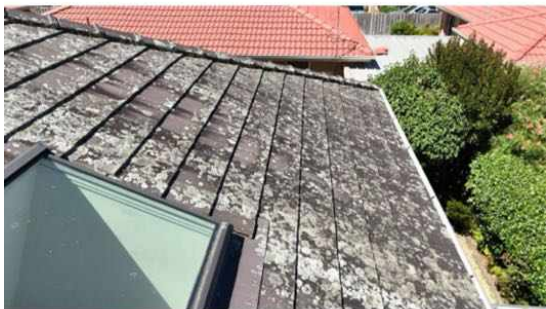
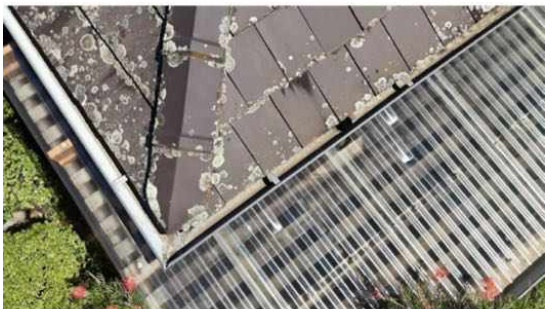
### Defects 3.19

Building: Main Building

Location: Roof Exterior  
Finding: Roof Requires Cleaning and Ongoing Maintenance  
Information: The roof covering was observed to be heavily soiled, with visible build-up of fungal growth, organic matter, bird droppings, and general surface contamination. The extent of the build-up limits clear visual assessment of the roof surface in some areas.

Accumulated organic matter may retain moisture, accelerate surface deterioration, and contribute to premature ageing of roofing materials. Regular maintenance is essential to preserve roof integrity and drainage performance.

It is recommended that a qualified roofing contractor undertake comprehensive pressure cleaning using appropriate methods suitable for the roof material. Following cleaning, the roof should be inspected for any damaged or displaced tiles, defective ridge capping, or other maintenance issues. Ongoing annual inspections (approximately every 12 months) by a roofing specialist are advised, and sealing treatments may be considered if recommended by the contractor to enhance durability and weather resistance.

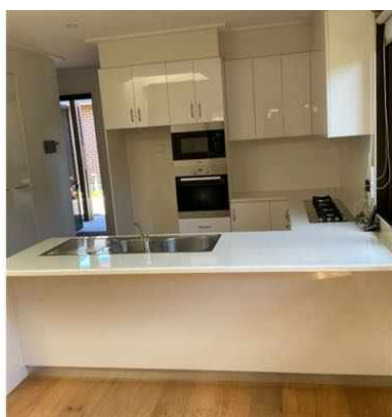
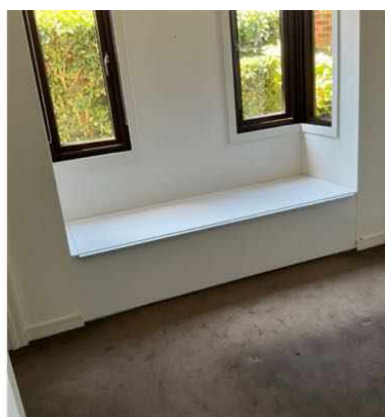
#### Noted Item

Building: Main Building  
Location: All Internal Areas  
Finding: Obstructions and Limitations - Interior  
Information: These photographs are an indication of the obstructions and limitations which impeded the inspection of the internal areas of the property at the time of inspection. These obstructions can hide an array of defects and should be removed to allow full inspection to be carried out. A re-inspection is recommended once the areas are made accessible.

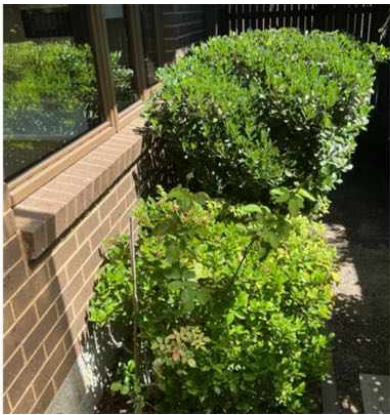
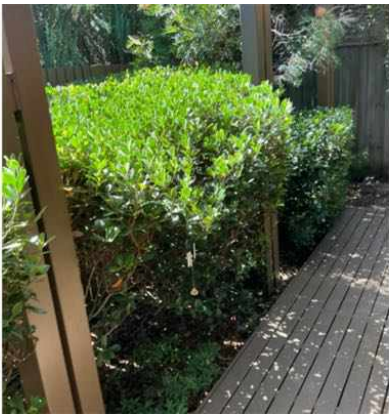
#### Noted Item

Building: Main Building  
Location: All External Areas  
Finding: Obstructions and Limitations - Exterior  
Information: These photographs are an indication of the obstructions and limitations which impeded the inspection of the external areas of the property at the time of inspection. These obstructions can hide an array of defects and should be removed to allow full inspection to be carried out. A re-inspection is recommended once the areas are made accessible.

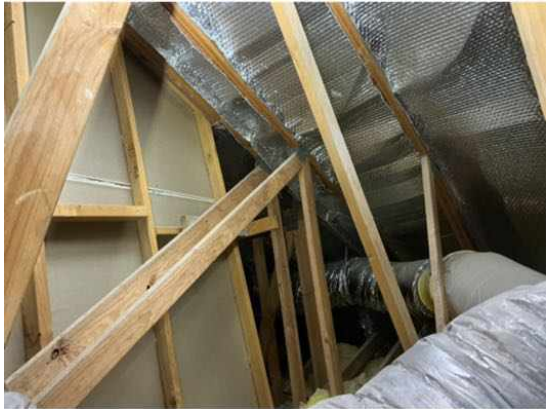
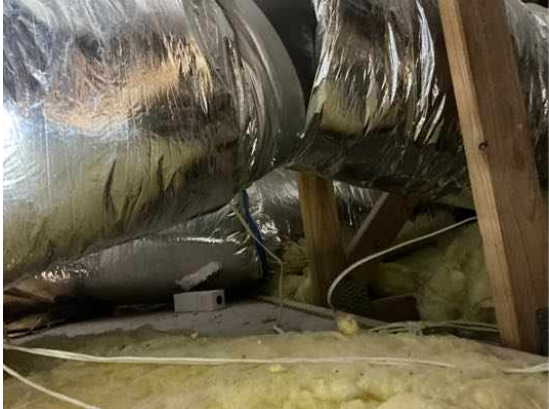
**Noted Item**

Building: Main Building  
Location: Roof Void  
Finding: Obstructions and Limitations - roof cavity  
Information: These photographs are an indication of the obstructions and limitations which impeded the inspection of the roof cavity area of the property at the time of inspection. These obstructions can hide an array of defects and should be removed to allow full inspection to be carried out. A re-inspection is recommended once the areas are made accessible.
