# Building and Timber Pest Inspection Report

Inspection Date: Wed, 4 Feb 2026

Property Address: 5/41 Hope Street, Penrith NSW 2750

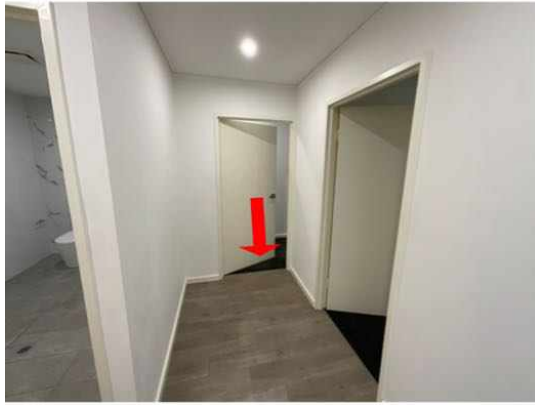
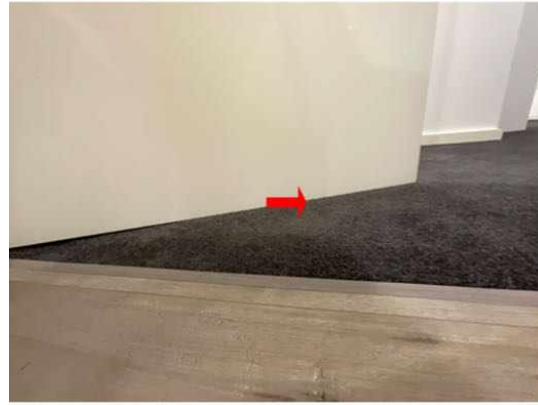
Building:	Main Building
Location:	Bedroom - Master
Finding:	Door - Binding on floor or carpet (insufficient clearance)...
Information:	During standard operation, it was observed that one door is binding or rubbing against the floor covering due to insufficient clearance between the bottom edge of the door and the finished floor level. This condition impedes smooth operation of the door and is classified as a defect.

- **Functionality:** The affected door(s) do not open or close freely, which compromises intended use and occupant convenience.
- **Wear and Damage:** Continued rubbing may cause damage to the floor covering, such as scuffing, tearing, or indentation (particularly on carpet, vinyl, or timber surfaces).
- **Door Damage:** The bottom edge of the door may also suffer wear, swelling (if unsealed), or delamination over time.
- **Compliance:** Doors are expected to operate without obstruction in accordance with good building practice and the tolerances outlined in Guide to Standards and Tolerances.

The bottom edge of the affected door(s) should be planed or trimmed to provide sufficient and uniform clearance above the floor surface. Following adjustment, the exposed edge must be appropriately sealed to prevent future moisture ingress or material degradation. All works should be carried out by a qualified tradesperson in accordance with manufacturer recommendations and industry standards.

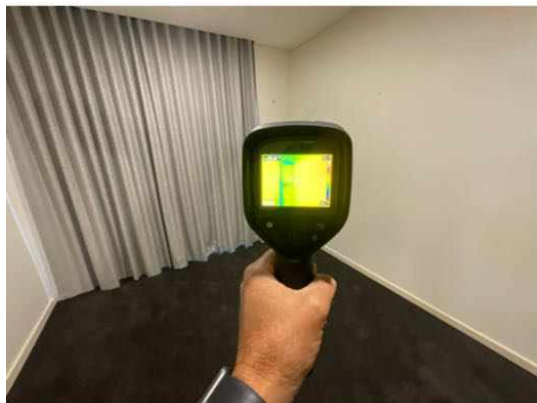
At the time of the inspection, no abnormalities indicating live termite activity were observed. However, it's important to note that various factors—such as obstructions, ambient temperature, and wall material/thickness—can impact the accuracy of thermal readings. In cases where surfaces are visually restricted or obstructed, a comprehensive thermal scan may not always be feasible.

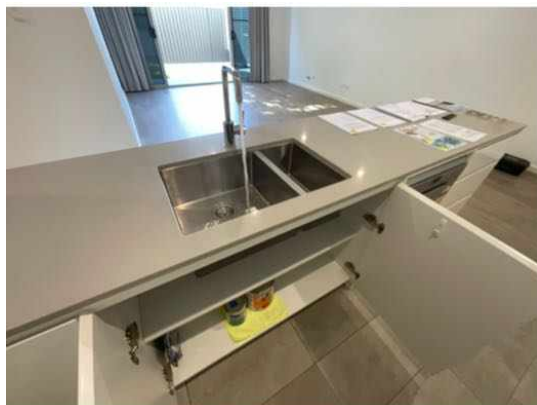
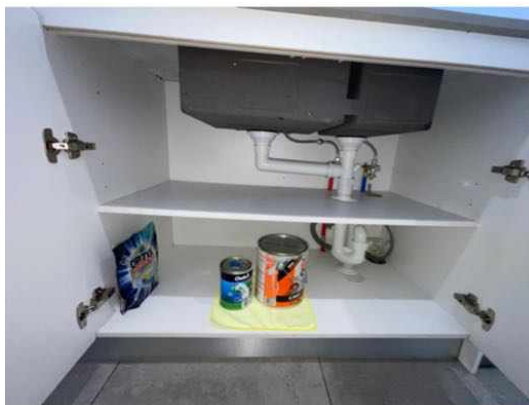
Building: Main Building  
 Location: Kitchen  
 Finding: Kitchen Sink – Overall Condition & Recommendations.  
 Information: Observations:

- The kitchen sink tap(s) were water tested at the time of inspection, with no evidence of leaks or blockages observed in the visible plumbing or drainage.
- No significant water damage was observed to the cabinetry/unit

- Further monitoring and testing are recommended once the tap(s) are in constant use, to identify any drainage issues or signs of slow leaks not evident during the limited inspection.

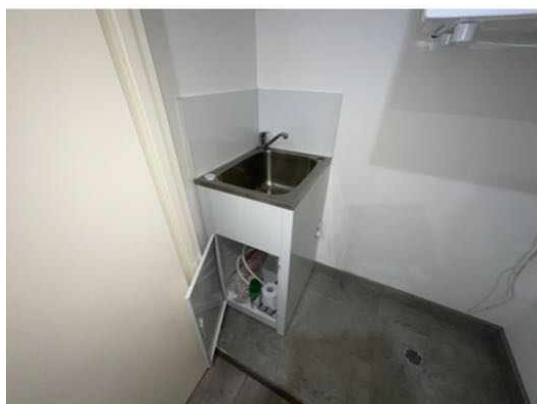
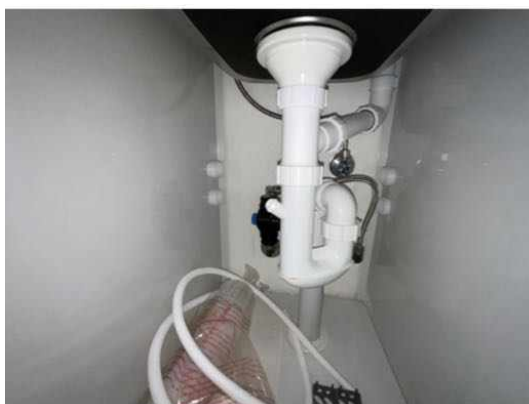
Building: Main Building  
 Location: Laundry  
 Finding: Tap/s - Not Operational (2 way tap connection).  
 Information: Tap Not Operational – Laundry

- If issues persist, a licensed plumber should be engaged to assess and repair as required.

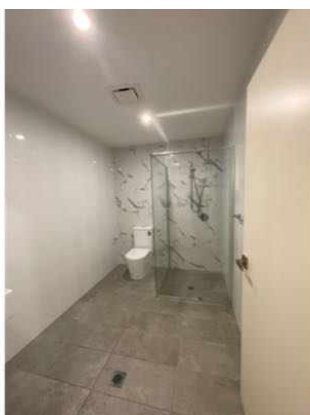
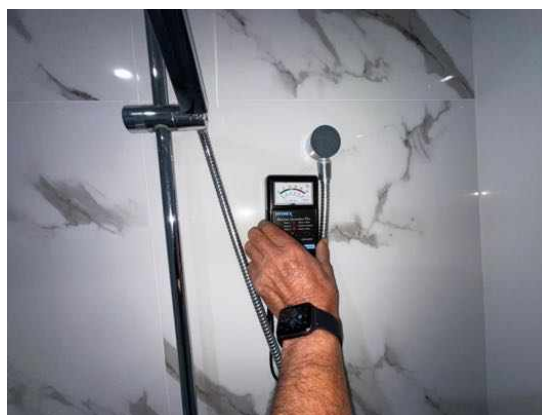
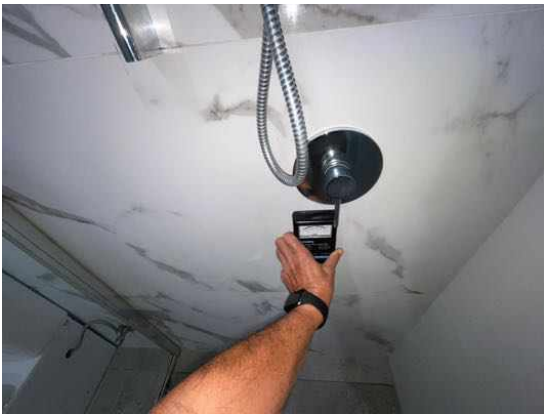
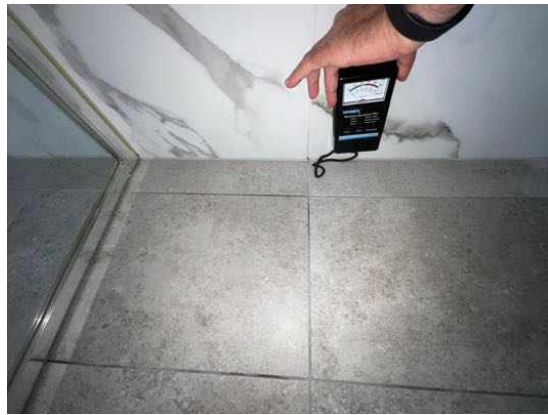
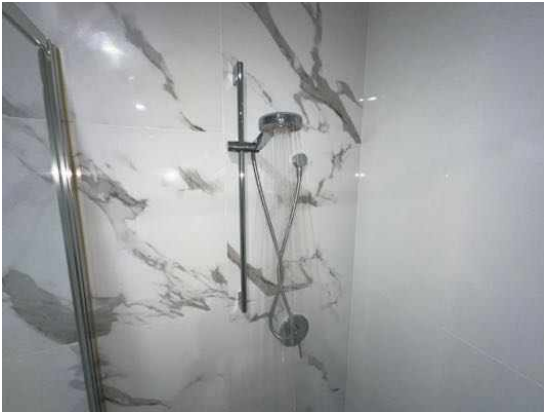
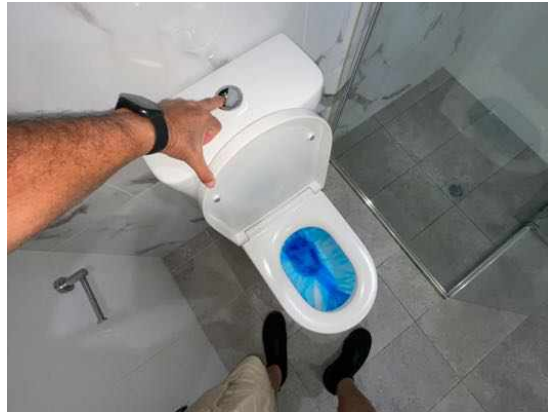
Building: Main Building  
 Location: Bathroom  
 Finding: Wet Areas - Bathroom(s) - Overall Condition & Recommendations.  
 Information: Overall Condition & Recommendations

- Floor waste was found to be clear and free of blockages at the time of inspection. Further monitoring is advised after consistent use to identify any drainage issues or buildup requiring cleaning.

- No elevated moisture readings were detected around the tap fittings or behind the shower walls (as viewed from adjacent rooms), suggesting no active plumbing leaks at the time of inspection.

- Sealing of grout and tiles is recommended to prevent moisture buildup and mould growth in damp areas such as showers.
- The condition of grout and sealant appeared to be good.

- Flood testing of the shower recess is recommended. This may reveal inadequacies in the waterproofing or shower screens, which could lead to water damage in surrounding areas.

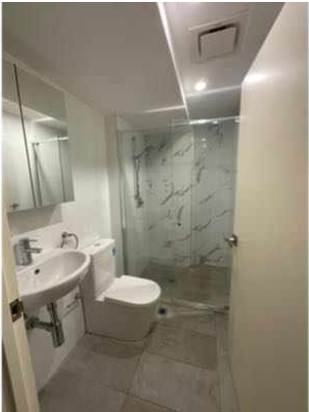
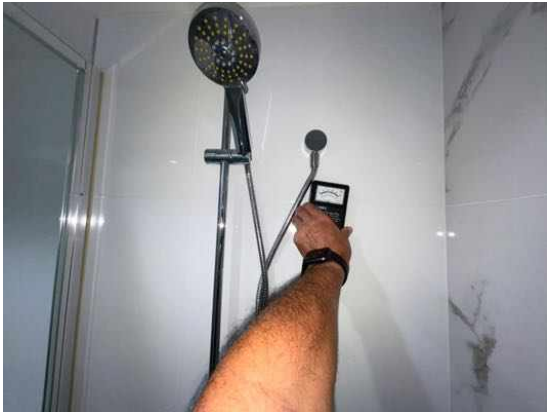
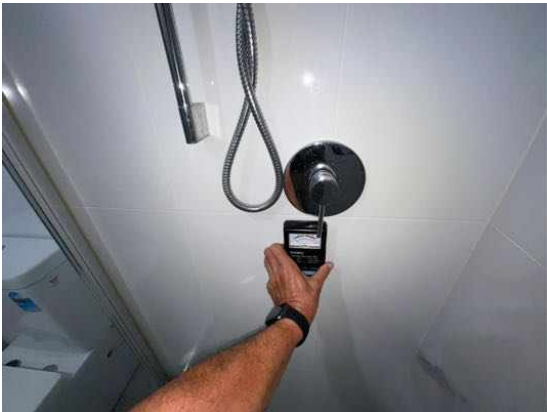
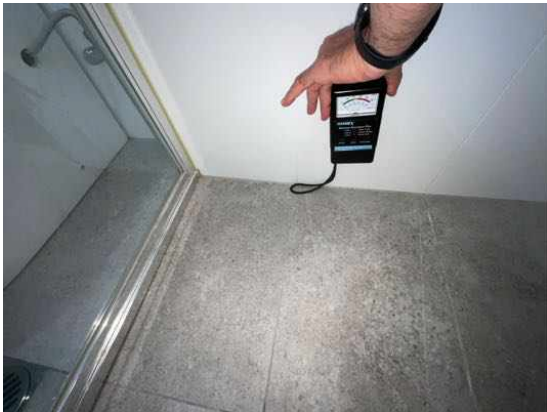
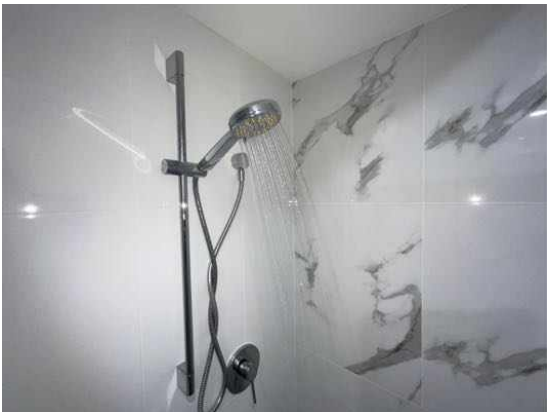
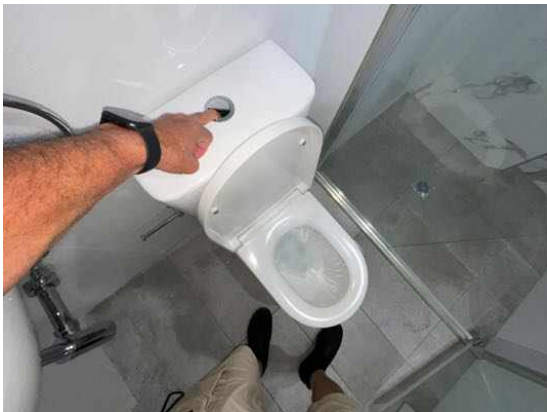
Building: Main Building  
Location: Ensuite  
Finding: Wet Areas - Bathroom(s) - Overall Condition & Recommendations.  
Information: Overall Condition & Recommendations

- Flood testing of the shower recess is recommended. This may reveal inadequacies in the waterproofing or shower screens, which could lead to water damage in surrounding areas.
- Floor waste was found to be clear and free of blockages at the time of inspection. Further monitoring is advised after consistent use to identify any drainage issues or buildup requiring cleaning.
- No elevated moisture readings were detected around the tap fittings or behind the shower walls (as viewed from adjacent rooms), suggesting no active plumbing leaks at the time of inspection.
- Sealing of grout and tiles is recommended to prevent moisture buildup and mould growth in damp areas such as showers.
- The condition of grout and sealant appeared to be good.
- The exhaust fan appeared to be operational, which supports moisture control in the bathroom.

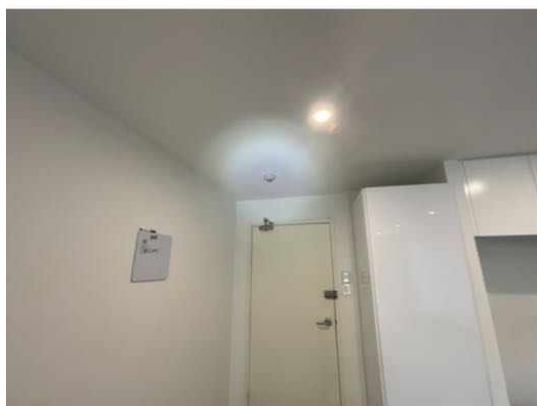
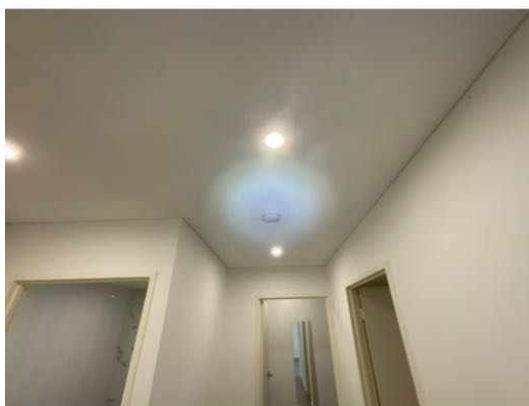
Building:	Main Building
Location:	All Areas
Finding:	Smoke Detectors / Alarms.
Information:	Reporting on the presence, type, location, or compliance of smoke detectors or alarms, including hard-wired smoke detection systems and their legislative requirements, is outside the scope of this inspection report.

To ensure compliance and safety, further inspection and/or advisory services from a qualified specialist are recommended. These services can confirm the sufficiency, type, location, and functionality of all smoke detection devices within the property.
