Building and Timber Pest Inspection Report

Inspection Date: Mon, 30 Mar 2026

Property Address: 17 Scoresby Ave, Shepparton VIC 3630,
Australia

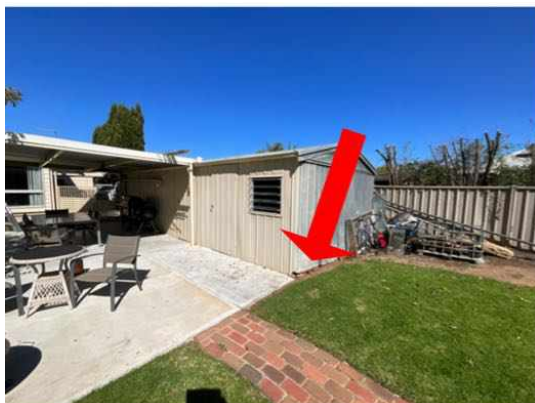
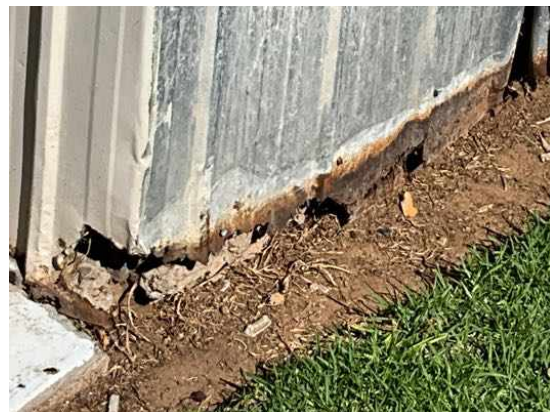
Finding 3.01

Building: Building 1
 Location: Garage
 Finding: Rust- metal component
 Information: The metal element in this area is rusted. This will further deteriorate if not addressed.

Appropriate trades should be contacted at the discretion of the client, to restore the area to improve utility.

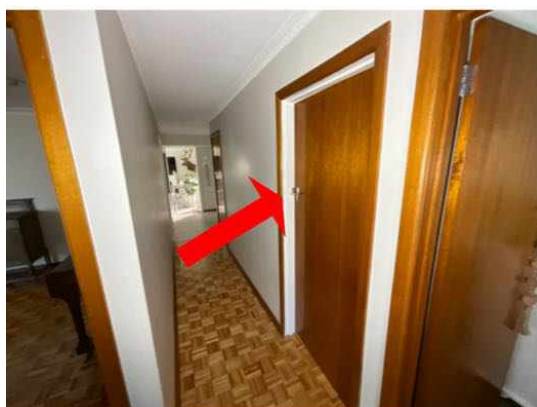
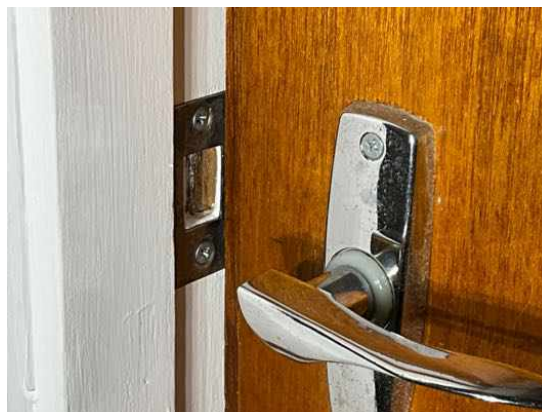
Finding 3.02

Building: Building 1
 Location: Bedroom 3
 Finding: Door - Striker plate misaligned
 Information: The striker plate to this door appears to have become misaligned and has consequently resulted in the door's operation being compromised.

This is a common defect and is expected in a property of this age, whether being due to substandard installation or general deterioration of the door hardware.

Readjustment of the striker plate is recommended at client discretion. Works such as

these can be completed by a general handyman or qualified carpenter.

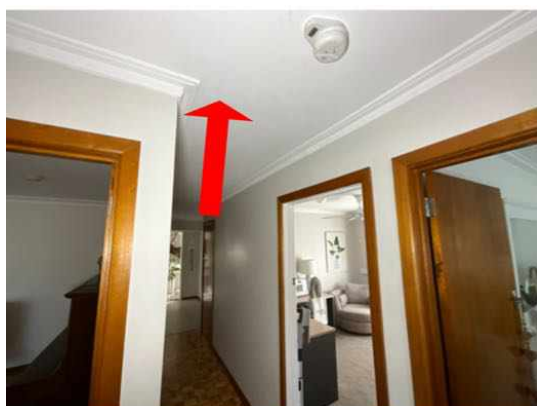
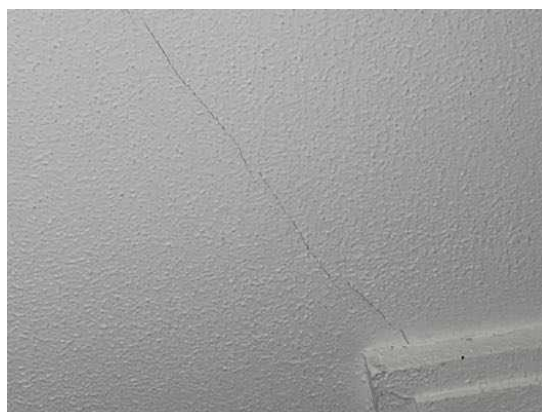
Finding 3.03

Building:	Building 1
Location:	Hall
Finding:	Cracking - Damage Category 1 - Fine (up to 1mm)
Information:	Although fine cracks are quite noticeable, they are often only considered to be an appearance defect, and usually do not indicate any structural damage. Generally, the cause of a fine crack is indicative of a separation between building materials and finishes (e.g. paint, plaster, etc.) along joins.

Cracking of this nature can generally be repaired with minor sanding, filling and/or repainting. Such works should be performed by a qualified painter or a general handyman.

Monitoring of all cracking should be conducted frequently. Always contact a building inspector should cracks widen, lengthen, or become more numerous.

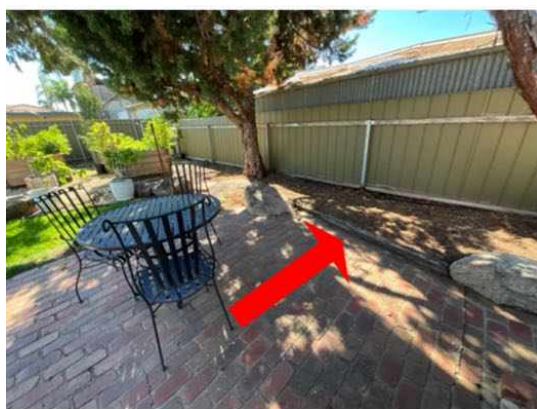
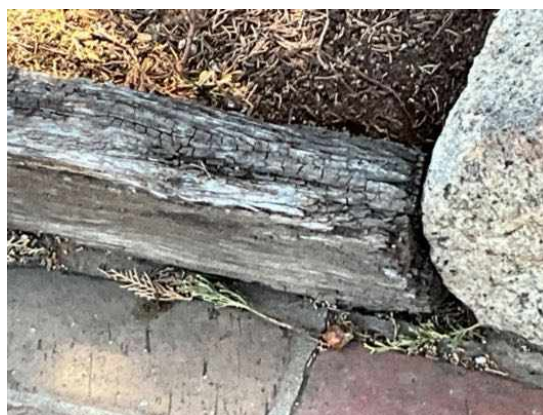
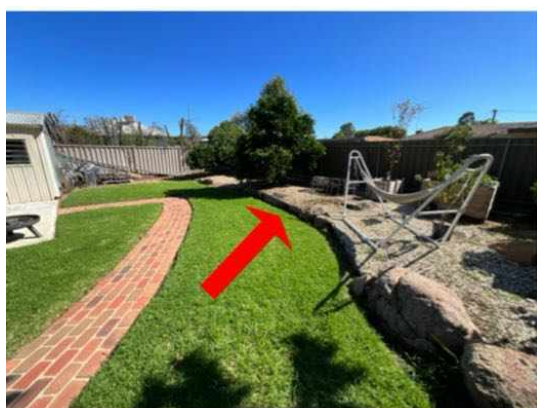
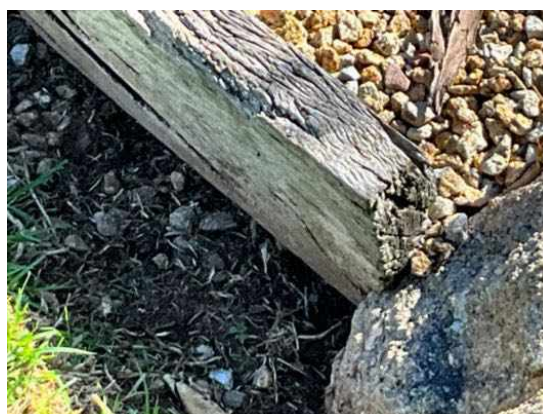
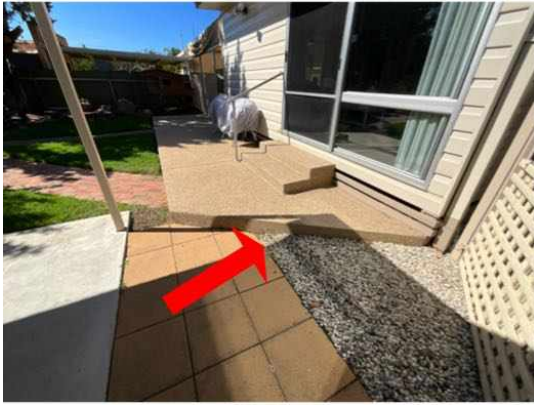
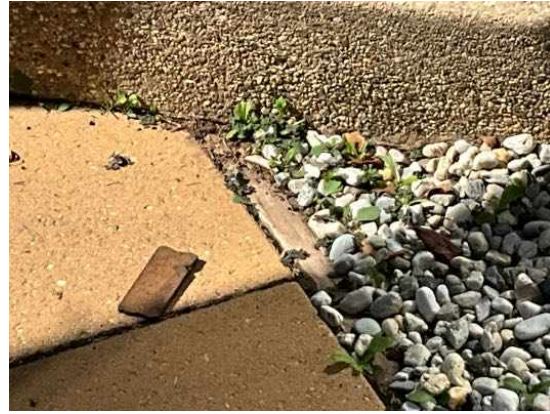
Finding 6.01

Building: Building 1
Location: Yard - Back
Finding: Untreated or non-durable timbers in a hazardous environment
Information: To reduce the risk of timber pest attack it is essential that timber used in a hazardous environment (e.g. in direct contact with the ground or frequently exposed to damp conditions) is of sufficient durability and/or is adequately preservative treated.

Untreated timbers in direct contact with the ground are likely to develop severe wood rot and/or fungal decay if left unattended creating attraction for subterranean termites to infest the timbers from surrounding areas.

If untreated or non-durable timbers are found to be in a hazardous environment it is highly advised that replacement of these building elements be performed as soon as possible to aid the protection of the property against termite / timber pest attack.

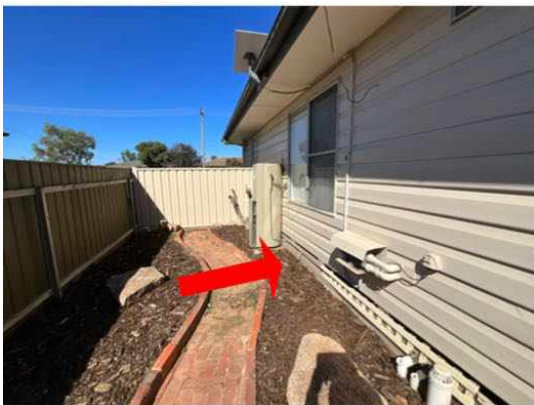
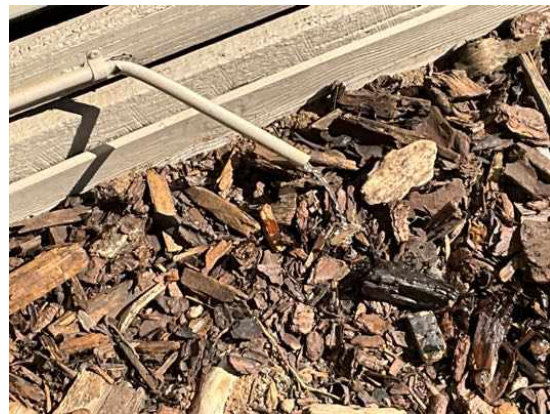
Finding 6.02

Building: Building 1
 Location: Yard - Side
 Finding: HWS Overflow - Not Connected
 Information: The Hot Water System (HWS) overflow was found to be disconnected from storm water drainage and is creating excessive moisture in the surrounding area.

These damp conditions can lead to secondary defects such as rot, rust or corrosion of associated building elements, the formation of fungal decay, or even the creation of potential slip hazards. When coupled with poor site drainage, pooling of water may also attract termite activity to this area.

It is highly recommended that a licensed plumber be appointed to connect the HWS overflow in order to prevent such an environment from being created. These minor works should be carried out as soon as possible.

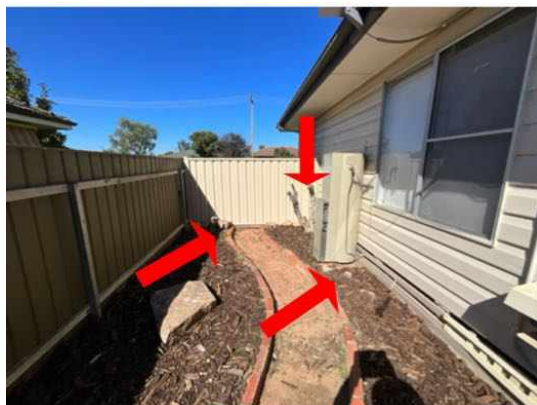
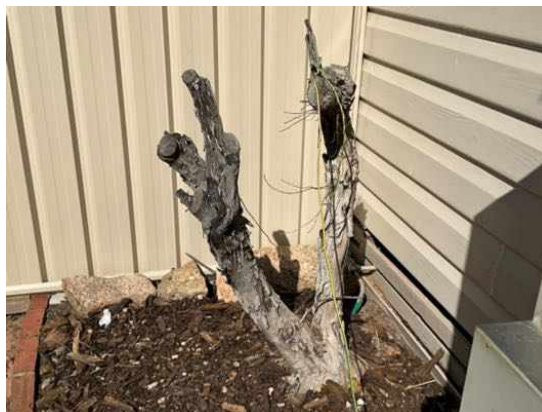
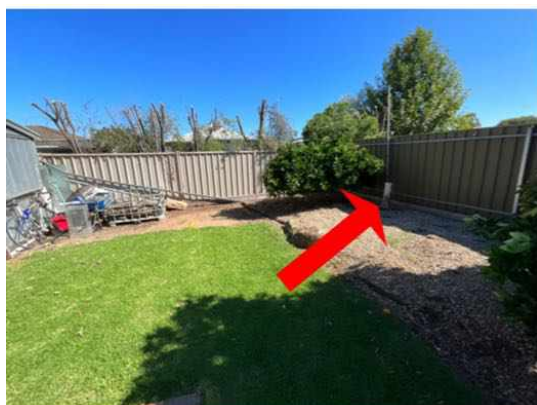
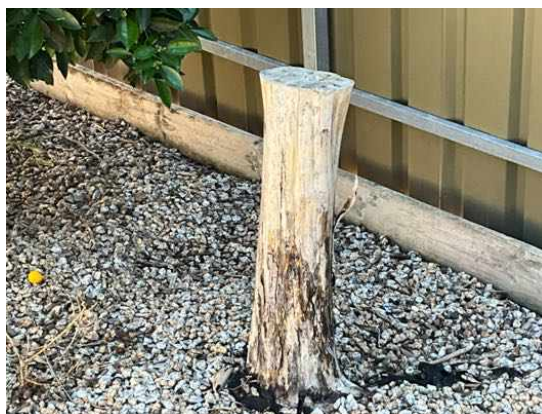
Finding 6.03

Building: Building 1
 Location: Yard - Side, back
 Finding: Tree Stump in Ground
 Information: Any tree stumps in the yard not removed during the tree removal process provides the

opportunity for Termite infestation and is likely to be subject to decay from damp conditions against the stump.

All tree stumps should be removed by professional tree removal services where possible. Meanwhile regular inspections are advised to identify any termite activity in the areas identified.

Services for tree stump removal should be contacted as soon as possible to reduce the risk of timber pest attack.

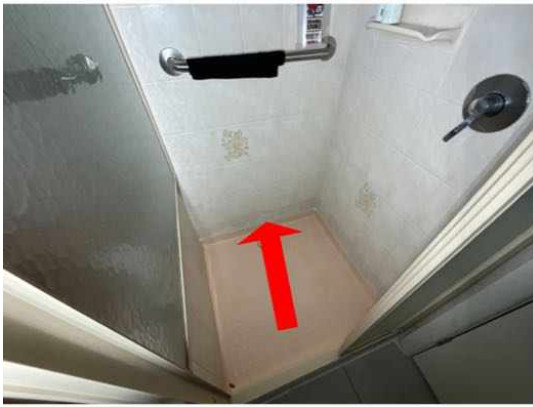
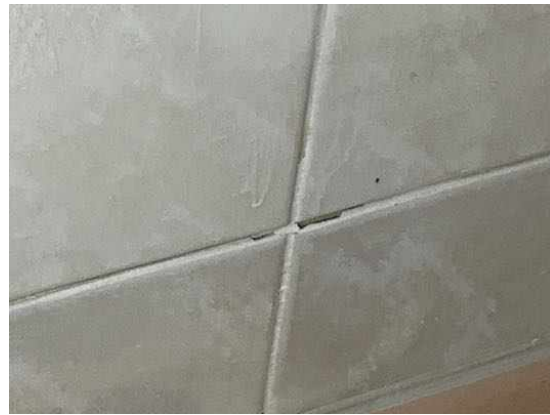
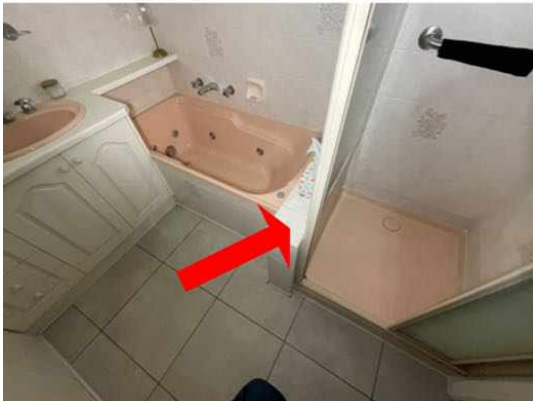
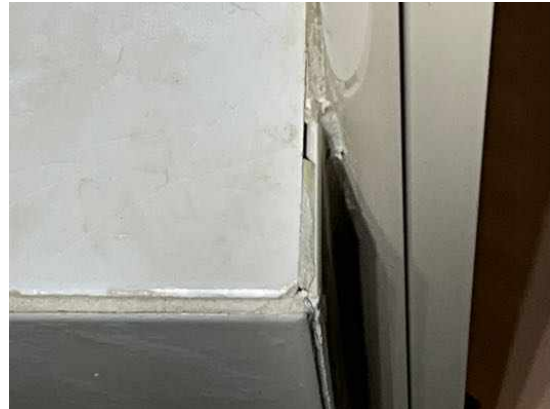
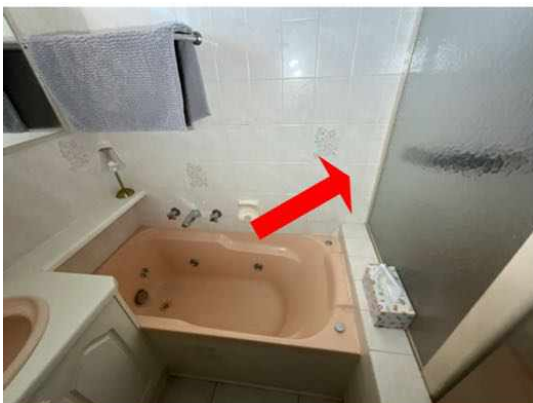
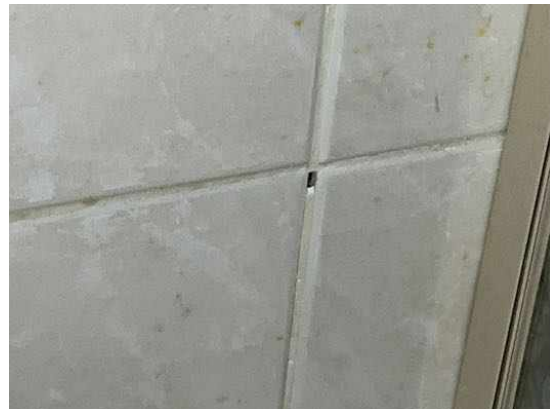
Finding 6.04

Building:	Building 1
Location:	Bathroom
Finding:	Inadequate sealant or Grout
Information:	This area has a lack of effective Sealant or Grout. This is allowing the ingress of water to the structure inside the wall.

The presence of water encourages Termite attack, Mould and Fungal Decay.

A Tiler or General Handy person must be contacted as soon as possible to effect repairs and prevent further deterioration.

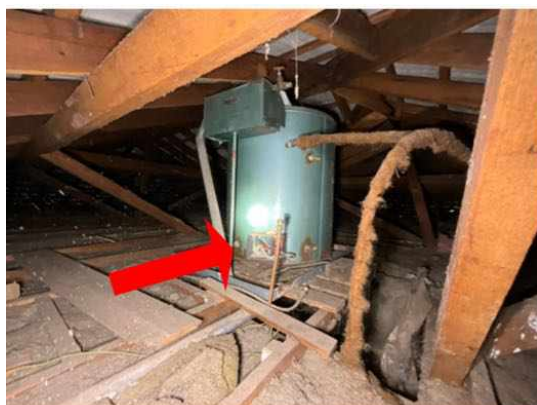
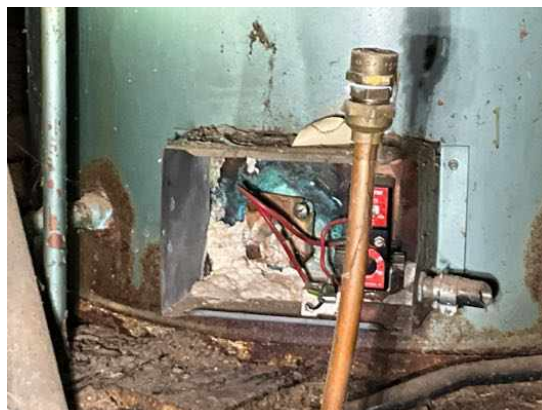
Finding 6.05

Building:	Building 1
Location:	Roof Void
Finding:	Gravity-Fed HWS - Disconnected
Information:	It was noted at the time of inspection that a disconnected gravity-fed hot water system (HWS) remains in this area.

Despite this plumbing structure being unused, it is likely to be storing residual water, and is therefore susceptible to rust and corrosion. If allowed to continue, rust and corrosion is likely to lead to damage to adjoining building elements, and may also make the area susceptible to termite or timber pest activity.

While it is a costly exercise to remove the disused gravity-fed HWS, it is advisable in the short-term future to prevent any further damage to the area. Further consultation with a licensed plumber is required to gain further advice on removal of the structure.

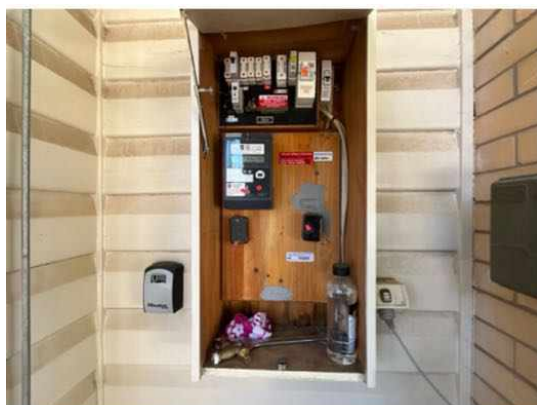
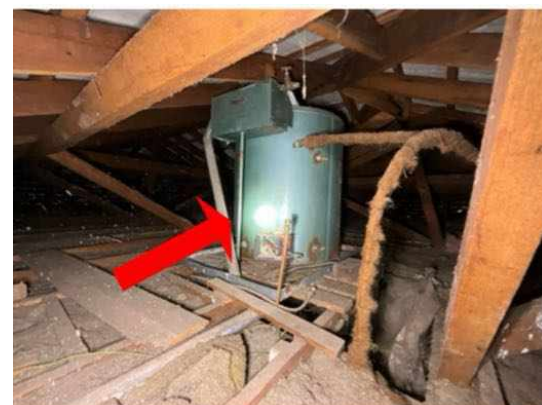
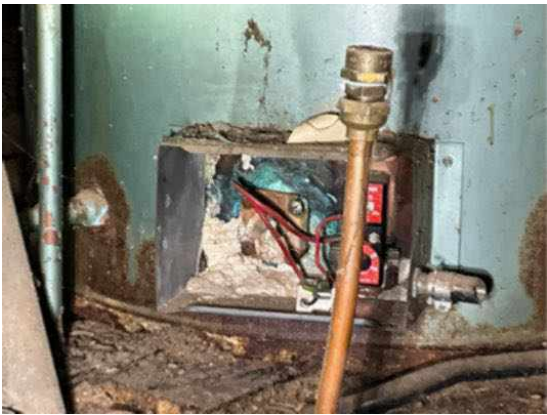
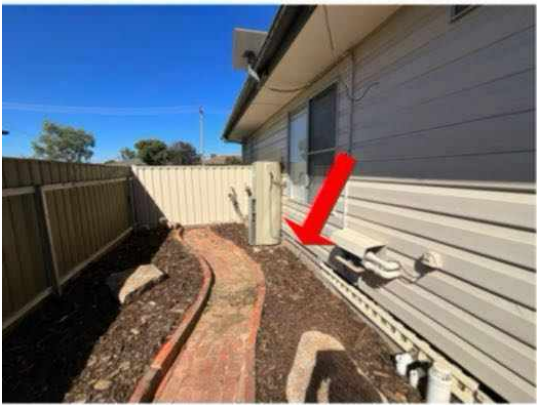
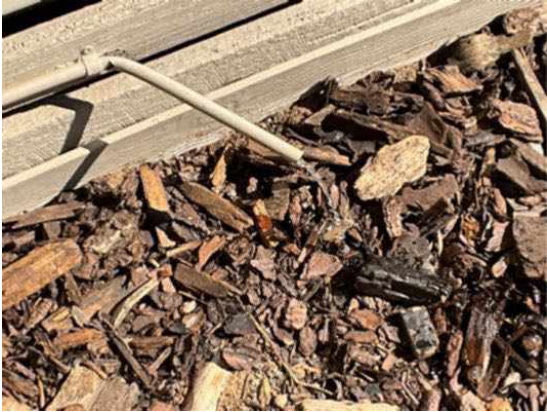
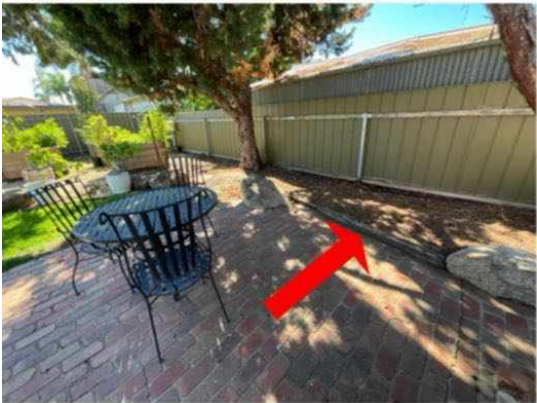
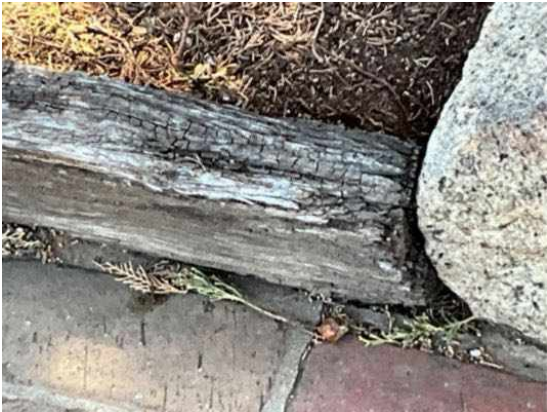
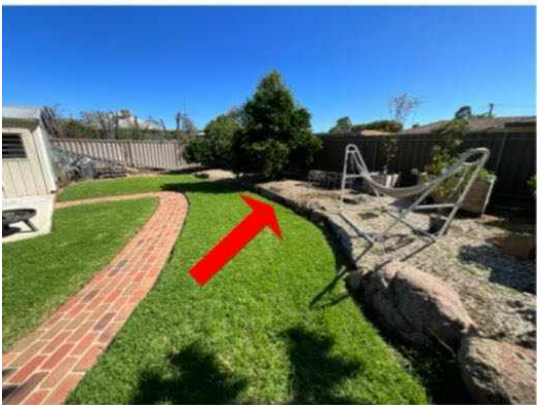
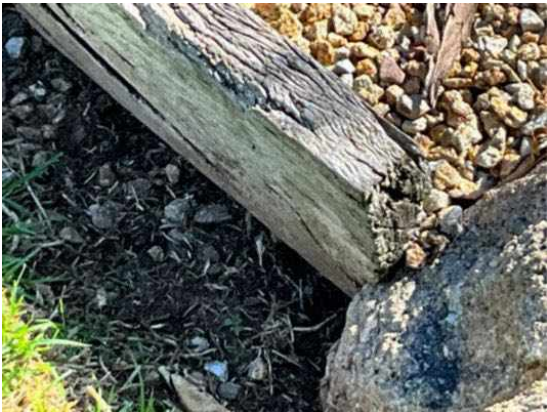
Finding 6.06

Building:	Building 1
Location:	All External Areas
Finding:	Termite Management System - no evidence of a chemical installation
Information:	The application of a post-construction chemical termite barrier is highly recommended for all properties, particularly if live termite activity has been found on the site previously. Such barriers are highly effective in preventing termite attack on any timber building elements throughout the property.

A durable notice should be placed in the switchboard unit to indicate current termite barriers. At the time of inspection, it appeared as though no termite management system has been installed, with no evidence to suggest preventative works taking place.

The client may consider gaining further advice from a pest controller as to the costs and procedures involved with this application. It is recommended that obtaining such advice be a short-term priority.

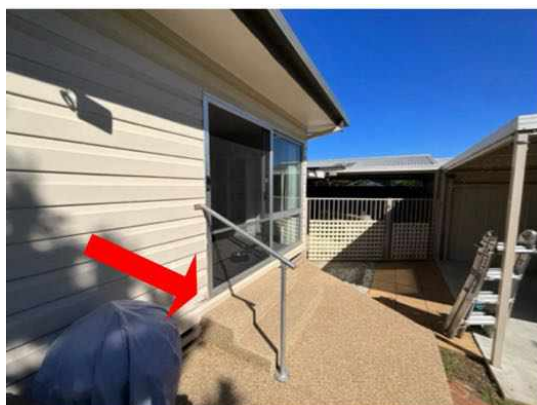
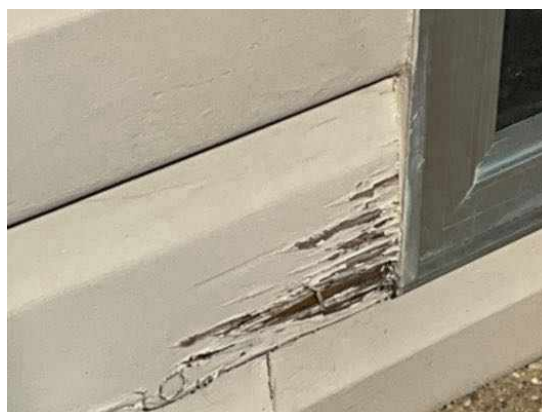
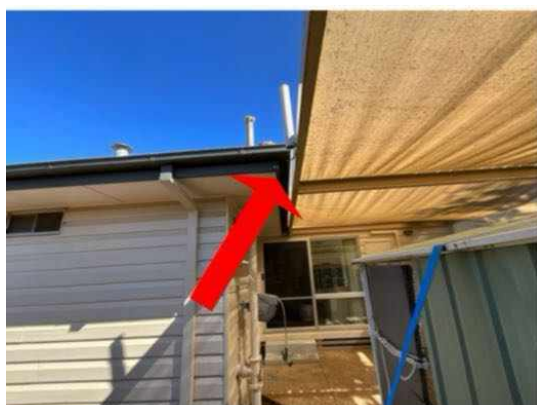
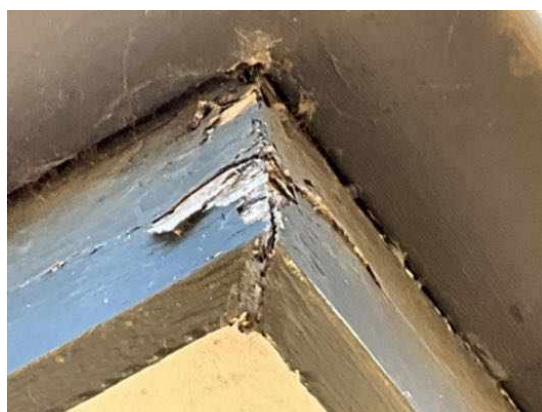
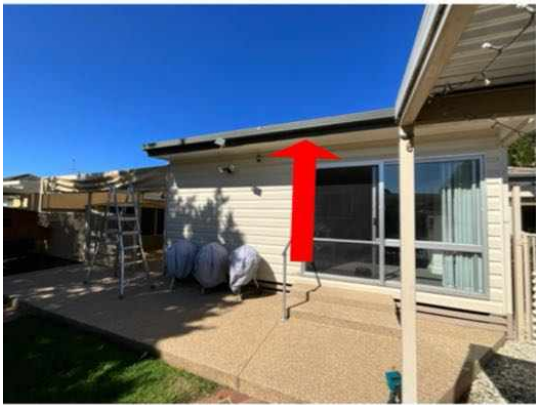
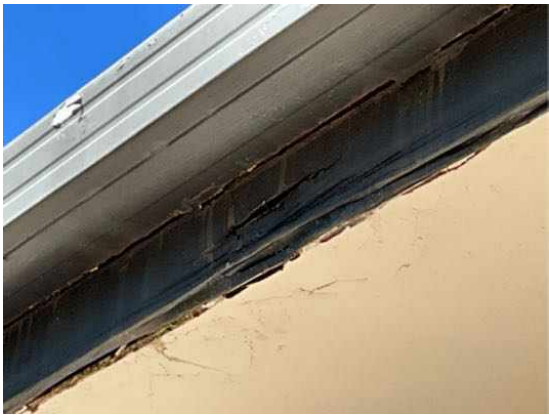
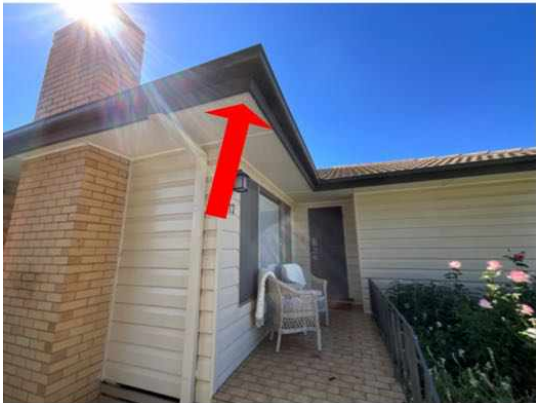
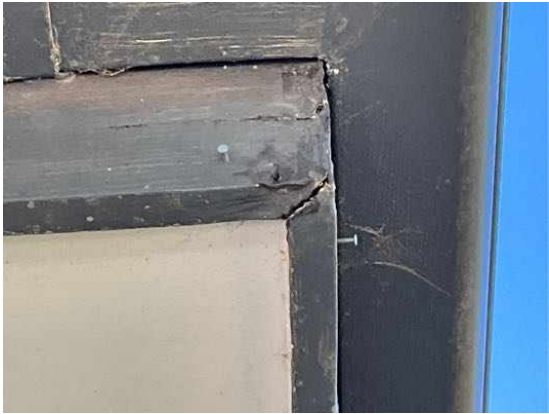
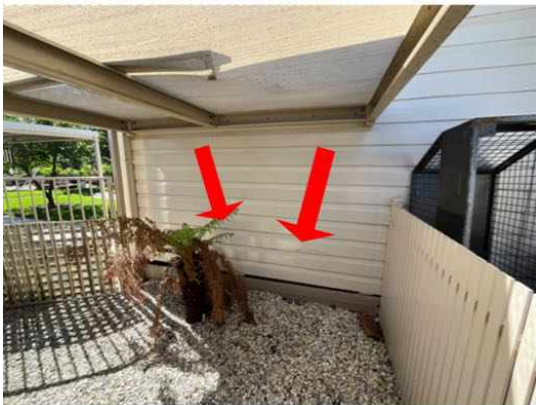
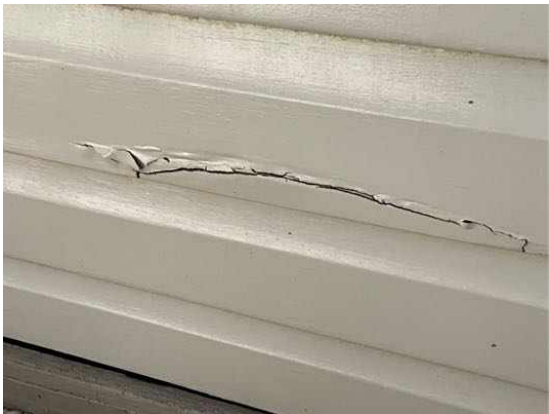
Finding 7.01

Building:	Building 1
Location:	Back door, eaves
Finding:	Fungal decay - present (localised)
Information:	Fungal decay also known as wood decay or wood rot generally refers to the deterioration of timber elements when in contact with excessive levels of moisture for a prolonged period of time.

The development of fungal decay is accelerated by temperatures in the range of 5degreeC to 40degreeC as well as the presence of oxygen. Generally fungal decay develops on timber elements that are in use in an external environment which are exposed to rain penetration.

In this case although the affected timber element is in a decaying state the extent of any visible damage appears to be localised to a specific area and is yet to spread to other parts of the building element or affect adjoining structures. The fungal decay is therefore likely to be of a relatively superficial nature with minimal impact on the structural integrity or tensile strength of the timber element.

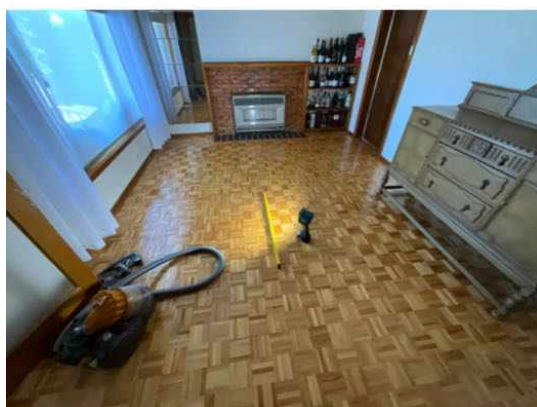
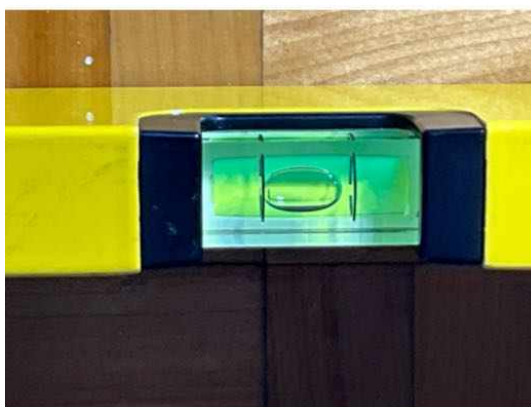
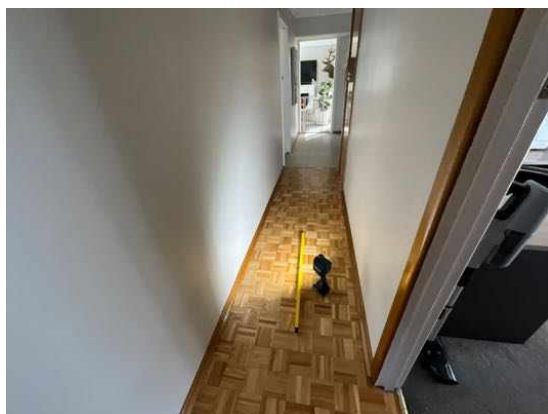
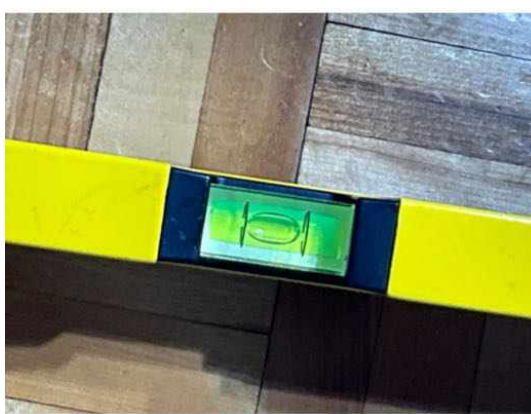
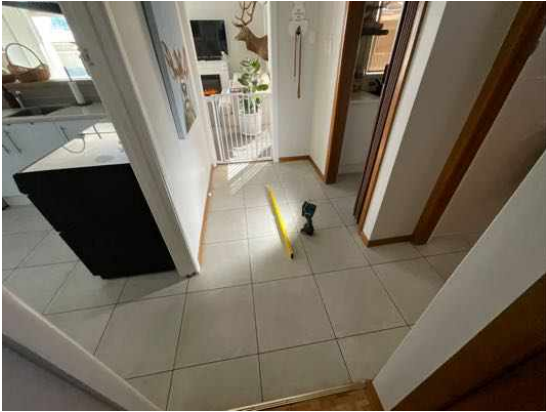
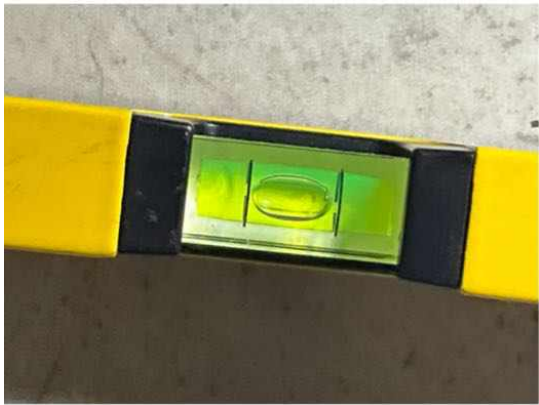
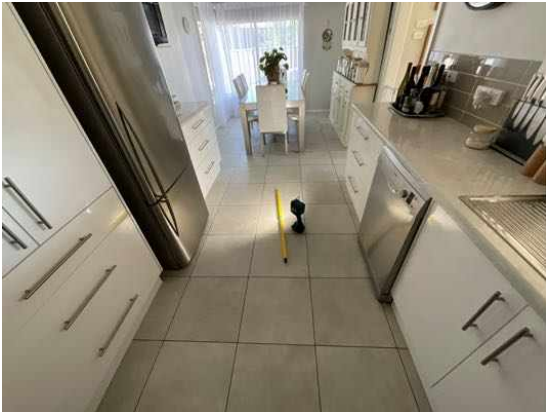
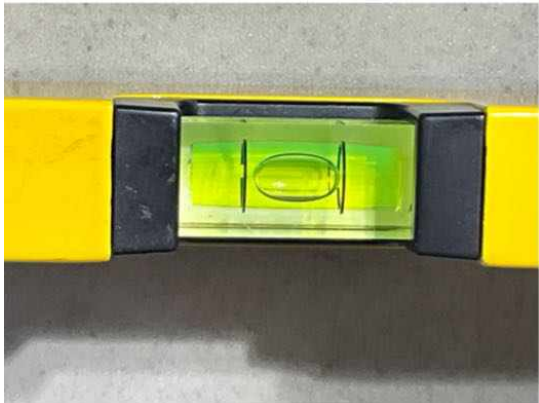
Building: Building 1
Location: All Internal Areas
Finding: Flooring - slightly uneven
Information: The internal flooring in this area is out of level and uneven. Uneven flooring is likely to indicate minor defects such as expected movement of the foundations of the property, but may also indicate subsidence of the associated subfloor stumps.

It is advised that the flooring be closely monitored to identify any further movement. Where flooring remains relatively unchanged for an extended period of time (i.e. several months), it is likely that this defect has been caused by expected movement of the foundations of the property.

However, where flooring is increasingly uneven, potentially invasive inspection of the subfloor structures and stumps in this area is required. In this case, works to repair are likely to be required, and would be carried out by a registered builder specialising in re-stumping.

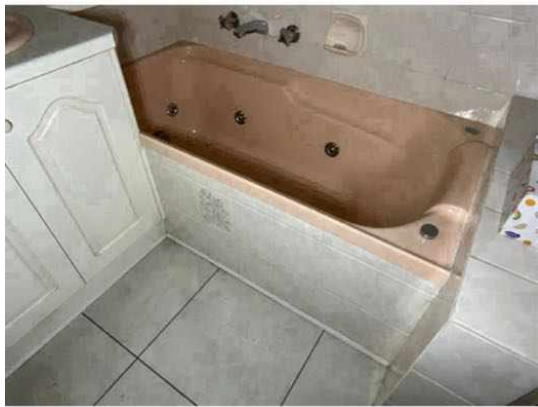
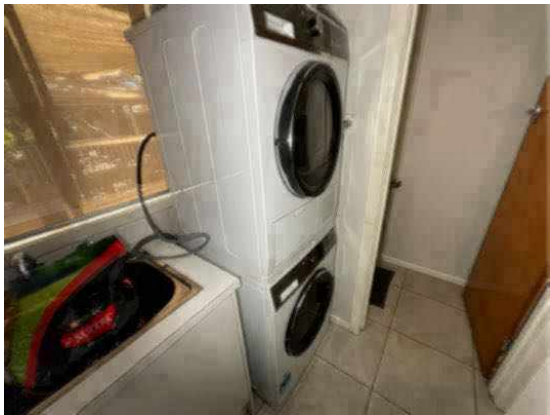
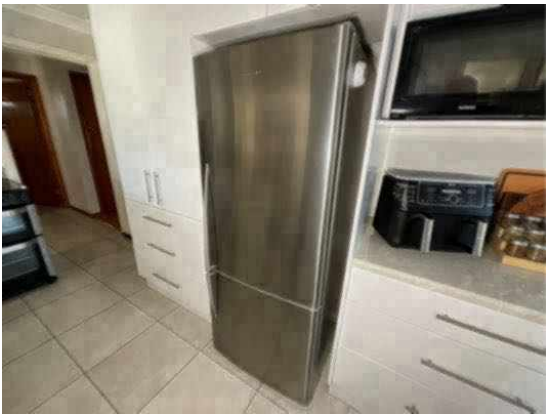
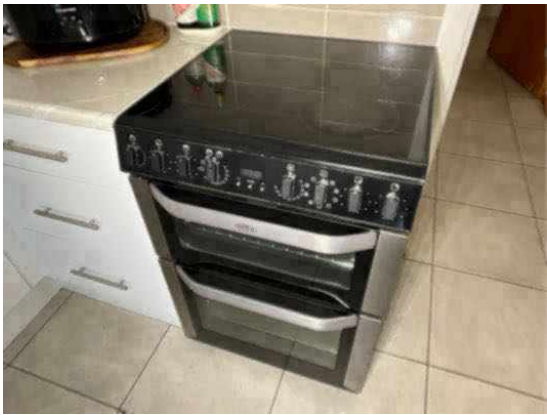
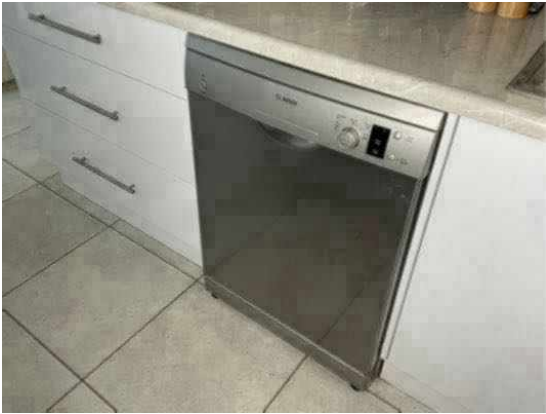
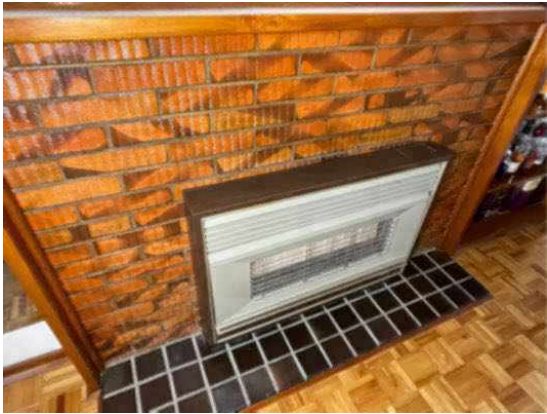
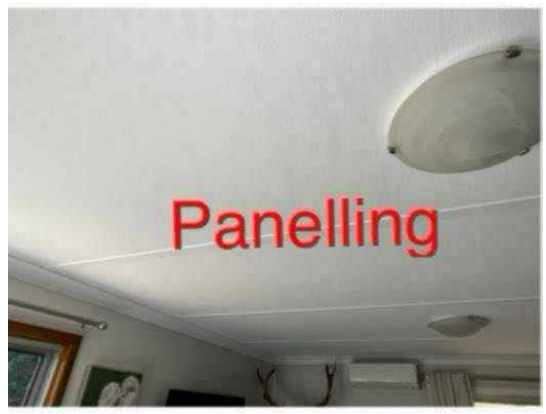
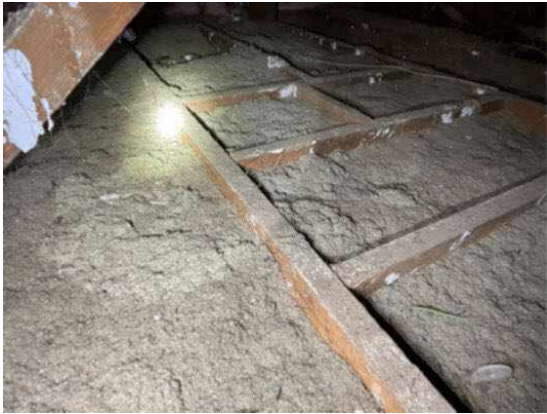
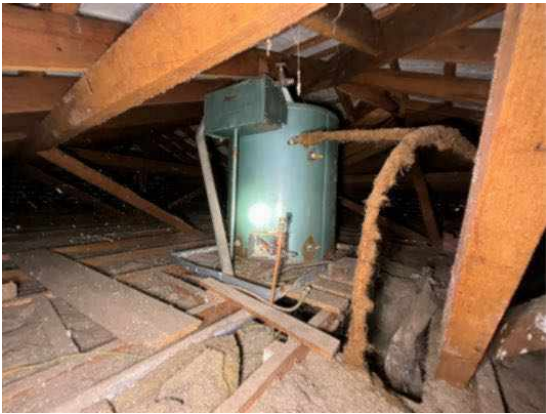
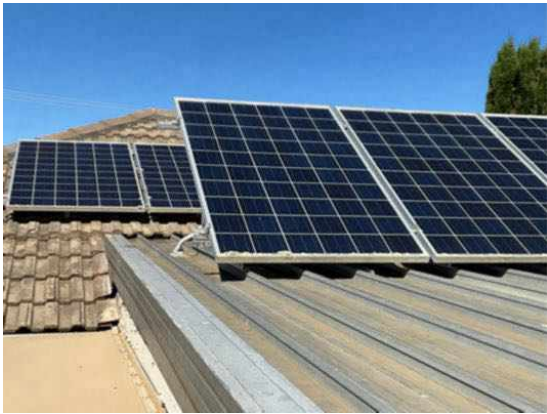
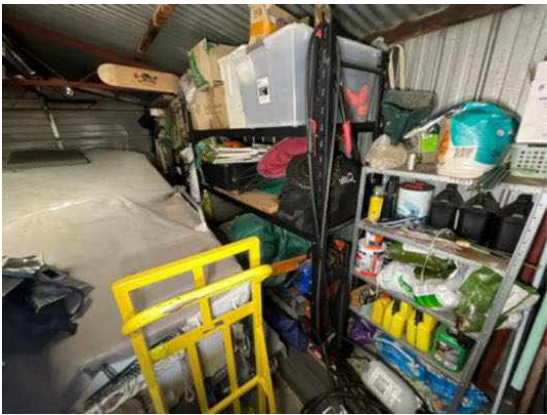
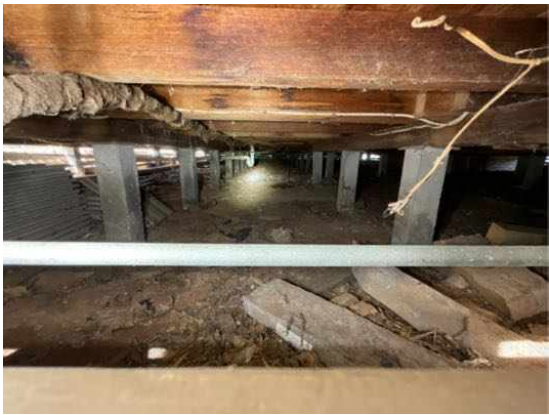
Building: Building 1
Location: All Areas
Finding: Additional Photos - Obstructions and Limitations
Information: These photographs are an indication of the obstructions and limitations which impeded full inspection of the property at the time of inspection. These obstructions can hide an array of defects and should be removed to allow full inspection to be carried out. A re-inspection is recommended once the areas are made accessible.
