Building Inspection Report

Inspection Date: Wed, 4 Feb 2026

Property Address: 23 Craighlands Ave, GORDON, NSW, 2072,
Australia

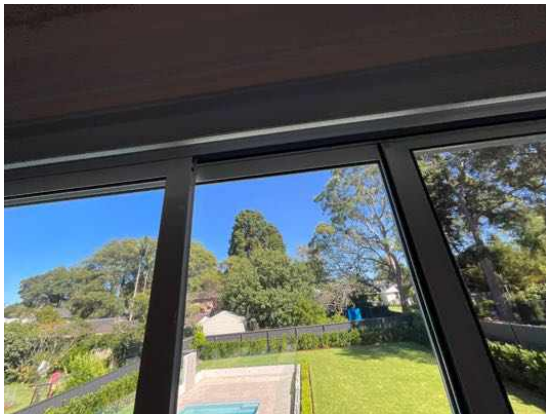
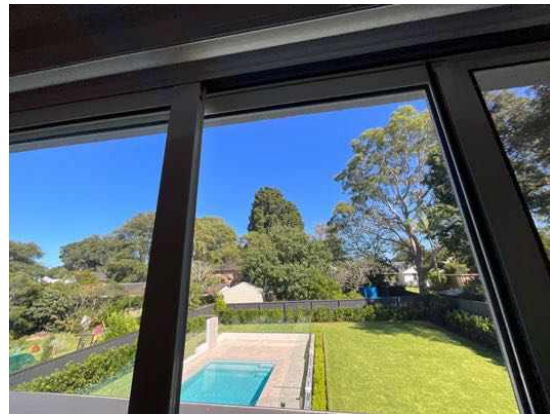
Defects 1.03

Building: Main Building
Location: All Areas
Finding: Window child lock missing
Information: The window in question lacks a child lock mechanism, which poses a potential safety risk to young occupants in the premises. As per Australian Standards windows accessible to children should be equipped with appropriate child safety locks to prevent accidental opening, reducing the risk of falls and ensuring compliance with safety regulations.

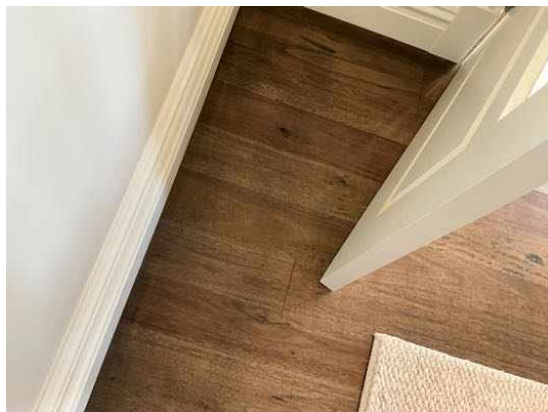
Defects 3.05

Building: Main Building
Location: Home office
Finding: Missing Door Stopper
Information: The door lacks a stopper, which is essential to prevent the door from swinging too far and potentially damaging the wall or the door handle. The absence of a door stopper increases the likelihood of impact damage to both the door and surrounding surfaces over time.

- **Damage Risk:** Moderate risk of damage to the door handle, wall, or door itself from repeated impacts when the door is opened forcefully or by a gust of wind.
- **Wear and Tear Risk:** Increased wear on door hardware and hinges due to the potential for abrupt stops without a dedicated stopper.

This issue is a minor defect but should be addressed to prevent potential damage and maintain the integrity of the door and surrounding areas.

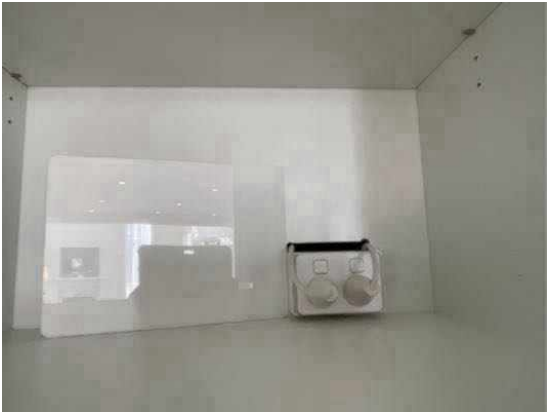
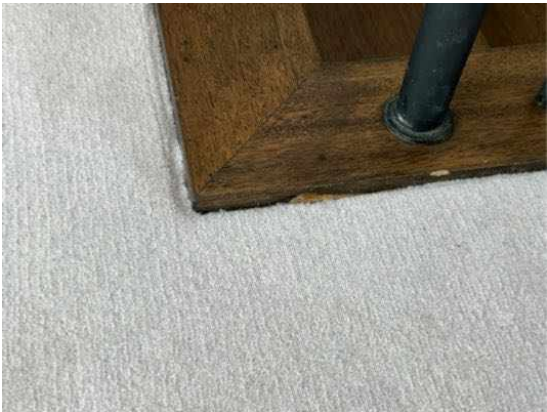
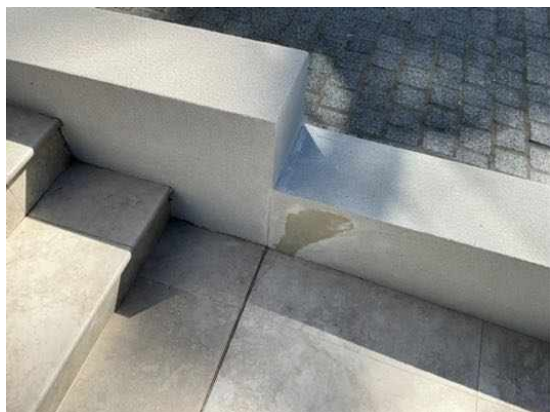
Defects 3.06

Building:	Main Building
Location:	All Areas
Finding:	Substandard Work- Various Areas of the Building
Information:	Substandard work has been identified in multiple areas throughout the building, failing to meet the requirements specified by Australian Guides and Tolerances.

- ****Paint Application:**** Inconsistent and incomplete paint coverage on walls, ceilings, and downpipes, with visible brush marks, drips, and streaks.
- ****Surface Preparation:**** Poor surface preparation resulting in inadequate paint adhesion and flaking..
- ****Plasterwork:**** Cracks in plaster exceeding the acceptable width as specified in the Guide to Standards and Tolerances.
- ****Fixtures and Fittings:**** Misaligned or improperly installed fixtures and fittings, not meeting the standard requirements for level and alignment.

- Accelerated deterioration and reduced durability of the affected elements.
- Compromised aesthetic quality and overall value of the property.
- Potential safety hazards and increased maintenance costs.

- Repainting surfaces with proper surface preparation and uniform application.
- Repairing or replacing cracked plaster to ensure compliance with acceptable standards.
- Realigning and properly installing fixtures and fittings.

A comprehensive inspection should be conducted post-repairs to ensure all rectifications comply with the required standards.

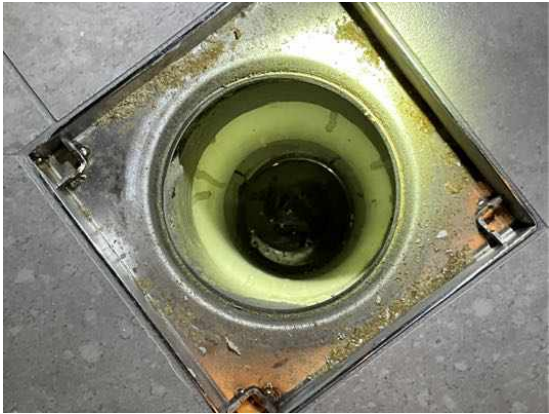
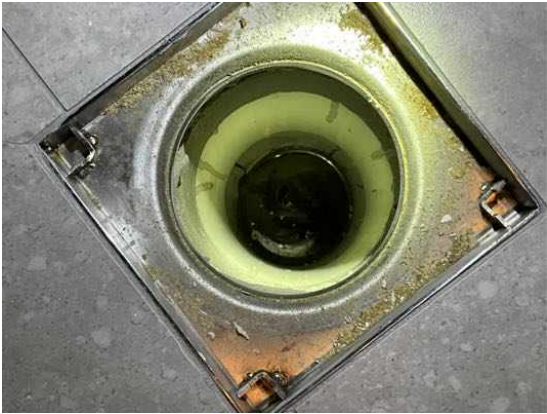
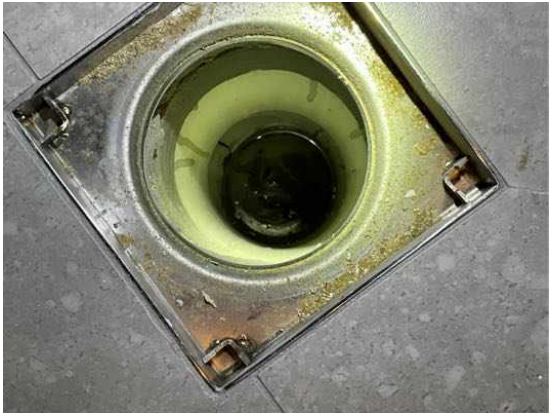
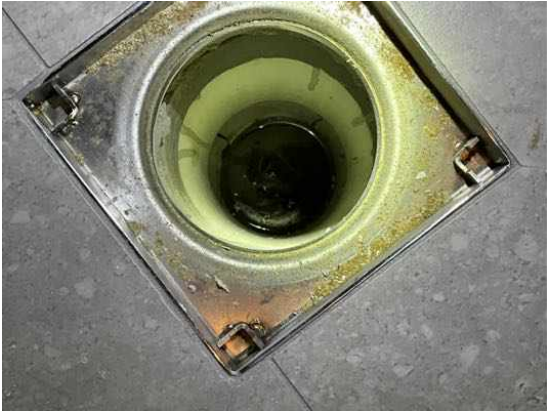
Defects 3.07

Building:	Main Building
Location:	All Areas
Finding:	Floor waste Debris
Information:	It was noted that there is builder debris in the floor waste drainage. Debris in the plumbing system may lead to blockages in the future.

Building sites are defective if they are not clear of building debris. All floor wastes need to be checked and cleared prior to handover.

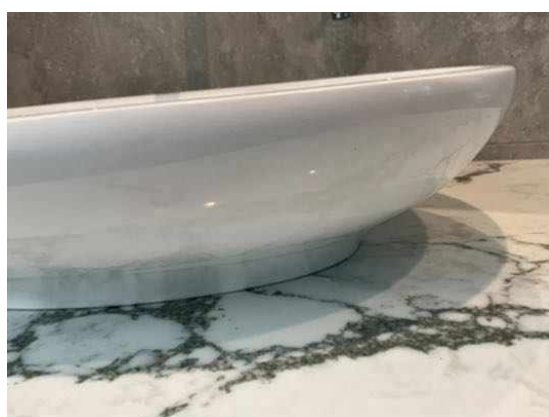
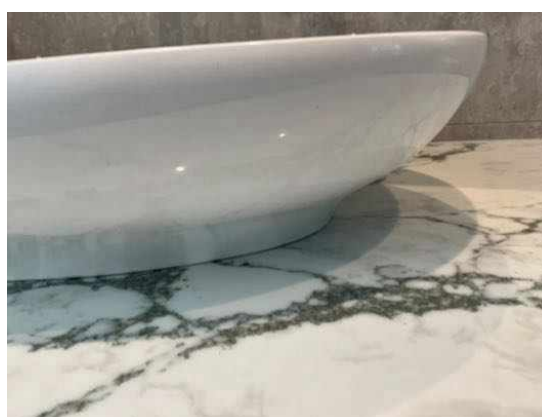
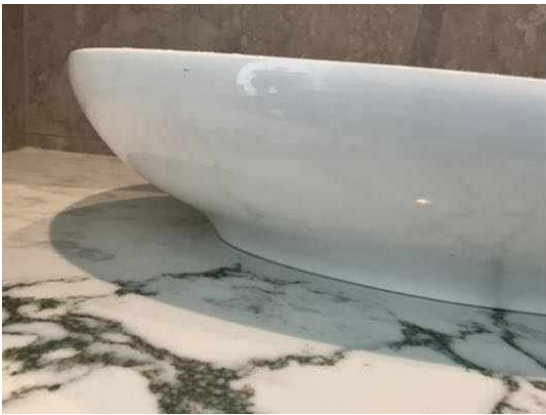
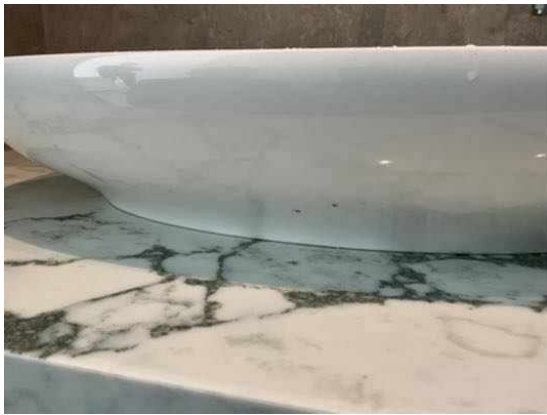
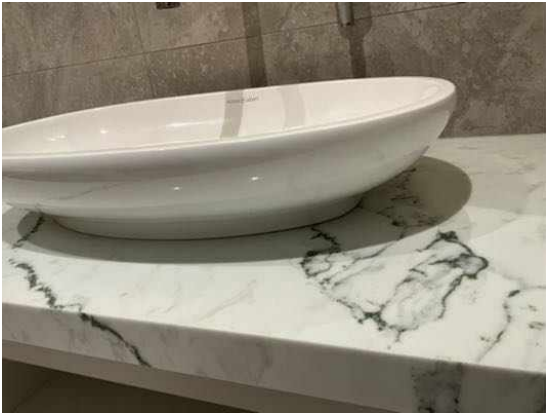
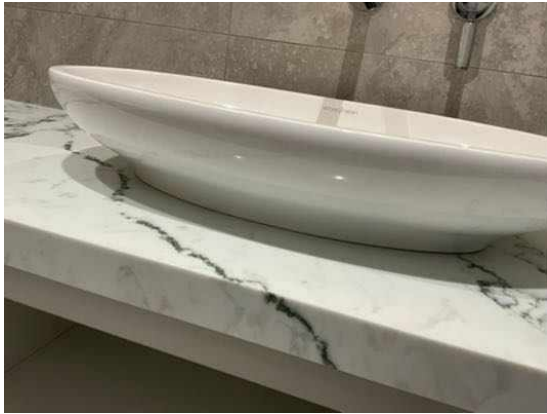
Defects 3.08

Building: Main Building
Location: All Areas
Finding: Silicone- Missing Sealant Around Basin
Information: No silicone sealant was observed around the perimeter of the vessel basin where it meets the benchtop surface. This is considered non-compliant with good building practice and may allow moisture ingress, leading to potential swelling, mould growth, and damage to cabinetry and surrounding finishes.

In accordance with the NCC and the Guide to Standards and Tolerances 2017, joints between sanitary fixtures (such as basins) and adjoining surfaces must be properly sealed with a flexible waterproof sealant to ensure water resistance and durability.

It is recommended that a qualified tradesperson apply a continuous bead of mould-resistant, sanitary-grade silicone sealant to all exposed joints to prevent future water damage and ensure compliance with standards.

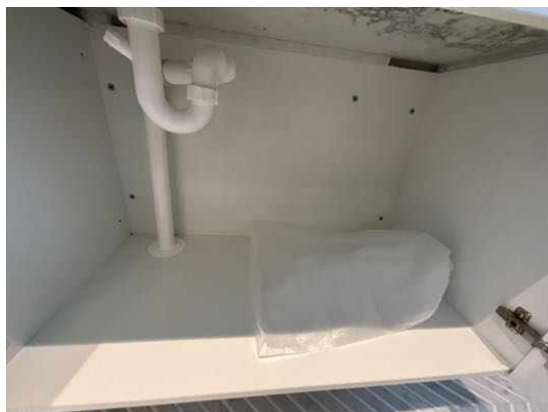
Defects 3.11

Building: Main Building
Location: All Areas
Finding: Joinery - screw caps/ stickers missing
Information: Screws inside cabinets, wardrobes, vanities and the like should be capped or covered. This is to be completed prior to handover.

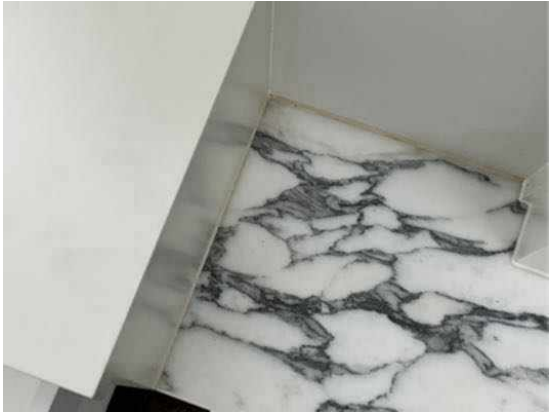
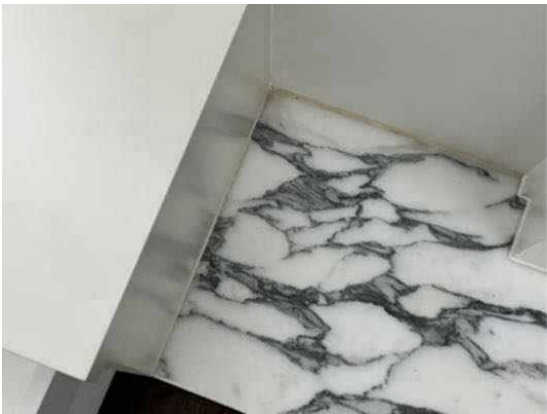
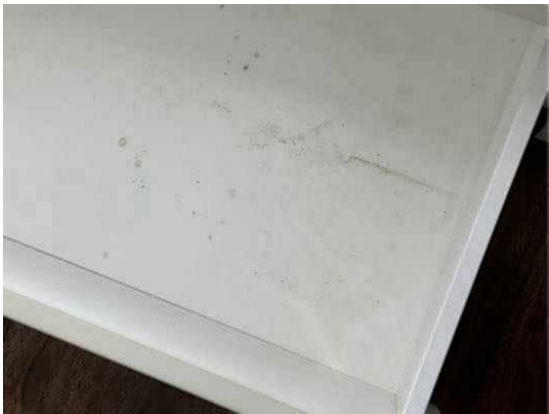
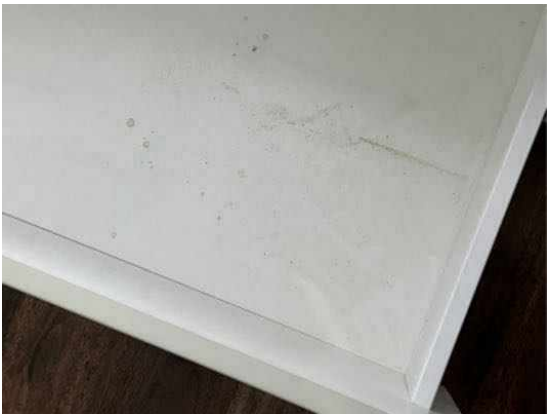
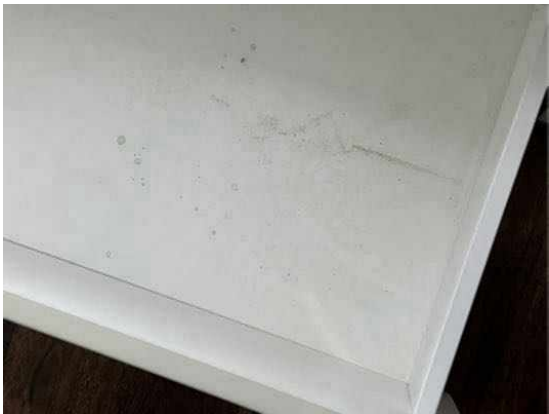
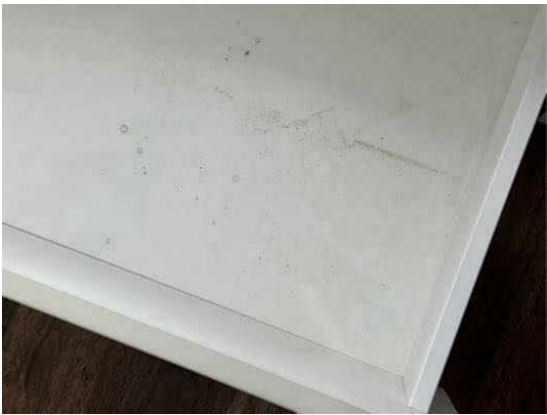
Defects 3.12

Building:	Main Building
Location:	All Areas
Finding:	Cleaning required
Information:	It was observed that the house requires cleaning.

Works are defective where windows are not clean, floors are not swept, mopped or vacuumed as appropriate, tiles, sinks, basins, baths, windows or any other area throughout the property are not cleaned, and shelving, drawers and cupboards are not ready for use not cleaned and ready for use at handover.

Please note: Not all cleaning defects were documented with photographs. However, it is the responsibility of the builder to attend to all cleaning issues, regardless of whether they were captured in the provided images. It is important for the builder to thoroughly inspect the property and address any and all cleaning deficiencies to ensure the property is in optimal condition for the new occupants at handover. Failure to do so may result in further inspections and delays.

This is to be addressed prior to handover.

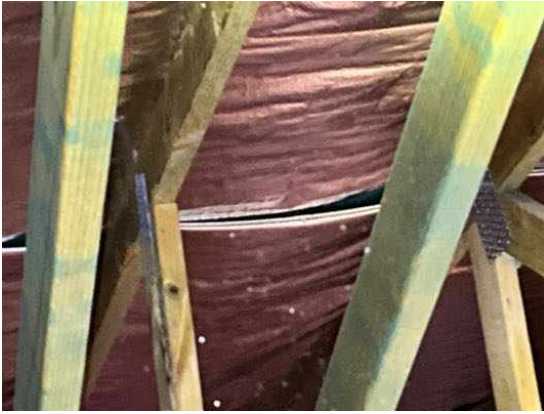
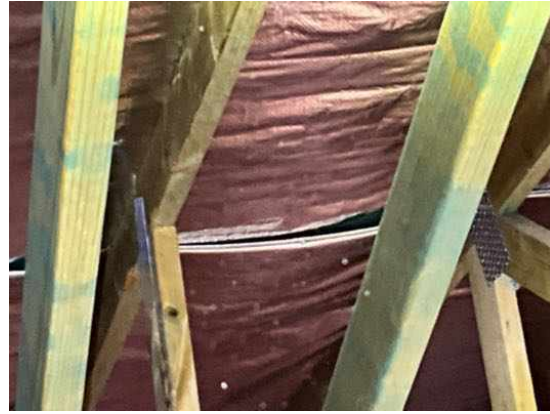
Defects 3.13

Building:	Main Building
Location:	Roof Void
Finding:	Sarking - substandard installation
Information:	The sarking in the roof cavity is not properly covering some joints and is not overlapping in other areas, indicating substandard installation.

****Risk:**** Improper sarking installation can lead to inadequate moisture and thermal protection, resulting in potential water damage, reduced energy efficiency, and increased susceptibility to mold growth.

****Recommended Action:**** A professional roofer should be engaged to re-install or

repair the sarking to ensure it is properly covering all joints and correctly installed, providing adequate protection for the roof structure.
