## Building Inspection Report

Inspection Date: Tue, 17 Feb 2026

Property Address: 6 Avenza St, Mentone VIC 3194, Australia

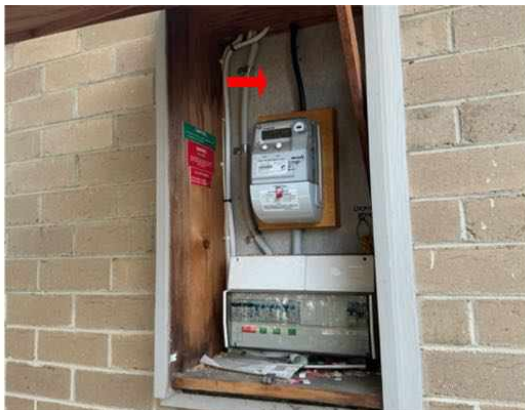
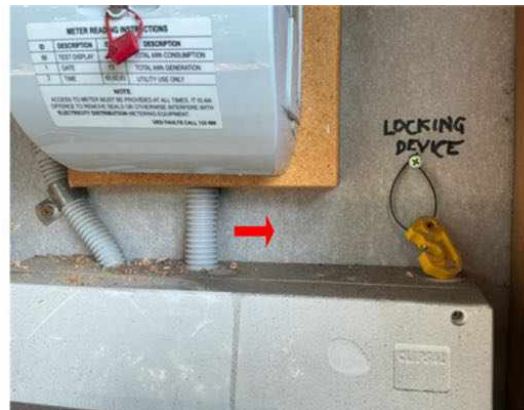
#### Defects 1.01

Building:	Main Building
Location:	Electrical Switchboard
Finding:	Asbestos - Suspected ACM Identified on Site
Information:	Reporting on Asbestos is outside the Scope of this Report. This suspected defect is highlighted as a caution only. We suspect, based on our experience in the building industry, that there is a higher risk of the identified building element containing asbestos.

As Asbestos Reporting is outside the scope of this report, we advise that you consider a separate Asbestos Inspection and Condition Audit, which can include the taking of samples for definitive confirmation of the presence of Asbestos.

In the interim, the client is advised to act with caution, especially when considering any damage to building materials general wear and tear renovations extensions demolition and general maintenance activities due to the suspected presence of Asbestos.

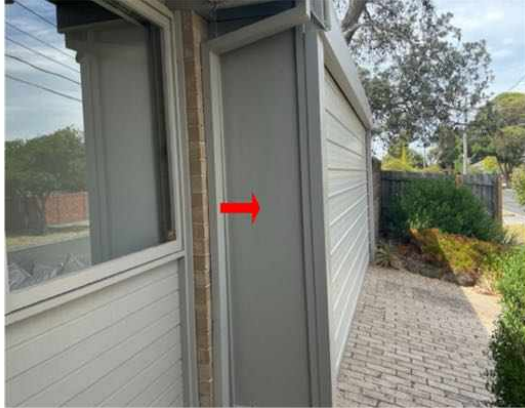
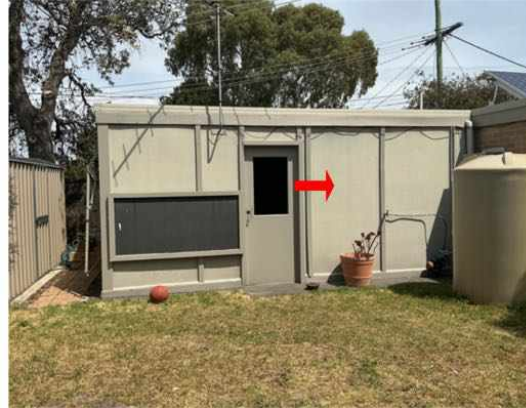
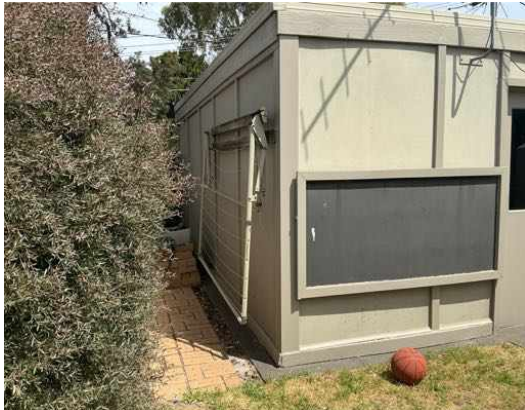
#### Defects 1.02

Building:	Main Building
Location:	Garage
Finding:	Asbestos - Suspected ACM Identified on Site
Information:	Reporting on Asbestos is outside the Scope of this Report. This suspected defect is highlighted as a caution only. We suspect, based on our experience in the building industry, that there is a higher risk of the identified building element containing asbestos.

As Asbestos Reporting is outside the scope of this report, we advise that you consider a separate Asbestos Inspection and Condition Audit, which can include the taking of

samples for definitive confirmation of the presence of Asbestos.

In the interim, the client is advised to act with caution, especially when considering any damage to building materials general wear and tear renovations extensions demolition and general maintenance activities due to the suspected presence of Asbestos.

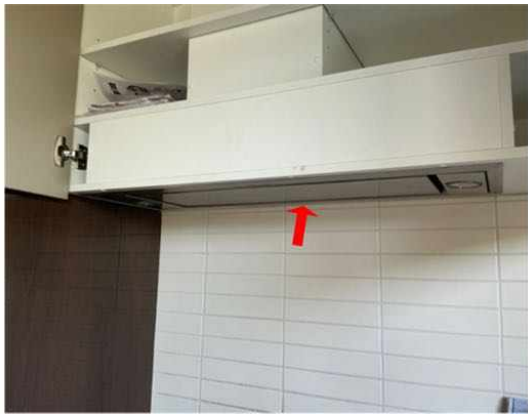
### Defects 3.01

Building: Main Building  
Location: Kitchen  
Finding: Rangehood - not working  
Information: This appliance was not working at the time of inspection.

A licensed electrician should be appointed to replace the range hood to restore it to a fully operational state.

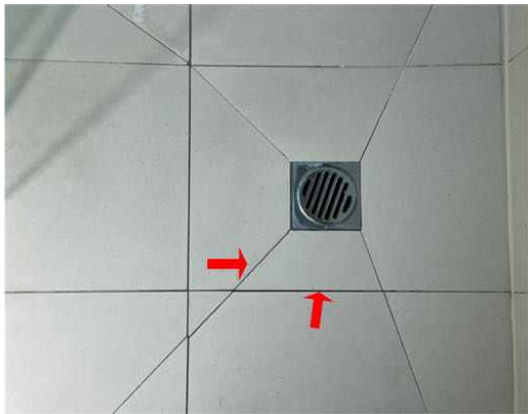
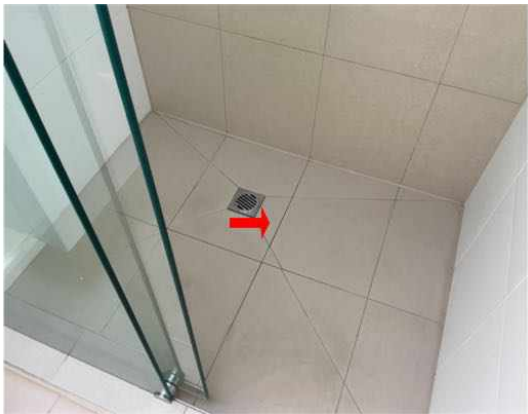
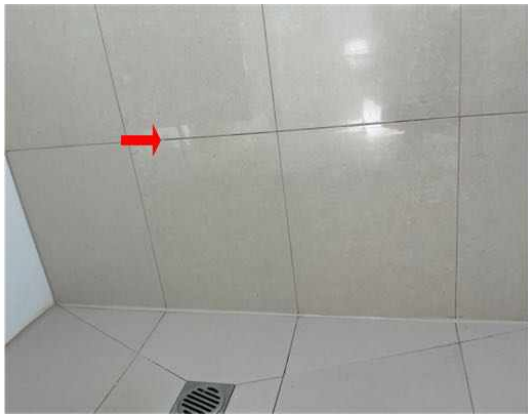
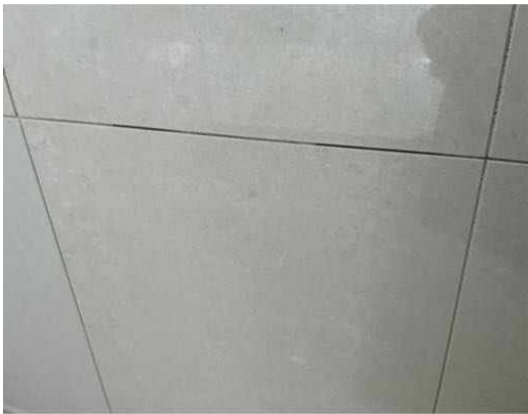
**Defects 3.02**

Building: Main Building  
Location: Ensuite - Master  
Finding: Grout - Missing  
Information: Grout is missing in this area. Grout is used to protect gaps and crevices in building materials to ensure that they are water-tight and prevent water penetration to the associated structures.

Where grout is missing, a tiling contractor should be appointed immediately to apply grout and re-apply any silicone where necessary. Failure to do so is likely to lead to water damage to the surrounding area.

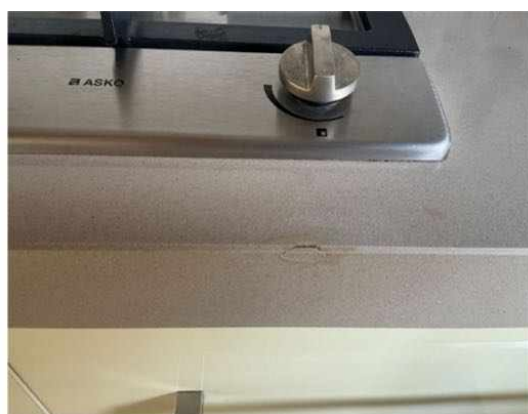
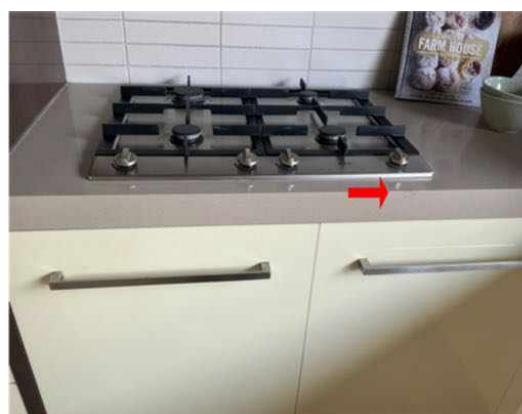
### Defects 3.03

Building:	Main Building
Location:	Kitchen
Finding:	Surface - Chipped
Information:	The surface of this building element appears to have chipped as a result of general wear and tear. While being an appearance defect, such damage is expected of a property of this age and condition.

Chipped surfaces rarely impede on the structure or functionality of the affected building element and generally only create a blemish on its appearance. Chipped surfaces may be left in situ at client discretion, as no repairs or replacement are necessarily required. However, the client may wish to seek quotations for the cost of refurbishment or replacement of the identified building element.

A qualified carpenter or cabinet maker should be appointed to repair chipped surfaces and replace building elements where major damage has occurred.

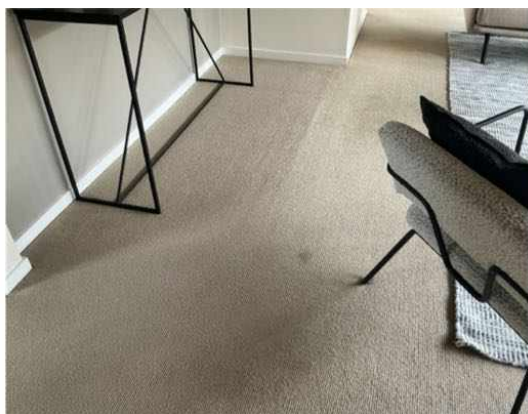
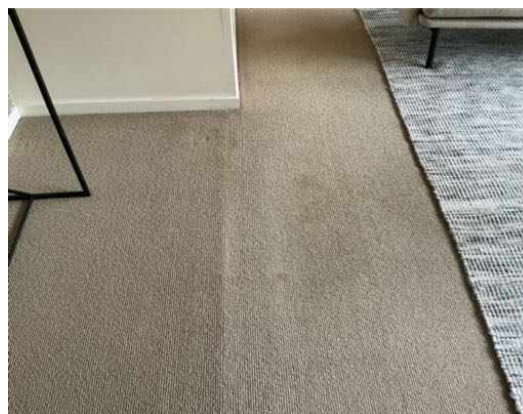
### Defects 3.04

Building:	Main Building
Location:	All Areas
Finding:	Carpet - Deteriorated
Information:	Sections of the carpet floor covering throughout were worn and stained, these carpets may be replaced at the clients convenience.

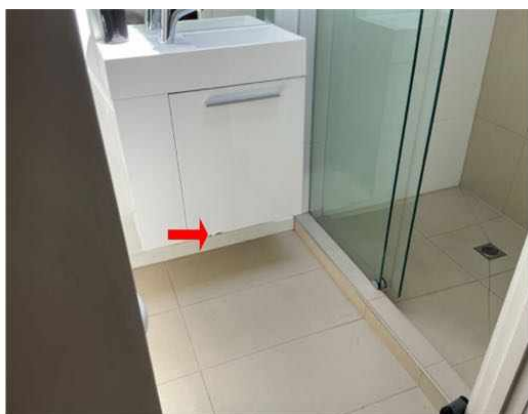
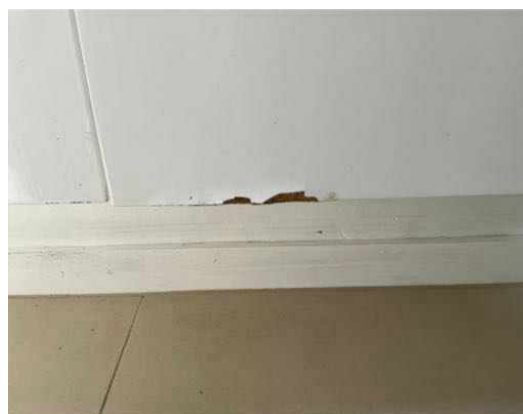
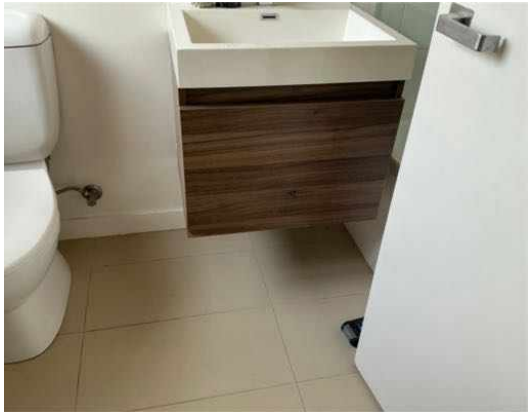
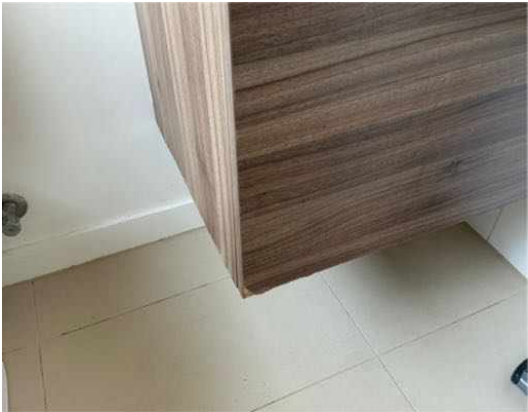
### Defects 3.05

Building:	Main Building
Location:	Ensuite - Master
Finding:	Building element - Swollen
Information:	Swollen building elements generally indicate that the building materials have been affected by excessive moisture over a prolonged period of time, and have swollen as a result. The formation and development of mould/fungi or mildew is also a likely consequence of excessive moisture, which may pose major respiratory issues for occupants, particularly the elderly, the very young and those with existing illnesses and could be potential health safety hazards. In these cases an appropriately qualified inspector/tester should also be contacted for advice and/or technical assistance.

The structural integrity of swollen building elements can not be guaranteed, and further damage is likely to develop if left unmanaged. Excessive moisture is likely to lead to the development of secondary damage to any associated building elements, which may necessitate major reparation works if prolonged.

Rectification of the cause of the water leak should be addressed prior to any remedial works to the swollen building elements. A licensed plumber should be appointed immediately to identify the cause of the leak and provide advice on remedial works as necessary, Repair and/or replacement of swollen building elements should be conducted as a matter of urgency by a registered builder or qualified carpenter.

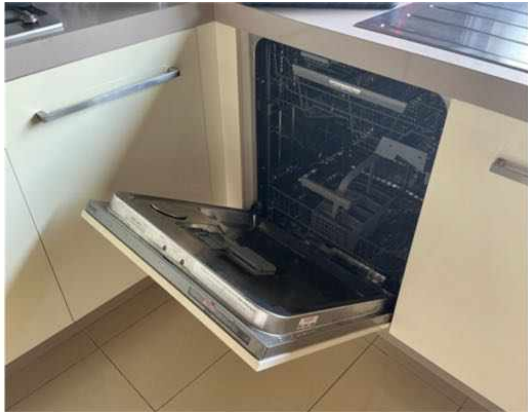
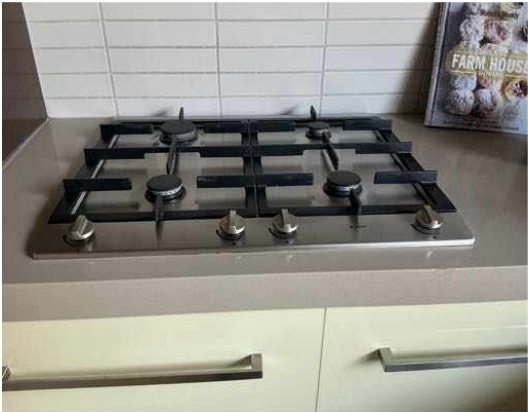
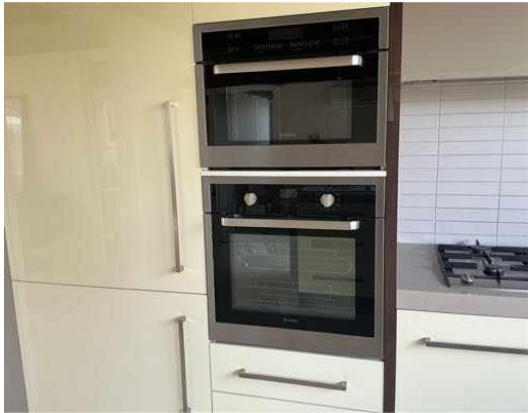
**Noted Item**

Building: Main Building  
Location: All Areas  
Finding: Warranty - Expired  
Information: Where appliances are beyond their warranty period, the owner should be prepared to meet the cost of replacement or repair of the item at any time. The operation of the appliance can not be guaranteed and further inspection by an appropriately qualified tradesperson may be required.

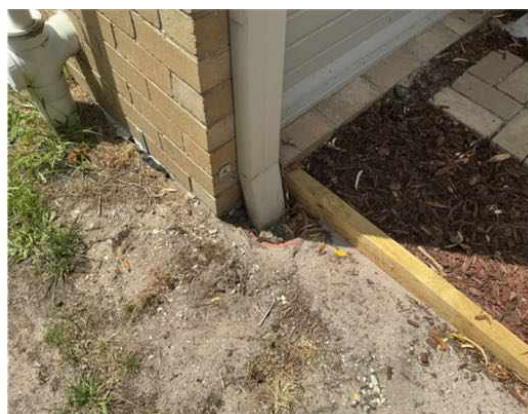
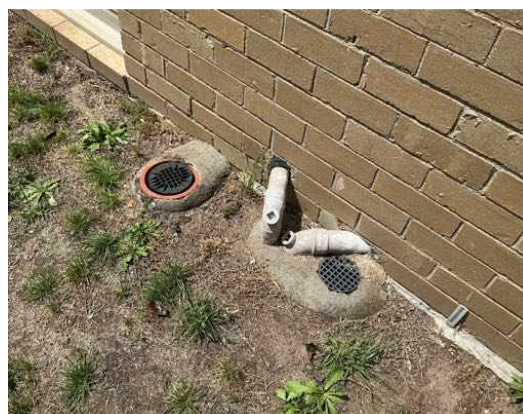
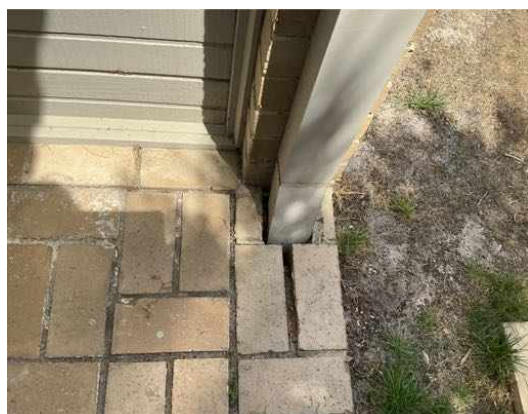
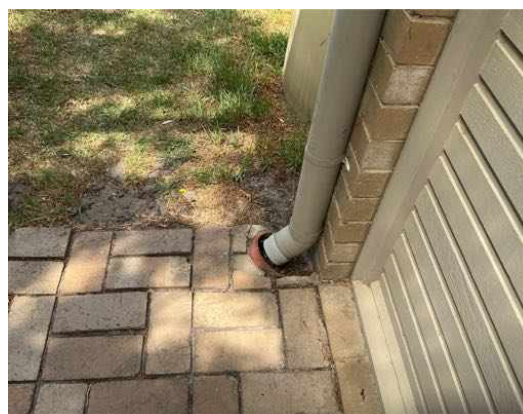
**Noted Item**

Building:	Main Building
Location:	All Areas
Finding:	Terracotta pipes
Information:	<p>Terracotta drainage pipes (sometimes referred to as clay or vitrified clay pipes) have been used for many many years. The use of clay drainage pipes dates back to the Romans, who used the clay pipe system as it was easy to manufacture, straightforward to lay and, for the most part, reliable. However, due to the rigid and brittle nature of clay or terracotta pipes problems can begin to occur over time. Even if they're functioning fine now, clay pipes will need replacing eventually.</p> <p>The average lifespan of a clay pipe sewer system is 60 years — which means an upgrade is decades overdue for many homes. For your peace of mind you may wish to have your sewer pipes inspected and replaced before a major problem occurs</p>

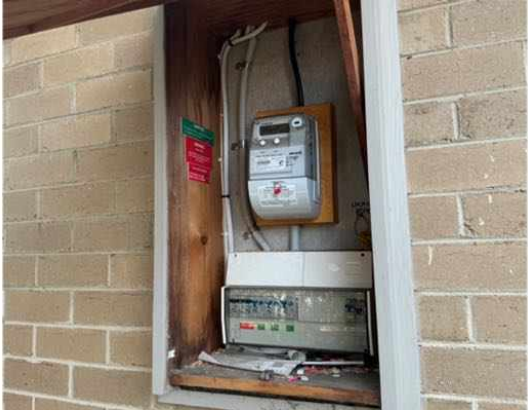
### Noted Item

Building:	Main Building
Location:	Electrical Switchboard
Finding:	Termite Management System - no evidence of a chemical installation
Information:	<p>The application of a post-construction chemical termite barrier is highly recommended for all properties, particularly if live termite activity has been found on the site previously. Such barriers are highly effective in preventing termite attack on any timber</p>

building elements throughout the property.

A durable notice should be placed in the switchboard unit to indicate current termite barriers. At the time of inspection, it appeared as though no termite management system has been installed, with no evidence to suggest preventative works taking place.

The client may consider gaining further advice from a pest controller as to the costs and procedures involved with this application. It is recommended that obtaining such advice be a short-term priority.
