# Building and Timber Pest Inspection Report

Inspection Date: Wed, 1 Apr 2026

Property Address: 9 Myall Ct, Golden Grove SA 5125,  
Australia

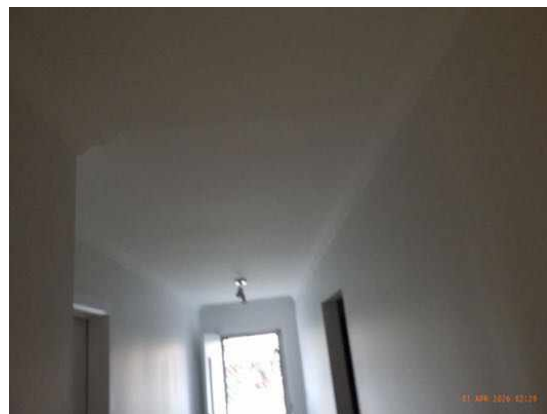
Please note that this defect is highlighted as a caution only. We suspect, based on our experience in the building industry, that the absence of smoke detectors, or their poor condition, should be addressed as a matter of urgency to improve occupant safety.

Always ensure sufficient working and suitable smoke detectors are installed prior to occupying any building. Additionally, it is advised that all smoke detectors be tested by the homeowner on a monthly basis.

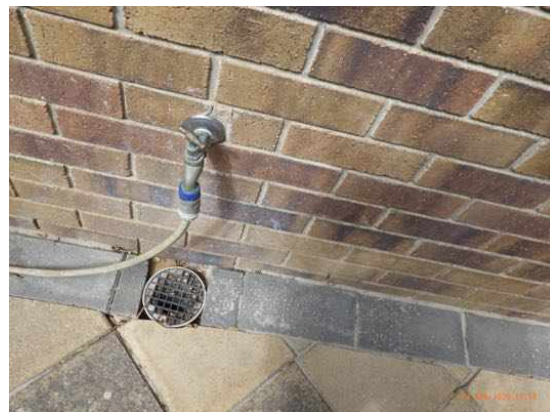
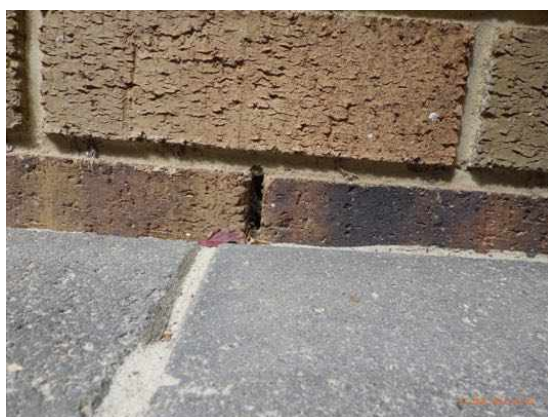
#### Finding 2.01

This bridges the required inspection zone and compromises the intended moisture management system. The minimum clearance of approximately 75 mm between the finished paving level and the slab edge / DPC has not been maintained, restricting visual inspection and allowing moisture to track across the DPC into the structure.

In addition, obstruction of weep holes prevents adequate drainage and ventilation of the wall cavity, increasing the likelihood of moisture build-up, damp ingress, and subsequent deterioration of masonry, internal linings, and adjacent building elements.

This condition also presents a heightened risk of concealed termite ingress.

Rectification is required to reinstate an inspection zone by lowering or removing the paving to achieve a minimum 75 mm clearance below the DPC and ensuring all weep holes are fully exposed and operational. Ongoing maintenance of this clearance is essential, and a licensed builder should be engaged to assess and carry out the required remedial works.

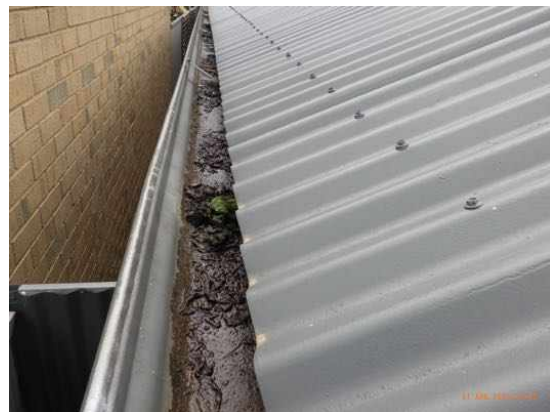
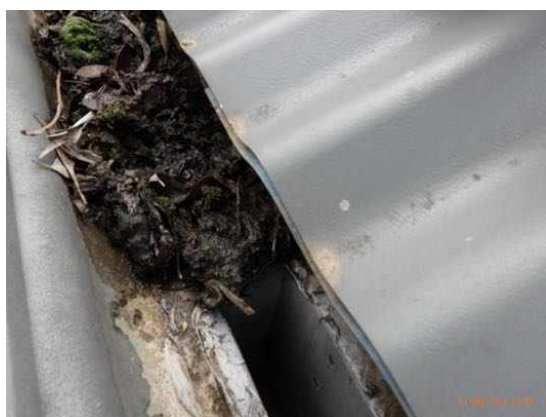
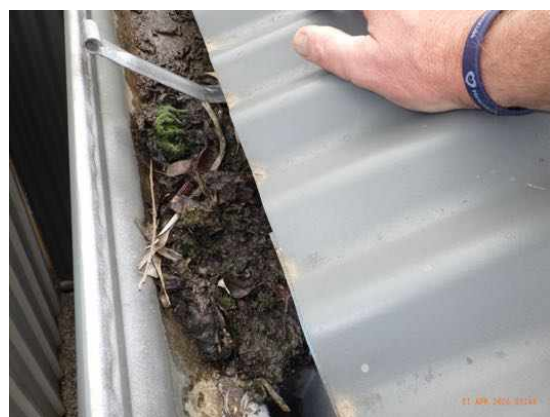
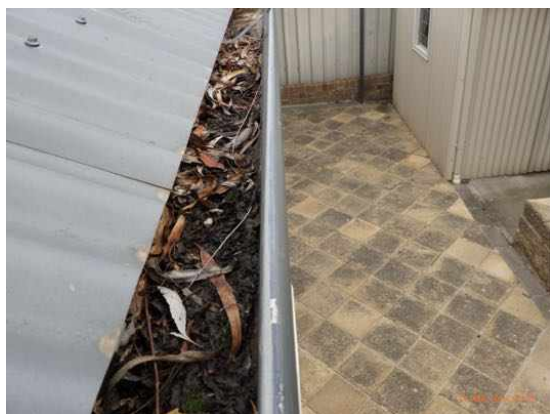
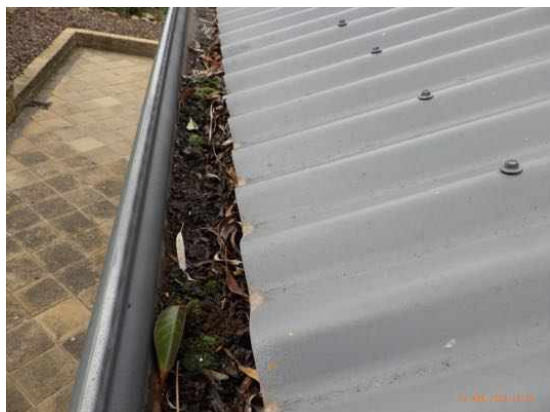
## Finding 2.02

Building:	Building 1
Location:	Roof Exterior
Finding:	Gutters - Blocked

Blocked gutters are likely to lead to high levels of moisture in the affected areas. Such moisture will not only cause rust and decay of the associated building materials, but can also provide conditions that are conducive to termite and timber pest activity. Blockages in gutters should therefore be removed immediately to ensure dry conditions are maintained.

Consult a Licensed Plumber for further specific advice on remedial works that may be required. In the interim, it is highly advised that blocked gutters be removed by the homeowner or a general handyperson as a matter of urgency.

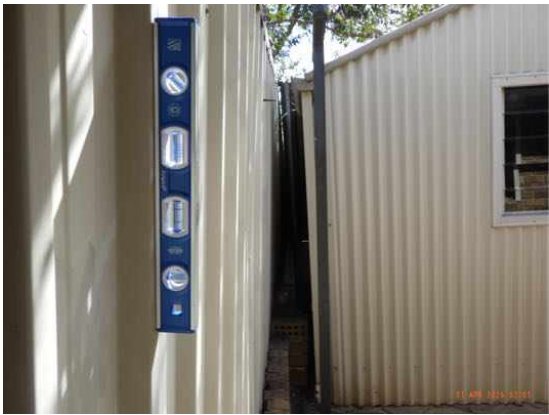
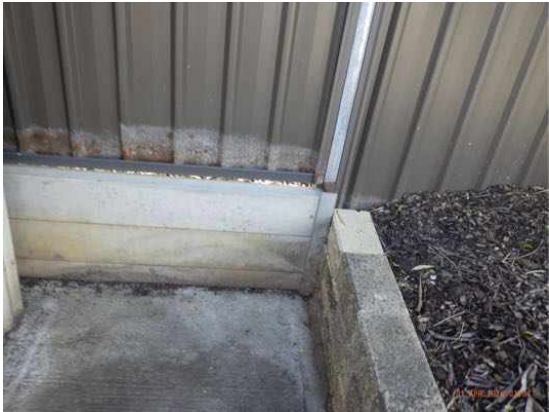
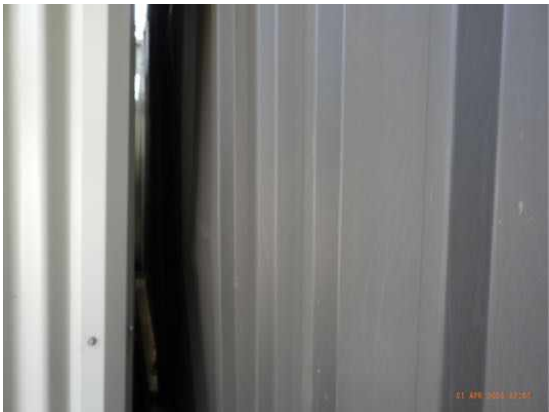
### Finding 3.01

Building:	Building 1
Location:	Yard - Back
Finding:	Fencing - Deteriorated
Information:	It was noted at the time of inspection that sections of the fencing throughout the property have deteriorated. Typically fencing deteriorates due to age and or wear, rot and or rust which is generally expected for a structure of this age, due to prolonged exposure to weather conditions. Sometimes inadequate installation or maintenance can be to blame.

If left unattended, it is likely that further damage will occur. It is suspected that repair of several elements of the fencing may be required however replacement may be a consideration of the client also.

A licensed fencing contractor should be appointed to provide further advice and perform rectification works as necessary.

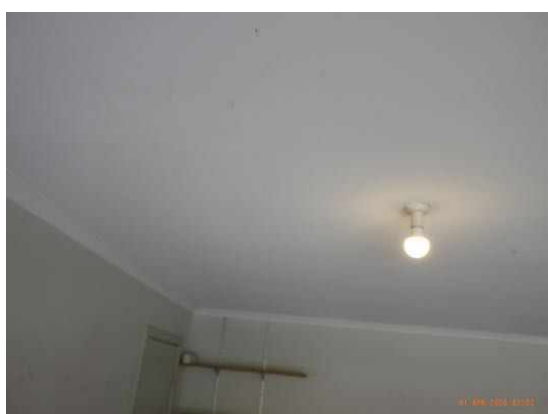
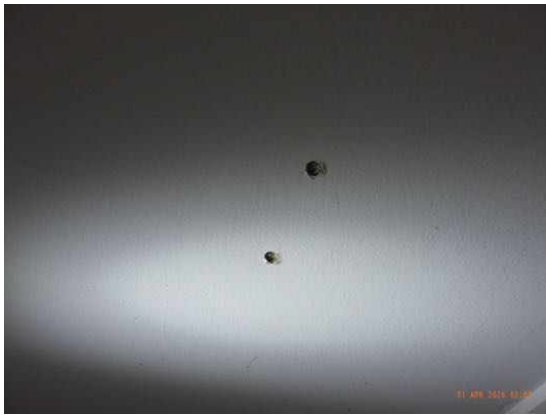
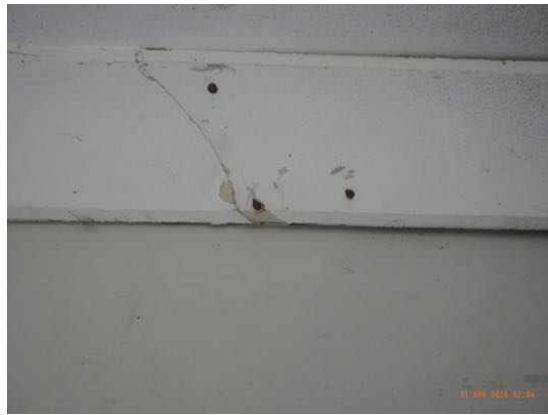
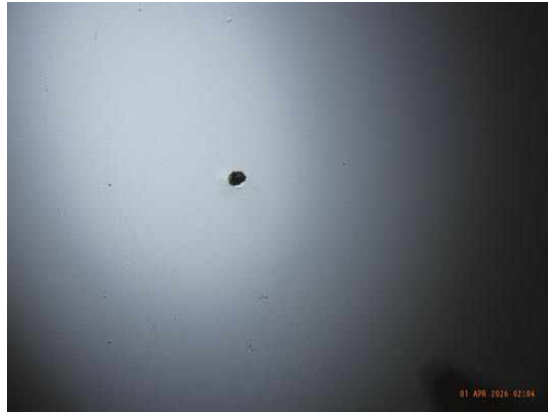
Finding 3.02

Building: Building 1  
Location: Carport  
Finding: Ceiling sagging - garage  
Information: Sections of the ceiling were found to have sagging evident to the garage ceiling with some repairs already evident at the time of inspection.

Sagging to the fixed ceiling structure generally indicates that the building materials have swollen, due to contact with water, or that fixings (e.g. nails or glue) have become loose and require reattachment.

This is a very common defect in carports due to their lack of insulation and or their susceptibility to moisture. Condensation builds up in the roof and rests on the plasterboard softening it somewhat which makes it more likely to sag and release from its fixing points.

Repairs to the ceiling will be required and should be carried out by licensed builders, plasterers and painters in the short term. Fixing battens to the ceiling can be a good short term repair especially adjacent to roller doors.

Insulating the area is also highly recommended.

Repair garage ceiling

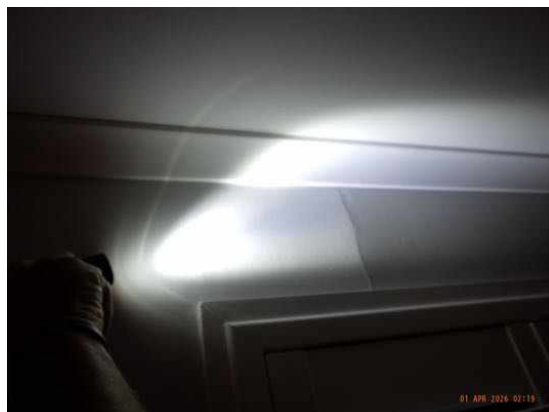
Building:	Building 1
Location:	All Internal Areas
Finding:	Cracking - Damage Category 1 - Fine (up to 1mm)
Information:	There were fine cracks evident to the walls and ceilings throughout the dwelling at the time of inspection.

Although fine cracks are quite noticeable, they are often only considered to be an appearance defect, and usually do not indicate any structural damage. Generally, the cause of a fine crack is indicative of a separation between building materials and finishes (e.g. paint, plaster, etc.) along joints.

Cracking of this nature can generally be repaired with minor sanding, filling and/or repainting. Such works should be performed by a qualified painter or a general handyman.

Monitoring of all cracking should be conducted frequently. Always contact a building inspector should cracks widen, lengthen, or become more numerous.

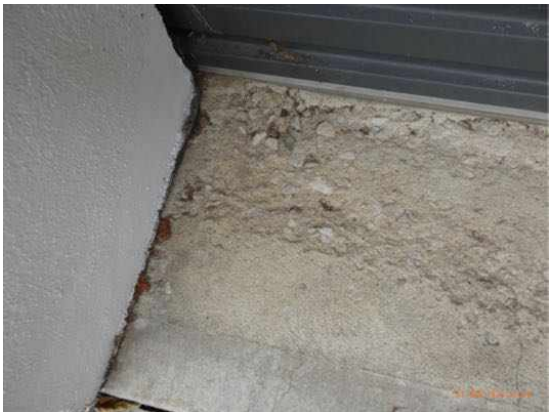
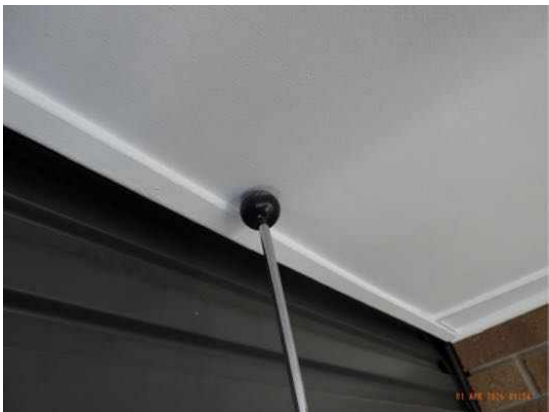
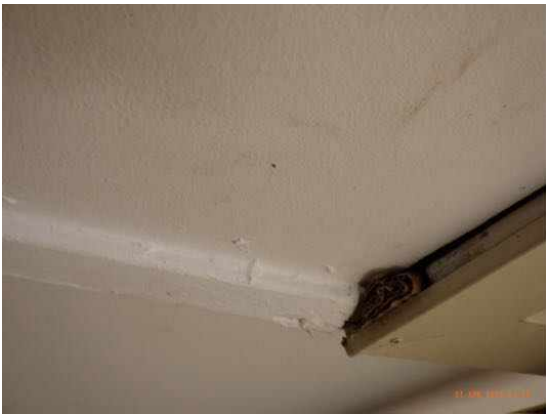
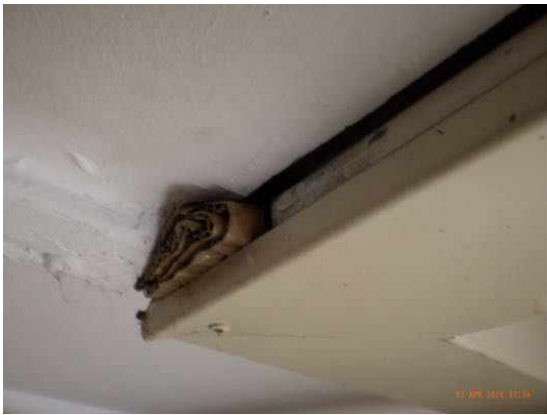
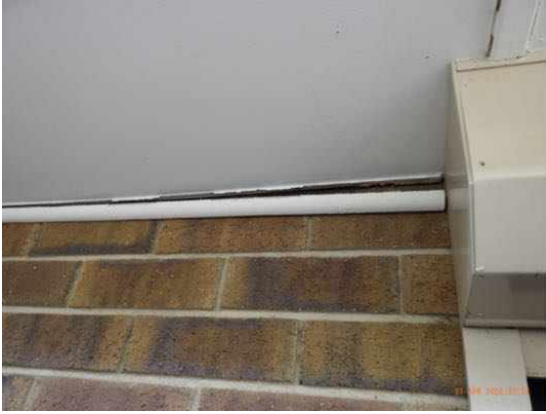
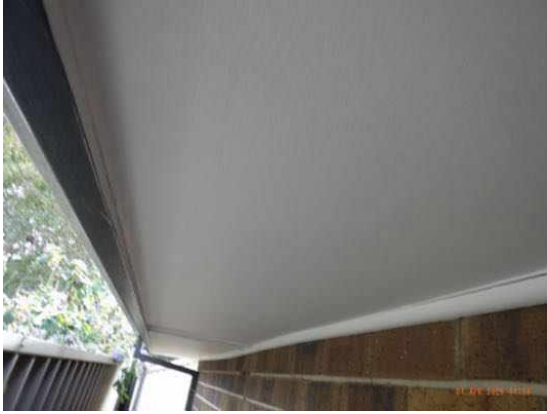
### Finding 3.05

Building:	Building 1
Location:	All Areas
Finding:	Minor defects present
Information:	Minor defects were evident throughout the dwelling at the time of inspection, which are consistent with normal wear and tear and considered appropriate for a property of this age.

- Eaves shows signs of minor movement and sag.
- Concrete deteriorating to garage entry
- Crack to front porch tile
- Laundry tap loose
- Window lock not operating - spring gone
- Several doors rubbing throughout home

be addressed as part of routine and ongoing property maintenance to prevent further deterioration. Repairs and maintenance works should be carried out by appropriately licensed and qualified tradespeople to ensure the continued serviceability and longevity of the dwelling.

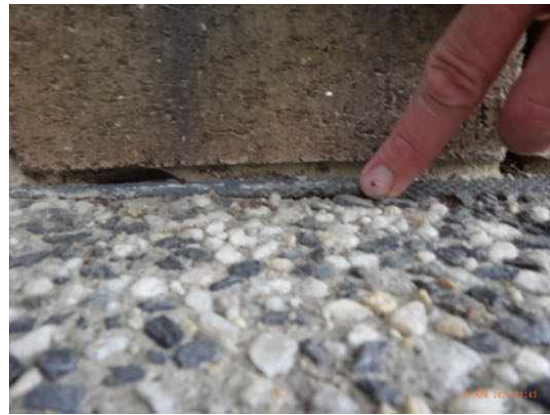
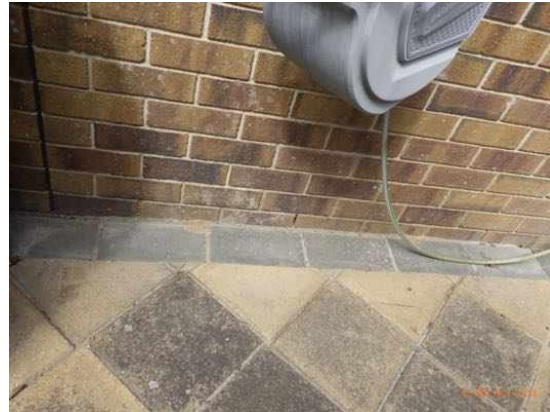
If the slab edge is not properly exposed there is a high risk of concealed termite attack which your inspector will likely not be able to see. Sometimes, in order to determine the type of slab, a suitably qualified person such as an architect or builder may be required to consult construction plans.

Where the slab edge cannot be properly inspected, it is highly recommended that termite or timber pest inspections be carried out every 6-12 months to aid protection of the property against infestation and termite treatment advice is followed closely.

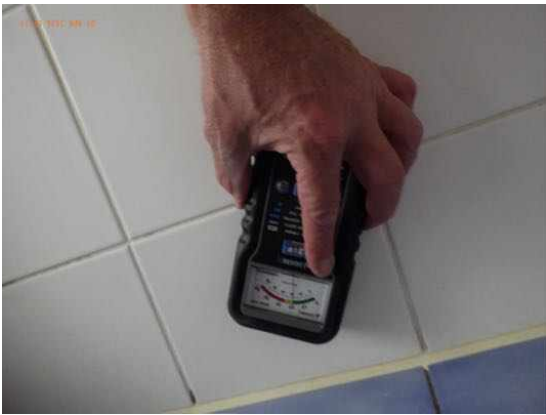
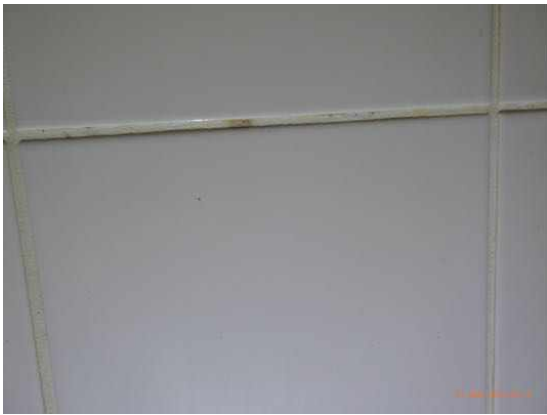
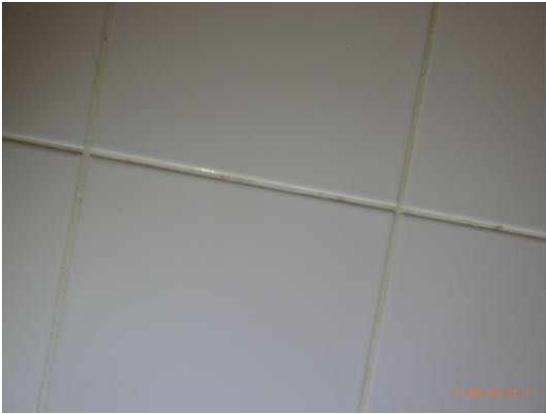
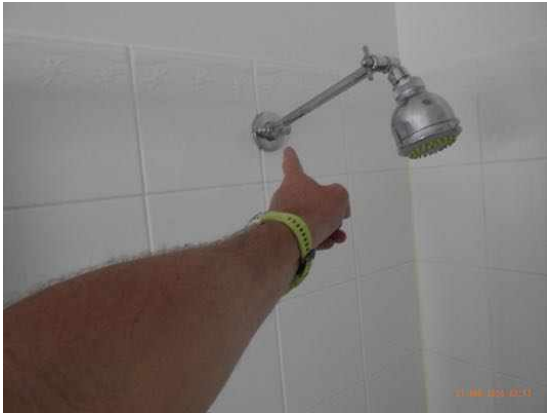
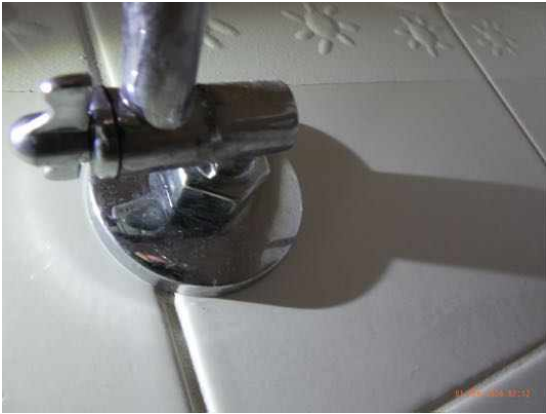
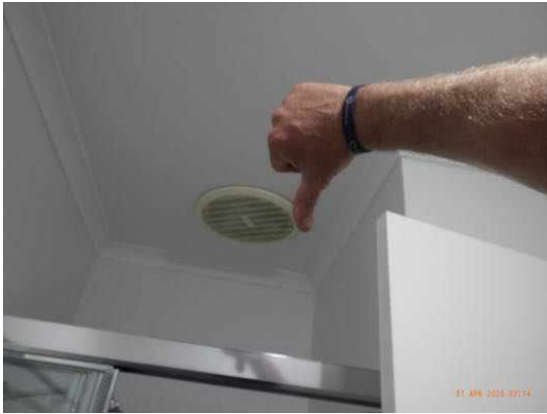
Finding: Shower damp and other minor issues  
Information: Multiple defects were identified to both bathrooms at the time of inspection, including deteriorated and missing grout to tiled surfaces, leaking showerheads, a loose and inadequately secured vanity unit, and an exhaust fan that was not operational.

There was a small area of localised high moisture reading evident to the ensuite bathroom. High moisture around timber building elements creates a perfect environment for termite activity and as such further investigation could uncover currently concealed defects.

Deteriorated grout allows water to penetrate behind tiled surfaces, increasing the risk of moisture ingress and concealed damage to wall and floor substrates, while leaking plumbing fixtures contribute to unnecessary water exposure and potential long-term deterioration.

The loose vanity unit presents a functional and durability concern, and the non-operational exhaust fan reduces ventilation, contributing to elevated moisture levels, condensation, and potential mould growth within the wet areas.

Repairs and replacement of defective components are required, including re-grouting of affected areas, rectification or replacement of leaking fixtures, secure fixing of the vanity unit, and repair or replacement of the exhaust fan to restore adequate ventilation.

A licensed plumber, electrician, and/or builder should be engaged as appropriate to complete these works, ensuring the wet areas perform as intended and to support the long-term durability and serviceability of the bathrooms.

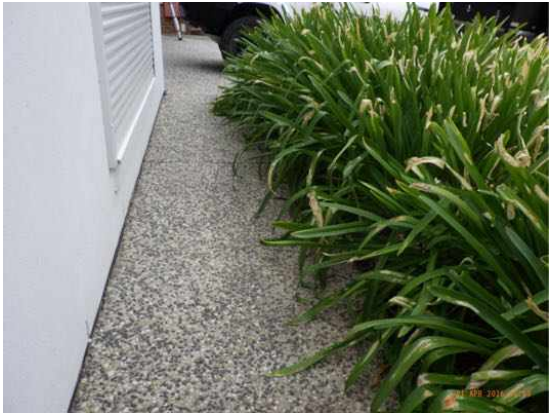
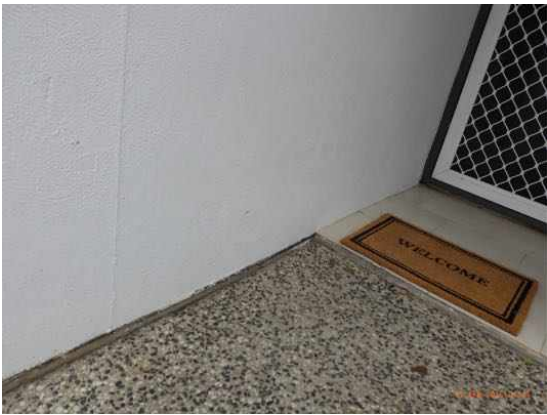
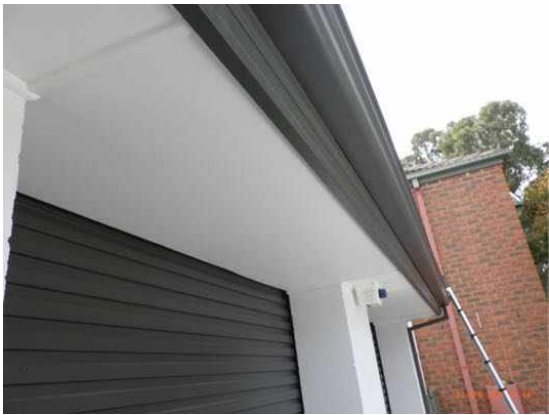
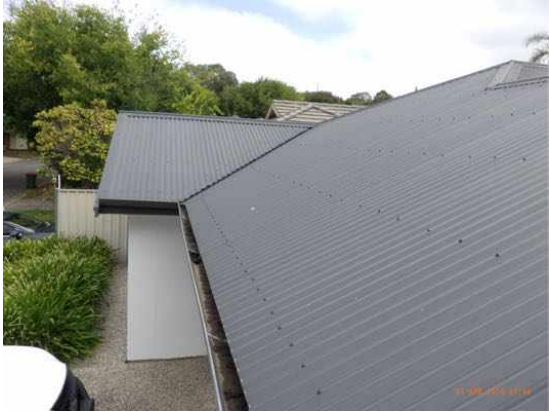
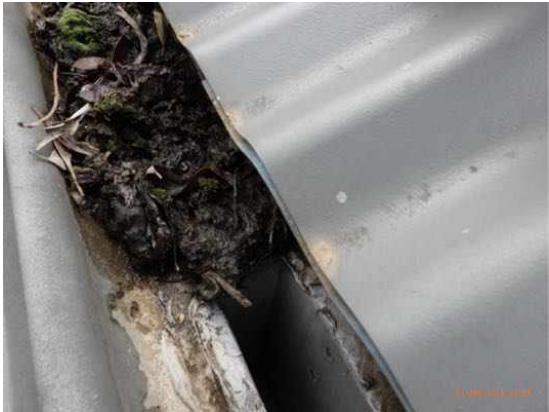
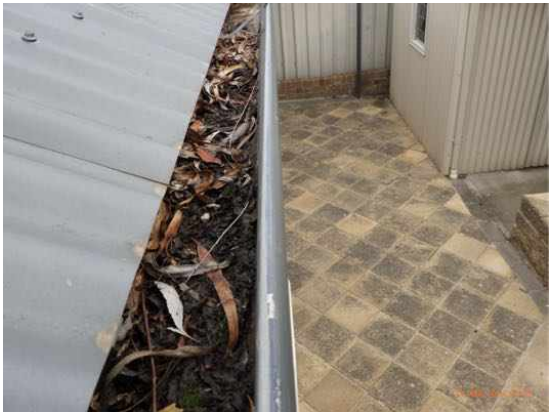
**Noted Item**

Building: Building 1  
 Location: All Areas  
 Finding: Additional Photos - Obstructions and Limitations  
 Information:

These photographs are an indication of the obstructions and limitations which impeded full inspection of the property at the time of inspection. These obstructions can hide an array of defects and should be removed to allow full inspection to be carried out.
