## Building Inspection Report

Inspection Date: Fri, 27 Feb 2026

Property Address: 17 Buttercup St, Macquarie Fields NSW  
2564, Australia

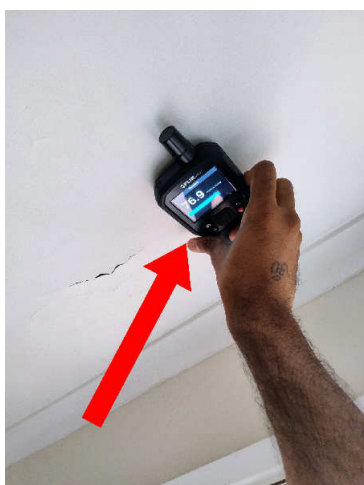
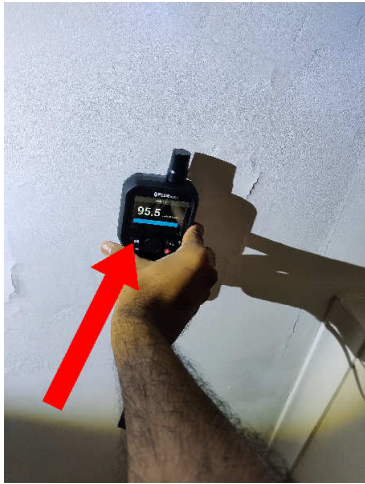
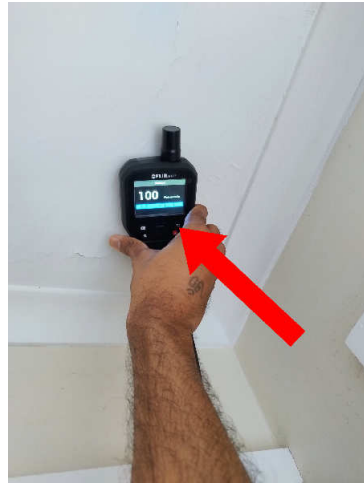
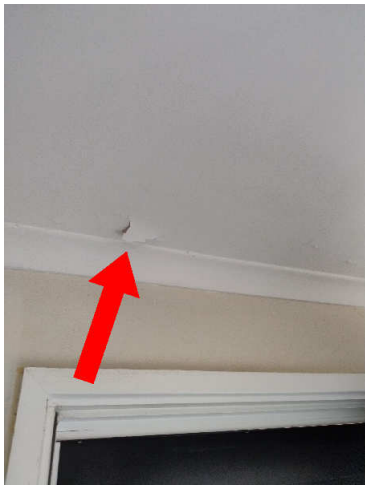
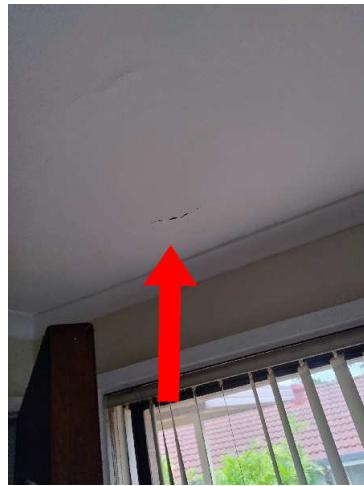
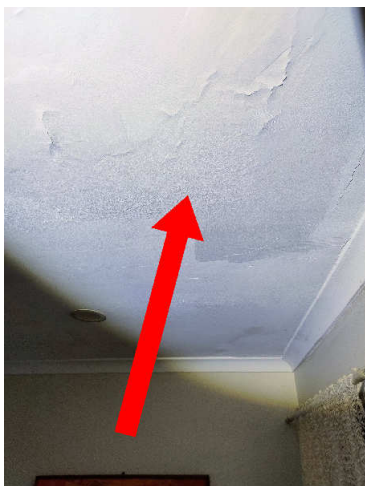
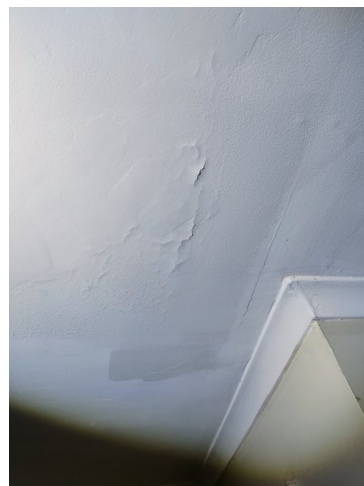
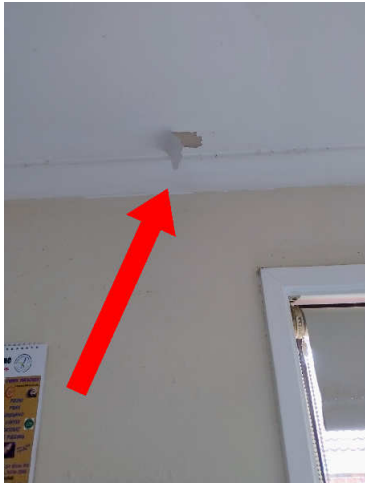
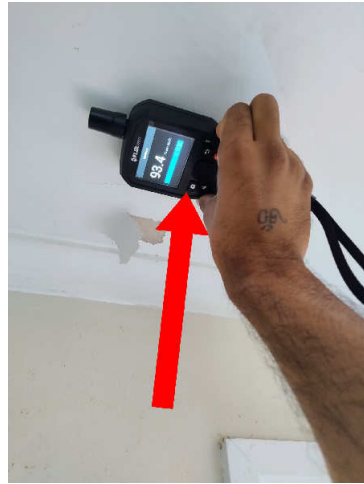
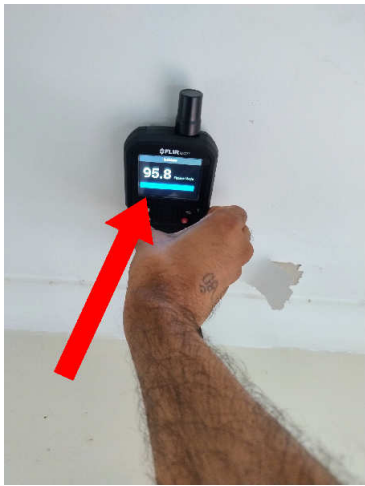
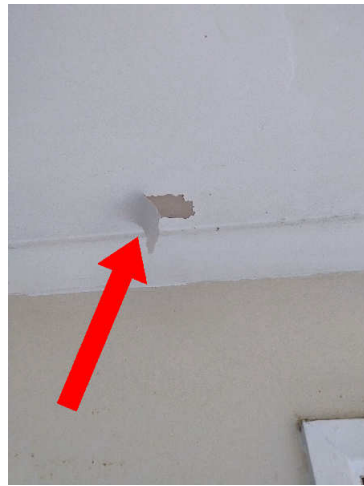
#### Defects 2.01

Finding: Evidence of Excessive moisture - identified - Major Defect

Information: Evidence of excessive moisture recorded by moisture meter in the dining room ceiling.

Excessive moisture can attract termites and produce conditions that promote fungal growth and wood decay.

Excessive moisture is generally caused by deteriorated, inadequate or missing roof drainage, leaking plumbing pipes or fixtures, poorly plumbed HWS overflows or condenser units and poor site drainage.

Prior to any remedial works being performed a qualified plumber should be appointed to further inspect the property and to identify the cause of the excessive moisture. Works to remove affected building elements may then be necessary and should be performed by an appropriate tradesperson.

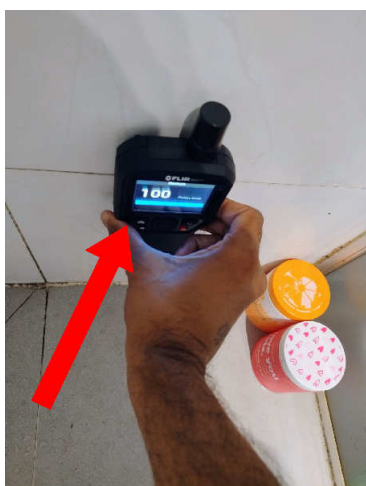
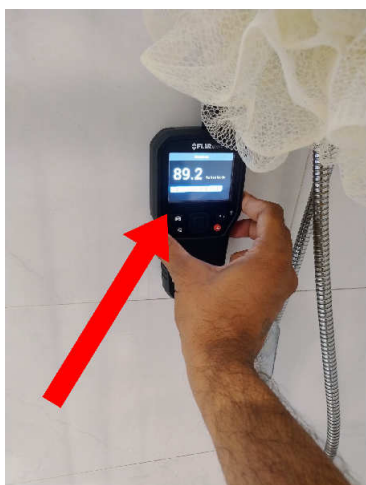
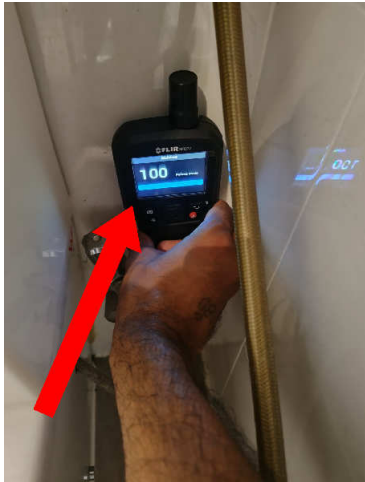
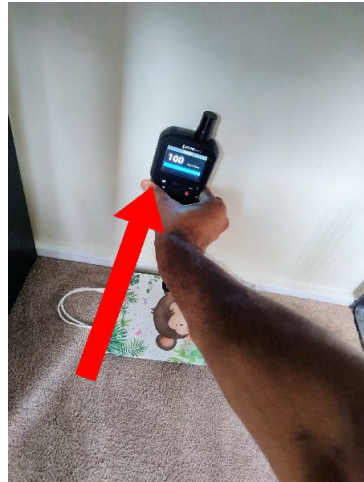
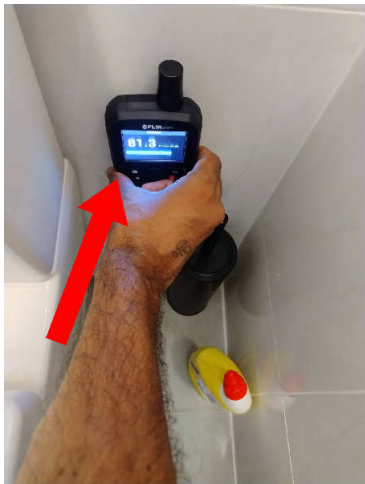
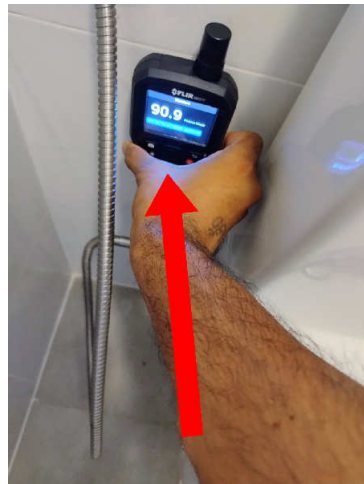
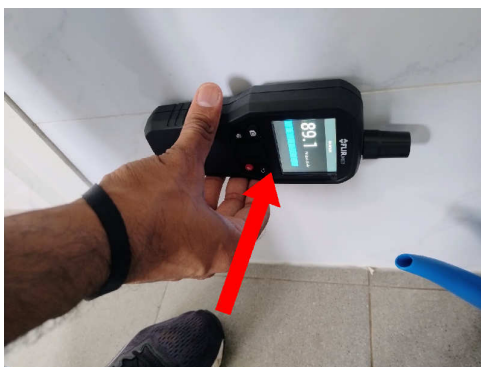
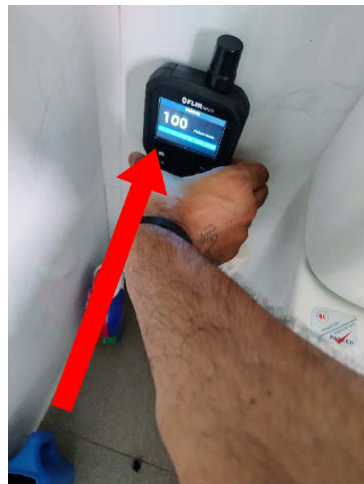
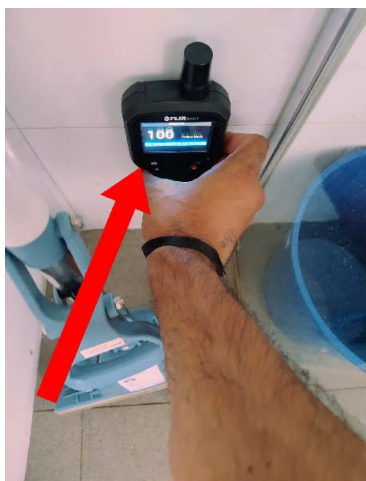
### Defects 2.02

Building: Main Building  
Location: Both Main and Granny unit Bathroom walls  
Finding: Evidence of Excessive moisture - identified in both bathroom

Evidence of excessive moisture recorded by moisture meter in both Bathroom walls ( Main builds and Granny Flat ) and shower area walls at the time of inspection. Excessive moisture can attract termites and produce conditions that promote fungal growth and wood decay.

Excessive moisture is generally caused by deteriorated, inadequate or missing roof drainage, leaking plumbing pipes or fixtures, poorly plumbed HWS overflows or condenser units and poor site drainage.

Prior to any remedial works being performed a qualified plumber should be appointed to further inspect the property and to identify the cause of the excessive moisture. Works to remove affected building elements may then be necessary and should be performed by an appropriate tradesperson as soon as possible.

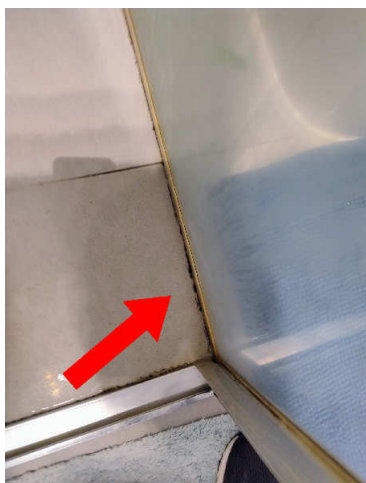
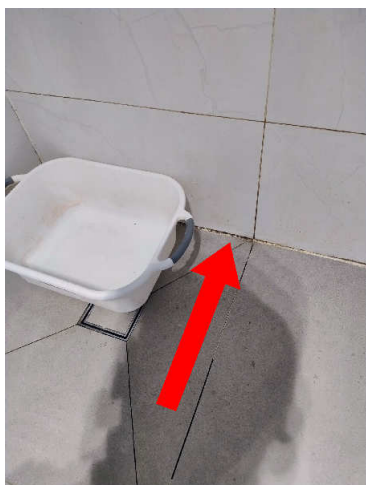
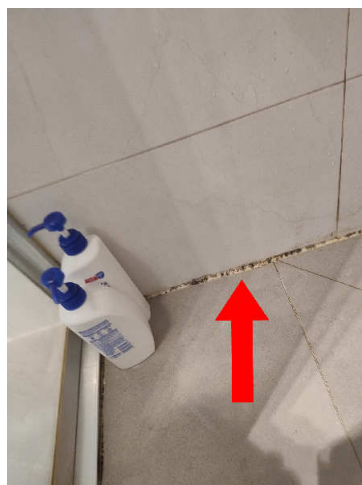
### Defects 2.03

Information: Mould were observed at the time of inspection in bathroom area. Where evidence of mould growth was noted, there may be environmental, biological or health issues associated with the report. A specialist inspection by a suitably qualified environmental health inspector is warranted, where mould is extensive or where any queries regarding air quality spores or other related issues apply.

Generally, the client is advised to ensure that the general environment is free of moisture and humidity to aid in the prevention of mould formation and development. Any mould found during the inspection should be cleaned immediately by a cleaning contractor or the homeowner as applicable.

Please note that severely affected building elements may require replacement by a registered builder or qualified carpenter.

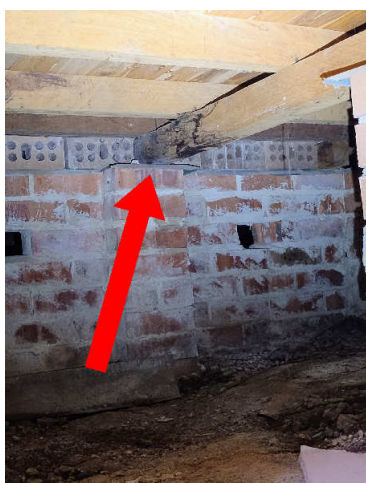
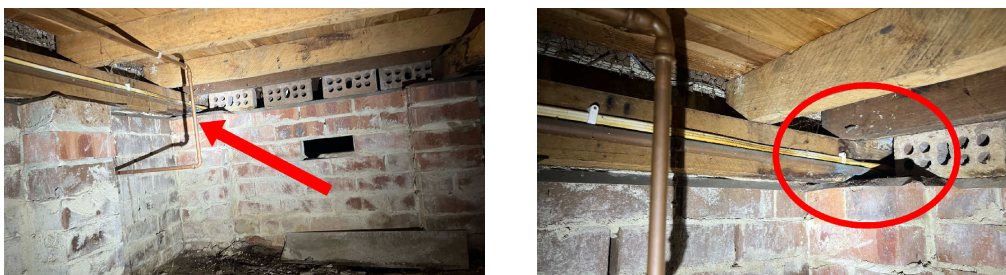
### Defects 2.04

Building: Main Building  
Location: Subfloor  
Finding: Water leak - Active - Detoriation to timber flooring

Water ponding was observed near the pipe in subfloor at the time of inspection near toilet and bathroom area. And Tiber structure below floor is deteriorated due to water leak at the time of inspection.

Generally, water leaks occur when a particular area of the property is not weather or water tight. As the surrounding area was found to be very damp at the time of inspection, the leak is considered ongoing and hence requires urgent action.

Regardless of the location, even minor leaks that are left unmanaged can lead to serious damage of associated building elements and result in the need for replacement of building materials. Mould and other hazards such as electrical hazards may also arise if the leak is left to develop.

It is highly advised that the cause of the leak be identified and resolved immediately by a licensed plumber to prevent any further damage. Depending on the extent of the damage previously sustained, repair and/or replacement of any affected building materials may be required.

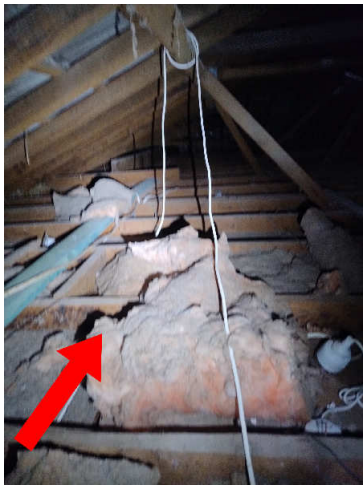
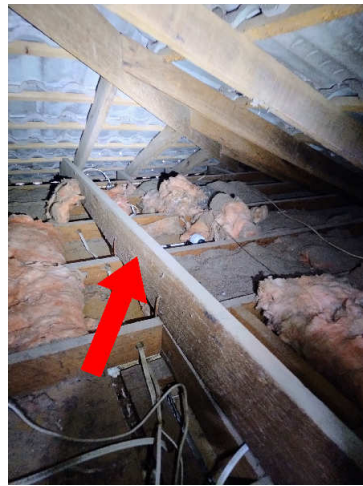
### Defects 3.01

Finding: Insulation - Missing and misplaced

Information: Upon inspection of the roof void it was noted that insulation is not properly placed and missing at some location.

Insufficient insulation will result in a comparatively higher cost to heat and cool a property as there is a lack of Insulation (or uneven coverage of insulation) which works as a barrier to heat transfer. This helps to keep out unwanted heat in summer and preserves warmth inside your home in winter. It can also help soundproof your home from unwanted airborne noise transfer.

Where insulation is absent, the area does not meet current Australian Standards. Installation of adequate insulation is required and should be conducted as soon as possible.

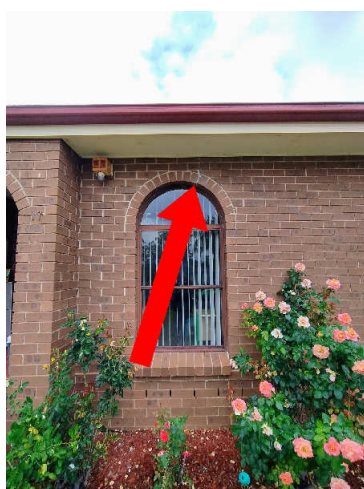
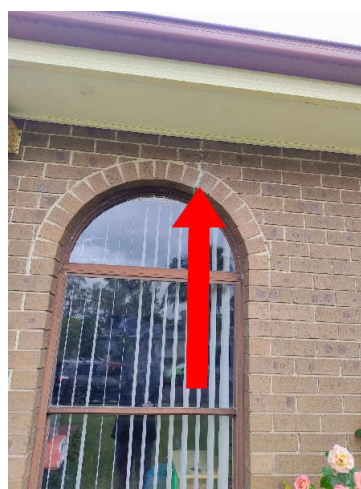
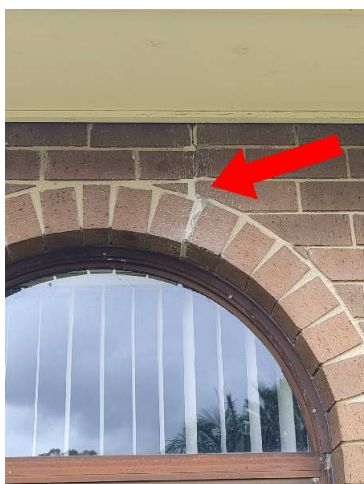
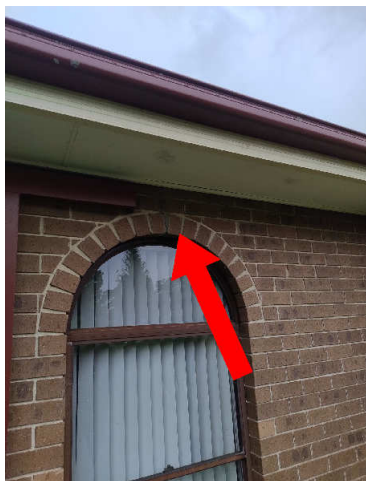
**Defects 3.02**

Finding: Brickwork - Cracking [Fine] - external wall

Information: Several cracks were observed in the side wall under patio and the exterior rear walls rear elevation.  
Generally, the cause of a fine crack is indicative of a separation between brickwork and mortar throughout the structure, but single bricks may also show cracks of this nature.

Cracking of this nature can generally be repaired with minor filling and should be conducted by a qualified bricklayer.

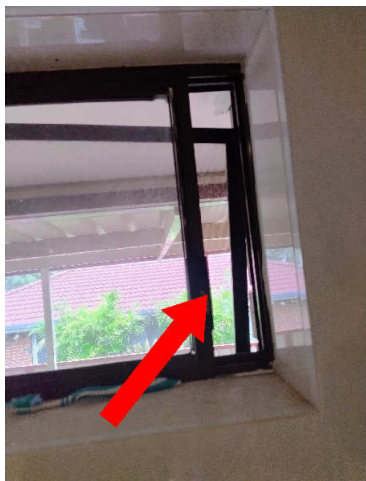
### Defects 3.03

Finding: Outer screen - Damaged

Information: Outer partition screen were found to be Damaged in right side elevation area at the time of inspection.

A general handyperson may be appointed to replace flyscreens at the discretion of the client.

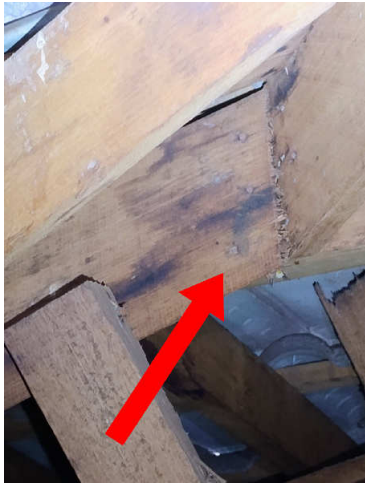
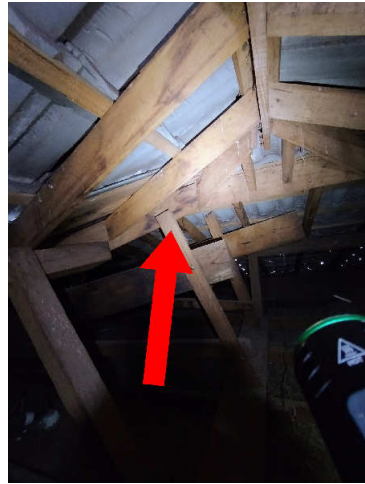
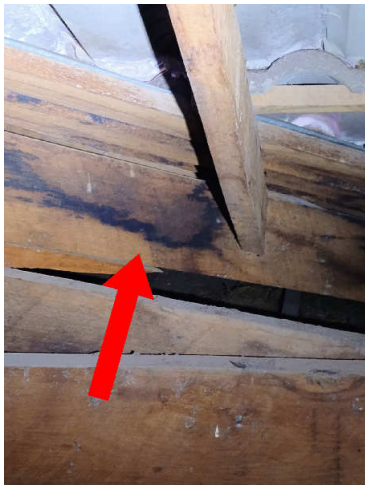
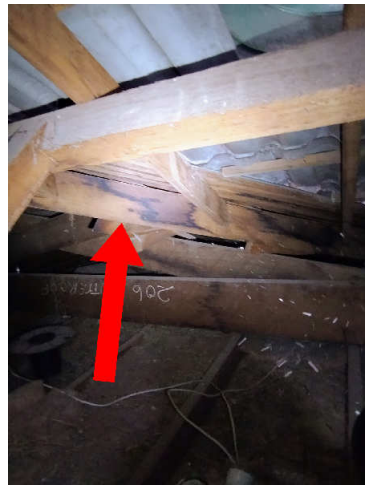
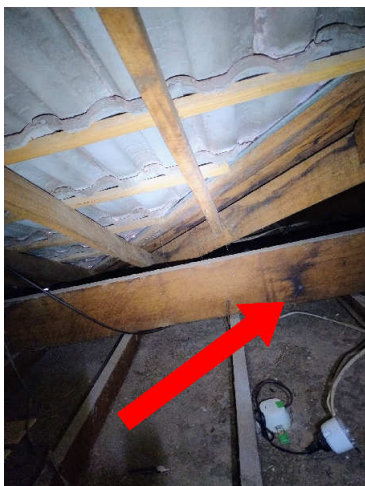
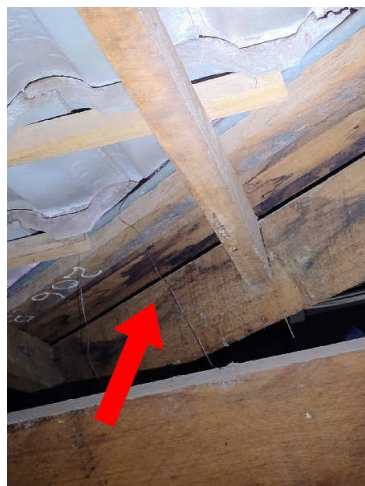
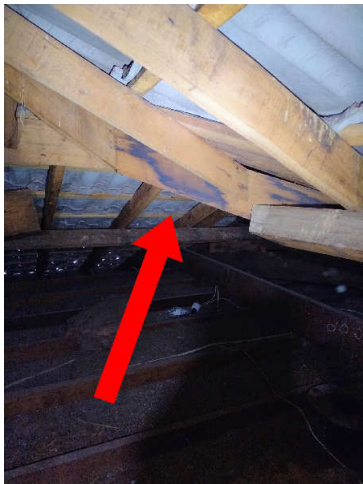
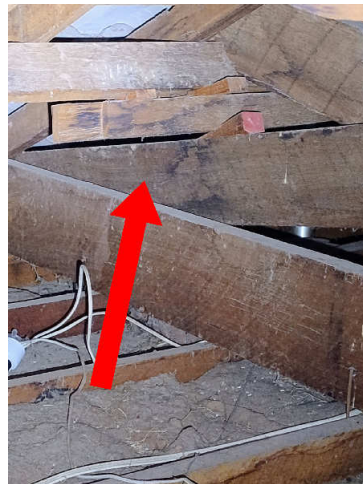
### Defects 3.04

Finding: Stained timbers

Information: At the time of the inspection, water staining was observed in Roof void areas. The staining was visually evident, with discoloration and marks present on the surface.

This suggests that the staining is likely a result of a previous water intrusion event that has since dried. It is recommended that the cause of the water staining be further investigated by means of an invasive inspection, to ensure that there are no underlying issues that could lead to a MAJOR defect and future moisture problems.

The vendor or the real estate agent might be able to provide further information on the cause of the staining and potential rectification at the time. Otherwise, a roofing contractor is recommended to investigate the roof flashings for any areas of water ingress as soon as possible.

It is also advisable to monitor the area for any signs of recurring moisture or new staining.

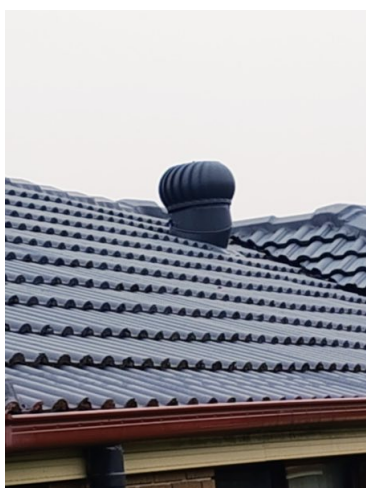
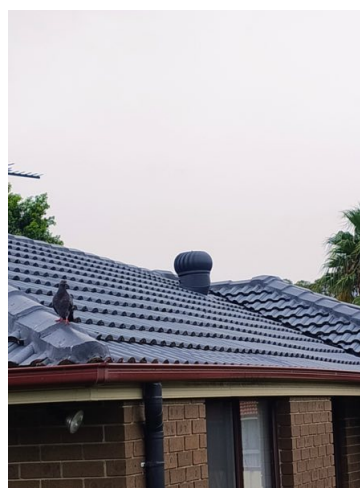
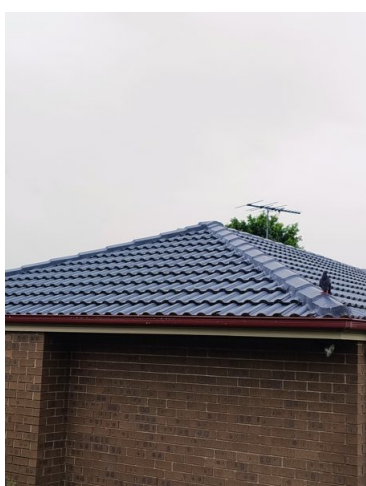
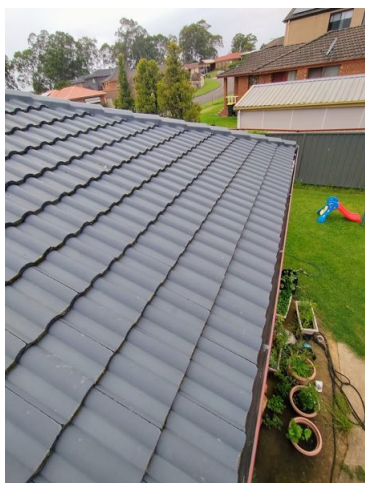
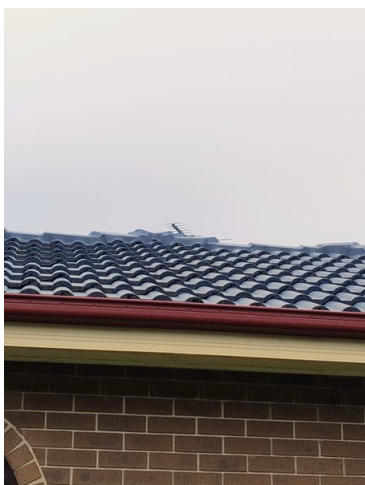
### Defects 3.05

Building: Main Building  
Location: Roof Exterior  
Finding: Roof tiles - Weathered

Upon inspection of the exterior roofing, the majority of roof tiles were considered to be in a fair condition. While weathering of the tiles is consistent with the age of the property, maintenance works are required.

Isolated areas of mortar have come loose in the valleys and minor cracking is also present. Re-pointing and re-sealing the may be considered as an interim solution by the client to help preserve and extend the life span of the tiles.

Where left unmanaged, deteriorating roof tiles are likely to lead to a number of secondary defects, including minor water leaks and weather exposure to internal roofing structures.

Consultation with a roofing contractor is highly advised to gain advice on cost of remedial works that may be required in the short to medium term. Remedial works are likely to increase the longevity of the exterior roofing structure.

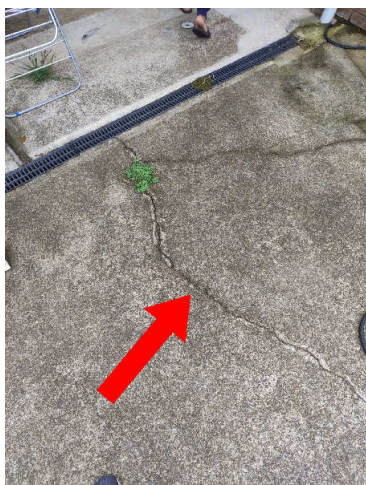
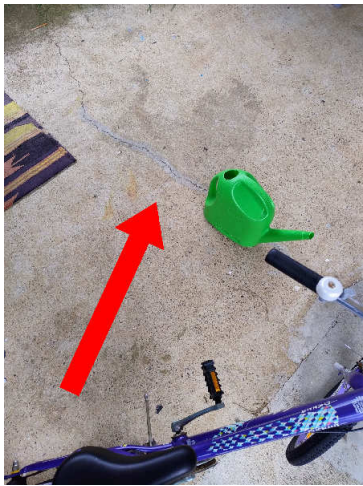
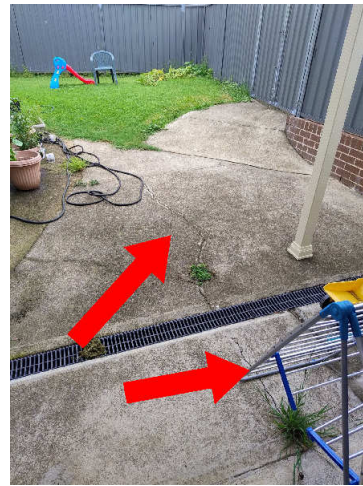
### Defects 3.08

Finding: Crack in concrete slab - Category 2

Information: A crack coded as Category 2 was identified in the slab in carport area at the time of inspection. A Category 2 crack is described as a distinct crack, with the slab being noticeably curved or changed in level.

To be considered Category 2, the approximate width of the crack is less than 2.0mm, or a change in offset of less than 15mm when a 3m straight edge is placed over the defect.

Category 2 cracks to slabs should be monitored for a period of 12 months. At the end of the monitoring period, cracks rated greater than Category 2 are considered defects that require rectification.

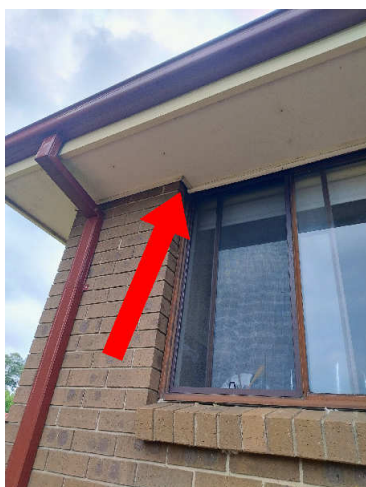
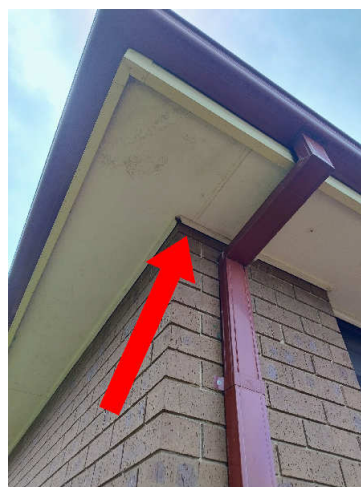
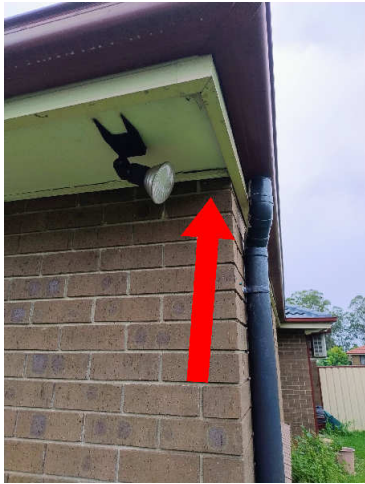
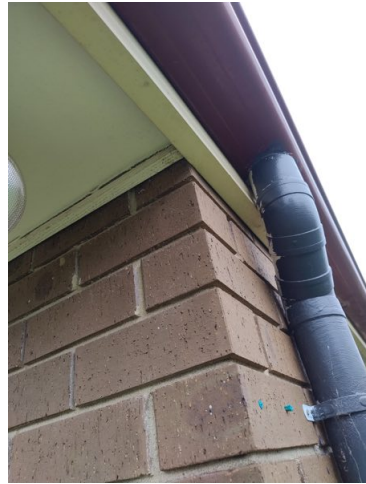
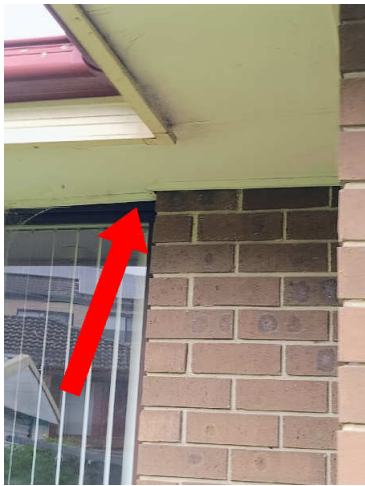
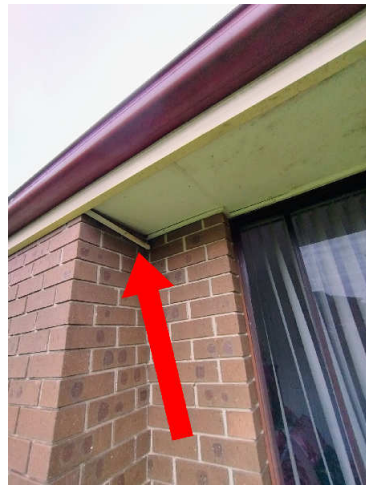
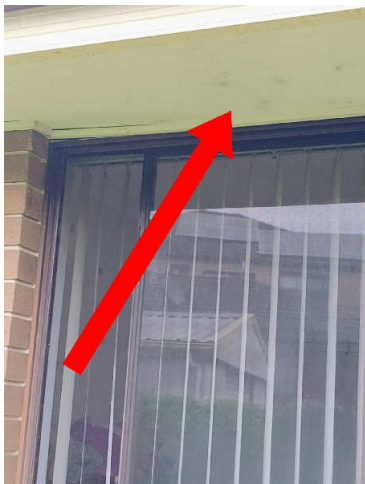
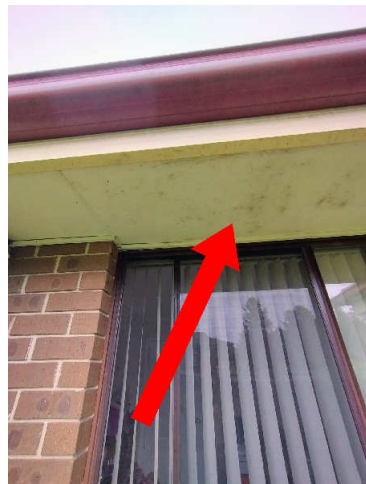
**Defects 3.09**

Building: Main Building  
Location: Exterior walls - left and Right side  
Finding: Cracking - Damage Category 2 - Noticeable Mould

Cracks damage and moulds were observed to the exterior of ceiling soffit of both side face unit.

Noticeable cracks are a common occurrence as a result of many primary defects. Such causes may include age, general wear and tear, expected building movement, general expansion/contraction of building materials in different weather conditions, and/or minor failings in the installation or application of building materials. Also mould represents the wet and moisture attracted condition within the surface.

Noticeable cracks may result in minor sticking or jamming of associated doors and windows, which require easement. However, noticeable cracks are easily filled and repaired. A plasterer can be consulted to install an expansion joint at this point to allow for this movement during different weather conditions.

Monitoring of all cracking should be conducted frequently. Always contact a building inspector should cracks widen, lengthen, or become more numerous. Additionally, your building inspector should also be contacted if associated building elements such as doors and windows become more difficult to operate over time.

Relevant tradespeople, such as carpenters, painters and plasterers, should be appointed to perform remedial works, as deemed necessary.

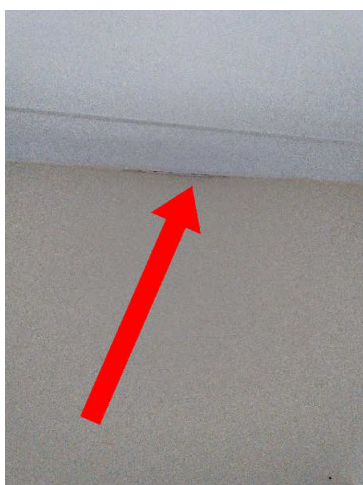
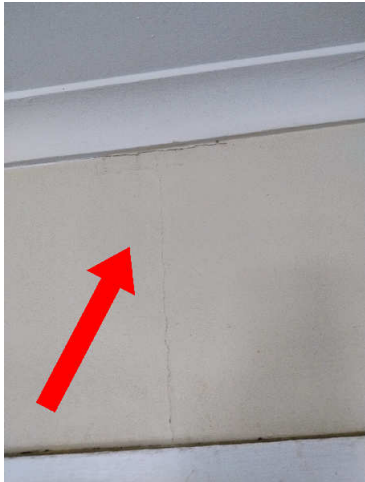
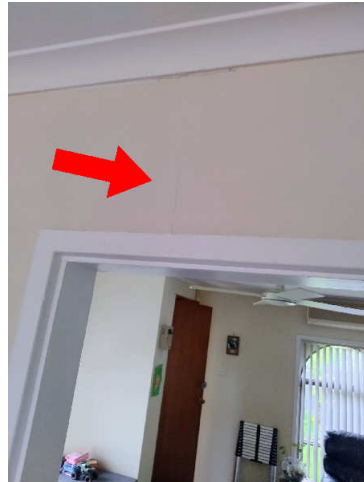
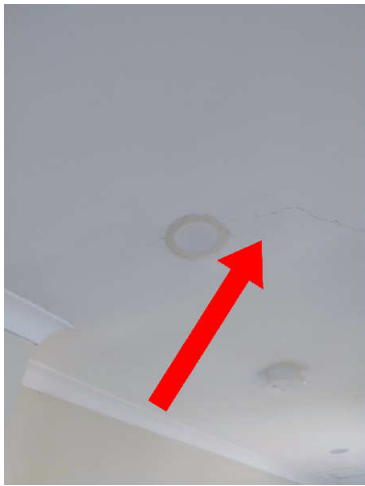
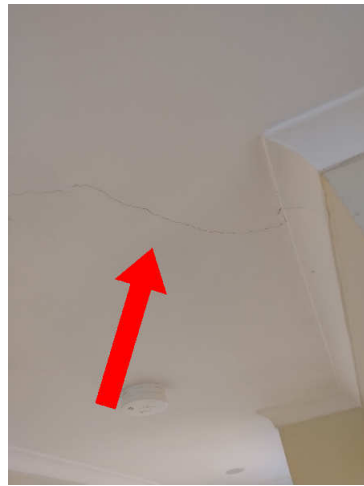
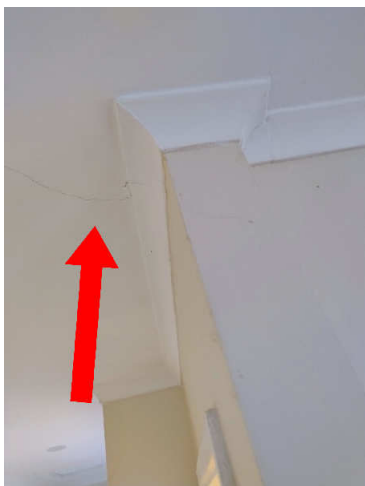
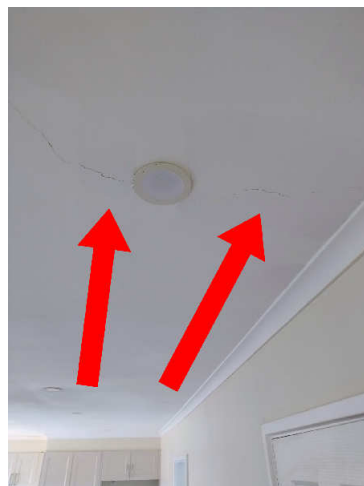
**Defects 3.10**

Finding: Cracking - Damage Category 2 - Noticeable (up to 5mm)

Information: Several cracks in all internal areas were observed at the time of inspection. Noticeable cracks are a common occurrence as a result of many primary defects. Such causes may include age, general wear and tear, expected building movement, general expansion/contraction of building materials in different weather conditions, and/or minor failings in the installation or application of building materials.

Noticeable cracks may result in minor sticking or jamming of associated doors and windows, which require easement. However, noticeable cracks are easily filled and repaired. A plasterer can be consulted to install an expansion joint at this point to allow for this movement during different weather conditions.

Monitoring of all cracking should be conducted frequently. Always contact a building inspector should cracks widen, lengthen, or become more numerous. Additionally, your building inspector should also be contacted if associated building elements such as doors and windows become more difficult to operate over time.

Relevant tradespeople, such as carpenters, painters and plasterers, should be appointed to perform remedial works, as deemed necessary.

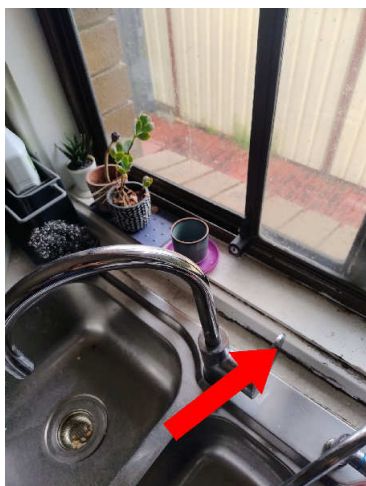
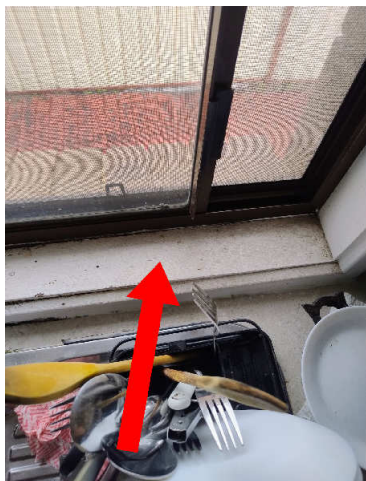
**Defects 3.11**

Information: Window timber near kitchen wash basin area was observed to be swollen at the time of inspection. Swollen building elements generally indicate that the building materials have been affected by excessive moisture over a prolonged period of time, and have swollen as a result. The formation and development of mould/fungi or mildew is also a likely consequence of excessive moisture, which may pose major respiratory issues for occupants, particularly the elderly, the very young and those with existing illnesses and could be potential health safety hazards. In these cases an appropriately qualified inspector/tester should also be contacted for advice and/or technical assistance.

The structural integrity of swollen building elements can not be guaranteed, and further damage is likely to develop if left unmanaged. Excessive moisture is likely to lead to the development of secondary damage to any associated building elements, which may necessitate major reparation works if prolonged.

Rectification of the cause of the water leak should be addressed prior to any remedial works to the swollen building elements. A licensed plumber should be appointed immediately to identify the cause of the leak and provide advice on remedial works as necessary, Repair and/or replacement of swollen building elements should be conducted as a matter of urgency by a registered builder or qualified carpenter.

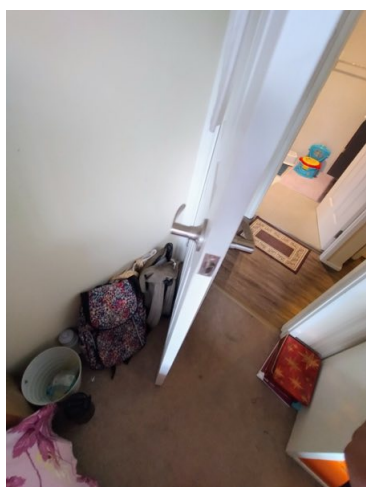
### Defects 3.12

Finding: Door stop - Missing

Information: The door stop was missing and was inadequate to stop the door handle from damaging the wall in all bedrooms at the time of inspection. Although some building elements may seem irrelevant or unnecessary, all building elements play a key role in the operation and function of the overall structure and its performance.

Re-installation or replacement of the door stop is advised as soon as possible to prevent any subsequent damage to the door or associated structures. A general handyman may be appointed to perform these works at client discretion.

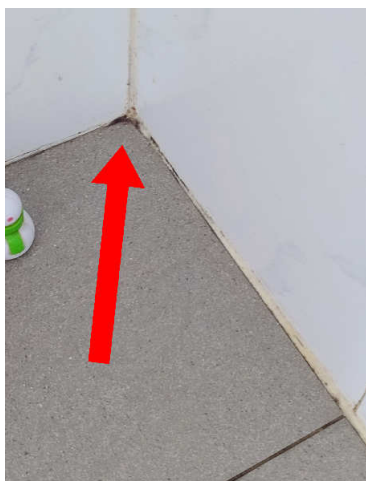
### Defects 3.15

Building:	Granny-Flat
Location:	Bathroom
Finding:	Sealant and Grouting - Damaged or Detoriorated

It was noted on inspection that sealant or grout is degraded to the tiled shower alcove and or other areas of the bathroom in Granny flat.

Different materials and floor areas move at different rates, generally causing cracking to grout or sealant at this point. A flexible sealant is required to allow for expected expansion and contraction, while keeping the joint water tight and protective of all associated building materials.

There mould to the sealant and grout which will likely require scraping out and replacement.

This can lead to water ingress into the shower base and creates conducive condition to termite activity. If left unmanaged can cause further deterioration to building elements.

Flexible and mould resistant materials should be applied to affected areas to prevent any subsequent water damage that is likely to occur. Regular maintenance and replacement of damage or missing or damaged sealant and grout is highly recommended to the wet areas, as this is a regular wear and tear defect. Sealant and grouting in areas that come into regular contact with water should be maintained for the long term care of your property.

Qualified trade person or plumber must be appointed for rectification on priority.

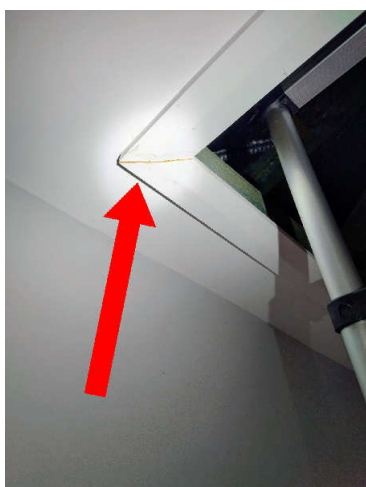
### Defects 3.16

Building:	Granny-Flat
Location:	Roof Void
Finding:	Roof void entrance side timber - Damaged
Information:	<p>Timber at the rood void entrance was observed to be damaged at the time of inspection.</p> <p>Breakage occurs generally when the building materials have either aged and decayed, or as a result of damage (accidental or deliberate).</p>

Repair and/or replacement of broken elements is advised to ensure that additional secondary defects do not arise as a consequence. Such works are necessary, as all building elements play a key role in the operation and function of the overall structure and its performance.

A relevant tradesperson should be appointed to repair or replace the affected building element prior to any subsequent damage being caused.

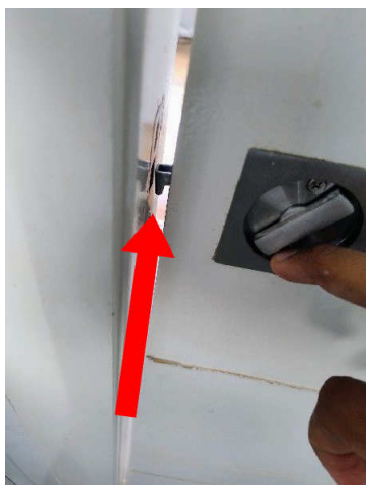
### Defects 3.17

Information: It was noted that the door in bathroom area was not latching during operation at the time of inspection. Whilst detracting from the functionality of this building element, this minor defect may also be a security risk, and may therefore have serious implications if left unattended.

It is suspected that this defect has occurred due to minor issues with the associated hinges. Such damage is identified as general wear and tear, which is expected for building elements of this age.

A qualified carpenter or general handyperson may be appointed to perform rectification works as necessary, at client discretion. If left unattended, further functional impairment is likely to occur.
