Building and Timber Pest Inspection Report

Inspection Date: Fri, 30 Jan 2026

Property Address: 4 Clyde Ct, West Wodonga VIC 3690,
Australia

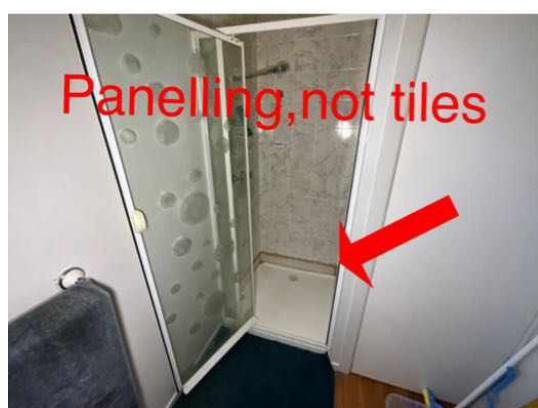
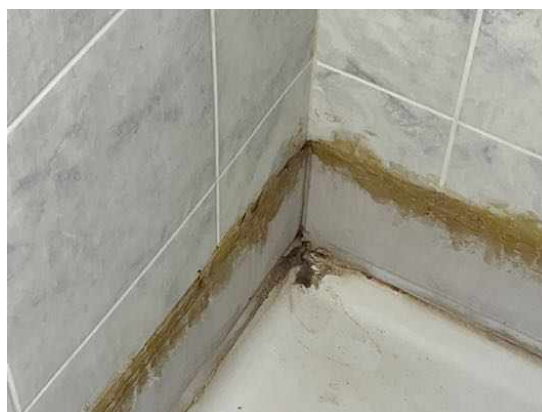
Finding 3.01

Building:	Building 1
Location:	Bungalow
Finding:	Installation - substandard or incomplete
Information:	The installation of this building element appears to have been completed to a substandard level of workmanship or is incomplete. Generally substandard repairs or installation are related to poor workmanship, the use of inappropriate materials, or a failure to complete installation to a suitable standard.

Where installation is substandard and/or incomplete, the client should contact the responsible trade to undertake rectification. Unfinished and substandard building works are likely to degrade more quickly and may create potential for secondary defects to associated building elements.

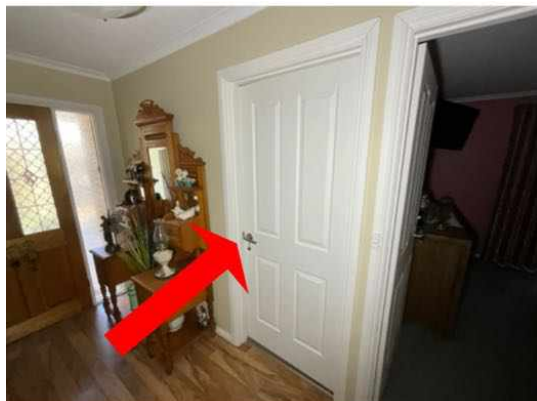
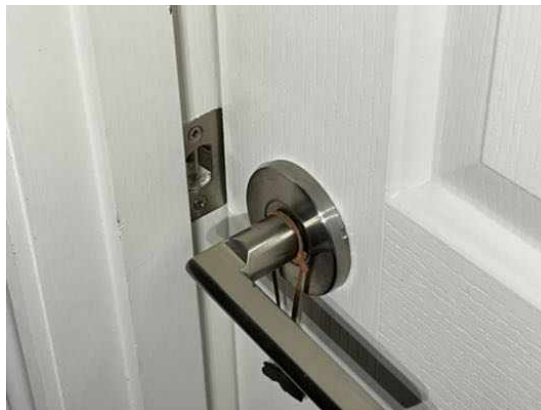
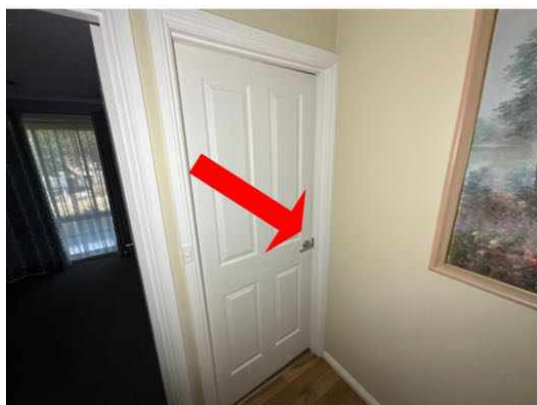
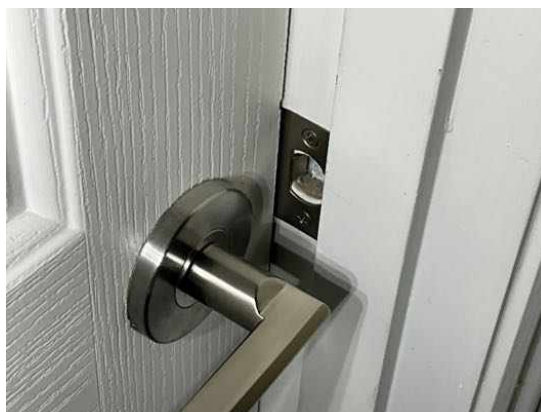
Finding 3.02

Building:	Building 1
Location:	Bedroom 1, 2
Finding:	Door - Striker plate misaligned
Information:	The striker plate to this door appears to have become misaligned and has consequently resulted in the door's operation being compromised.

This is a common defect and is expected in a property of this age, whether being due to substandard installation or general deterioration of the door hardware.

Readjustment of the striker plate is recommended at client discretion. Works such as these can be completed by a general handyman or qualified carpenter.

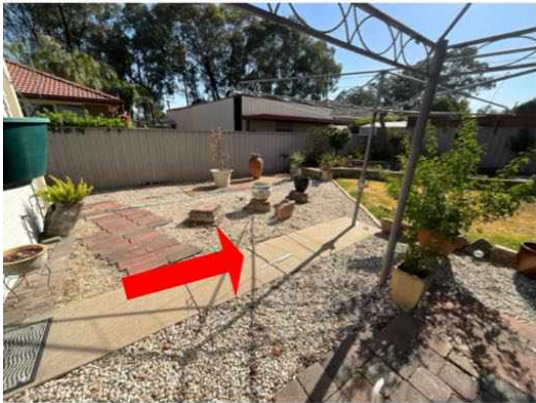
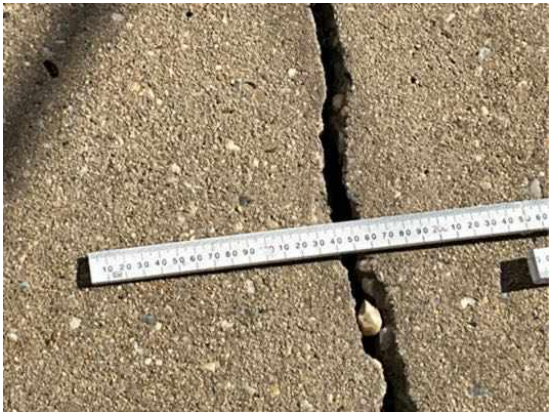
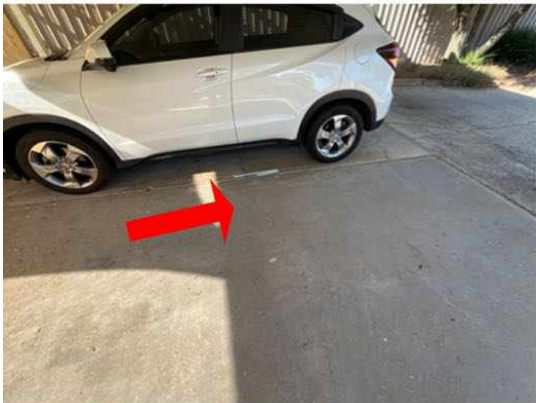
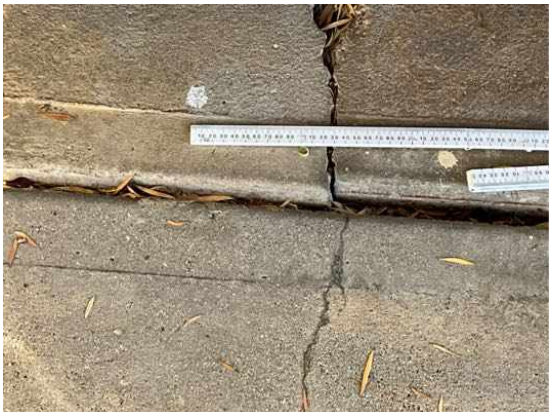
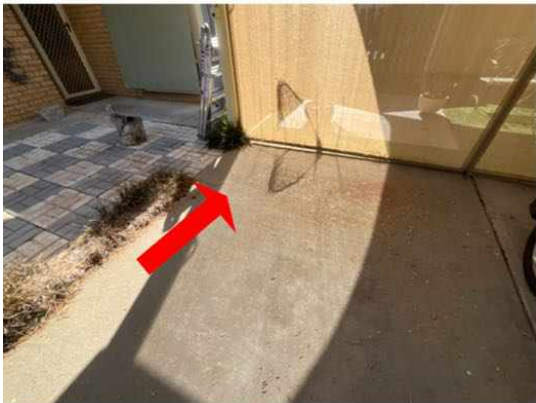
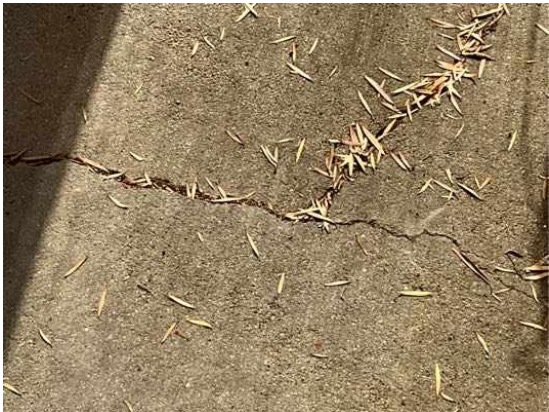
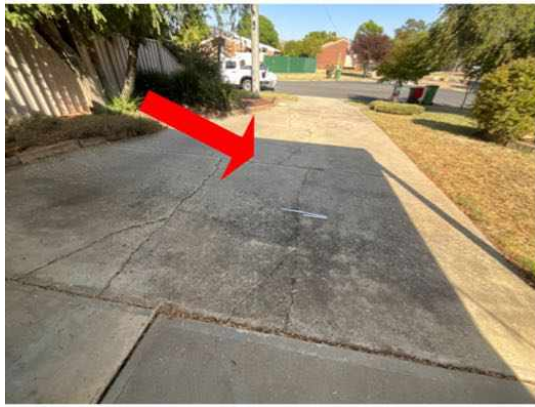
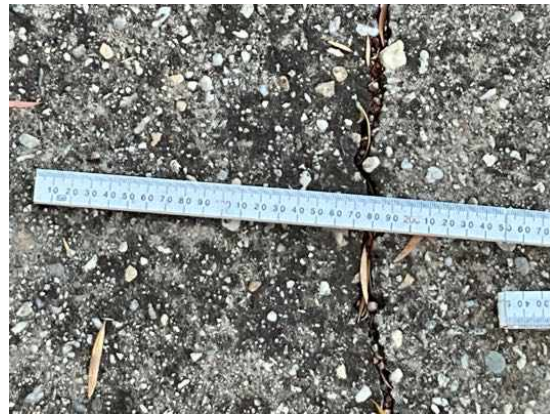
Finding 3.03

Building:	Building 1
Location:	Yard - Back, carport, driveway
Finding:	Cracking - External Concrete Paving Damage Category 4 - Gaps in Slab (4mm - 10mm +)
Information:	Gaps in the slab were identified in external concrete paving. Gaps in the slab are significant and are likely to lead to the development of safety hazards and secondary defects if left unmanaged, such as the creation of a trip hazard.

General age and expected deterioration of the paved areas is a common cause of this type of cracking. However, expansion and contraction of the slab may also have occurred due to environmental factors. Such factors include variable moisture and weather conditions, the presence of trees and their roots having a settling or lifting affect on the soil, or the effect of load bearing, e.g. heavy vehicles over a sustained period of time.

Cracking to this degree may also be due to poor original installation of the concrete. Factors such as poor compaction of the sub surface and/or inadequate reinforcing of the slab may create cracking and other secondary defects. Gaps in the concrete paving may also have a more significant structural cause, such as subsidence of soils.

Where gaps in the concrete paving are adjacent to structural elements of the building, the advice of a Structural Engineer is advisable before undertaking repairs. Significant repair and likely replacement of the concrete paving is probable.

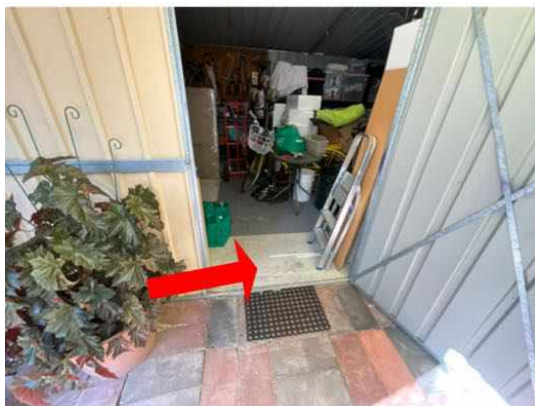
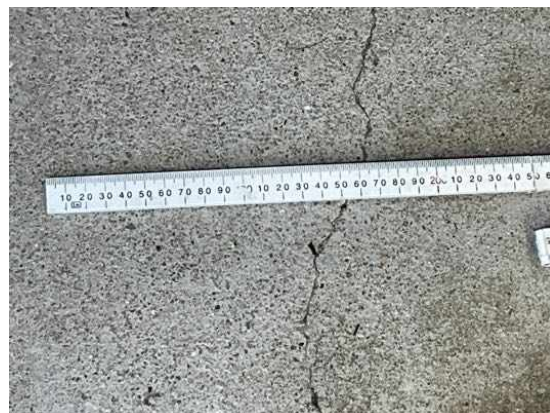
Finding 3.04

Building:	Building 1
Location:	Shed
Finding:	Cracking - External Concrete Paving Damage Category 1 - Fine (less than 2mm)
Information:	Fine cracks were identified in external concrete paving. Although fine cracks are quite noticeable, they are often only considered to be an appearance defect, and usually do not indicate any structural damage. To be considered a Category 1 or fine crack, the crack is found to be less than 2mm in width.

Generally the cause of a hairline crack in existing concrete paving such as driveways and pathways is indicative of the expansion and contraction of the concrete. Such causes are generally due to environmental factors, such as moisture levels, weather conditions, root systems of nearby trees or the soil types on which they are laid.

Fine cracks may also be due to poor original installation of the concrete. Factors such as poor compaction of the sub surface and/or inadequate reinforcing of the slab may create cracking and other secondary defects.

Monitoring of all cracking should be conducted frequently. Always contact a building inspector should cracks widen, lengthen, or become more numerous.

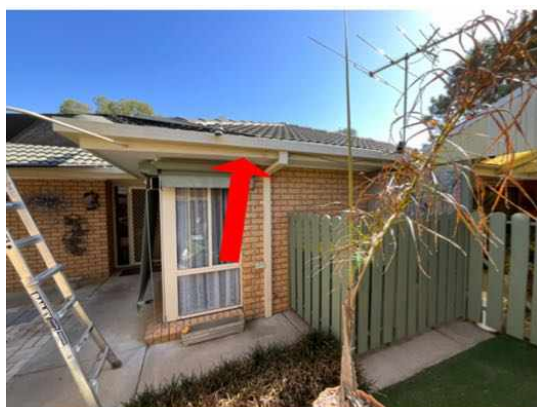
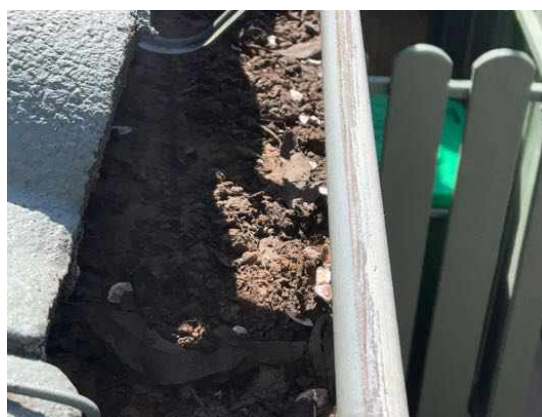
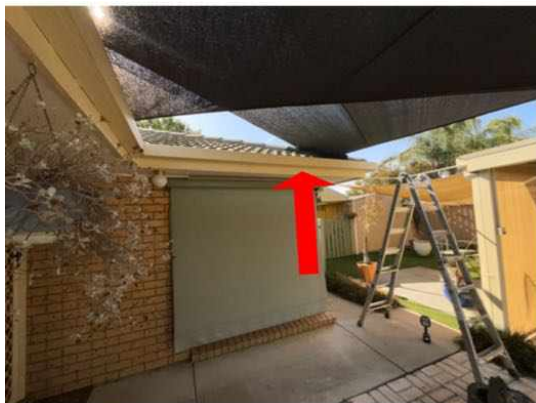
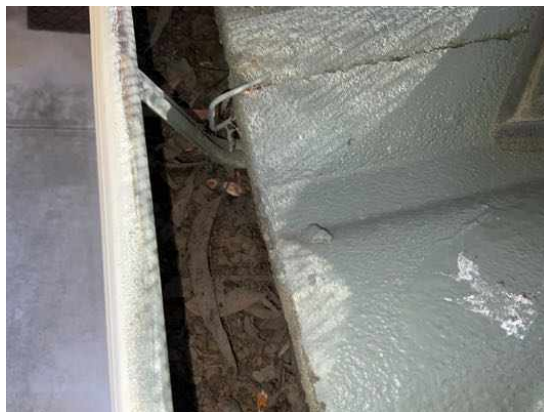
Finding 6.01

Building: Building 1
Location: Eaves
Finding: Gutters- Blocked
Information: Roof plumbing structures, such as guttering and downpipes, should be free of all debris to prevent blockages. Blockages of the guttering and downpipes will lead to pooling and accumulated water overflows, which is likely to subsequently flood eaves and exterior walls.

Blocked gutters are likely to lead to high levels of moisture in the affected areas. Such moisture will not only cause rust and decay of the associated building materials, but can also provide conditions that are conducive to termite and timber pest activity. Blockages in gutters should therefore be removed immediately to ensure dry conditions are maintained.

Consult a Licensed Plumber for further specific advice on remedial works that may be required. In the interim, it is highly advised that blocked gutters be removed by the homeowner or a general handyperson as a matter of urgency.

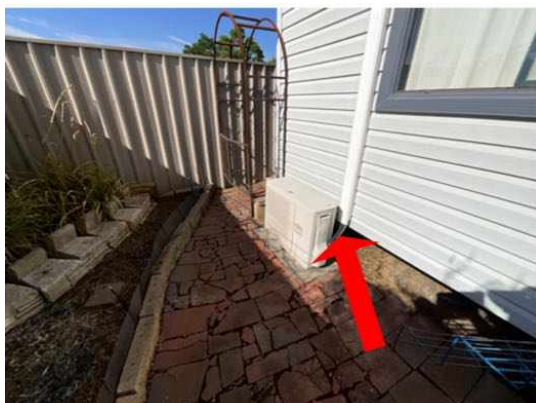
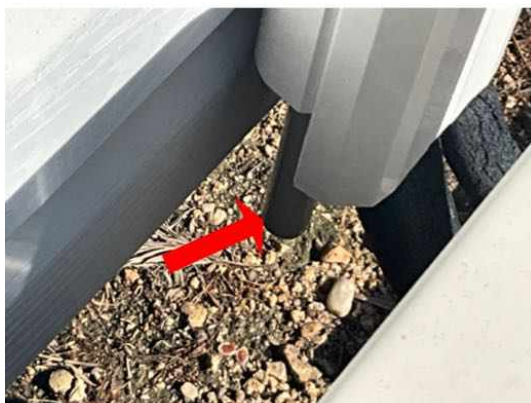
Finding 6.02

Building: Building 1
 Location: Yard - Back
 Finding: Air conditioner - Disconnected overflow
 Information: The Air Conditioner (A/C) overflow was found to be disconnected from storm water drainage and is creating excessive moisture in the surrounding area.

Such leaking creates an environment which is conducive to an array of defects, including water damage to associated building elements and the attraction of termite or timber pest infestation.

It is highly recommended that a licensed plumber be appointed to connect the A/C overflow in order to prevent such an environment from being created. These minor works should be carried out as soon as possible.

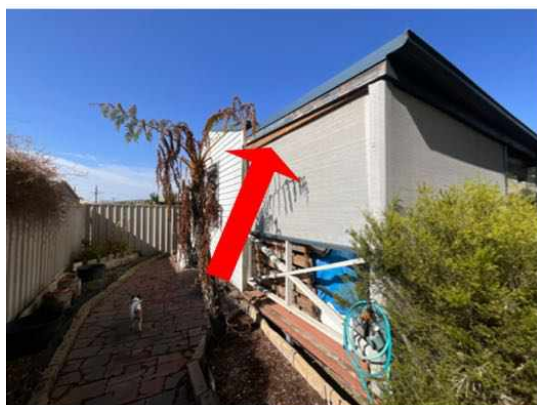
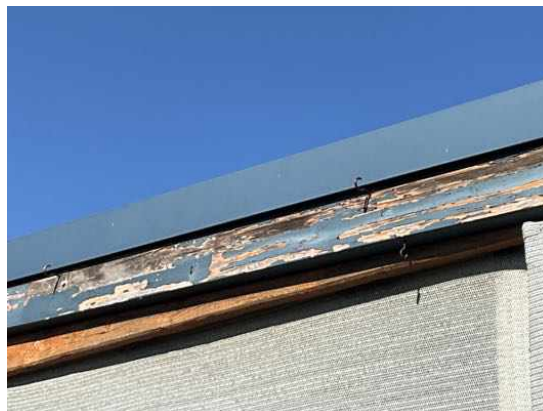
Finding 6.03

Building: Building 1
 Location: Bungalow
 Finding: Timber - exposed to weather
 Information: External timbers that are frequently exposed to harsh weather conditions require adequate protection in order to maintain their condition. Where timbers have not been

painted or treated adequately, general deterioration is likely to occur at an accelerated rate.

If left unattended, replacement of these timbers is likely to be necessary in the short-term future. Adequate treatment of these timbers is required as soon as possible by a painting contractor or general handyman.

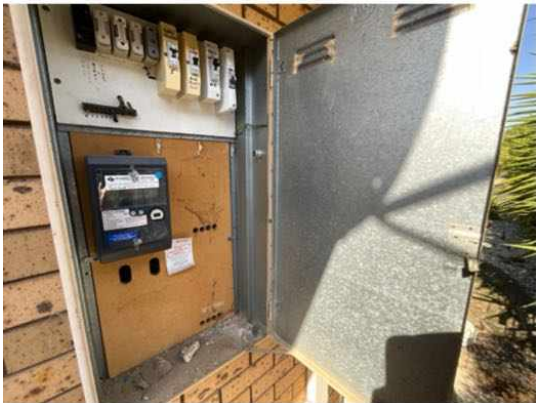
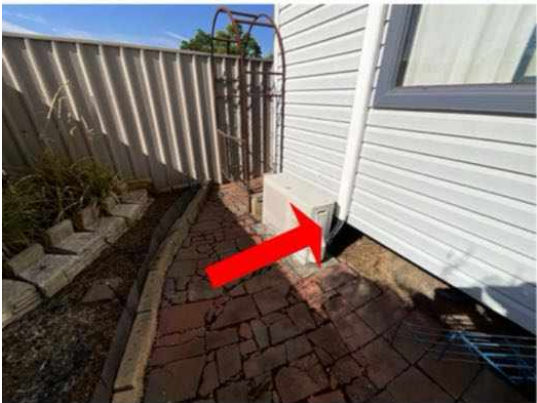
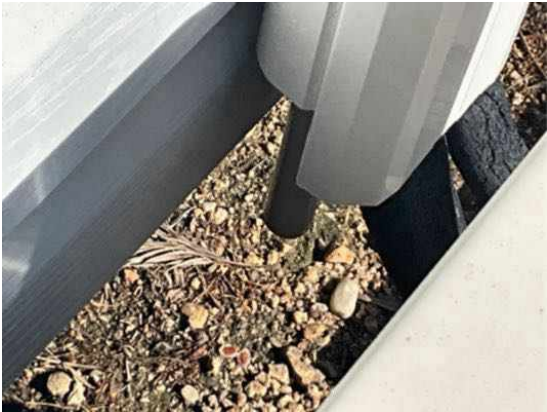
Finding 6.04

Building:	Building 1
Location:	All External Areas
Finding:	Termite Management System - no evidence of a chemical installation
Information:	The application of a post-construction chemical termite barrier is highly recommended for all properties, particularly if live termite activity has been found on the site previously. Such barriers are highly effective in preventing termite attack on any timber building elements throughout the property.

A durable notice should be placed in the switchboard unit to indicate current termite barriers. At the time of inspection, it appeared as though no termite management system has been installed, with no evidence to suggest preventative works taking place.

The client may consider gaining further advice from a pest controller as to the costs and procedures involved with this application. It is recommended that obtaining such advice be a short-term priority.

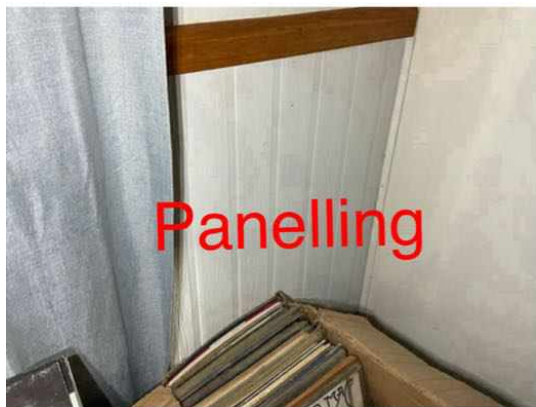
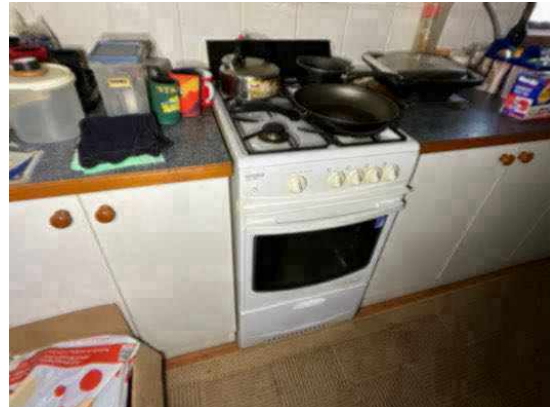
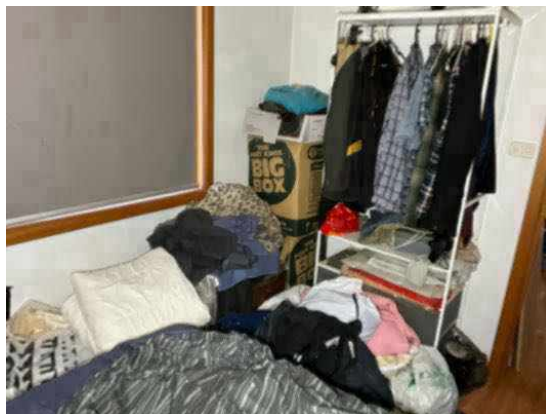
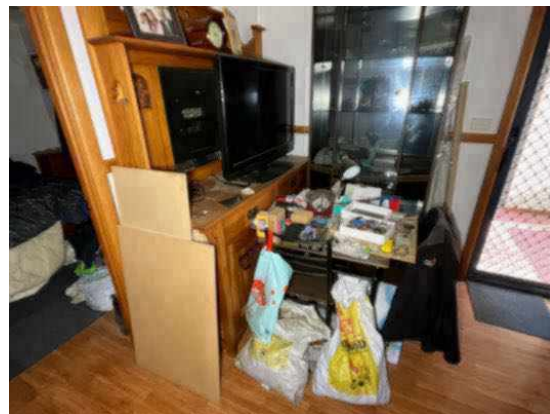
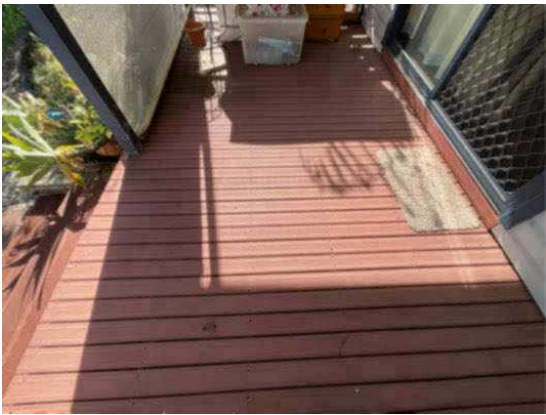
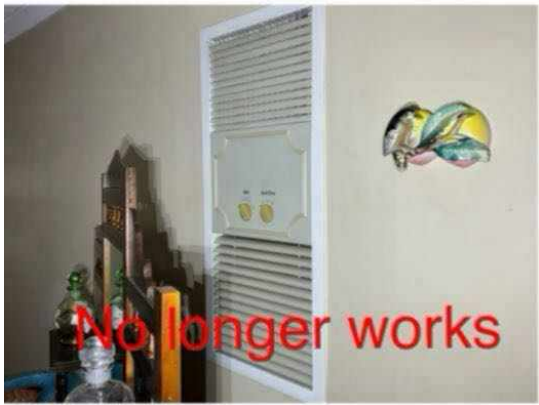
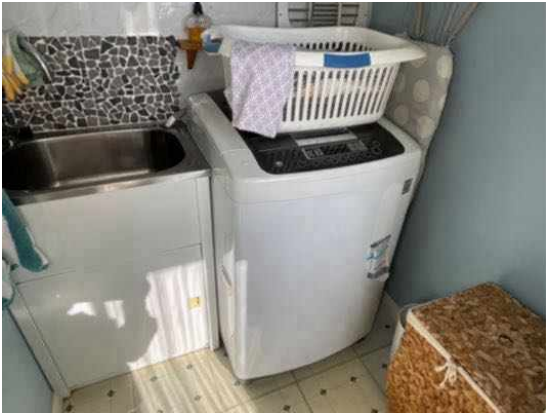
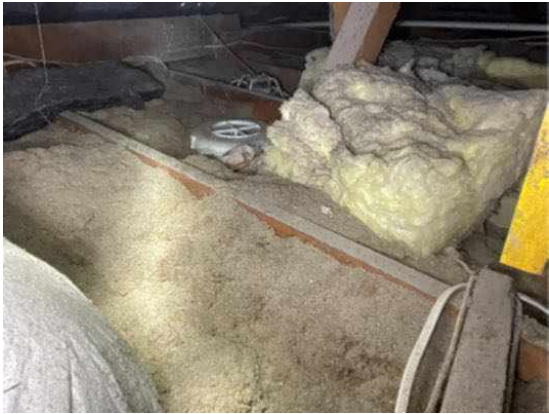
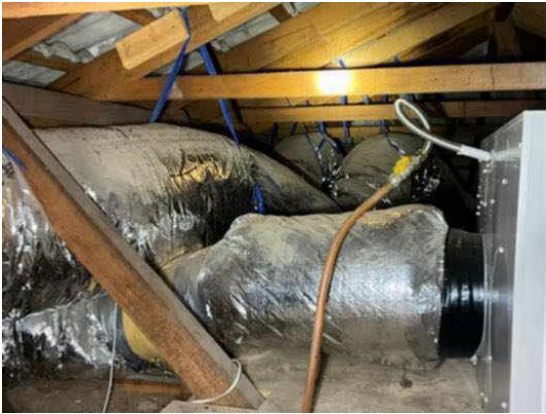
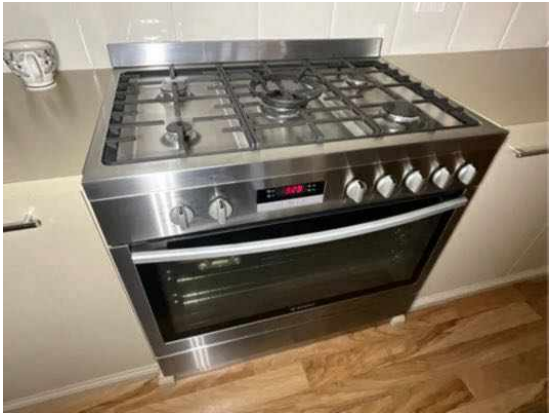
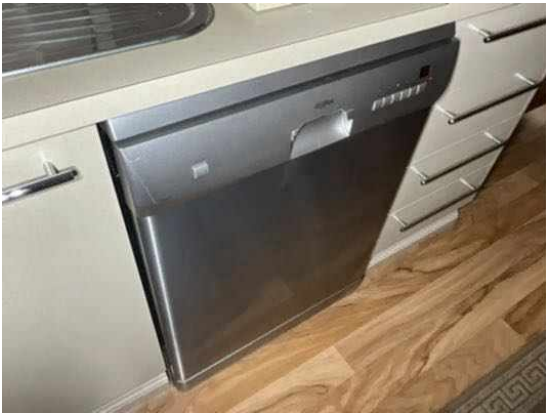
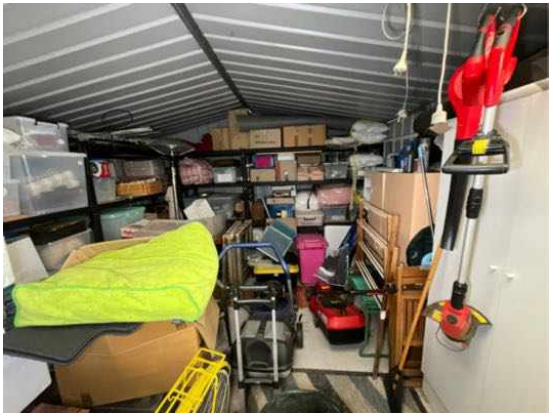
Noted Item

Building: Building 1
Location: All Areas
Finding: Additional Photos - Obstructions and Limitations
Information: These photographs are an indication of the obstructions and limitations which impeded full inspection of the property at the time of inspection. These obstructions can hide an array of defects and should be removed to allow full inspection to be carried out. A re-inspection is recommended once the areas are made accessible.
