Building and Timber Pest Inspection Report

Inspection Date: Sat, 7 Feb 2026

Property Address: 25 Hester Ave, Claymore NSW 2559,
Australia

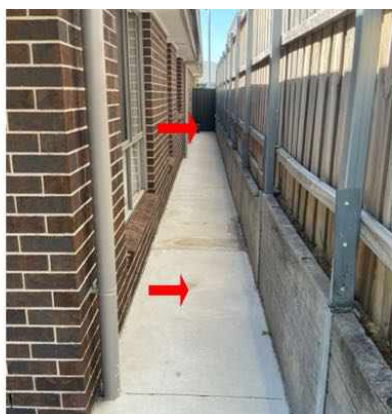
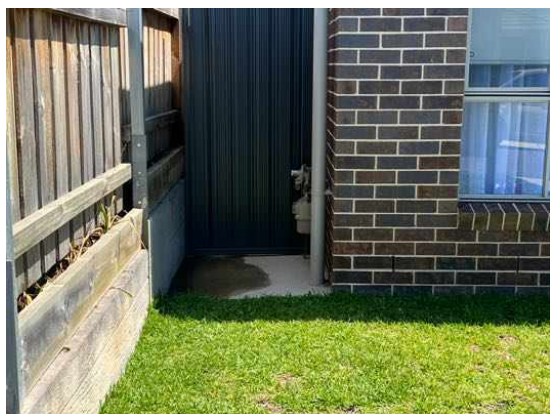
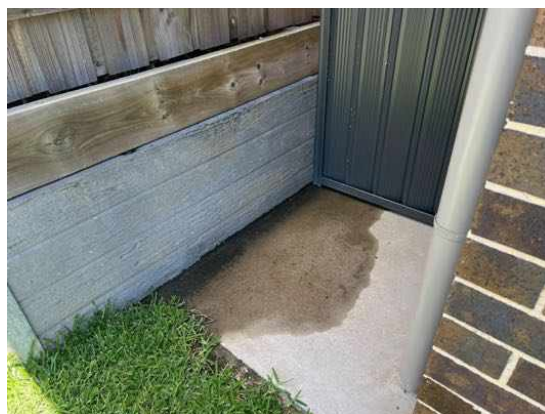
Building: Main Building
Location: All External Areas
Finding: Site drainage - Inadequate
Information: The site drainage in this area was found to be inadequate at the time of inspection, creating potential for subsequent water damage to associated building elements.

It is important that water does not lie against the base of walls; surrounding paths and ground levels should be sloped to drain water away from walls. Downpipes should not discharge stormwater onto lower walls or plinths. Stormwater should be carried away by large, regularly cleaned drains. Ground levels may need to be lowered to expose a buried DPC.

Where site drainage is inadequate, installation of an Agricultural (Aggie) Drain may be required. A qualified plumber should be appointed to further inspect the property and perform any remedial works as necessary. Water damage and secondary defects are likely to occur if left unmanaged.

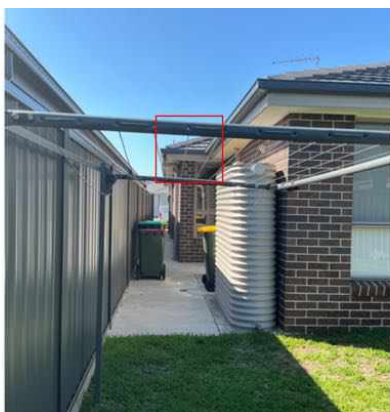
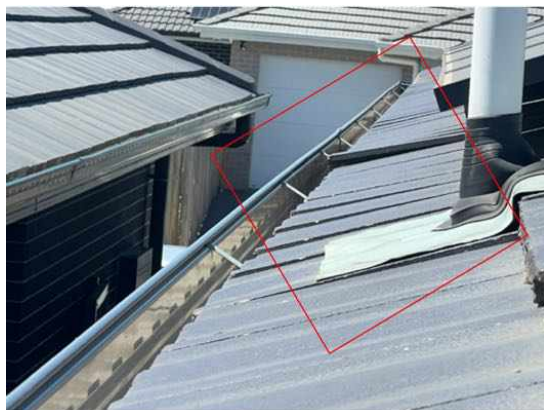
Finding 3.02

Building:	Main Building
Location:	Roof Exterior
Finding:	Roof tiles - Broken and lifting to some areas
Information:	Upon inspection of the exterior roof covering, broken roofing tiles were identified. Broken and friable roof tiles are generally the result of ageing and weathering of what is essentially a porous material.

If left to further deteriorate, broken and brittle roof tiles are likely to lead to water penetration via the roof into the ceiling space, causing secondary damage to ceiling linings, insulation and roof structures. Broken roof tiles are also likely to detract from the effectiveness of the roof drainage system, creating potential for secondary damage to the exterior roof covering and roof plumbing.

Replacement of broken tiles is required and should be performed by a roofing contractor as soon as possible.

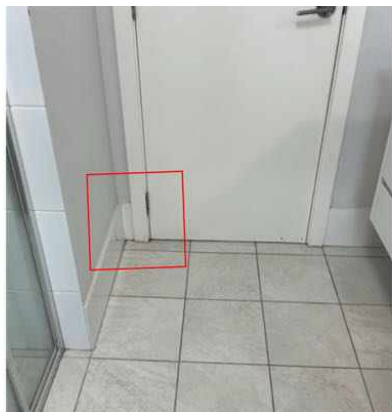
Finding 3.03

Building:	Main Building
Location:	Bathroom
Finding:	Wet-Area Door Jambs – Moisture Staining / Decay
Information:	Minor moisture staining and early signs of deterioration were observed at the base of the wet-area door jamb and architraves. This is commonly due to water splashing or moisture tracking from the bathroom floor into adjacent joinery. At the time of inspection.

It is recommended that the door junctions be resealed with a suitable moisture-resistant sealant and that ventilation and drainage within the bathroom be maintained to reduce further dampness. Where timber swelling or decay has progressed, localised repair or replacement using moisture-resistant materials (H3-treated or equivalent) should be undertaken.

Further inspection by a licensed carpenter or waterproofing contractor is recommended to confirm the extent of deterioration and verify whether any remedial sealing or minor replacement works are warranted.

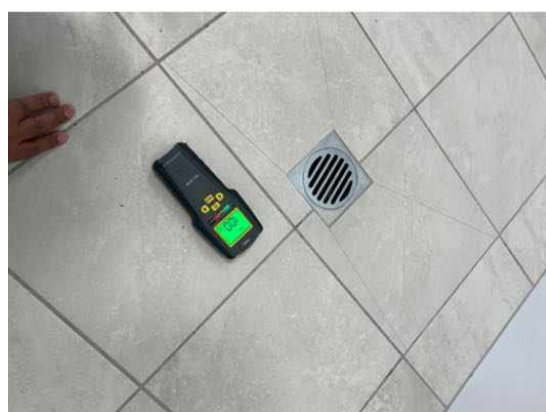
Finding 3.04

Building:	Main Building
Location:	Bathroom, Ensuite
Finding:	Elevated Moisture Bathroom (No visible deterioration noted)
Information:	Elevated moisture levels were detected to tiled surfaces in bathroom/shower areas. Persistent moisture ingress can lead to concealed damage, including timber rot and mould growth.

Elevated moisture readings in tiled wet areas can occur from normal shower use, age/deterioration of waterproofing membranes, plumbing leaks or moisture absorption through grout lines. While no damage was visible, elevated readings may indicate moisture retention behind tiles, which can be a conducive condition for future deterioration if not monitored.

No immediate action required. Monitor the area over time for signs of drumming, efflorescence, tile movement, or grout deterioration. If concerns arise, a licensed waterproofing specialist can perform further investigation (e.g., pressure testing, membrane assessment).

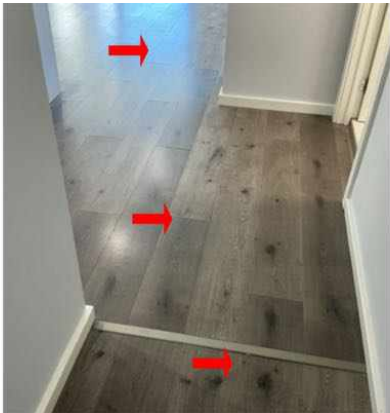
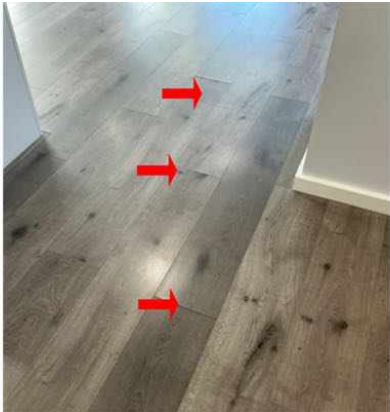
Finding 3.05

Building: Main Building
Location: All Internal Areas
Finding: Internal Flooring
Information:

The internal laminate/engineered timber flooring displays inconsistent installation quality, including visible gaps at board joints, uneven end-joint alignment, poor staggering, and/or unevenness to some areas. While the flooring remains serviceable, the defects detract from appearance and may lead to increased wear over time, rectification by a qualified flooring contractor is recommended to improve finish and long-term performance.

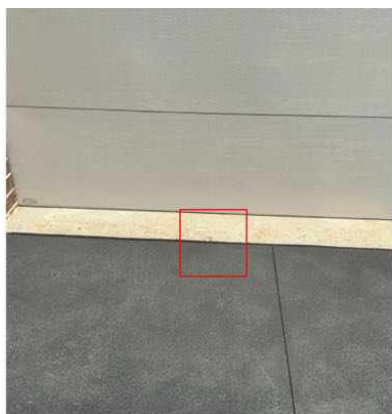
Finding 3.06

Building:	Main Building
Location:	Garage
Finding:	Building element - Damaged - Concrete damage/chipped
Information:	Breakage occurs generally when the building materials have either aged and decayed, or as a result of damage (accidental or deliberate).

Repair and/or replacement of broken elements is advised to ensure that additional secondary defects do not arise as a consequence. Such works are necessary, as all building elements play a key role in the operation and function of the overall structure and its performance.

A relevant tradesperson should be appointed to repair or replace the affected building element prior to any subsequent damage being caused.

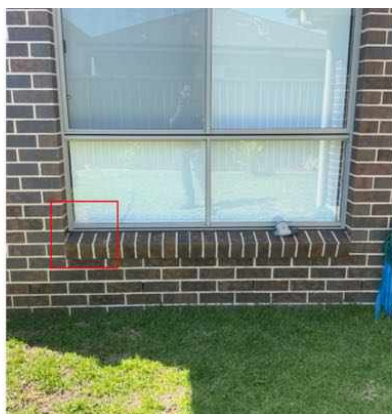
Finding 3.07

Building:	Main Building
Location:	All External Areas
Finding:	Gap Between Window Frame and Masonry
Information:	A visible gap is present between the external window frame and the adjacent masonry wall. This gap may allow water ingress, air infiltration, and potential pest entry if not adequately sealed. Over time, such exposure can contribute to frame deterioration, internal water damage, or reduced thermal performance. Sealing or filling the gap with a suitable weatherproof compound is recommended to maintain the integrity of the building envelope, in accordance with good building practice and AS 4349.1

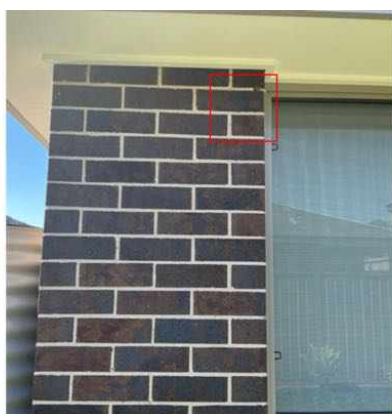
Finding 3.08

Building:	Main Building
Location:	All External Areas
Finding:	Brickwork - Deteriorated mortar to some areas
Information:	Mortar, or 'bedding', is the material which fills joints and intersections between bricks in masonry walls and structures. Sections of mortar in this brickwork were identified as having deteriorated, which is generally expected for a property of this age and condition.

Mortar may deteriorate as a result of age of building materials, minor movement of bricks, or frequent exposure to weathering. Mortar should be replaced to ensure that bricks remain in their intended location and to prevent gaps, which would allow water or moisture ingress and secondary damage as a result.

Mortar deterioration can be addressed by a bricklayer where areas of deterioration are localised and easily accessible. Alternatively, appointment of a registered builder is advised, to repoint large areas of decaying mortar. Where secondary structural defects have become evident, consultation with a structural engineer may be required.

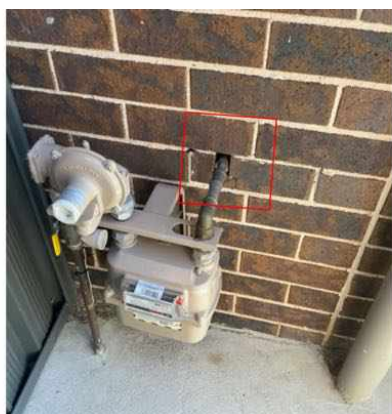
Finding 3.09

Building:	Main Building
Location:	All External Areas

Works that have not been completed to a satisfactory level create potential for the development of building defects and may impede on the safety and integrity of the overall structure.

It is highly recommended that the relevant trades be appointed to complete these works and ensure the safety of the area and the longevity of all associated building elements.

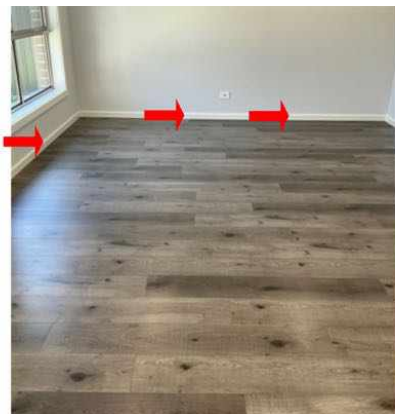
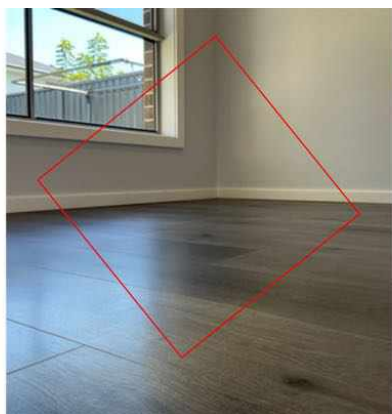
Finding: Gap Between Skirting and Timber flooring

Information: Visible gaps between the skirting board and the timber flooring was noted, commonly associated with natural shrinkage, seasonal movement of timber flooring, or installation tolerances. While no signs of moisture damage, distortion, or structural concern are evident at the time of inspection, the gap may detract from the finish and could allow minor moisture ingress or debris accumulation, and is therefore considered a minor defect. Rectification, if desired, typically involves adjustment or refixing of skirting boards or installation of appropriate flexible sealant or trim by a qualified carpenter, particularly where moisture exposure is likely.

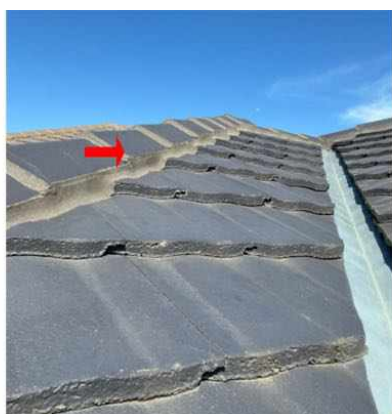
Finding 3.12

Building:	Main Building
Location:	Roof Exterior
Finding:	Mortar - Deterioration to some areas
Information:	Mortar, or 'bedding', is the material which fills joints and intersections between tiles and other building elements on the exterior roof covering, such as gable ends, hip capping and valleys. Upon inspection of the exterior roof, it was noted that sections of the mortar show varying levels of deterioration.

Mortar generally deteriorates as a result of frequent exposure to weather conditions over a prolonged period of time. Mortar that is deteriorating may allow water ingress into the roof void, putting associated building elements and roofing structures at risk of water damage. Deteriorated mortar also detracts from the functionality of roof tiles and other roofing elements, potentially decreasing weather tightness and roof drainage.

Mortar deterioration can be attended to by a handyperson where areas of deterioration are localised and easily accessible. Otherwise, consultation with a roofing contractor is advised where greater works are required.

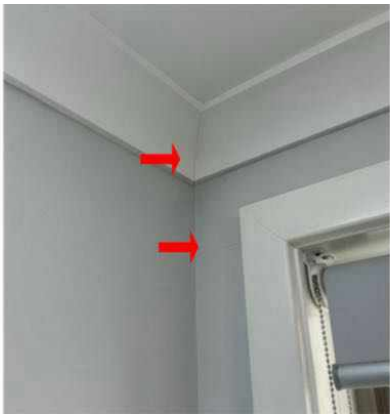
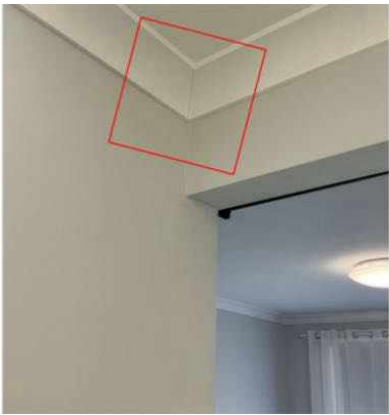
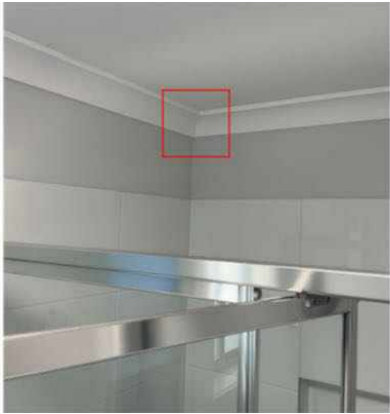
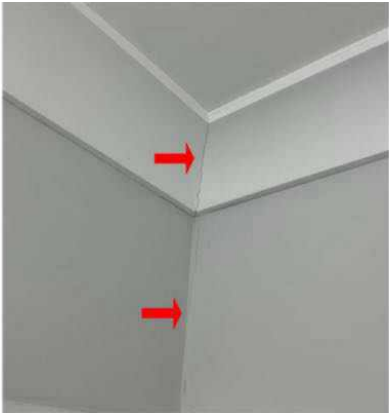
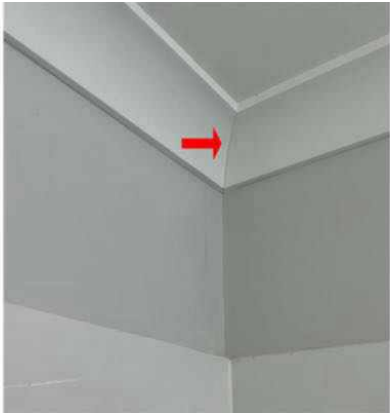
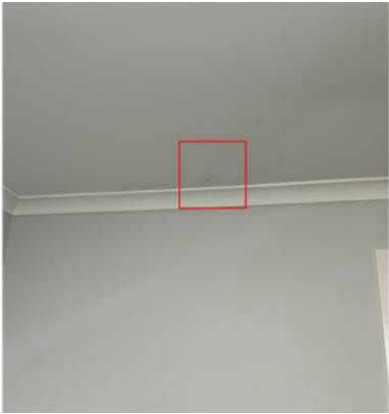
Building: Main Building
Location: All Internal Areas
Finding: Paint Finish & Hairline Cracking - To some areas
Information: The paint finish in this area was identified as being incomplete or substandard at the time of inspection including some hairline minor cracking/separation. Monitoring is recommended where cracking and separation is evident.

Whilst incomplete or missing paint finish is generally an appearance defect, it can also lead to the development of secondary building defects over time. Incomplete areas of paint finish expose the area to moisture, potentially accelerating the deterioration of underlying building materials.

Incomplete paint finishes should be sanded back, filled, leveled and painted, as applicable. Where inadequate or missing paint protection has led to the deterioration of the associated building element, repair and/or replacement of this building element may be required.

A painting contractor should be appointed as soon as possible to perform necessary works to aid the appearance of the affected area and to ensure the area is protected against further deterioration. Alternatively, the homeowner following manufacturer instructions may perform these works.

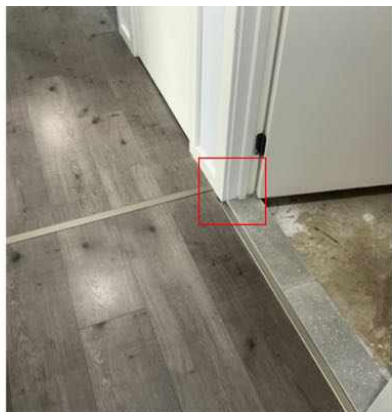
Finding 3.15

Building:	Main Building
Location:	All Internal Areas
Finding:	Sealant and grouting - Missing or degraded
Information:	It was noted on inspection that sealant or grout is degraded.

Different materials and floor areas move at different rates, generally causing cracking to grout or sealant at this point. A flexible sealant is required to allow for expected expansion and contraction, while keeping the joint water tight and protective of all associated building materials.

Excessive mould to the sealant and grout may require scraping out and replacement.

Flexible and mould resistant materials should be applied to affected areas to prevent any subsequent water damage that is likely to occur. Regular maintenance and replacement of damage or missing or damaged sealant and grout is highly recommended to the wet areas, as this is a regular wear and tear defect. Sealant and grouting in areas that come into regular contact with water should be maintained for the long term care of your property.

A sealant specialist or tiling contractor should be appointed to complete these works as soon as possible

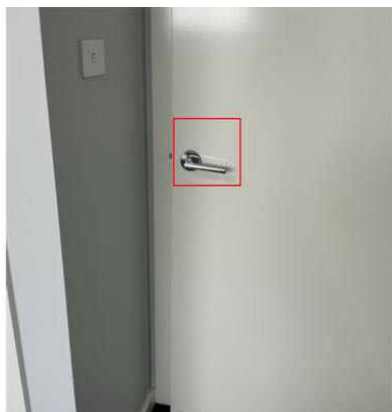
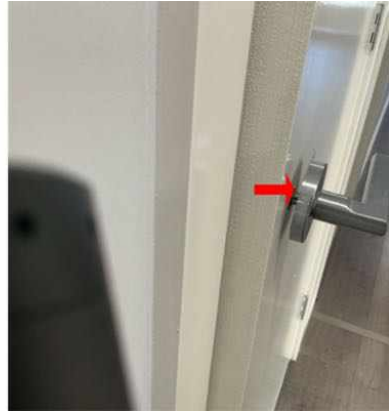
Finding 3.16

Building:	Main Building
Location:	Bedroom, hallway
Finding:	Building element - Damaged - Door handle loose
Information:	Breakage occurs generally when the building materials have either aged and decayed, or as a result of damage (accidental or deliberate).

Repair and/or replacement of broken elements is advised to ensure that additional secondary defects do not arise as a consequence. Such works are necessary, as all building elements play a key role in the operation and function of the overall structure and its performance.

A relevant tradesperson should be appointed to repair or replace the affected building element prior to any subsequent damage being caused.

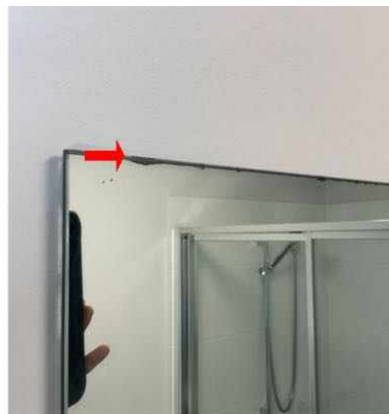
Finding 3.17

Building:	Main Building
Location:	Ensuite, main bath
Finding:	Mirror Desilvering at Bathroom Vanity
Information:	Desilvering is evident along the bottom edge of the bathroom mirror above the vanity unit. This defect is located in the main bathroom and presents as brown-black deterioration of the reflective backing of the mirror. The desilvering is likely caused by prolonged exposure to moisture or water splashes from the basin below. This issue is considered a minor defect under AS 4349.1, affecting aesthetic appearance rather than function, and may worsen over time if left unaddressed. A licensed bathroom contractor or glazier should replace the mirror, and adequate sealing or ventilation should be ensured to prevent recurrence.

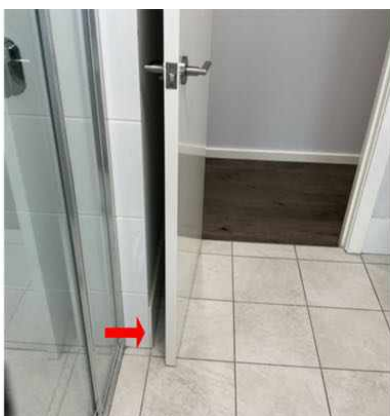
Finding 3.18

Building:	Main Building
Location:	All Internal Areas
Finding:	Door stop - Missing to some areas
Information:	The door stop is missing or is inadequate to stop the door handle from damaging the wall. Although some building elements may seem irrelevant or unnecessary, all building elements play a key role in the operation and function of the overall structure and its performance.

Re-installation or replacement of the door stop is advised as soon as possible to prevent any subsequent damage to the door or associated structures. A general handyman may be appointed to perform these works at client discretion.

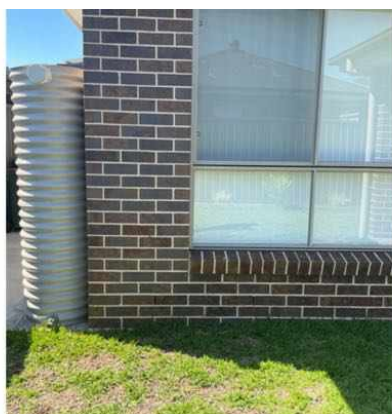
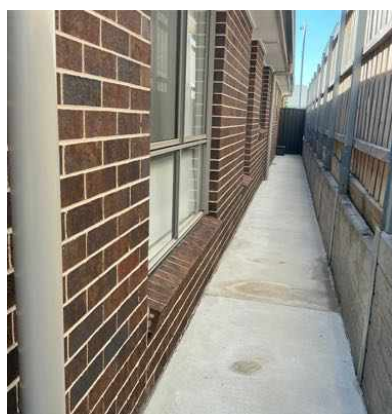
If the slab edge is not properly exposed there is a high risk of termite attack. Sometimes, in order to determine the type of slab, a suitably qualified person such as an architect or builder may be required to consult the construction plans.

Where the slab edge cannot be properly inspected, it is highly recommended that termite or timber pest inspections be carried out every 6-12 months to aid protection of the property against infestation.

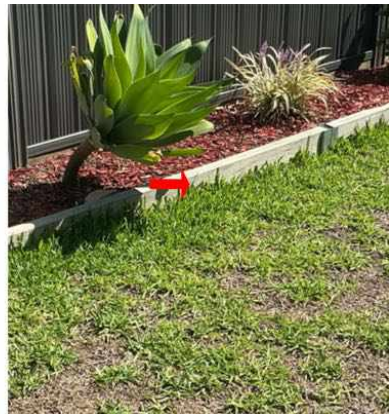
Finding 6.02

Building:	Main Building
Location:	All External Areas
Finding:	In ground contact - Timber
Information:	Any timbers in direct ground contact provide opportunity for concealed termite entry and are likely to be subject to premature rot and decay as the soil retains moisture or damp conditions against the timbers.

Remove untreated timber that is in direct contact with external grounds. Consider replacement with more durable materials i.e. treated timber or non timber elements. Frequent pest inspections are advised to readily identify any termite activity in these areas.
