Building and Timber Pest Inspection Report

Inspection Date: Thu, 29 Jan 2026

Property Address: 43 Richard Ave, Earlwood NSW 2206,
Australia

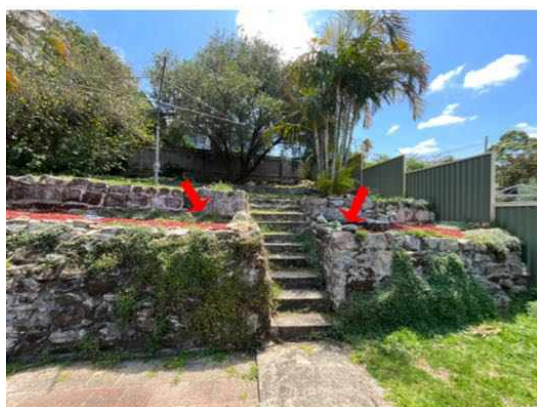
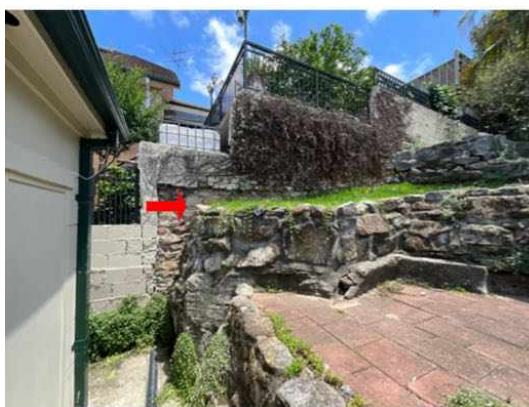
Finding 1.01

Building:	Yard
Location:	Yard - Back
Finding:	Balustrade - Missing
Information:	This area does not have an approved balustrade to all sides.

This report does not cover compliance issues however it is the opinion of the inspector that the area is not safe and may require a balustrade to be installed.

A licensed builder could be appointed to provide necessary works to the areas.

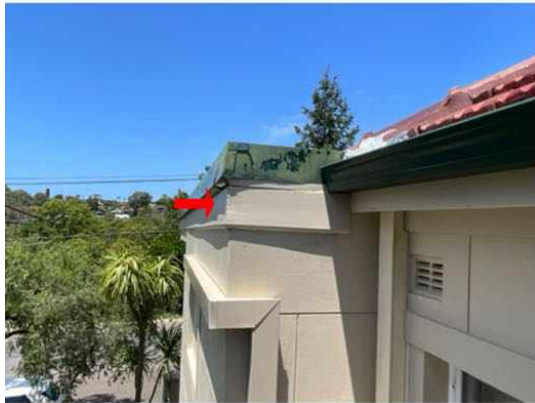
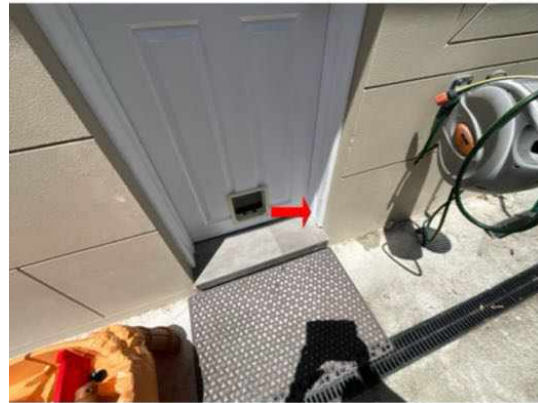
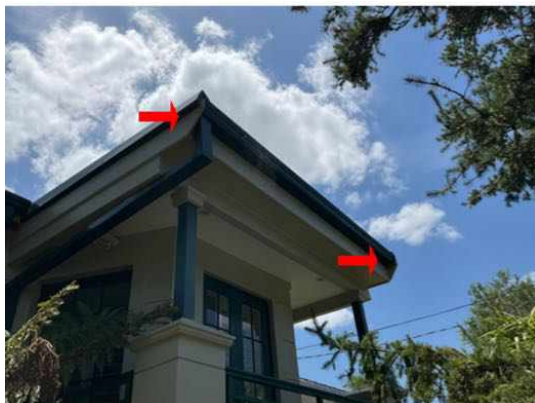
Finding 3.01

Building:	Main Building
Location:	External Areas
Finding:	Wood rot
Information:	This building element shows evidence of wood rot. Wood rot, also known as Fungal Decay, occurs when timbers and other cellulose building materials are exposed to damp conditions on an ongoing basis. This could be the result of exposure to weathering over a prolonged period of time, or the attraction of excessive moisture from other abutting building materials.

Early intervention and regular maintenance, particularly of exterior timbers, will prolong the useful life of these building elements. Prior to any works being performed, the cause of the moisture that has created the visible wood rot should be identified and addressed in a suitable manner. Replacement of affected timbers may then be a necessary step in protecting surrounding building elements from such deterioration.

A qualified carpenter or registered builder may also be required to replace affected building materials.

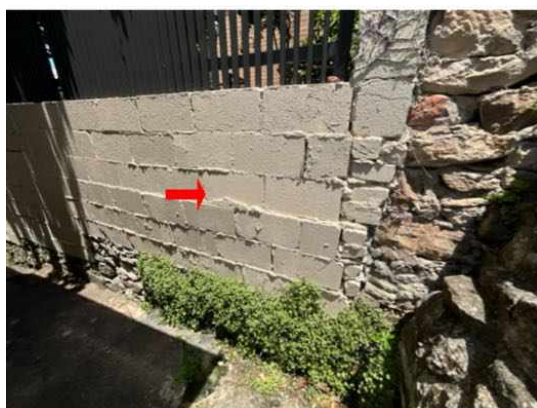
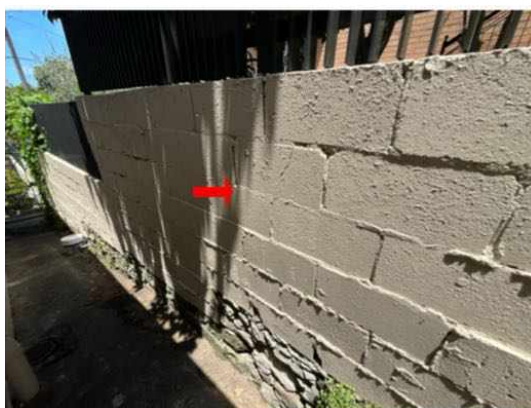
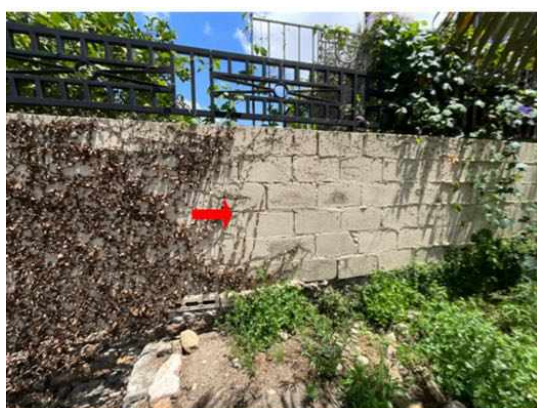
Finding 3.02

Building:	Yard
Location:	Block Fencing
Finding:	Blockwork - Cracking noticeable
Information:	There were several cracks and or crack repairs evident to external blockwork.

Noticeable cracks are a common occurrence in external blockwork and are a likely result of age expected building movement, general expansion, and/or contraction of building materials in different weather conditions.

It is highly advised that a qualified bricklayer be appointed to provide necessary works to cracked brickwork to prevent any further damage.

Always monitor these cracks and contact a building inspector should cracks widen,

lengthen, or become more numerous.

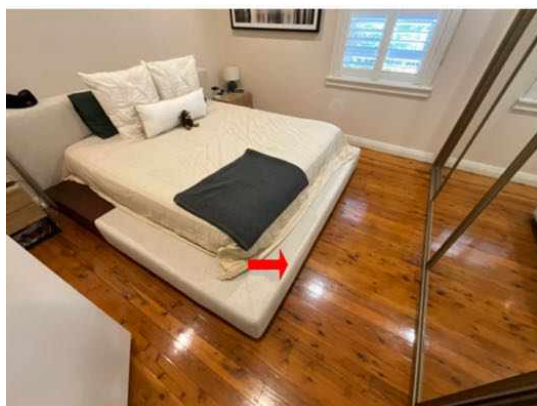
Finding 3.03

Building:	Main Building
Location:	Bedroom
Finding:	Floors - bouncy
Information:	The internal flooring in this area was identified as being bouncy at the time of inspection. A bouncy floor surface generally presents as a discernible change in level as they are walked across, in noisy or creaking flooring, or in consequent movement of surrounding furniture and fixtures.

Bouncy floors generally indicate that the floorboards or the subfloor structures are coming loose from the joists that they are installed on. Bouncy flooring may also be the result of gaps between flooring and joist structures, which require packing.

The client is advised to seek quotations for required repairs from a Registered Builder.

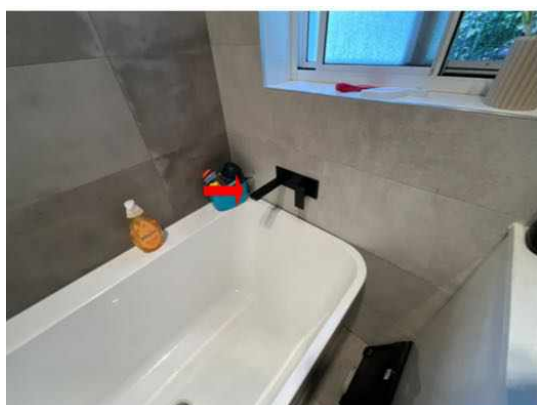
Finding 3.04

Building:	Main Building
Location:	Bathroom
Finding:	Tap - Water hammer
Information:	This tap shows evidence of water hammer being present. Water hammer, a pressure surge resulting when a fluid is forced to suddenly change direction, is a common defect in plumbing fittings, particularly those that are aged and not frequently maintained. Water hammer is generally caused by factors that create high water pressure in the affected plumbing fixture, usually evidenced by a faint banging noise during operation of the affected tap.

Although water hammer is generally considered to be a minor defect, subsequent damage such as erosion of tap hardware and/or water damage to associated building elements is likely to occur if left unmanaged.

A licensed plumber should be appointed as soon as possible to replace any affected tap hardware and perform any remedial works as necessary. Please be advised that the appointment of a cabinet maker or qualified carpenter may be necessary if water damage to associated building elements has occurred.

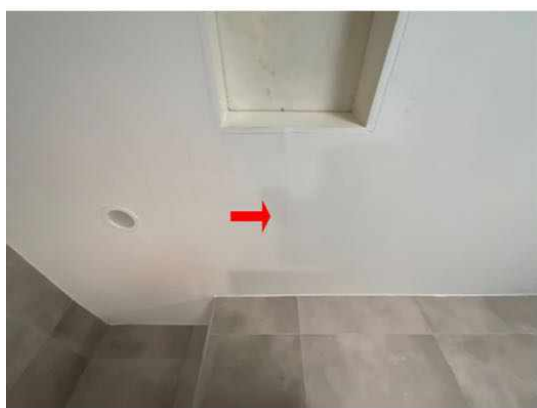
Finding 3.05

Building:	Main Building
-----------	---------------

Location: Internal Areas
 Finding: Cracking - Damage Category 1 - Fine (up to 1mm)
 Information: Although fine cracks are quite noticeable, they are often only considered to be an appearance defect, and usually do not indicate any structural damage. Generally, the cause of a fine crack is indicative of a separation between building materials and finishes (e.g. paint, plaster, etc.) along joins.

Cracking of this nature can generally be repaired with minor sanding, filling and/or repainting. Such works should be performed by a qualified painter or a general handyman.

Monitoring of all cracking should be conducted frequently. Always contact a building inspector should cracks widen, lengthen, or become more numerous.

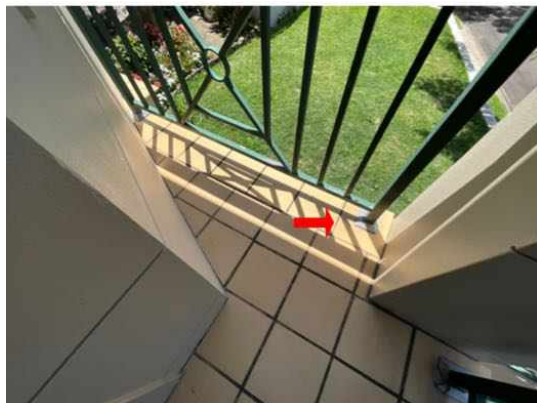
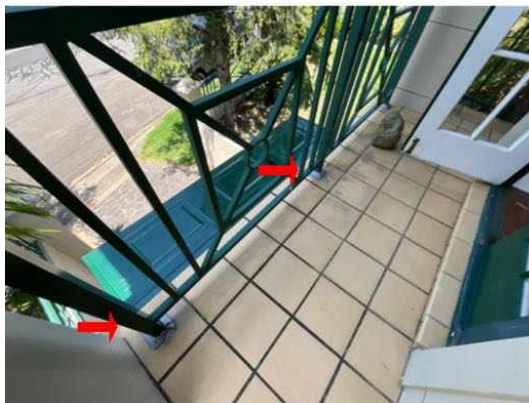
Finding 3.06

Building: Main Building
 Location: Balcony
 Finding: Building element - Rusted or corroded
 Information: This building element shows evidence of rusting and corrosion, which is likely to have developed as a result of excessive exposure to moisture and or inadequate coatings.

As surface rust provides no protection to the underlying iron, the deteriorating condition is likely to worsen if not addressed in the short-term future.

Where possible, the use of galvanized (treated) metals or aluminium coated metals aid in rust prevention, as does regular general maintenance. Rust formation can be controlled with coatings, such as paint, that isolate the iron from the environment.

Rusting and corrosion should be managed by ideally removing or limiting the affected surface from exposure to moisture.

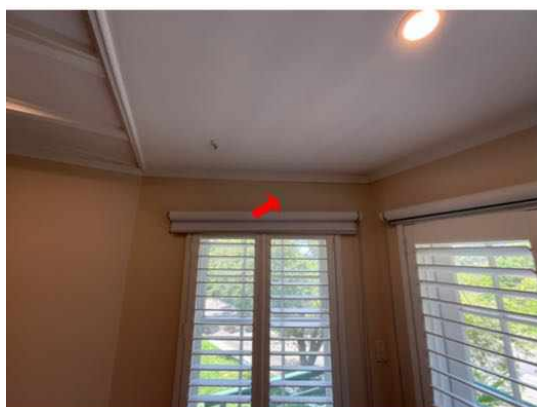
Finding 3.07

Building:	Main Building
Location:	Bedroom
Finding:	Ceiling - Water stained
Information:	Water staining to ceiling linings in this area was evident at the time of inspection. Water staining indicates that surfaces have been exposed to excessive moisture over time. The minerals and other elements in the water lead to staining, which may graduate to corrosion and deterioration if left unmanaged.

Although there was no moisture detected in the ceiling I would recommend monitoring and acting on one of the following.

Where water staining is active, a licensed plumber must be consulted to identify the cause of the staining and to provide advice on any reparation works that may be required. Replacement of any damaged structures is advised.

Conversely, where water staining is old and inactive, affected building materials may be repaired or replaced at client discretion.

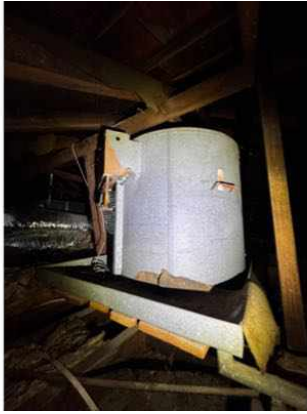
Finding 3.08

Building:	Main Building
Location:	Roof Void

Finding: Gravity-Fed HWS - Disconnected
 Information: It was noted at the time of inspection that a disconnected gravity-fed hot water system (HWS) remains in this area.

I recommend appointing a plumber to see what necessary works are required to remove the unit from the area.

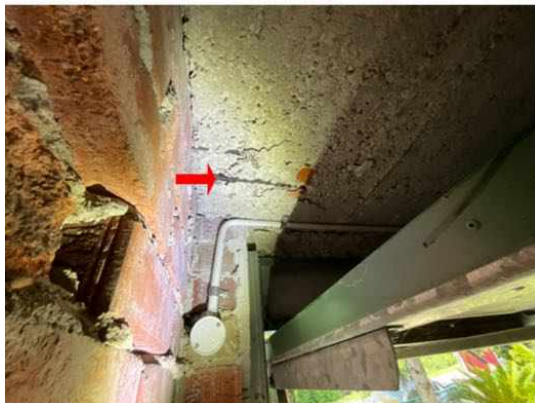
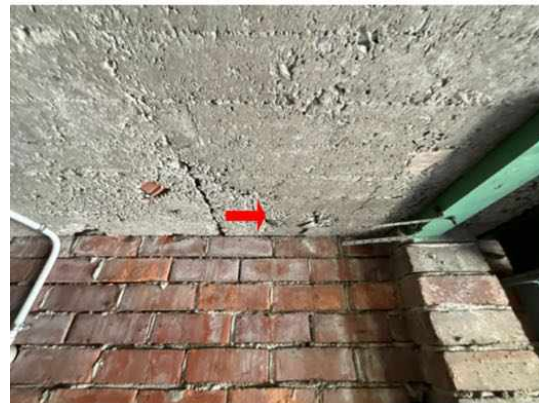
Finding 3.09

Building: Main Building
 Location: Garage
 Finding: Concrete - Spawling/cancer
 Information: Concrete spawling/cancer is the common term used to describe a number of factors which cause concrete construction to deteriorate. Generally, water penetration causes the concrete reinforcement to rust and expand, creating stresses on the surrounding concrete and in turn causing it to spall (or break away).

Although it does appear to be in its early stages I would recommend appointing a remedial builder to get further advice.

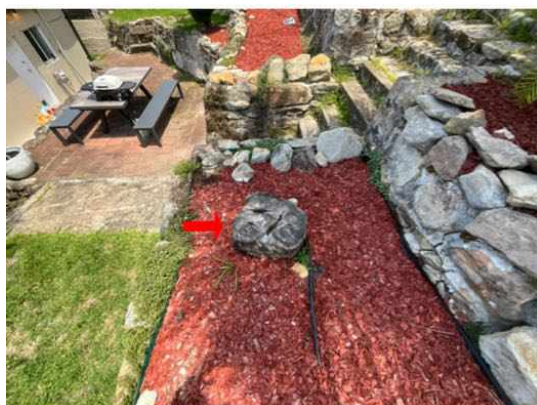
Finding 6.01

Building:	Yard
Location:	Yard - Back
Finding:	Tree Stump
Information:	There was a tree stump located in this area of the property.

I would highly recommend removal of the tree stump as this heightens the risk of a termite infestation at the property.

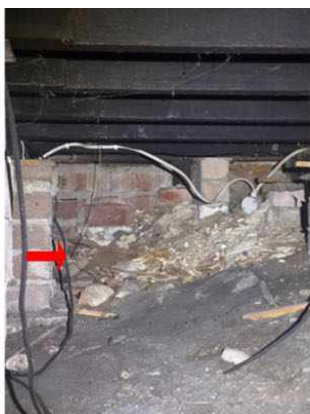
Finding 6.02

Building:	Main Building
Location:	Subfloor
Finding:	Subfloor - Debris
Information:	An array of debris was found in the subfloor area at the time of inspection. Debris in this area restricts subfloor ventilation and creates potential for concealed pest entry. Stored timbers and other materials may also make the area susceptible to termite activity and wood rot.

A clear and empty subfloor will be better ventilated and easier to maintain in a dry condition. The removal of any timber debris is vital in minimising the risk of termite or wood borer activity.

Debris in the subfloor should be removed as soon as possible. Depending on the location and amount of debris and stored items, the homeowner may elect to

undertake this task. Alternatively there are a large number of rubbish removal subcontractors that could undertake these works.

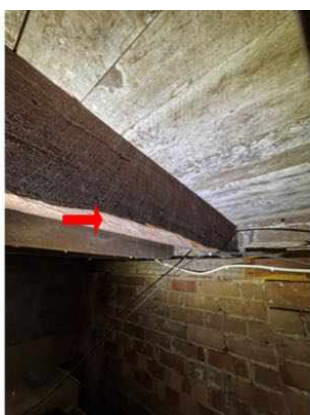
Finding 6.03

Building:	Main Building
Location:	Subfloor
Finding:	Evidence of wood borer activity identified
Information:	Wood borers small beetles that colonise in exposed timber elements are a common timber pest that are regularly mistaken for termites.

The Lyctid borer which generally attacks hardwoods such as subfloor and roofing structures is generally identified by a fine dust surrounding the affected timbers.

As no live wood borer activity was identified treatment is not required at this time.

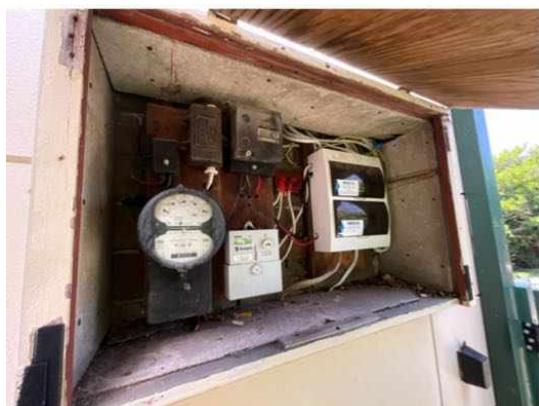
Finding 7.01

Building:	Main Building
Location:	All Areas

Finding: Termite Management System - no evidence of a chemical installation

Information: The application of a post-construction chemical termite barrier is highly recommended for all properties, particularly if live termite activity has been found on the site previously. Such barriers are highly effective in preventing termite attack on any timber building elements throughout the property.

A durable notice should be placed in the switchboard unit to indicate current termite barriers. At the time of inspection, it appeared as though no termite management system has been installed, with no evidence to suggest preventative works taking place.

The client may consider gaining further advice from a pest controller as to the costs and procedures involved with this application. It is recommended that obtaining such advice be a short-term priority.

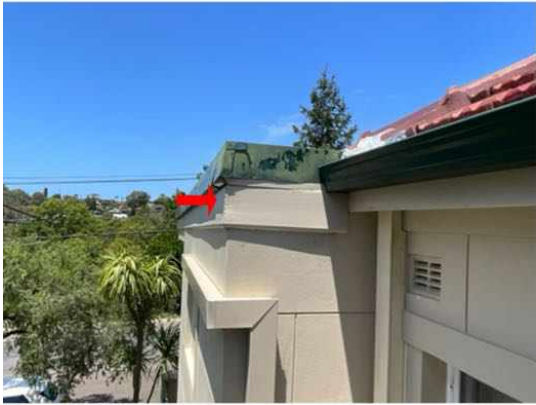
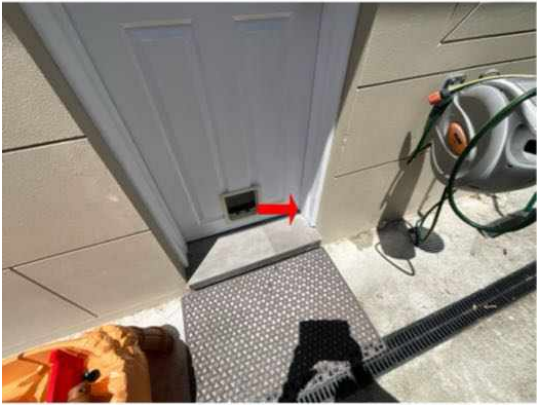
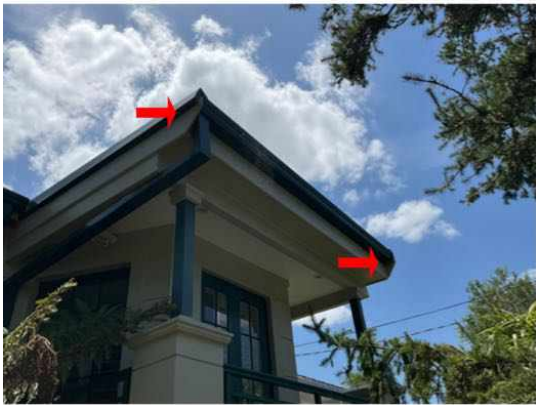
Finding 7.02

Building: Main Building

Location: External Areas

Finding: Fungal decay - present (localised)

Information: Fungal decay also known as wood decay or wood rot generally refers to the deterioration of timber elements when in contact with excessive levels of moisture for a prolonged period of time.

The development of fungal decay is accelerated by temperatures in the range of 5degreeC to 40degreeC as well as the presence of oxygen. Generally fungal decay develops on timber elements that are in use in an external environment which are exposed to rain penetration.

In this case although the affected timber element is in a decaying state the extent of any visible damage appears to be localised to a specific area and is yet to spread to other parts of the building element or affect adjoining structures. The fungal decay is therefore likely to be of a relatively superficial nature with minimal impact on the structural integrity or tensile strength of the timber element.
