Building and Timber Pest Inspection Report

Inspection Date: Mon, 23 Feb 2026

Property Address: 183-205 Broken Head Rd, Suffolk Park NSW
2481, Australia

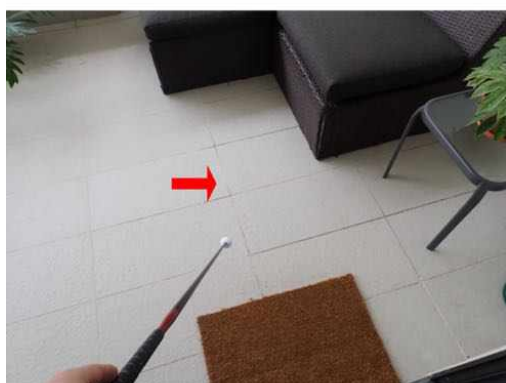
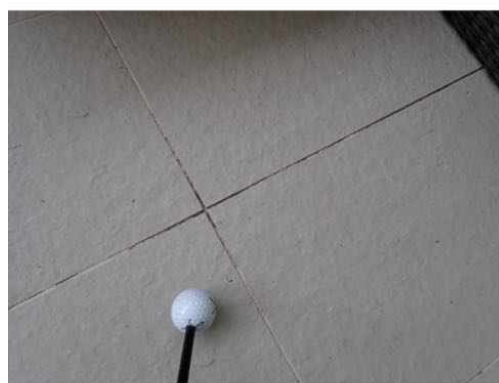
Finding 3.01

Building:	Main Building
Location:	Balcony
Finding:	Deteriorated Grout to Isolated Areas of Balcony Floor Tiles
Information:	Deteriorated grout was identified to isolated areas within the balcony floor tiles. The grout is cracked and breaking down, reducing its effectiveness as a weather-resistant seal between tiles. In simple terms, some of the grout between the balcony tiles is worn and starting to fail. This condition is commonly caused by age, weather exposure and movement in the substrate. If left unaddressed, moisture penetration may occur, potentially affecting the tile bed or underlying structure over time. It is recommended that a licensed tiler remove and replace the affected grout and assess surrounding tiles for soundness, with re-sealing as required. Repairs can be undertaken at the owner's discretion as part of ongoing maintenance.

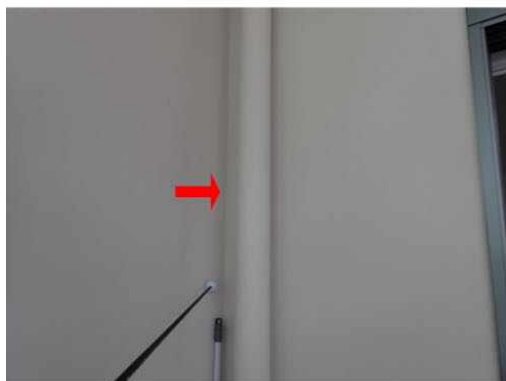
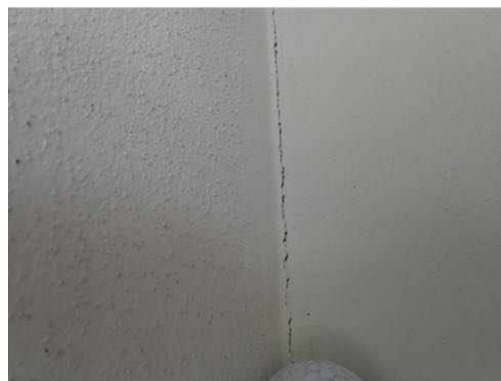
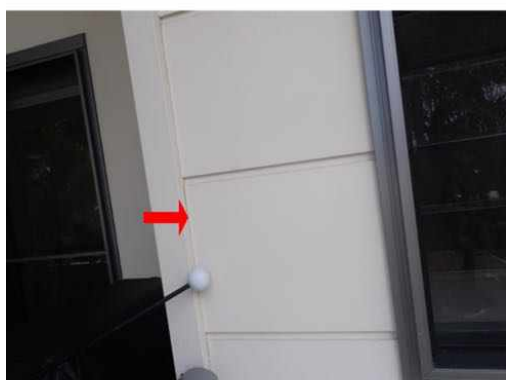
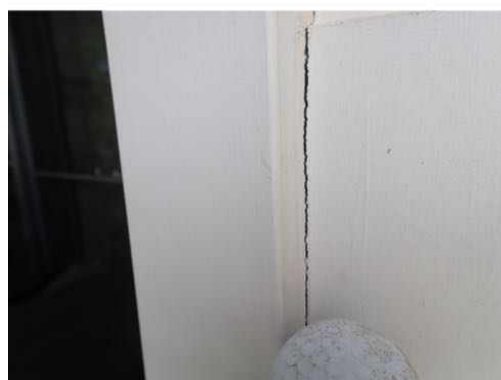
Finding 3.02

Building:	Main Building
Location:	Balcony and external wall cladding
Finding:	Minor Silicone Cracking to External Walls/Cladding
Information:	Minor cracking was identified to silicone sealant joints at sections of the external

walls/cladding. The sealant is beginning to deteriorate and lose flexibility, which may reduce its effectiveness in preventing moisture penetration at joints and junctions. In simple terms, some of the external sealant is slightly cracked and starting to wear out. This is a common maintenance item due to age and weather exposure. If left unaddressed, further deterioration may allow moisture ingress into wall cavities. It is recommended that a qualified tradesperson or general handyman remove and replace the affected silicone as required. Repairs can be undertaken at the owner's discretion as part of routine property maintenance.

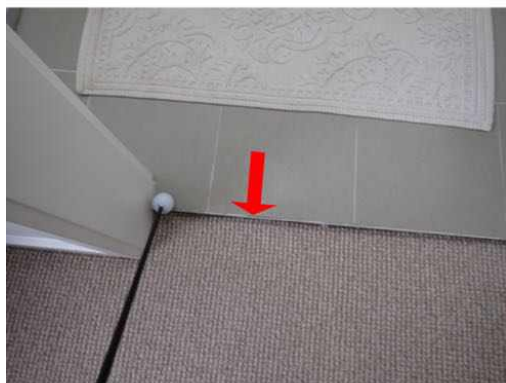
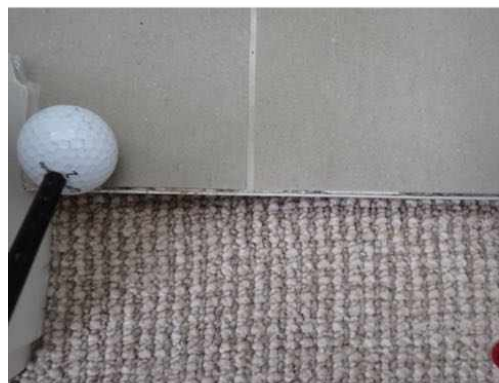
Finding 3.03

Building:	Main Building
Location:	Ensuite
Finding:	Deteriorated Silicone to Floor Tile/Door Angle in Ensuite
Information:	Deterioration of silicone sealant was identified at the floor tile to door angle junction within the ensuite. The sealant is cracked and breaking down, reducing its effectiveness in preventing moisture penetration at this junction. In simple terms, the silicone where the floor tiles meet the door frame in the ensuite is worn and starting to fail. This condition is commonly caused by age, moisture exposure and minor movement. If left unaddressed, water may track into adjoining materials over time. It is recommended that a licensed tiler or suitably qualified tradesperson remove and replace the affected silicone to maintain a watertight seal. Repairs can be undertaken at the owner's discretion as part of routine maintenance.

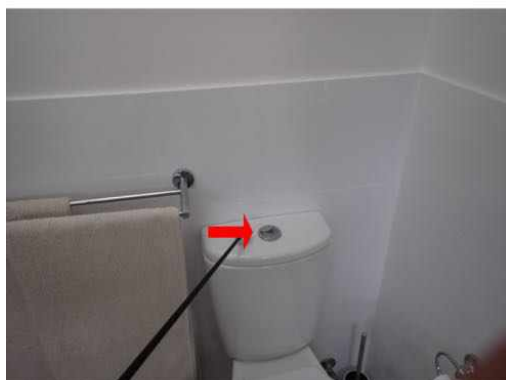
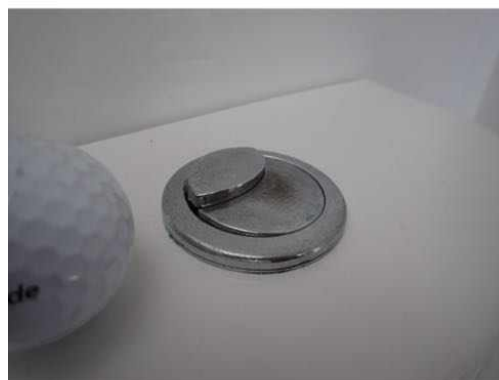
Finding 3.04

Finding: Ensuite Half-Flush Toilet Button Broken

Information: The half-flush button to the ensuite toilet cistern was found to be broken and not operating as intended. The flushing mechanism may not function correctly, which can affect water efficiency and normal use. In simple terms, one of the toilet flush buttons in the ensuite is broken. This condition is commonly caused by wear and tear to the internal plastic components over time. It is recommended that a licensed plumber repair or replace the flush button assembly or associated cistern components as required. Repairs can be undertaken at the owner's discretion to restore proper operation.

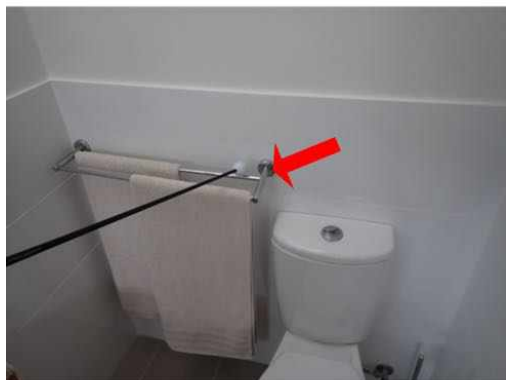
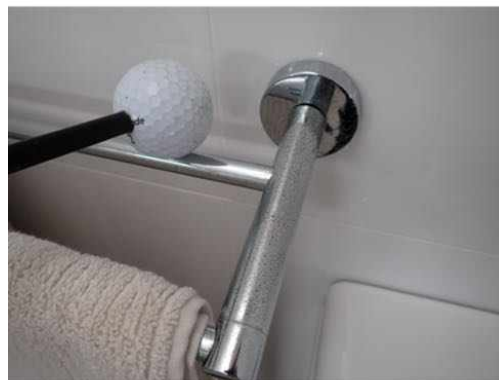
Finding 3.05

Finding: Loose Towel Rails to Bathroom and Ensuite

Information: Loose towel rails were identified within the bathroom and ensuite. The fixtures are not securely fixed to the wall and may detach with continued use. In simple terms, the towel rails are wobbly and not properly secured. This condition is commonly caused

by loose fixings, inadequate anchoring into wall linings or general wear and tear. If left unaddressed, the rails may pull away from the wall and cause damage to surrounding tiles or wall surfaces. It is recommended that a qualified handyman or carpenter re-secure or refix the towel rails with appropriate fixings. Repairs can be undertaken at the owner's discretion.

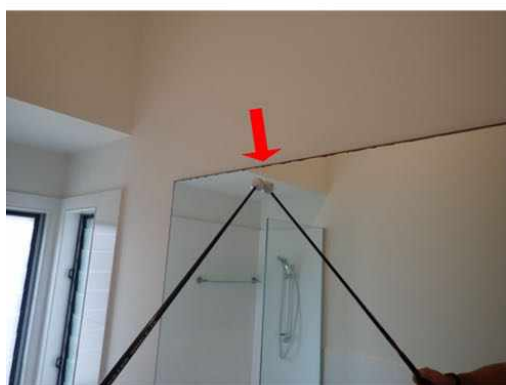
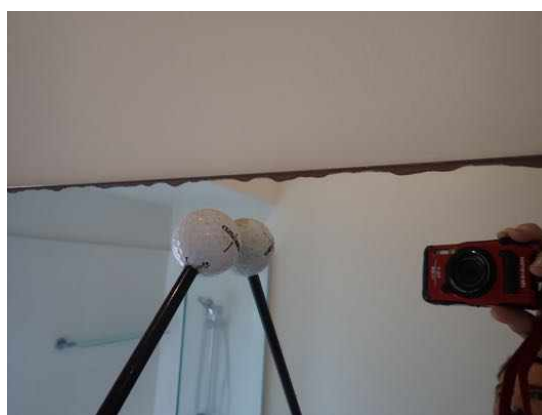
Finding 3.06

Finding: Mirror Edges Deteriorating to Bathroom and Ensuite

Information: The mirrors in the bathroom and ensuite were observed to be turning black around the edges. This condition indicates deterioration of the mirror backing (desilvering), commonly caused by age and prolonged exposure to moisture. In simple terms, the edges of the mirrors are going black due to moisture damage behind the glass. This is a common defect in wet areas over time. While primarily cosmetic at this stage, deterioration may continue and affect overall appearance. It is recommended that a glazier or suitably qualified tradesperson replace the affected mirrors if desired. Replacement can be undertaken at the owner's discretion as part of cosmetic upgrades or routine maintenance.

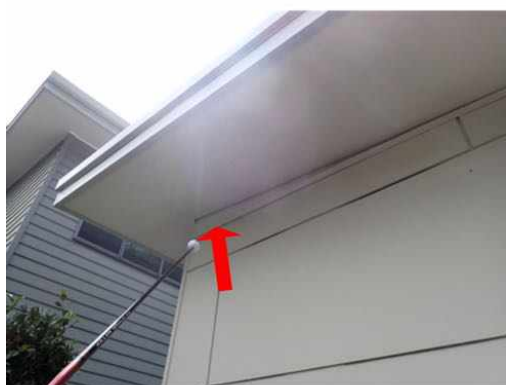
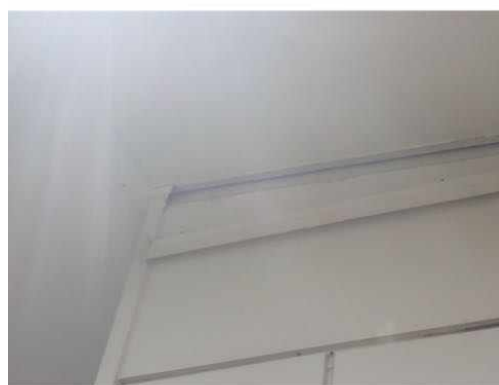
Finding 3.07

Building:	Garage
Location:	Left hand side of garage
Finding:	Timber Eave Trim Loose to Left-Hand Side of Garage
Information:	The timber eave trim to the left-hand side of the garage was found to be loose. The trim is not securely fixed and may detach if not re-secured. In simple terms, the timber trim under the roof edge on the left side of the garage is coming loose. This condition is commonly caused by fixing failure, timber movement or age-related deterioration. If left unaddressed, the trim may fall or allow moisture and pests to enter the eaves cavity. It is recommended that a qualified carpenter re-secure or replace the affected trim and check adjacent sections for stability. Repairs can be undertaken at the owner's discretion to prevent further movement or damage.

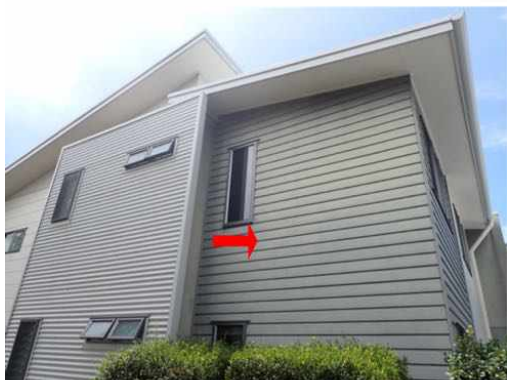
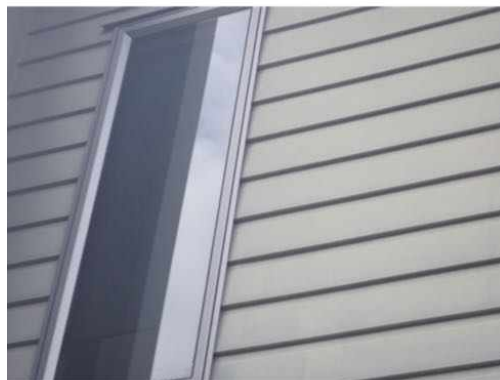
Finding 3.08

Building:	Main Building
Location:	Left hand side wall
Finding:	Fading Paint to Left-Hand Side Weatherboard Cladding
Information:	Fading of the painted finish was identified to the weatherboard cladding on the left-hand side of the building. The coating shows signs of UV exposure and age-related deterioration. In simple terms, the paint on the left side weatherboards is fading and losing its colour. This is a common condition due to long-term sun and weather exposure. While primarily cosmetic at this stage, continued breakdown of the protective coating may reduce protection to the underlying timber over time. It is recommended that a qualified painter prepare and re-coat the affected areas as required. Repainting can be undertaken at the owner's discretion as part of routine exterior maintenance.

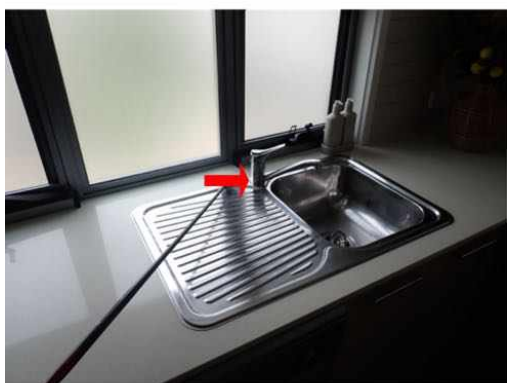
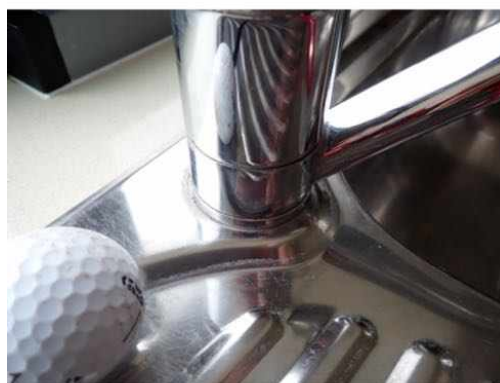
Finding 3.09

Building:	Main Building
Location:	Kitchen
Finding:	Kitchen Mixer Tap Loose
Information:	The kitchen mixer tap was found to be loose at its base and not securely fixed to the benchtop/sink. Movement of the tap may place strain on associated plumbing connections. In simple terms, the kitchen tap is wobbly. This condition is commonly caused by loose fixings or wear over time. If left unaddressed, continued movement may result in leaks beneath the sink or damage to surrounding fittings. It is recommended that a licensed plumber or suitably qualified handyman tighten, secure or refit the tap as required. Repairs can be undertaken at the owner's discretion to prevent further issues.

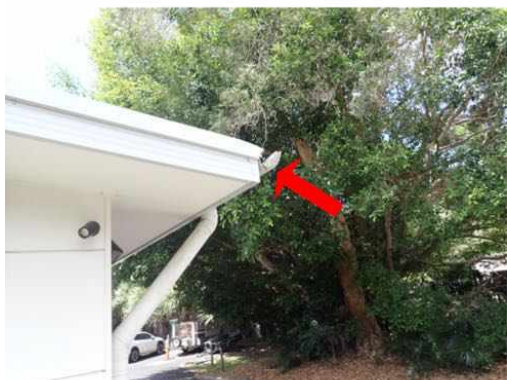
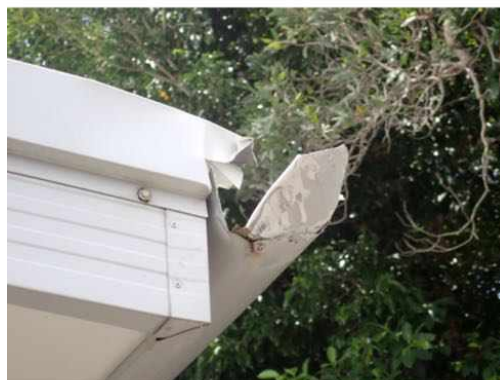
Finding 3.10

Building:	Garage
Location:	Front left hand corner
Finding:	Impact-Related Damage to Garage Roof Gutter – Front Left-Hand Corner
Information:	Impact-related damage was identified to the garage roof gutter at the front left-hand corner of the building. The gutter shows signs of deformation consistent with external force, which may affect its ability to effectively collect and discharge stormwater. In simple terms, the front left garage gutter has been dented or damaged from impact. If

left unaddressed, the damaged section may lead to water overflow or improper drainage. It is recommended that a suitably qualified tradesperson repair or replace the affected gutter section and ensure correct falls and connections are maintained. Repairs can be undertaken at the owner's discretion to maintain proper stormwater performance.

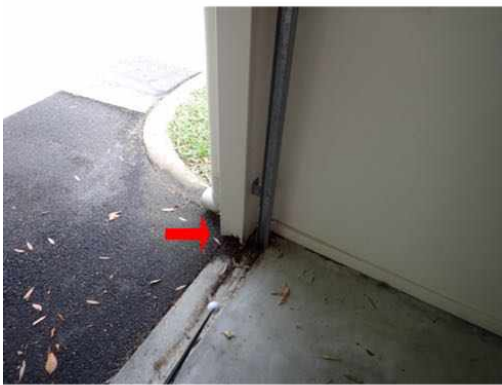
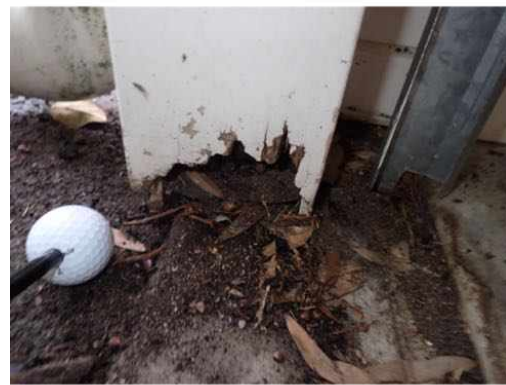
Finding 7.01

Building:	Main Building
Location:	Garage door
Finding:	Wood Rot Identified to Bottom of Garage Door Jambs
Information:	Wood rot was identified to the lower sections of the garage door jambs. The timber shows signs of decay consistent with moisture exposure at ground level. In simple terms, the bottom of the garage door frame timber is rotting. This condition is commonly caused by ongoing moisture contact, poor drainage and/or inadequate sealing of the timber. If left unaddressed, deterioration may worsen and affect the structural integrity of the door frame. It is recommended that a qualified carpenter remove and replace the affected timber sections and ensure the area is properly sealed and protected from moisture. Repairs should be undertaken to prevent further

decay and associated damage and can be arranged at the owner's discretion.

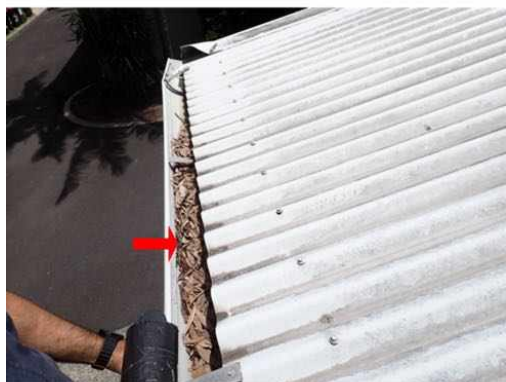
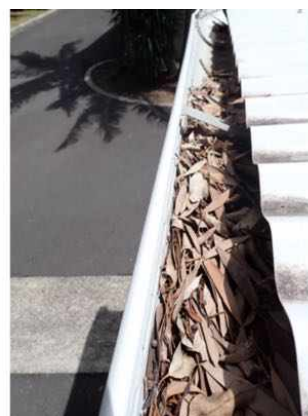
Noted Item

Building:	Main Building
Location:	Left hand side wall
Finding:	Gutter Blocked with Leaves
Information:	A section of the roof guttering was found to be blocked with accumulated leaves and organic debris, which may impede the effective discharge of stormwater. In simple terms, leaves are clogging part of the gutter. This is a common maintenance issue, particularly in areas with nearby trees. If left unaddressed, blocked gutters can lead to overflow, moisture damage to fascia boards and potential water ingress. It is recommended that the gutters and associated downpipes be cleaned and cleared of debris. Ongoing regular cleaning should be carried out as part of routine property maintenance at the owner's discretion.

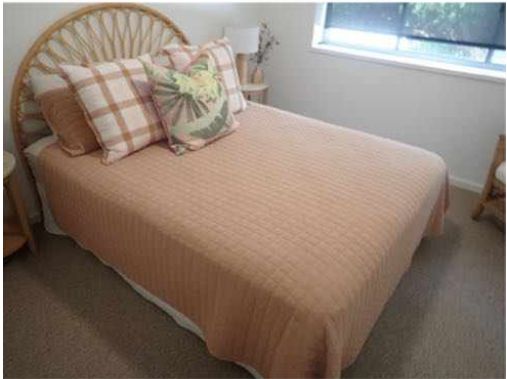
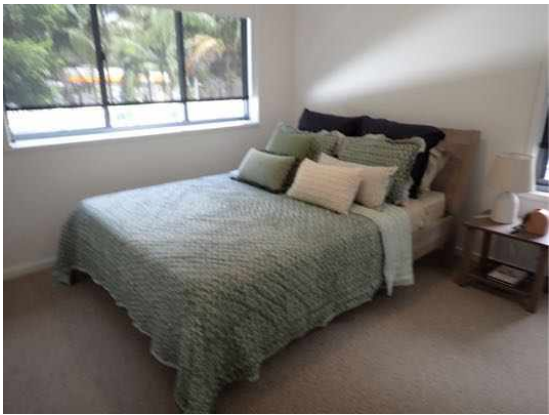
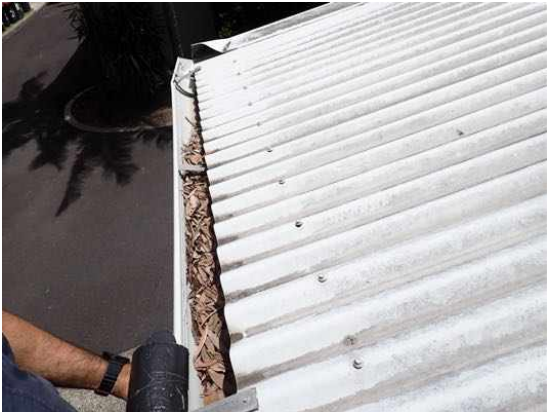
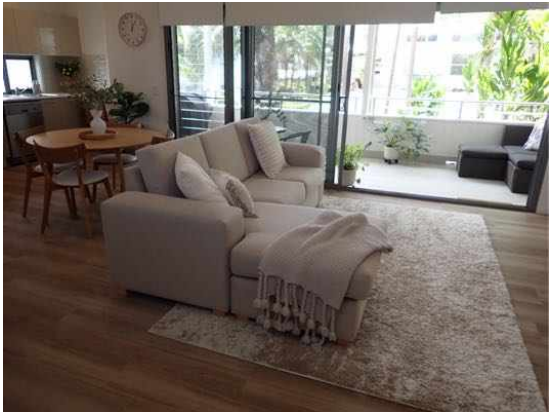
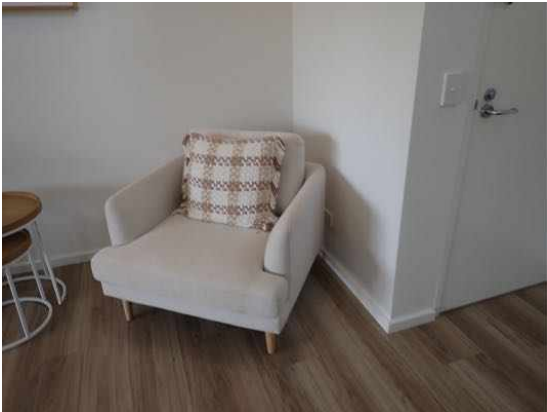
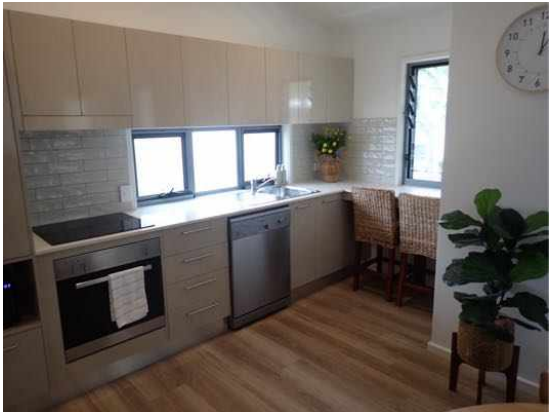
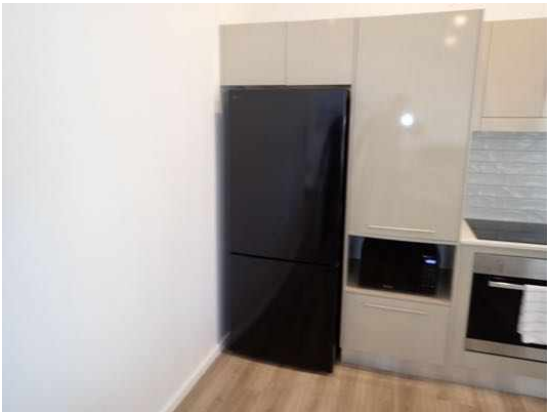
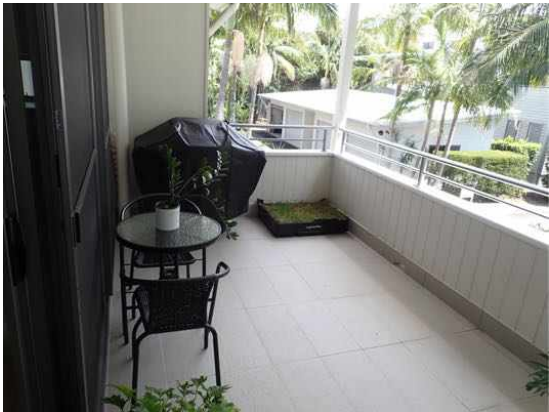
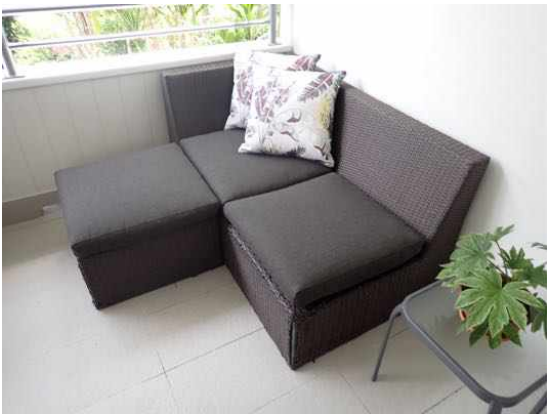
Noted Item

Building:	Main Building
Location:	All Areas
Finding:	Additional Photos - Obstructions and Limitations
Information:	These photographs are an indication of the obstructions and limitations which impeded full inspection of the area at the time of inspection. These obstructions can hide an array of defects and should be removed to allow full inspection to be carried out. A re-inspection is recommended once the areas are made accessible.
