# Building and Timber Pest Inspection Report

Inspection Date: Fri, 6 Feb 2026

Property Address: 1/792 Nepean Hwy, Mornington VIC 3931,  
Australia

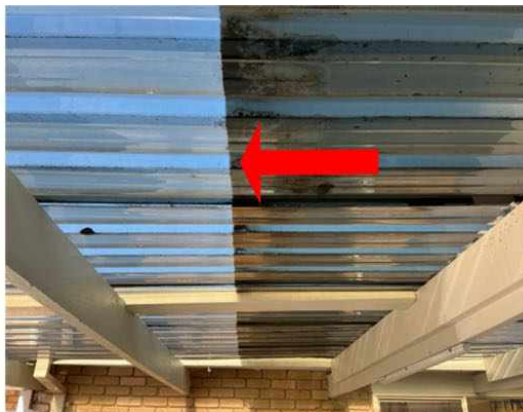
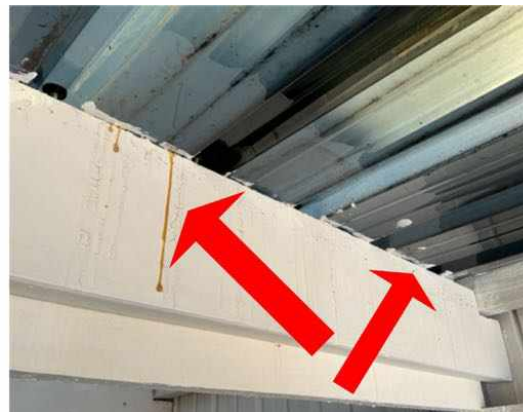
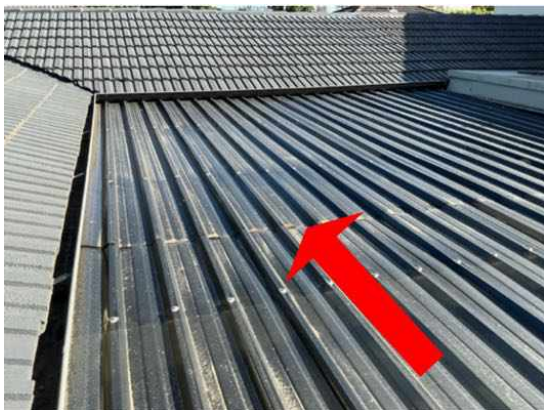
Building: Main Building  
Location: Carport  
Finding: Inadequate roof sheet installation and evidence of water ingress  
Information: At the time of inspection, the roof sheets to the carport were observed to be installed in two separate lengths with the horizontal joint occurring approximately midway between supporting rafters rather than directly over a structural support. This installation method is considered poor practice and increases the risk of water penetration. Evidence of water staining was observed to one of the rafters beneath the sheet joint, indicating that water ingress has occurred, particularly during periods of heavy rainfall. This suggests the roof sheeting is not effectively weatherproof at the sheet joint.

It is recommended that a qualified roofing contractor being engaged to rectify this defect. Remedial works should include removal of the existing roof sheets and replacement with new roof sheets installed in single continuous lengths.

Repairs should be undertaken promptly to prevent further water ingress and potential damage.

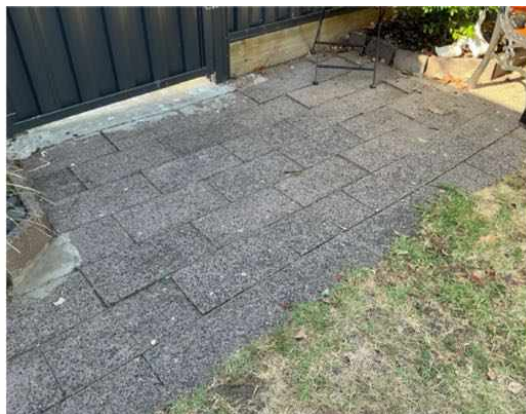
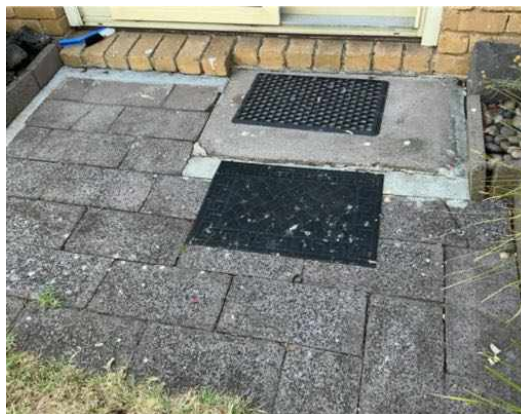
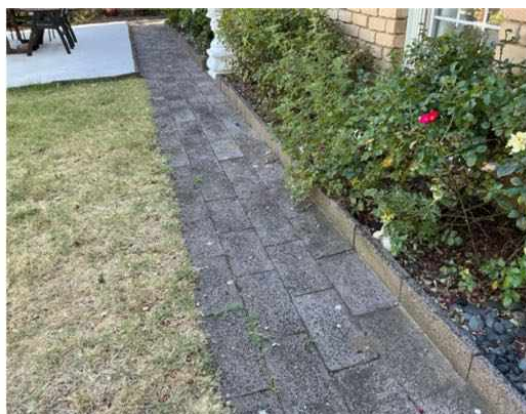
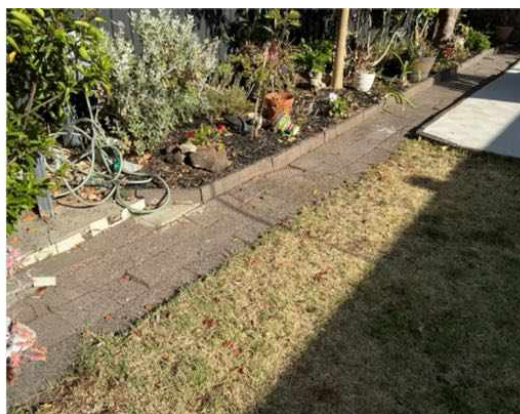
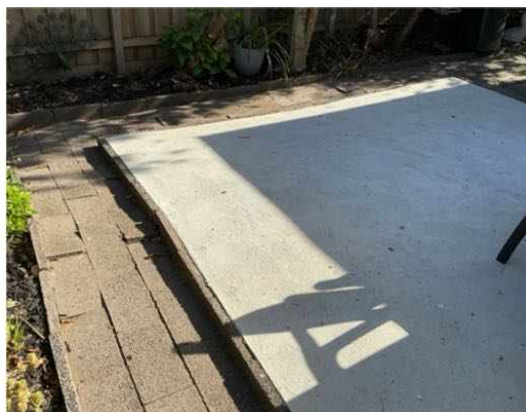
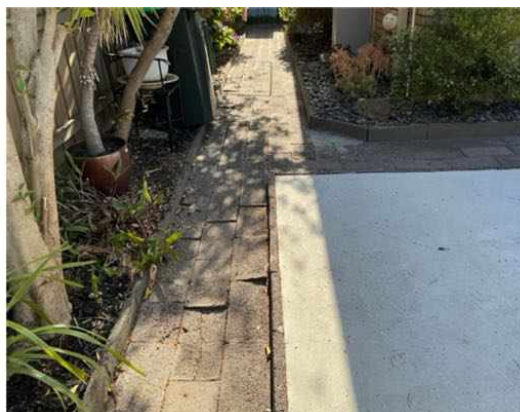
### Finding 3.02

Information: Sections of the external paved area are uneven, creating a potential trip hazard. It appears as though the area has been subject to rough installation, or that paving sections have lifted due to movements in the foundation of the property.

Where paving creates a trip hazard, personal injury may ensue if due caution is not taken by all persons within this area.

Re-paving of the area is required as soon as possible to remedy this situation. Further consultation with a specialist paver is advised.

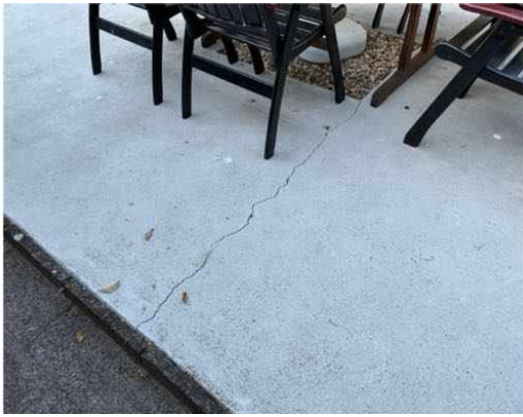
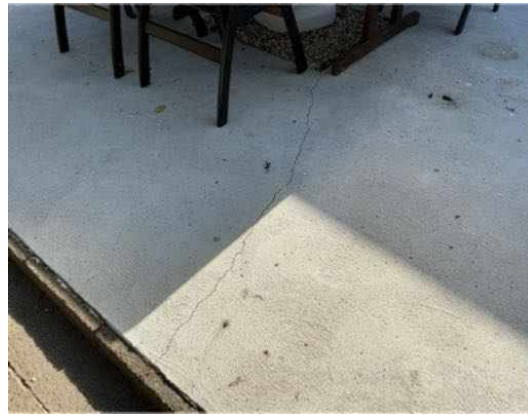
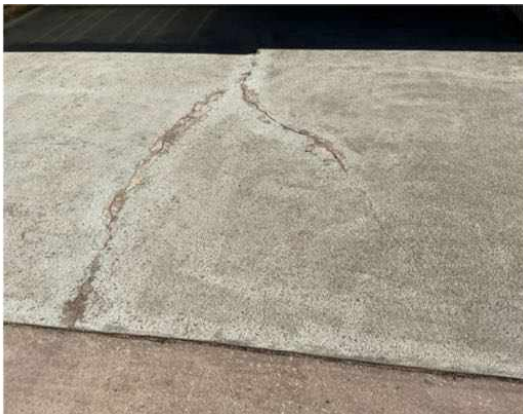
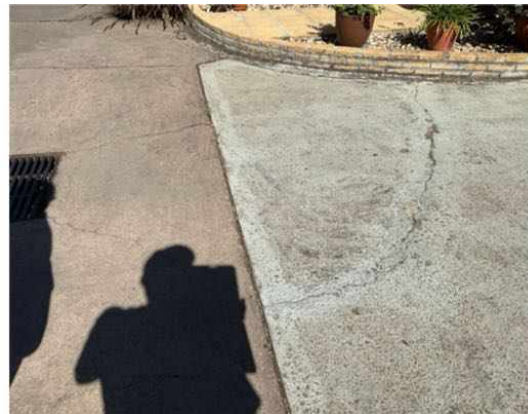
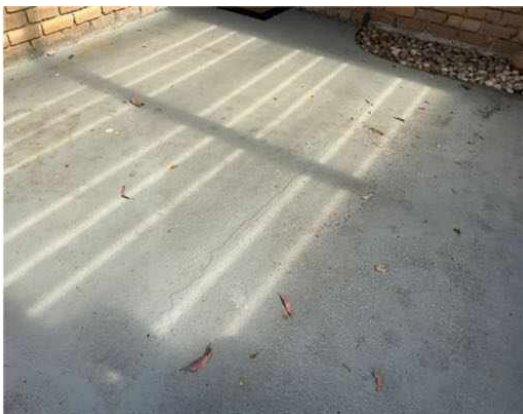
### Finding 3.03

Building:	Main Building
Location:	Driveway and pathways
Finding:	Driveway and pathway Cracking - External Concrete Paving Damage Category 1 - Fine (less than 2mm)

Information: Fine cracks were identified in the driveway and pathway external concrete paving. Although fine cracks are quite noticeable, they are often only considered to be an appearance defect, and usually do not indicate any structural damage. To be considered a Category 1 or fine crack, the crack is found to be less than 2mm in width.

Generally the cause of a hairline crack in existing concrete paving such as driveways and pathways is indicative of the expansion and contraction of the concrete. Such causes are generally due to environmental factors, such as moisture levels, weather conditions, root systems of nearby trees or the soil types on which they are laid.

Fine cracks may also be due to poor original installation of the concrete. Factors such as poor compaction of the sub surface and/or inadequate reinforcing of the slab may create cracking and other secondary defects.

Monitoring of all cracking should be conducted frequently. Always contact a building inspector should cracks widen, lengthen, or become more numerous.

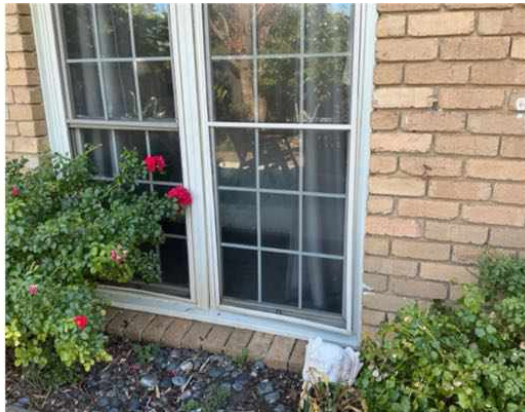
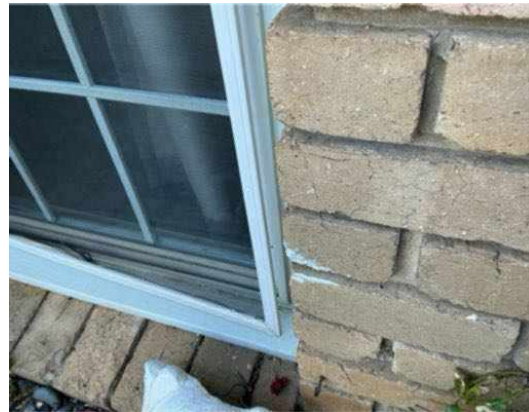
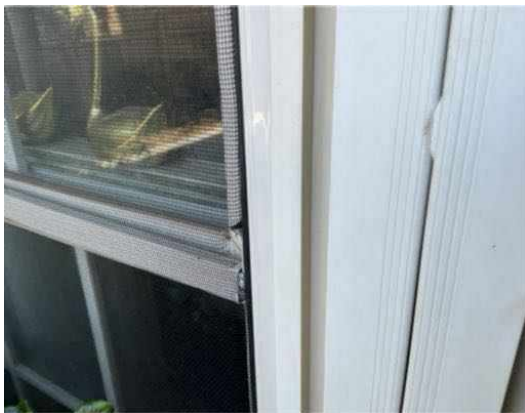
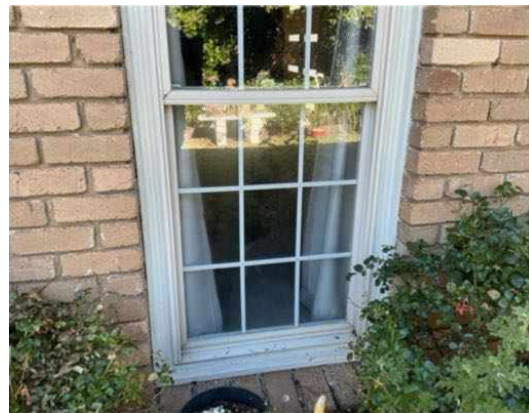
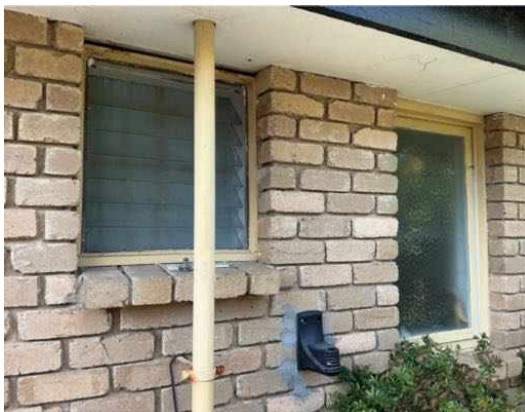
### Finding 3.04

Building:	Main Building
Location:	Various parts of the building
Finding:	Flyscreens - damaged or missing
Information:	Some of the flyscreens were found to be damaged or missing at the time of inspection. This can happen overtime with deterioration in harsh weather conditions or accidental impact damage.

Where not replaced, damaged flyscreens allow pest and insect ingress into the adjoining room/s. It is advised that all damaged flyscreens be replaced in order to ensure the full function of all building structures.

A general handyperson may be appointed to replace flyscreens at the discretion of the client.

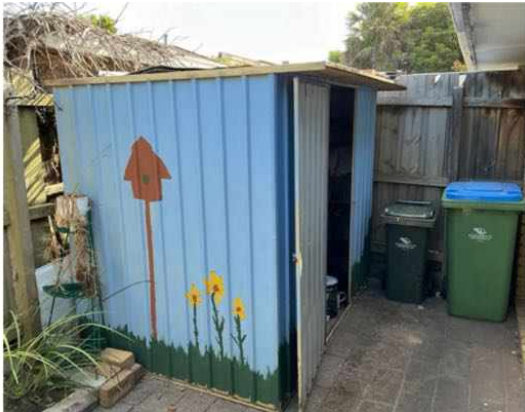
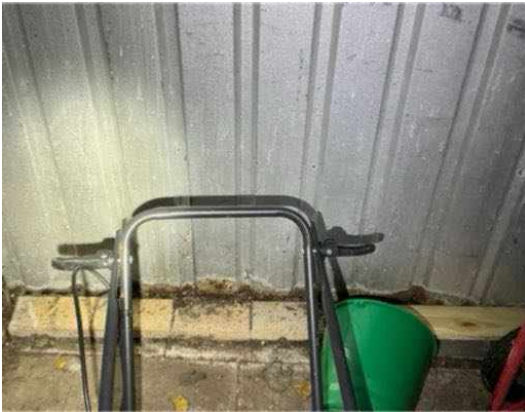
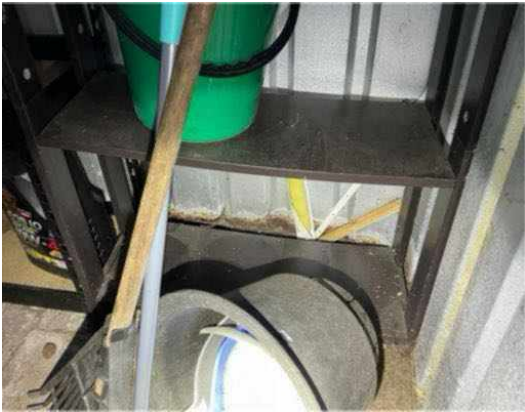
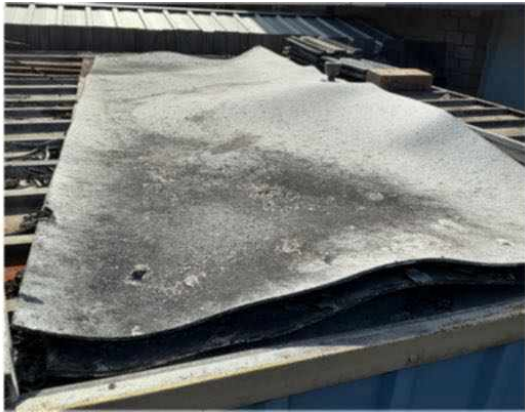
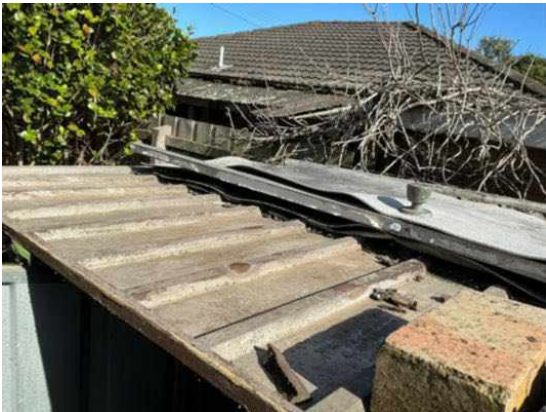
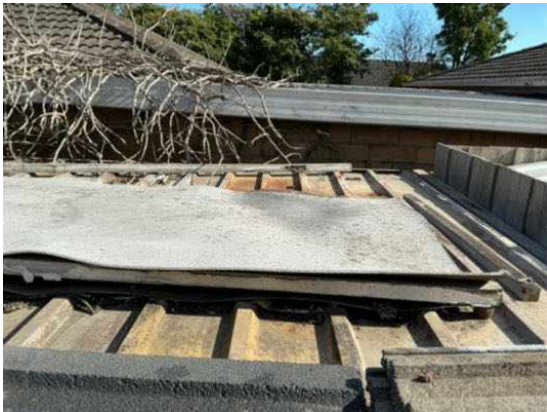
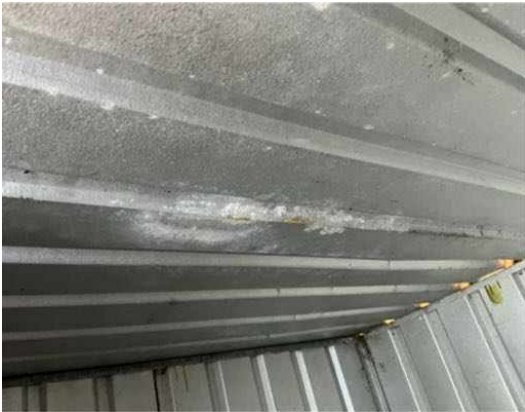
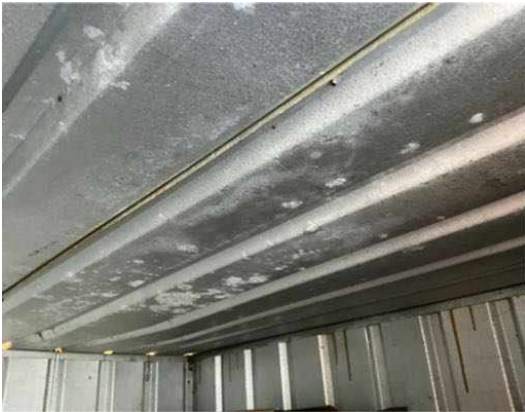
### Finding 3.05

Building: Main Building  
Location: Yard - Back  
Finding: Rust and damage to shed  
Information: Rust and damage to parts of the shed. Recommend repair/replacement by a handyman or carpenter to reduce the risk of future deterioration at the owners discretion.

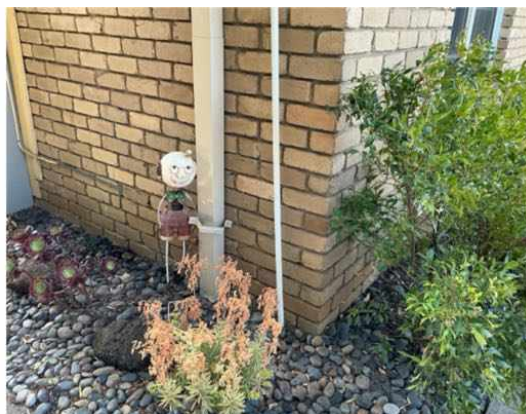
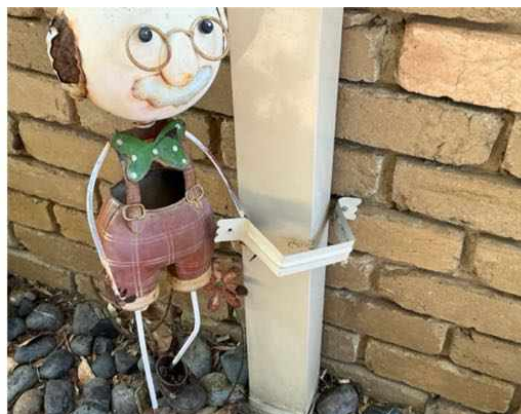
Finding 3.06

Building: Main Building  
 Location: Exterior walls - rear  
 Finding: Down pipe clip damaged/loose  
 Information: The rear down pipe clip to the property is damaged/loose due to poor installation.

It is recommended that a plumber be appointed to further inspect the area and to install/repair clips where necessary at the owners discretion.

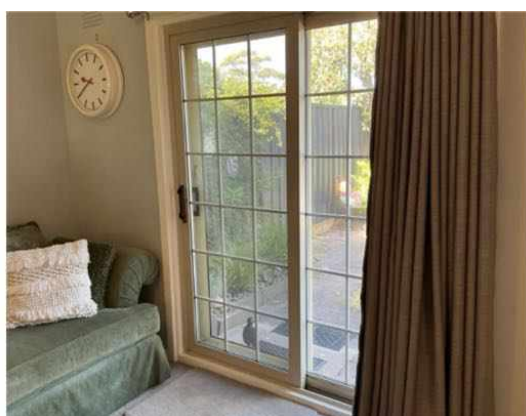
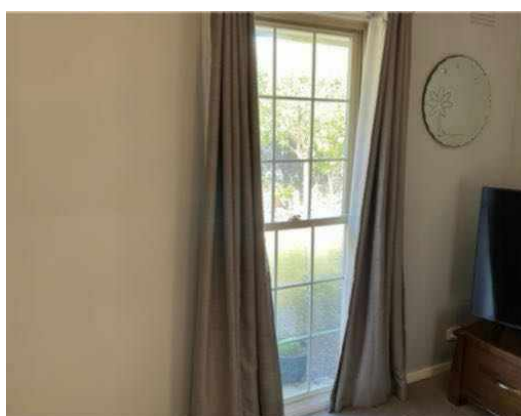
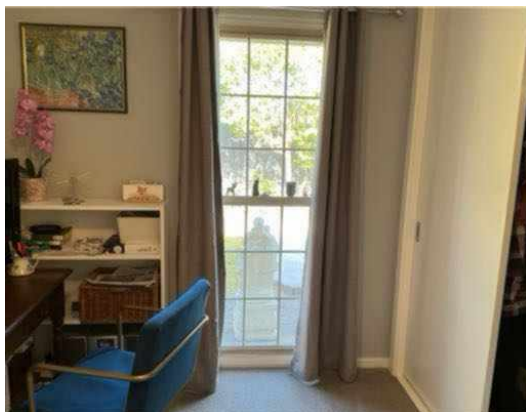
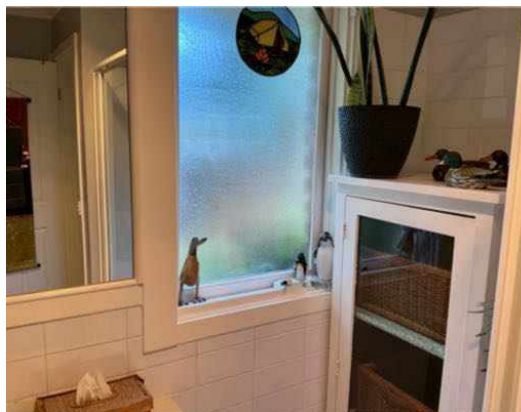
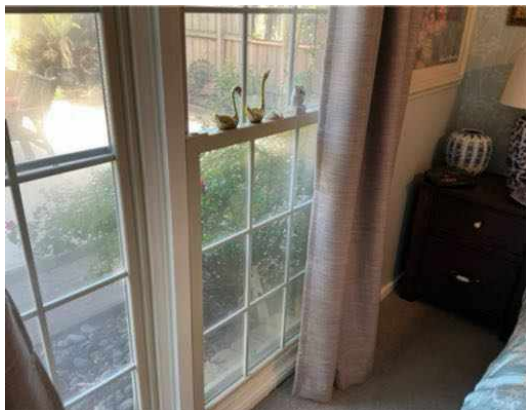
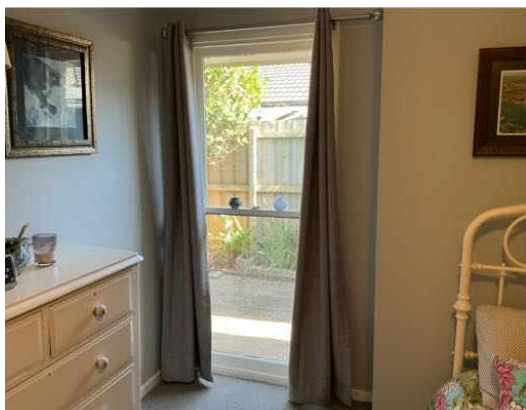
### Finding 3.07

Building: Main Building  
 Location: Various parts of the building  
 Finding: Doors and windows required maintenance  
 Information: Some of the doors and windows to the building require some maintenance or repair to make them operate more smoothly. This can happen overtime with deterioration or lack of maintenance. Recommend engaging a carpenter to repair/maintain windows and doors at the owners discretion.

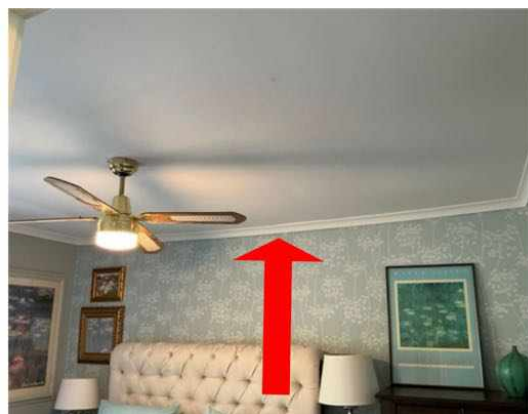
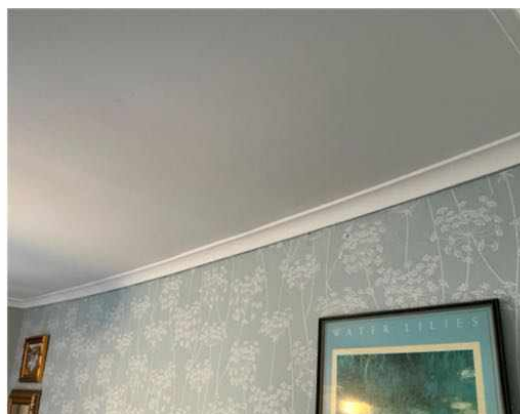
### Finding 3.08

Building: Main Building  
 Location: Bedroom - Master  
 Finding: Bedroom Ceiling - Sagging/loose  
 Information: Sections of the master bedroom ceiling were found to be sagging/loose at the time of inspection. Sagging to the fixed ceiling structure generally indicates that the fixings (e.g. nails or glue) have become loose and require reattachment.

In some cases, sagging ceiling linings may also indicate that there are structural issues, causing surfaces to warp, twist or sag. Where sagging appears to be major, appointment of a structural engineer is advised to further inspect the property and identify the source and rectification works required.

Where minor sagging is evident, comparatively minor works, such as re-gluing of ceiling sheets, may be required. Such works may be performed by relevant tradespeople, such as plasterers and painters. Where excessive moisture has caused the roofing structure to swell and sag, the source of the water leak should primarily be

The appropriate action should be taken by the client as soon as possible to ensure that any potential further damage is limited.

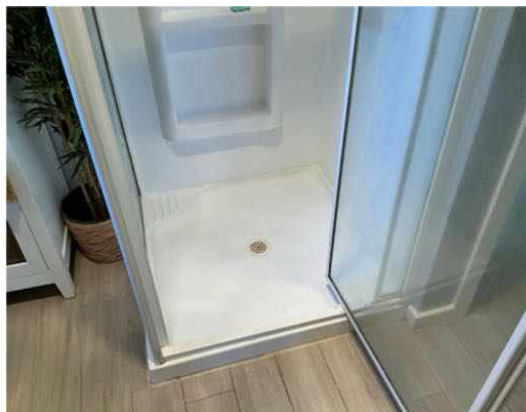
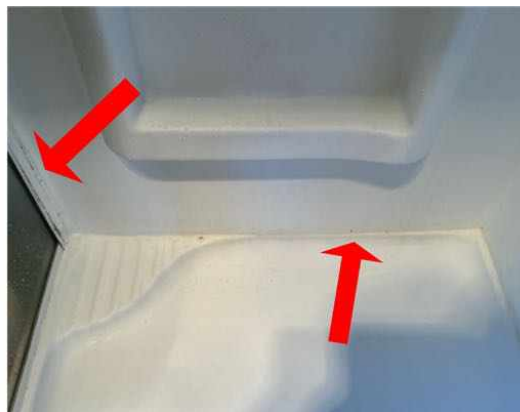
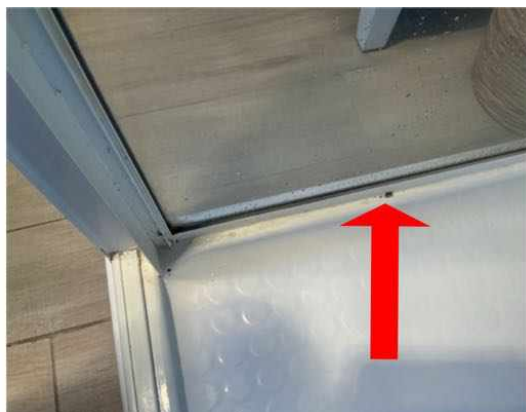
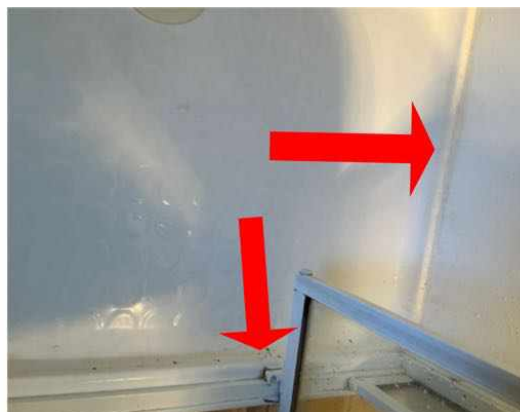
### Finding 3.09

Building:	Main Building
Location:	Bathroom
Finding:	Bathroom Sealant grouting - Missing or damaged degraded
Information:	It was noted on inspection that sealant or grout is degraded/missing or damaged to the tiled shower alcoves and or other areas of the bathrooms.

Different materials and floor areas move at different rates, generally causing cracking to grout or sealant at this point. A flexible sealant is required to allow for expected expansion and contraction, while keeping the joint water tight and protective of all associated building materials.

Flexible and mould resistant materials should be applied to affected areas to prevent any subsequent water damage that is likely to occur. Regular maintenance and replacement of damage or missing or damaged sealant and grout is highly recommended to the wet areas, as this is a regular wear and tear defect. Sealant and grouting in areas that come into regular contact with water should be maintained for the long term care of your property.

A sealant specialist or tiling contractor should be appointed to complete these works as soon as possible

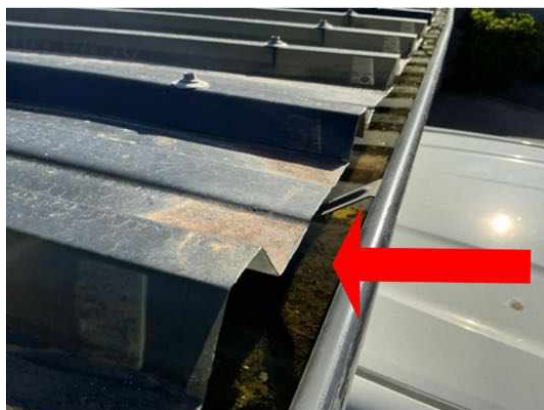
### Finding 6.02

Building: Main Building  
 Location: Carport  
 Finding: Gutters - Water pooling  
 Information: Water was found to be pooling in the carport roof guttering. This creates excessive moisture which can attract termites. This is generally a secondary defect caused by blocked or partially blocked gutters/downpipes or if the gutters do not have enough fall to the down pipes. Such blockages and subsequent water pooling are likely to lead to rust and water damage to associated structures if left unattended.

Any areas of guttering that shows evidence of water pooling should be checked for partial or full blockages and any secondary damage that may have occurred as a result. Depending on the extent of the damage, building elements may require repair and/or replacement to ensure adequate roof drainage and function of exterior plumbing system.

A roofing plumber should be appointed as soon as possible to rectify this issue. It is highly advised that all gutters be maintained on a frequent basis to ensure the condition of roof plumbing.

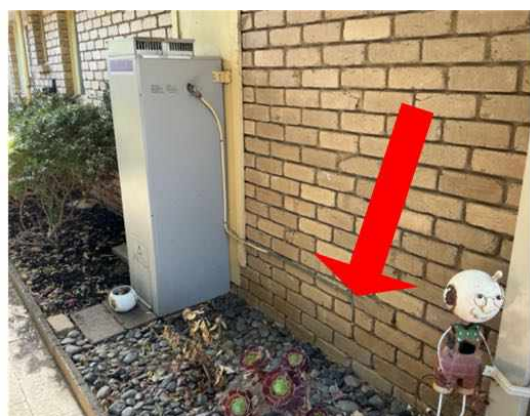
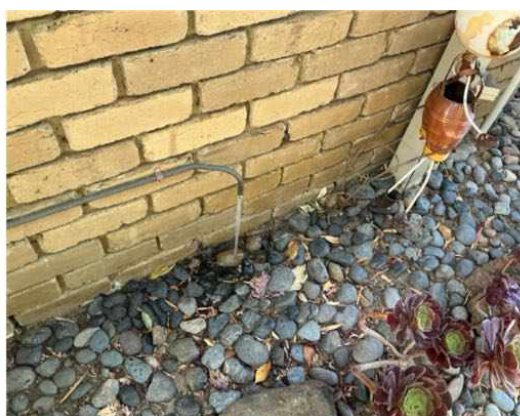
### Finding 6.03

Building: Main Building  
 Location: Yard - Back  
 Finding: HWS Overflow - Not Connected  
 Information: The Hot Water System (HWS) overflow was found to be disconnected from storm water drainage and is creating excessive moisture in the surrounding area.

These damp conditions can lead to secondary defects such as rot, rust or corrosion of associated building elements, the formation of fungal decay, or even the creation of potential slip hazards. When coupled with poor site drainage, pooling of water may also attract termite activity to this area.

It is highly recommended that a licensed plumber be appointed to connect the HWS overflow in order to prevent such an environment from being created. These minor works should be carried out as soon as possible.

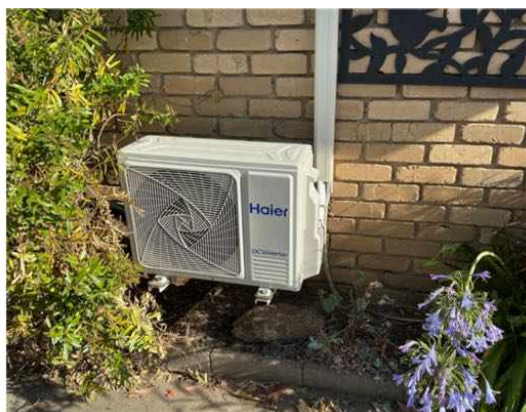
### Finding 6.04

Building: Main Building  
 Location: Yard - Front  
 Finding: Air conditioning unit overflow -Not plumbed for drainage  
 Information: The overflow to the air conditioning unit is not plumbed or connected to suitable

drainage, which has resulted in the surrounding area becoming excessively damp. These damp conditions can lead to secondary defects such as rot, rust or corrosion of associated building elements, the formation of fungal decay, or even the creation of potential slip hazards. When coupled with poor site drainage, pooling of water may also attract termite activity to this area. It is highly recommended that a qualified plumber be appointed to install adequate drainage to the overflow. These works will ensure that the area remains dry and free of any secondary defects.

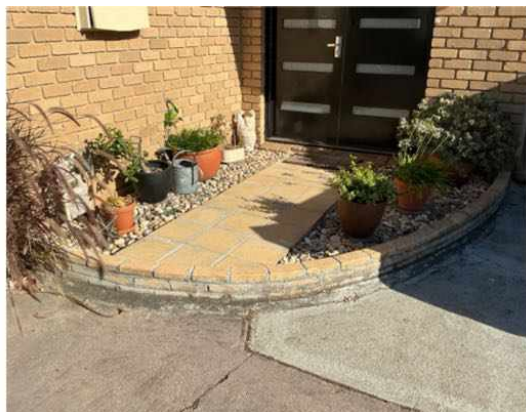
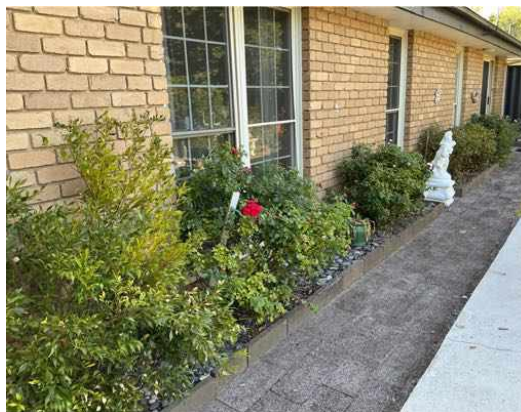
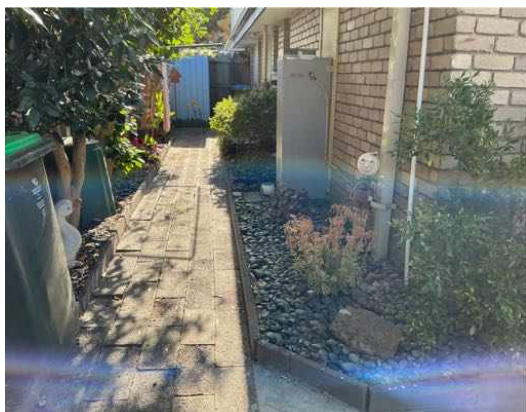
### Finding 6.05

Building:	Main Building
Location:	Yards
Finding:	Site drainage - poor/inadequate
Information:	The site drainage to parts of the yards was found to be inadequate at the time of inspection, creating potential for subsequent water damage to associated building elements. Excessive moisture will attract termites.

It is important that water does not lie against the base of walls; surrounding paths and ground levels should be sloped to drain water away from walls. Downpipes should not discharge stormwater onto lower walls or plinths. Stormwater should be carried away by large, regularly cleaned drains. Ground levels may need to be lowered to expose a buried DPC.

Where site drainage is inadequate, installation of an Agricultural (Aggie) Drain may be required. A qualified plumber should be appointed to further inspect the property and perform any remedial works as necessary. Water damage and secondary defects are likely to occur if left unmanaged.

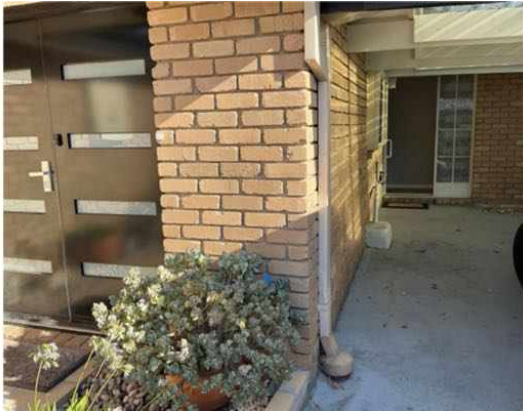
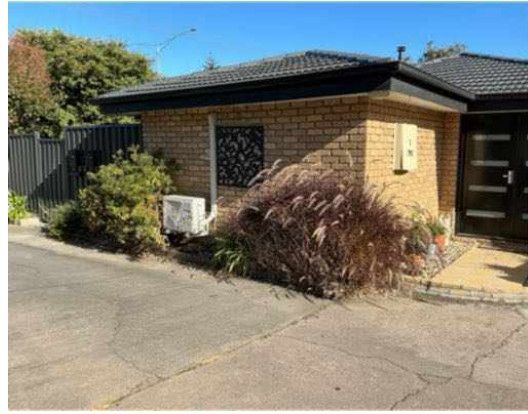
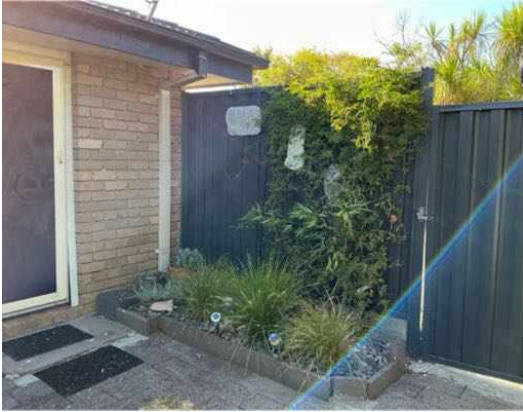
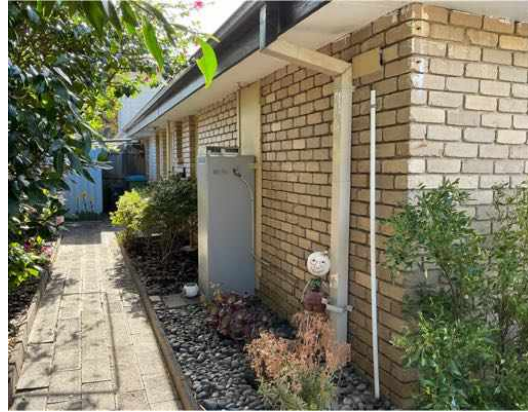
### Finding 6.06

Building:	Main Building
Location:	Various parts of the building
Finding:	Bridging attachments to buildings
Information:	Bridging occurs when items against a building provide a concealed entry point for termites into the building or by passing around a termite management system.

Where any part of an attachment to a building is not isolated and is not provided with a clear gap of not less than 25mm from building, bridging occurs. Attachments to buildings such as hot water services, downpipes, verandahs, decks, steps, fences, service conduits and the like provide the opportunity for concealed entry.

Building attachments of this nature need to be frequently inspected for termite activity by a qualified inspector.

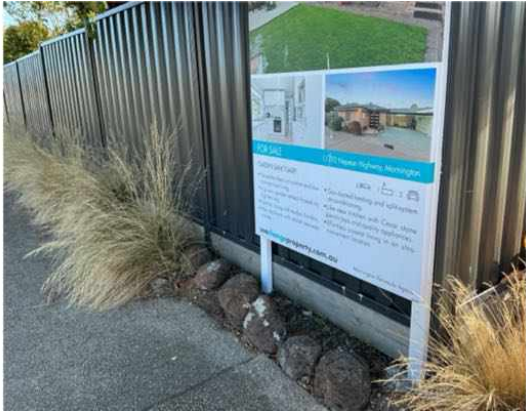
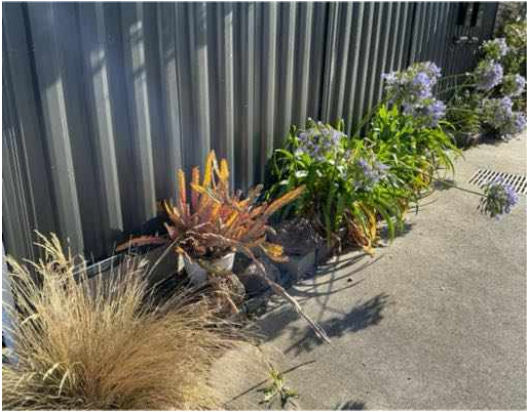
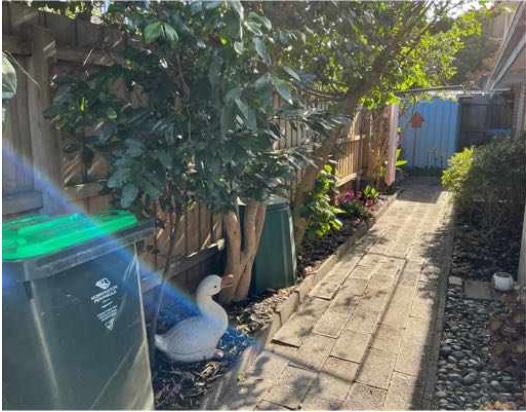
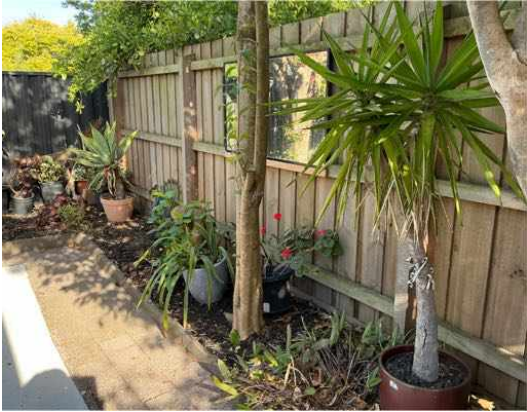
### Finding 6.07

Building:	Main Building
Location:	Various parts of the building
Finding:	In ground contact
Information:	Any timbers in direct ground contact provide opportunity for concealed termite entry and are likely to be subject to premature rot and decay as the soil retains moisture or damp conditions against the timbers.

Remove untreated timber that is in direct contact with external grounds. Consider replacement with more durable materials i.e. treated timber or non timber elements. Frequent pest inspections are advised to readily identify any termite activity in these areas.

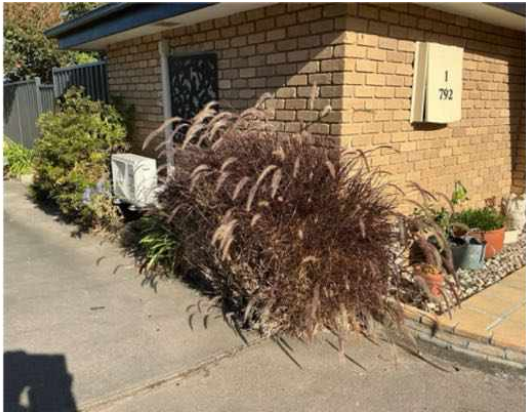
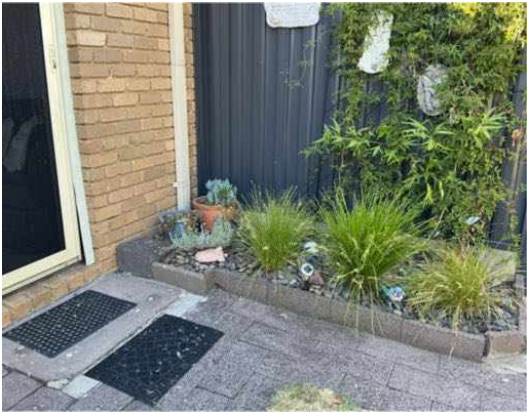
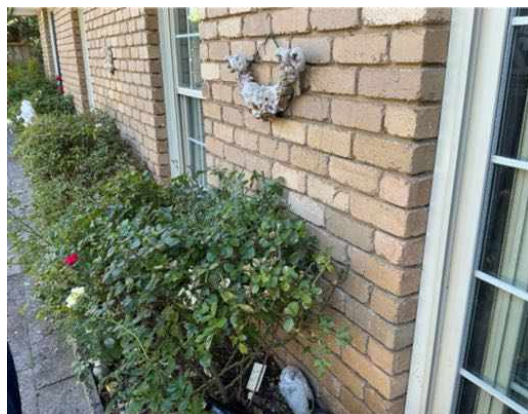
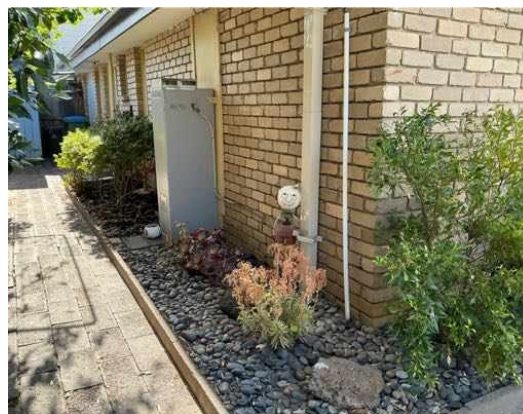
**Finding 6.08**

Building: Main Building  
 Location: Yards  
 Finding: Garden Beds Conditions Conducive to Termites  
 Information: Garden beds were found to be evident in close proximity to the building. Garden beds immediately adjacent to the perimeter of the building block the visual inspection of these areas, providing a concealed termite entry point.

These garden beds can include untreated timber, and with a combination of moisture from watering hosing can make conditions conducive to termite activity and termite ingress.

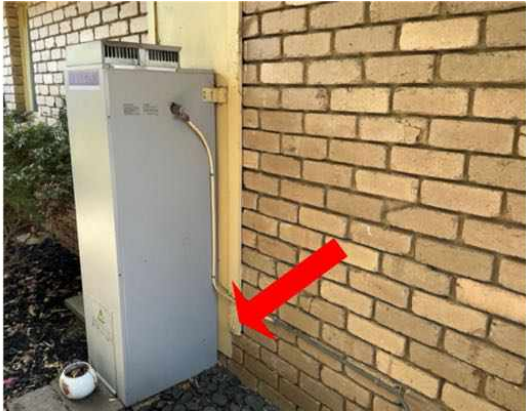
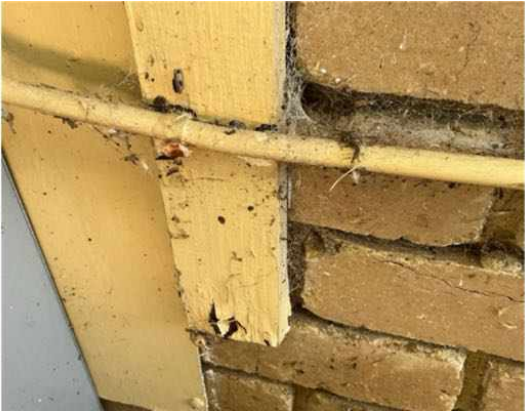
### Finding 7.01

Finding: Wood rot

Information: The external architrave near the hot water service shows evidence of wood rot. Wood rot, also known as Fungal Decay, occurs when timbers and other cellulose building materials are exposed to damp conditions on an ongoing basis. This could be the result of exposure to weathering over a prolonged period of time, or the attraction of excessive moisture from other abutting building materials. Contributing factors also include poor air ventilation in the area.

Wood rot is often associated with general damp problems and is evidenced by a 'musty' smell or mould and mildew occurring on surfaces. If left unmanaged, damp conditions can lead to further health problems and the decay of timbers will continue.

Early intervention and regular maintenance, particularly of exterior timbers, will prolong the useful life of these building elements. Prior to any works being performed, the cause of the moisture that has created the visible wood rot should be identified and addressed in a suitable manner. Replacement of affected timbers may then be a necessary step in protecting surrounding building elements from such deterioration.

A qualified plumber may be appointed to assess the cause of excessive moisture and to provide advice on any remedial works as required. A qualified carpenter or registered builder may also be required to replace affected building materials.
