Building and Timber Pest Inspection Report

Inspection Date: Fri, 20 Feb 2026

Property Address: 34 Fantail Cres, Erskine Park NSW 2759,
Australia

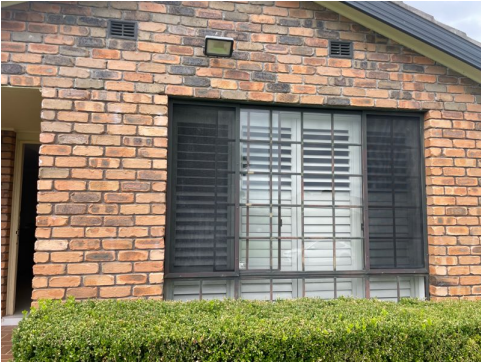
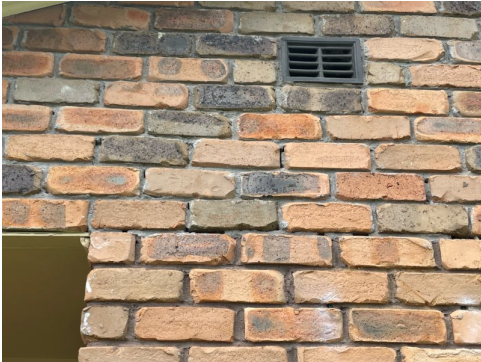
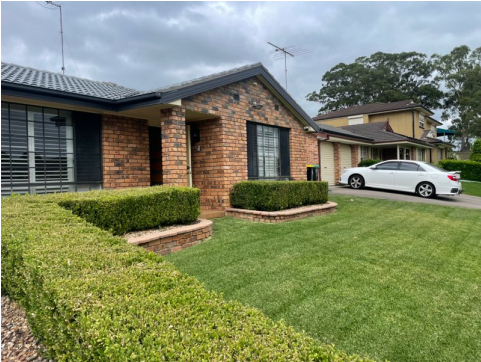
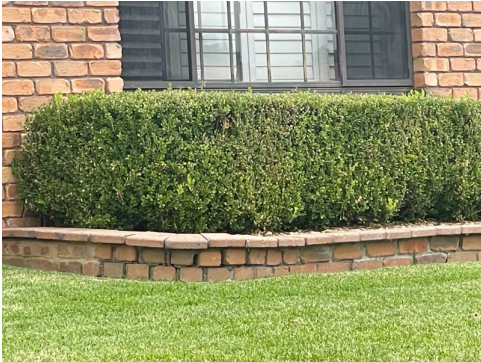
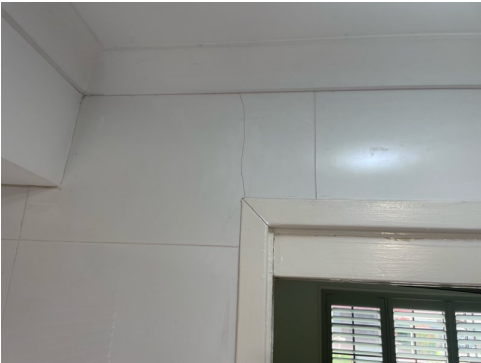
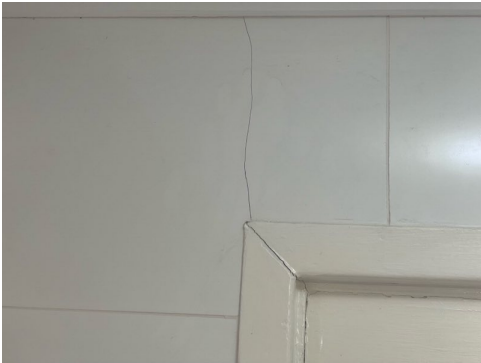
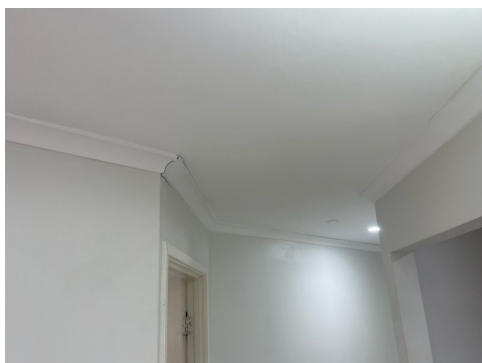
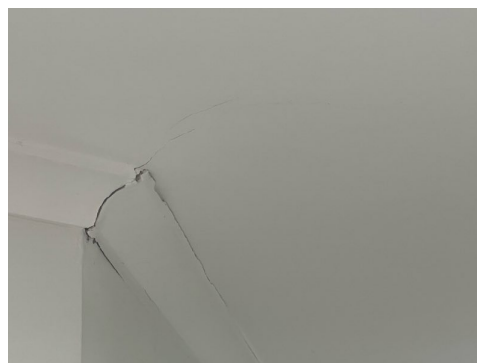
Finding: Brickworks - Movement Related – Previously Repaired

Information: During the inspection, the masonry wall above the window opening was noted to have been recently re-pointed. At the time of inspection, no visible open cracking was observed within the mortar joints; however, the location corresponds with previously identified step cracking and movement-related distress. The articulation joint in this vicinity appears widened, and historical cracking was also reported to internal cornice, bathroom tiles, and ceiling finishes following recent renovation works. Step cracking of this nature is typically associated with differential footing settlement or differential movement between suspended slabs and masonry walls, consistent with common building movement behaviour under NCC performance requirements and relevant masonry standards.

Although the mortar joints have been re-pointed and appear visually intact at present, such rectification is cosmetic unless the underlying cause of movement has been addressed. Re-pointing can conceal active cracking temporarily, and renewed internal cracking following renovation suggests that structural or footing-related movement may still be occurring. If differential movement continues, cracking may reappear over time.

At the time of inspection, the condition is not presenting as an open structural defect; however, it represents a movement-related risk area requiring monitoring. Ongoing observation is recommended, particularly across mortar joints, articulation joints, and internal finishes. Should cracking reoccur or articulation gaps increase, a suitably qualified structural engineer should be engaged to assess footing performance and overall structural behaviour.

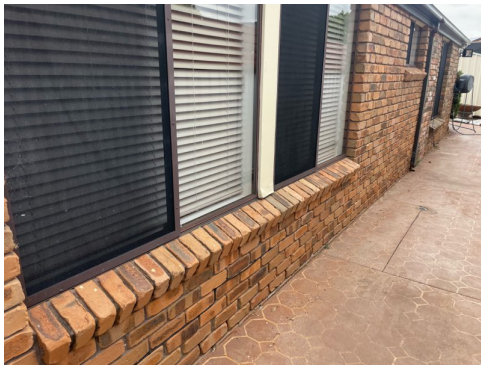
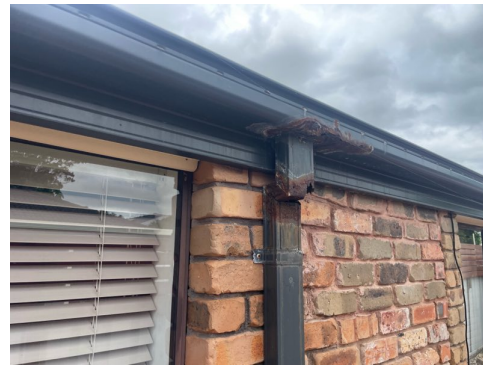
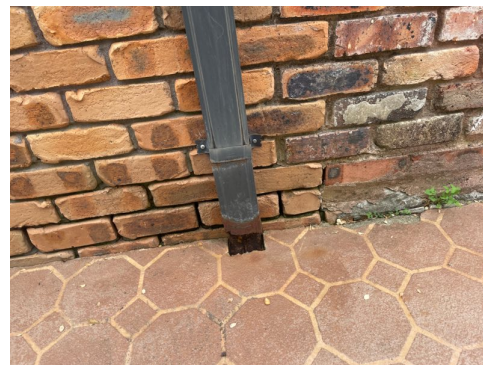
Finding 2.02

Finding: Gutters – Corroded

Information: During the inspection, the gutters were found to be heavily corroded along their base, with visible rust, pitting, and surface deterioration. In some areas, the corrosion appears advanced, indicating prolonged exposure to standing water and inadequate maintenance.

Corrosion at the gutter base reduces the material's structural integrity and can lead to leaks, water overflow, and potential damage to fascias, eaves, and adjoining wall surfaces. It also increases the risk of water ingress into the roof cavity during heavy rainfall.

It is recommended that the affected gutters be inspected and replaced by a licensed roof plumber or qualified trade as a short-term priority to restore effective roof drainage and prevent further water-related damage.

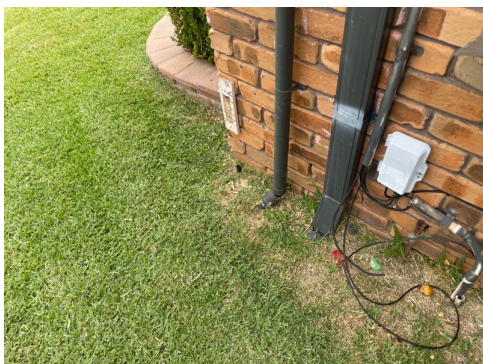
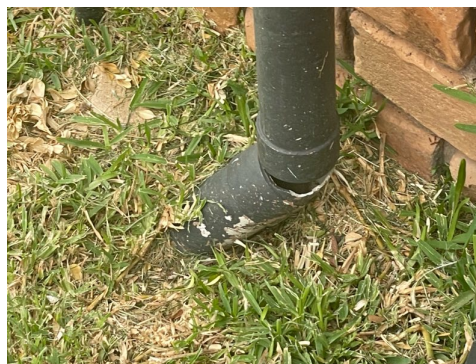
Finding 3.01

Building: Main Building
Location: Front Elevation
Finding: Downpipe(s) – Broken / Damaged Sections

Information: During the inspection, a section of the downpipe was observed to be broken/damaged. The defect affects the stormwater drainage system, which is intended to collect and discharge roof water in accordance with the performance requirements of the NCC and AS/NZS 3500 (Plumbing and Drainage).

The damage was noted externally along the vertical length of the downpipe servicing the roof gutter system. The pipe appears cracked/dislodged, which may allow rainwater to discharge directly against the building envelope or footing area rather than into the stormwater system. Such conditions can contribute to surface erosion, increased moisture levels adjacent to the slab or footings, and potential long-term foundation movement or damp-related issues. Responsibility for rectification would typically rest with the property owner/vendor, depending on the contractual arrangement.

While the defect is considered minor at the time of inspection, it should be rectified to ensure effective stormwater disposal and to reduce the risk of moisture-related damage to the building structure and surrounding areas.

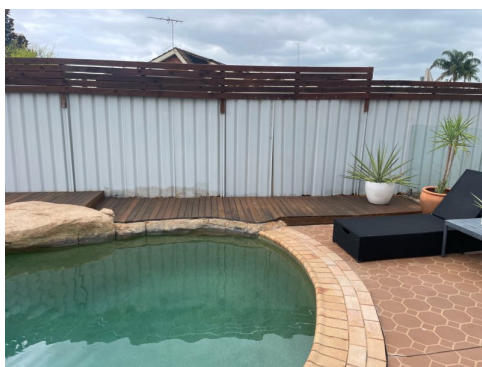
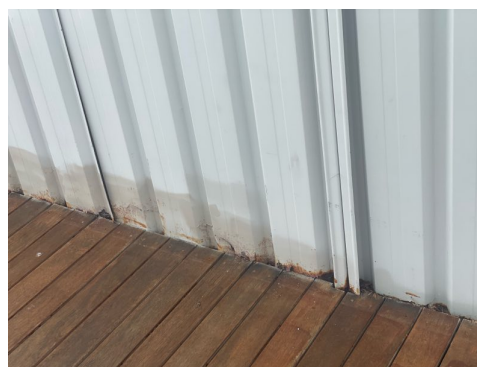
Finding 3.02

Building: Main Building
Location: Yard - Front
Finding: Building element - Rusted or corroded

Information: This building element shows evidence of rusting and corrosion, which is likely to have developed as a result of excessive exposure to moisture and or inadequate coatings.

As surface rust provides no protection to the underlying iron, the deteriorating condition is likely to worsen if not addressed in the short-term future.

Rusting and corrosion should be managed by ideally removing or limiting the affected surface from exposure to moisture. A registered builder may be appointed to replace any building elements that have been severely affected by rust or water damage.

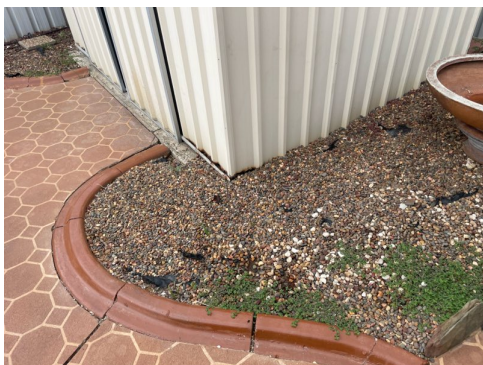
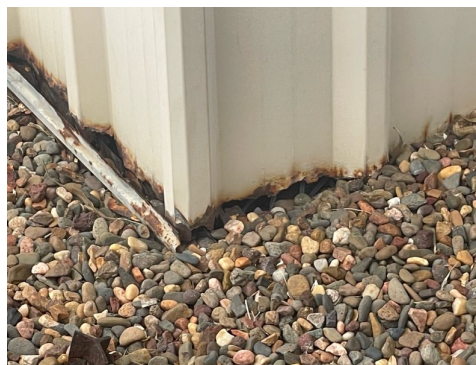
Finding 3.03

Building: Main Building
Location: Shed
Finding: Building element - Rusted or corroded

Information: This building element shows evidence of rusting and corrosion, which is likely to have developed as a result of excessive exposure to moisture and or inadequate coatings.

As surface rust provides no protection to the underlying iron, the deteriorating condition is likely to worsen if not addressed in the short-term future.

Rusting and corrosion should be managed by ideally removing or limiting the affected surface from exposure to moisture. A registered builder may be appointed to replace any building elements that have been severely affected by rust or water damage.

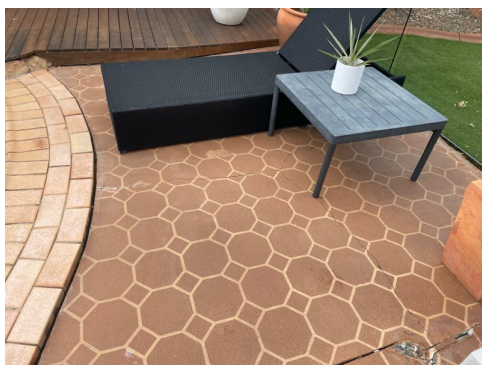
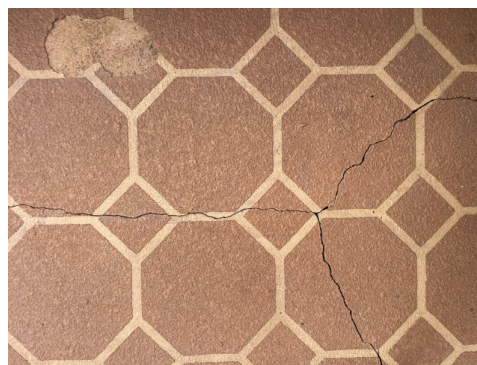
Finding 3.04

Finding: Crack in concrete slab - Category 2

Information: A crack coded as Category 2 was identified in the slab. A Category 2 crack is described as a distinct crack, with the slab being noticeably curved or changed in level.

To be considered Category 2, the approximate width of the crack is less than 2.0mm, or a change in offset of less than 15mm when a 3m straight edge is placed over the defect.

Category 2 cracks to slabs should be monitored for a period of 12 months. At the end of the monitoring period, cracks rated greater than Category 2 are considered defects that require rectification.

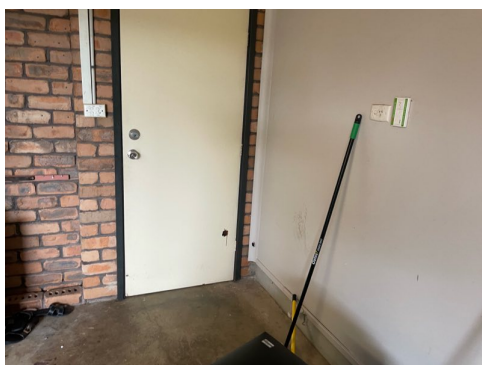
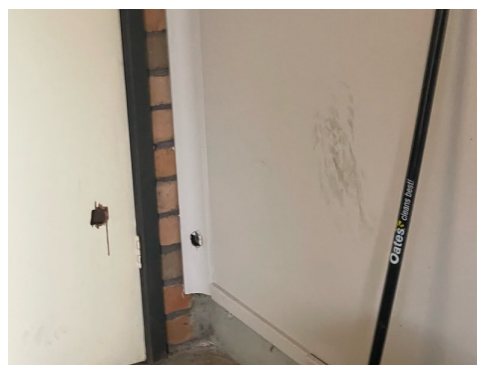
Finding 3.05

Finding: Door – Impact Damage and Rupturing

Information: The door was observed to have sustained significant damage, including impact marks and rupturing of the surface material. The defect was readily visible and has affected both the appearance and integrity of the door.

A damaged and ruptured door may not operate correctly, can compromise security and privacy, and detracts from the overall presentation of the property. If left unmanaged, the damage may worsen with continued use.

This matter is considered a repair defect. It is recommended that a suitably qualified carpenter or builder assess the extent of the damage and carry out repairs or replacement of the affected door to restore full function and appearance.

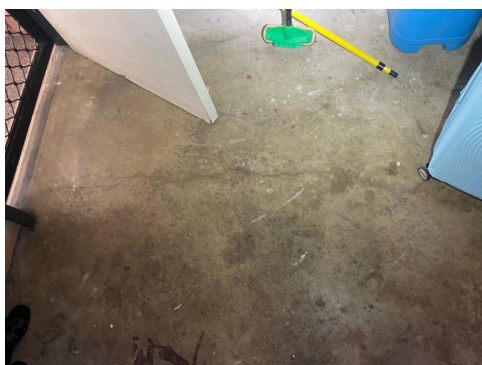
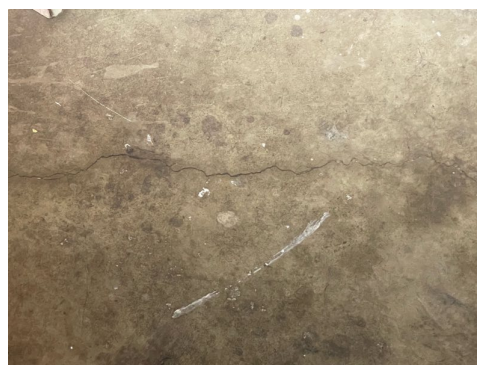
Finding 3.06

Finding: Crack in concrete slab - Category 1

Information: A crack coded as Category 1 was identified in the slab. A Category 1 crack is described as a fine but noticeable crack, with the slab at an otherwise reasonable level.

To be considered Category 1, the approximate width of the crack is less than 1.0mm, or a less than 10mm change in offset when a 3m straight edge is placed over the defect.

Category 1 cracks should be monitored for a period of 12 months. At the end of the monitoring period, identified cracks that are rated greater than Category 2 are considered defects, and require rectification.

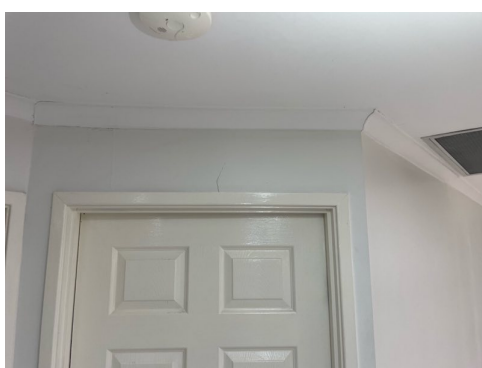
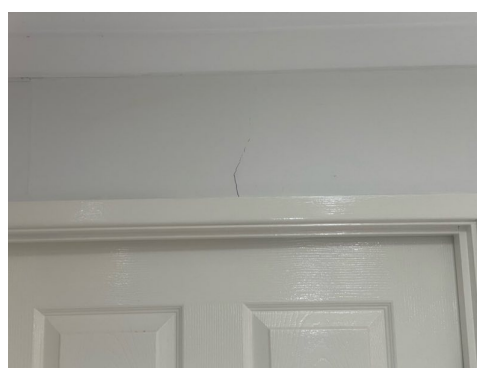
Finding 3.07

Finding: Cracking - Damage Category 1 - Fine (up to 1mm)

Information: Although fine cracks are quite noticeable, they are often only considered to be an appearance defect, and usually do not indicate any structural damage. Generally, the cause of a fine crack is indicative of a separation between building materials and finishes (e.g. paint, plaster, etc.) along joins.

Cracking of this nature can generally be repaired with minor sanding, filling and/or repainting. Such works should be performed by a qualified painter or a general handyman.

Monitoring of all cracking should be conducted frequently. Always contact a building inspector should cracks widen, lengthen, or become more numerous.

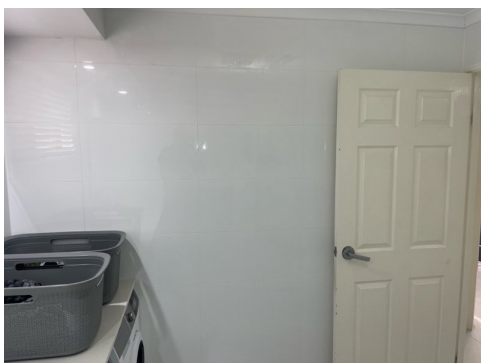
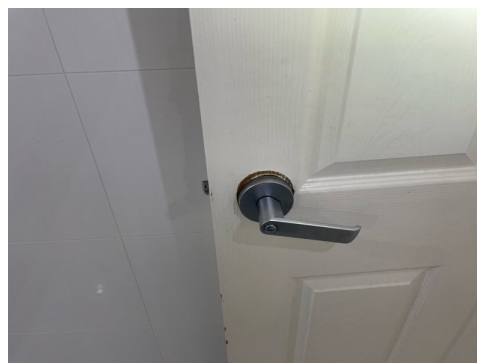
Finding 3.08

Finding: Door handle – Missing or loose

Information: During the inspection a door handle was found to be missing or loose. The handle is not fixed firmly to the door so it moves when used or is not present where it should be installed.

This type of defect often happens due to normal wear and tear poor installation or loose or missing screws over time. A loose or missing handle can affect the correct operation of the door and may reduce security and privacy and in some cases create a minor safety risk if the door cannot be opened or closed easily.

Repair or replacement of the affected door handle by a suitably qualified tradesperson is recommended. Works may include tightening and refixing the existing hardware or installing a new handle set so that the door operates smoothly and the opening can be used and secured as intended.

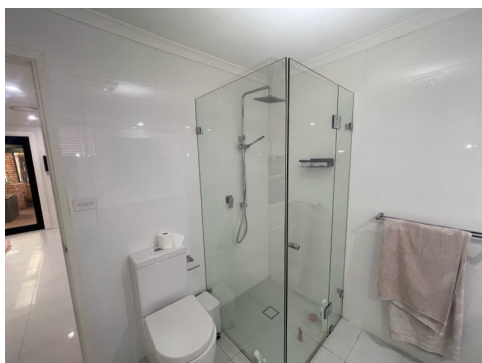
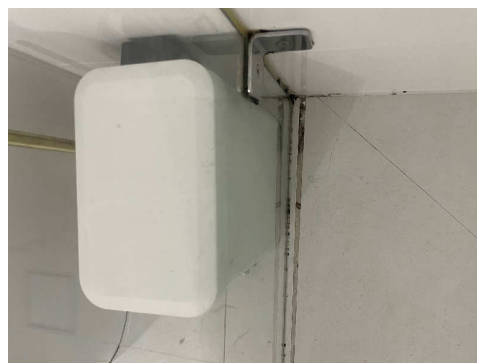
Finding 3.09

Information: During the inspection, the shower screen was observed to extend past the intended shower enclosure angle within the wet area. The screen alignment does not appear consistent with the designed shower recess boundary, which may affect the containment of water within the designated wet area as required under NCC performance provisions and AS 3740 (Waterproofing of Domestic Wet Areas).

Where shower screens extend beyond the enclosure angle or are misaligned, water may escape onto adjacent floor areas outside the waterproofed zone. Over time, this may increase the risk of moisture penetration, deterioration of finishes, swelling of skirtings or door jambs, and potential damage to underlying substrates.

Although no significant water damage was visible at the time of inspection, rectification by a licensed glazier or bathroom installer is recommended to ensure the screen is properly aligned and sealed to maintain effective water containment within the shower recess.

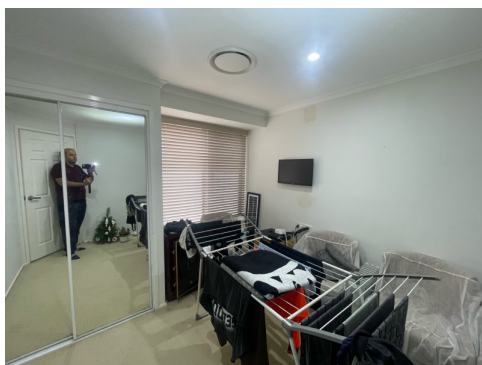
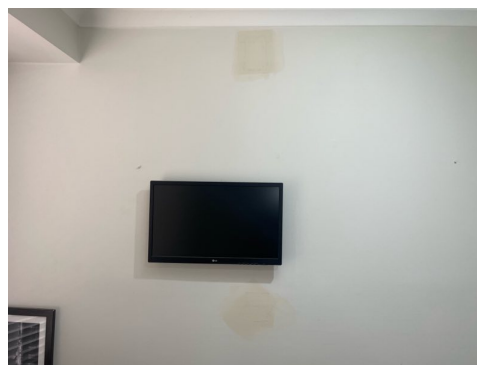
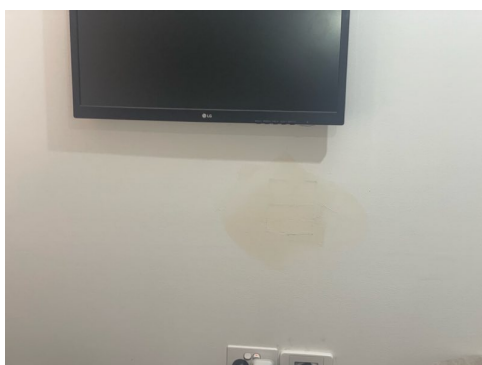
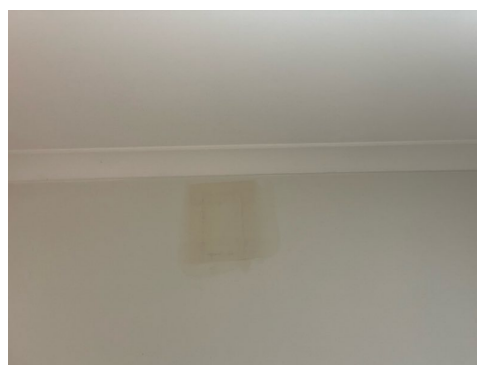
Finding 3.10

Whilst incomplete or missing paint finish is generally an appearance defect, it can also lead to the development of secondary building defects over time. Incomplete areas of paint finish expose the area to moisture, potentially accelerating the deterioration of underlying building materials.

Incomplete paint finishes should be sanded back, filled, leveled and painted, as applicable. Where inadequate or missing paint protection has led to the deterioration of the associated building element, repair and/or replacement of this building element may be required.

A painting contractor should be appointed as soon as possible to perform necessary works to aid the appearance of the affected area and to ensure the area is protected against further deterioration. Alternatively, the homeowner following manufacturer instructions may perform these works.

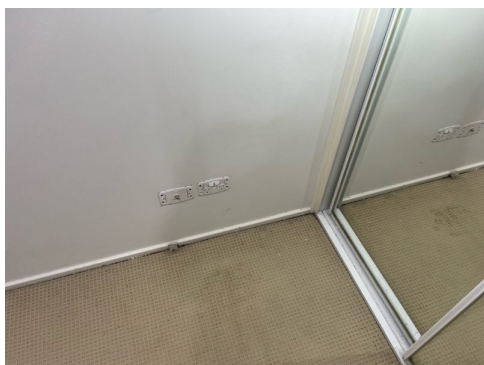
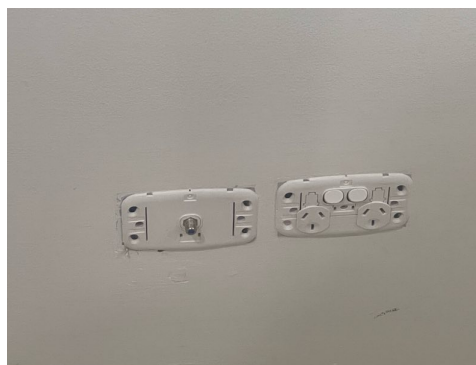
Finding 3.11

Finding: Electrical Socket – Cover Plate Missing

Information: During the inspection, it was observed that an electrical power outlet (socket) was missing its cover plate. This condition leaves internal components partially exposed and indicates incomplete installation or deterioration.

A missing cover plate presents a potential electrical safety hazard, including the risk of accidental contact with live parts, ingress of dust or moisture, and reduced protection of the outlet. This condition does not meet acceptable safety and maintenance standards.

It is recommended that the socket be made safe and the cover plate reinstated or replaced by a licensed electrician as a priority to restore safety and compliance.

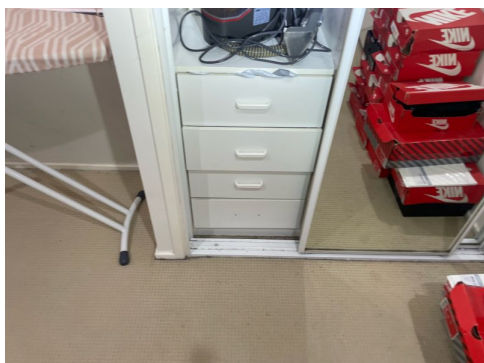
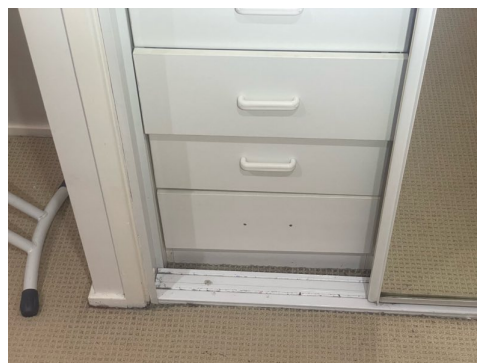
Finding 3.12

Finding: Door handle – Missing or loose

Information: During the inspection a door handle was found to be missing or loose. The handle is not fixed firmly to the door so it moves when used or is not present where it should be installed.

This type of defect often happens due to normal wear and tear poor installation or loose or missing screws over time. A loose or missing handle can affect the correct operation of the door and may reduce security and privacy and in some cases create a minor safety risk if the door cannot be opened or closed easily.

Repair or replacement of the affected door handle by a suitably qualified tradesperson is recommended. Works may include tightening and refixing the existing hardware or installing a new handle set so that the door operates smoothly and the opening can be used and secured as intended.

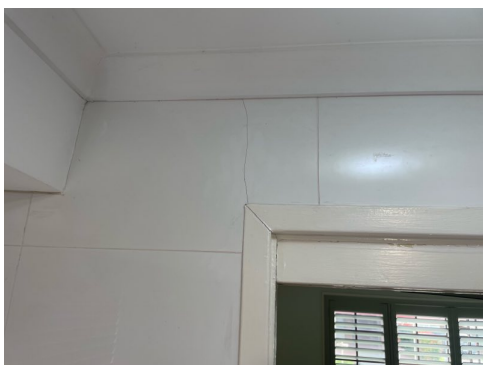
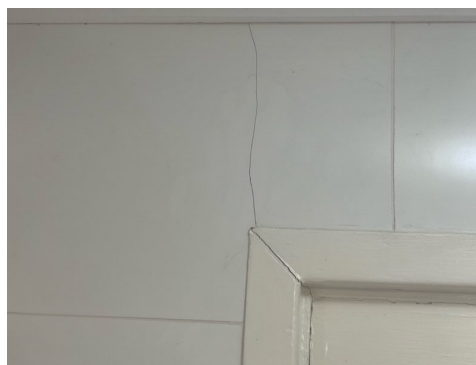
Finding 3.13

Finding: Tiles - Cracked or damaged

Information: Cracking was evident to the tiling in this area at the time of inspection. While the cracking appears to be minor, this area is frequently exposed to water, allowing potential for water penetration into adjoining sections of walls or flooring.

If left unmanaged, water penetration to these areas may lead to subsequent water damage, which is likely necessitate repair work to affected building elements.

A tiling contractor should be appointed to ensure that no further water damage occurs. The re-application of silicone and grouting throughout remaining tile work is also advised, to further protect the area against water penetration.

Where water penetration has led to water damage, appointment of a relevant tradesperson may be required to repair damaged building elements.

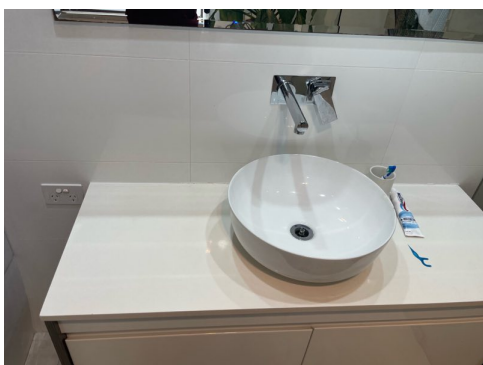
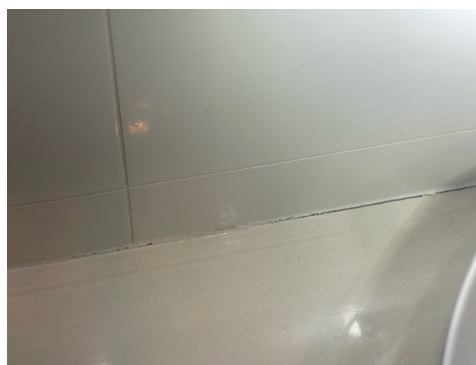
Finding 3.14

Finding: Cabinetry – Missing or Deteriorated Corner Sealant

Information: The cabinetry was observed to have missing or deteriorated sealant at the internal corners. In some areas, the sealant had not been applied, while in others it had broken down and no longer provided an effective seal.

Incomplete or deteriorated sealant can allow water, moisture, or debris to penetrate behind cabinetry panels, which may lead to swelling, staining, or damage to the cabinetry materials over time. It also detracts from the overall finish and appearance of the installation.

This matter is considered a maintenance defect. It is recommended that the affected cabinetry corners be re-sealed by a suitably qualified tradesperson to restore protection and appearance.

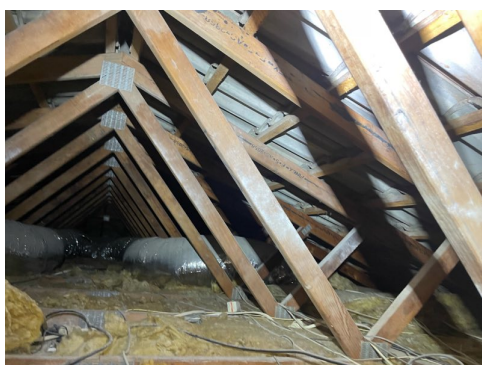
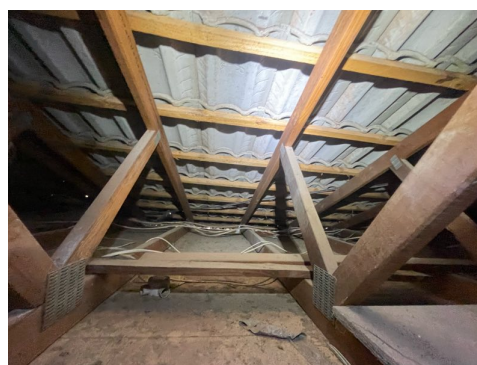
Finding 3.15

Finding: Sarking - Missing

Information: Sarking is missing under the roof sheeting. Sarking acts as an insulator that helps with noise reduction and protects against water penetration. Sarking plays a key role in the operation and function of the overall roofing structure and its performance.

Although not a requirement at the time of construction, replacement of any missing building element is advisable (although this can be quite expensive to do after the time of construction). Where sarking is missing, regular inspections of the roof tiles for cracking and potential moisture penetration is required.

Sarking may be retrospectively fitted by a registered builder at the discretion of the client.

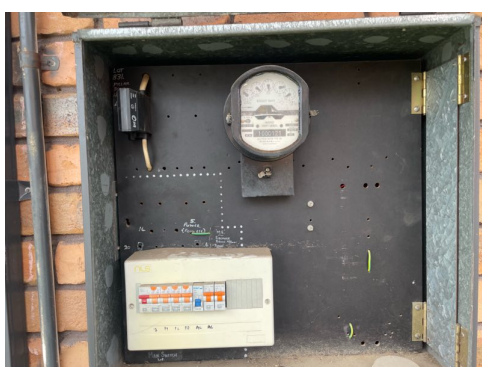
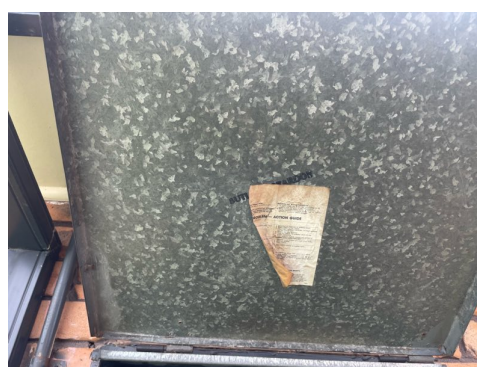
Conditions Conducive to Timber Pest Activity**Finding 6.01**

A post-construction chemical termite barrier is strongly recommended, particularly given the history of termite activity, to help protect timber building elements and reduce the risk of concealed termite damage.

It is recommended that a licensed pest controller confirm whether any termite protection exists and its condition, and if not, arrange installation as a short-term priority. Annual timber pest inspections are recommended in accordance with AS 4349.3 and ongoing termite management practices consistent with AS 3660.2.

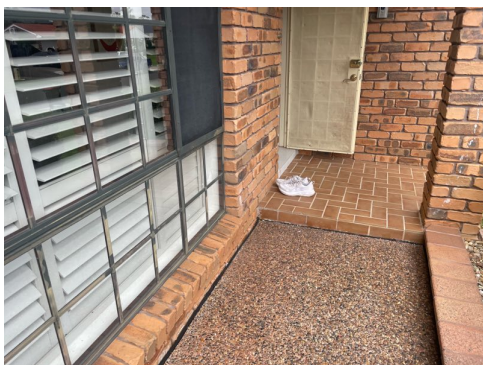
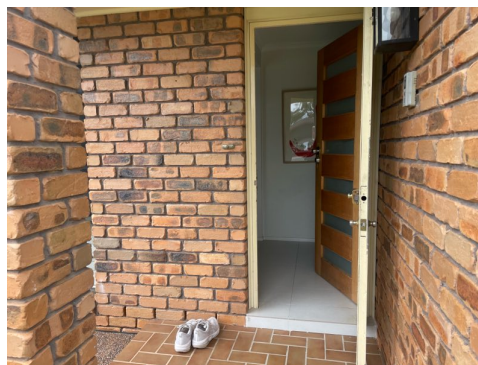
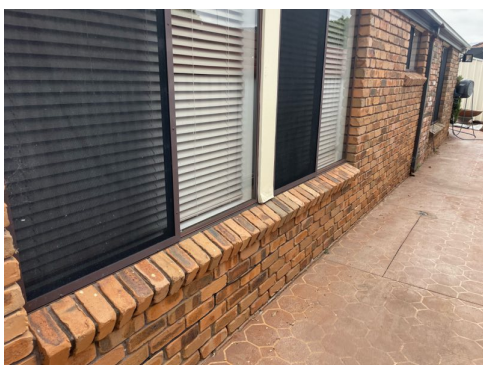
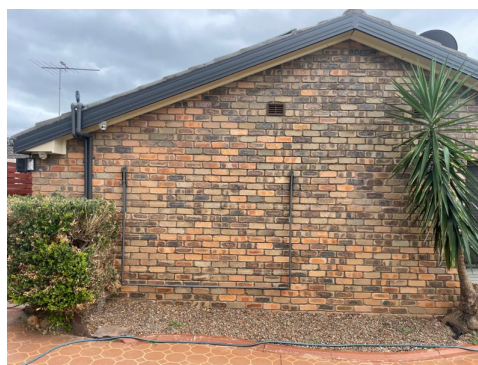
Finding 6.02

If the slab edge is not properly exposed there is a high risk of termite attack. Sometimes, in order to determine the type of slab, a suitably qualified person such as an architect or builder may be required to consult the construction plans.

Where the slab edge cannot be properly inspected, it is highly recommended that termite or timber pest inspections be carried out every 6-12 months to aid protection of the property against infestation.

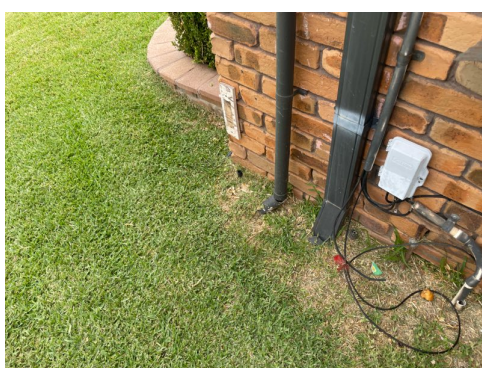
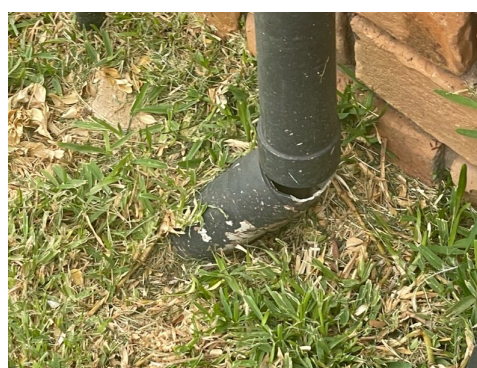
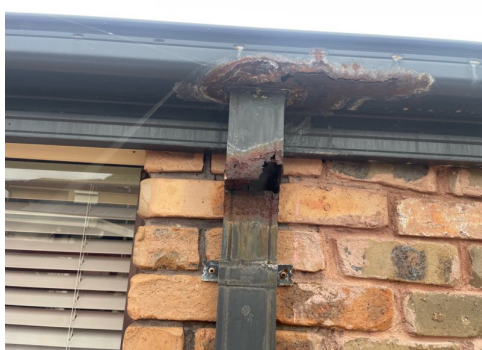
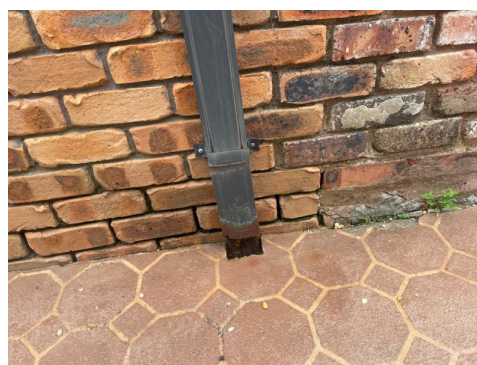
**Finding 6.03**

Where roof plumbing doesn't drain adequately, the area at the base perimeter can become excessively damp, potentially creating an environment that is susceptible to rust and corrosion of surrounding building elements, as well as attracting termites and other pests.

It is highly recommended that a plumber be appointed to further inspect the area and to install adequate drainage equipment where necessary.

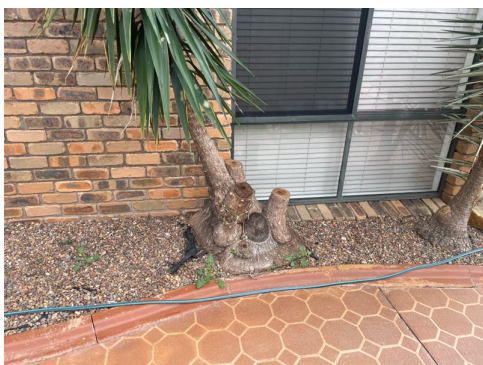
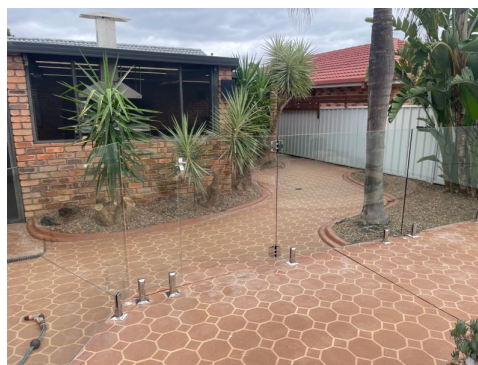
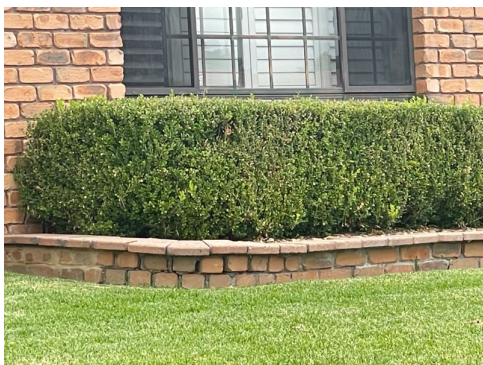
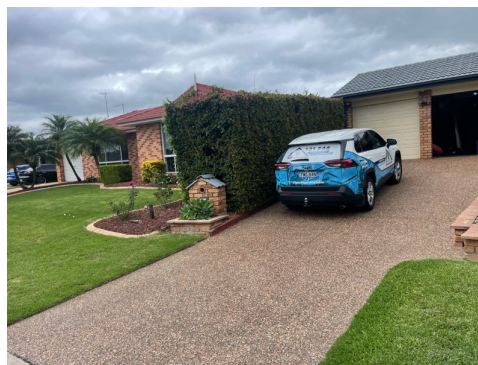
Finding 6.06

Building:	Main Building
Location:	Yard
Finding:	Large trees/stumps within 30m of house

Regular inspections are recommended. Consider test drilling any large trees. A pest controller can be contacted to carry out such testing at the owners discretion.
