# Building and Timber Pest Inspection Report

Inspection Date: Tue, 10 Mar 2026

Property Address: 119 Glenmore Ridge Drive, Glenmore Park  
NSW 2745

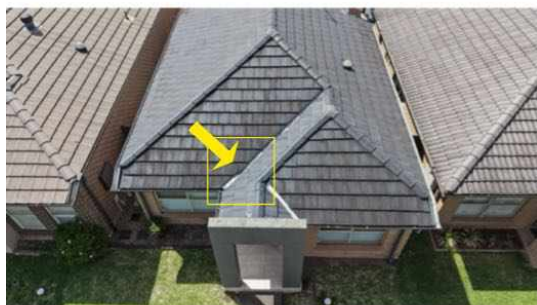
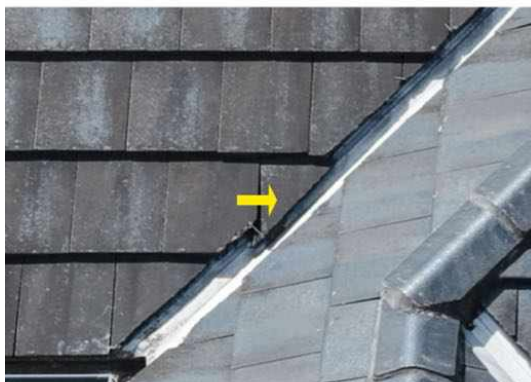
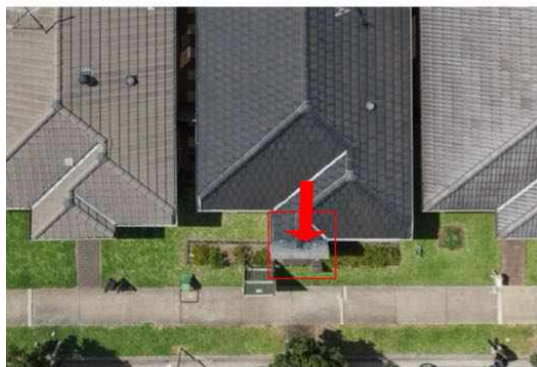
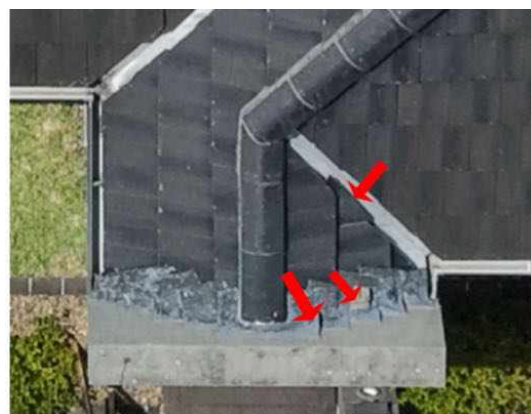
Loose or displaced tiles observed

Loose flashings noted

The roof tiles appeared generally well seated with no widespread cracking or significant dislodgement observed at the time of inspection. Localised areas of minor displacement were noted to some valley tiles. Minor weathering and general wear consistent with the age and environmental exposure of the roof covering were also observed. Overall, the tiled roof covering and associated components appeared to be in satisfactory condition for their apparent age. Minor maintenance may be beneficial to preserve the waterproofing performance of the roof and extend its serviceable life.

The concrete tiled roof covering was observed to be in generally sound and serviceable condition at the time of inspection, with no evidence of active leaks detected in the accessible areas. Localised minor displacement of some valley cut tiles and flashing was noted and may require minor adjustment or maintenance to maintain optimal water shedding in these areas.

Routine roof maintenance is recommended, including periodic inspection, cleaning of valleys and gutters, and maintenance of ridge pointing and flashings where required. Regular upkeep will assist in maintaining the weather resistance and serviceable life of the roof covering.

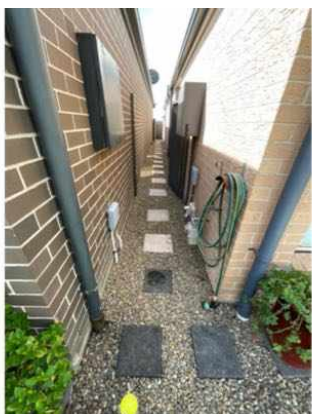
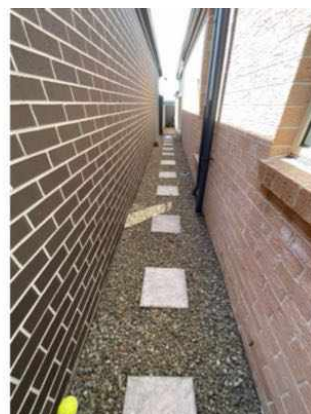
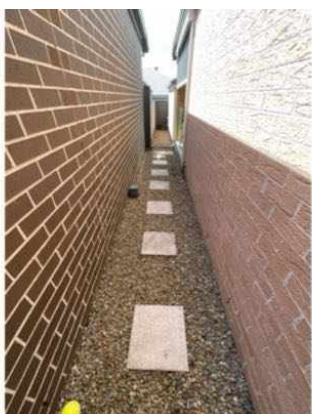
### Finding 3.02

Building: Main Building  
 Location: Exterior - left side  
 Finding: Site/Yard Drainage – Average.  
 Information:

however, no surface drains observed. Ground surfaces adjacent to the building is pebble.

- Monitoring during periods of heavy rainfall is recommended to evaluate the current site grading and surface runoff conditions
- Install or upgrade surface water drainage (e.g. strip drains, spoon drains, grated channels) if required

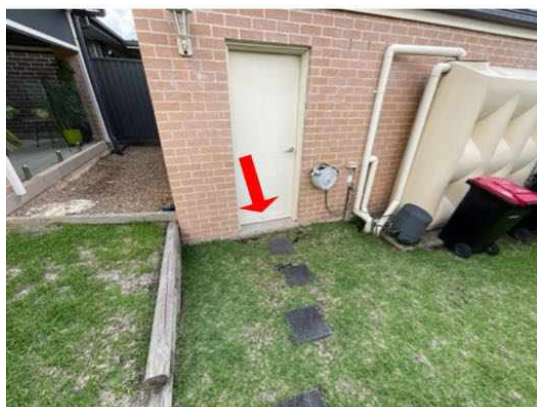
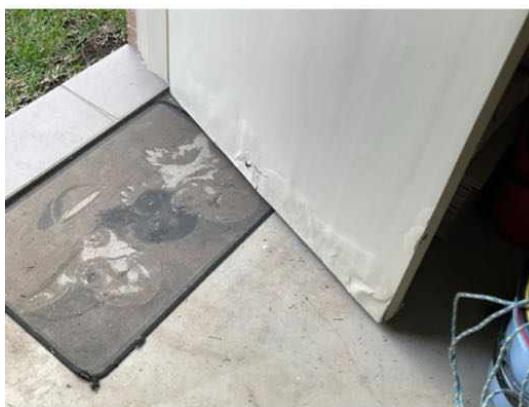
### Finding 3.03

Building:	Garage
Location:	Entry
Finding:	Minor Defect – Deterioration to External Garage Door
Information:	Observation

At the time of inspection, deterioration was noted to the lower edge of the external garage door. The bottom section of the door shows signs of water damage, likely resulting from prolonged exposure to moisture at ground level. Minor wood rot and fungal decay were also observed to sections of the adjacent timber door frame. The affected areas appear localised and primarily impact the lower portions of the door assembly.

Timber components in direct or repeated contact with moisture can deteriorate over time due to fungal decay and timber rot. While the observed deterioration currently appears minor and is largely cosmetic in nature, ongoing moisture exposure may allow

the damage to progressively worsen. If left unaddressed, this may lead to further deterioration of the door structure and frame, potentially affecting durability, operation, and weather resistance. Continued deterioration may eventually require partial or full replacement of the door or affected framing components.

Maintenance repairs are recommended in the short term to address the affected areas and help prevent further deterioration. Repairs may include removal of decayed timber, treatment of affected areas, sealing, and repainting or similar protective measures. Addressing the issue at this stage may help extend the serviceable life of the door.

The client may wish to engage a suitably qualified carpenter or building contractor to undertake repairs and assess the extent of deterioration. Replacement of the door or affected framing components may be required in the future should deterioration continue. All works may be carried out at the client's discretion.

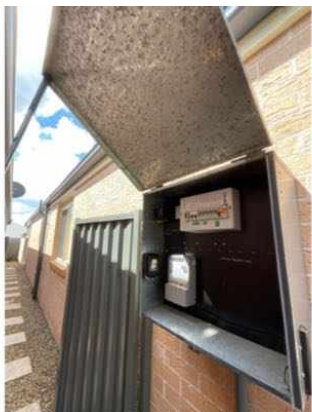
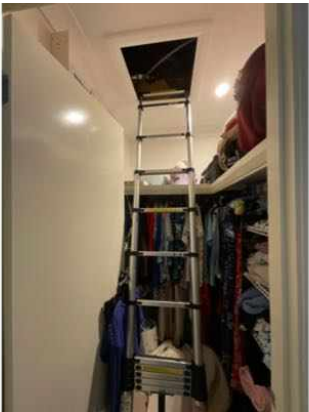
## Noted Item

Building:	Main Building
Location:	Roof Void
Finding:	Roof Void – Limited Accessibility..
Information:	Observation:

Installation of an additional manhole is recommended to facilitate a re-inspection and enable a more thorough assessment of the roof void in the future. This will help ensure that all structural elements and concealed areas are properly evaluated.
