Building and Timber Pest Inspection Report

Inspection Date: Wed, 18 Mar 2026

Property Address: 6 Wirreanda Cl, WARRAWEE, NSW, 2074,
Australia

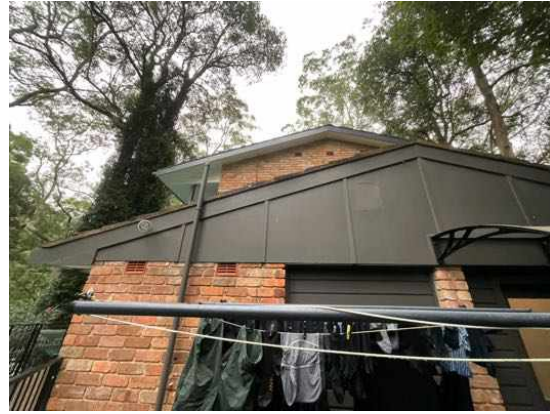
Building:	Main Building
Location:	All Areas
Finding:	Asbestos - Suspected ACM Identified on Site
Information:	Reporting on Asbestos is outside the Scope of this Report. This suspected defect is highlighted as a caution only. We suspect, based on our experience in the building industry, that there is a higher risk of the identified building element containing asbestos.

As Asbestos Reporting is outside the scope of this report, we advise that you consider a separate Asbestos Inspection and Condition Audit, which can include the taking of samples for definitive confirmation of the presence of Asbestos.

In the interim, the client is advised to act with caution, especially when considering any damage to building materials general wear and tear renovations extensions demolition and general maintenance activities due to the suspected presence of Asbestos.

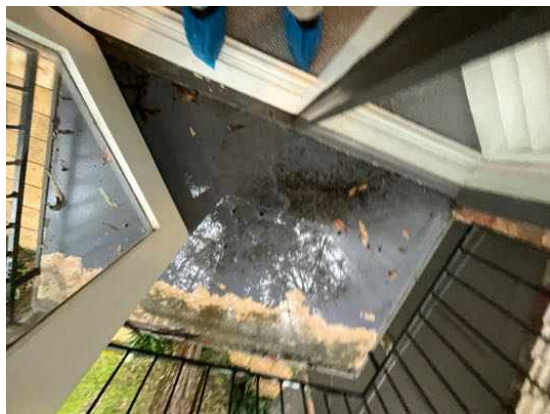
Finding 1.02

Building: Main Building
 Location: All Areas
 Finding: External timber balcony or deck-structural stability
 Information: The load capacity of the external balcony or deck could not be verified during the inspection.

External timber structures are also constantly exposed to weather deteriorates in an exhilarate manner, ongoing assessments are required.

It is highly recommended that a structural engineer further, assess the external timber balcony or a deck to inform the client of its load capacity.

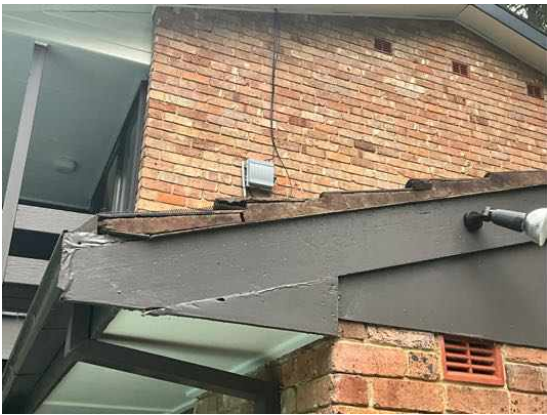
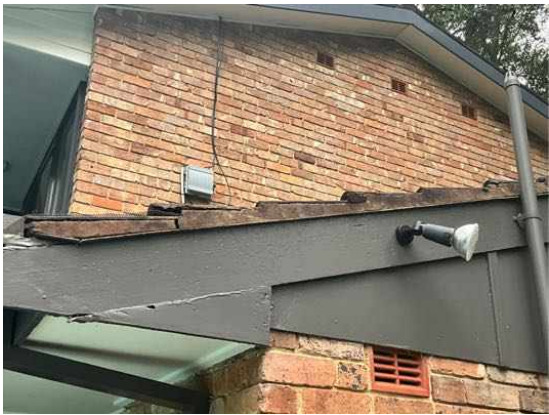
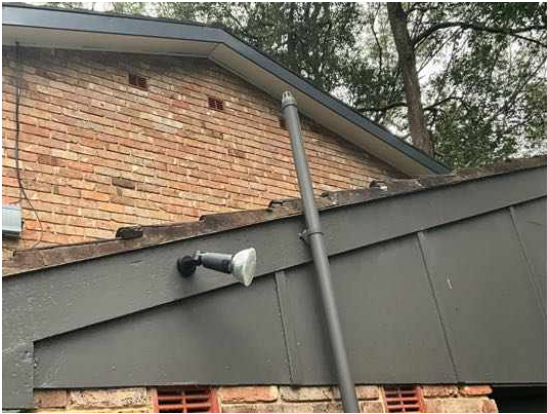
Building:	Main Building
Location:	Roof Exterior
Finding:	Roof Weathered
Information:	Upon inspection of the exterior roofing, the majority of roof was not in a fair condition. While weathering of the roof is consistent with the age of the property, maintenance works are required.

Isolated areas of mortar have come loose in the valleys and minor cracking is also present. Re-pointing and re-sealing the may be considered as an interim solution by the client to help preserve and extend the life span of the tiles.

Where left unmanaged, deteriorating roof are likely to lead to a number of secondary defects, including minor water leaks and weather exposure to internal roofing structures.

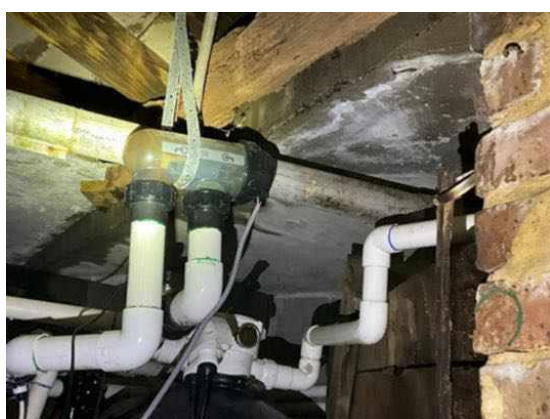
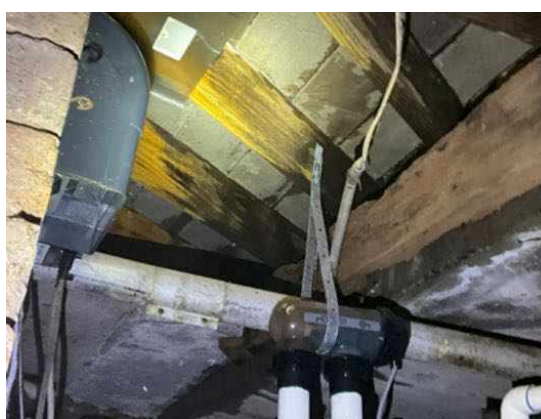
Building:	Main Building
Location:	Subfloor
Finding:	Subfloor- leaking plumbing fittings
Information:	Evidence of leaking plumbing fittings was observed within the subfloor area. Moisture staining and timber deterioration suggest prolonged water exposure from faulty pipe joints or fixtures.
Risk:	<ul style="list-style-type: none"> • Structural damage to timber framing and flooring due to continuous moisture exposure. • Mould growth and decay, posing potential health risks and further degradation of building materials. • Pest attraction, as damp environments are conducive to termites and other pests. • Non-compliance with plumbing standards and risk of escalation if not addressed promptly.
Who Can Fix It:	<ul style="list-style-type: none"> • A licensed plumber should be engaged to identify the exact source of leakage,

repair or replace faulty fittings, and confirm watertight integrity. A builder may also be required to assess and rectify any structural damage.

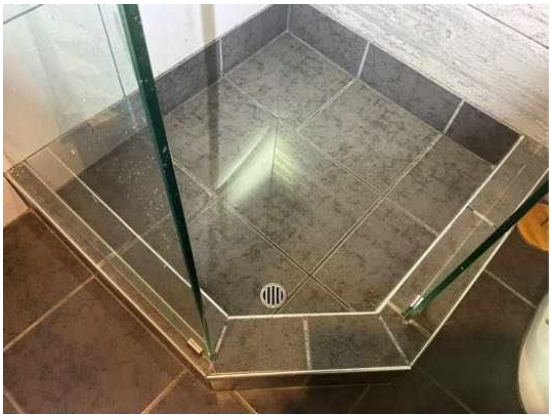
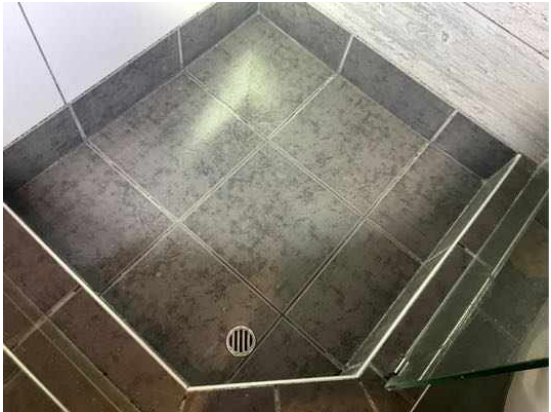
Finding 2.07

Building:	Main Building
Location:	Bathroom studio
Finding:	Shower base - Water pooling
Information:	Evidence of water pooling around the floor waste in the shower recess was noticed at the time of inspection. It is suspected that this excessive moisture is attributed to insufficient fall in the shower floor tiles.

This pooling is major overall and considered unsatisfactory, as standard tiling practices would not permit this situation to occur. Pooling water around floor wastes can create a slip hazard in extreme cases and create conditions that are conducive to mould growth over time. Where left unmanaged, the degradation of sealant and grouting is also likely to occur, possibly necessitating further repair works.

Remedial works may involve some sections of tiling and flooring repair and replacement. A tiling contractor or bathroom specialist should be appointed to provide further advice on reparation options and to perform works as necessary.

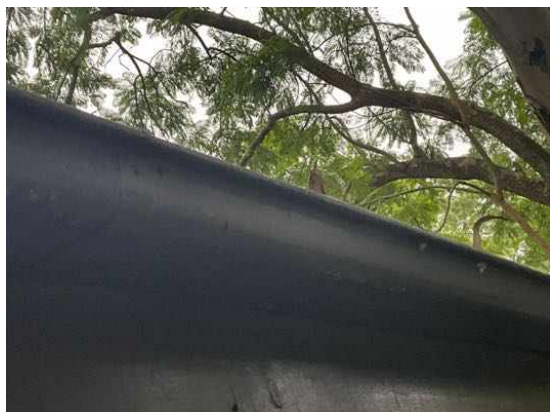
Building:	Main Building
Location:	Garage
Finding:	Blocked gutters - organic debris
Information:	The roof gutter system was observed to be blocked with organic debris and moss growth, as evident in the provided images.

- Water ingress into the eaves or walls,
- Timber rot or deterioration of fascia and soffits,
- Accelerated moss and algae growth, promoting further blockages,
- Potential foundation issues if water pools near the base of the structure.

A licensed roofing contractor or qualified gutter cleaning service should be engaged to remove the debris and inspect the system for any further issues.

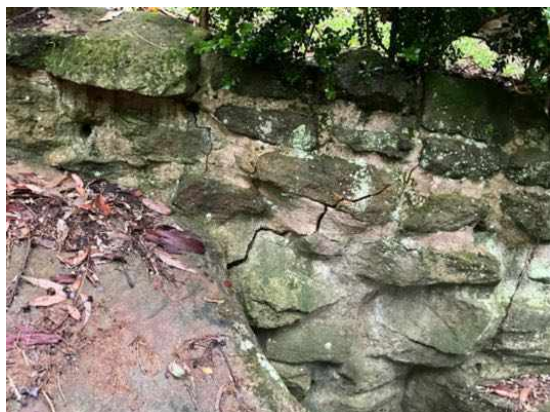
Finding: Retaining wall - Defective

Information: The retaining wall in this area was found to be defective at the time of inspection. Generally, defective retaining walls are caused by poor original design or material use. However, deteriorated retaining walls may also be a result of substandard construction, poor site drainage or unmanaged stormwater flows.

If left unmanaged, the retaining wall may become a safety hazard if it continues to destabilise. Where retaining walls further rot and decay, an environment is created that is conducive to termite and pest infestation.

Significant repair and replacement should be expected. Where retaining walls are considered structural walls, a structural engineer / surveyor should be consulted regarding required remedial works. Otherwise, a landscaper or retaining wall installer may be appointed to repair or replace the wall, at the discretion of the client.

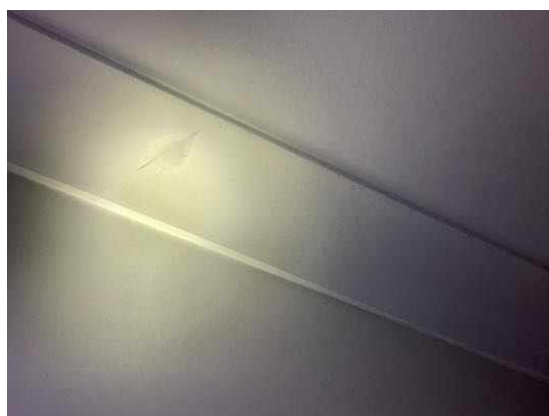
Finding 3.04

Information: A visible paint bubble (or blister) was identified on the surface. The deformation appears as a raised area in the paint film, typically resulting from adhesion failure between the paint and substrate, possibly due to moisture, poor surface preparation, or incompatible paint layers.

As per AS 4349.1-2007, this is considered a minor defect. However, if moisture is the cause, it may indicate an underlying issue such as water ingress or high humidity, which could worsen over time and lead to mould growth or plasterboard deterioration if left unattended.

Minor Defect — unless associated with active moisture ingress, in which case it may be upgraded depending on extent and cause.

A licensed painter or plasterer should assess the cause of the blister. If moisture is present, the source must be identified and rectified before repairs. Once dry, the affected area should be scraped back, sealed, patched, and repainted. Further investigation may be required if there is suspicion of plumbing or roofing leaks above the ceiling.

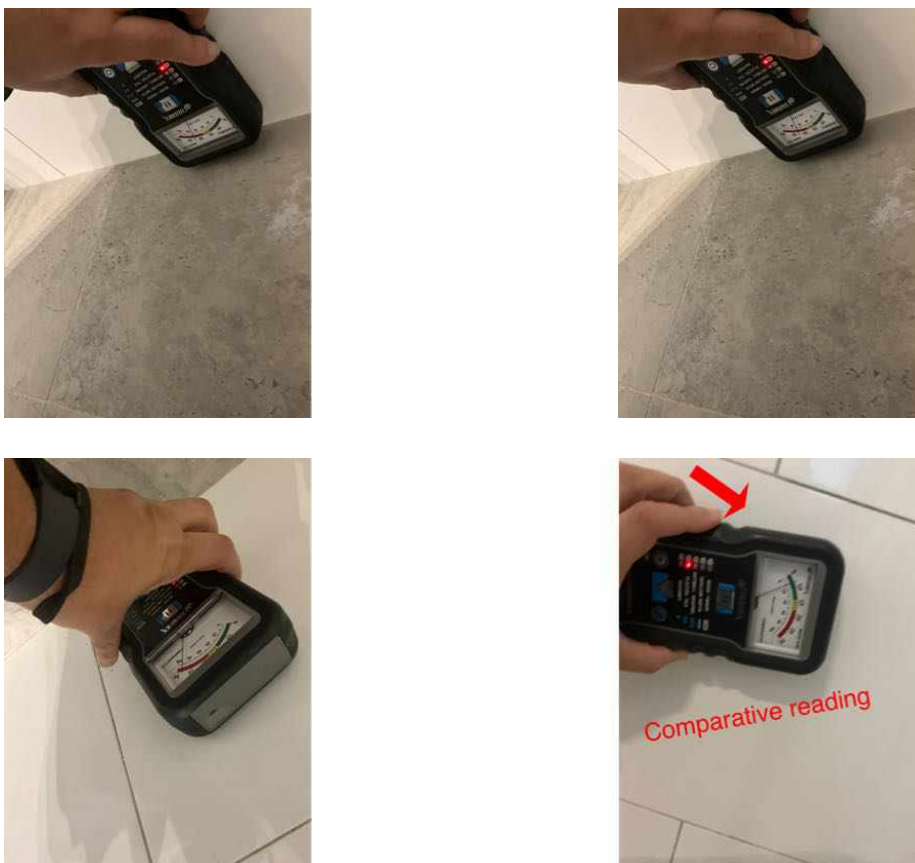
Building:	Main Building
Location:	Living Room
Finding:	Evidence of excessive moisture - Drywall
Information:	Excessive moisture is present at the time of , indicating a potential water leakage issue within the wall.

The prolonged presence of moisture can lead to mold growth, deteriorate the structure, and create an environment conducive to health hazards. Additionally, it may

A licensed plumber or a qualified contractor specializing in water damage remediation should investigate the source of the moisture, fix any leaks, and address the damage. Additionally, replacing affected tiles and ensuring proper waterproofing are crucial to preventing future issues.

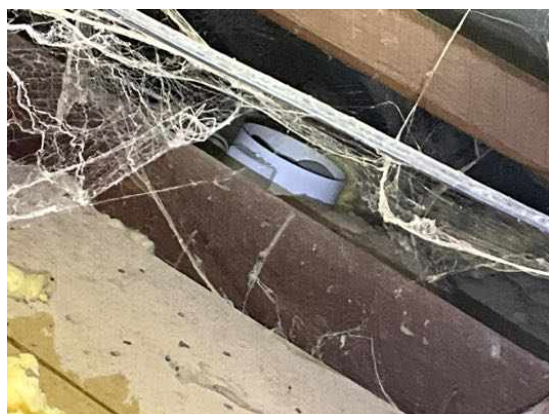
Finding 3.10

Building:	Main Building
Location:	Roof Void
Finding:	Exhaust fan not vented out
Information:	The exhaust fan located within the roof void is not appropriately ducted to the external atmosphere and is currently discharging moist air directly into the roof space. This is considered a defect under AS 4349.1, as it does not meet the minimum standard of residential building performance expected under normal residential building practices.

It is recommended that the exhaust fan be modified by a licensed HVAC contractor or qualified builder, ensuring it is properly ducted to discharge externally in accordance with manufacturer specifications, the National Construction Code (NCC), and applicable Australian Standards.

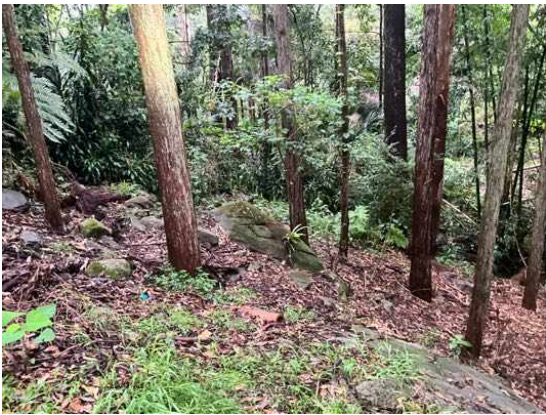
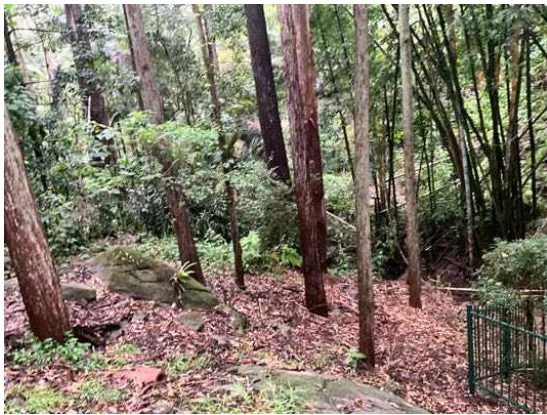
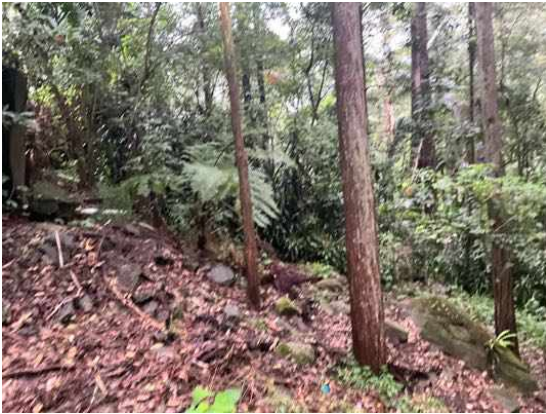
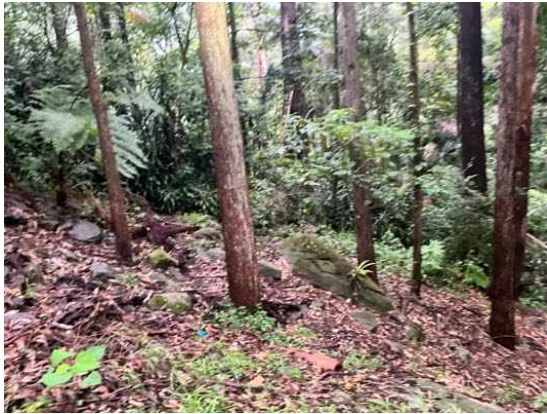
Finding 6.02

Building: Main Building
Location: All Areas
Finding: Dense vegetation around a property can increase the risk of termite infestation
Information: The presence of dense vegetation around a property can increase the risk of termite infestation, as it provides a conducive environment for them. To address this, consider maintaining a clear space between the vegetation and your home. If you suspect a termite issue, it's advisable to consult with a licensed pest control professional for inspection and treatment.

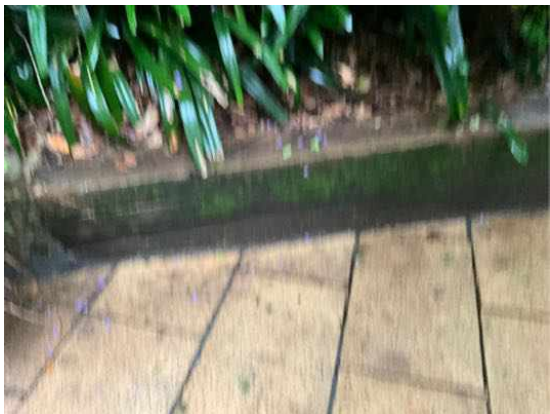
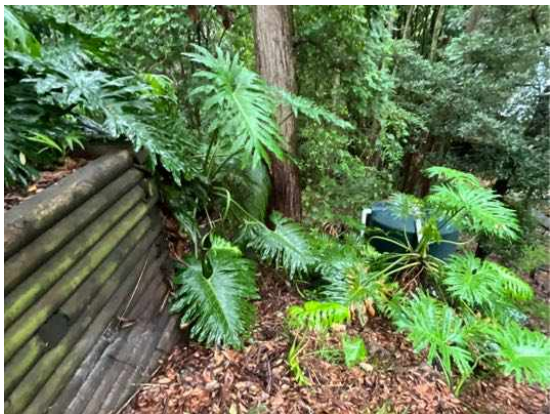
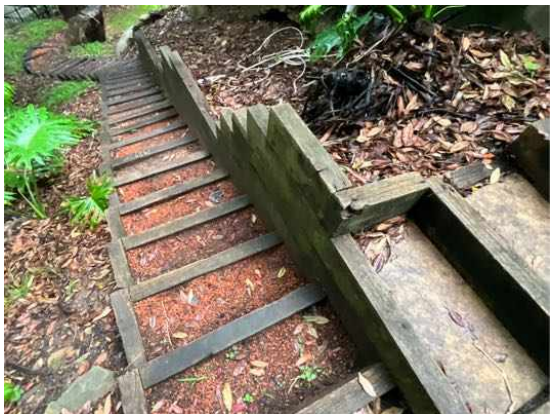
Finding 6.03

Building: Main Building
 Location: All Areas
 Finding: Timber on ground / conducive conditions to termite damage
 Information: Timber on the ground is indeed conducive to termite damage. Termites are known to thrive in moist environments, and wood in contact with soil or moisture is more susceptible to infestation.

To prevent this, it's important to keep timber elevated and away from direct ground contact. Regular inspections and proper termite control measures are also essential to protect your wooden structures from termite damage.

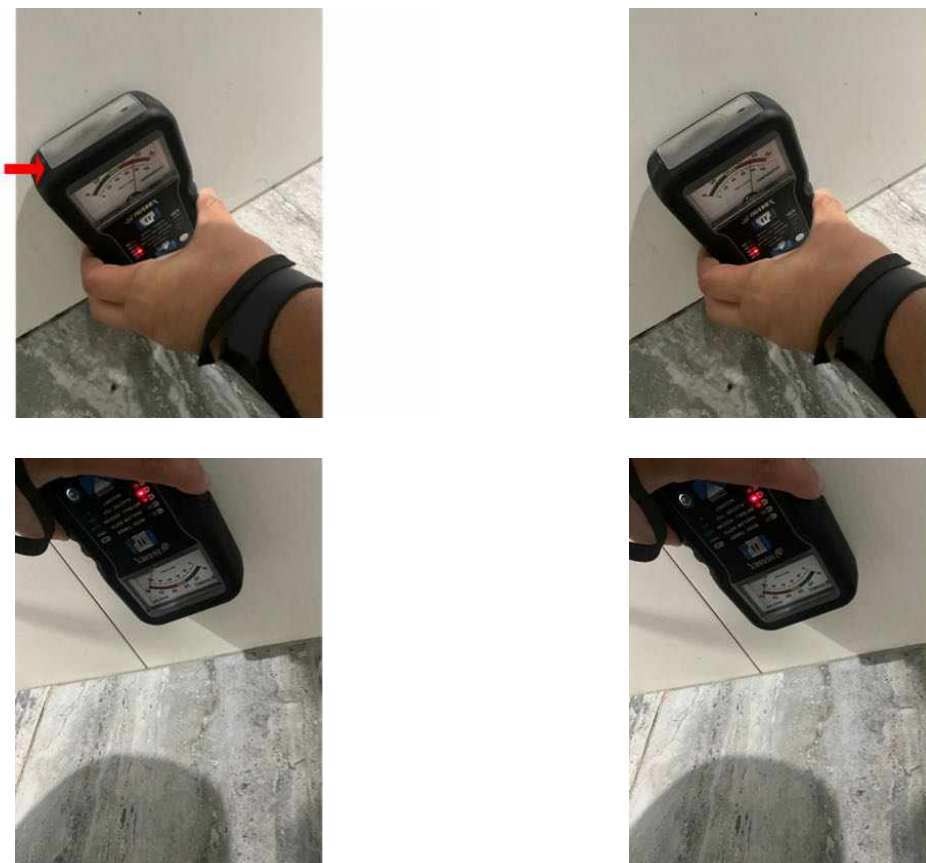
Finding 6.07

Building:	Main Building
Location:	Bathroom studio
Finding:	Excessive moisture - Conducive to Timber pest
Information:	Excessive moisture can attract termites and produce conditions that promote fungal growth and wood decay.

If mould growth has been found there may be environmental biological or health issues involved. In these cases an appropriately qualified inspector should also be contacted.

Prior to any remedial works being performed a qualified plumber should be appointed to further inspect the property and to identify the cause of the excessive moisture. Works to remove affected building elements may then be necessary and should be performed by an appropriate tradesperson.
