# Building and Timber Pest Inspection Report

Inspection Date: Wed, 28 Jan 2026

Property Address: 1 Stanton Ct, Glen Waverley VIC 3150,  
Australia

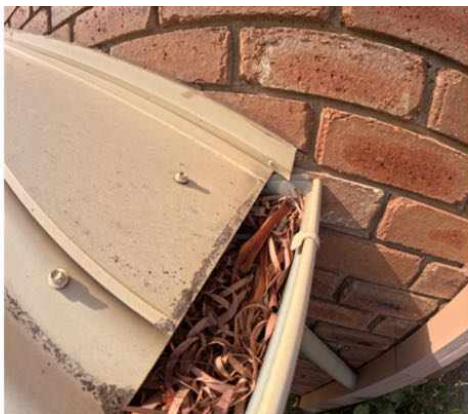
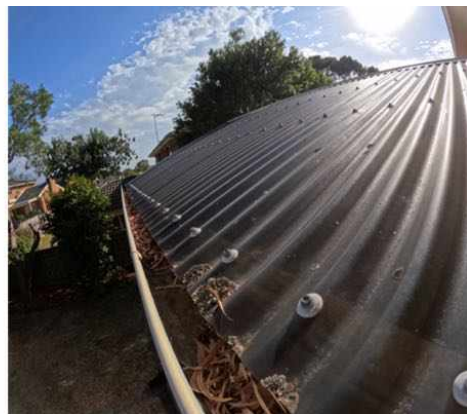
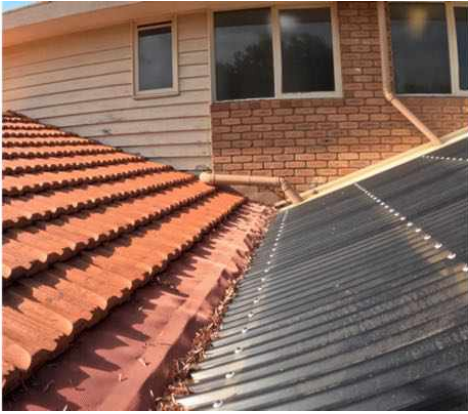
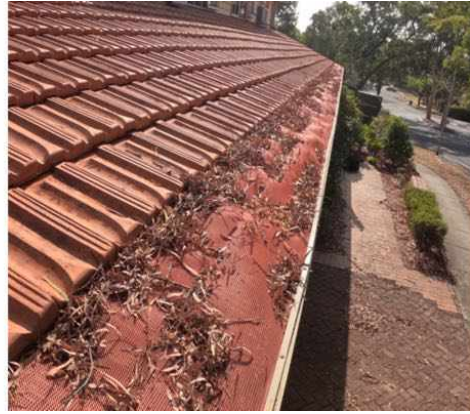
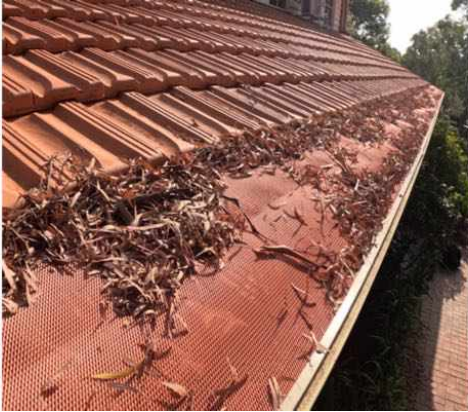
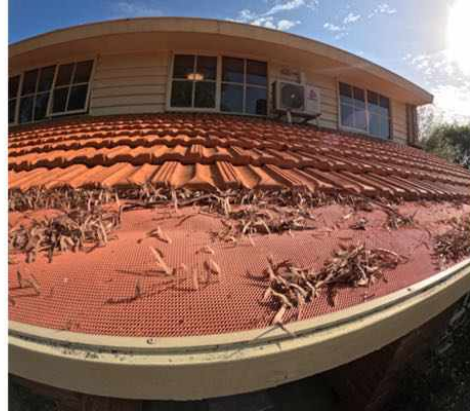
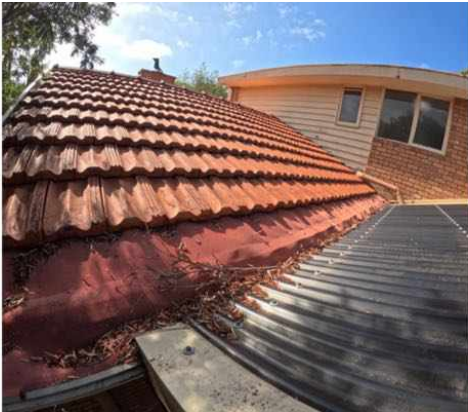
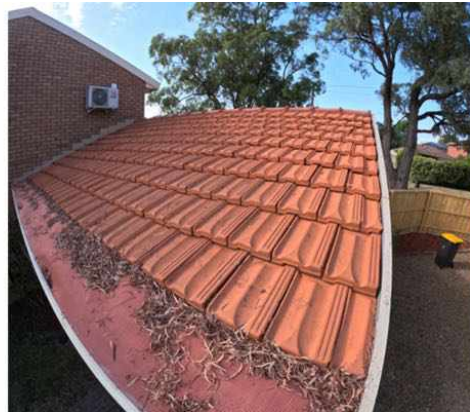
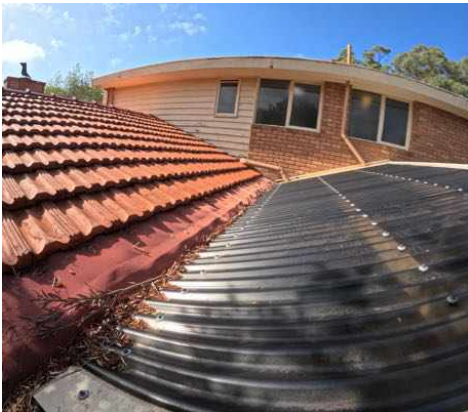
#### Finding 3.01

Building: Main Building  
Location: Roof Exterior  
Finding: Gutter debris accumulation and inadequate drainage  
Information: The gutters exhibit debris accumulation (e.g., leaves, dirt) and green organic growth (algae/moss), indicating water pooling due to inadequate drainage. This poses risks of blockages, overflow during rainfall, and potential damage to fascia boards, walls, or foundations. Prolonged moisture retention may accelerate corrosion and attract pests. Immediate action is advised: clear debris, flush gutters and downpipes, remove organic growth, and inspect gutter slope/downpipe functionality.

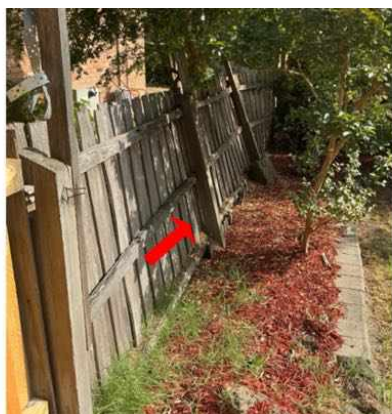
Finding 3.02

Building:	Yard
Location:	Fencing
Finding:	Leaning Fence
Information:	Sections of the fence were observed to be leaning and out of alignment. This may be due to footing movement, poor anchoring, or gradual deterioration over time. Although no immediate structural failure was noted, the leaning condition may worsen and could eventually compromise stability or appearance.

Recommend monitoring the fence over time. If further movement occurs or stability becomes a concern, engage a qualified fencing contractor or builder to assess and undertake appropriate rectification work.

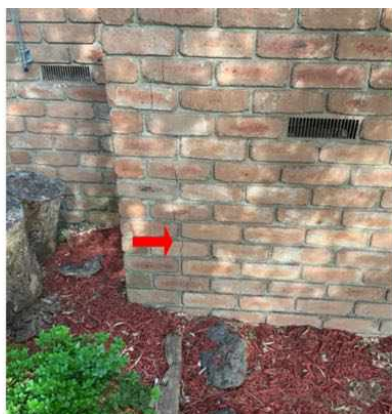
### Finding 3.03

Building:	Main Building
Location:	Walls
Finding:	Brickwork - Cracking noticeable
Information:	Noticeable cracks are a common occurrence in external brickwork and are a likely result of age expected building movement, general expansion, and/or contraction of building materials in different weather conditions. Noticeable cracks in brickwork may develop if left unattended, with potential for necessitating major remedial works or replacement of the brickwork.

It is highly advised that a qualified bricklayer be appointed to provide necessary works to cracked brickwork to prevent any further damage.

Always monitor these cracks and contact a building inspector should cracks widen, lengthen, or become more numerous.

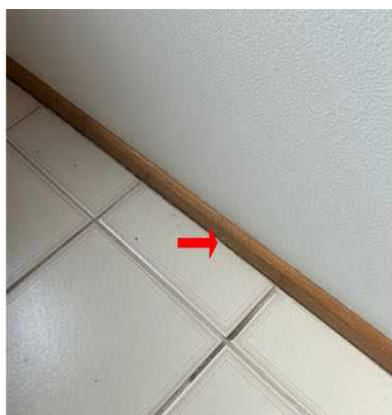
**Finding 3.04**

Building: Main Building  
 Location: Toilet (WC)  
 Finding: Sealant deteriorate  
 Information: The compromised sealant may allow water to penetrate into the substrate beneath the tiles. Over time, this can lead to deterioration of the underlying waterproofing membrane, increasing the risk of moisture ingress and potential structural damage.

A licensed waterproofing contractor should be engaged to remove the degraded sealant and reapply suitable waterproof-grade sealant.

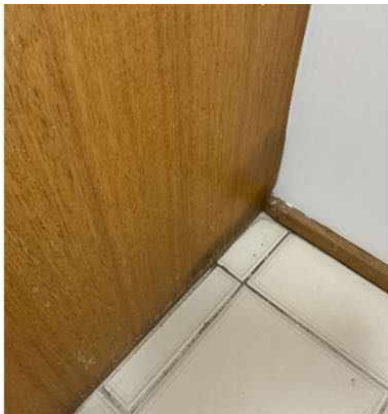
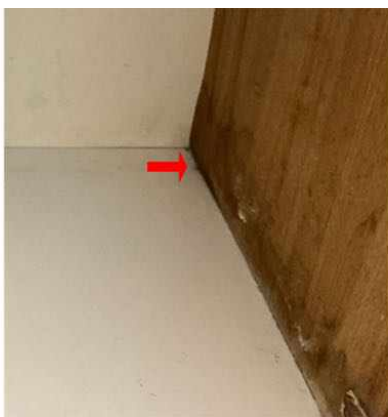
**Finding 3.05**

Building: Main Building  
 Location: Laundry  
 Finding: Timber swelling- minor  
 Information: The swelling observed at the base of the cabinet appears to be caused by moisture exposure, likely due to inadequate sealing or water ingress from nearby wet areas. It may also result from water splashing onto the floor after showering and not being wiped up promptly. Typically, the base of cabinetry should be sealed with a waterproof coating or raised slightly above the floor surface to prevent direct contact with moisture. It is recommended to engage a qualified carpenter to repair or replace

the affected timber and ensure appropriate sealing or clearance is provided to prevent future water-related damage.

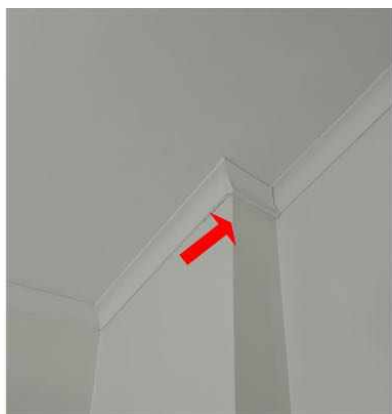
### Finding 3.06

Finding: Plaster cracks

Information: Interior plaster cracks can result from factors such as normal settling, temperature and humidity changes, structural movement, or poor application.

Please continue to monitor these cracks. If they worsen or raise concerns, consider consulting a professional structural engineer to assess potential underlying issues

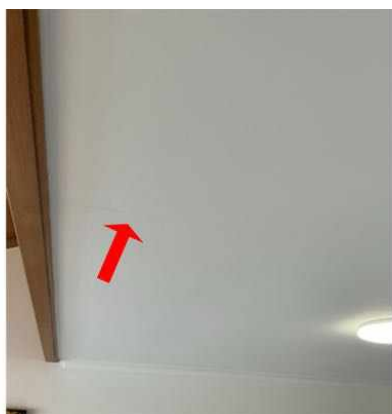
### Finding 3.07

Building:	Main Building
Location:	Living Room
Finding:	Ceiling plaster crack
Information:	Ceiling plaster cracks are a common occurrence in homes. It's important to monitor them over time, as they can affect both the appearance and structural integrity of the property. If the cracks worsen, it's advisable to consult structural engineer. They can assess the situation and recommend appropriate repairs based on the specific conditions of your home.

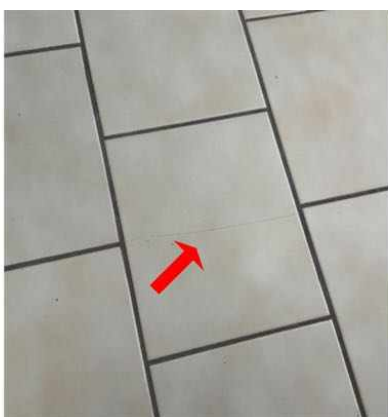
Finding: Tile crack

Information: Cracked tiles were observed in the bathroom floor. This type of cracking is often caused by minor foundation settlement or thermal expansion and contraction of materials. If the appearance is of concern, the client may engage a qualified tiler to replace the affected tiles and restore the surface finish.

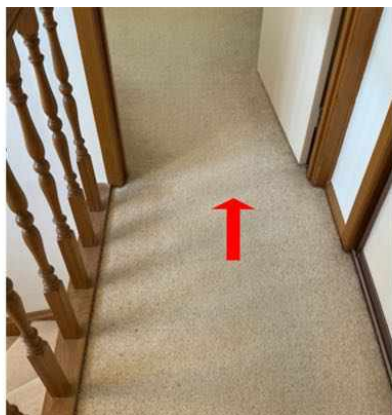
### Finding 3.12

Information: Localised “squeaky/squishy” sound and slight movement is noted when pressure is applied to the floor surface in the affected area. This is typically consistent with minor flooring movement, loose fixings, or subfloor friction/movement.

Ongoing movement may lead to worsening noise, loosening of floor finishes, and potential damage to joints/edges over time.

Engage a licensed carpenter/builder (or flooring contractor) to investigate the flooring fixings and rectify as required (e.g., re-fix, pack/level, add adhesive, or address subfloor movement).

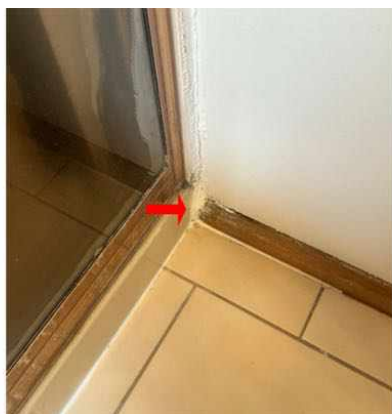
### Finding 3.13

Building: Main Building  
 Location: Ensuite - Master  
 Finding: Wood decay— skirting  
 Information: Rot/decay to the skirting at the outside corner of the shower was observed, with an elevated moisture meter reading (~46.7 in pinless mode) recorded at the affected area (higher than adjacent sections, indicating a localised moisture issue).

Ongoing moisture exposure can cause further timber deterioration and concealed damage to wall lining/framing, and may contribute to mould/odour and finish failure.

Engage a licensed plumber (and builder if required) to investigate the moisture source (e.g., shower waterproofing failure, leaking plumbing, failed silicone/tiles/grout), and carry out invasive investigation if needed; complete rectification and drying before replacing the skirting and repainting.

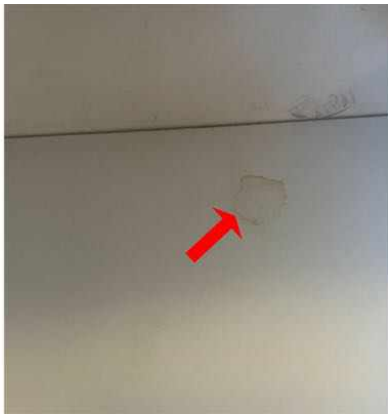
### Finding 3.14

Building: Main Building  
 Location: Ensuite - Master  
 Finding: Water staining  
 Information:

Water staining was evident in this area at the time of inspection. Water staining indicates that surfaces have been exposed to excessive moisture over time. The minerals and other elements in the water lead to staining, which may graduate to corrosion and deterioration if left unmanaged.

While mostly an appearance defect, water staining can be indicative of more serious defects, which may be currently concealed by other building elements.

At time of inspection, water staining is old and inactive, affected building materials may be repaired or replaced at client discretion. A qualified carpenter or registered builder may be appointed to perform these works.

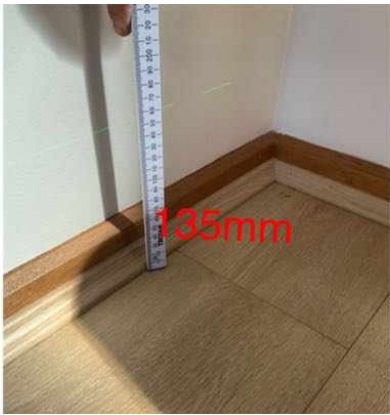
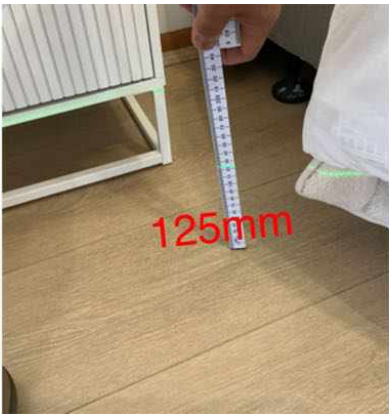
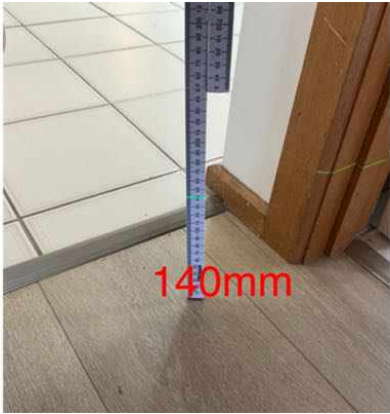
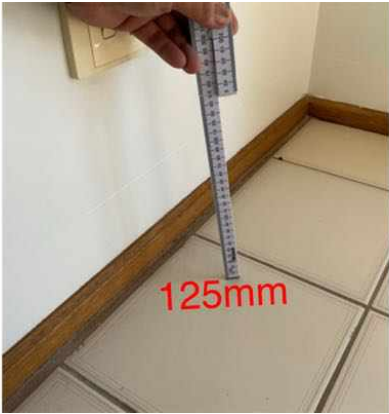
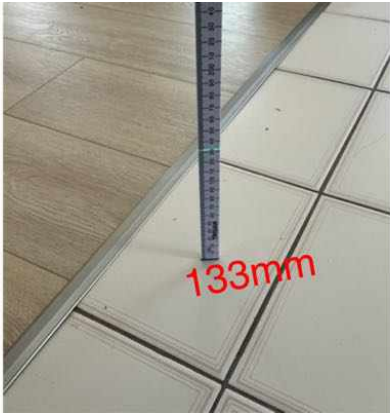
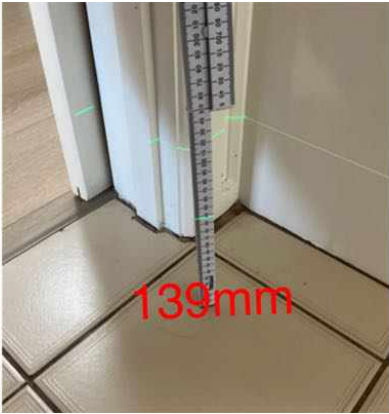
Considering the age of the property and no visible significant cracks were observed at time of inspection. This degree of settlement is generally within an acceptable range for a building of its era. However, for buyers who have higher expectations regarding floor levelness or sensitivity to uneven floors, it should be noted that restumping or re-leveling can involve a considerable cost. This should be taken into account when planning the overall purchase budget.

All laser level readings were taken on surfaces of the same material type to ensure consistency in measurement. For example, if the laser line in the photo shows readings taken off the tile, the laser device itself was also positioned on a tiled surface during testing. This ensures that the recorded floor deviation accurately reflects level variation within that specific flooring material and area.

For further information or investigation, contact a licensed builder for cost estimation and a structural engineer to assess the extent of settlement and the condition of the stumps.

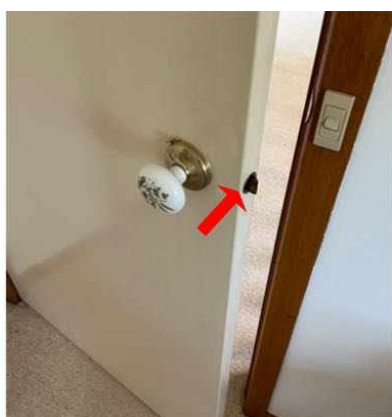
Finding 3.17

Building: Main Building  
 Location: Bedroom - Master  
 Finding: Door handle - Not latching  
 Information: It was noted that the door in this area was not latching during operation at the time of inspection. Whilst detracting from the functionality of this building element, this minor defect may also be a security risk, and may therefore have serious implications if left unattended.

It is suspected that this defect has occurred due to minor issues with the associated hinges. Such damage is identified as general wear and tear, which is expected for building elements of this age.

A qualified carpenter or general handyperson may be appointed to perform rectification works as necessary, at client discretion. If left unattended, further functional impairment is likely to occur.

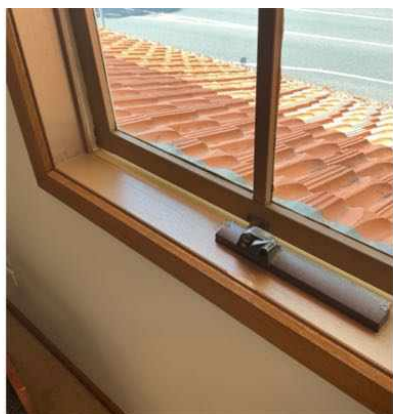
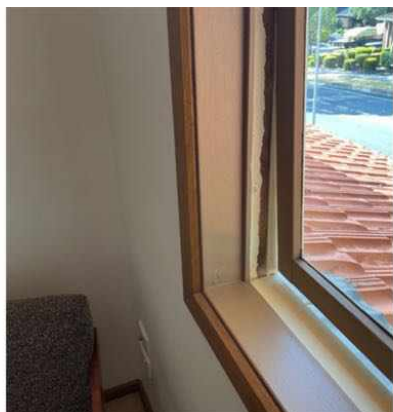
### Finding 3.18

Building: Main Building  
 Location: Bedroom - Master  
 Finding: Window - Stiff to operate  
 Information: The window in this area was jammed and difficult to operate at the time of the inspection. Windows provide ventilation to the adjoining area and should be at a fully operational level to ensure user comfort. Restricted function of the window may also pose as a potential safety hazard if required for emergency egress from the building.

Generally, factors such as general age of the building element and a lack of maintenance are the usual causes for this type of defect.

Replacement of window hardware or frame may be required, as well as minor repairs and cleaning. A registered builder or general handy person will be required to repair the window.

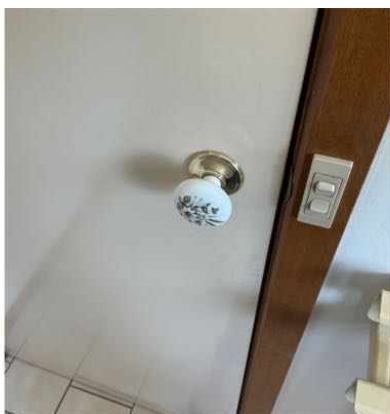
### Finding 3.19

Building:	Main Building
Location:	Ensuite - Master
Finding:	Door handle - Not latching
Information:	It was noted that the door in this area was not latching during operation at the time of inspection. Whilst detracting from the functionality of this building element, this minor defect may also be a security risk, and may therefore have serious implications if left unattended.

It is suspected that this defect has occurred due to minor issues with the associated hinges. Such damage is identified as general wear and tear, which is expected for building elements of this age.

A qualified carpenter or general handyperson may be appointed to perform rectification works as necessary, at client discretion. If left unattended, further functional impairment is likely to occur.

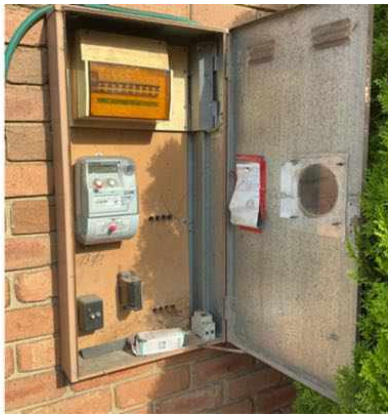
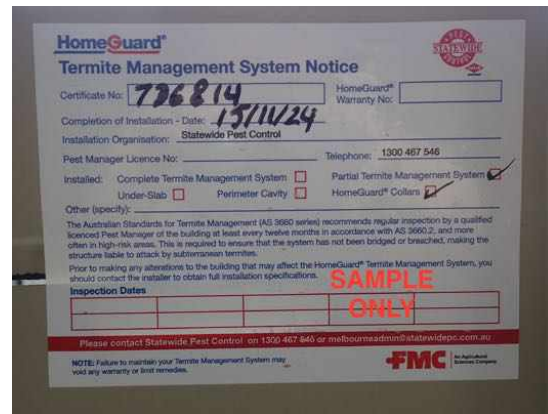
Building: Main Building  
 Location: Electrical switchboard  
 Finding: Termite Management System - no evidence of a chemical installation  
 Information: The application of a post-construction chemical termite barrier is highly recommended for all properties, particularly if live termite activity has been found on the site previously. Such barriers are highly effective in preventing termite attack on any timber building elements throughout the property.

A durable notice should be placed in the switchboard unit to indicate current termite barriers. At the time of inspection, it appeared as though no termite management system has been installed, with no evidence to suggest preventative works taking place.

The client may consider gaining further advice from a pest controller as to the costs and procedures involved with this application. It is recommended that obtaining such advice be a short-term priority.

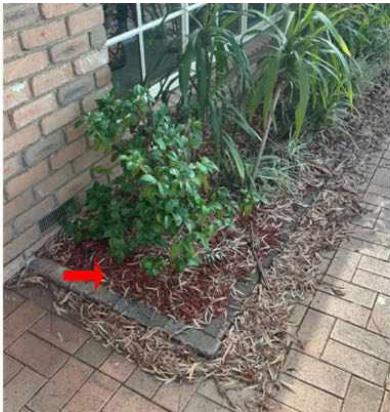
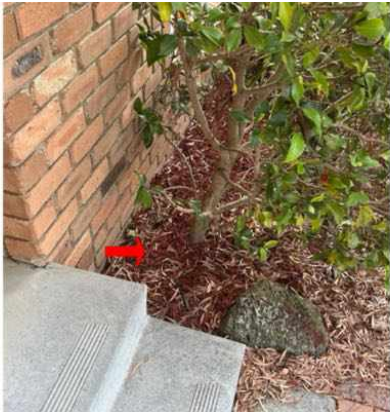
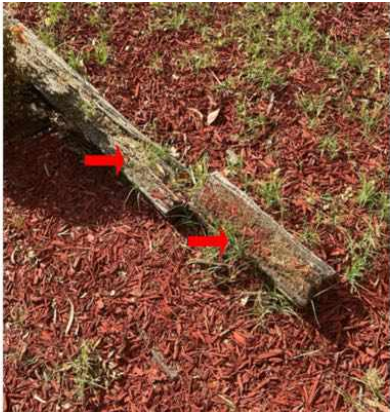
bark mulch) increases the risk of termite activity being present. As they are likely to come into contact with weather conditions or excessive moisture wood rot is likely to develop on timbers that are not treated.

It is highly recommended that any stored timbers be immediately removed from areas in which they may attract any termite / timber pest attack. Minimisation of risk / prevention of termite attack is far more adequate than dealing with the presence of termite activity.

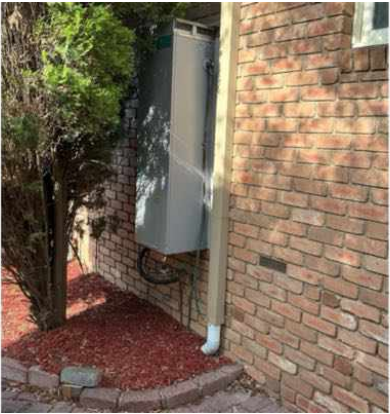
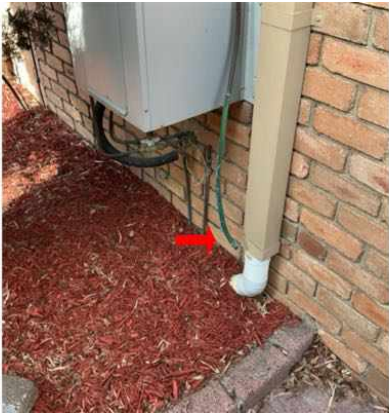
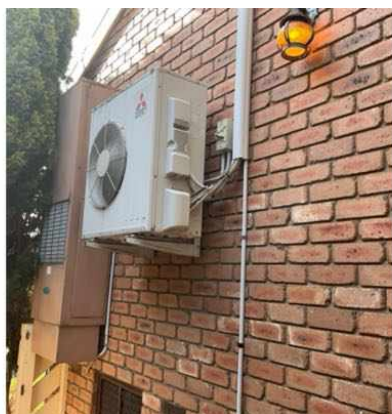
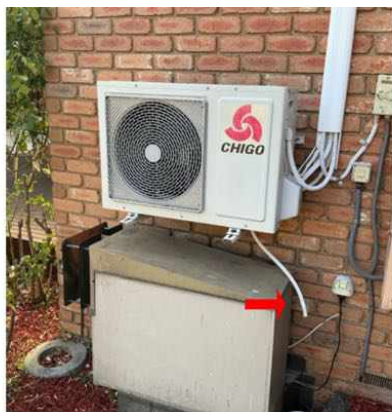
**Finding 6.04**

Building: Main Building  
Location: Hot water/aircon unit(s)  
Finding: The air conditioning overflow pipe is not properly connected and discharges directly into the soil adjacent to the building.  
Information: This creates a conducive condition for termite activity by providing a constant moisture source near the structure. It may also lead to soil erosion, mould growth, or damage to nearby building materials.

The overflow should be redirected to an appropriate discharge point—such as a stormwater connection or designated drainage area—away from the building foundation, in accordance with plumbing and termite management standards.

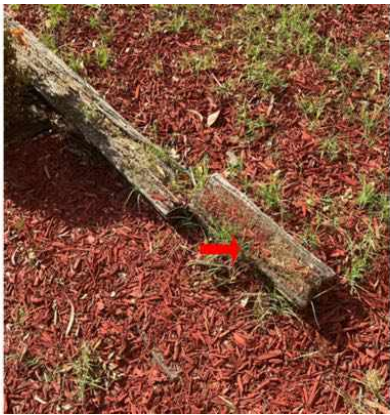
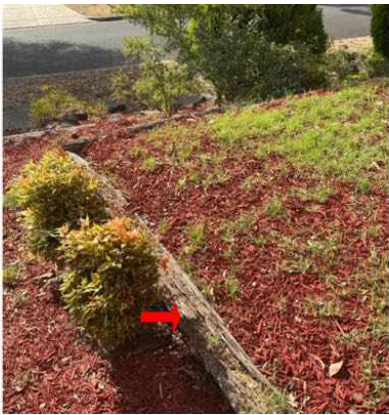
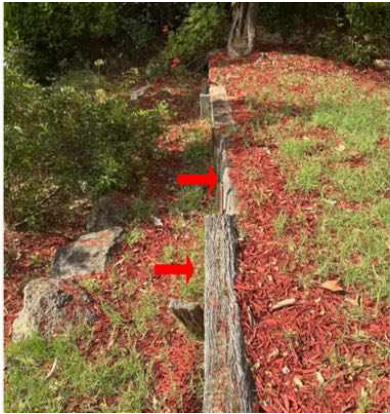
### Finding 6.05

Building:	Yard
Location:	Yard
Finding:	Wood rot-external timbers
Information:	Wood rot which is technically known as Fungal Decay occurs when timbers and other cellulose building materials are exposed to damp conditions on an ongoing basis. This could be the result of exposure to weathering in the long term or the pooling of water or absorbed moisture from other abutting building materials. It is advisable to remove these affected timbers to prevent any chance of attack in the future.

Wood decay is more susceptible to termite attack and these timbers should be replaced to limit termite attack.

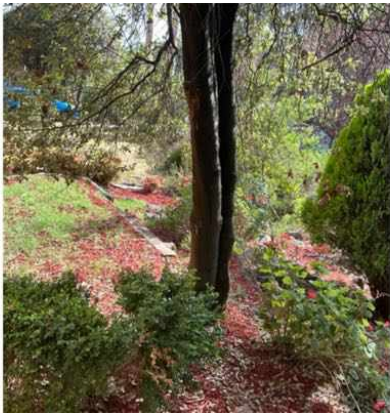
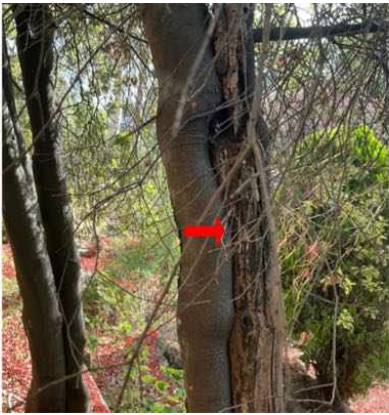
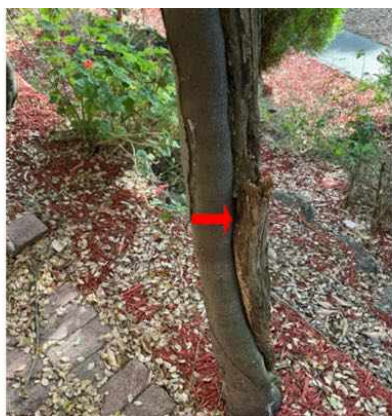
**Finding 6.06**

Building: Yard  
 Location: Yard  
 Finding: Large trees/stumps within 30m of house  
 Information: There are a number of large trees/stumps within 30m of the house which may contain natural termite activity. It is important to monitor these areas to ensure no natural activity is allowed to progress into the main house.

Regular inspections are recommended. Consider test drilling any large trees.

A pest controller can be contacted to carry out such testing at the owners discretion.

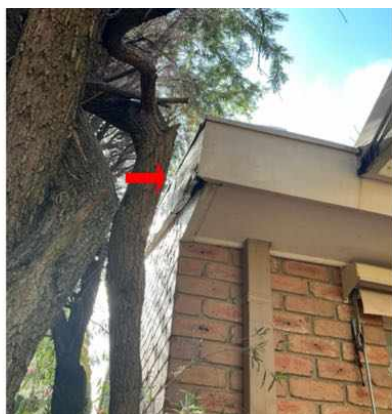
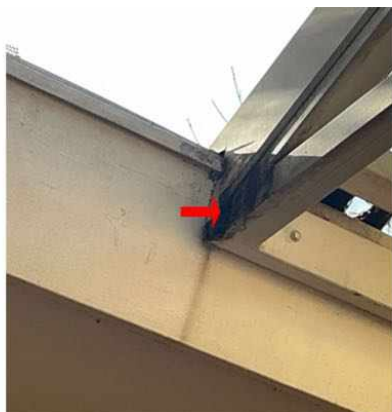
### Finding 7.01

Finding: Fascias - Wood rot

Information: Wood rot was found to be affecting fascias and barges in this area, evidenced by the presence of mould on the surface in some areas. Wood rot, also known as Fungal Decay, occurs when timbers and other cellulose building materials are exposed to damp conditions on an ongoing basis.

It is likely that this wood rot has developed as a result of faults in the roof plumbing, creating excessive moisture in this areas. Frequent exposure to rain and other weather conditions also make fascias and barges susceptible to accelerated deterioration.

It is advised that a roof plumber be appointed to inspect all roof plumbing and subsequently identify the cause of the wood rot. Replacement of affected fascias and barges may then be a necessary step in protecting surrounding building elements from such deterioration.

A qualified plumber may be appointed to assess the cause of excessive moisture and to provide advice on any remedial works as required. A qualified carpenter or registered builder may also be required to replace affected building materials.

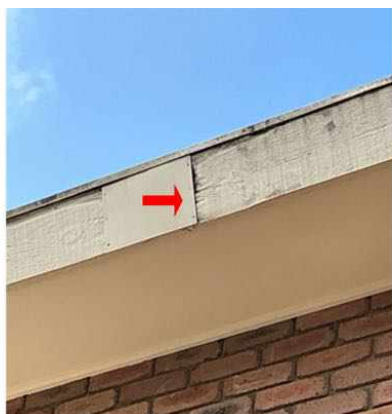
### Finding 7.02

Building:	Main Building
Location:	Roof Exterior
Finding:	Fascias - Wood rot
Information:	Wood rot was found to be affecting fascias and barges in this area, evidenced by the presence of mould on the surface in some areas. Wood rot, also known as Fungal Decay, occurs when timbers and other cellulose building materials are exposed to damp conditions on an ongoing basis.

It is likely that this wood rot has developed as a result of faults in the roof plumbing, creating excessive moisture in this areas. Frequent exposure to rain and other weather conditions also make fascias and barges susceptible to accelerated deterioration.

It is advised that a roof plumber be appointed to inspect all roof plumbing and subsequently identify the cause of the wood rot. Replacement of affected fascias and barges may then be a necessary step in protecting surrounding building elements from such deterioration.

A qualified plumber may be appointed to assess the cause of excessive moisture and

to provide advice on any remedial works as required. A qualified carpenter or registered builder may also be required to replace affected building materials.

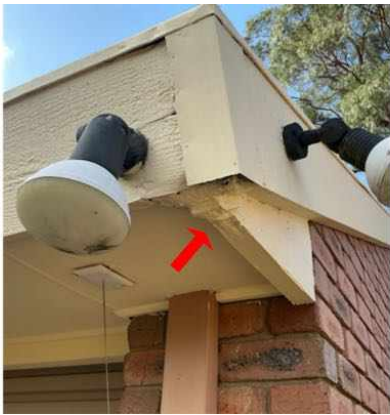
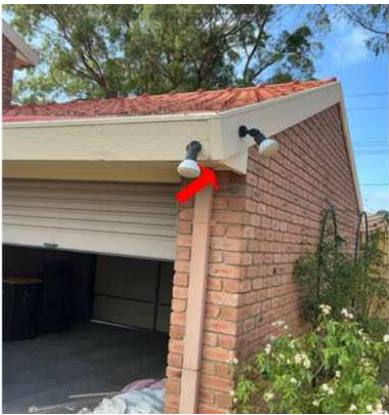
### Finding 7.03

Finding: Fascias - Wood rot

Information: Wood rot was found to be affecting fascias and barges in this area, evidenced by the presence of mould on the surface in some areas. Wood rot, also known as Fungal Decay, occurs when timbers and other cellulose building materials are exposed to damp conditions on an ongoing basis.

It is likely that this wood rot has developed as a result of faults in the roof plumbing, creating excessive moisture in this areas. Frequent exposure to rain and other weather conditions also make fascias and barges susceptible to accelerated deterioration.

It is advised that a roof plumber be appointed to inspect all roof plumbing and subsequently identify the cause of the wood rot. Replacement of affected fascias and barges may then be a necessary step in protecting surrounding building elements from such deterioration.

A qualified plumber may be appointed to assess the cause of excessive moisture and to provide advice on any remedial works as required. A qualified carpenter or registered builder may also be required to replace affected building materials.
