Building and Timber Pest Inspection Report

Inspection Date: Fri, 13 Feb 2026

Property Address: 9/93 Duncan St, Maroubra NSW 2035,
Australia

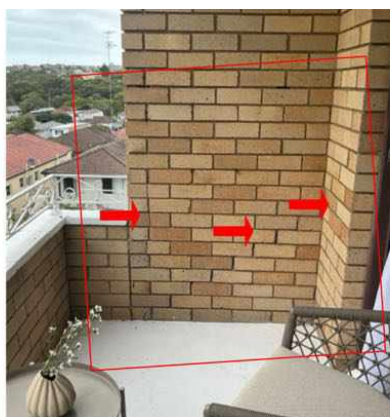
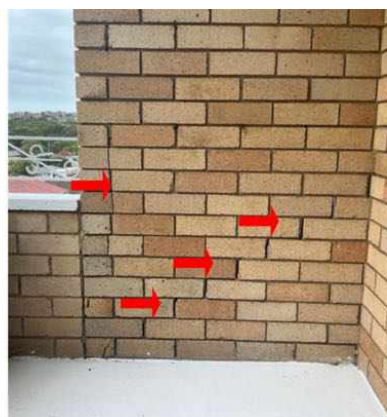
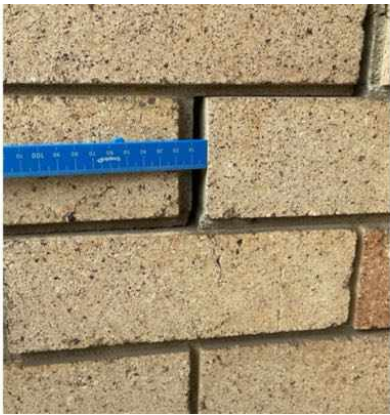
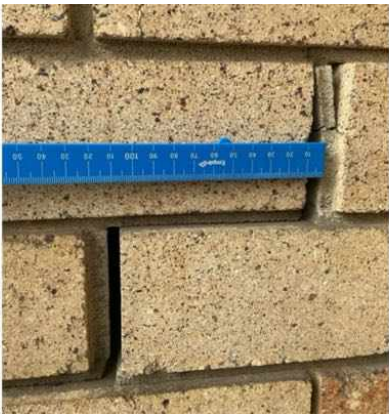
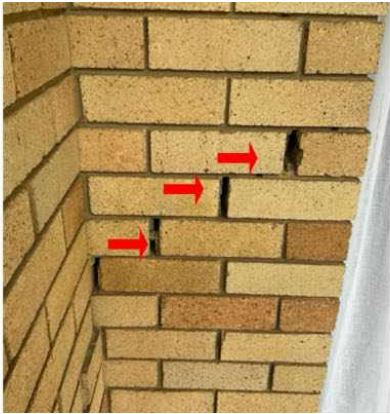
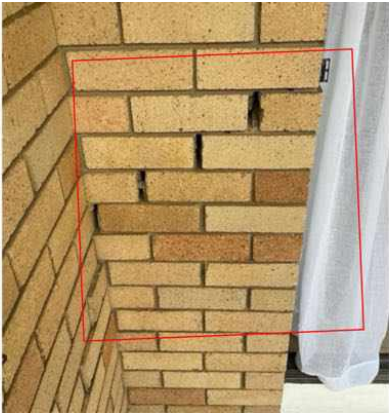
Building: Main Building
Location: Balcony
Finding: Brickwork - Step cracking (Further investigation by a Structural Engineer Required) - Also refer to 3.1
Information: Step cracking was identified to the brickwork in this area at the time of inspection. Step cracking, which is similar to other forms of cracking, has a variety of possible causes. However, the most common is the subsidence of adjacent footings.

Step cracking is a relatively common defect, and is most likely to occur adjacent to windows, doors and other openings. Mortar failure in the gaps between affected bricks indicates the stresses and tensions affecting the wall.

Where step cracking is extensive or severe, the client is advised to consult a structural engineer. Minor step cracking can be used as a warning sign to address factors causing stress to the wall, which can include the effect of surrounding trees, water leaks, soil erosion, or even the presence of reactive soils in the surrounding area.

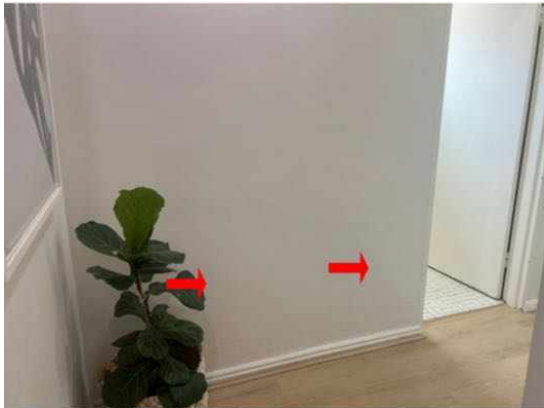
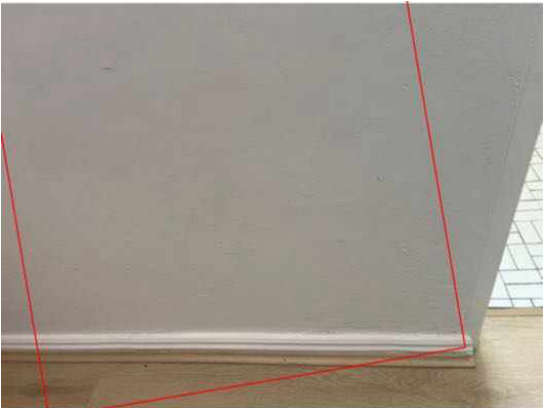
Finding 3.02

Building: Main Building
Location: Laundry , Kitchen
Finding: Elevated Moisture – Further Investigation Recommended
Information: Elevated moisture readings were detected in several locations, with some areas also showing signs of dampness or past repairs while others did not present visible surface issues, although no significant structural damage was evident at the time of inspection, dampness can contribute to deterioration if left unaddressed. A further investigation by a licensed plumber or waterproofing specialist is recommended to confirm the source and ensure no concealed issues are developing.

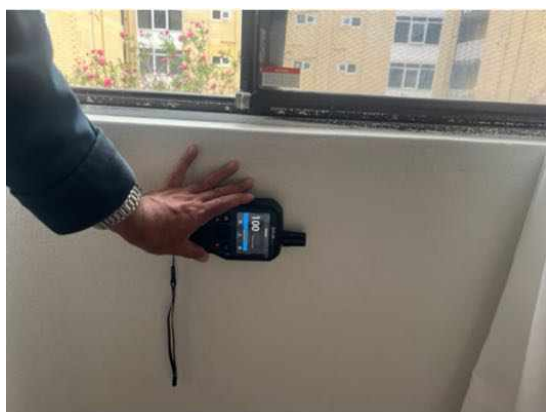
| Finding: | Elevated Moisture Detected - Strata |
| Information: | Elevated moisture levels were detected on external walls in rear bedroom and lounge. The areas should be monitored for and changes to existing conditions e.g damp , paint bubbling of staining. Further invasive investigation by a licensed plumber or waterproofing specialist is recommended to confirm the source and extent of water ingress. As this relates to a multi-residential building, the source of water ingress may |

involve common property, a suitably qualified waterproofing contractor is recommended to determine cause, responsibility, and scope if required.

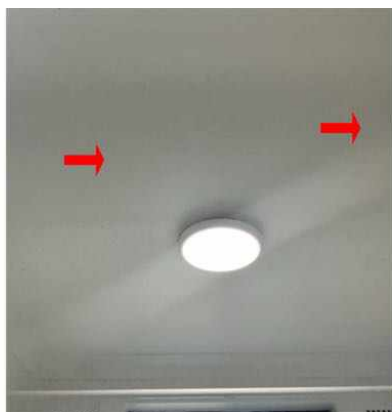
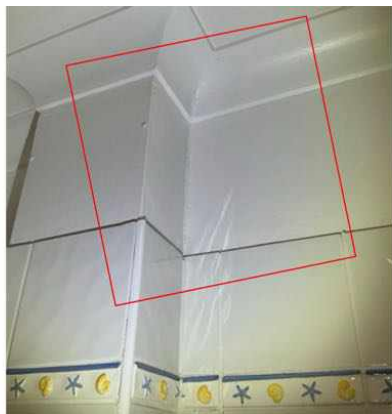
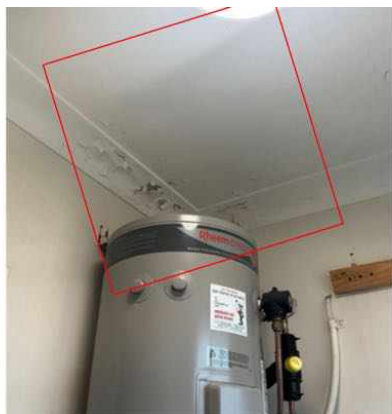
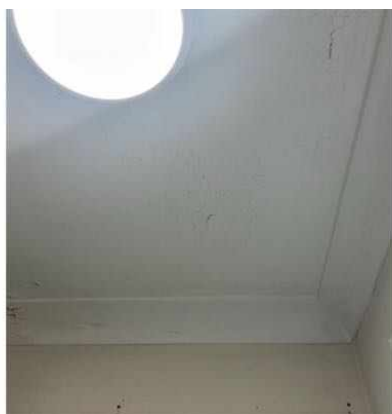
| Information: | Sections of paint in this area was found to have bubbled and deteriorated. Paint bubbling is generally an indication of excessive moisture in the area, that is currently hidden by the painted surface. |

The presence of excessive moisture can have major implications on associated building elements if left unattended. While only seemingly minor at this stage, the damage cannot be determined due to the paint obstructing any further inspection of the damage.

It is highly advised that the affected paint be cleaned to allow a further, more invasive inspection by a licensed plumber. Failure to act on this defect may necessitate major works in the future.

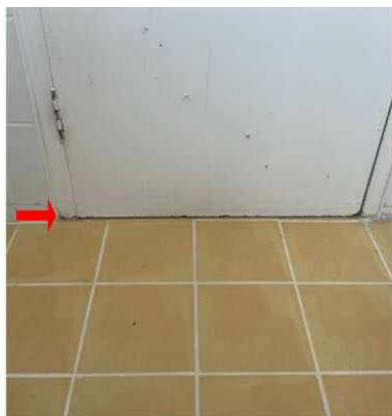
Finding 3.07

| Finding: | Wet-Area Door Jambs – Moisture Staining / Decay |
| Information: | moisture staining and deterioration were observed at the base of the wet-area door jamb. This is commonly due to water splashing or moisture tracking from the bathroom floor into adjacent joinery or inadequate waterproof transition at the bathroom threshold. |

Further inspection by a licensed waterproofing contractor is recommended to verify exact cause and remedial measures

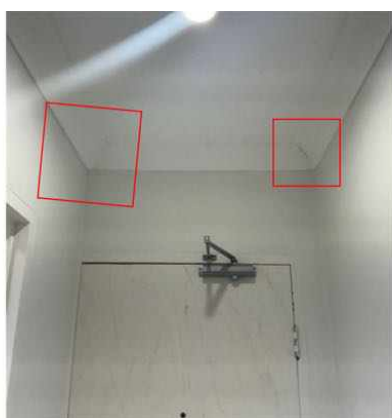
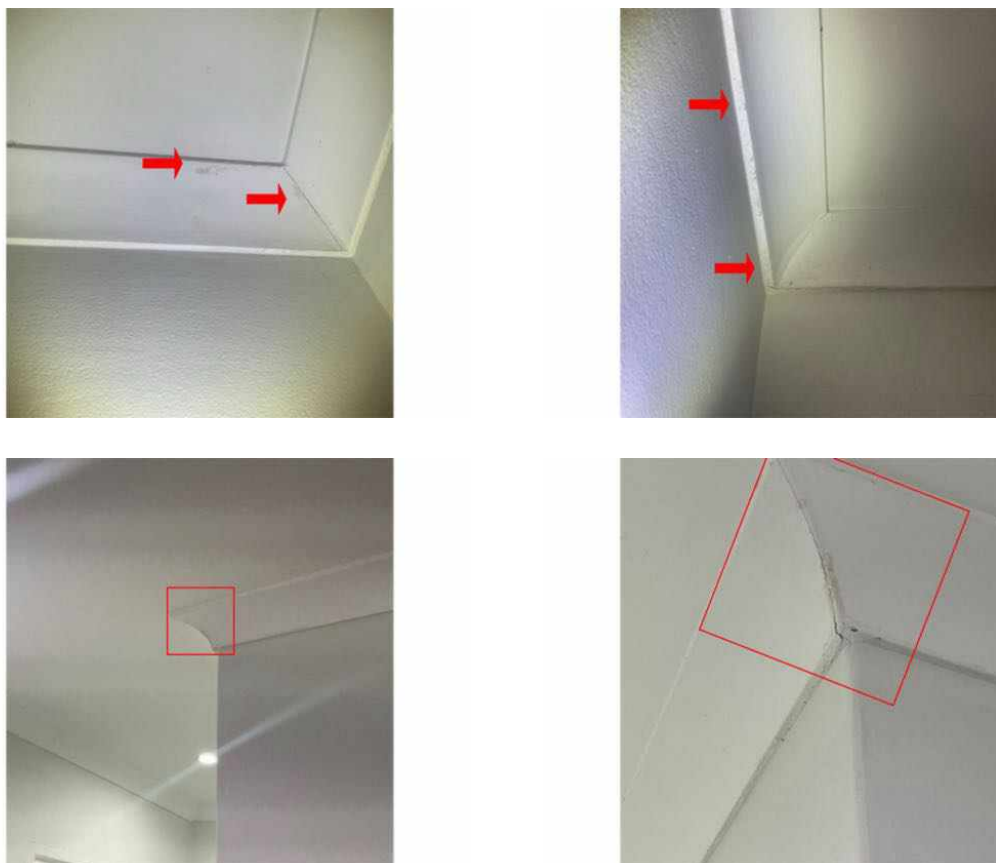
Finding 3.08

| Finding: | Water staining |
| Information: | Water staining was evident in this area at the time of inspection. Water staining indicates that surfaces have been exposed to excessive moisture over time. The minerals and other elements in the water lead to staining, which may graduate to corrosion and deterioration if left unmanaged. |

While mostly an appearance defect, water staining can be indicative of more serious defects, which may be currently concealed by other building elements.

Where water staining is active, a licensed plumber must be consulted to identify the cause of the staining and to provide advice on any reparation works that may be required. Replacement of any broken or damaged structures is advised.

Conversely, where water staining is old and inactive, affected building materials may be repaired or replaced at client discretion. A qualified carpenter or registered builder may be appointed to perform these works.

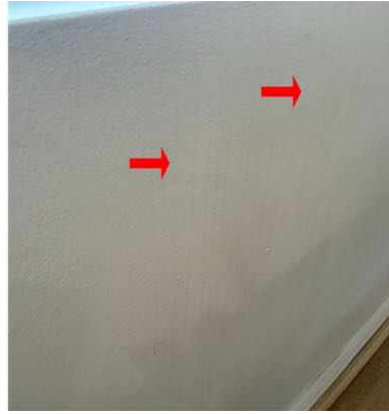
Finding 3.09

Building: Main Building
 Location: Lounge Room
 Finding: Walls - Water stained
 Information:

Water staining to sections of the walls in this area was evident at the time of inspection. Water staining indicates that surfaces have been exposed to excessive moisture over time. The minerals and other elements in the water lead to staining, which may graduate to corrosion and deterioration if left unmanaged. Given the proximity to the window, the condition may be associated with past water ingress, condensation, or inadequate sealing to external elements.

While mostly an appearance defect, water staining can be indicative of more serious defects, which may be currently concealed by wall linings.

Where water staining is active, a licensed plumber must be consulted to identify the cause of the staining and to provide advice on any repair work that may be required. Replacement of any broken or damaged structures is advised.

Conversely, where water staining is old and inactive, affected building materials may be repaired or replaced at client discretion.

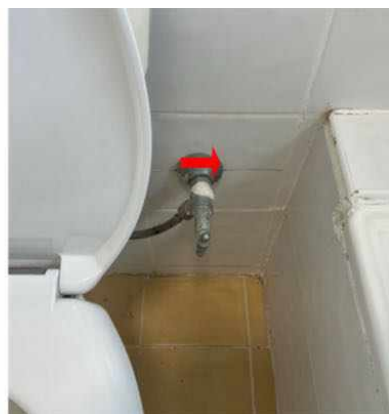
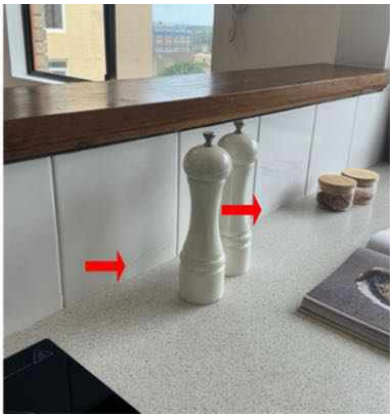
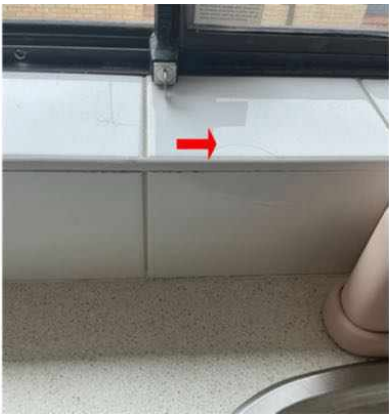
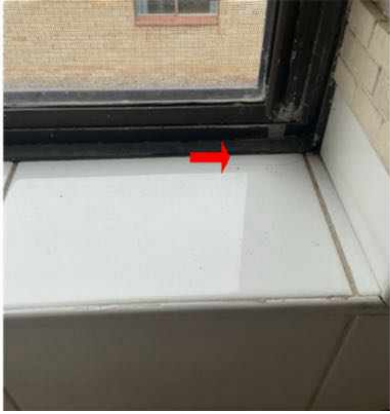
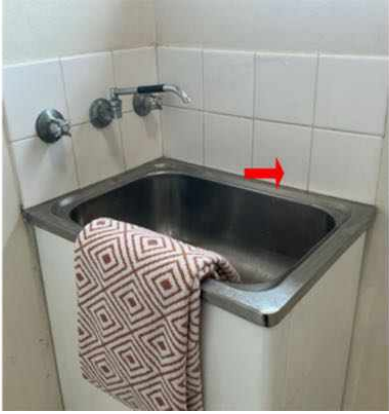
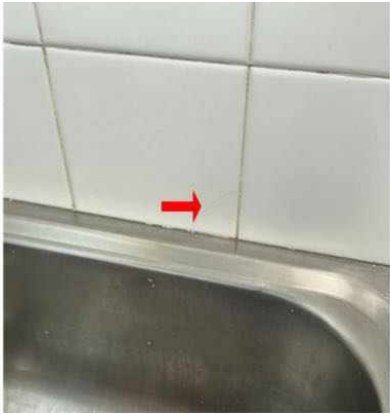
Finding 3.10

Finding: Tiles - Cracked or damaged to some areas

Information: Cracking was evident to the tiling in this area at the time of inspection. While the cracking appears to be minor, this area is frequently exposed to water, allowing potential for water penetration into adjoining sections of walls or flooring.

If left unmanaged, water penetration to these areas may lead to subsequent water damage, which is likely necessitate repair work to affected building elements.

A tiling contractor should be appointed to ensure that no further water damage occurs. The re-application of silicone and grouting throughout remaining tile work is also advised, to further protect the area against water penetration.

Where water penetration has led to water damage, appointment of a relevant tradesperson may be required to repair damaged building elements.

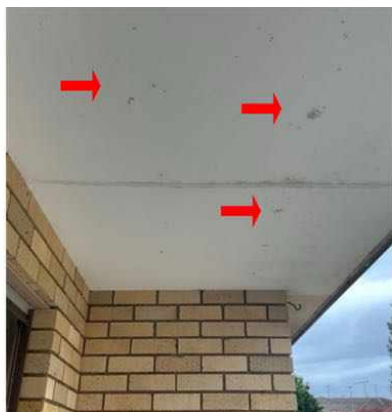
Finding 3.11

Building: Main Building
Location: Balcony
Finding: Water staining
Information:

Water staining was evident in this area at the time of inspection. Water staining indicates that surfaces have been exposed to excessive moisture over time. The minerals and other elements in the water lead to staining, which may graduate to corrosion and deterioration if left unmanaged.

While mostly an appearance defect, water staining can be indicative of more serious defects, which may be currently concealed by other building elements.

Where water staining is active, a licensed plumber must be consulted to identify the cause of the staining and to provide advice on any reparation works that may be required. Replacement of any broken or damaged structures is advised.

Conversely, where water staining is old and inactive, affected building materials may be repaired or replaced at client discretion. A qualified carpenter or registered builder may be appointed to perform these works.

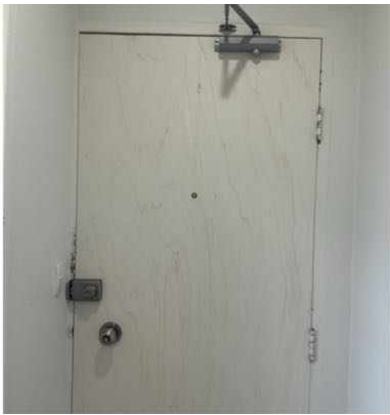
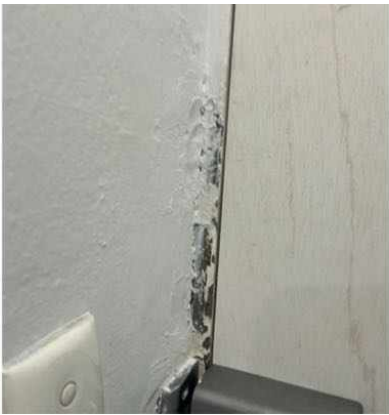
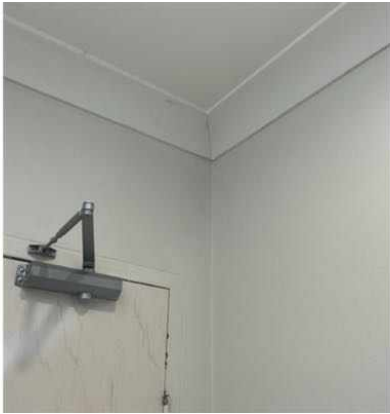
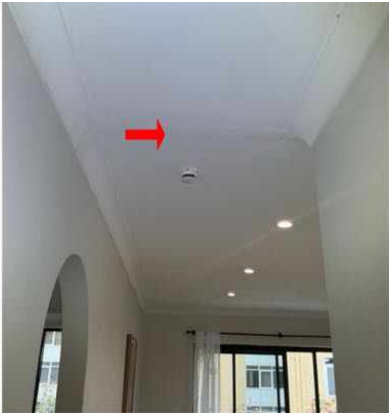
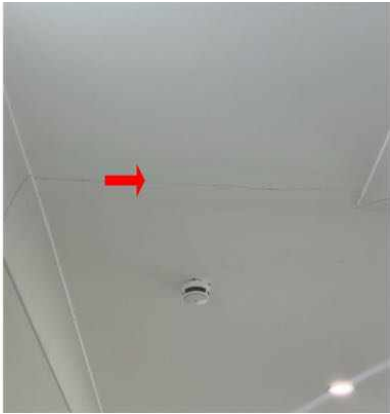
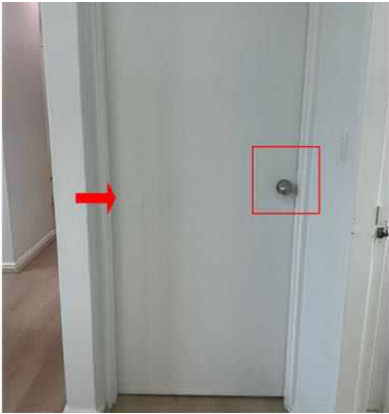
Finding 3.12

| Finding: | Paint finish and hairline cracking |
| Information: | The paint finish in this area was identified as being incomplete at the time of inspection including some hairline minor cracking. |

Whilst incomplete or missing paint finish is generally an appearance defect, it can also lead to the development of secondary building defects over time. Incomplete areas of paint finish expose the area to moisture, potentially accelerating the deterioration of underlying building materials.

Incomplete paint finishes should be sanded back, filled, leveled and painted, as applicable. Where inadequate or missing paint protection has led to the deterioration of the associated building element, repair and/or replacement of this building element may be required.

A painting contractor should be appointed as soon as possible to perform necessary works to aid the appearance of the affected area and to ensure the area is protected against further deterioration. Alternatively, the homeowner following manufacturer instructions may perform these works.

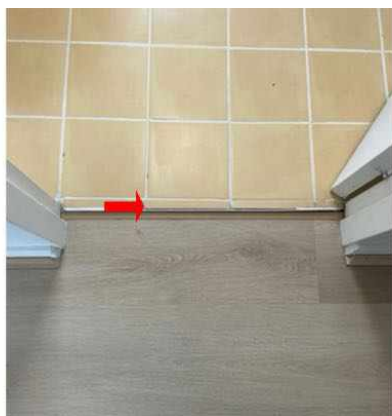
Finding 3.13

Building: Main Building
Location: All Internal Areas
Finding: Sealant and grouting - Missing or degraded
Information: It was noted on inspection that sealant or grout is degraded. There is also evidence of poor workmanship and excessive use of sealant. Silicone should never be used as a first line of defence against waterproofing. Further inspection by a licensed waterproofing contractor is highly recommended.

Different materials and floor areas move at different rates, generally causing cracking to grout or sealant at this point. A flexible sealant is required to allow for expected expansion and contraction, while keeping the joint water tight and protective of all associated building materials.

There appears to be excessive mould to the sealant and grout which will likely require scraping out and replacement.

Flexible and mould resistant materials should be applied to affected areas to prevent any subsequent water damage that is likely to occur. Regular maintenance and replacement of damage or missing or damaged sealant and grout is highly recommended to the wet areas, as this is a regular wear and tear defect. Sealant and grouting in areas that come into regular contact with water should be maintained for the long term care of your property.

A sealant specialist or tiling contractor should be appointed to complete these works as soon as possible.

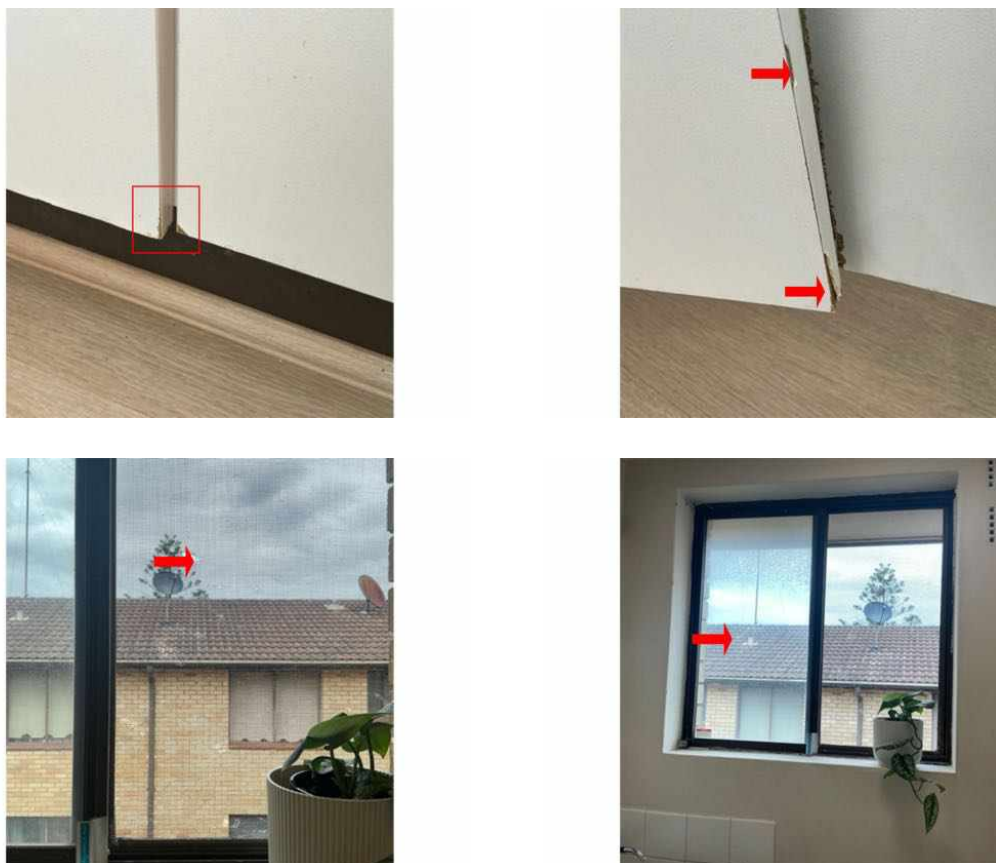
Finding 3.14

Building: Main Building
Location: All Internal Areas
Finding: Building element - Damaged , Trim missing , skirting damaged and loose , kitchen cabinet chipped , flyscreen damaged laundry and balcony
Information: Breakage occurs generally when the building materials have either aged and decayed, or as a result of damage (accidental or deliberate).

Repair and/or replacement of broken elements is advised to ensure that additional secondary defects do not arise as a consequence. Such works are necessary, as all building elements play a key role in the operation and function of the overall structure and its performance.

A relevant tradesperson should be appointed to repair or replace the affected building element prior to any subsequent damage being caused.

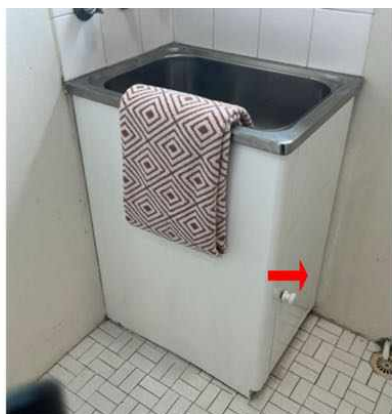
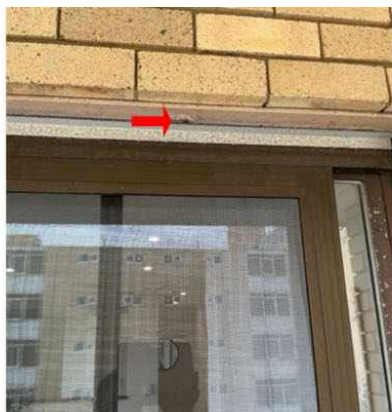
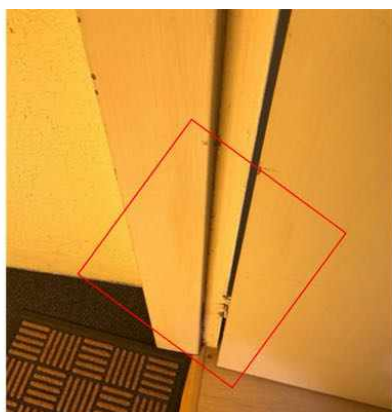
Finding 3.15

| Finding: | Building element - Rusted or corroded |
| Information: | This building element shows evidence of rusting and corrosion, which is likely to have developed as a result of excessive exposure to moisture and or inadequate coatings. |

As surface rust provides no protection to the underlying iron, the deteriorating condition is likely to worsen if not addressed in the short-term future.

Where possible, the use of galvanized (treated) metals or aluminium coated metals aid in rust prevention, as does regular general maintenance. Rust formation can be controlled with coatings, such as paint, that isolate the iron from the environment.

Rusting and corrosion should be managed by ideally removing or limiting the affected surface from exposure to moisture. A registered builder may be appointed to replace any building elements that have been severely affected by rust or water damage.

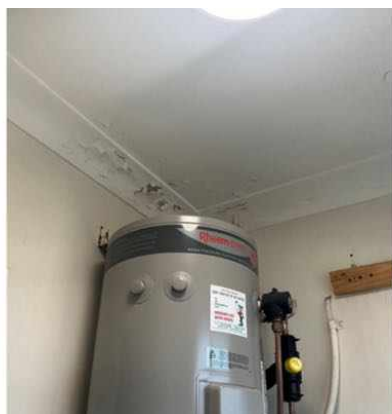
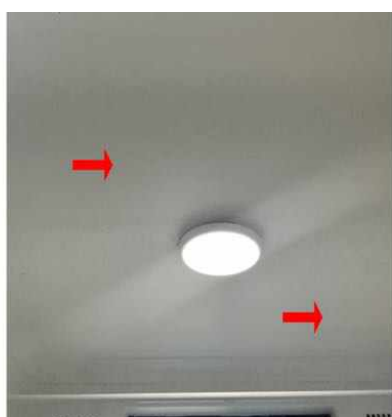
Finding 3.16

| Finding: | Building element - Missing - No ventilation fans |

Replacement of any missing building element should be conducted as soon as possible to ensure that no damage or functional issues occur to associated building materials.

The appropriate tradesperson should be appointed as soon as possible to replace the missing building element.

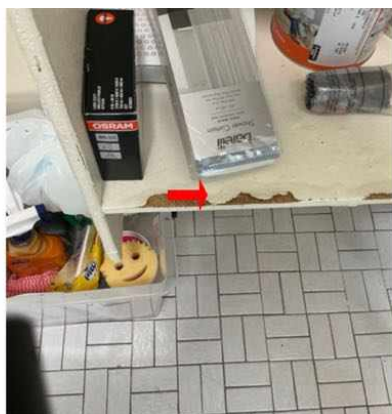
| Finding: | Building element - Damaged - Cabinet moisture damaged |
| Information: | Breakage occurs generally when the building materials have either aged and decayed, or as a result of damage (accidental or deliberate). |

Repair and/or replacement of broken elements is advised to ensure that additional secondary defects do not arise as a consequence. Such works are necessary, as all building elements play a key role in the operation and function of the overall structure and its performance.

A relevant tradesperson should be appointed to repair or replace the affected building element prior to any subsequent damage being caused.

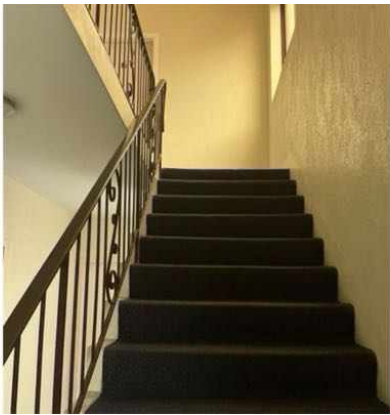
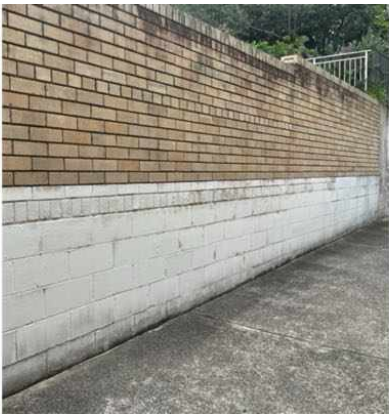
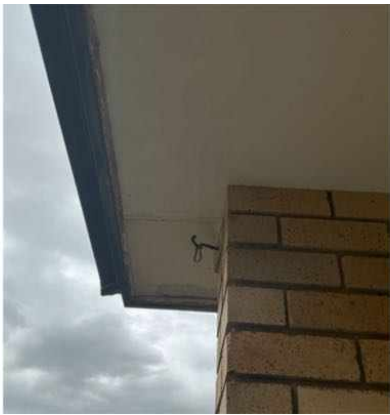
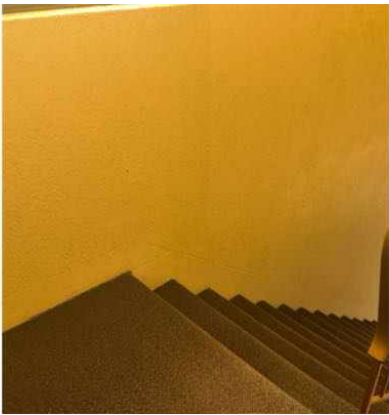
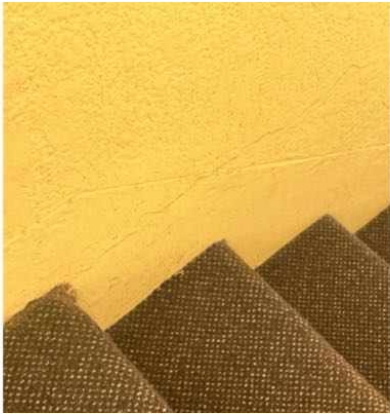
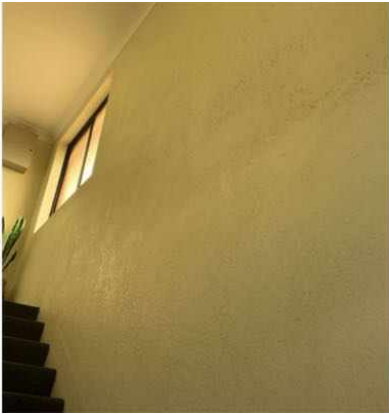
Noted Item

Building: Main Building
Location: All External Areas
Finding: Additional Photos - Obstructions and Limitations
Information: These photographs are an indication of the obstructions and limitations which impeded full inspection of the property at the time of inspection. These obstructions can hide an array of defects and should be removed to allow full inspection to be carried out. A re-inspection is recommended once the areas are made accessible.
