Building Inspection Report

Inspection Date: Thu, 18 Dec 2025

Property Address: 411/240 Barkly St, Footscray VIC 3011,
Australia

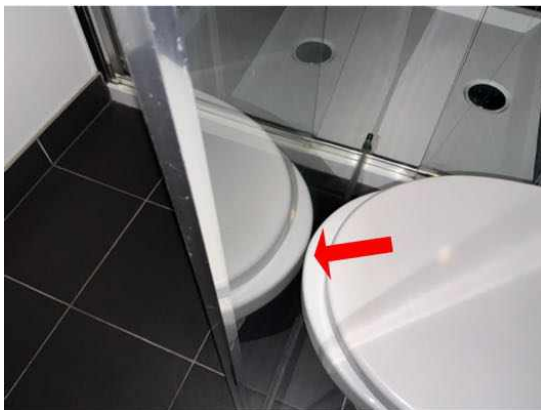
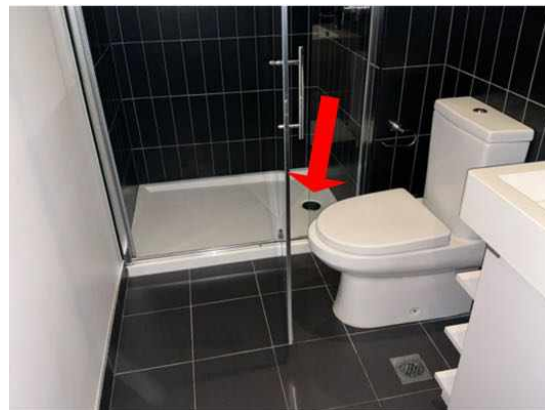
Defects 1.01

Building: Main Building
 Location: Bathroom
 Finding: Shower screen glass door hitting WC
 Information: It was noted at the time of the inspection that the glass door to the shower screen was hitting the ceramic toilet bowl when opened.

Without any restraint or doorstop of any kind, heavy handed use could cause the glass door to shatter against the toilet bowl or damage the toilet bowl.

A General handyman should be engaged to review immediately

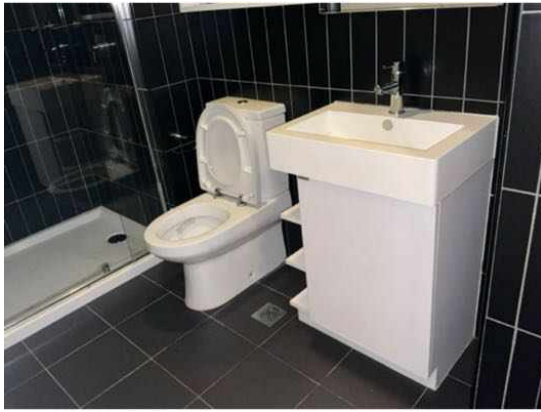
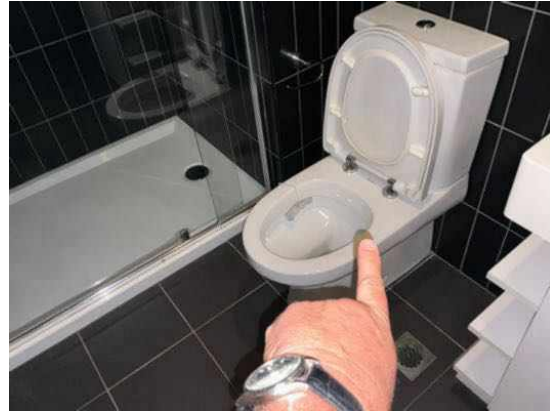
Defects 1.02

Building: Main Building
 Location: Bathroom
 Finding: Toilet seat loose
 Information: It was observed that the toilet seat was loose and unstable.

Loose seats can cause fall injury to persons while in use and lead to serious injury

A licensed sanitary plumber should be engaged to review prior to use

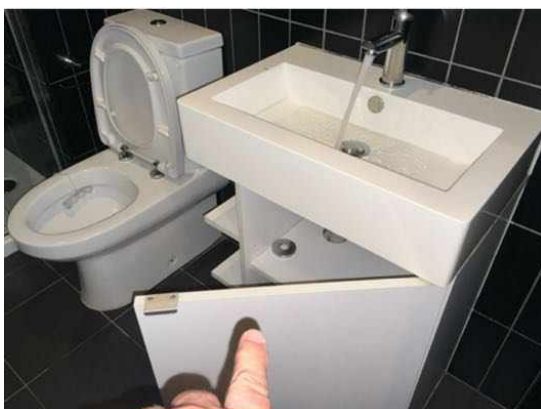
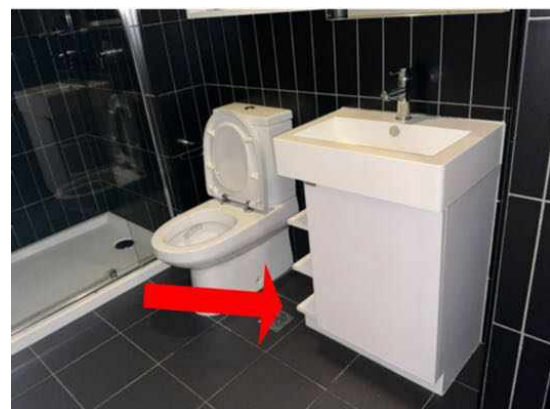
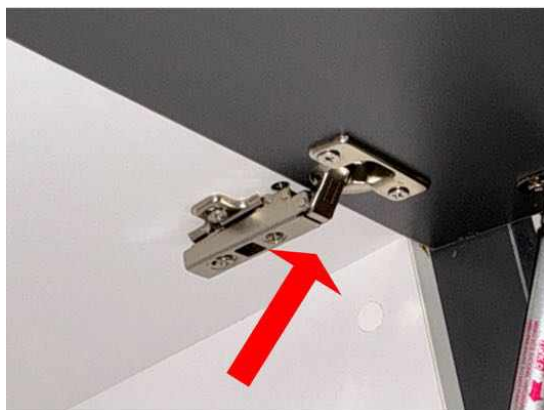
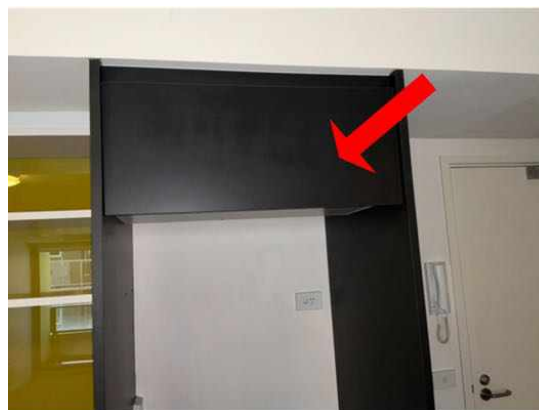
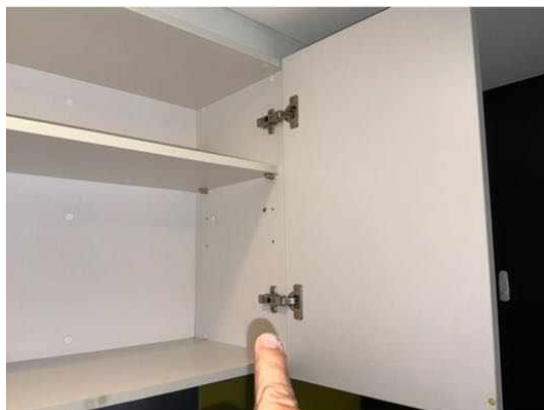
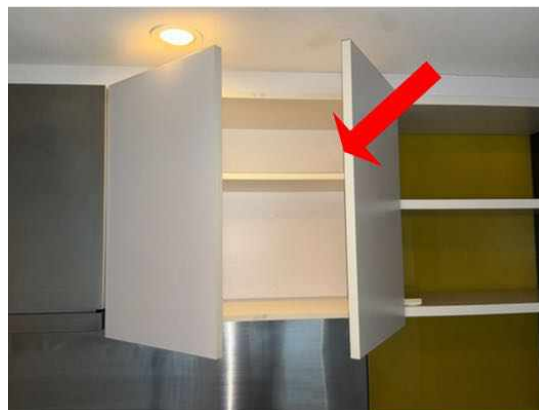
Defects 3.01

Building: Main Building
Location: Bathroom
Finding: Cabinet doors adjustment
Information: It was observed that many cabinet doors to the kitchen require adjustment of the hinges.

Unattended to the doors will continue to jam and operate ineffectively, which in time could cause further damage to the doors

A qualified carpenter should be engaged to review at the owners discretion

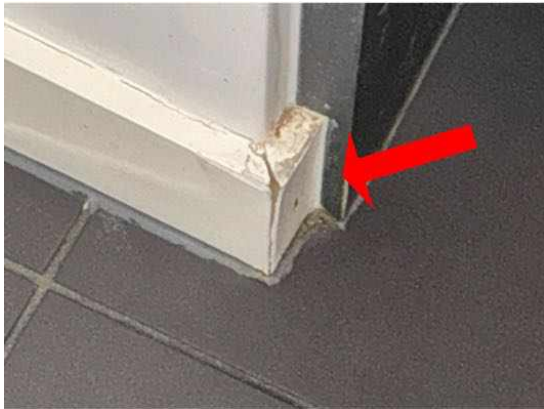
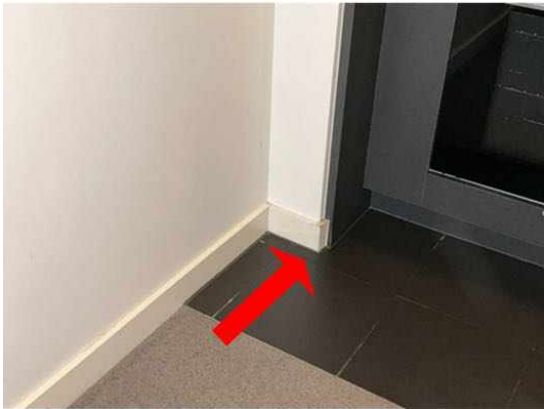
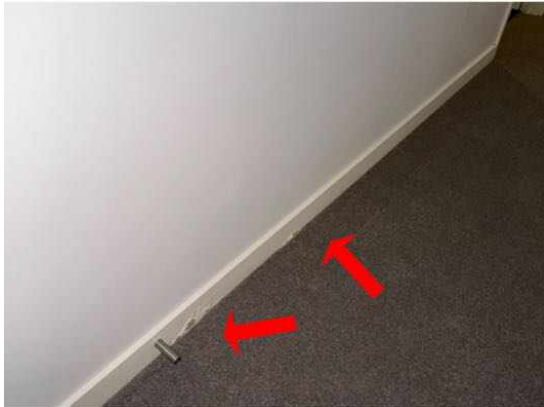
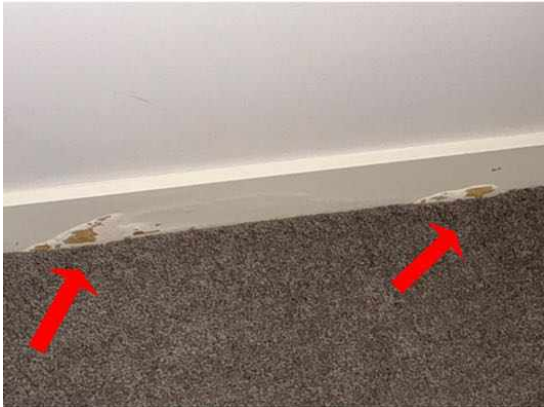
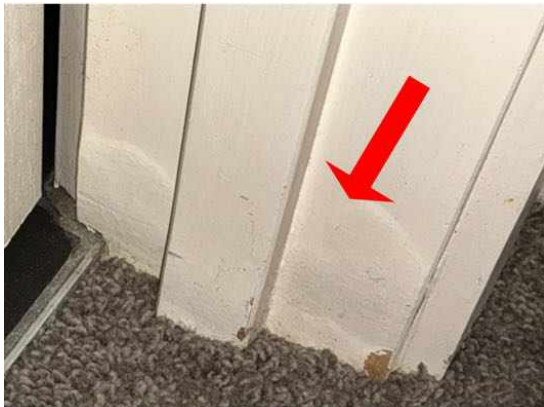
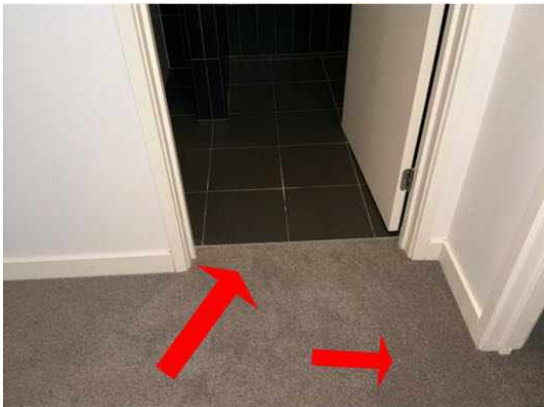
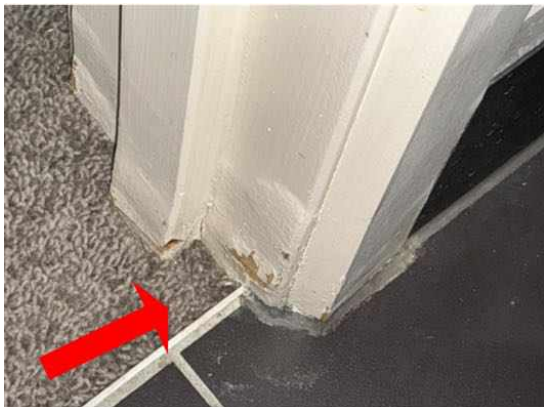
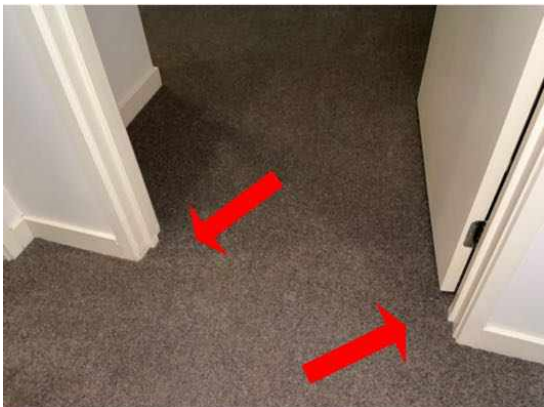
Defects 3.02

Building:	Main Building
Location:	All Internal Areas
Finding:	Water leak - Inactive
Information:	Water leaks generally occur when a particular area of the property is not weather- or water-tight. While the damage in this area appears to be from an old inactive water leak, the area should be monitored frequently for the recurrence of any dampness.

It was noted that customer would build elements have swollen and become water damaged

Repair and / or replacement of previously affected building elements is at client discretion. Consider a further invasive inspection: removal of obstructions around the damaged area may reveal further damage which has been concealed. A more significant or major defect may be identified at this time.

Where recurrence of an active water leak is identified, a qualified plumber should be appointed immediately to rectify the leak and advise on any further preventative works as necessary.

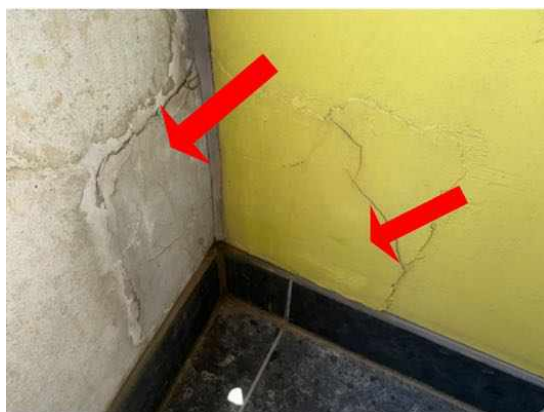
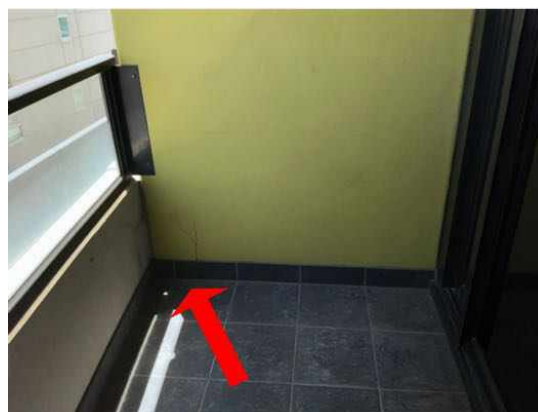
Defects 3.03

Building:	Main Building
Location:	Balcony
Finding:	Minor cracking to concrete panel
Information:	It was observed that there was minor cracking occurring to the concrete panel grouting. The area which the cracking is occurring appears to be a grouted connection bracket used to connect the concrete structural panels together. This is a minor defect and can be easily repaired by application of some structural grout and painting repair by a general handyman of the owners discretion.

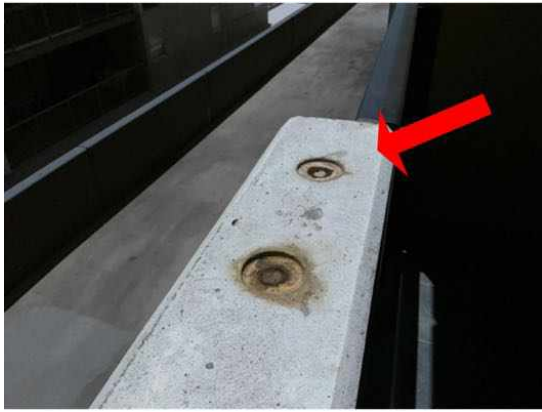
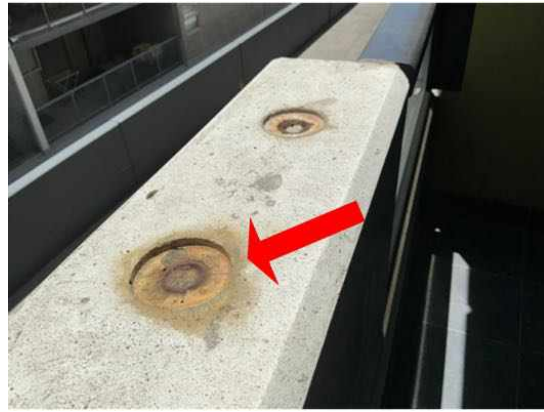
Defects 3.04

Building:	Main Building
Location:	Balcony
Finding:	Steel Ferrules rusting
Information:	<p>It was observed at the time of the inspection that the steel Ferrules built into the concrete panel are showing signs of minor rust and corrosion. The ferrules should have been grouted over with structural grout at the time of the construction.</p> <p>Unattended to the ferrules could rust further expand and cause spalling to the concrete panel.</p> <p>A general handyman should be engaged to cover these steel ferrules with structural grout to protect them from moisture and further corrosion. This can be undertaken at the clients discretion.</p>

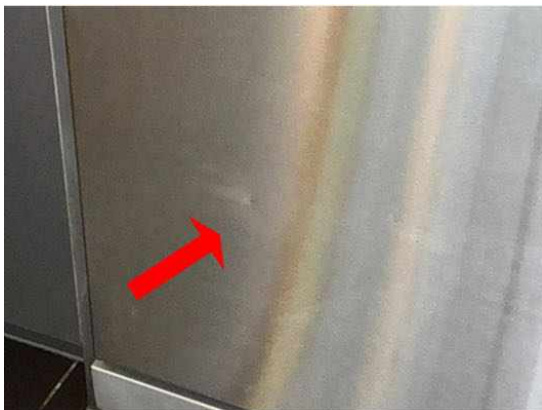
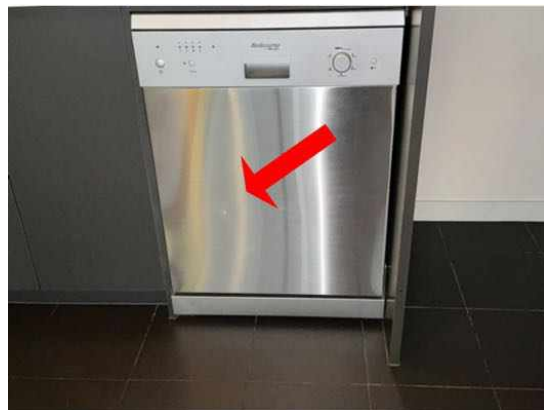
Defects 3.05

Building:	Main Building
Location:	Kitchen
Finding:	Dishwasher door tinted
Information:	It was observed that there was a minor dent to the stainless steel dishwasher door. Although this is a minor and aesthetic defect, it detracts from the overall appearance of the building.

An appliance repair specialist should be engaged to review at the owners discretion.

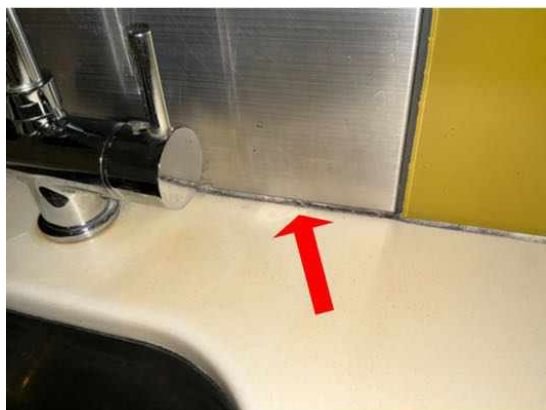
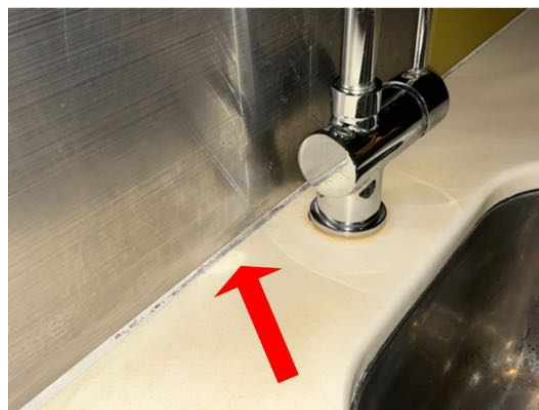
Defects 3.06

Building:	Main Building
Location:	Kitchen
Finding:	Mould - Present- minor
Information:	Where evidence of mould growth was noted, there may be environmental, biological or health issues.

Generally, the client is advised to ensure that the general environment is free of moisture and humidity to aid in the prevention of mould formation and development. Any mould found during the inspection should be cleaned immediately by a cleaning contractor or the homeowner as applicable.

Please note that severely affected building elements may require sealant replacement by a General handyman

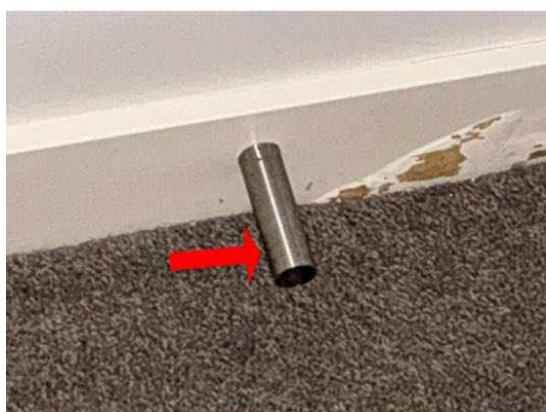
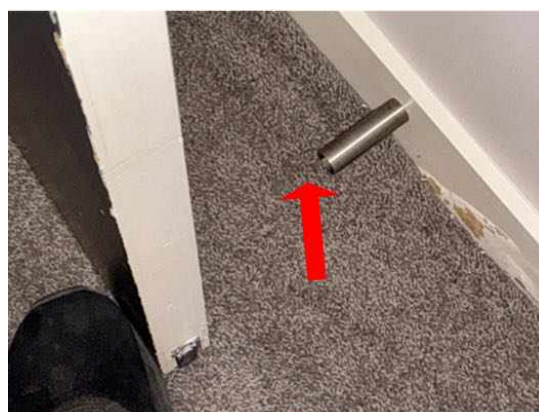
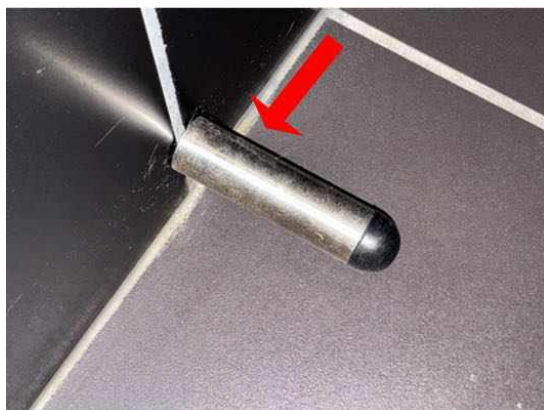
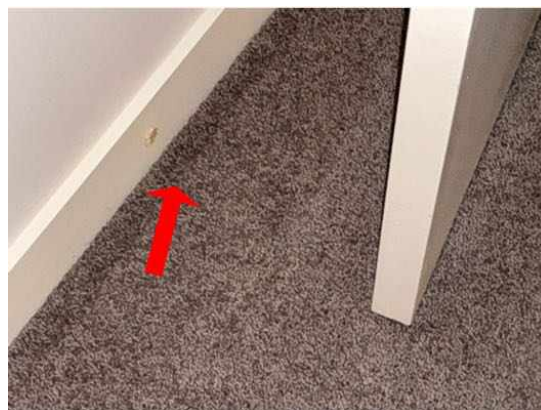
Defects 3.07

Building: Main Building
 Location: All Internal Areas
 Finding: Door stop - Missing- damaged - loose.
 Information: The door stops are missing, damaged or loose, or is inadequate to stop the door handle from damaging the wall. Although some building elements may seem irrelevant or unnecessary, all building elements play a key role in the operation and function of the overall structure and its performance.

Re-installation or replacement of the door stop is advised as soon as possible to prevent any subsequent damage to the door or associated structures. A general handyman may be appointed to perform these works at client discretion.

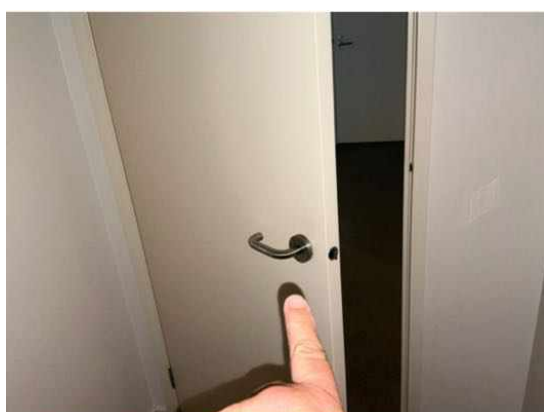
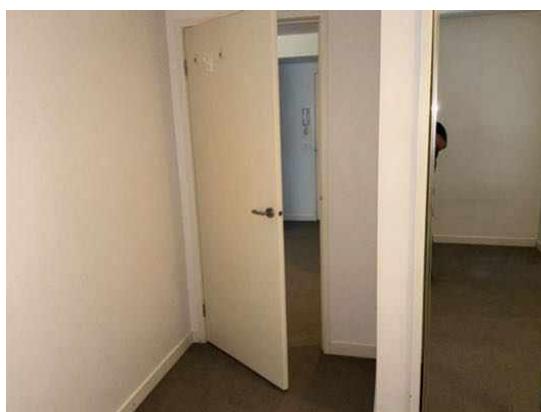
Defects 3.08

Building: Main Building
 Location: Bedroom
 Finding: Door handle loose
 Information: The door handle to the bedroom was found to be loose.

Unattended to the handle could fall off and make the door inoperative.

A carpenter/handy man should be appointed immediately to review and adjust at the owners discretion.

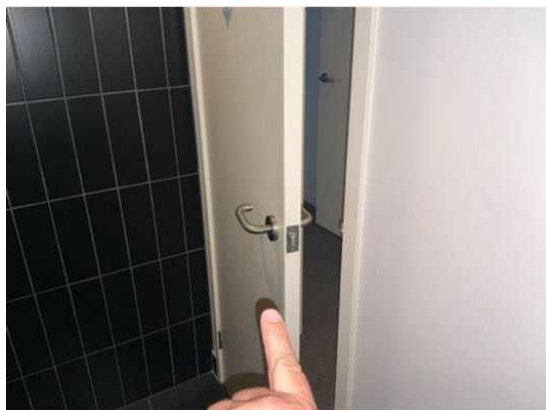
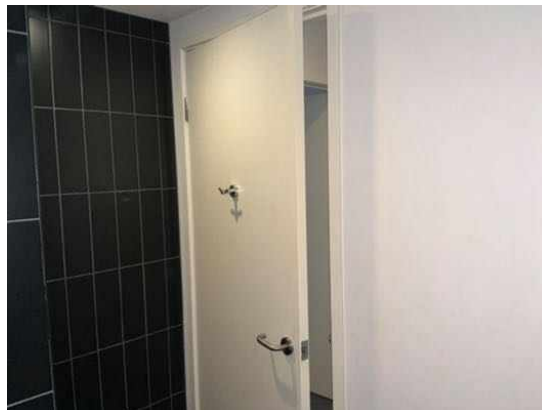
Defects 3.09

Building: Main Building
 Location: Bathroom
 Finding: Door handle - Not latching
 Information: It was noted that the door in the bathroom was not latching during operation at the time of inspection. Whilst detracting from the functionality of this building element, this minor defect may also be a security risk, and may therefore have serious implications if left unattended.

It is suspected that this defect has occurred due to minor issues with the associated hinges. Such damage is identified as general wear and tear, which is expected for

building elements of this age.

A qualified carpenter or general handyperson may be appointed to perform rectification works as necessary, at client discretion. If left unattended, further functional impairment is likely to occur.

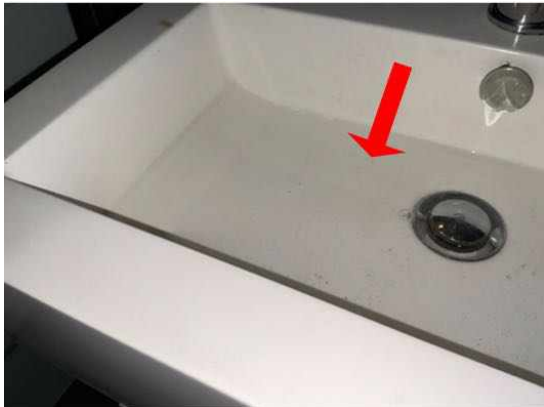
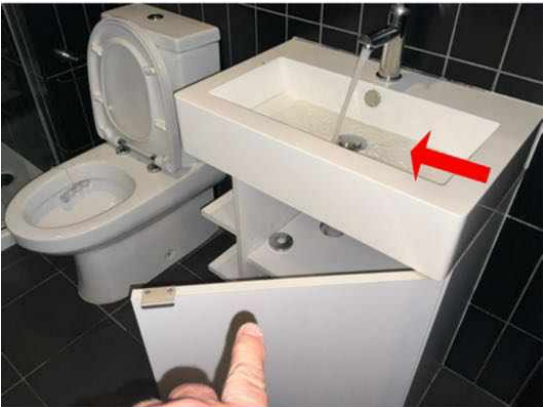
Defects 3.10

Building: Main Building

Location: Bathroom

Finding: Basin - Blocked

Information: The basin drain appeared to be blocked at the time of inspection. Blockages prevent building elements from operating as intended. If left unmanaged, a lack of general maintenance may lead to the development of more significant defects, such as water damage to surrounding building materials.

It is advised that the blockage be removed prior to any further inspection or remedial works. Additionally, check for any secondary or concealed damage and then attempt to address the cause of the blockage to prevent any water damage to associated structures.

A licensed plumber should be appointed as soon as possible to perform any remedial works where required. Please be advised that a cabinet maker or qualified carpenter may be required if water damage is evident.

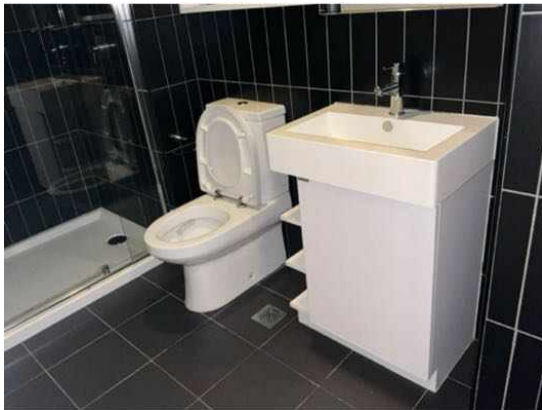
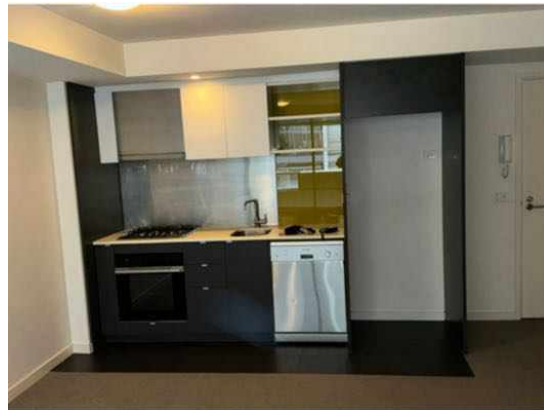
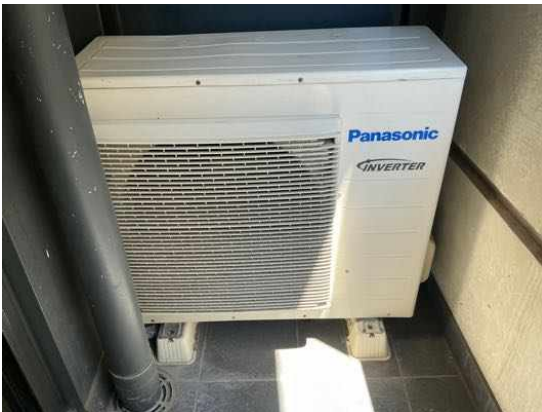
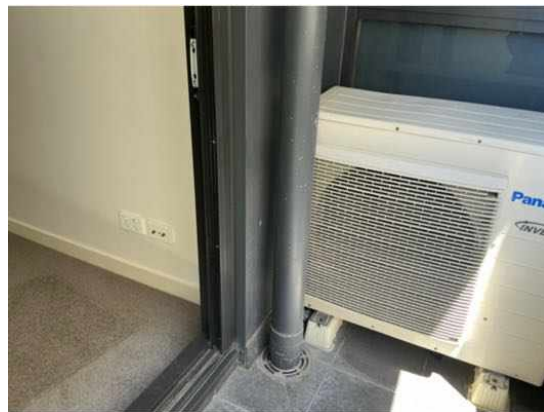
Building: Main Building
 Location: All Areas
 Finding: Additional Photos - Obstructions and Limitations
 Information: These photographs are an indication of the obstructions and limitations which impeded full inspection of the property at the time of inspection. These obstructions can hide an array of defects and should be removed to allow full inspection to be carried out. A re-inspection is recommended once the areas are made accessible.
