Building Inspection Report

Inspection Date: Fri, 20 Mar 2026

Property Address: 15 Manna Gum Dr, Pakenham VIC 3810,
Australia

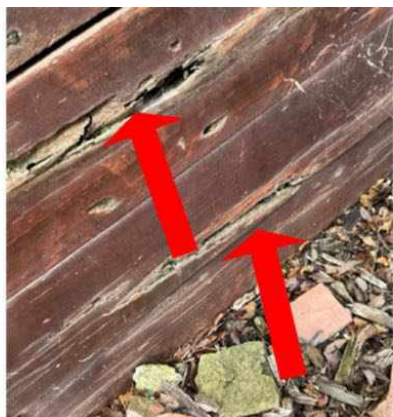
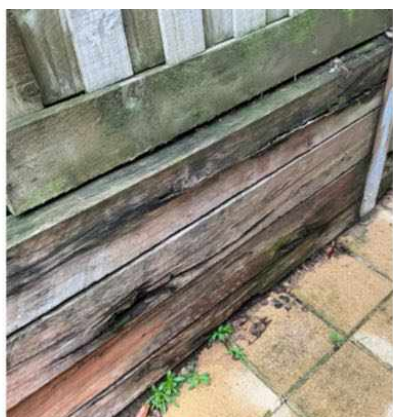
Defects 3.01

Building: Main Building
Location: All External Areas
Finding: Defective Retaining Wall Timber – Deterioration and Decay
Information:

The timber retaining wall elements surrounding the dwelling were observed to be deteriorated, with visible signs of decay and weathering to multiple sections. The affected components exhibit loss of material integrity and are no longer in sound condition.

Deterioration of retaining wall timbers can compromise their structural performance, potentially leading to soil movement, reduced lateral support, and eventual failure of the retaining system. This may also contribute to ground instability in adjacent areas of the property if not addressed.

A qualified carpenter or suitably experienced retaining wall specialist should be engaged to assess the full extent of the deterioration. The affected timber elements should be removed and replaced, with all new materials properly treated for external in-ground use. Associated works, including reinstatement of structural support and drainage provisions where required, should be completed to ensure the retaining wall performs as intended.

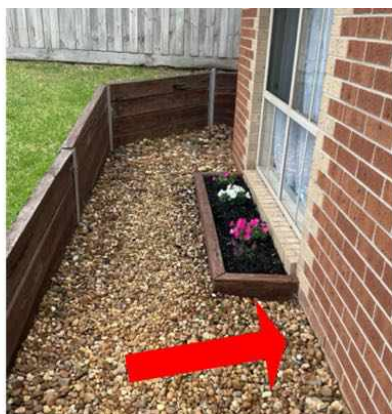
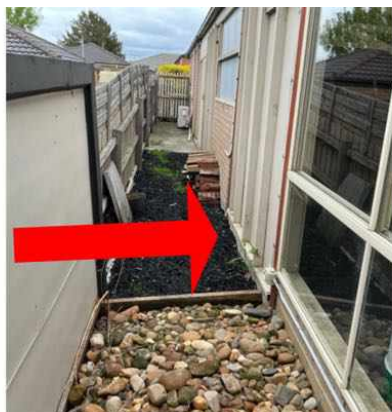
Defects 3.02

| Finding: | Site drainage - Inadequate |
| Information: | The site drainage in the yards was found to be inadequate at the time of inspection, creating potential for subsequent water damage to associated building elements. |

It is important that water does not lie against the base of walls; surrounding paths and ground levels should be sloped to drain water away from walls. Downpipes should not discharge stormwater onto lower walls or plinths. Stormwater should be carried away by large, regularly cleaned drains. Ground levels may need to be lowered to expose a buried DPC.

Where site drainage is inadequate, installation of an Agricultural (Aggie) Drain may be required. A qualified plumber should be appointed to further inspect the property and perform any remedial works as necessary. Water damage and secondary defects are likely to occur if left unmanaged.

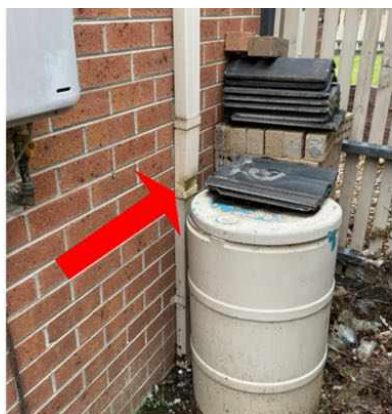
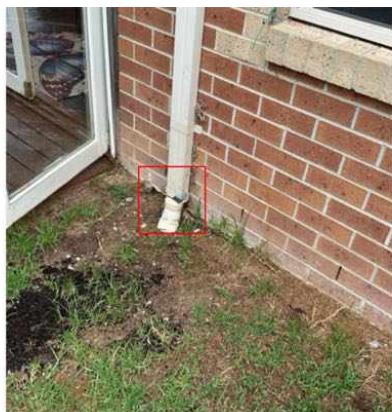
Defects 3.03

| Finding: | Defective Downpipes – Detachment and Damage |
| Information: | A number of downpipes around the dwelling, including within the side yard, were observed to be in defective condition. One downpipe is partially detached from its joint connection point, while another shows damage at the lower section near the stormwater connection. These conditions indicate compromised integrity of the rainwater disposal system. |

Defective or damaged downpipes can lead to uncontrolled discharge of roof water, which may result in water pooling around the base of the structure, increased risk of moisture ingress, and potential foundation movement or deterioration over time.

A licensed plumber should be engaged to resecure the partially detached downpipe and repair or replace the damaged section of piping at the stormwater connection. All works should ensure proper alignment, secure fixing, and effective discharge of stormwater away from the structure.

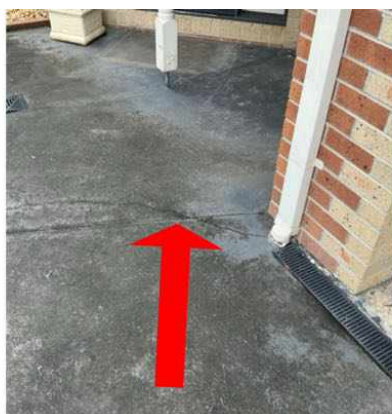
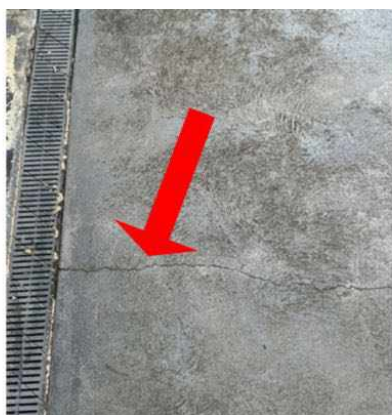
Defects 3.04

| Finding: | Cracking - External Concrete Paving Damage Category 2 - Distinct (less than 3mm) |
| Information: | Distinct cracks were identified in external concrete paving. Distinct cracks are generally found in older concrete paving, and may also present as a trip hazard as consequence of an uneven or curved surface. |

General age and expected deterioration of the paved areas is a common cause of this type of cracking. However, expansion and contraction of the slab may also have occurred due to environmental factors. Such factors include variable moisture and weather conditions, the presence of trees and their roots having a settling or lifting affect on the soil, or the effect of load bearing, e.g. heavy vehicles over a sustained period of time.

Cracking to this degree may also be due to poor original installation of the concrete. Factors such as poor compaction of the sub surface and/or inadequate reinforcing of the slab may create cracking and other secondary defects.

Repairs are likely to be required to prevent further cracking and to reduce hazards associated with cracking, such as tripping. Monitoring of all cracking should be conducted frequently. Always contact a building inspector should cracks widen, lengthen, or become more numerous.

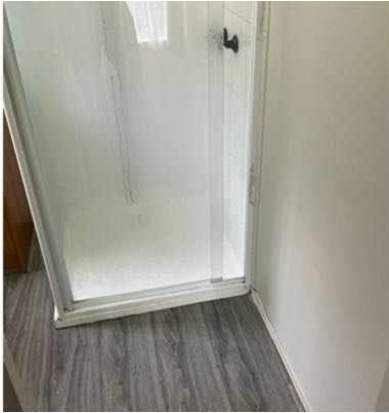
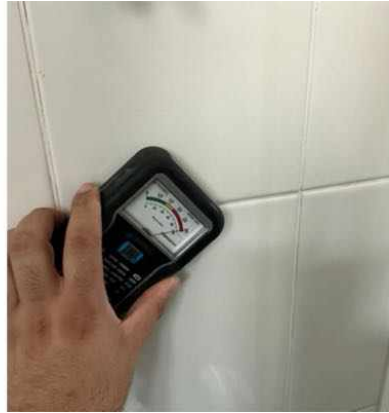
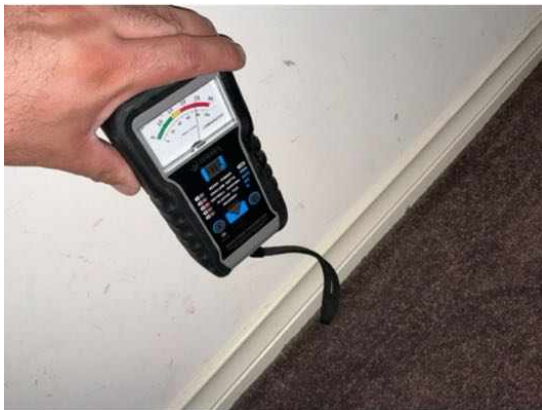
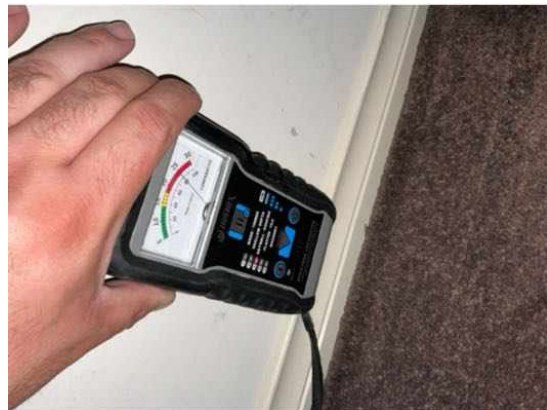
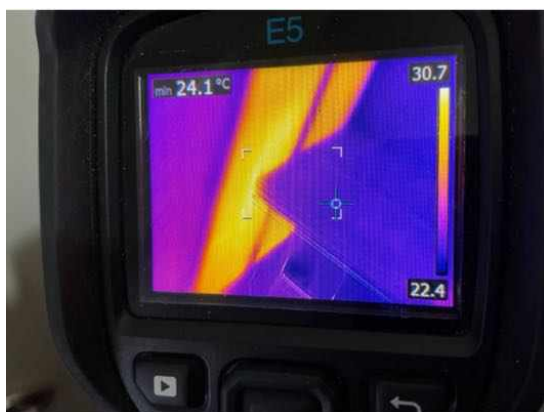
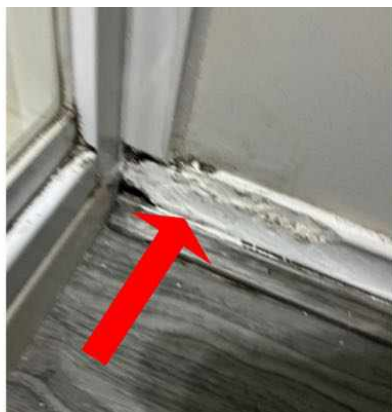
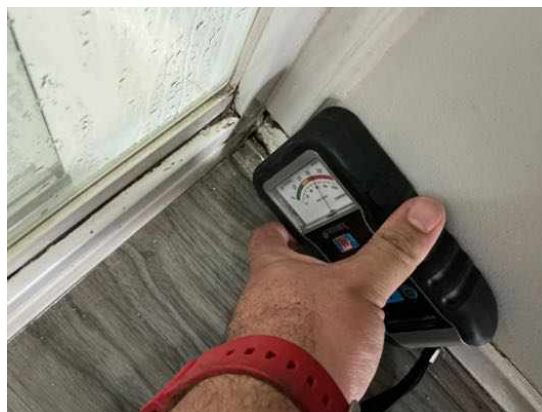
Defects 3.05

| Finding: | Excessive Moisture Detected to Shower Area and Adjacent Elements |
| Information: | Elevated moisture readings were recorded to the shower wall tiles, the plasterboard walls behind the shower from both sides, and the adjacent skirting boards using a non-invasive moisture meter. The skirting boards show signs of prior water damage that appears to have been painted over; however, high moisture levels remain present. The shower was operated continuously for approximately 45–60 minutes, and thermal imaging was undertaken, which did not identify any active moisture migration beyond the immediate area at the time of inspection. No visible surface damage was noted to the wall linings behind the shower from both sides; however, the assessment is limited to a visual, non-invasive inspection. |

Excessive moisture in wet areas may indicate underlying defects such as leaking plumbing components, failed or deteriorated waterproofing, or water ingress through grout lines or junctions. If not addressed, this condition can lead to concealed damage to wall framing, linings, and finishes, and may contribute to mould growth and long-term structural deterioration.

A licensed plumber should be engaged as a matter of urgency to undertake further

investigation to determine the exact source of the moisture ingress. This may include invasive inspection where required. All identified defects should be rectified accordingly, and any damaged materials (including skirting boards and wall linings) should be repaired or replaced following устранation of the moisture source.

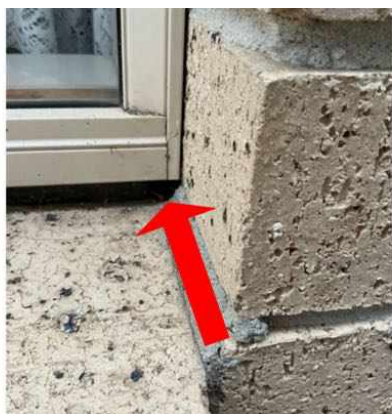
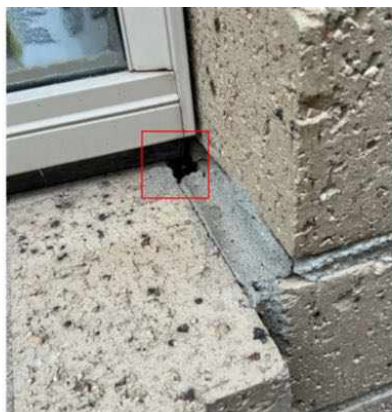
Defects 3.06

| Finding: | Window seals - deteriorated |
| Information: | The window seals have deteriorated and are in a generally poor condition. Due to frequent exposure to weather conditions and subsequent moisture, deterioration of window seals is expected in a property of this condition and age. |

Where window seals have deteriorated, the window is no longer weather-tight; rain penetration and subsequent water damage is therefore likely to ensue. Insulation of the area against external weather conditions will also be compromised.

It is recommended that all deteriorated window seals be replaced by a general handyman or sealant expert to prevent any further damage and to restore the window to a fully functional level.

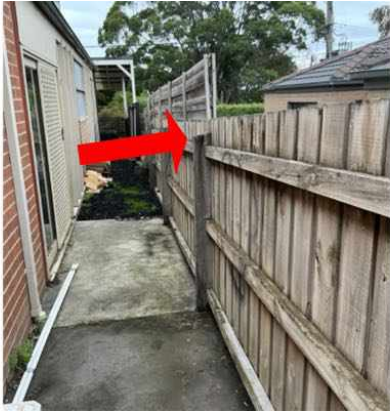
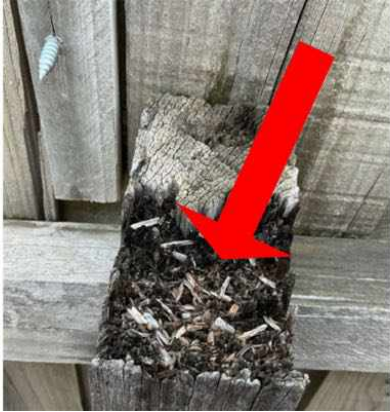
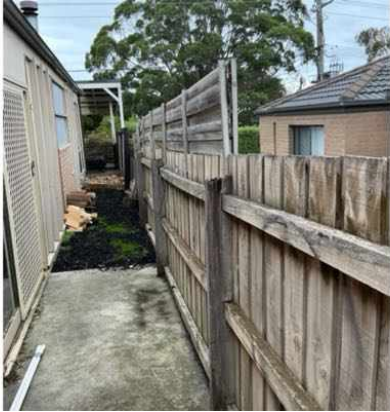
Defects 3.07

| Finding: | Fencing - Deteriorated |
| Information: | It was noted at the time of inspection that sections of the fencing throughout the property have deteriorated. Typically fencing deteriorates due to age and or wear, rot and or rust which is generally expected for a structure of this age, due to prolonged exposure to weather conditions. Sometimes inadequate installation or maintenance can be to blame. |

If left unattended, it is likely that further damage will occur. It is suspected that repair of several elements of the fencing may be required however replacement may be a consideration of the client also.

A licensed fencing contractor should be appointed to provide further advice and perform rectification works as necessary.

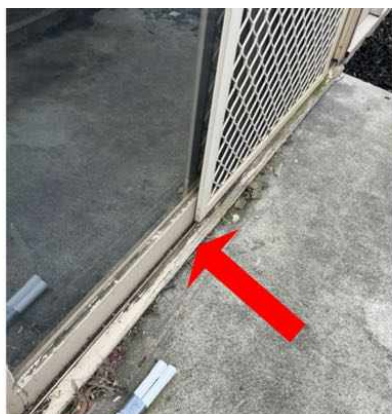
Defects 3.08

Building: Main Building
Location: Yard - Side
Finding: Rotten Timber Trim Below Sliding Door
Information:

The timber trim located beneath the sliding door in the side yard was observed to be deteriorated and affected by rot. The timber shows loss of integrity consistent with prolonged exposure to moisture and weathering.

Deteriorated and rotten timber elements can continue to degrade over time, potentially allowing moisture ingress into adjacent building components and compromising the durability of the door framing and surrounding finishes.

A qualified carpenter should be engaged to remove and replace the affected timber trim with suitably treated material designed for external exposure. All works should ensure proper sealing and protection to prevent future moisture-related deterioration.

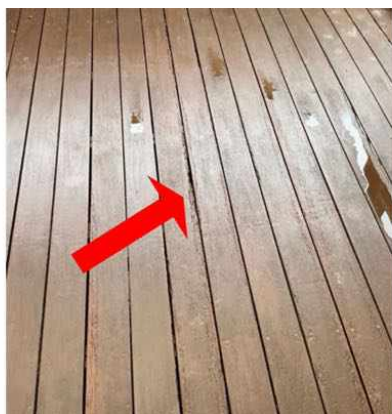
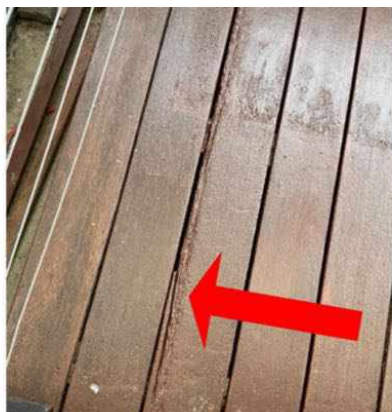
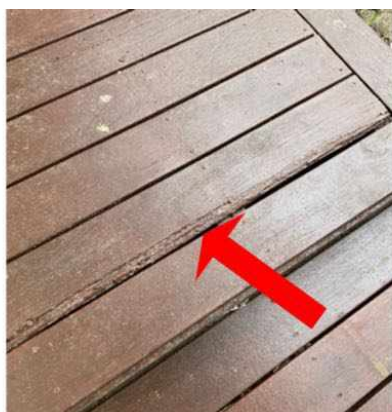
Defects 3.09

Finding: Minor Deterioration to Timber Decking Boards

A section of the timber decking in the backyard was observed to exhibit early signs of deterioration to the decking boards, likely associated with weathering and possible moisture exposure over time. The affected area appears to have been previously painted, and the boards were found to be firm underfoot at the time of inspection, with no significant structural movement noted.

While currently minor and largely cosmetic in nature, continued exposure to moisture and environmental conditions may result in progressive timber decay if not maintained, potentially leading to future loss of durability and performance of the decking surface.

A qualified carpenter or decking specialist may be consulted to assess the affected boards. Maintenance works such as sanding, sealing, or localised replacement of deteriorated boards can be undertaken at the client's discretion to preserve the condition and longevity of the deck.

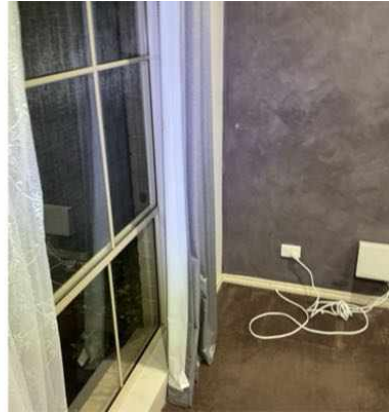
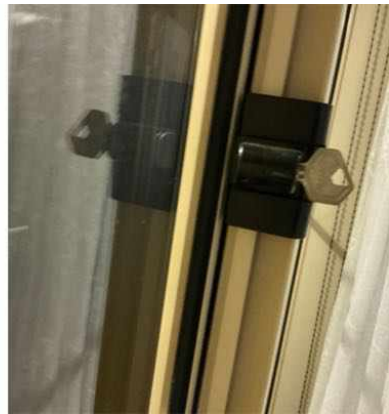
Defects 3.10

| Information: | Several windows throughout the property were jammed and difficult to operate at the time of the inspection. Windows provide ventilation to the adjoining area and should be at a fully operational level to ensure user comfort. Restricted function of the window may also pose as a potential safety hazard if required for emergency egress from the building. |

Generally, factors such as general age of the building element and a lack of maintenance are the usual causes for this type of defect.

Replacement of window hardware or frame may be required, as well as minor repairs and cleaning. A registered builder or general handy person will be required to repair the affected windows.

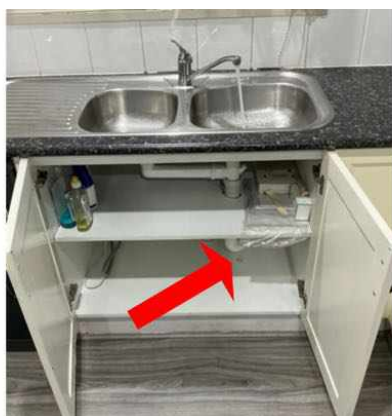
Defects 3.11

| Finding: | Kitchen plumbing pipes - Leaking |
| Information: | The plumbing pipes in the kitchen were found to be leaking at the time of inspection. |

This is a common defect that is consistent with general ageing of the building element. However, it may be indicative of substandard plumbing workmanship if the tap is relatively new.

While this defect only seems minor, if left unmanaged, it is likely to result in the development of rust, water damage and/or extensive water usage.

It is advised that a handyman or licensed plumber be appointed to perform remedial works on the affected tap. Such works should be performed prior to the development of secondary defects to ensure adequate functionality of all associated building elements

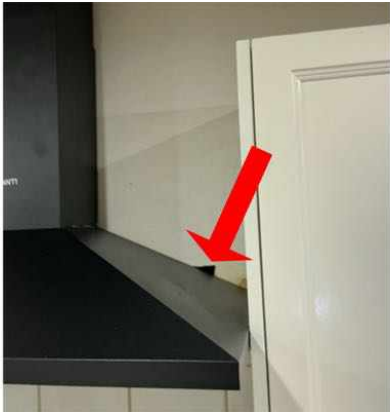
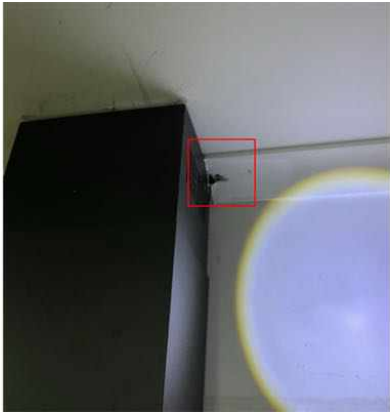
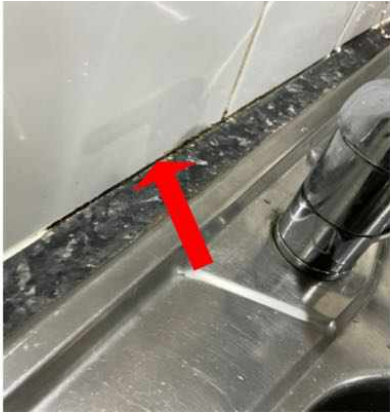
Defects 3.12

Building: Main Building
 Location: Kitchen
 Finding: Defective Finishes to Kitchen Rangehood Area and Splashback
 Information:

Gaps were observed behind the rangehood area, along with a crack at the junction between the underside of the rangehood bulkhead and the adjacent cornice. Additionally, the splashback tiles behind the kitchen tap show deteriorated or missing grout, particularly at the base junction. These conditions indicate incomplete or defective finishes to the kitchen wall and tiled surfaces.

Open gaps and cracked junctions may allow moisture, grease, and contaminants to penetrate into wall cavities, potentially leading to deterioration of internal linings and finishes over time. Defective or missing grout to splashback tiles can permit water ingress behind the tiles, increasing the risk of concealed moisture damage and mould development in the surrounding areas.

A qualified plasterer should be engaged to properly fill and finish the gaps and cracks around the rangehood and cornice junctions, followed by sanding and painting to match adjacent surfaces. A qualified tiler should be engaged to regrout and seal the splashback tiles, particularly at the base, to ensure the area is adequately sealed and protected against moisture ingress.

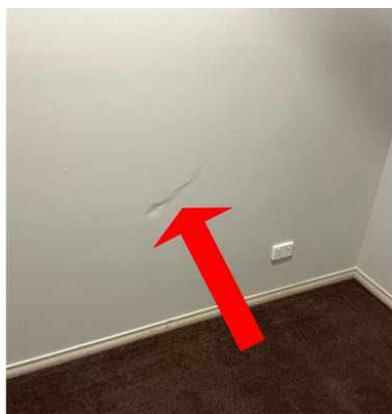
Defects 3.13

Building: Main Building
Location: Bedroom 3
Finding: Defective Plaster Finish to Bedroom Three Wall
Information:

A section of the plaster wall in Bedroom Three was observed to be defective, with visible paint bubbling to the surface. Upon light pressure, the affected area appeared hollow, indicating a lack of proper plaster backing or patching behind the painted finish. This suggests the area has been previously damaged and inadequately repaired.

Defective plaster finishes and poorly patched areas can lead to ongoing deterioration of wall linings and finishes. If left unaddressed, the affected section may worsen over time, resulting in further delamination, cracking, and potential exposure of underlying wall components.

A qualified plasterer should be engaged to remove the defective section, reinstate the wall lining properly, and ensure a sound substrate. Following this, a qualified painter should complete appropriate preparation, finishing, and repainting of the area to match the surrounding surfaces.

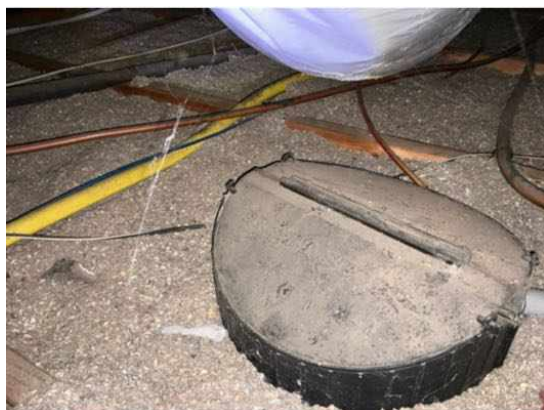
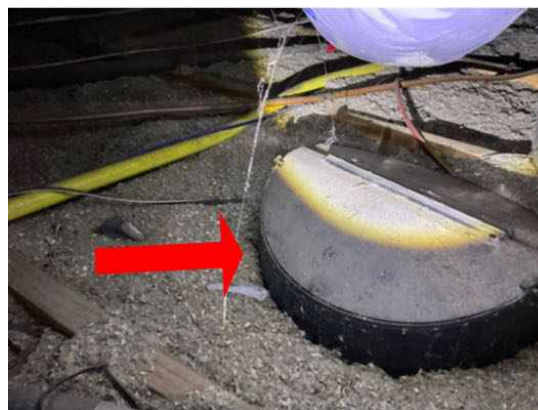
Defects 3.14

| Information: | The exhaust fans installed in the bathrooms were observed to be discharging directly into the roof cavity rather than being ducted to the external atmosphere. This configuration does not comply with best practice ventilation standards, as it allows moist air to accumulate within the roof space. |

Prolonged moisture build-up in the roof cavity can lead to elevated humidity levels, which may contribute to mould growth, timber decay, and potential damage to insulation or other roof components over time.

It is recommended that a licensed ventilation specialist or electrician be engaged to install compliant ducting that vents the exhaust air to the outside of the building, in accordance with current building regulations and ventilation standards.

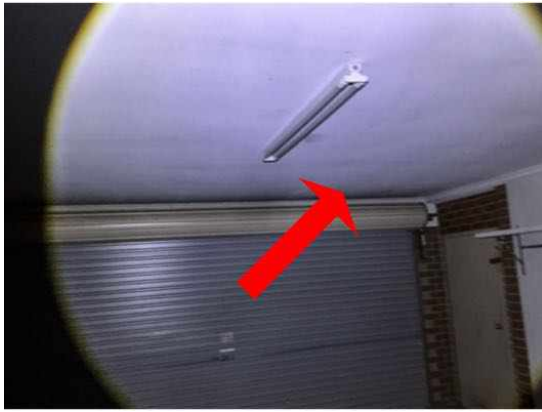
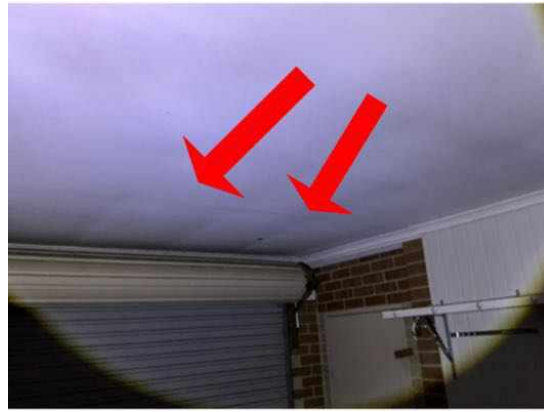
Defects 3.15

| Information: | Sections of the ceiling were found to be sagging at the time of inspection. Sagging to the fixed ceiling structure generally indicates that the building materials have swollen, due to contact with water, or that fixings (e.g. nails or glue) have become loose and require reattachment. This is a very common defect in carports due to their lack of insulation and or their susceptibility to moisture. Condensation builds up in the roof and rests on the plasterboard softening it somewhat which makes it more likely to sag and release from its fixing points. |

Where minor sagging is evident, comparatively minor works, such as re-gluing of ceiling sheets, may be required. Such works may be performed by relevant tradespeople, such as plasterers and painters. Where excessive moisture has caused the roofing structure to swell and sag, the source of the water leak should primarily be identified prior to any remedial works being performed.

In some cases, sagging ceiling linings may also indicate that there are structural issues, causing surfaces to warp, twist or sag. Where sagging appears to be major, appointment of a structural engineer is advised to further inspect the property and identify the source and rectification works required.

While damage is minimal at this stage a licensed plasterboard contractor should be appointed to repair the ceiling. Insulating the area could be considered by the client once repaired.

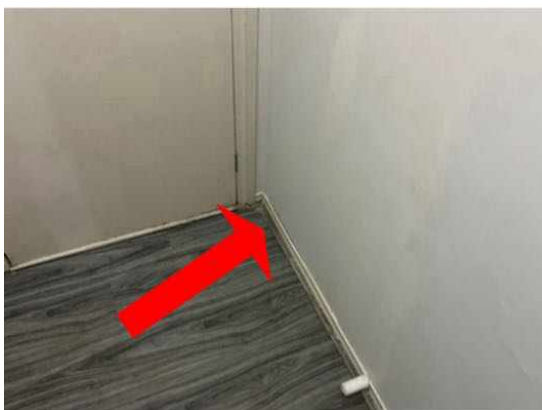
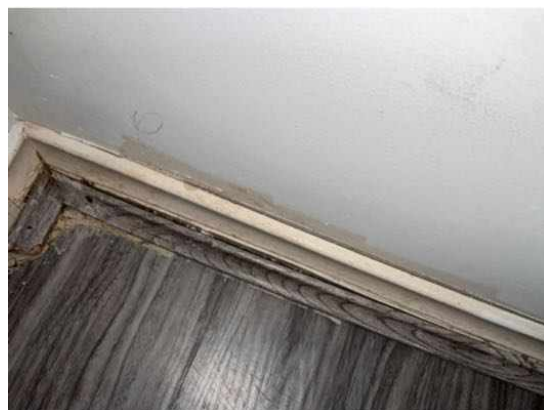
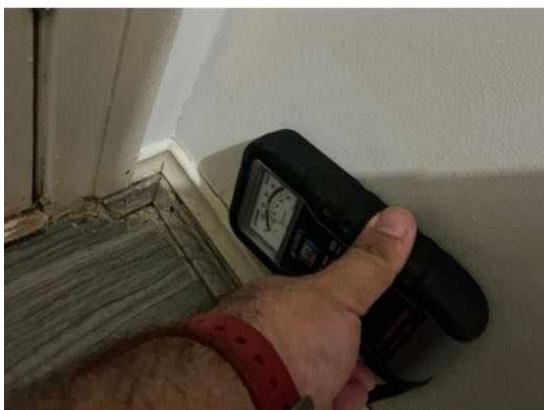
Defects 3.16

Building: Main Building
 Location: Laundry
 Finding: Minor Damage and Detachment to Laundry Trims and Skirting
 Information:

Minor damage was observed to the trims and skirting boards adjacent to the laundry door, including slight detachment and signs of minor surface deterioration. The affected elements appear to have experienced previous wear or minor water exposure; however, moisture testing at the time of inspection did not record any elevated readings, and the area was found to be dry.

While currently minor and cosmetic in nature, loose or detached trims and skirting boards may worsen over time if not secured, and can impact the overall finish and durability of the area.

A qualified carpenter should be engaged to resecure the loose trims and skirting boards and undertake minor repairs as required to restore proper fixing and finish.

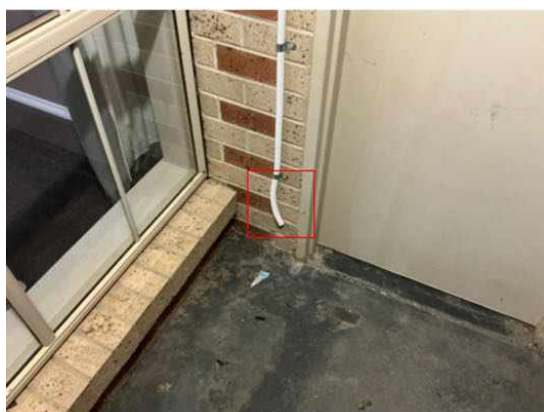
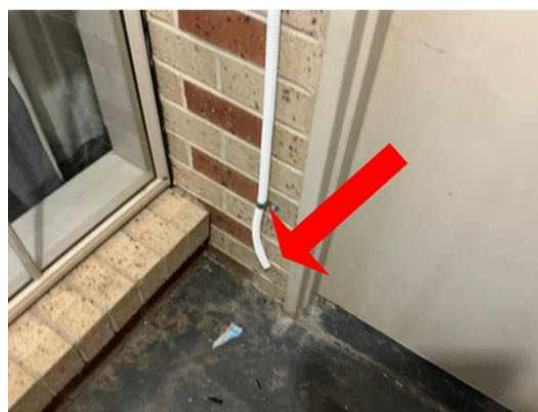
Defects 3.17

| Information: | Upon inspection, it was found that the AC overflow is not plumbed or connected to suitable drainage. This could lead to the surrounding area becoming excessively damp, which in turn may cause secondary defects such as rot, rust, corrosion of associated building elements, and the formation of fungal decay. In addition, prolonged damp conditions could create potential slip hazards. Poor site drainage may exacerbate the issue, potentially attracting termite activity to the area. |

We recommend that a licensed plumber be appointed to properly plumb the AC overflow and connect it to suitable drainage. This will help ensure that the area remains dry and free from secondary defects.

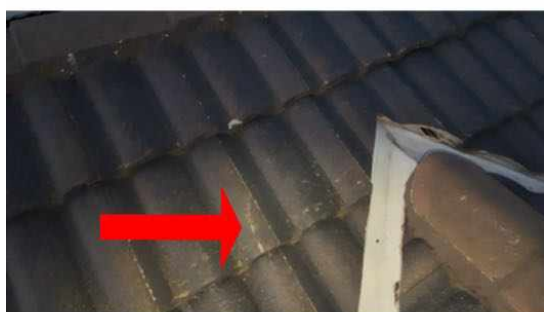
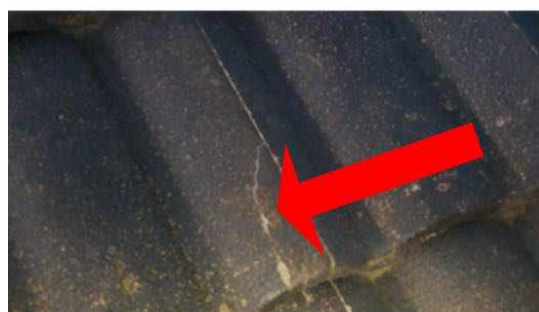
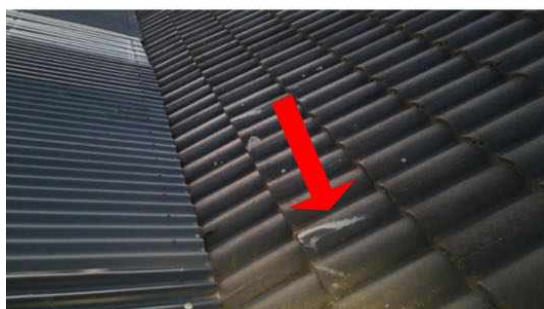
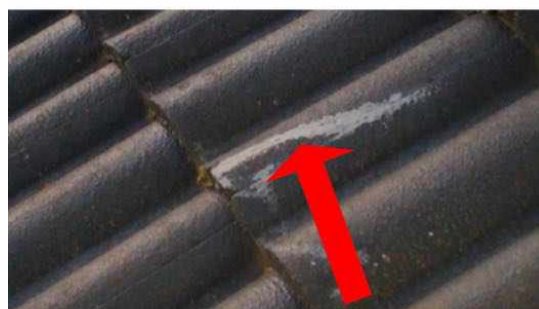
Defects 3.18

| Finding: | Roof tiles - Broken |
| Information: | Upon inspection of the exterior roof covering, broken roofing tiles were identified. Broken and friable roof tiles are generally the result of ageing and weathering of what |

If left to further deteriorate, broken and brittle roof tiles are likely to lead to water penetration via the roof into the ceiling space, causing secondary damage to ceiling linings, insulation and roof structures. Broken roof tiles are also likely to detract from the effectiveness of the roof drainage system, creating potential for secondary damage to the exterior roof covering and roof plumbing.

Replacement of broken tiles is required and should be performed by a roofing contractor as soon as possible.

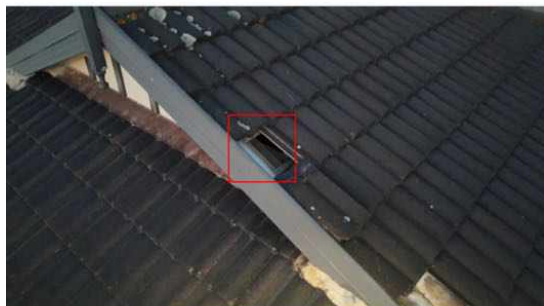
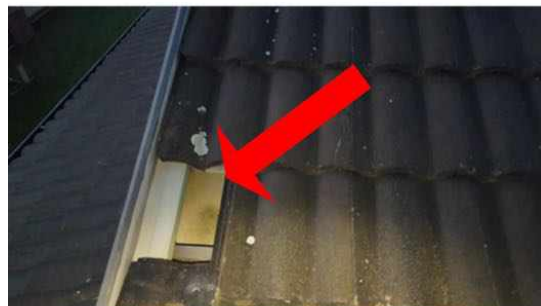
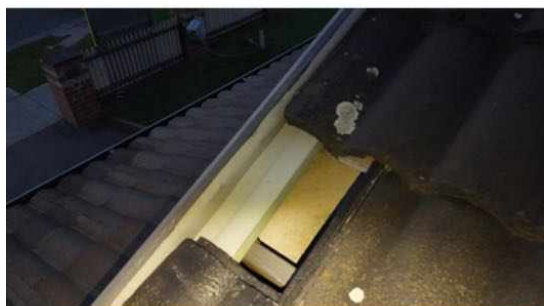
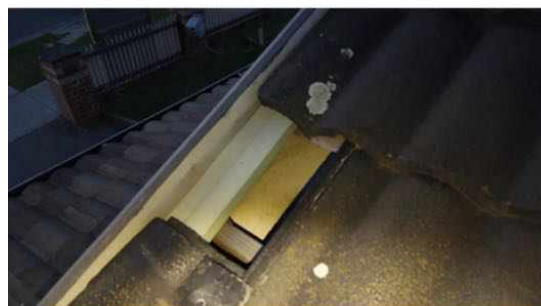
Defects 3.19

| Finding: | Missing Roof Tile – Immediate Rectification Required |
| Information: | A roof tile was observed to be missing, leaving an exposed section of the roof covering. This creates a direct opening through which water, debris, and pests may enter the roof space. |

A missing roof tile can lead to water ingress during rainfall, potentially causing damage to roof sarking, insulation, ceiling linings, and structural timber elements. If not addressed promptly, this may result in internal water damage and deterioration of building components.

A licensed roof plumber should be engaged as a matter of urgency to supply and install a matching replacement roof tile. The surrounding tiles and roof area should also be inspected to ensure no additional defects are present and that the roof covering is watertight.

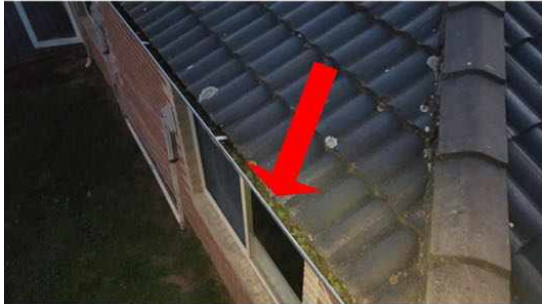
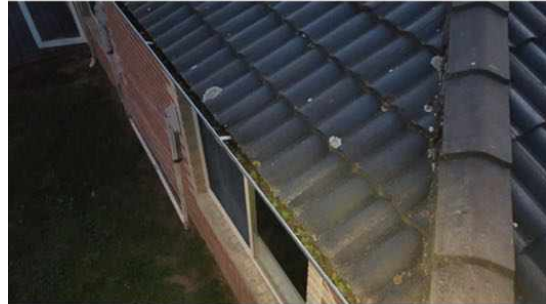
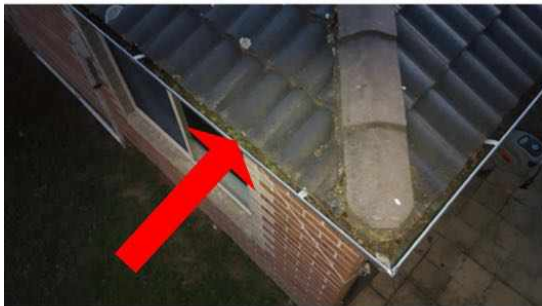
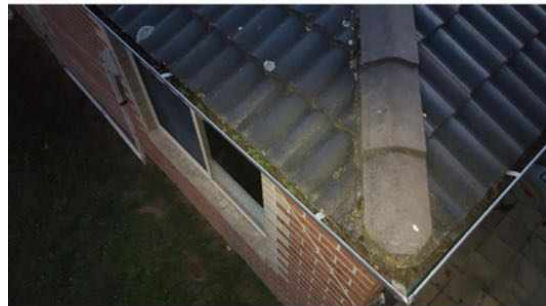
Defects 3.20

Blockages in gutters should therefore be removed immediately to ensure dry conditions are maintained.

Consult a Licensed Plumber for further specific advice on remedial works that may be required. In the interim, it is highly advised that blocked gutters be removed by the homeowner or a general handyman as a matter of urgency.

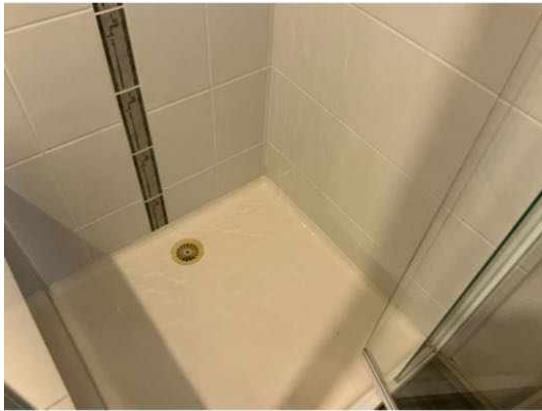
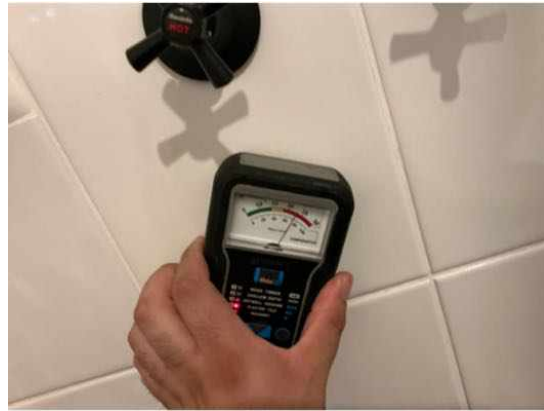
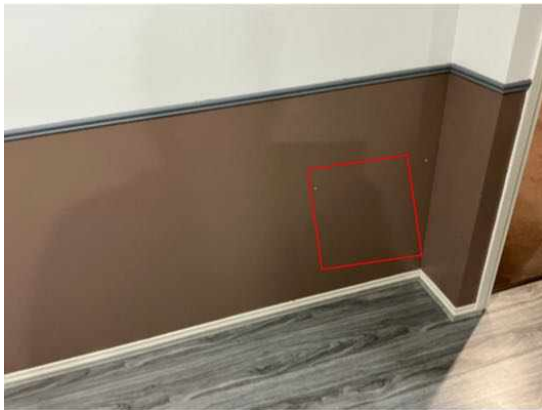
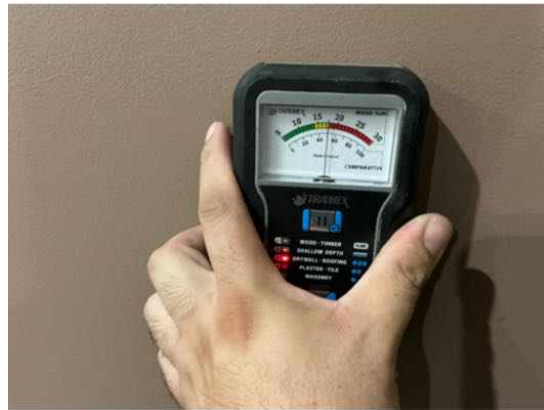
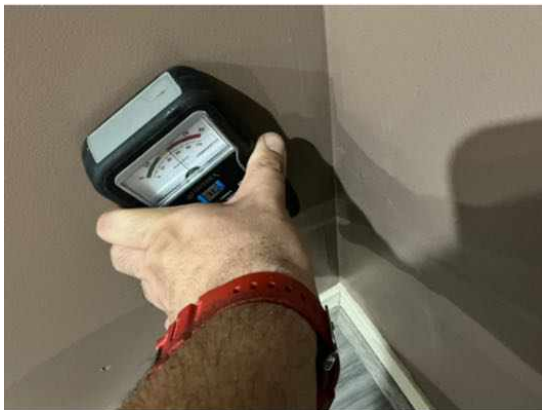
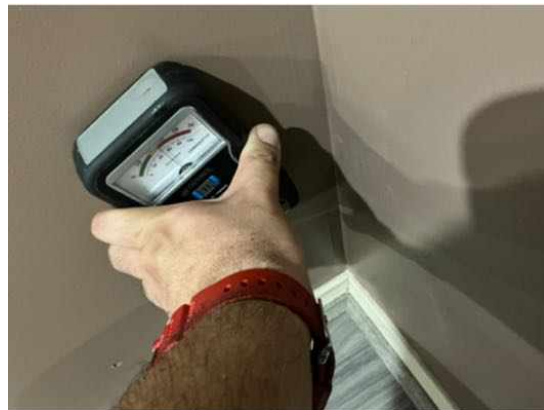
Defects 3.21

Building: Main Building
 Location: Bathroom 2
 Finding: Excessive Moisture Detected to Bathroom 2 Shower Area
 Information:

Excessive moisture in wet areas may indicate underlying issues such as leaking plumbing components, failed waterproofing, or water ingress through tile joints and junctions. If left unaddressed, this condition can lead to concealed damage to wall linings, framing, and finishes, and may contribute to mould growth and further deterioration.

A licensed plumber should be engaged immediately to undertake further investigation, including invasive inspection where required, to determine the exact source of moisture ingress. All identified defects should be rectified accordingly to ensure the area is watertight and functioning as intended.

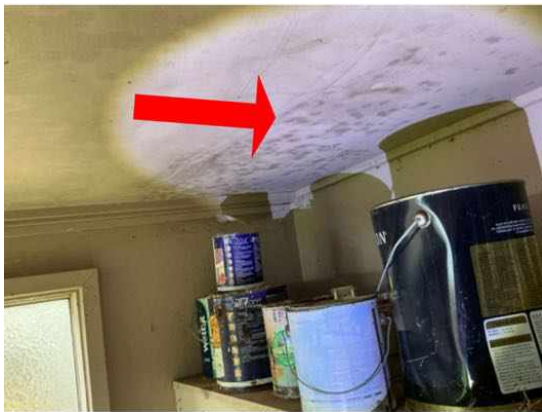
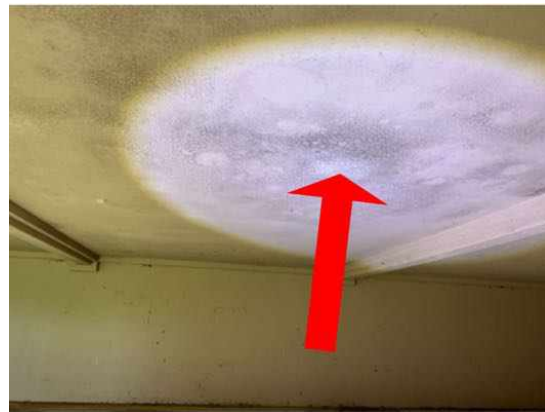
Defects 3.22

Building: Main Building
 Location: Shed
 Finding: Suspected Mould Growth to Shed Ceiling
 Information: Dark staining was observed to the ceiling lining within the backyard shed, which is

Suspected mould may indicate underlying moisture issues and, if confirmed, can pose health risks and contribute to deterioration of building materials if left unaddressed.

A qualified mould assessor should be engaged to undertake appropriate testing, including sampling if required, to confirm the presence and extent of mould. Any necessary remediation should be carried out in accordance with the assessor's recommendations.

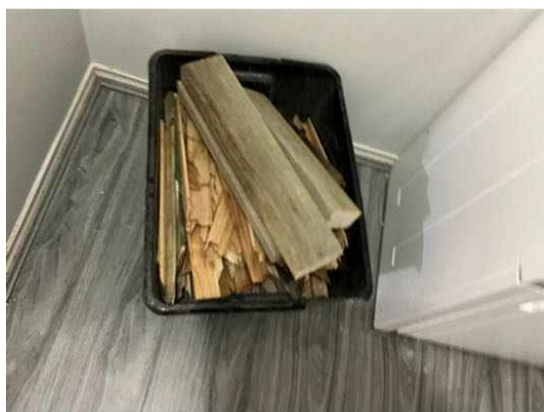
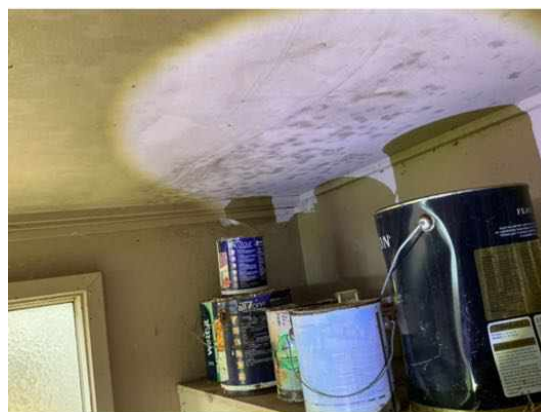
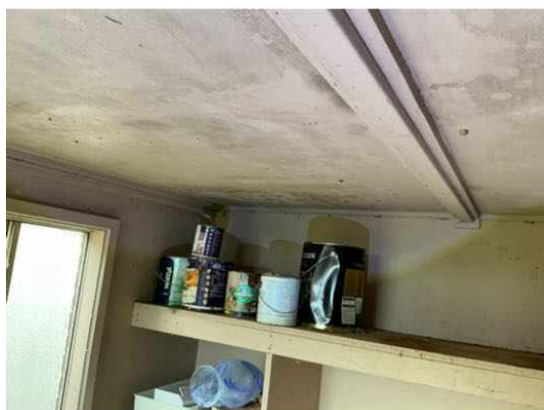
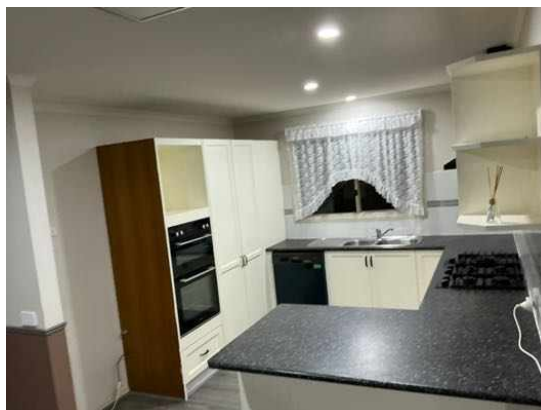
| Finding: | Obstructions and Limitations - Interior |
| Information: | These photographs are an indication of the obstructions and limitations which impeded the inspection of the internal areas of the property at the time of inspection. These obstructions can hide an array of defects and should be removed to allow full inspection to be carried out. A re-inspection is recommended once the areas are made accessible. |

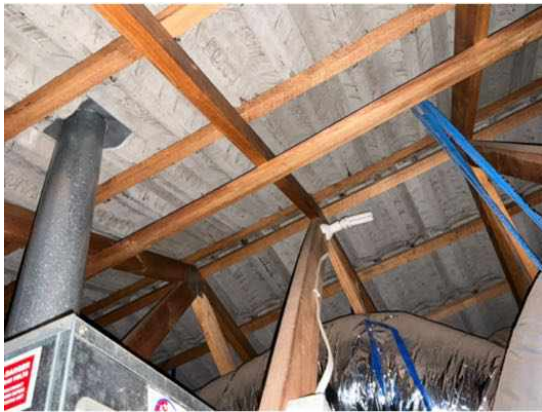
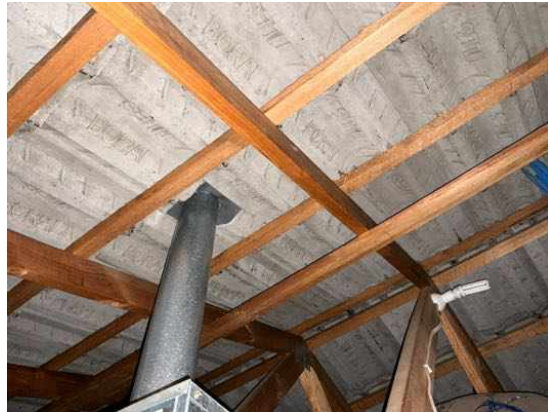
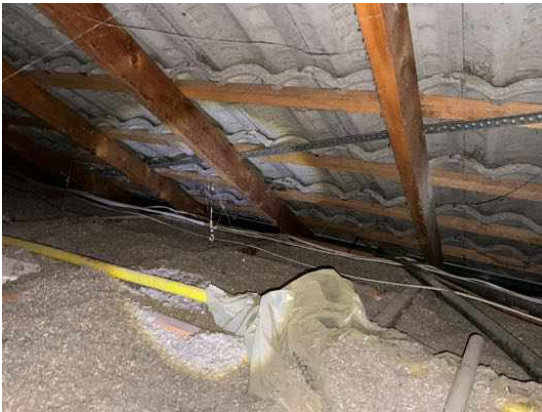
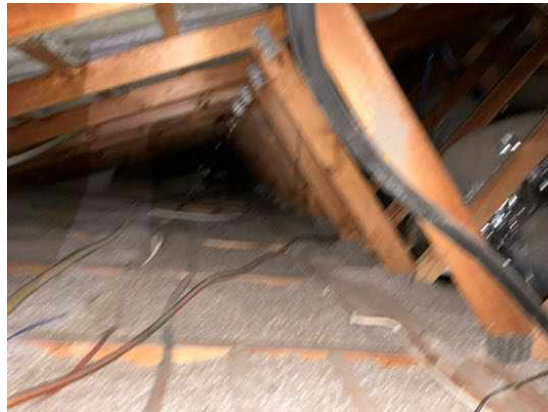
These obstructions can hide an array of defects and should be removed to allow full inspection to be carried out. A re-inspection is recommended once the areas are made accessible.

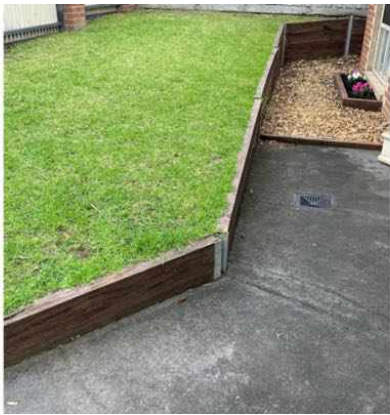
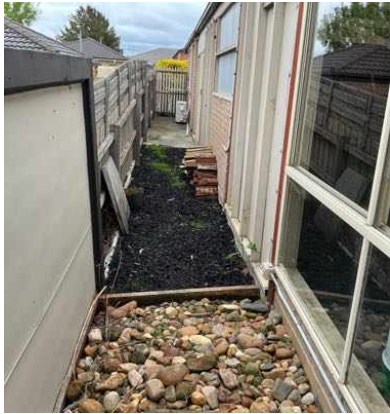
| Finding: | Obstructions and Limitations - Exterior |
| Information: | These photographs are an indication of the obstructions and limitations which impeded the inspection of the external areas of the property at the time of inspection. These obstructions can hide an array of defects and should be removed to allow full inspection to be carried out. A re-inspection is recommended once the areas are made accessible. |
