Building and Timber Pest Inspection Report

Inspection Date: Tue, 17 Feb 2026

Property Address: 16 Ardrossan Cres, St Andrews NSW 2566,
Australia

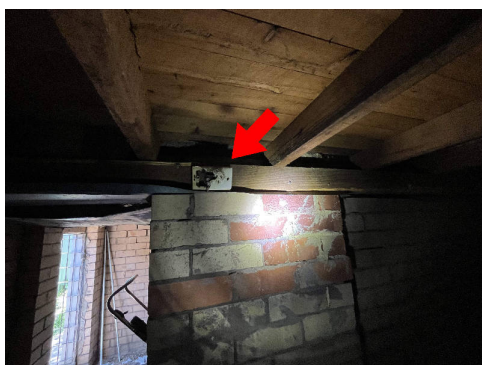
Finding: Light fitting Damaged

Information: The light fitting in the subfloor area was found to be severely damaged at the time of inspection, with the casing broken and internal components exposed. This damage appears to have resulted from impact or deterioration over time.

The exposed electrical components present a potential safety hazard, particularly in the subfloor environment where moisture may be present. The damaged casing no longer provides adequate protection to the electrical wiring and connections, increasing the risk of electrical faults or shock hazards.

A licensed electrician should be appointed to inspect the electrical installation and replace the damaged light fitting with an appropriate fixture suitable for subfloor conditions. These works should be undertaken as a matter of urgency to eliminate the safety hazard.-

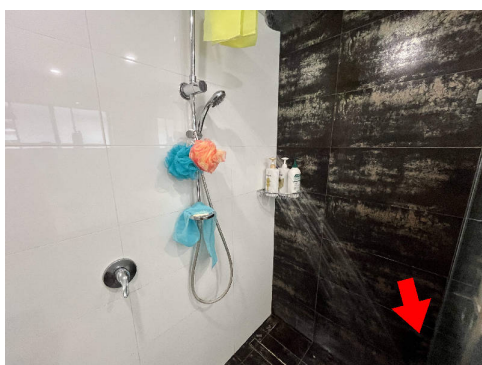
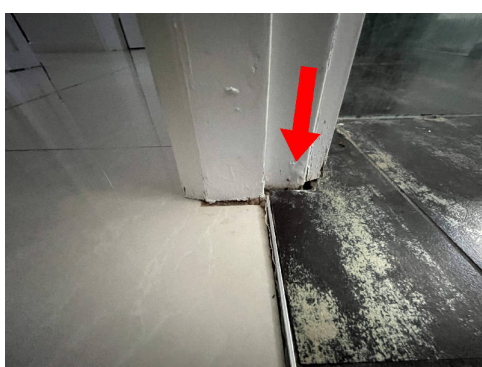
Finding: Shower screen sealant deteriorated

Information: The shower screen seals against the wall have deteriorated, allowing water to pass through the gap. The door frame next to the shower shows signs of elevated moisture, indicating potential water ingress. This could lead to water damage, mold, or mildew issues if not addressed. A plumber or shower screen specialist should inspect and seal the gap to prevent further water penetration.

The moisture reading to the adjoining walls of the showers have no sign of elevated moisture at the time of inspection.

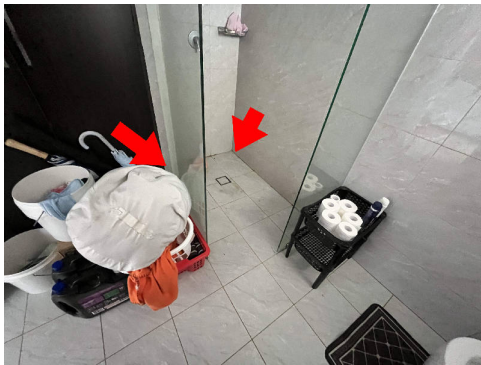
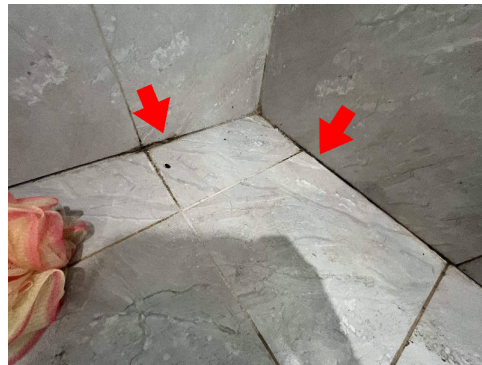
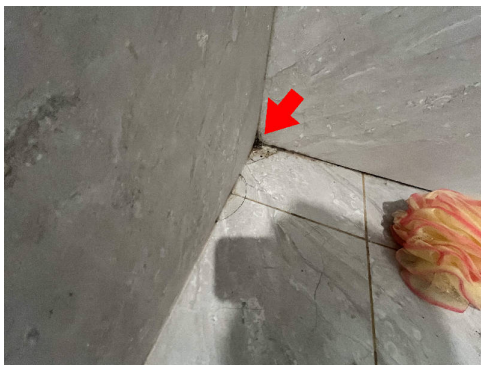
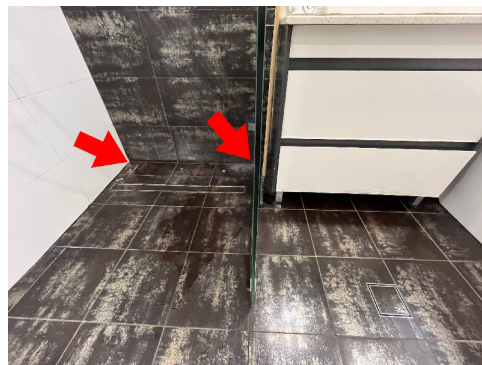
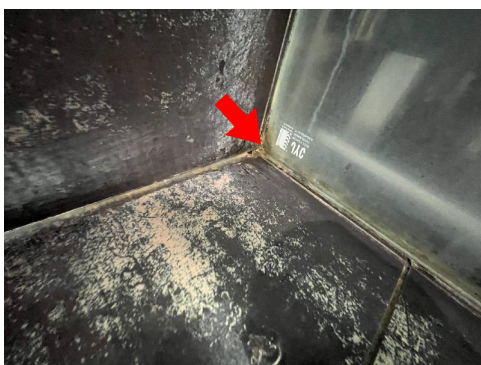
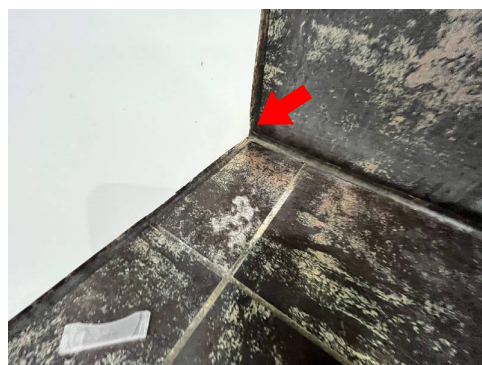
Finding 3.02

Finding: Sealant and grouting - Missing or damaged

Information: It was noted on inspection that sealant or grout is degraded to the tiled shower alcove and or other areas of the bathroom.

Different materials and floor areas move at different rates, generally causing cracking to grout or sealant at this point. A flexible sealant is required to allow for expected expansion and contraction, while keeping the joint water tight and protective of all associated building materials.

There appears to be excessive mould to the sealant and grout which will likely require scraping out and replacement.

Flexible and mould resistant materials should be applied to affected areas to prevent any subsequent water damage that is likely to occur. Regular maintenance and replacement of damage or missing or damaged sealant and grout is highly recommended to the wet areas, as this is a regular wear and tear defect. Sealant and grouting in areas that come into regular contact with water should be maintained for the long term care of your property.

A sealant specialist or tiling contractor should be appointed to complete these works as soon as possible

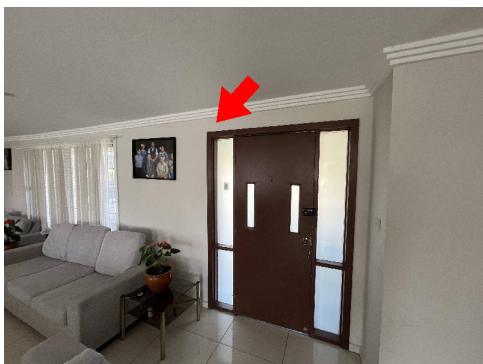
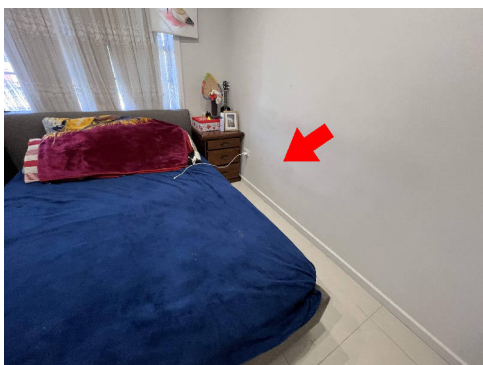
Finding 3.03

Finding: Cracking - Damage Category 1 - Fine (up to 1mm)

Information: Although fine cracks are quite noticeable, they are often only considered to be an appearance defect, and usually do not indicate any structural damage. Generally, the cause of a fine crack is indicative of a separation between building materials and finishes (e.g. paint, plaster, etc.) along joins.

Cracking of this nature can generally be repaired with minor sanding, filling and/or repainting. Such works should be performed by a qualified painter or a general handyman.

Monitoring of all cracking should be conducted frequently. Always contact a building inspector should cracks widen, lengthen, or become more numerous.

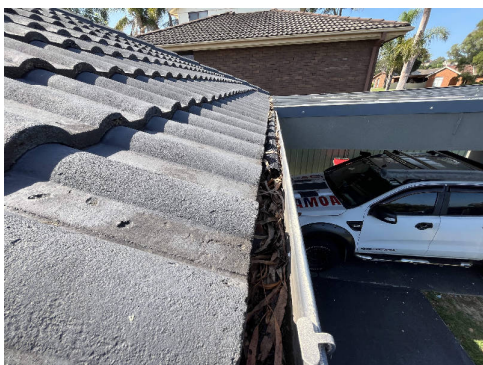
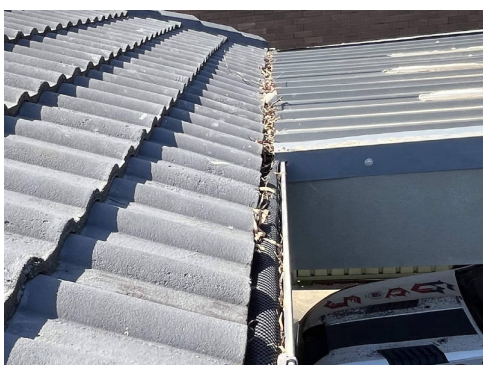
Finding 3.04

Blocked gutters are likely to lead to high levels of moisture in the affected areas. Such moisture will not only cause rust and decay of the associated building materials, but can also provide conditions that are conducive to termite and timber pest activity. Blockages in gutters should therefore be removed immediately to ensure dry conditions are maintained.

Consult a Licensed Plumber for further specific advice on remedial works that may be required. In the interim, it is highly advised that blocked gutters be removed by the homeowner or a general handyperson as a matter of urgency.

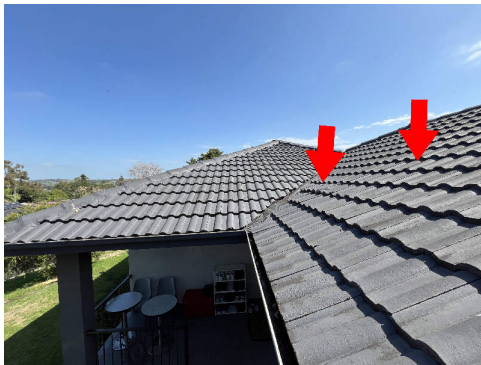
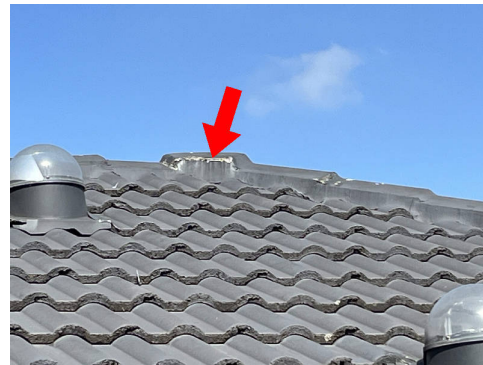
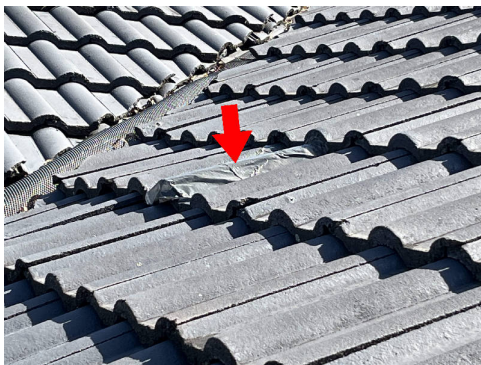
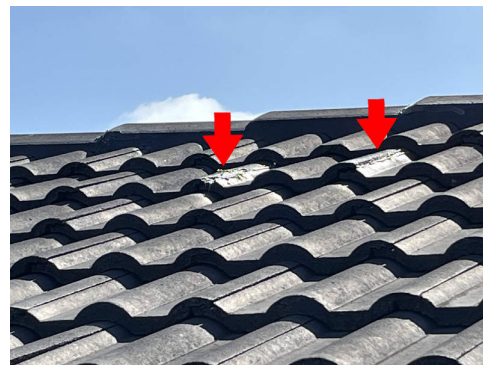
Finding 3.05

Finding: Roof tiles - weathered/cracked

Information: Several roof tiles were found to be cracked at the time of inspection. It appears an attempt was made to cover/seal the tiles, however a roofer should be appointed to assess the tiles. There was no evidence of water ingress in the roof void at the time of inspection.

Some areas along the ridge capping were found to have fine cracks in the pointing/mortar, but this is relatively minor. A roofing contractor should inspect and repair or replace the cracked tiles to prevent further damage.

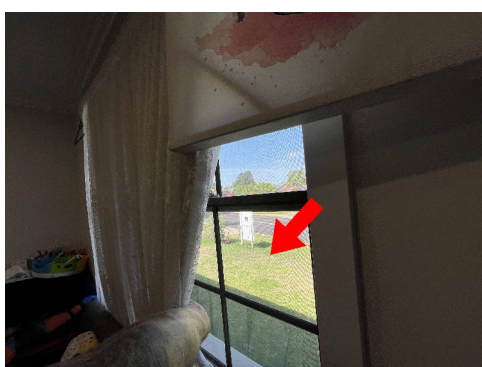
Finding 3.06

Finding: Window crack

Information: Cracks were identified in the window in this area. Cracking in windows is generally the result of impact damage, and is likely to develop further when left unmanaged.

The likelihood of this windowpane further cracking and shattering is increased exponentially, providing a safety hazard in the area. The cracked window also impairs the weather tightness of the building, creating potential for minor water leaks.

A qualified glazier is required to repair the window as soon as possible. Depending on the extent of the cracking, replacement of the window may be required. Please be advised that any persons coming into contact with the cracked window should do so with due caution to avoid any personal injury that may ensue.

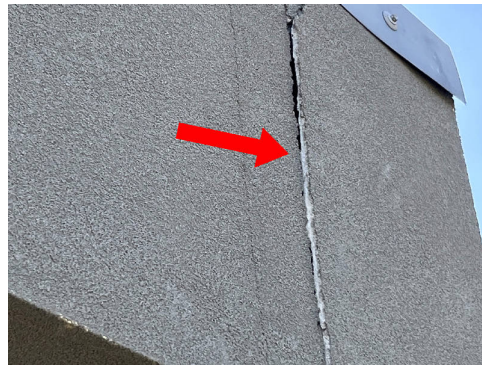
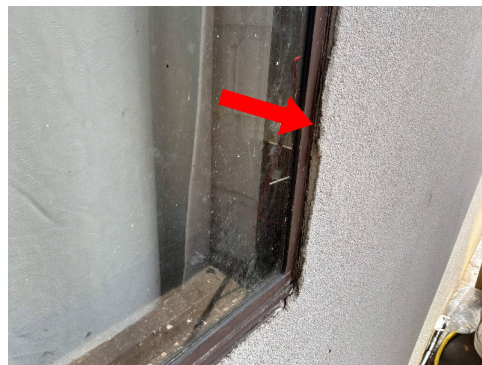
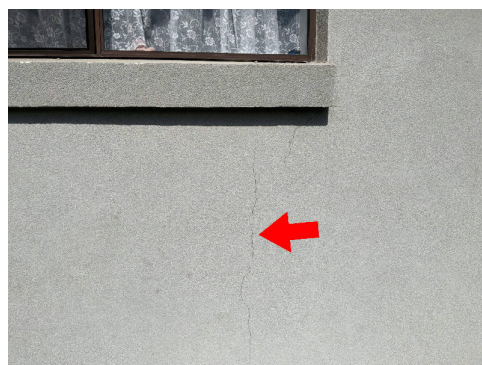
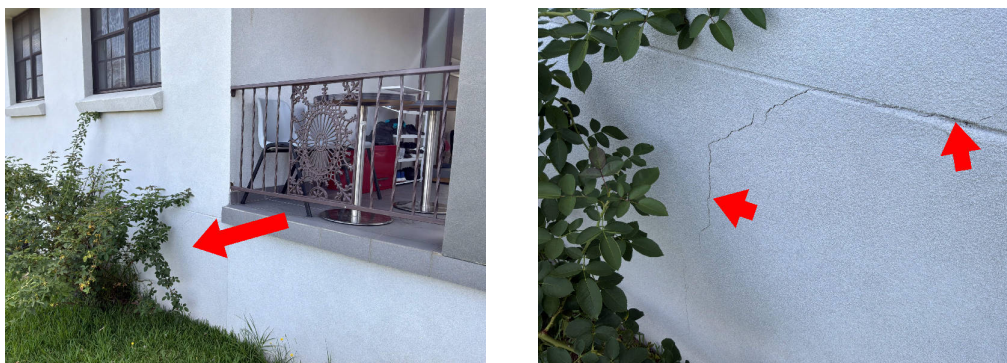
Finding 3.07

Finding: Cracking in render

Information: The external render is cracked and deteriorated in areas, with visible gaps and fissures. This could potentially lead to water penetration and damage. Possible causes include age-related wear, weathering, or poor initial application. A builder or renderer should inspect and repair the render, addressing any underlying issues and applying a suitable coating or finish to protect the surface.

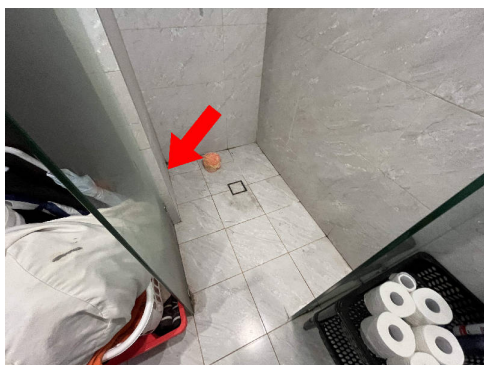
Finding 3.08

Finding: Tiles - Cracked or damaged wet area

Information: Cracking was evident to the tiling in this area at the time of inspection. While the cracking appears to be minor, this area is frequently exposed to water, allowing potential for water penetration into adjoining sections of walls or flooring.

If left unmanaged, water penetration to these areas may lead to subsequent water damage, which is likely to necessitate repair work to affected building elements.

A tiling contractor should be appointed to ensure that no further water damage occurs. The re-application of silicone and grouting throughout remaining tile work is also advised, to further protect the area against water penetration.

Where water penetration has led to water damage, appointment of a relevant tradesperson may be required to repair damaged building elements.

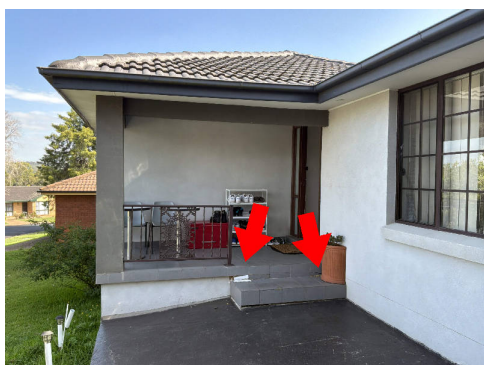
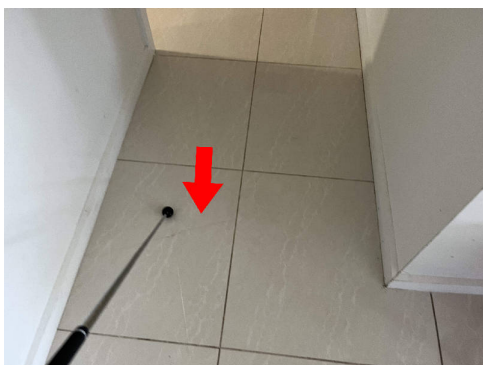
Finding 3.09

Finding: Cracked floor tiles

Information: Cracking in the floor tiles was evident in this area at the time of inspection. It is suspected that this cracking has occurred as a result of minor settlement or shrinkage of the slab.

Cracked tiles throughout the household detract from the overall appearance of the affected areas however it is unlikely to create or lead to any secondary defects.

While not considered a matter of urgency, replacement of cracked floor tiles is recommended at the clients discretion. A tiling contractor may be appointed to perform these works. Where cracks become more numerous, contact a licensed building inspector for further investigation.

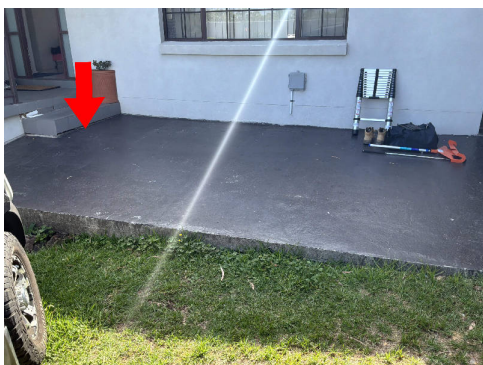
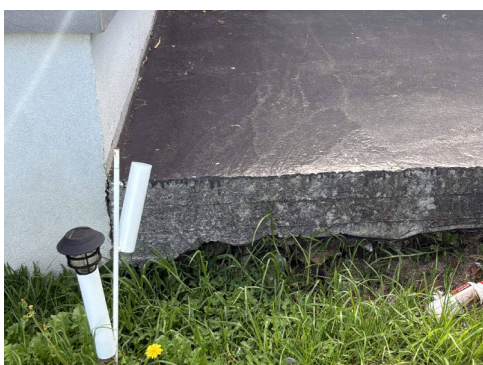
Information: The external concrete area shows signs of subsidence, with hairline cracking and unevenness. This could be due to soil movement, poor compaction, or inadequate drainage.

A structural engineer or builder should assess the area to determine the cause and recommend repairs to prevent further damage and potential safety hazards.

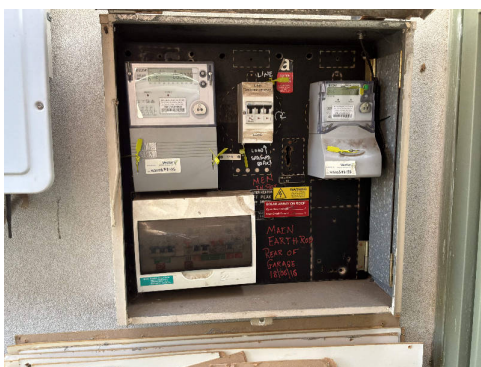
Information: The application of a post-construction chemical termite barrier is highly recommended for all properties, particularly if live termite activity has been found on the site previously. Such barriers are highly effective in preventing termite attack on any timber building elements throughout the property.

A durable notice should be placed in the switchboard unit to indicate current termite barriers. At the time of inspection, it appeared as though no termite management system has been installed, with no evidence to suggest preventative works taking place.

The client may consider gaining further advice from a pest controller as to the costs and procedures involved with this application. It is recommended that obtaining such advice be a short-term priority.

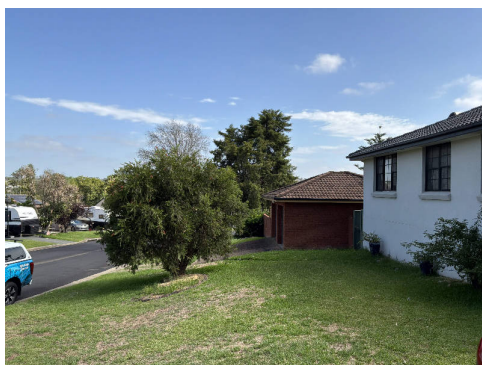
Finding 6.02

Building: Main Building
Location: All Areas
Finding: Trees within 30m of building.

Information: The presence of trees in the surrounding area may be a factor in the building's termite risk profile. Nearby trees and vegetation can contribute to termite activity and potential entry points.

To confirm the presence or absence of termites, an invasive inspection by a licensed pest controller is recommended.

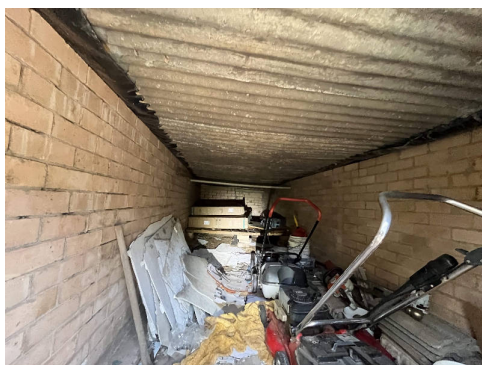
Finding 6.03

Information: The storing of timbers in the subfloor space or around the external property increases the risk of termite activity being present. As they are likely to come into contact with weather conditions or excessive moisture wood rot is likely to develop on timbers that are not treated.

It is highly recommended that any stored timbers be immediately removed from areas in which they may attract any termite / timber pest attack. Minimisation of risk / prevention of termite attack is far more adequate than dealing with the presence of termite activity.

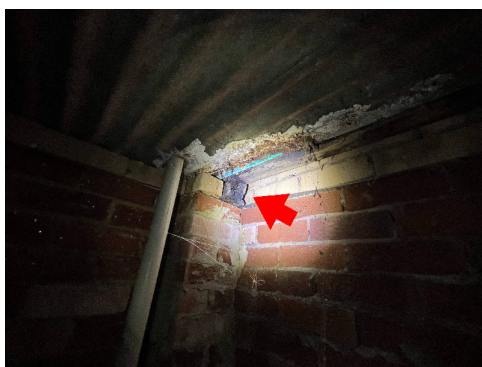
Building: Main Building
Location: Beneath bathroom
Finding: Fungal decay

Fungal decay (wood rot) has been identified in an external timber element, likely caused by prolonged exposure to excessive moisture. The decay is localized to a specific area, with no visible spread to other parts of the building element or adjoining structures. Given the temperature range and presence of oxygen, it's likely the decay has developed due to rain penetration.

The hazard class for this element is H3, indicating a moderate decay risk. The decay appears superficial, with minimal impact on structural integrity or tensile strength. Moisture content likely exceeds 20%, creating an environment conducive to fungal growth.

A qualified carpenter should assess and treat the affected area. Treatment should include removing and replacing decayed timber, and applying compatible preservatives. Proper surface preparation and maintenance are crucial to prevent future moisture accumulation.

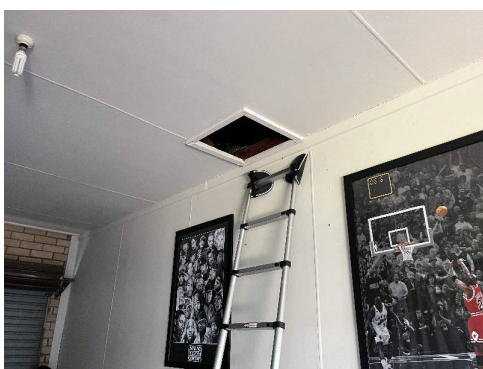
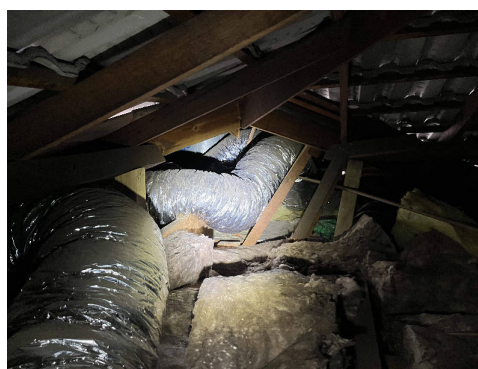
Finding: Second manhole recommend

Information: Due to insulation, trusses not trafficable and ducting in the roof void, it is highly advised that a second access point be installed to the north end of the property to gain access into the roof void for a full inspection. An inspection can not be guaranteed if the area is inaccessible.

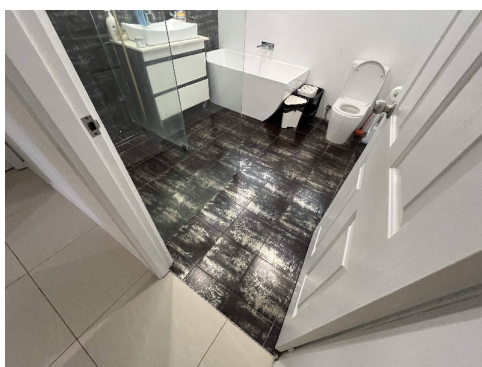
With older property's where this information is unavailable all wet areas should be monitored. Generally waterproofing certificates are only valid for approximately 7-8yrs. If any leaks, water staining, peeling or bubbling of the paint become evident to any adjacent walls or ceilings below a licensed builder or waterproofing specialist is recommended to investigate further.
