Building and Timber Pest Inspection Report VR

Inspection Date: Mon, 9 Mar 2026

Property Address: 290 Valletta Dr, Gables NSW 2765,
Australia

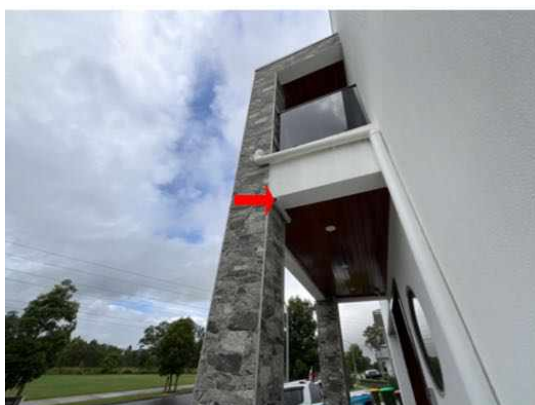
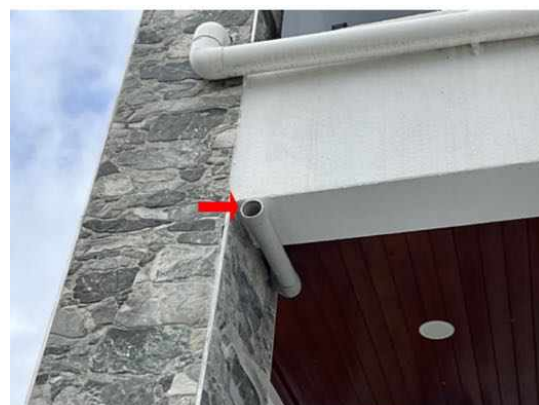
Where roof plumbing doesn't drain adequately, the area at the base perimeter can become excessively damp, potentially creating an environment that is susceptible to rust and corrosion of surrounding building elements, as well as attracting termites and other pests.

It is highly recommended that a licensed plumber be appointed to further inspect the area and to install adequate drainage equipment where necessary.

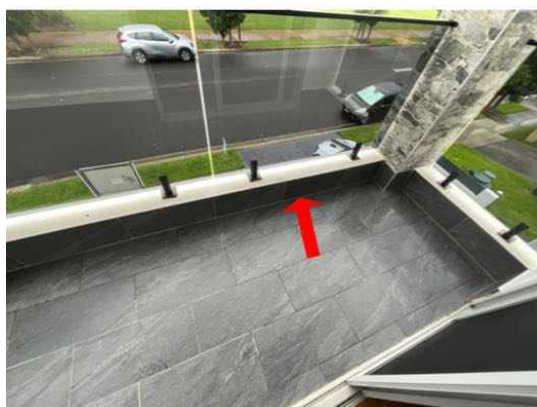
Finding 3.02

Building: Main Building
 Location: Balcony

Finding: Balcony — Missing overflow
 Information: NCC Volume Two (Housing Provisions), Part 10.6 and Part 10.7, and
 AS/NZS 3500.3: Plumbing and Drainage, Stormwater Drainage

Any area exposed to rainfall (including balconies, roofs, and podiums) with a drainage outlet must have an overflow provision to prevent water ingress during blockages. This must be designed for both 20 year ARI and a 100 year ARI.

The client is highly advised to seek further advice from a licensed plumber.

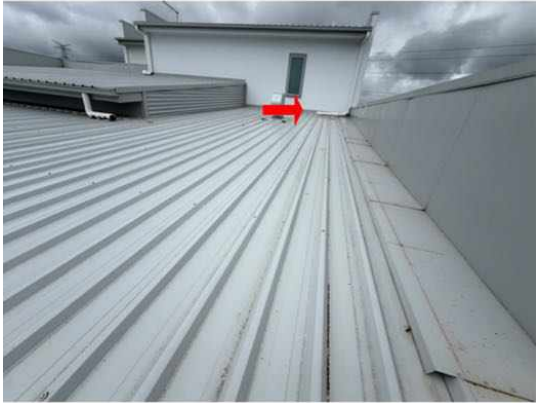
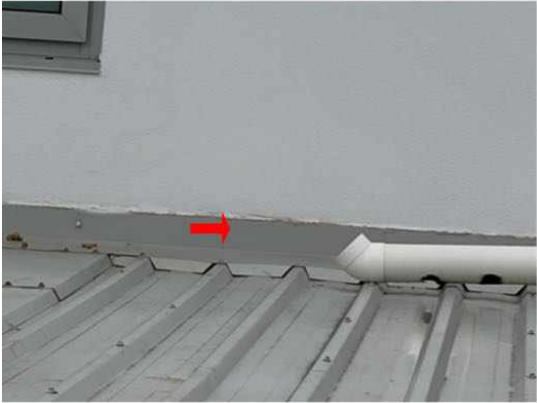
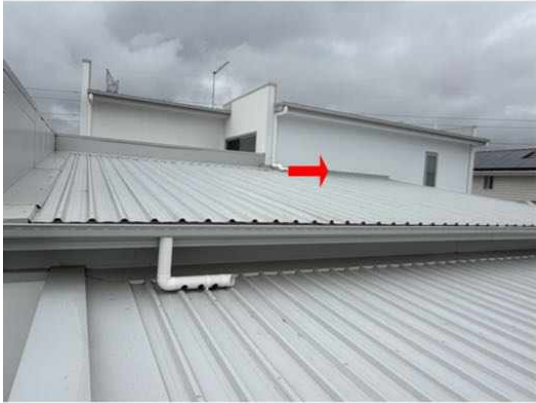
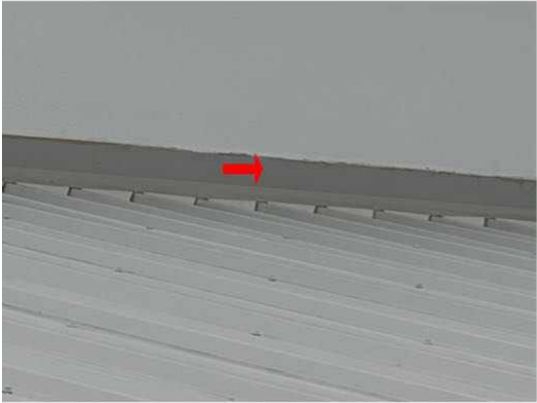
Finding 3.03

Building: Main Building
 Location: Rear elevation
 Finding: Flashing - Defective
 Information: Instances where flashings are defective were noted. It is expected the silicon to wear out causing water leaks in this area.

Flashings that are not installed adequately or are missing are likely to result in water penetration to the interior of the property, as well as creating excessively damp conditions against the exterior surfaces and around the base perimeter of the building.

Premature ageing and secondary building defects are imminent where roof plumbing is missing or inadequately installed. Additionally, water pooling also creates an environment that is susceptible to termite and pest infestation.

The client is highly advised to ensure the manufacturer installation guide is followed.

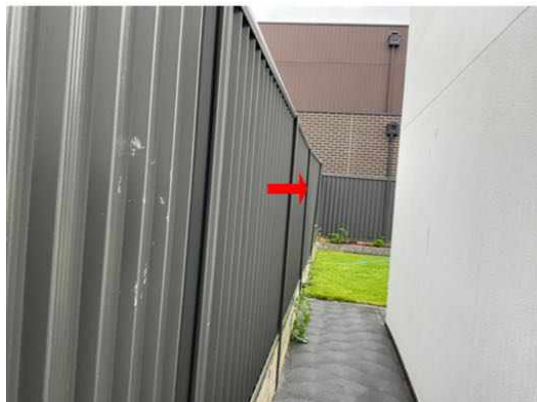
Finding 3.04

Building: Main Building
 Location: Fencing
 Finding: Fencing - Deteriorated
 Information: It was noted at the time of inspection that sections of the fencing in this area has deteriorated. Typically fencing deteriorates due to age and or wear, rot and or rust which is generally expected for a structure of this age, due to prolonged exposure to

weather conditions. Sometimes inadequate installation or maintenance can be to blame.

If left unattended, it is likely that further damage will occur. It is suspected that repair of several elements of the fencing may be required however replacement may be a consideration of the client also.

A licensed fencing contractor should be appointed to provide further advice and perform rectification works as necessary.

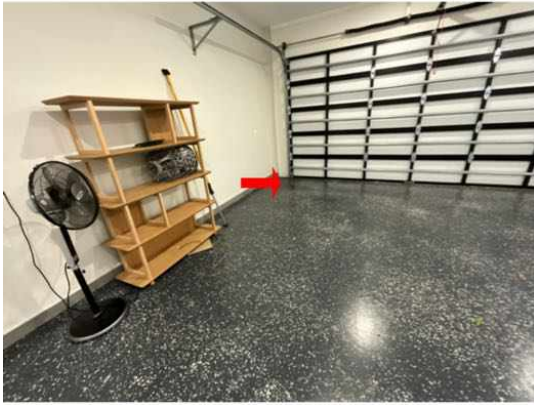
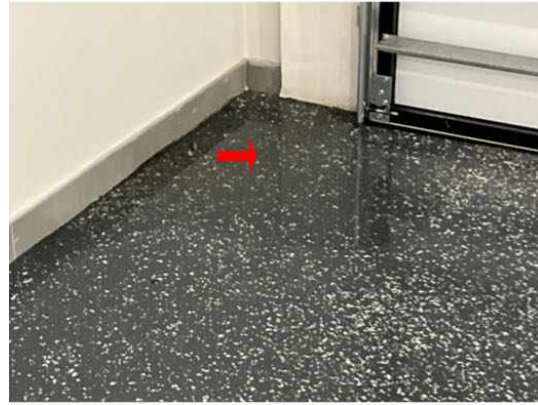
Finding 3.05

Building:	Main Building
Location:	Garage
Finding:	Inadequate Garage Slab Fall
Information:	The concrete garage slab does not have adequate fall toward the garage door/ exterior in this area. As a result, water is unable to drain effectively and pooling occurs on the garage floor. This indicates the slab has been constructed or finished with insufficient grading to direct surface water away from the structure.

Standing water within the garage is considered poor building practice as it can contribute to moisture ingress, deterioration of finishes, potential mould growth and long-term deterioration of the concrete and adjacent building elements.

Good building practice requires surfaces subject to water exposure to be graded to a suitable drainage point. The current condition is inconsistent with the intent of guidance published VSW Fair Trading in the Guide to Standards and Tolerances, which states that external surfaces should be constructed to allow adequate drainage and prevent ponding.

Rectification should be undertaken to improve drainage, which may involve regrading the slab surface or another appropriate drainage measure to ensure water flows away from the garage.

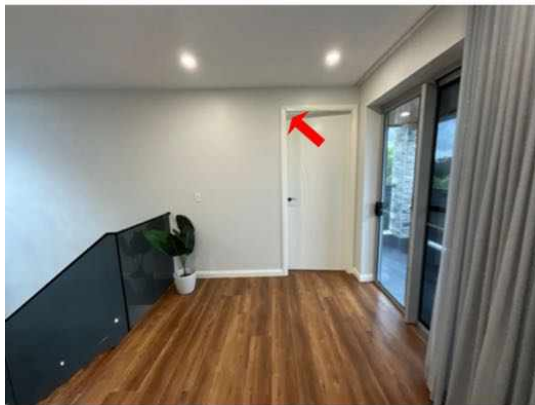
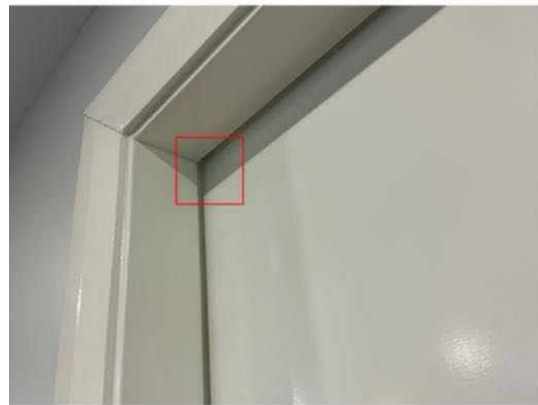
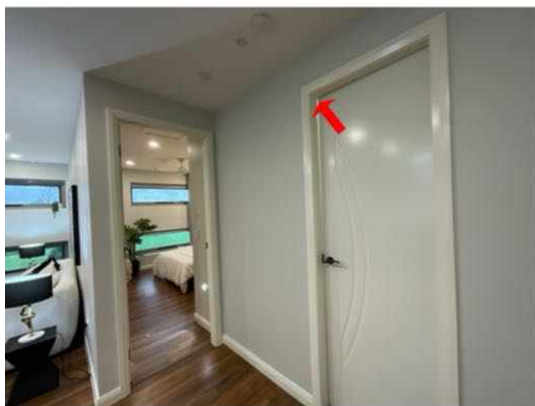
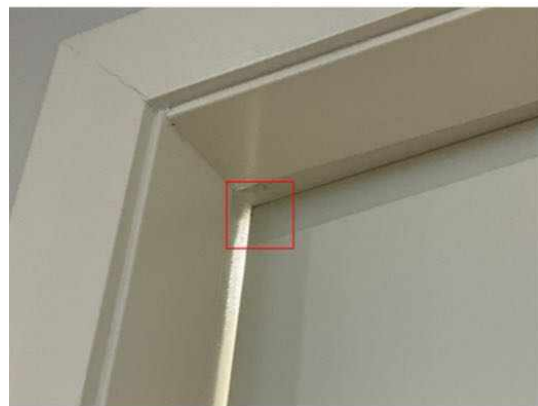
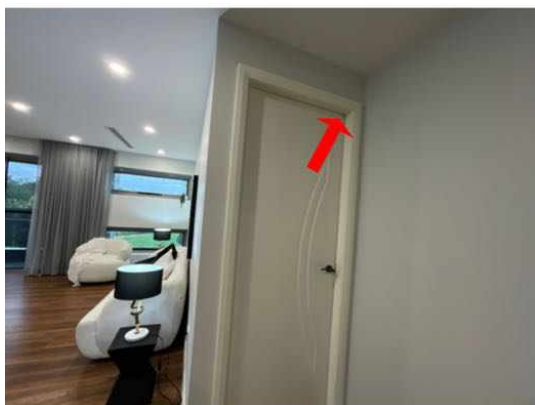
Binding and/or jamming of this door is evident during standard operation. This defect inhibits the functionality of the affected door as well as creating potential for secondary defects to associated building elements, such as damage to the floor covering or adjacent frame.

A door that binds to flooring or to the associated door frame may have several causes, ranging from minor defects, such as poor installation of the door or deteriorated hinges.

A licensed carpenter should be appointed to perform minor rectification works at client discretion.

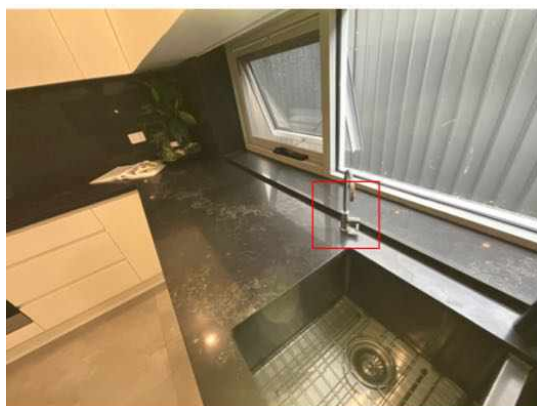
Finding 3.09

Building: Main Building
Location: Pantry - Walk In
Finding: Building element - Not operating
Information:

Non-operational items should be addressed to ensure that the full function of the building structure is available. Where some building elements are not operating as intended, it is possible that secondary building defects could arise due to their non-operation.

Repair and/or replacement of the faulty building element is recommended. It is highly recommended that a licensed plumber be engaged to perform any necessary works.

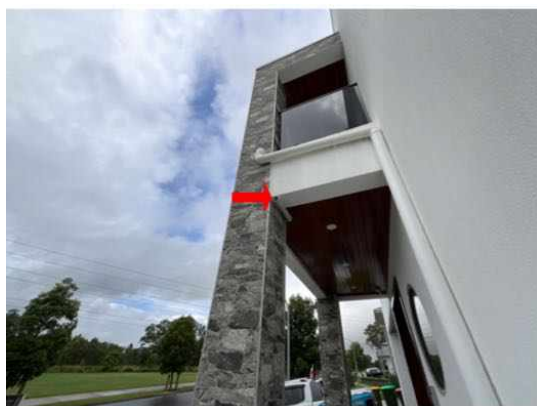
Where roof plumbing doesn't drain adequately, the area at the base perimeter can become excessively damp, potentially creating an environment that is susceptible to rust and corrosion of surrounding building elements, as well as attracting termites and other pests.

It is highly recommended that a plumber be appointed to further inspect the area and to install adequate drainage equipment where necessary.

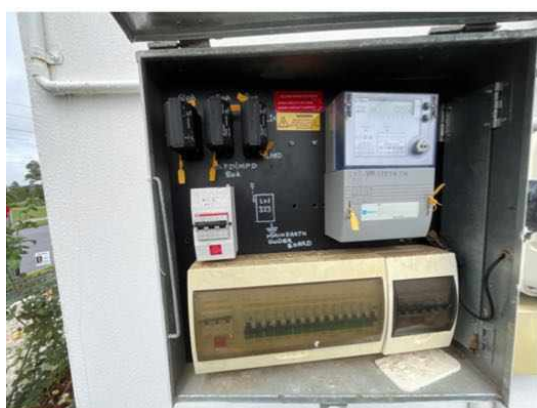
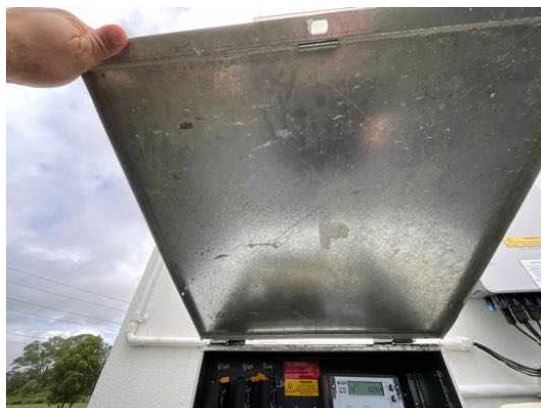
Finding 6.02

Building:	Main Building
Location:	Meterbox
Finding:	Termite Management System - no evidence of installation
Information:	The application of a post-construction chemical termite barrier is highly recommended for all properties, particularly if live termite activity has been found on the site previously. Such barriers are highly effective in preventing termite attack on any timber building elements throughout the property.

A durable notice should be placed in the switchboard unit to indicate current termite barriers. At the time of inspection, it appeared as though no termite management system has been installed, with no evidence to suggest preventative works taking place.

The client may consider gaining further advice from a pest controller as to the costs and procedures involved with this application. It is recommended that obtaining such advice be a short-term priority.

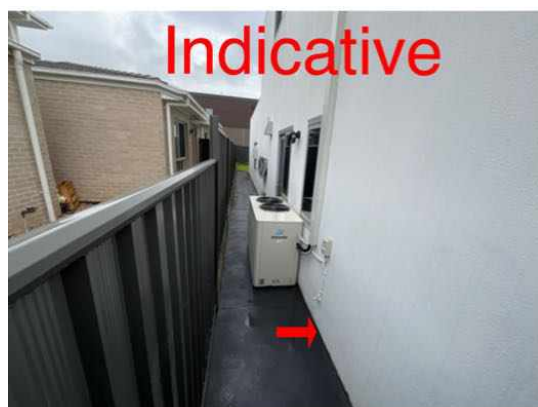
Finding 6.03

Building:	Main Building
Location:	Perimeter

Finding: Slab Edge - Exposure
 Information: Slab Edge Exposure: Where external concrete slab edges are not exposed there is a high risk of concealed termite entry. In some buildings built since July 1995 the edge of the slab forms part of the termite shield system. In these buildings an inspection zone of at least 75mm should be maintained to permit detection of termite entry. The concrete edge should not be concealed by render, tiles, cladding, flashings, adjoining structures, paving, soil, turf or landscaping etc. Where this is the case you should arrange to have the slab edge exposed for inspection. Concealed termite entry may already be taking place but could not be detected at the time of the inspection. This may have resulted in concealed timber damage. Does the slab edge inspection zone fully comply?

Not able to comment. A very high proportion of termite attacks are over the edge of both Infill and other concrete slabs types. Covering the edge of a concrete slab makes concealed termite entry easy. Infill slab type construction has an even higher risk of concealed termite ingress as the slab edge is concealed due to the construction design and cannot be exposed. The type of slab may only be determined by assessment of the construction plans by a qualified person e.g. Builder, Architect. Construction Plans may be obtainable by your local Council or Builder. Termite activity and or damage may be present in concealed timbers of the building. We strongly recommend frequent regular inspections in accordance with AS 3660.2. Where the slab edge is not fully exposed or the slab is an infill slab or the slab type cannot be determined then we strongly recommend inspections every 3 to 6 months in accordance with AS 3660.2 or AS 4349.3.

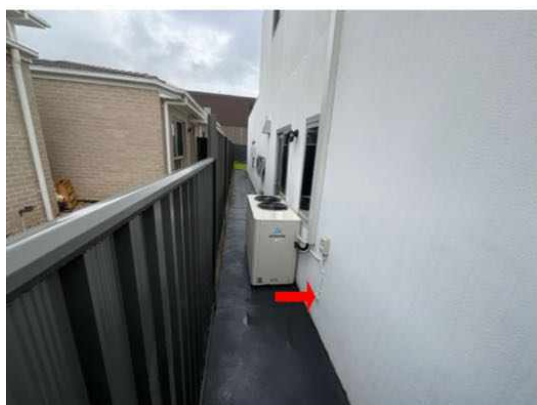
These damp conditions can lead to secondary defects such as rot, rust or corrosion of associated building elements, the formation of fungal decay, or even the creation of potential slip hazards. When coupled with poor site drainage, pooling of water may also attract termite activity to this area.

It is highly recommended that a licensed plumber be appointed to install adequate drainage to the overflow. These works will ensure that the area remains dry and free of any secondary defects.

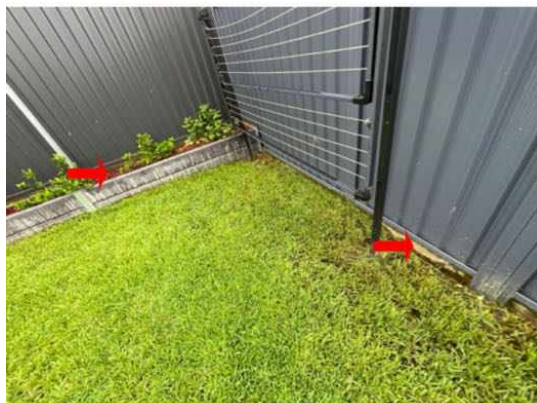
Finding 6.06

Building:	Main Building
Location:	Fencing & Landscaping
Finding:	Building materials in direct ground contact - conducive to termites
Information:	Where timber elements are in direct contact with the ground and consequently

moisture or dampness they become conducive to termite activity. Whether timber is used as a building element part of a fencing structure or stored as an unused item they can provide an environment that is attractive to termite infestation.

When met with excessive moisture timber begins to decay and develop wood rot. Any timbers that are in direct contact with external grounds especially if left untreated or non-durable also provide ingress for subterranean termites into that particular element.

The removal of any such materials that may be conducive to termite activity should be removed as soon as possible to minimise the risk of termite attack.

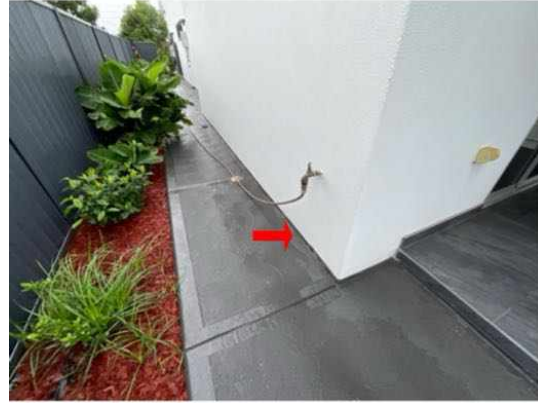
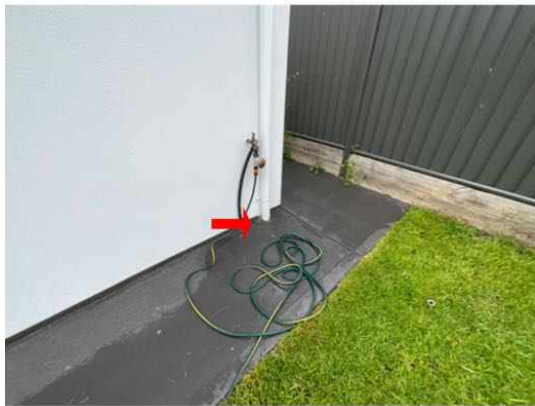
Information: The external tap in this area was noted to have no drain at the time of inspection.

This keeps the surrounding surfaces damp while using the tap, which becomes conducive to termite activity.

A licensed plumber must be appointed to ensure an appropriate drain is installed.
