# Building and Timber Pest Inspection Report

Inspection Date: Wed, 14 Jan 2026

Property Address: 31 Lady Jamison Drive, Glenmore Park  
NSW 2745

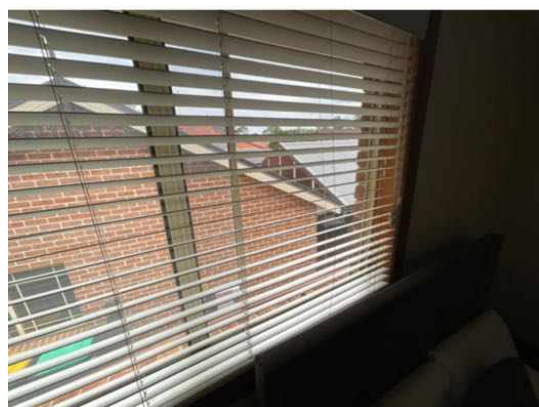
Building:	Main Building
Location:	All Areas
Finding:	Caution: Missing Window Restriction Devices.
Information:	Please note that this is highlighted as a caution only.

It has been noted that window restriction devices are either missing or not installed on the affected windows.

It is strongly recommended that window restrictors be installed to mitigate this safety hazard. A qualified window specialist should be appointed to fit the appropriate safety devices as soon as possible to comply with safety standards and ensure the protection of occupants.

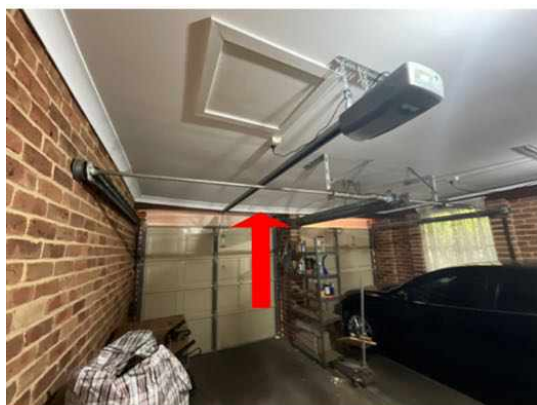
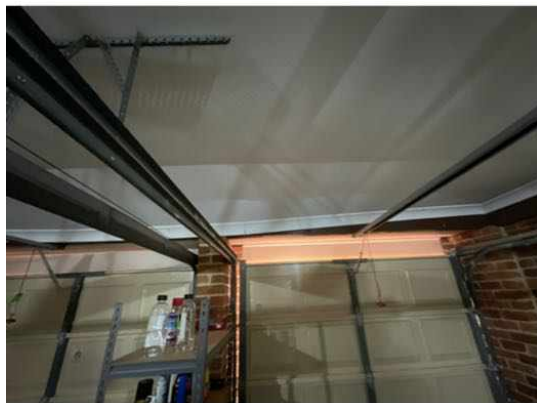
#### Finding 2.01

Finding: Ceiling lining - Localised Ceiling Sagging / Damage.

During the inspection, isolated sections of the ceiling lining were observed to be sagging adjacent to the garage doorway. Partial detachment of ceiling sheets and associated cracking were evident. This condition is commonly noted in garage areas and is typically related to long-term wear and environmental exposure.

- Age-related deterioration or failure of ceiling fixings (nails, screws, adhesives)
- Moisture exposure or humidity-related movement, potentially exacerbated by inadequate or low-grade paint coatings

The partial detachment and cracking of the ceiling lining constitute a major defect, as the integrity of the ceiling system has been compromised. If not addressed, further deterioration is likely, increasing the risk of progressive sagging or localised failure of the ceiling lining.

It is recommended that a suitably qualified trade contractor (such as a plasterer or general interior tradesperson) be engaged to assess the extent of the defect and undertake necessary repairs. Works may include re-gluing and re-fixing the ceiling sheets to the joists and, where appropriate, repainting with a moisture-resistant coating suitable for garage environments. Buyers should allow for repair and maintenance costs. Timely rectification is advised to prevent further deterioration and to restore the functional and visual condition of the ceiling.

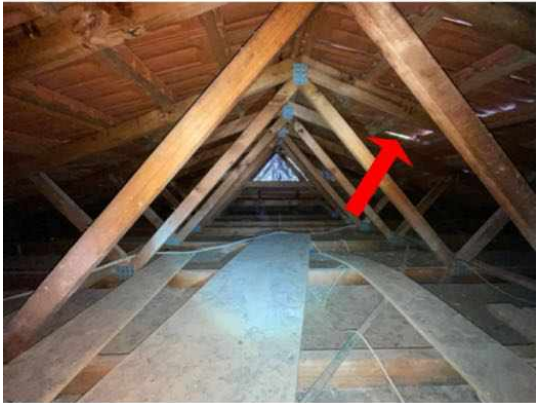
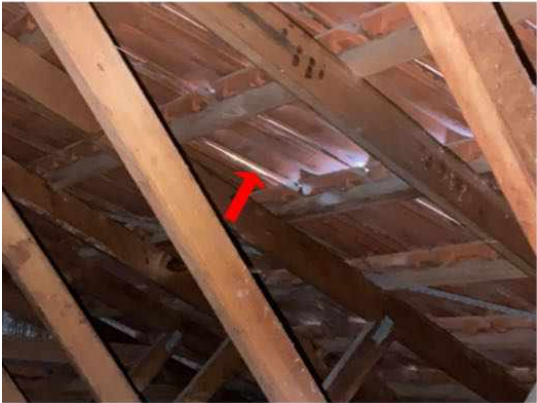
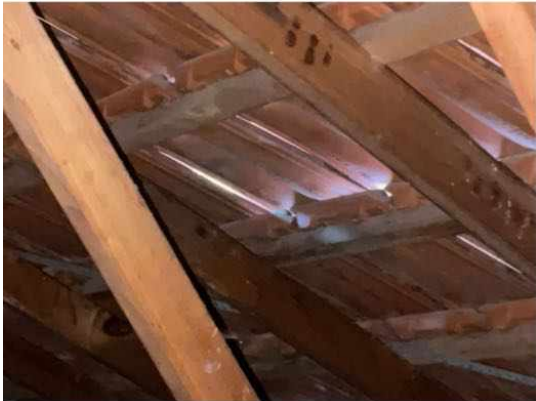
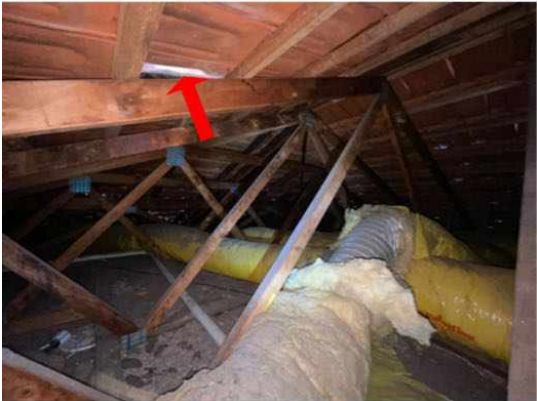
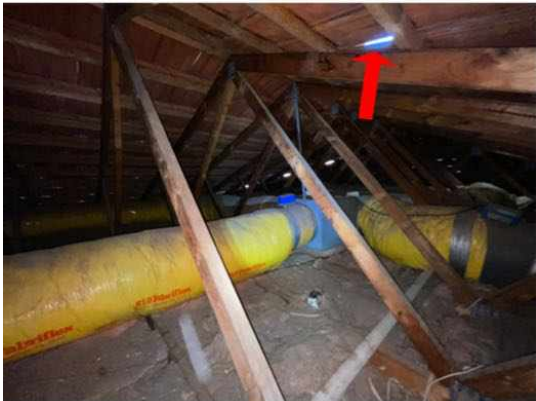
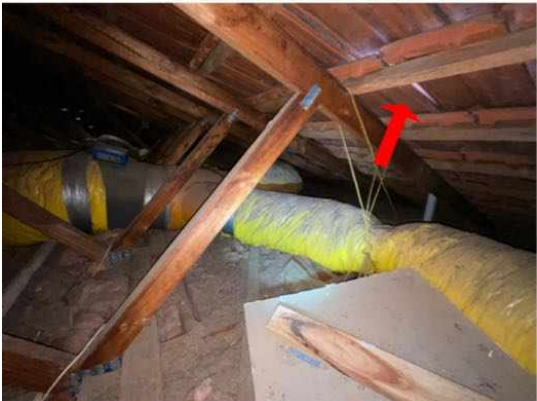
## Finding 2.02

Building:	Main Building
Location:	Roof Void
Finding:	Roof Tiles - Displaced or not seated
Information:	Observation

During the inspection, the roof covering was viewed from within the roof void. Several roof tiles were observed to be displaced and misaligned, creating a visible gap within the roof covering. The tiles were not correctly seated in its intended position, reducing the continuity and effectiveness of the roof's weatherproofing system.

This condition is classified as a major defect, as the displaced tile allows a direct pathway for moisture ingress into the roof cavity. Water penetration may result in deterioration of insulation, ceiling linings, and internal finishes, as well as decay of timber framing members and corrosion of metal fixings. If left unrectified, ongoing exposure to moisture may lead to progressive damage and increased repair costs. There is also a potential safety risk if the tile becomes further displaced during strong wind events.

- Thermal expansion and contraction of roof materials over time
- Minor roof frame movement or settlement
- Inadequate fixing or restraint of the tile at the time of installation
- Wind uplift acting on insufficiently secured tiles

It is recommended that a suitably qualified roofing contractor be engaged to assess

and rectify the defect. Works should include re-seating and securely fixing the displaced tiles and confirming that adjacent tiles are adequately supported and restrained. Rectification should be carried out promptly to reinstate the roof to a sound and weatherproof condition and to reduce the risk of further moisture ingress or tile displacement.

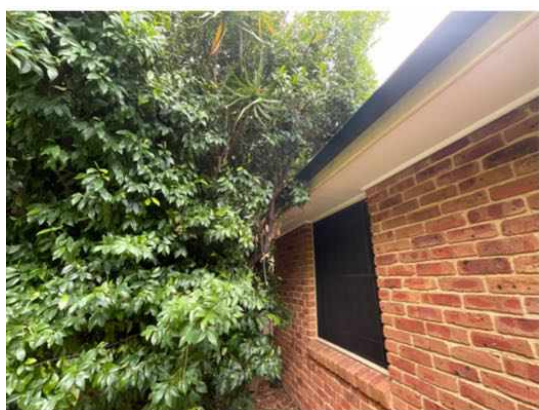
**Finding 3.01**

Location: Front Elevation  
 Finding: Overhanging Trees and Gutter Maintenance – Observations & Recommendations.  
 Information: Overhanging tree branches were observed above the roofline, contributing to the accumulation of leaf litter and debris within the gutters. This condition can adversely affect the performance of the roof plumbing system, particularly during periods of heavy rainfall.

Blocked or restricted gutters impede the effective discharge of stormwater, increasing the likelihood of water pooling or overflow. This may result in accelerated rusting and corrosion of gutters and downpipes, as well as the creation of damp conditions that are conducive to termite activity and other pest issues.

- Prune or remove overhanging tree branches to minimise debris accumulation.
- Clean all gutters and downpipes to restore full drainage capacity.
- Consider the installation of gutter guards as a preventative measure, particularly in heavily treed areas.

General gutter cleaning may be undertaken by the homeowner; however, pruning of larger branches should be carried out by a suitably qualified arborist or landscape contractor. A licensed roof plumber should be engaged to assess the condition of the guttering system and undertake any necessary remedial works. Regular maintenance will assist in preserving roof plumbing components, protecting the building envelope, and reducing the risk of moisture-related damage or pest activity.

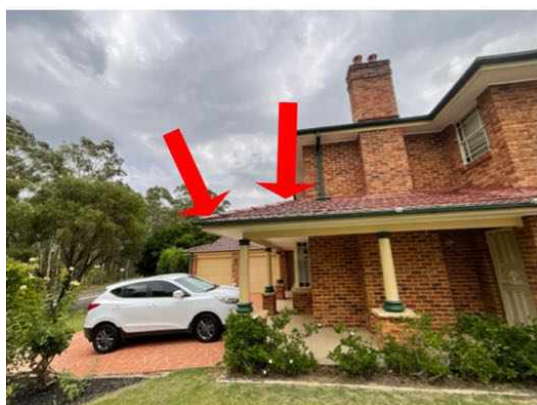
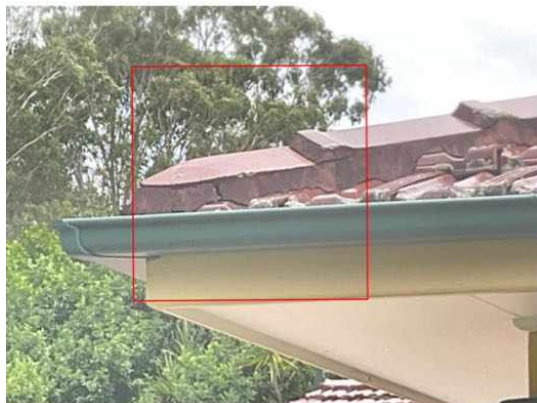
### Finding 3.02

Finding: Roof Tiles – Mortar Deterioration / Capping tile.

The roof tiles were observed to be in average condition at the time of inspection. Isolated areas of loose and cracked mortar were identified to ridge and hip capping tiles, indicating early signs of deterioration. These localized defects suggest that some capping tiles may no longer be fully secure.

This condition is classified as a minor defect at the time of inspection. However, if left unattended, deterioration of mortar to capping tiles may allow moisture ingress into the roof cavity. Over time, this may result in damage to ceiling linings, decay of timber roof framing components, and potential electrical safety hazards. Minor roof defects can worsen progressively and may lead to more extensive and costly repairs if not addressed in a timely manner.

Preventative maintenance is recommended to limit further deterioration and to maintain the overall performance and longevity of the roofing system. A suitably licensed roofing contractor should be engaged in the short to medium term to assess the affected areas and carry out re-pointing or other remedial works as required. Rectification at this stage is considered routine maintenance and will assist in preserving the weatherproofing and structural integrity of the roof.

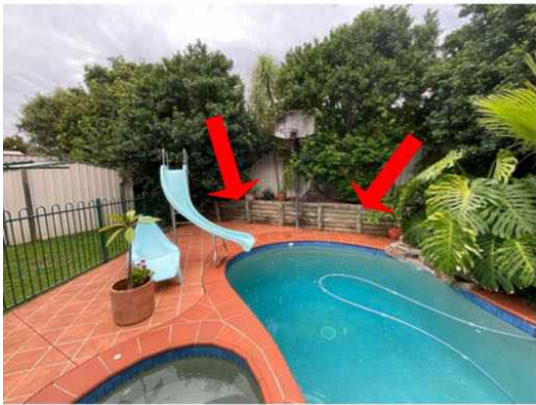
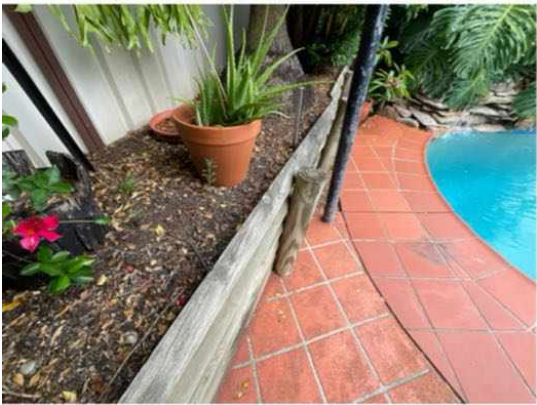
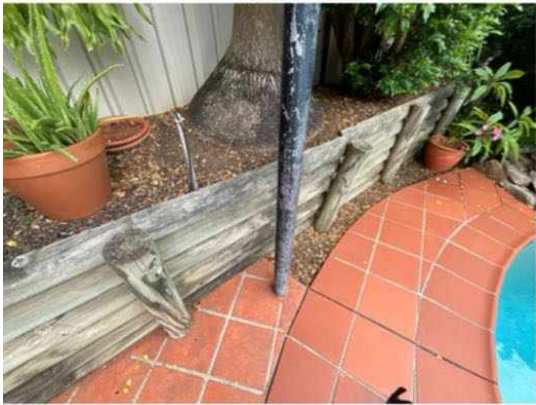
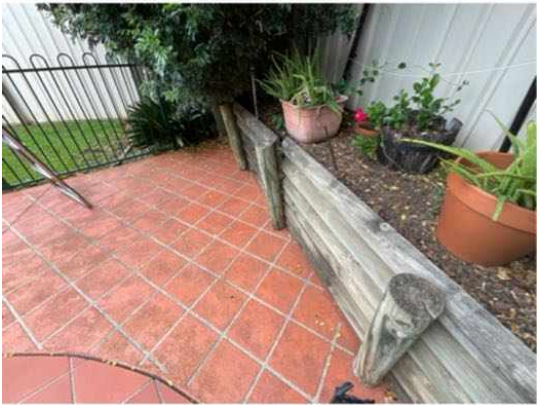
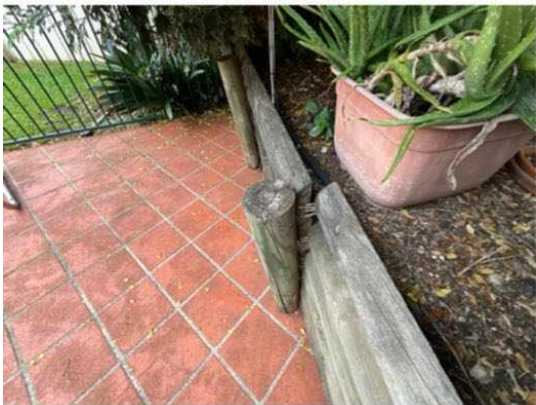
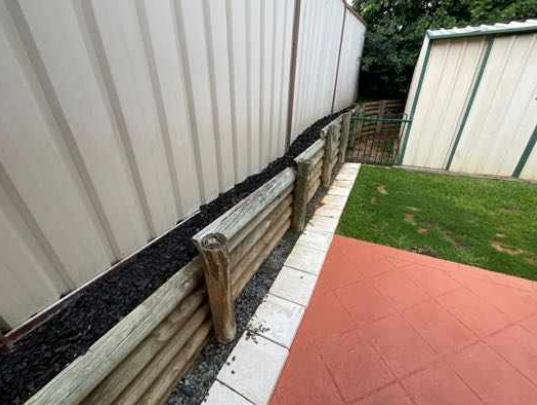
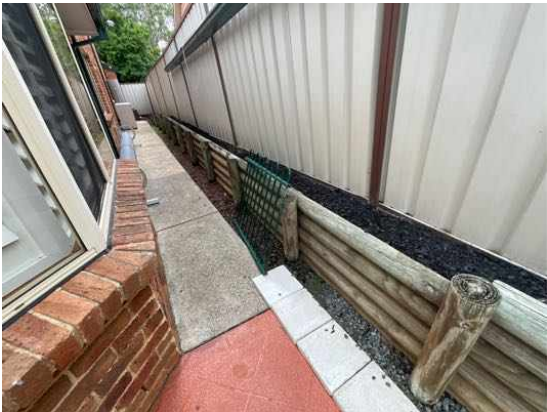
Finding 3.04

Building:	Yard
Location:	Yard - Back
Finding:	Retaining Walls – Treated Pine Sleepers.
Information:	The retaining walls on the property are constructed from treated pine sleepers and are currently assessed to be in average condition.

Minor leaning was noted in several areas, indicative of typical movement and wear expected with this type of construction and its age. While not currently severe, ongoing deterioration is likely over time.

Although the sleepers are treated to resist decay and pests, prolonged exposure to varying weather conditions can diminish the effectiveness of the treatment. As the treatment breaks down, the timber becomes increasingly susceptible to wood rot, general decay, and potential termite activity.

Repairs are advisable as well as regular monitoring of the retaining walls for further movement, leaning, or signs of timber decay become evident. It is recommended that a qualified landscaping contractor be engaged to assess the structure and undertake repair or replacement as necessary.

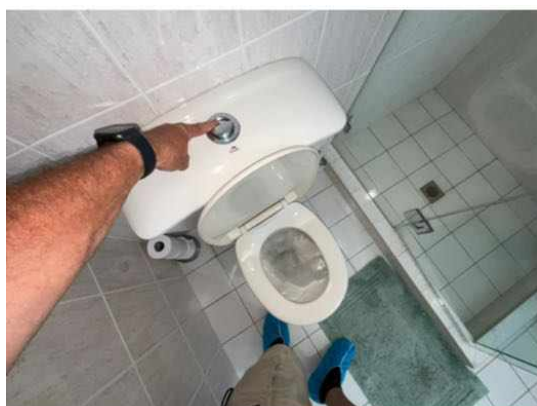
Building: Main Building  
 Location: Ensuite  
 Finding: Toilet - Leak During Operation.  
 Information: Observation

At the time of inspection, the toilet was observed to be leaking during operation, likely from a connection or seal. This type of issue is relatively common in plumbing fixtures.

While currently considered a minor defect, ongoing leakage may result in moisture damage to surrounding building elements, including flooring, wall linings, cabinetry, and structural timbers. If left unattended, continued moisture exposure may lead to decay, corrosion, and more extensive repair requirements.

It is recommended that a licensed plumber be engaged to inspect and repair the toilet as soon as practicable to prevent further deterioration and secondary moisture-related damage.

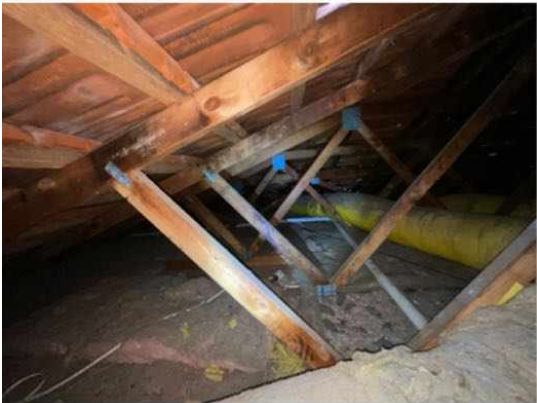
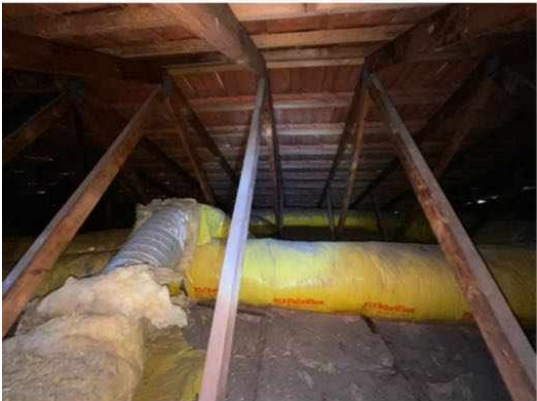
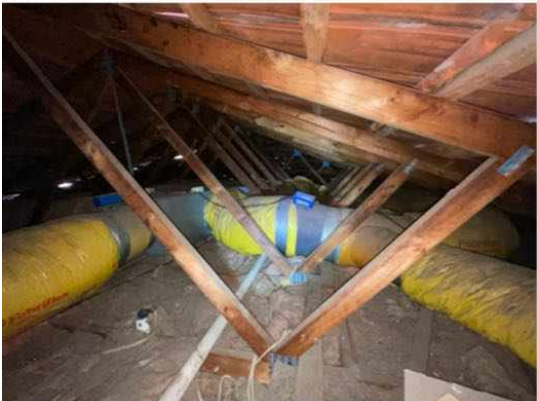
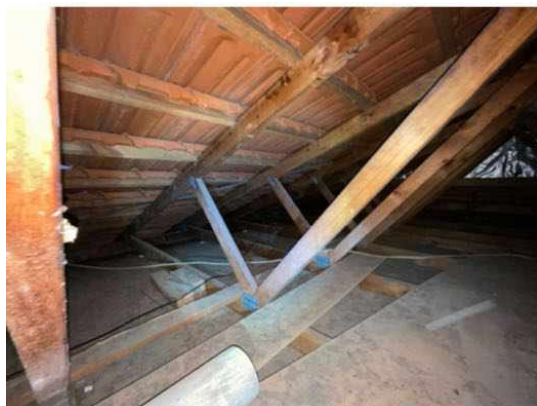
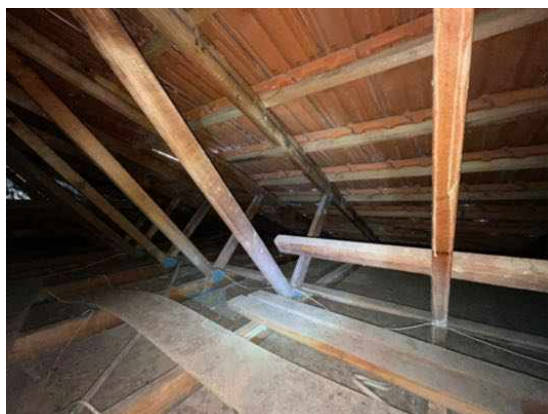
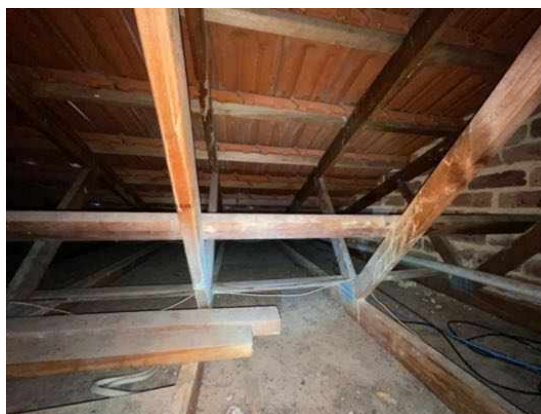
Building: Main Building  
 Location: Roof Void  
 Finding: Roof Void – Limited Accessibility..  
 Information: Observation:

Installation of an additional manhole is recommended to facilitate a re-inspection and enable a more thorough assessment of the roof void in the future. This will help ensure

that all structural elements and concealed areas are properly evaluated.

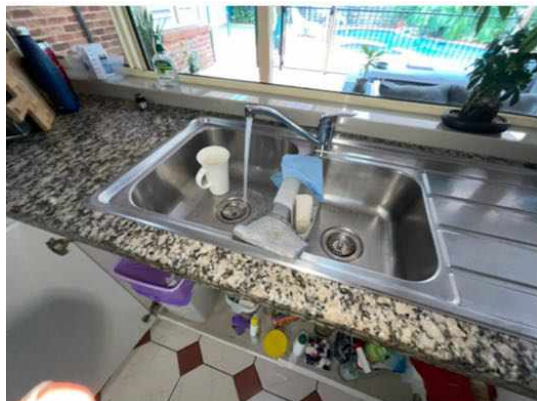
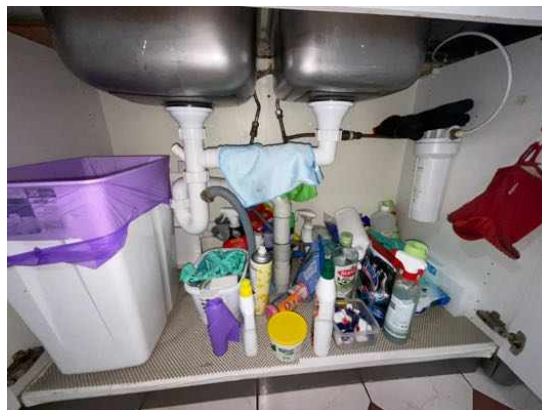
Building: Main Building  
 Location: Kitchen  
 Finding: Kitchen Sink – Overall Condition & Recommendations.  
 Information: Observations:

- It is recommended that the stored items beneath the sink be removed to allow for a full re-inspection of the plumbing and cabinetry, ensuring no concealed defects are present.

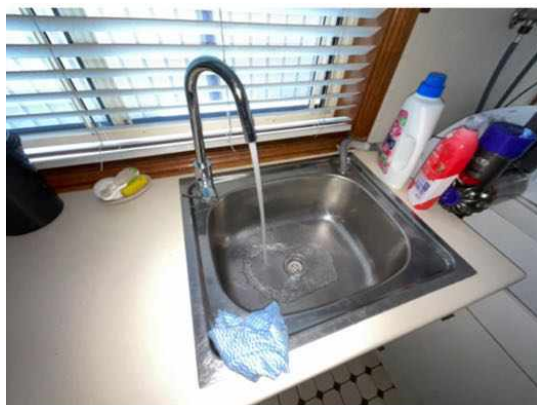
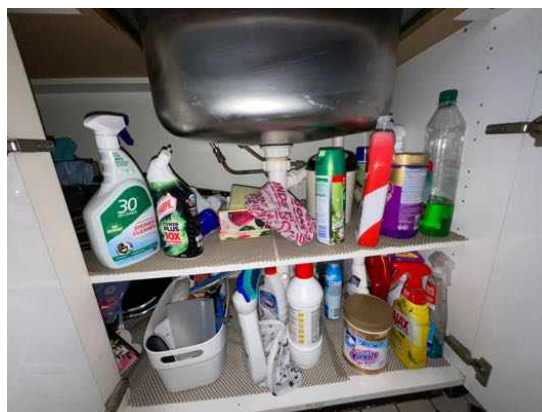
Building: Main Building  
 Location: Laundry  
 Finding: Laundry - Taps/Plumbing/Drainage.  
 Information: Observation: Laundry Tub – Taps, Plumbing, and Cabinetry

- Further monitoring or testing is recommended once the taps are placed into regular use, to ensure no leaks develop over time and that the drainage system continues to perform adequately.
- Flexible and mould-resistant sealant should be applied to junctions between the basin and the wall to prevent water ingress that may lead to damage.
- Regular maintenance and prompt replacement of missing or deteriorated sealant is highly recommended, as this is a common wear-and-tear issue.
- Sealant and grouting in wet areas should be maintained as part of the long-term care and upkeep of the property.

- Where required, a sealant specialist or qualified tiling contractor should be appointed to carry out remedial sealing works.
