Building and Timber Pest Inspection Report

Inspection Date: Fri, 20 Mar 2026

Property Address: 21 Gas St, Singleton NSW 2330, Australia

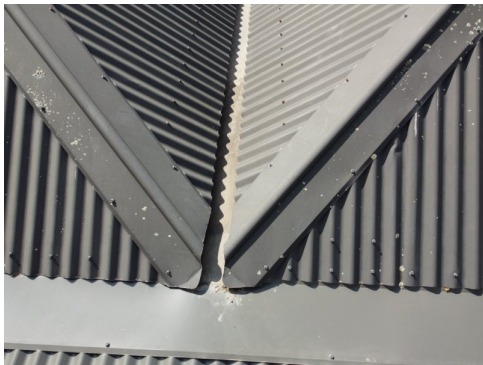
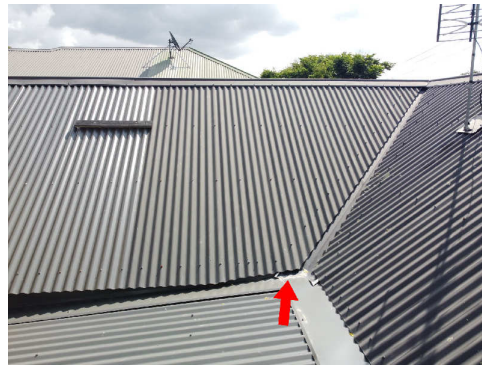
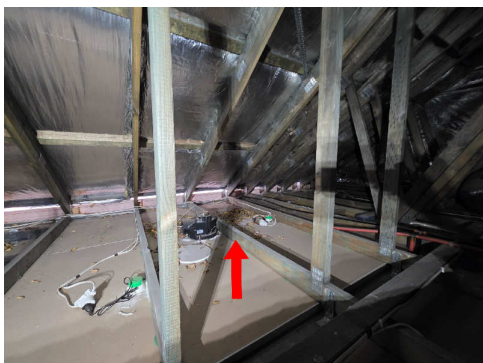
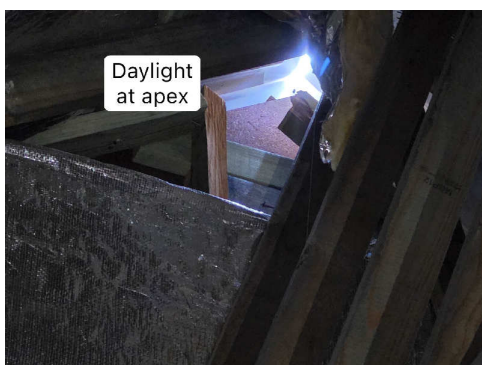
Finding: Defective and incomplete roof flashings, sealing and corrosion – Roof

Information: A number of roof flashings were observed to be incomplete and inconsistently installed across multiple areas. Sections contained holes from previous fixings, and some junctions have been sealed with mastic or silicone rather than properly formed flashing. Flashings showed denting, and barge flashings have been installed in multiple short lengths. Flashings at the base of the chimney appear undersized, with sealant at joints and some fixings exhibiting corrosion. Lichen growth was noted to roof sheeting, along with multiple rusted fixings. The box gutter receiving discharge from three roof planes shows visible corrosion. Within the extension roof space, insulation had not been installed, leaf litter was present indicating debris ingress, and daylight was visible at the roof apex, suggesting incomplete sealing. No active leaks were evident at the time of inspection.

These conditions indicate the roof covering and associated junctions are not fully sealed and may be ineffective in preventing water ingress over time. Corrosion to fixings and the box gutter indicates ongoing deterioration, which may progress to leakage and affect adjacent building elements. The condition of concealed areas could not be confirmed.

A licensed roofer should be engaged to carry out further investigation and rectify as required. This should be done without delay.

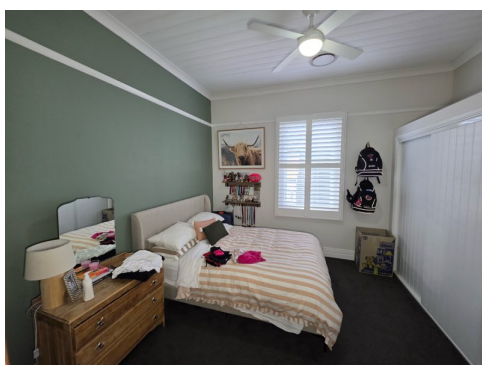
Finding 3.01

Bouncy floors generally indicate that the floorboards or the subfloor structures are coming loose from the joists that they are installed on. Bouncy flooring may also be the result of gaps between flooring and stumps or joist structures, which require packing.

The client is advised to seek quotations for required repairs from a Registered Builder specialising in re-stumping. The potential resolution may range from packing gaps in subfloor structures through to replacement of subfloors stumps and refixing of flooring.

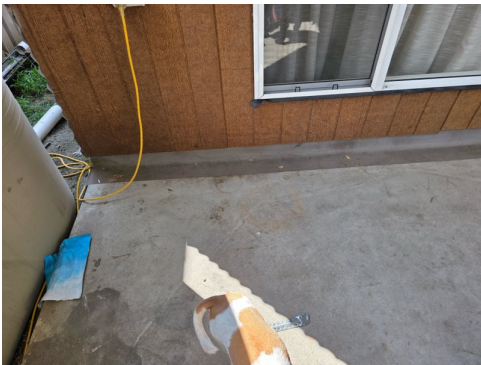
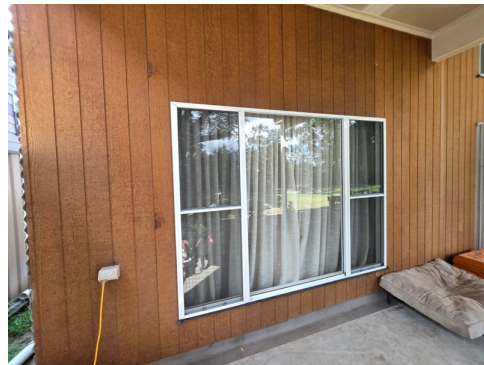
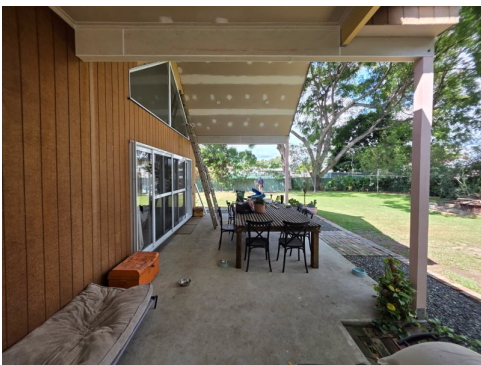
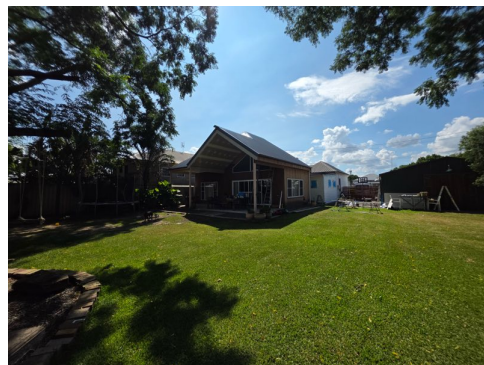
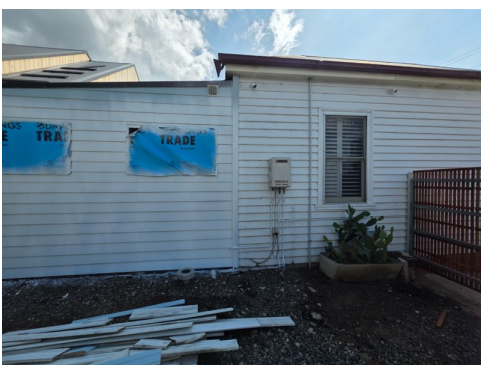
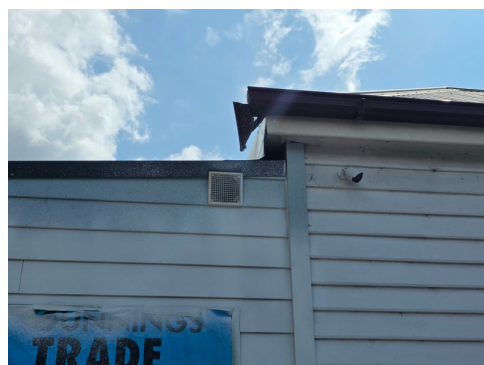
Finding 3.02

Information: External works to the building were observed to be incomplete at the time of inspection, with a builder present on site. Cladding installation is not finished in multiple areas, detailing around windows and doors remains incomplete, and alfresco flooring has not yet been installed. As a result, external envelope detailing and finishes are not complete, and performance in relation to weatherproofing and durability could not be fully assessed.

This condition limits the ability to confirm the standard of workmanship and whether the building envelope will perform as intended once completed. All works should be completed by the current builder, and completion, final detailing, and compliance should be confirmed prior to settlement.

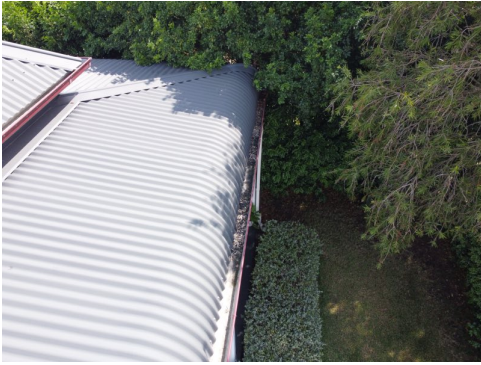
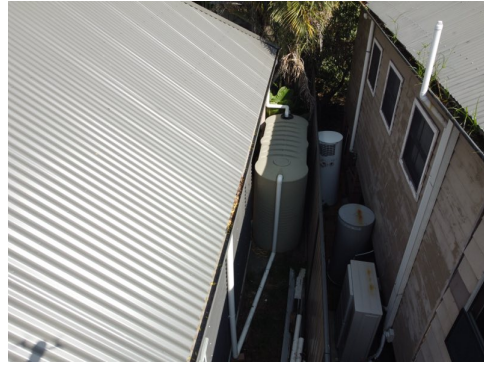
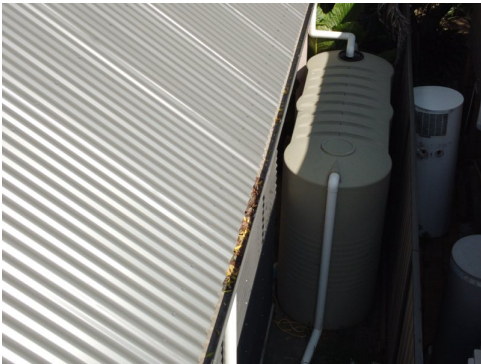
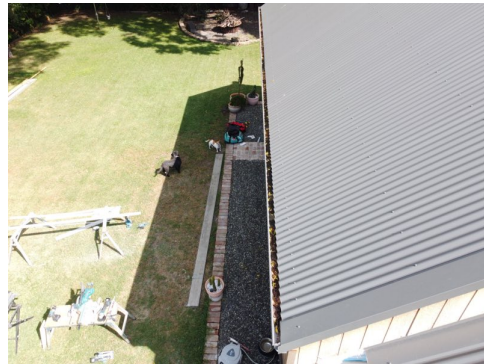
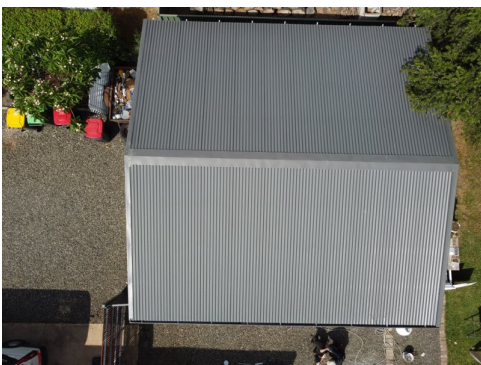
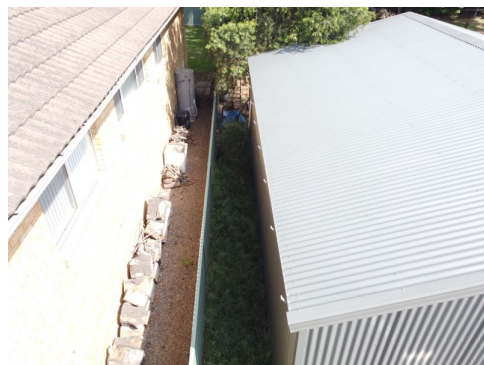
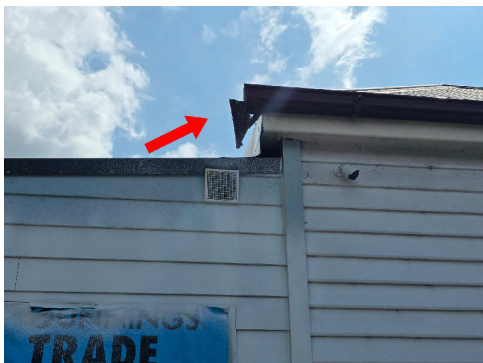
Finding 3.03

Information: A build-up of leaf litter and debris was observed on the verandah roof, within the rear roof valley and to both sides of the extension. This also aligns with debris observed entering the roof void of the new extension above the master suite.

No gutter is installed along the side of the garage adjacent to the boundary. The guttering is incomplete along the side of the original house with a missing downpipe observed along this wall as well.

Debris build-up and incomplete drainage may restrict water flow and contribute to overflow or moisture-related deterioration. A licensed roofer should be engaged to assess and rectify as required. This should be done as soon as practicable.

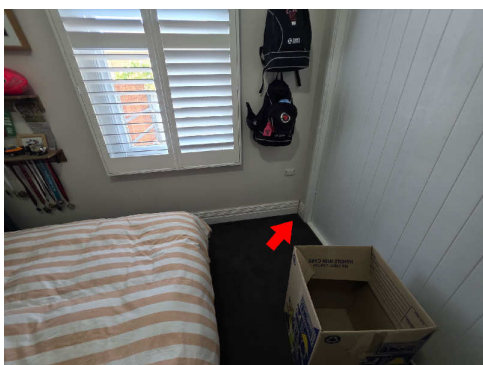
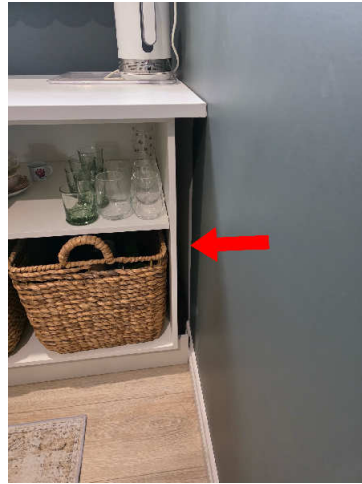
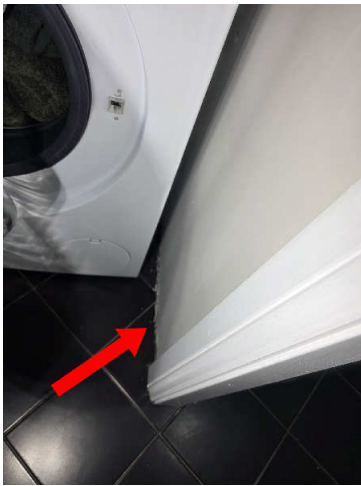
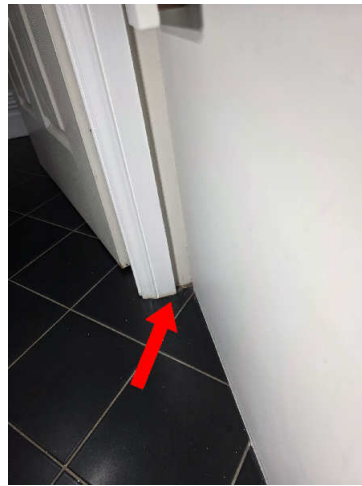
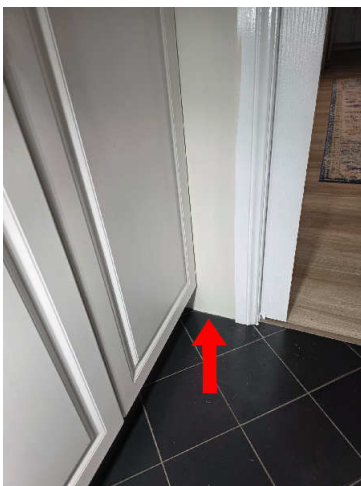
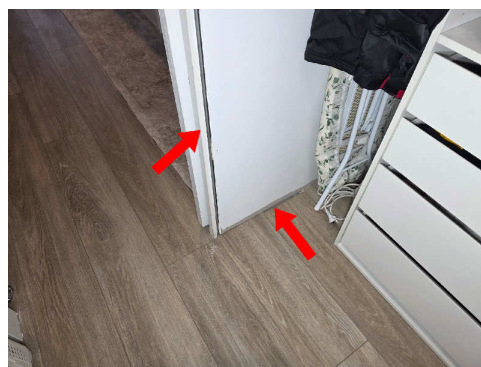
Finding 3.04

Information: A number of internal items remain incomplete following recent renovation works, including joinery, trims, doors and general finishes across multiple areas of the house.

These items are unfinished and may leave building elements more susceptible to damage until completed. A licensed builder should be engaged to assess and complete works as required. This should be done as soon as practicable.

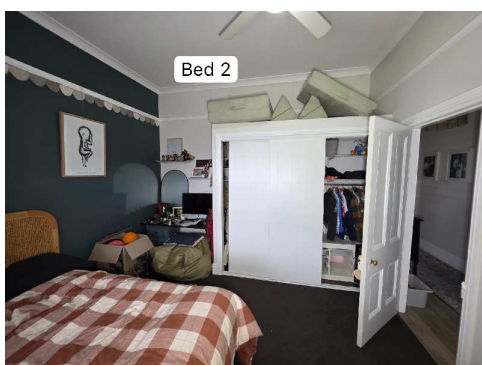
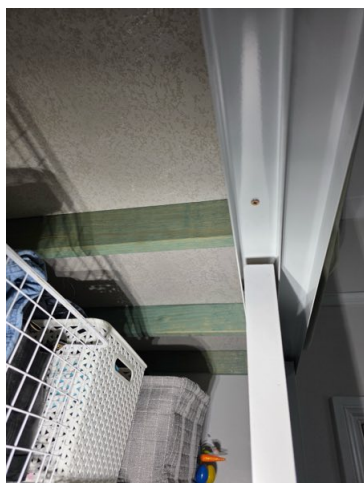
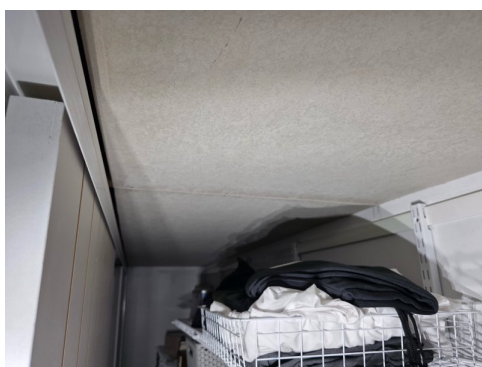
Finding 3.05

Information: The wardrobe in bedroom 2 is incomplete, with a missing sliding door and unlined wall and ceiling. The wardrobe in bedroom 3 has been sheeted but remains unfinished, with no setting, sanding or painting carried out.

A licensed builder should be engaged to assess and complete works as required. This should be done as soon as practicable.

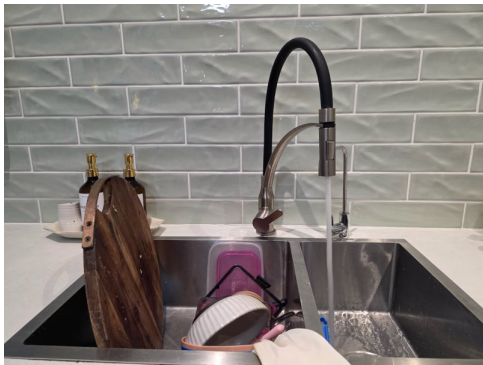
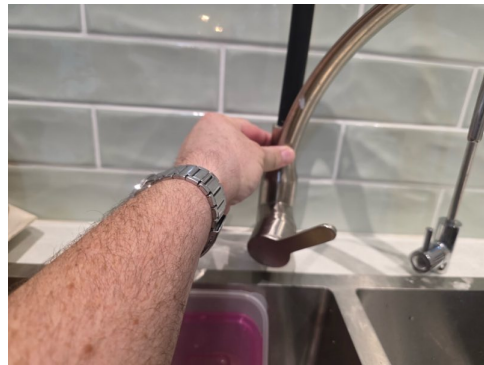
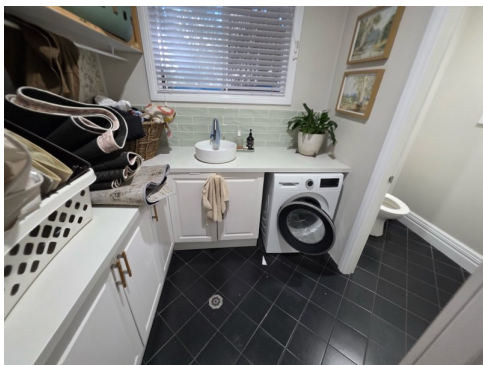
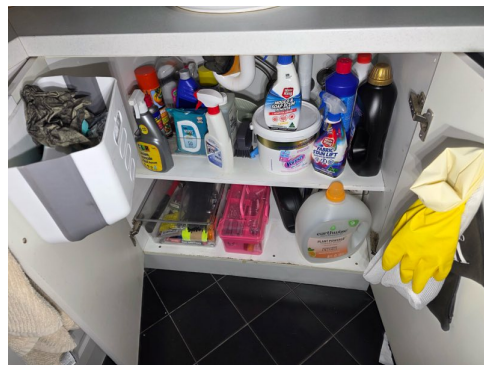
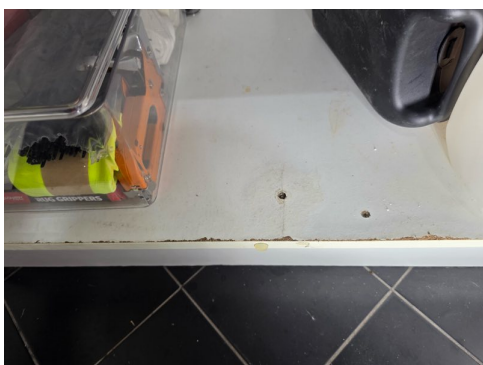
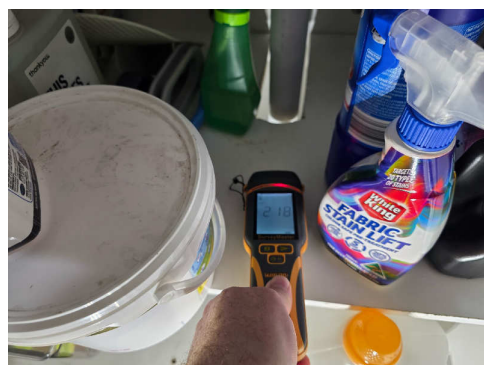
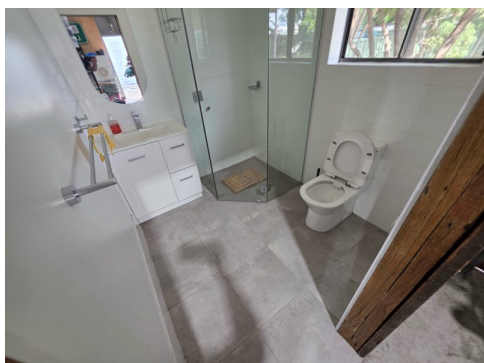
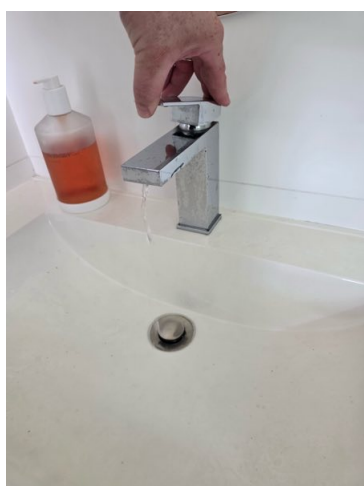
Finding 3.06

Building:	Main Building
Location:	Kitchen, Laundry, Garage
Finding:	Plumbing defects and moisture impact – Kitchen, laundry and garage
Information:	<p>The kitchen tap was loose at its base, moisture damage was observed to the cabinet beneath the laundry sink with low-level elevated moisture readings, and within the garage shower and toilet area no cold water was connected, with hot water discharging irregularly and forcefully. These conditions are consistent with defective or incomplete plumbing and localised moisture exposure.</p> <p>If left unaddressed, ongoing moisture may lead to further deterioration of cabinetry and unreliable use of fixtures. A licensed plumber should be engaged to carry out further investigation and rectify as required. This should be done as soon as practicable.</p>

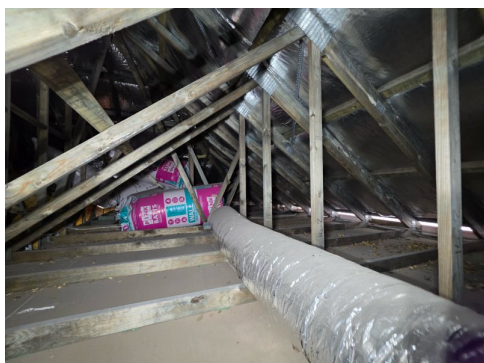
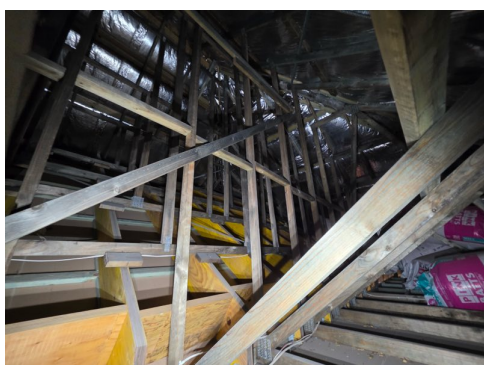
Finding 3.07

Information: Insulation batts were observed in the roof void over the new extension; however, these had not been laid out across the ceiling at the time of inspection. As a result, insulation coverage to this area is incomplete and the thermal performance of the ceiling could not be achieved in its current state.

This may result in reduced energy efficiency and inconsistent internal temperatures until installation is completed. The insulation should be properly laid out across the ceiling by the current builder to ensure full coverage. This should be completed prior to settlement.

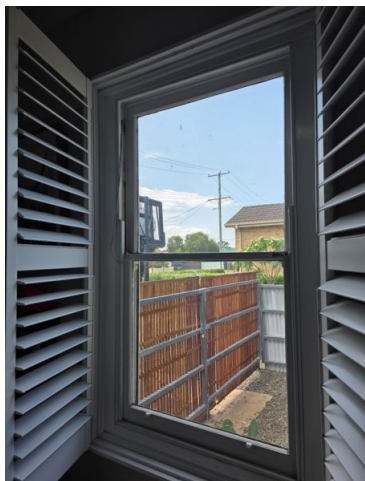
Finding 3.08

Finding: Loose sash cord – Bedroom 3 window

Information: The sash cord to the bedroom 3 window is loose, indicating the sash weight is not properly connected. The sash is unlikely to remain in position when opened.

This affects normal operation and may lead to further damage if used in this condition. A qualified carpenter should be engaged to assess and rectify as required. This should be done as soon as practicable.

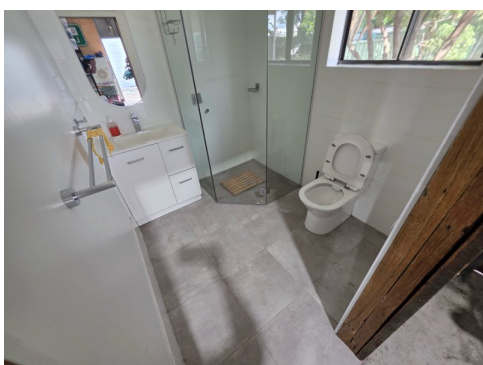
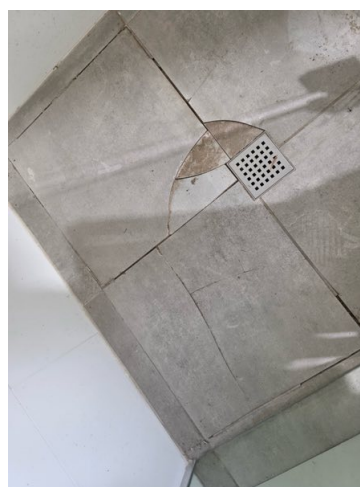
Finding 3.09

Finding: Broken floor tiles – garage shower

Information: Multiple floor tiles in the garage shower were observed to be cracked and fractured around the floor waste, consistent with impact damage from a heavy object. The damage is localised but has resulted in broken tile surfaces and compromised grout lines in this area. The condition of the underlying substrate and waterproofing could not be confirmed at the time of inspection.

Given the location in a wet area, the damaged tiles may allow water to penetrate beneath the surface and affect underlying materials over time. A licensed builder should be engaged to replace the affected tiles and make good as required. This should be done as soon as practicable.

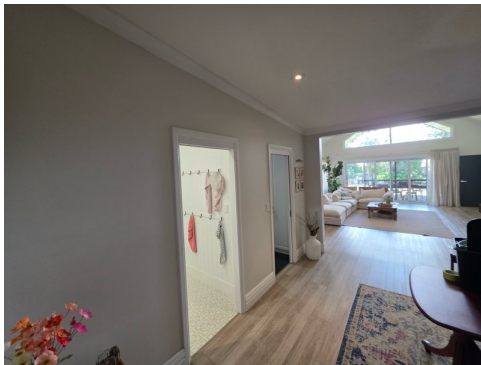
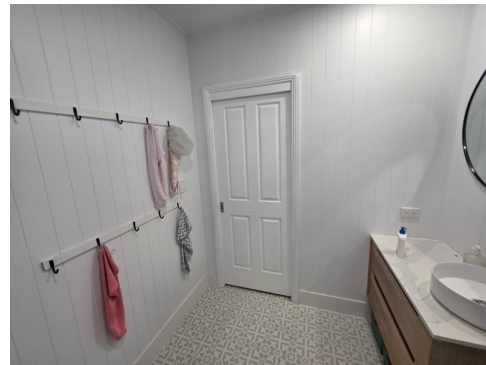
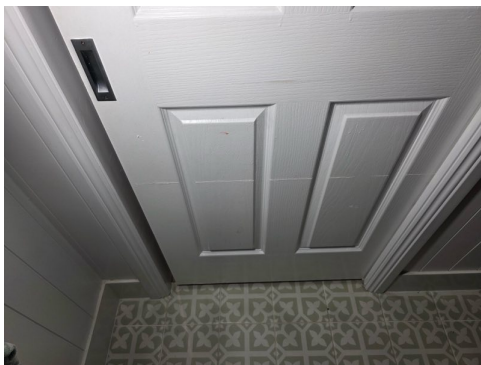
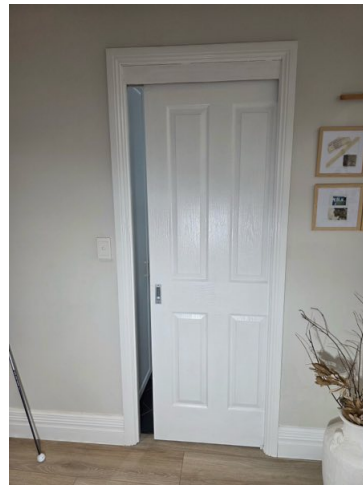
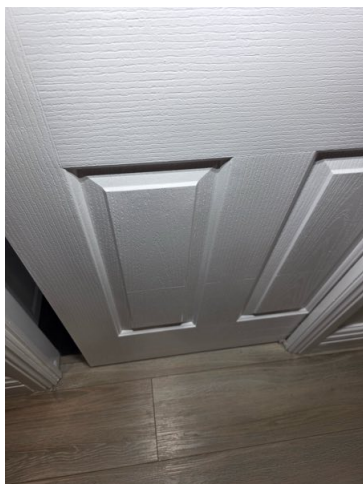
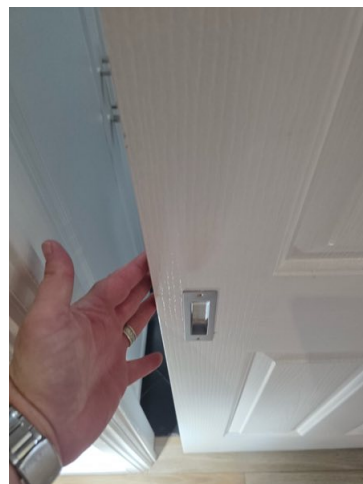
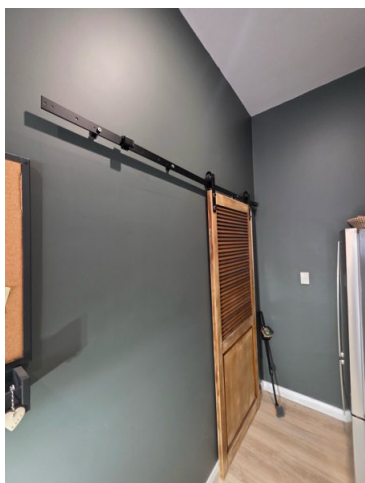
Finding 3.10

Finding: Damaged and restricted sliding doors

The sliding door to the laundry was noted to be stiff and difficult to operate, and also has a scratch to the door face consistent with contact against a protruding fixing within the cavity.

The sliding door in the pantry is mounted on a faced fixed track. This track is insufficiently fixed to the wall and is dipping in the middle.

Ongoing use in this condition may result in further damage and reduced functionality of the doors. A qualified carpenter should be engaged to assess and rectify as required, including removal or trimming of protruding fixings and adjustment of door operation. This should be done as soon as practicable.

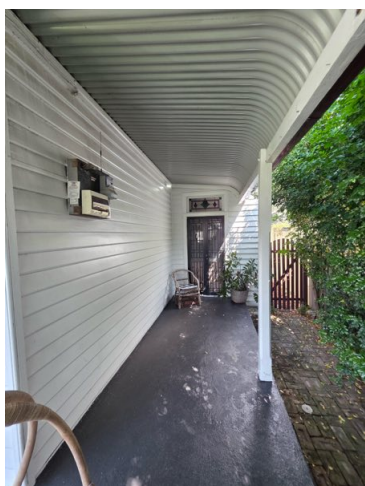
Finding 3.11

Information: The electrical meter board along the side of the verandah is not enclosed within a protective meter box and is exposed to weather.

Exposure may contribute to deterioration of components over time. A licensed electrician should be engaged to assess and rectify as required. This should be done as soon as practicable.

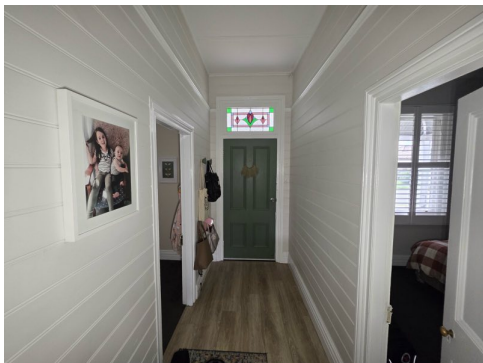
Finding 3.12

Information: The light switch adjacent to the front door did not operate at the time of inspection. The fault appears to be isolated to the switch or local circuit, however no further testing was carried out.

This affects normal use of the area. A licensed electrician should be engaged to assess and rectify as required. This should be done as soon as practicable.

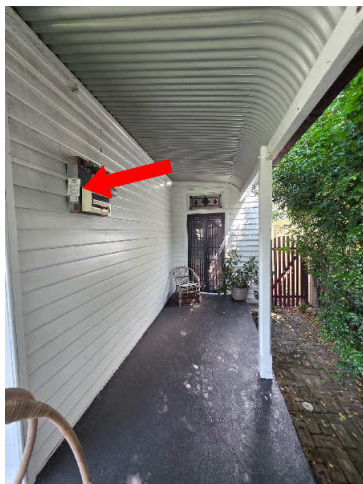
Building: Main Building
 Location: Verandah
 Finding: Durable Present - Durable notice observed in meter box

A durable notice was observed in the meter box at the time of inspection, indicating that a termite management system has been installed at the property. The notice provides information on the type of system and treatment date, as required under AS 3660.1 and AS 3660.2.

While this confirms the presence of a past treatment, it does not verify the current effectiveness of the system. It is strongly advised that an ongoing termite management plan be established by a licensed pest controller. This should be addressed without delay.
