Building and Timber Pest Inspection Report

Inspection Date: Wed, 18 Feb 2026

Property Address: 13 Jamieson Ct, West Wodonga VIC 3690,
Australia

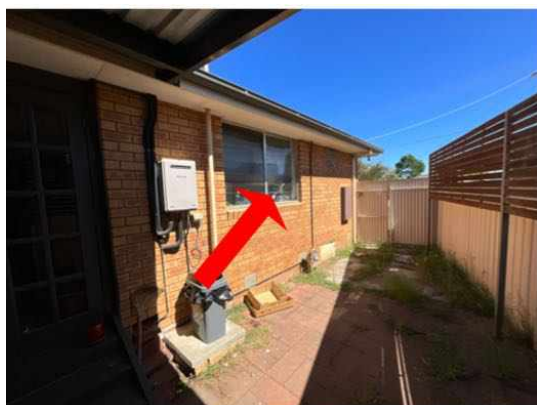
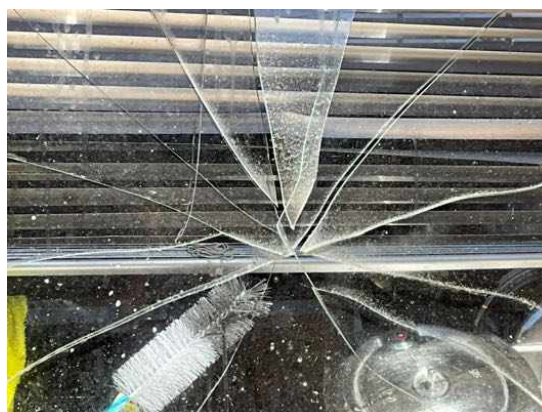
| Finding: | Window - Cracked |
| Information: | Cracks were identified in the window in this area. Cracking in windows is generally the result of impact damage, and is likely to develop further when left unmanaged. |

The likelihood of this windowpane further cracking and shattering is increased exponentially, providing a safety hazard in the area. The cracked window also impairs the weather tightness of the building, creating potential for minor water leaks.

A qualified glazier is required to repair the window as soon as possible. Depending on the extent of the cracking, replacement of the window may be required. Please be advised that any persons coming into contact with the cracked window should do so with due caution to avoid any personal injury that may ensue.

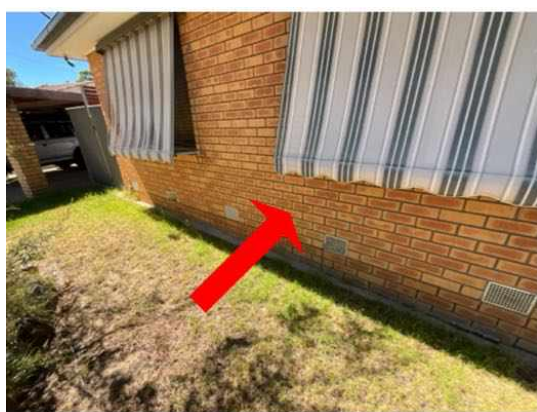
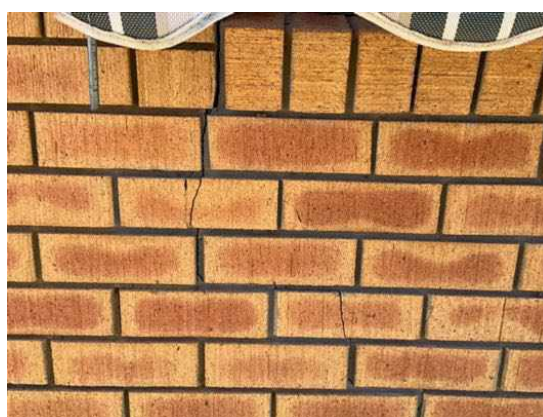
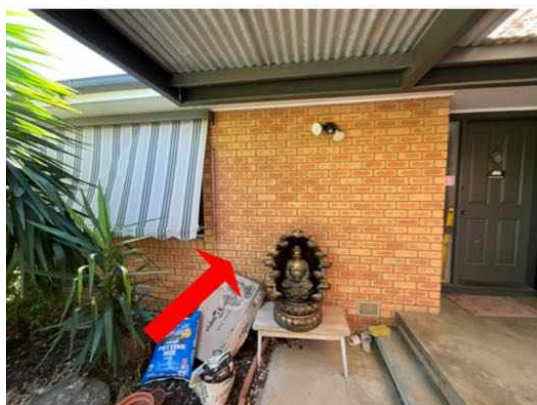
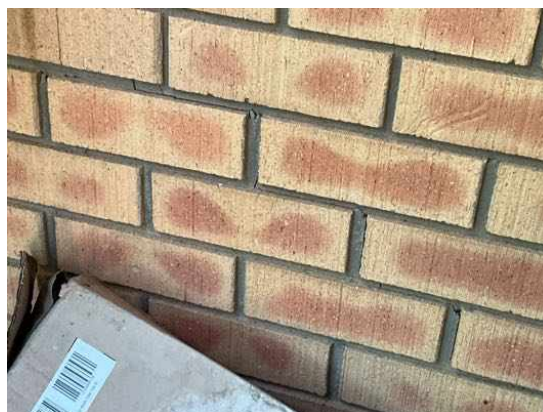
| Finding: | Brickwork- Step cracking |
| Information: | Step cracking was identified to the brickwork in this area at the time of inspection. |

Step cracking, which is similar to other forms of cracking, has a variety of possible causes. However, the most common is the subsidence of adjacent footings.

Step cracking is a relatively common defect, and is most likely to occur adjacent to windows, doors and other openings. Mortar failure in the gaps between affected bricks indicates the stresses and tensions affecting the wall.

Minor step cracking can be used as a warning sign to address factors causing stress to the wall, which can include the effect of surrounding trees, water leaks, soil erosion, or even the presence of reactive soils in the surrounding area.

If cracks increase in size or number contact a Licensed builder immediately to make all needed repairs.

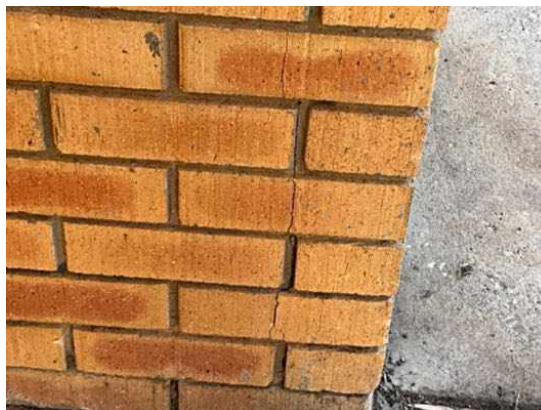
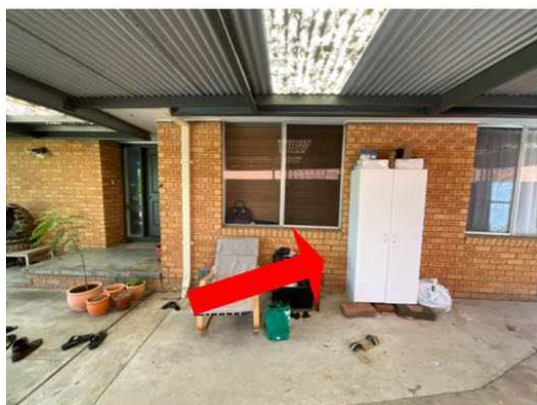
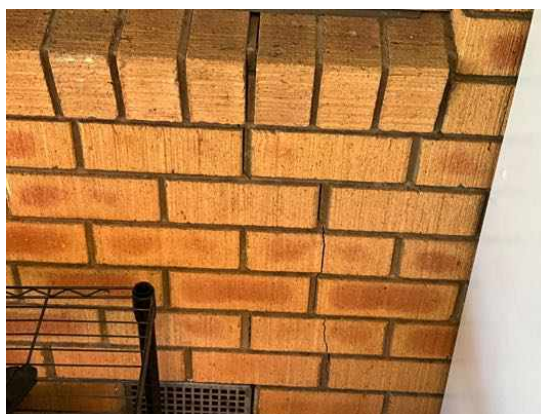
Finding 3.02

| Finding: | Brickwork - Cracking [Fine] |
| Information: | Although fine cracks are quite noticeable, they are often only considered to be an appearance defect and usually do not indicate any structural damage. Generally, the cause of a fine crack is indicative of a separation between brickwork and mortar throughout the structure, but single bricks may also show cracks of this nature. |

Cracking of this nature can generally be repaired with minor filling and should be conducted by a qualified bricklayer.

Always contact a building inspector should cracks widen lengthen or become more numerous.

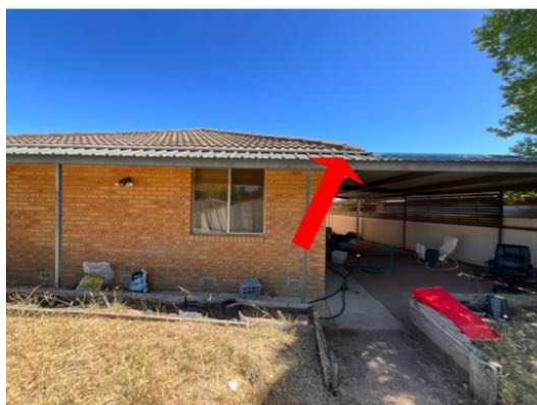
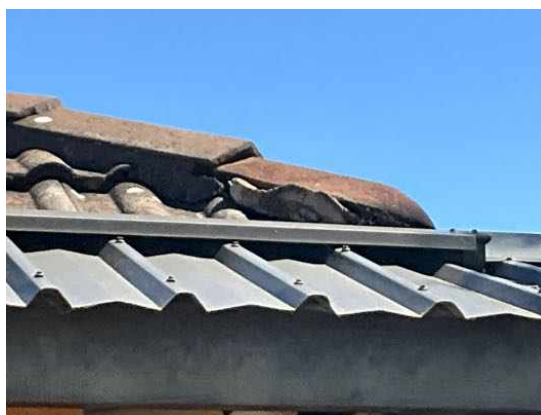
Finding 3.03

| Finding: | Mortar - Deterioration |
| Information: | Mortar, or 'bedding', is the material which fills joins and intersections between tiles and other building elements on the exterior roof covering, such as gable ends, hip capping and valleys. Upon inspection of the exterior roof, it was noted that sections of the mortar show varying levels of deterioration. |

Mortar generally deteriorates as a result of frequent exposure to weather conditions over a prolonged period of time. Mortar that is deteriorating may allow water ingress into the roof void, putting associated building elements and roofing structures at risk of water damage. Deteriorated mortar also detracts from the functionality of roof tiles and other roofing elements, potentially decreasing weather tightness and roof drainage.

Mortar deterioration can be attended to by a handyperson where areas of deterioration

are localised and easily accessible. Otherwise, consultation with a roofing contractor is advised where greater works are required.

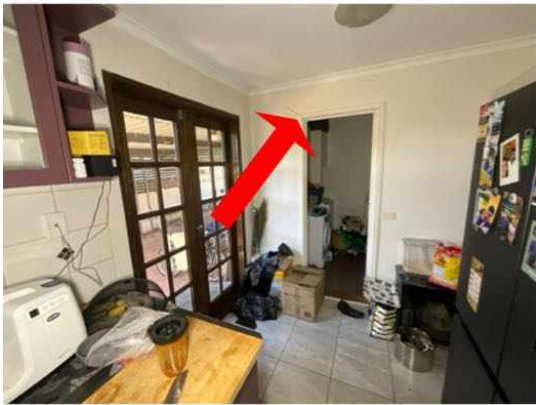
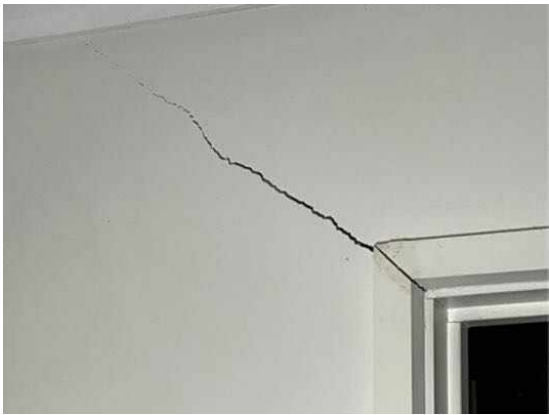
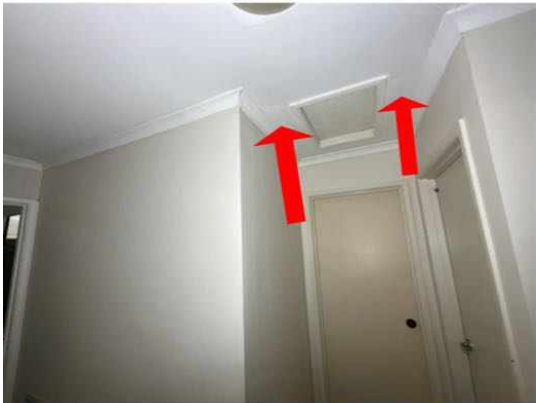
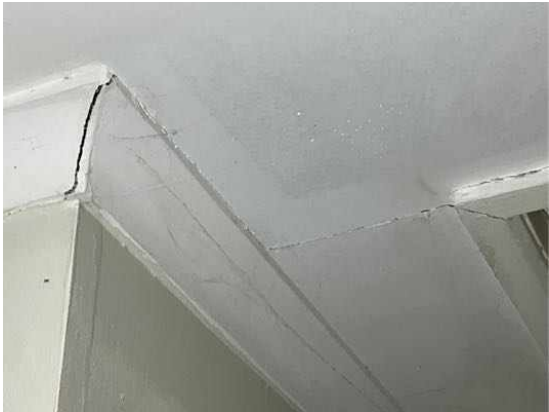
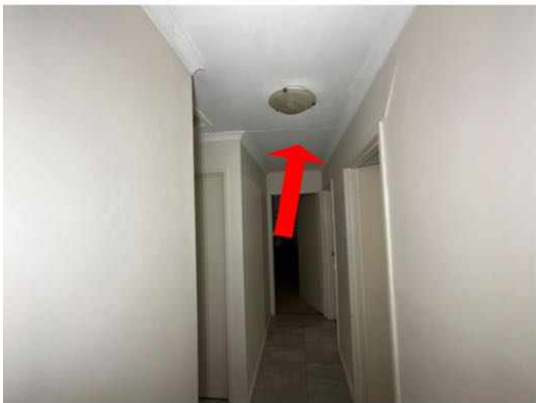
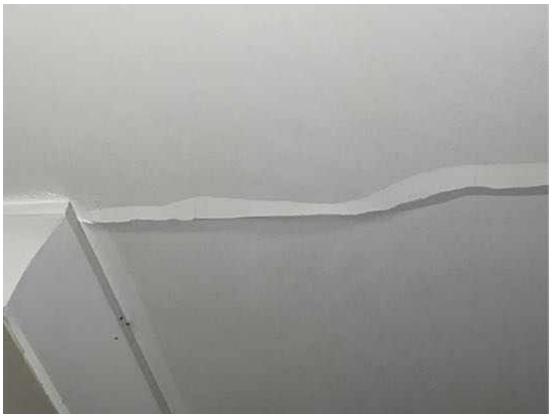
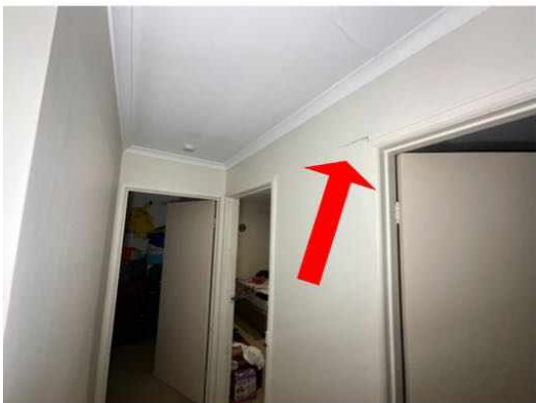
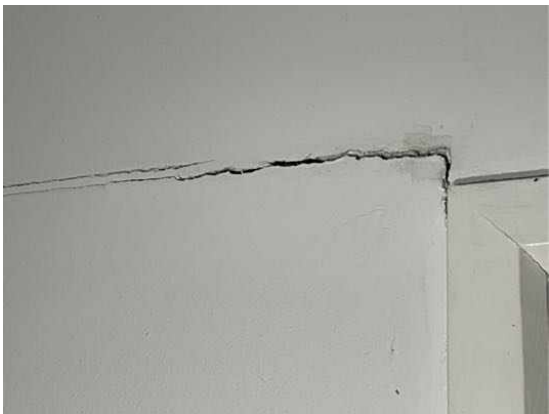
Finding 3.04

| Finding: | Cracking - Damage Category 2 - Noticeable (up to 5mm) |
| Information: | Noticeable cracks are a common occurrence as a result of many primary defects. Such causes may include age, general wear and tear, expected building movement, general expansion/contraction of building materials in different weather conditions, and/or minor failings in the installation or application of building materials. |

Noticeable cracks may result in minor sticking or jamming of associated doors and windows, which require easement. However, noticeable cracks are easily filled and repaired. A plasterer can be consulted to install an expansion joint at this point to allow for this movement during different weather conditions.

Monitoring of all cracking should be conducted frequently. Always contact a building inspector should cracks widen, lengthen, or become more numerous. Additionally, your building inspector should also be contacted if associated building elements such as doors and windows become more difficult to operate over time.

Relevant tradespeople, such as carpenters, painters and plasterers, should be appointed to perform remedial works, as deemed necessary.

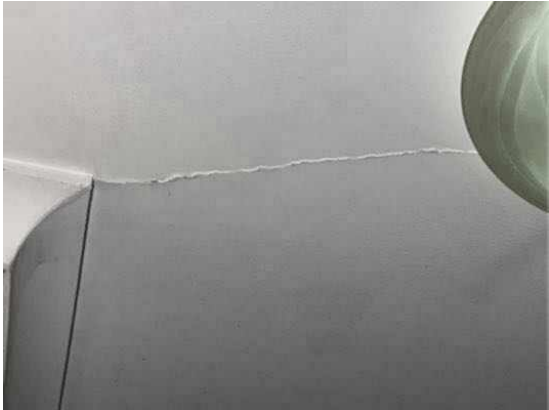
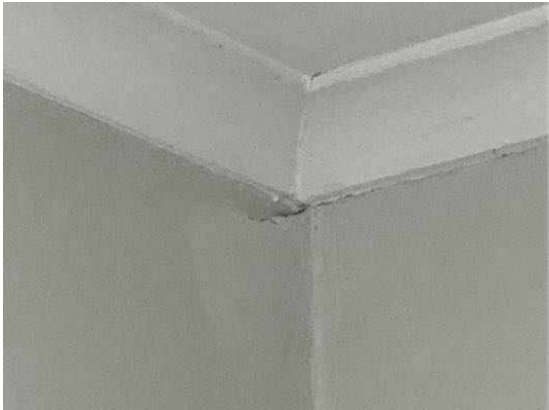
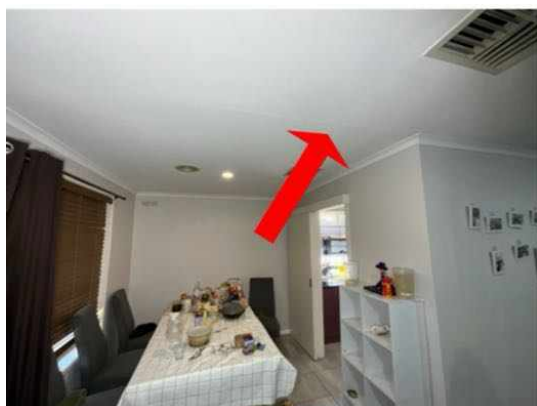
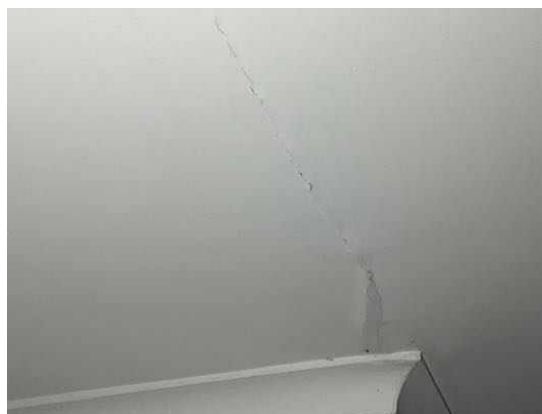
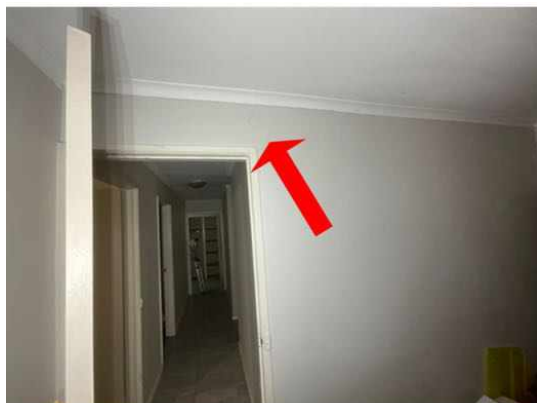
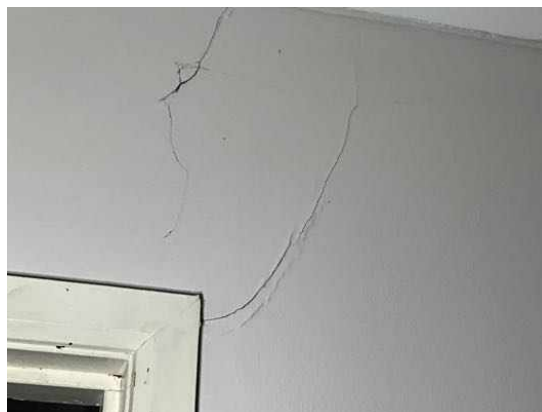
Finding 3.05

Building: Building 1
Location: Hall, living, bed 3,
Finding: Cracking - Damage Category 1 - Fine (up to 1mm)
Information: Although fine cracks are quite noticeable, they are often only considered to be an appearance defect, and usually do not indicate any structural damage. Generally, the cause of a fine crack is indicative of a separation between building materials and finishes (e.g. paint, plaster, etc.) along joins.

Cracking of this nature can generally be repaired with minor sanding, filling and/or repainting. Such works should be performed by a qualified painter or a general handyman.

Monitoring of all cracking should be conducted frequently. Always contact a building inspector should cracks widen, lengthen, or become more numerous.

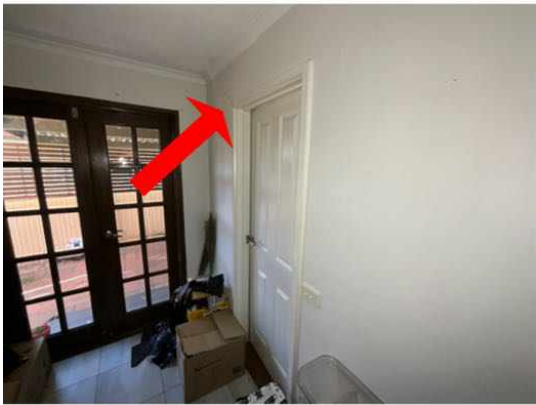
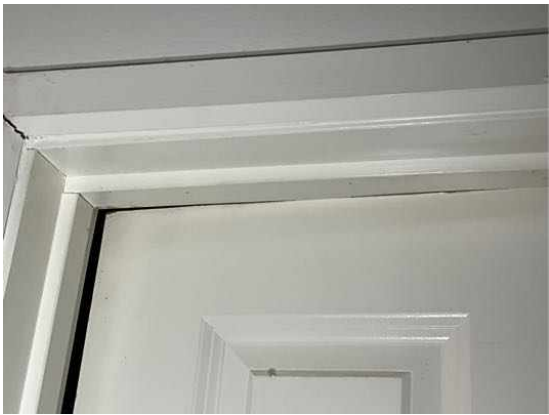
Finding 3.06

| Information: | Binding and/or jamming of this door is evident during standard operation. This defect inhibits the functionality of the affected door as well as creating potential for secondary defects to associated building elements, such as damage to the floor covering. |

A door that binds to flooring or to the associated door frame may have several causes, ranging from minor defects, such as poor installation of the door or deteriorated hinges, through to major structural issues, such as damage to subfloor structures.

A qualified carpenter or general handyperson should be appointed to perform minor rectification works at client discretion.

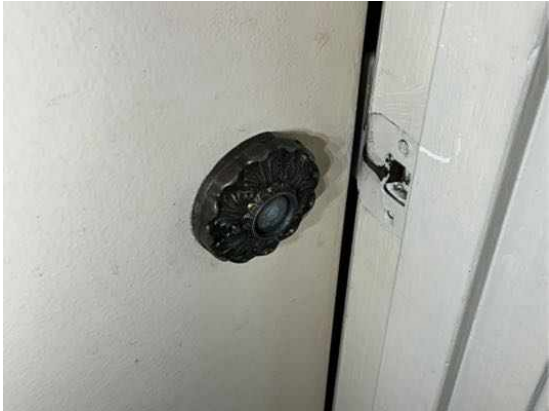
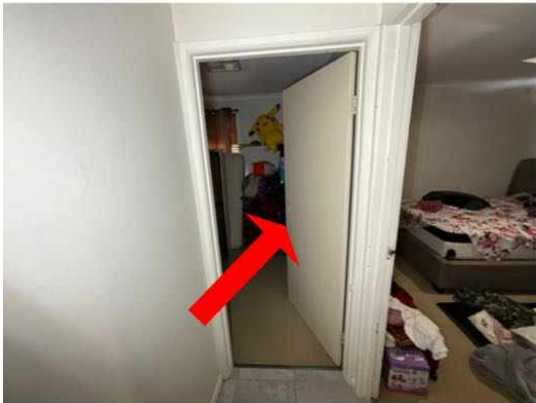
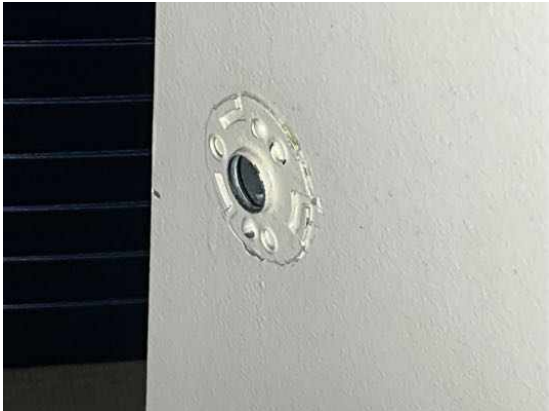
Finding 3.07

Building: Building 1
 Location: Toilet (WC), bed 3
 Finding: Door handle- Poor operation
 Information: The door handle/ catch in this area was found to be faulty during the visual inspection. This is most probably because of a lack of maintenance or wear and tear over time.

A general Handy person or lock specialist should be contacted to make needed repairs at the discretion of the owner and restore full function.

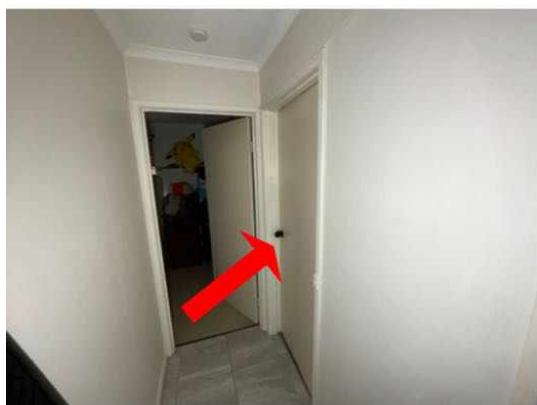
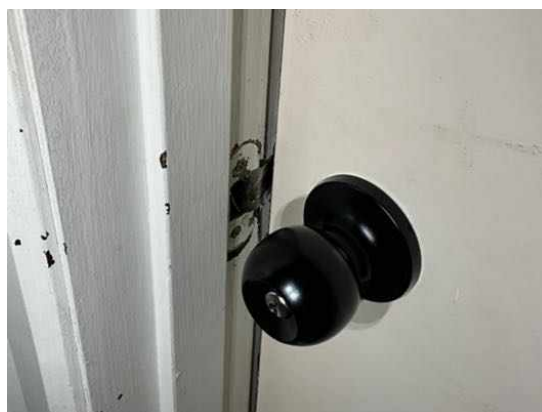
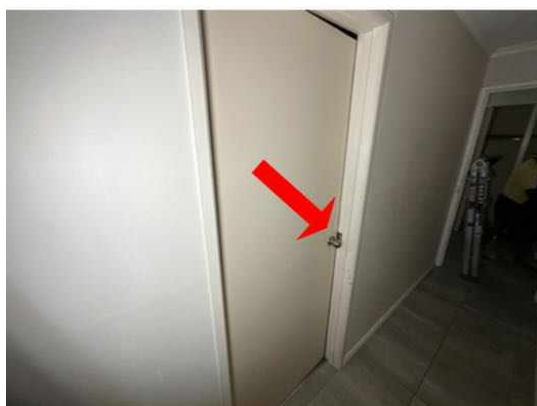
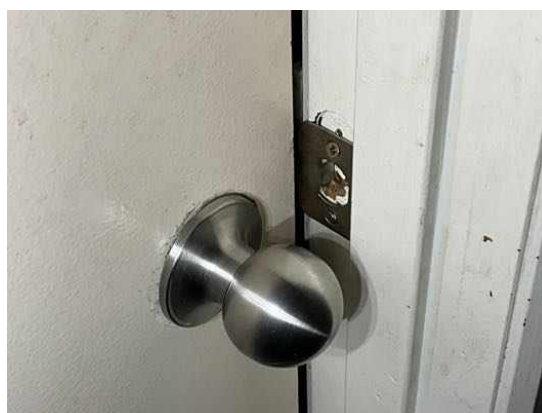
Finding 3.08

Building: Building 1
 Location: Bedroom - Master, bed 2
 Finding: Door - Striker plate misaligned
 Information: The striker plate to this door appears to have become misaligned and has consequently resulted in the door's operation being compromised.

This is a common defect and is expected in a property of this age, whether being due to substandard installation or general deterioration of the door hardware.

Readjustment of the striker plate is recommended at client discretion. Works such as these can be completed by a general handyman or qualified carpenter.

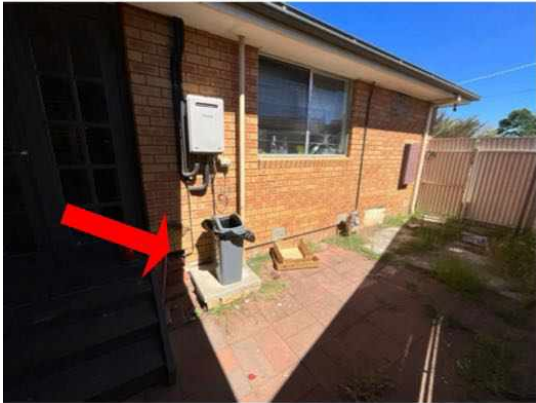
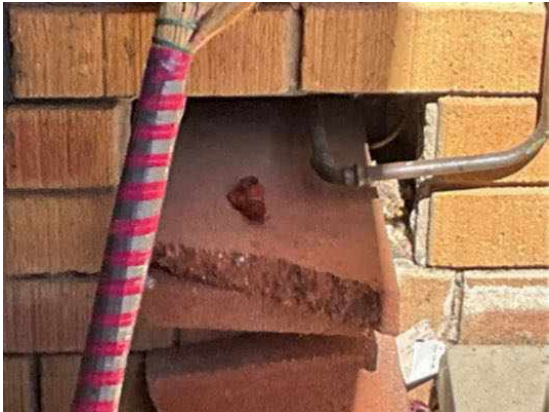
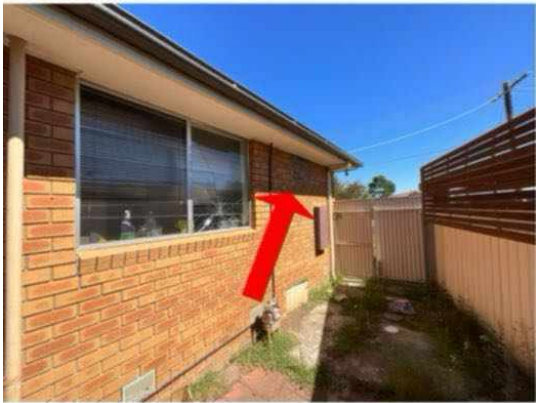
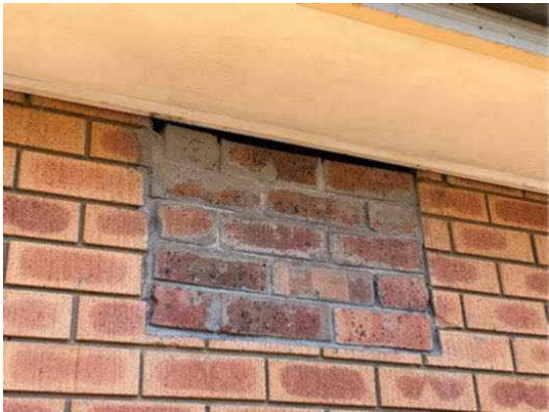
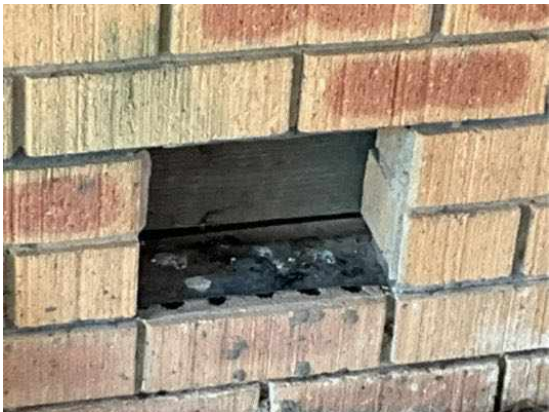
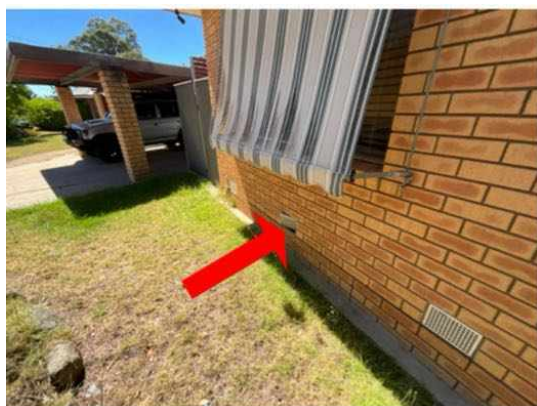
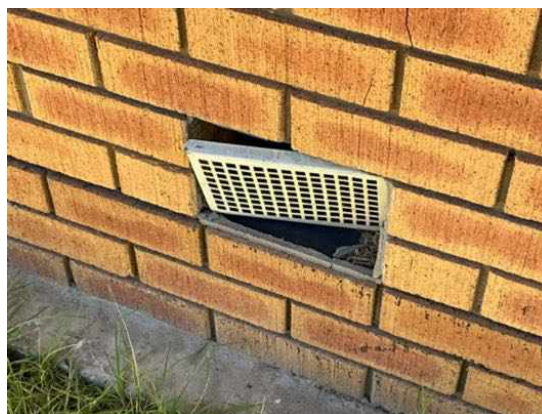
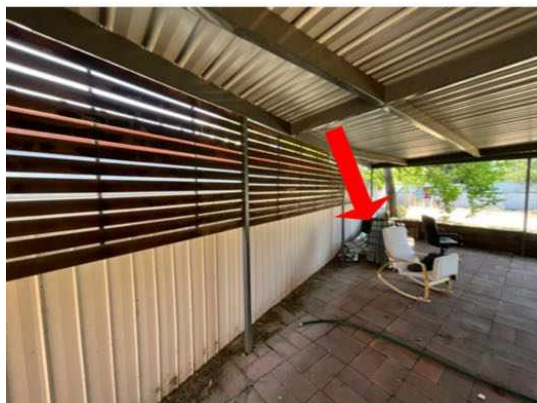
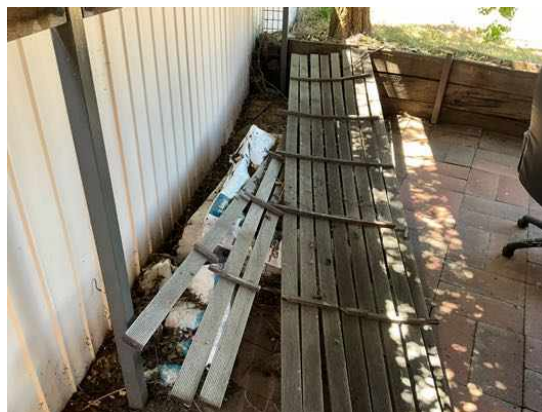
Finding 3.09

Building: Building 1
 Location:
 Finding: Incomplete or substandard works
 Information: The works to this area appear to be incomplete or have been completed to a substandard level.

Works that have not been completed to a satisfactory level create potential for the development of building defects and may impede on the safety and integrity of the overall structure.

It is highly recommended that the relevant trades be appointed to complete these works and ensure the safety of the area and the longevity of all associated building elements.

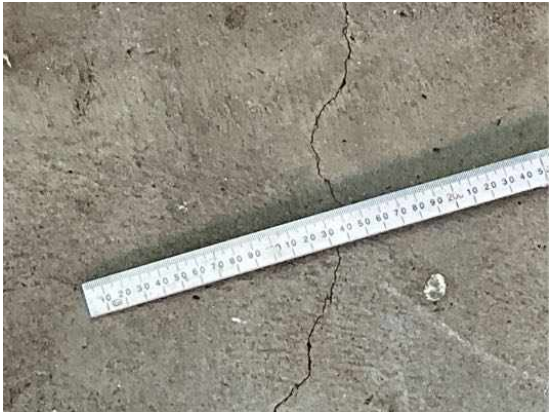
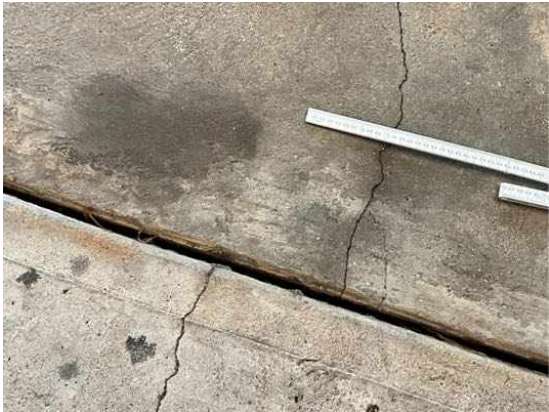
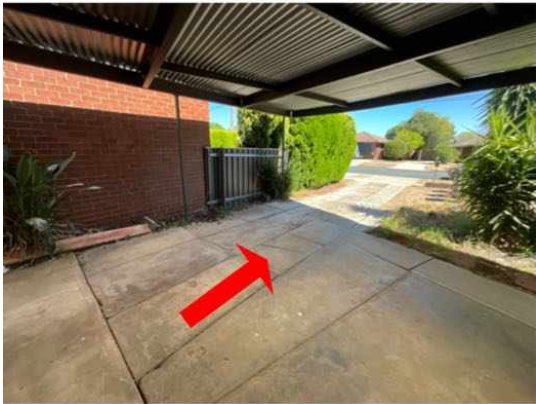
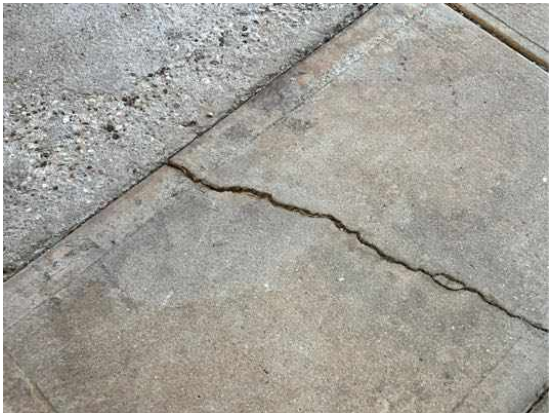
Finding 3.10

| Finding: | Cracking - External Concrete Paving Damage Category 2 - Distinct (less than 3mm) |
| Information: | Distinct cracks were identified in external concrete paving. Distinct cracks are generally found in older concrete paving, and may also present as a trip hazard as consequence of an uneven or curved surface. |

General age and expected deterioration of the paved areas is a common cause of this type of cracking. However, expansion and contraction of the slab may also have occurred due to environmental factors. Such factors include variable moisture and weather conditions, the presence of trees and their roots having a settling or lifting affect on the soil, or the effect of load bearing, e.g. heavy vehicles over a sustained period of time.

Cracking to this degree may also be due to poor original installation of the concrete. Factors such as poor compaction of the sub surface and/or inadequate reinforcing of the slab may create cracking and other secondary defects.

Repairs are likely to be required to prevent further cracking and to reduce hazards associated with cracking, such as tripping. Monitoring of all cracking should be conducted frequently. Always contact a building inspector should cracks widen, lengthen, or become more numerous.

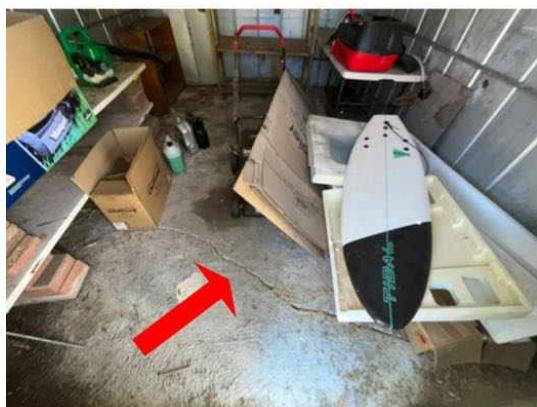
Finding 3.11

Building: Building 1
Location: Shed
Finding: Cracking - External Concrete Paving Damage Category 4 - Gaps in Slab (4mm - 10mm +)
Information: Gaps in the slab were identified in external concrete paving. Gaps in the slab are significant and are likely to lead to the development of safety hazards and secondary defects if left unmanaged, such as the creation of a trip hazard.

General age and expected deterioration of the paved areas is a common cause of this

type of cracking. However, expansion and contraction of the slab may also have occurred due to environmental factors. Such factors include variable moisture and weather conditions, the presence of trees and their roots having a settling or lifting affect on the soil, or the effect of load bearing, e.g. heavy vehicles over a sustained period of time.

Cracking to this degree may also be due to poor original installation of the concrete. Factors such as poor compaction of the sub surface and/or inadequate reinforcing of the slab may create cracking and other secondary defects. Gaps in the concrete paving may also have a more significant structural cause, such as subsidence of soils.

Where gaps in the concrete paving are adjacent to structural elements of the building, the advice of a Structural Engineer is advisable before undertaking repairs. Significant repair and likely replacement of the concrete paving is probable.

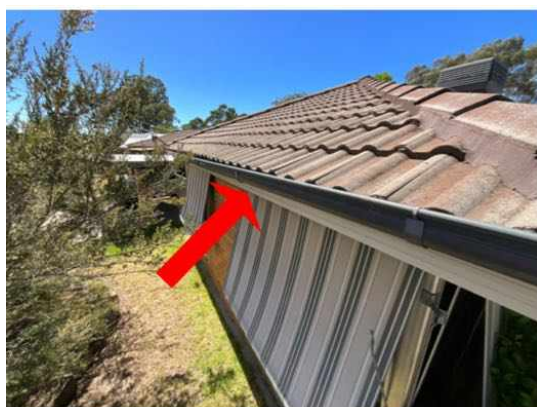
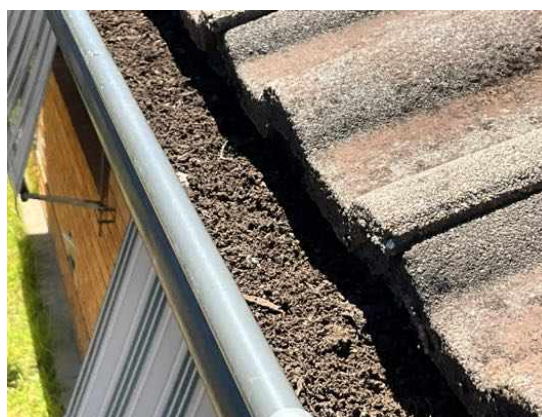
Blocked gutters are likely to lead to high levels of moisture in the affected areas. Such moisture will not only cause rust and decay of the associated building materials, but can also provide conditions that are conducive to termite and timber pest activity. Blockages in gutters should therefore be removed immediately to ensure dry conditions are maintained.

Consult a Licensed Plumber for further specific advice on remedial works that may be required. In the interim, it is highly advised that blocked gutters be removed by the homeowner or a general handyperson as a matter of urgency.

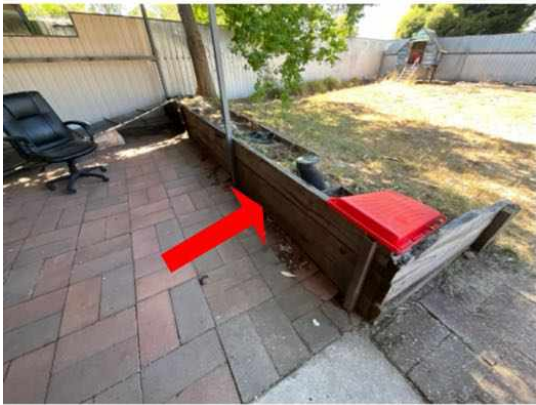
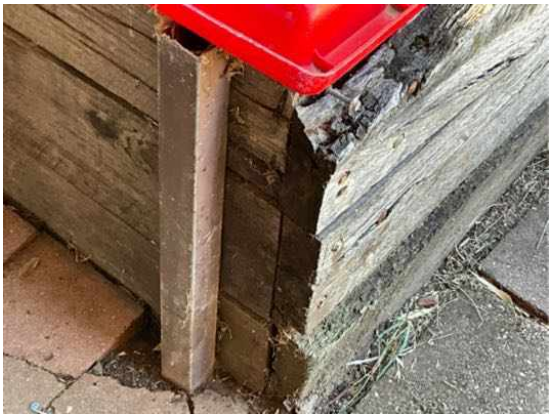
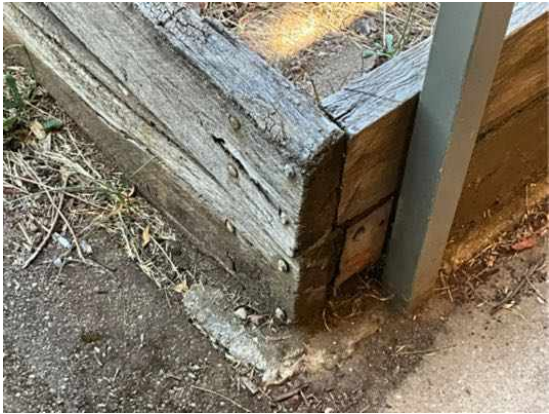
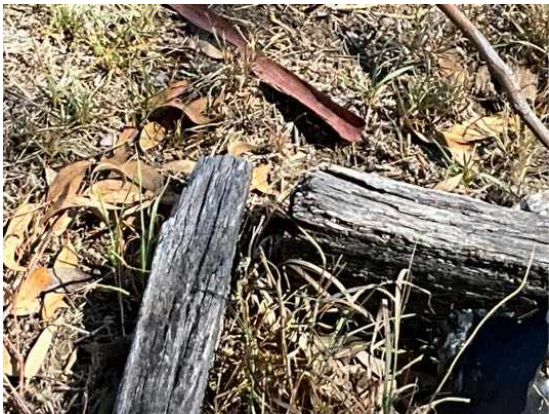
Finding 6.02

| Finding: | Untreated or non-durable timbers in a hazardous environment |
| Information: | To reduce the risk of timber pest attack it is essential that timber used in a hazardous environment (e.g. in direct contact with the ground or frequently exposed to damp conditions) is of sufficient durability and/or is adequately preservative treated. |

Untreated timbers in direct contact with the ground are likely to develop severe wood rot and/or fungal decay if left unattended creating attraction for subterranean termites to infest the timbers from surrounding areas.

If untreated or non-durable timbers are found to be in a hazardous environment it is highly advised that replacement of these building elements be performed as soon as possible to aid the protection of the property against termite / timber pest attack.

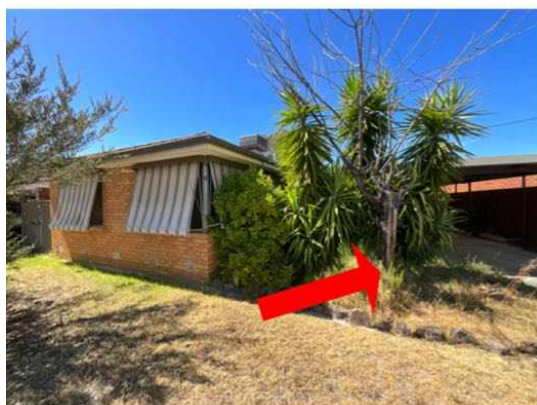
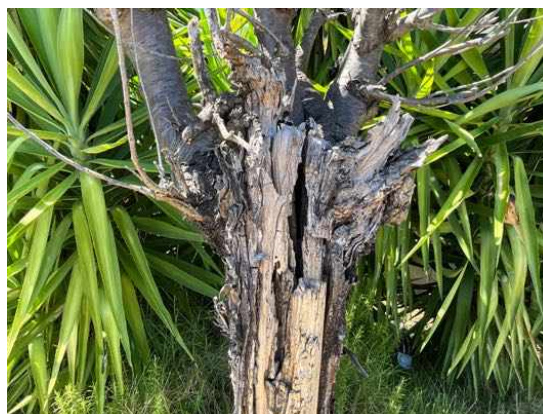
Finding 6.03

Building: Building 1
Location: Yard - Front
Finding: Tree Stump in Ground
Information: Any tree stumps in the yard not removed during the tree removal process provides the opportunity for Termite infestation and is likely to be subject to decay from damp conditions against the stump.

All tree stumps should be removed by professional tree removal services where possible. Meanwhile regular inspections are advised to identify any termite activity in the areas identified.

Services for tree stump removal should be contacted as soon as possible to reduce the risk of timber pest attack.

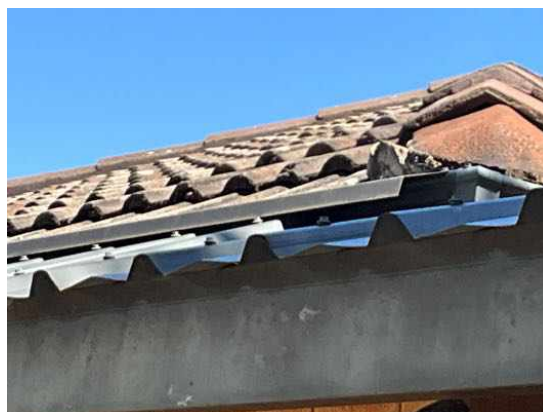
Finding 6.04

Building: Building 1
 Location: Yard - Back
 Finding: Guttering Missing
 Information: The Guttering in this area was missing at the time of inspection. Guttering, Downpipes and Stormwater drainage are vital to protect the integrity of the structure and to prevent an environment conducive to Timber Pest attack.

A Plumber should be contacted as soon as possible to replace and connect to drainage the missing Guttering.

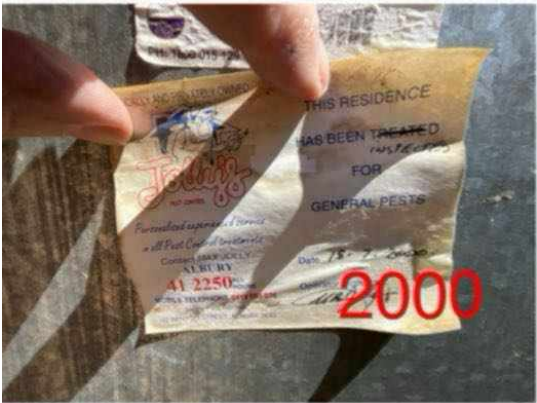
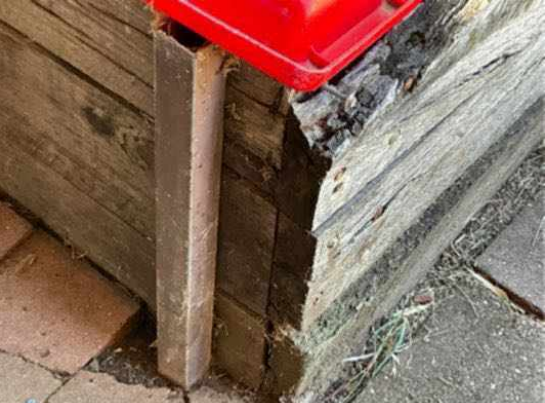
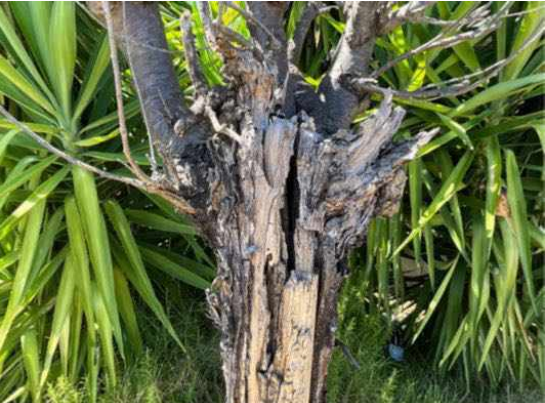
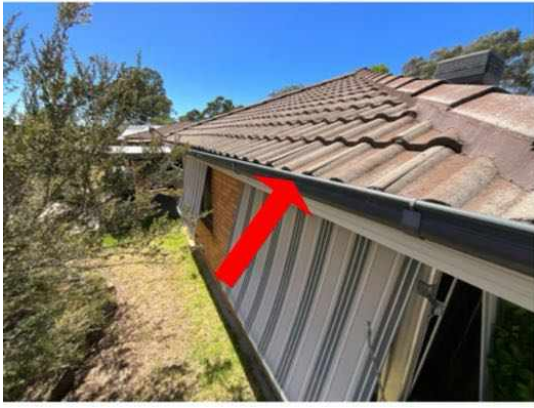
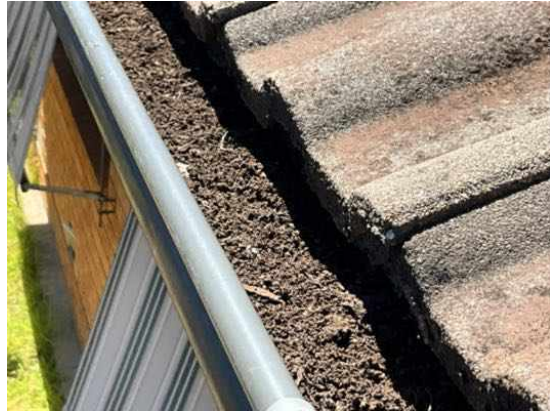
Finding 6.05

Building: Building 1
 Location: All External Areas
 Finding: Termite Management System - no evidence of a chemical installation
 Information: The application of a post-construction chemical termite barrier is highly recommended for all properties, particularly if live termite activity has been found on the site previously. Such barriers are highly effective in preventing termite attack on any timber

A durable notice should be placed in the switchboard unit to indicate current termite barriers. At the time of inspection, it appeared as though no termite management system has been installed, with no evidence to suggest preventative works taking place.

The client may consider gaining further advice from a pest controller as to the costs and procedures involved with this application. It is recommended that obtaining such advice be a short-term priority.

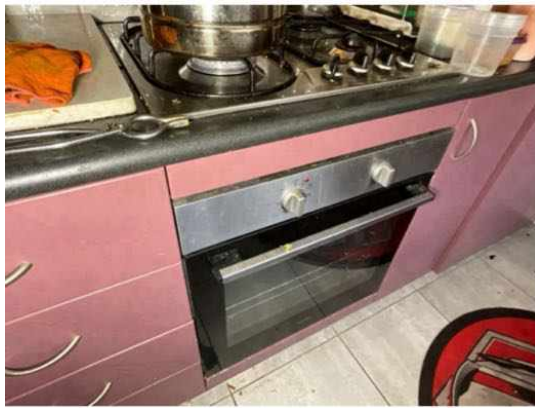
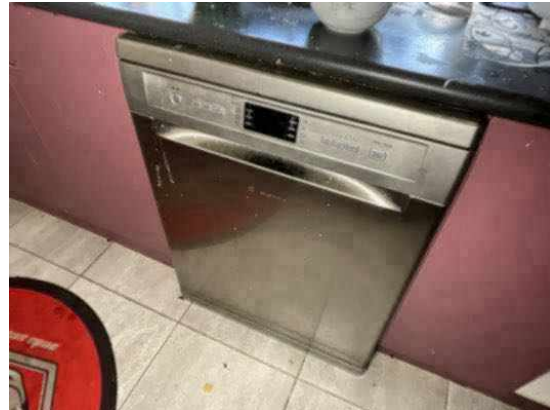
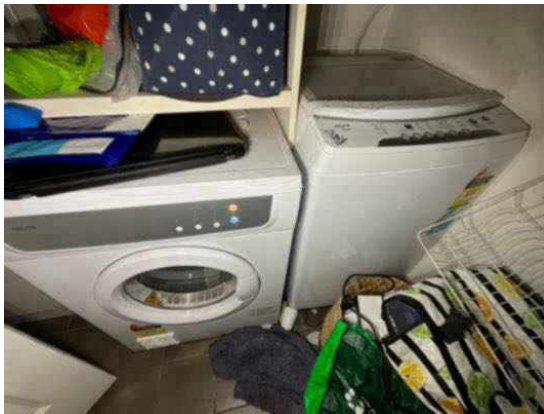
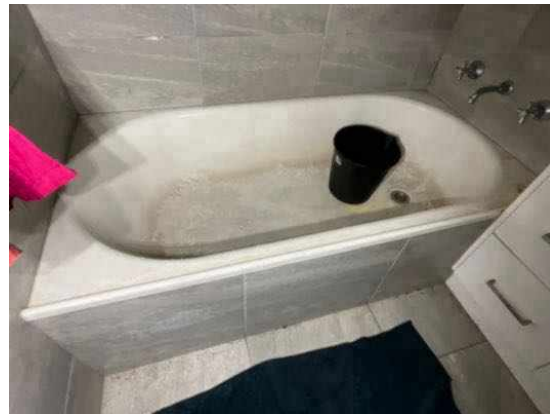
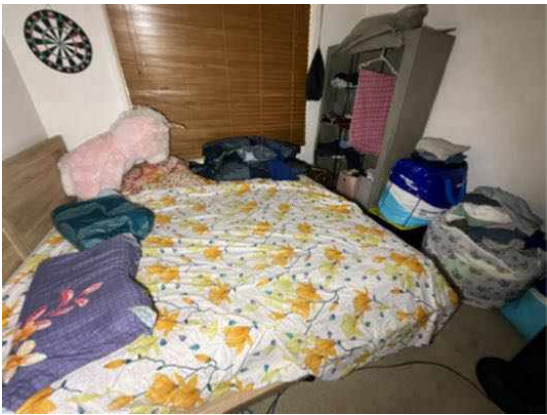
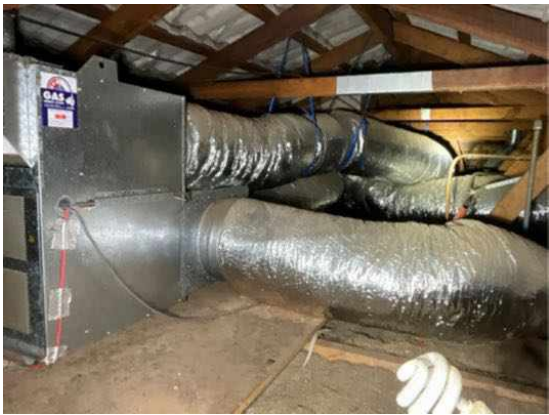
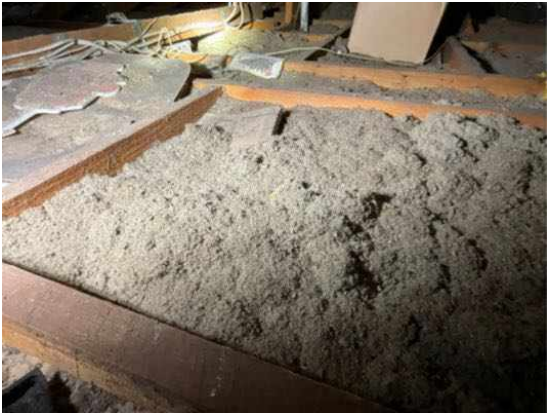
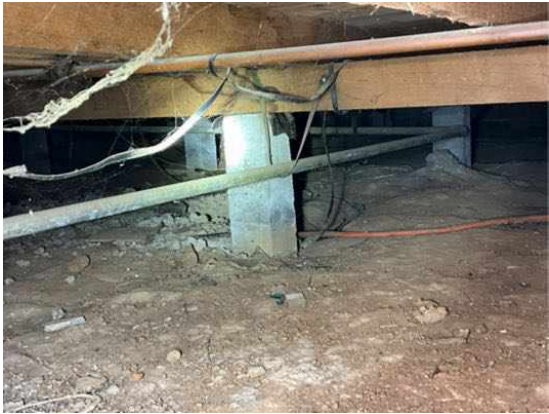
Building: Building 1
Location: All Areas
Finding: Additional Photos - Obstructions and Limitations
Information: These photographs are an indication of the obstructions and limitations which impeded full inspection of the property at the time of inspection. These obstructions can hide an array of defects and should be removed to allow full inspection to be carried out. A re-inspection is recommended once the areas are made accessible.
