Building and Timber Pest Inspection Report

Inspection Date: Thu, 5 Mar 2026

Property Address: 60 Yvonne St, Highworth QLD 4560,
Australia

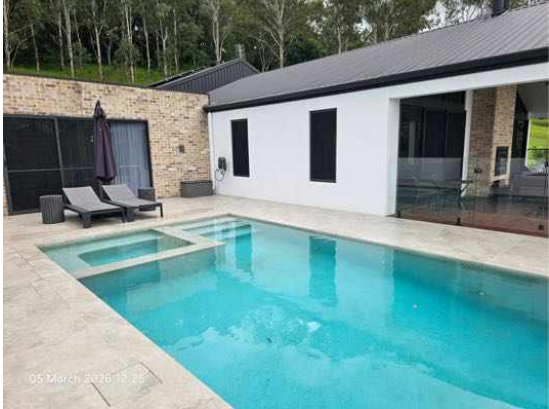
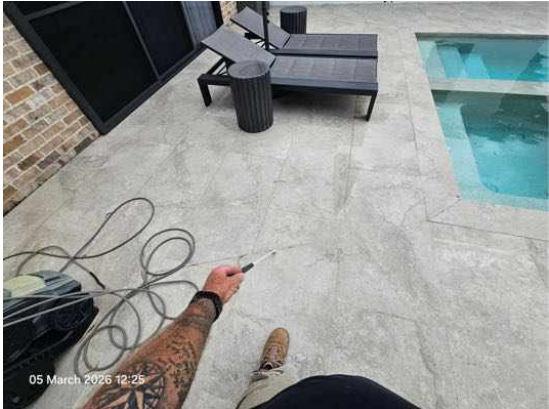
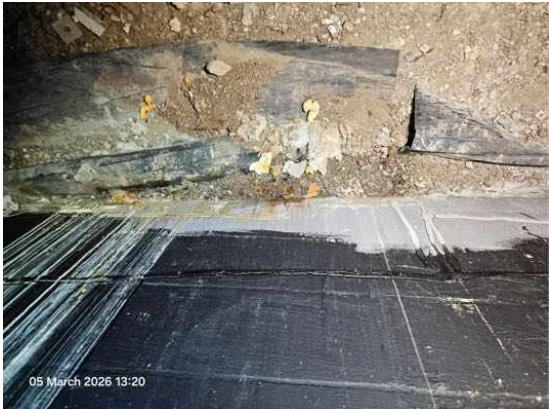
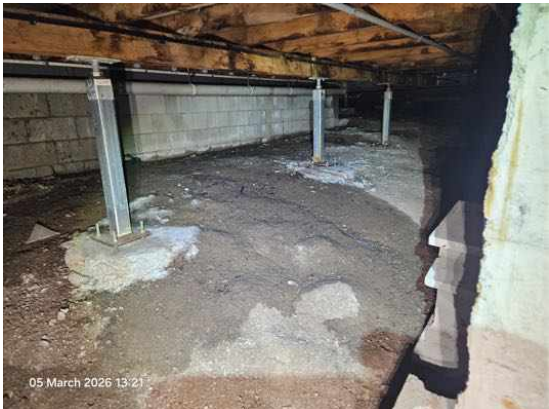
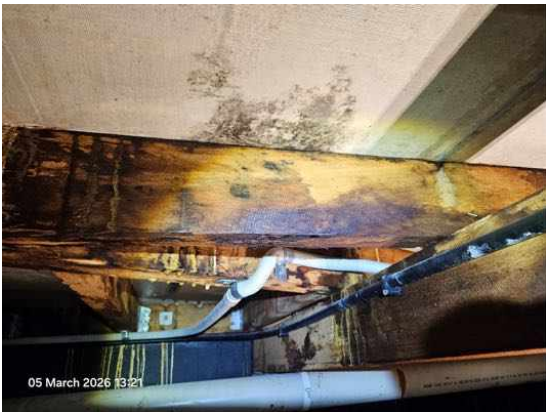
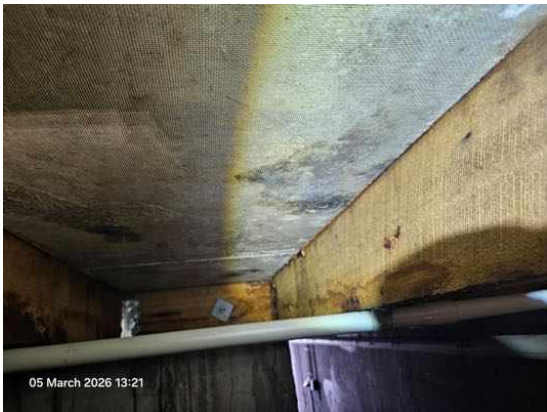
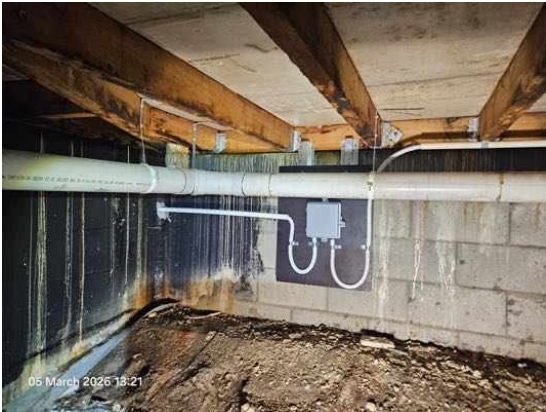
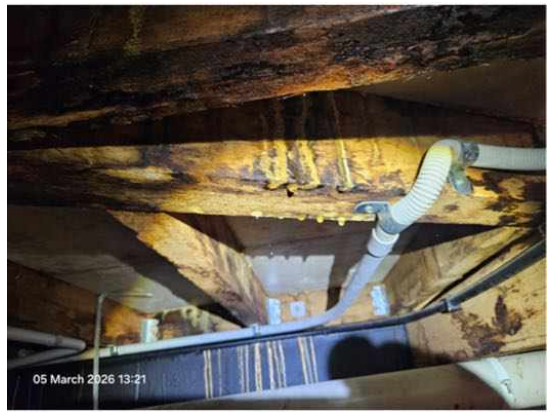
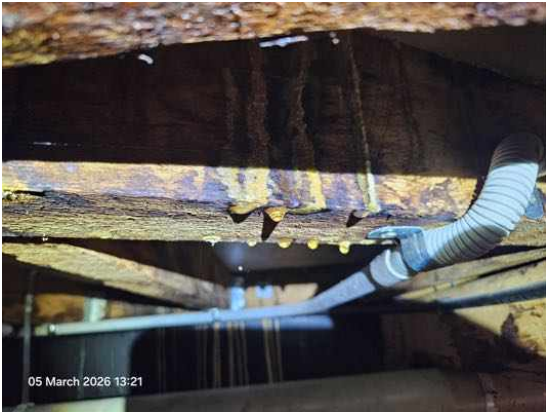
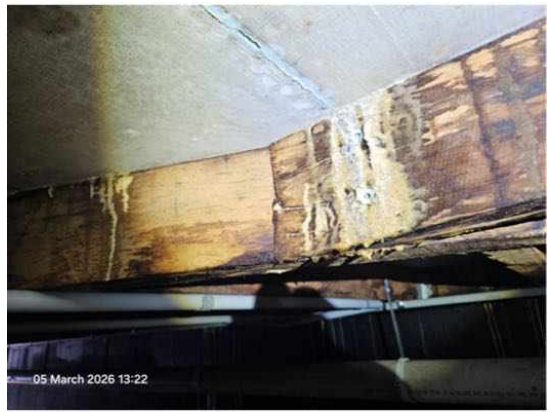
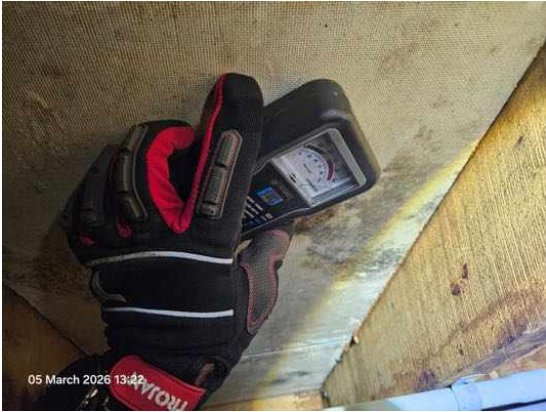
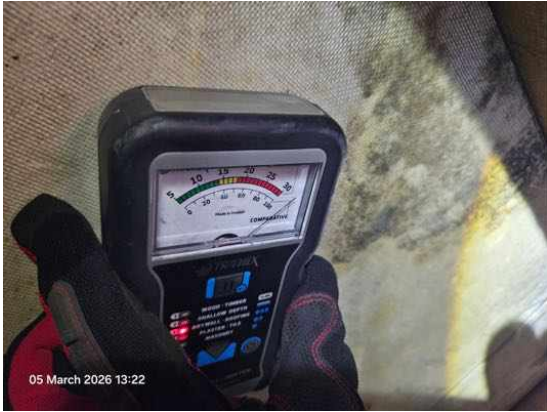
Finding 2.01

Building:	Main Building
Location:	Pool area
Finding:	Possible membrane failure
Information:	The photos taken during the inspection of the floor sheeting of the tile pool area from underneath show moisture penetration through the compressed fibre cement floor sheets.

At differing points of the flooring the underside of the sheets are developing mould and the flooring is wet to the touch. The readings confirm the level of moisture being above 30%. Active water leaks can be viewed and calcification is forming on the timber framing. This suggests a waterproofing membrane failure. There is the possibility that a membrane product incompatible with chlorinated salt water has been used. Many of the grout joints were degraded, which would be allowing constant exposure to rain and pool water.

The two major defects relate water ingress and distribution. The pool deck will require major intervention to remediate.

It is recommended that an independent assessment of the floor and associated structural elements be carried out with the view of remediation works re-instatement of the membrane.

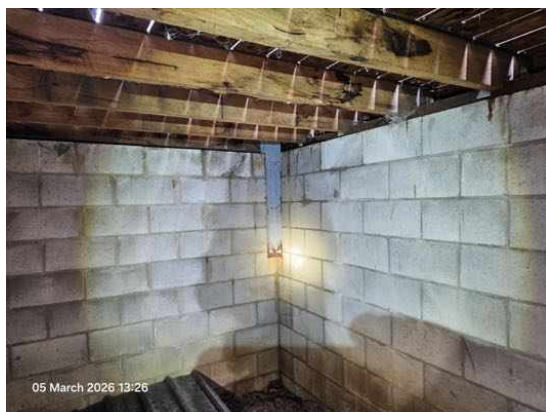
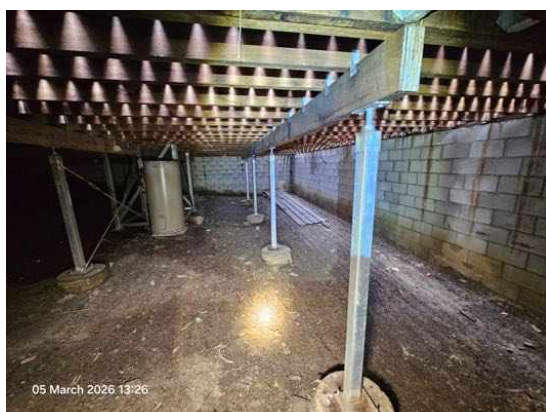
Finding 2.02

Building:	Main Building
Location:	Front deck
Finding:	Subfloor drainage - Inadequate
Information:	The subfloor drainage in the area beneath the front deck was found to be inadequate at the time of inspection, creating potential for subsequent water damage to associated building elements.

It is important that water does not lie against the base of walls, foundations or collect under the building. Stormwater should be carried away by regularly cleaned drains and downpipes should not discharge stormwater onto lower walls or plinths. Ground levels should be sloped to drain away from the building. The subfloor ground levels are graded; however, the drainage collects at the lower point in the front left corner. This would facilitate the installation of drainage through the wall to the outside garden.

Water damage and secondary defects are likely to occur if left unmanaged. Poor site drainage can lead to conducive conditions for timber pest infestation by creating excess moisture against the building perimeter.

Where site drainage is inadequate, a licensed plumber or landscaper should be appointed as soon as possible to further inspect the property and perform any remedial works as necessary.

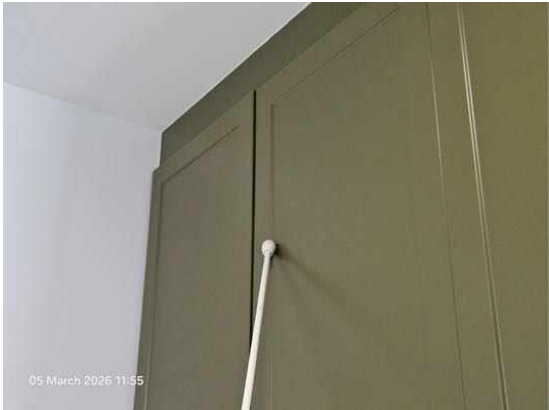
Finding 3.01

Building:	Out Building
Location:	Granny flat as shown
Finding:	Cabinetry defects - granny flat
Information:	It was observed during the inspection that some cabinetry of the interior of the granny flat requires repairs. Generally, the cabinetry is of a good quality; however, a common fault is bowing and cupping of the large panels and doors. Please refer to photos for positions and rooms.

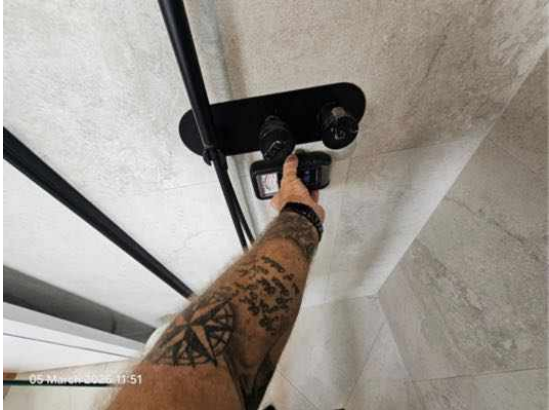
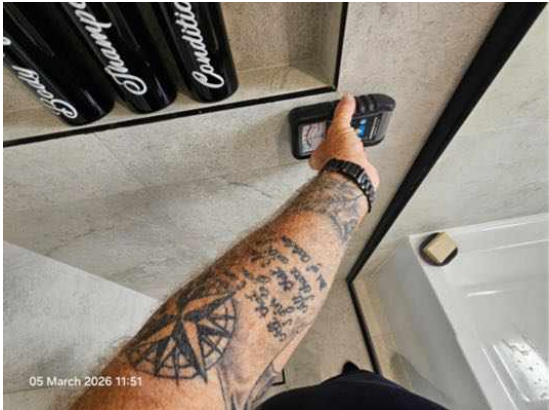
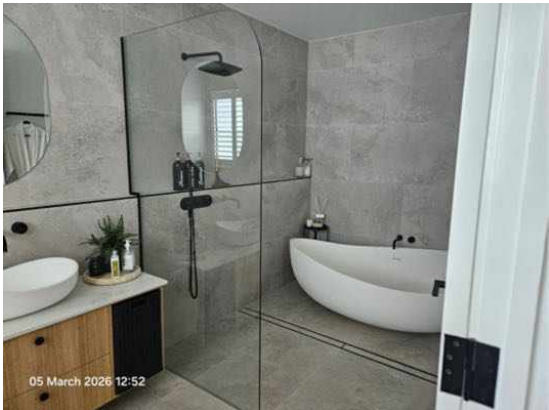
Finding 3.02

Building: Main Building
Location: Bathrooms, ensuite
Finding: No moisture detected in bathroom / ensuite
Information: On the day of inspection the showers in the bathroom/s and ensuite are measure for moisture using a "Tramex" moisture meter. During this inspection no moisture was detected in these areas and the tiled / sheeted surfaces appear to be in good order.

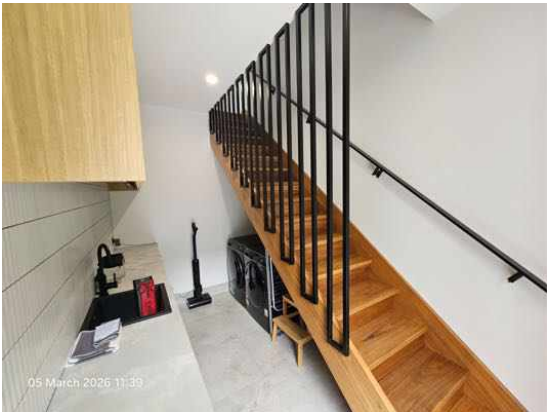
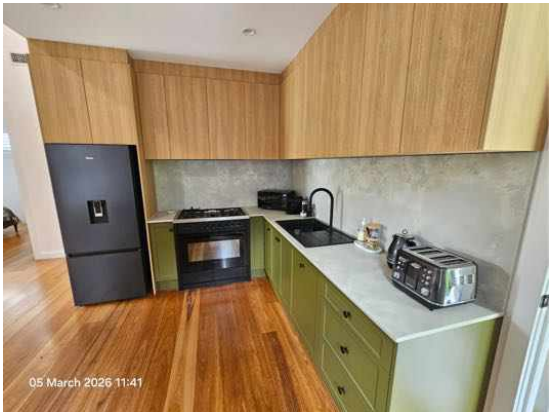
Building: Main Building
Location: All Areas
Finding: Additional Photos - Obstructions and Limitations
Information: These photographs are an indication of the obstructions and limitations which impeded full inspection of the property at the time of inspection. These obstructions can prevent full inspections of the areas shown.

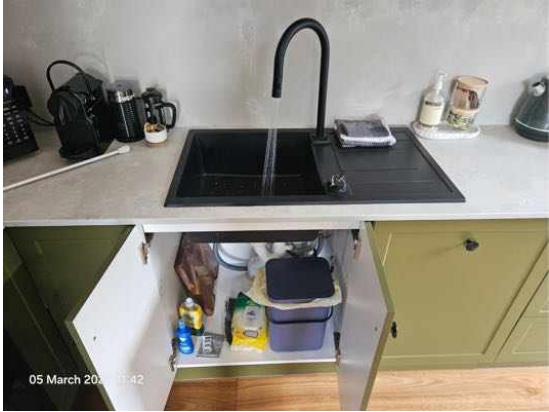
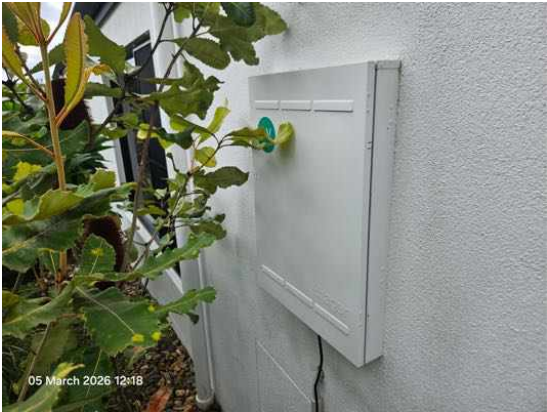
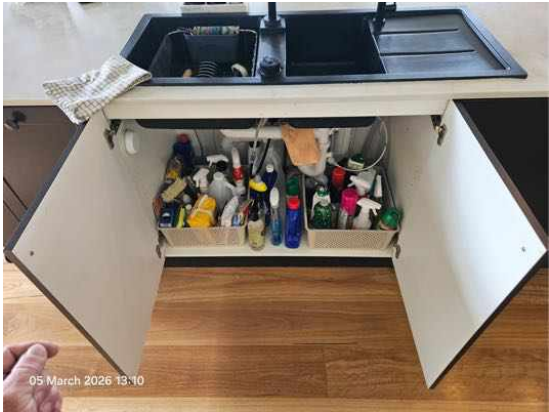
Building: Main Building
 Location: Meter box, kitchen cupboard
 Finding: Durable pest inspection notice - not assessable
 Information: On the day of inspection it was noted that the durable timber pest inspection / treatment notice was missing, not visible or out of date. These notices / stickers are to verify the timber pest inspection dates, the inspector, the currency and type of timber pest system / barrier in place or being used in and around the property.

Annual, or more regular, inspections are crucial in maintaining and managing the properties timber pest risk profile. By not having regular inspections of the property raises the properties risk of undetected defects and damage. Without regular inspection at intervals of not greater than annually the buildings risk profile will categorised as high. Properties with trees within 50m and with gardens close to the building are at greater risk and will have a high risk profile.

It is recommend that a licensed timber pest controller be contacted to assess the properties needs and provide costings for an annual inspection programme.
