# Building and Timber Pest Inspection Report

Inspection Date: Thu, 19 Feb 2026

Property Address: 8 Pereira St, Newington NSW 2127,  
Australia

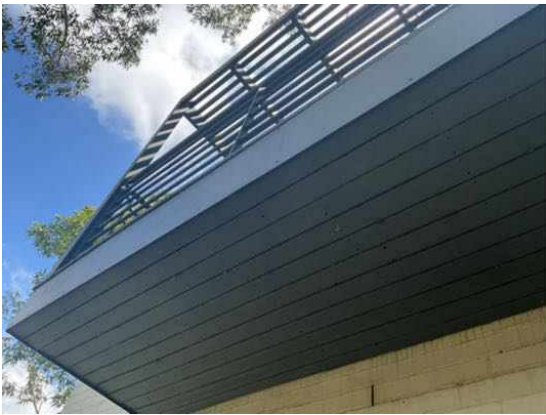
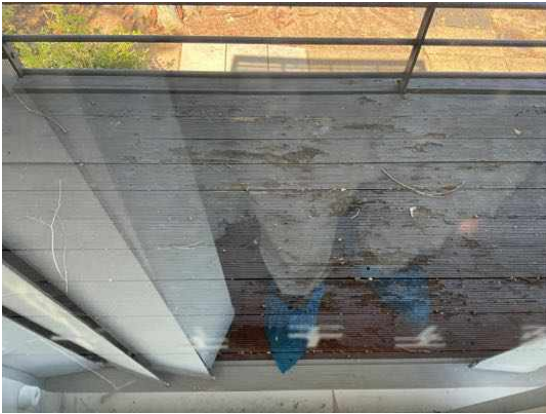
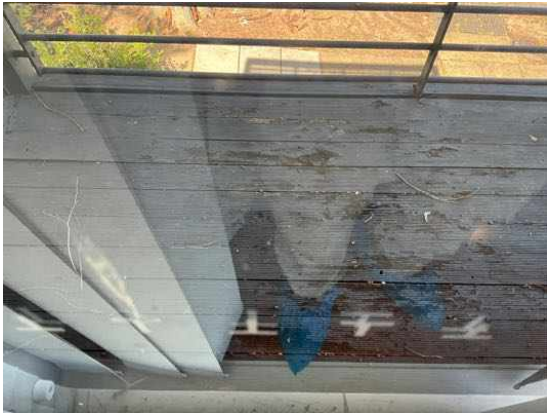
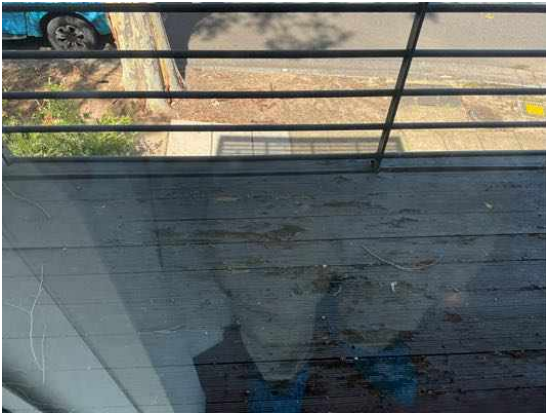
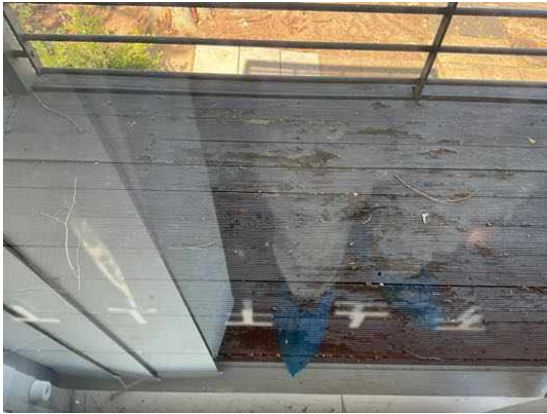
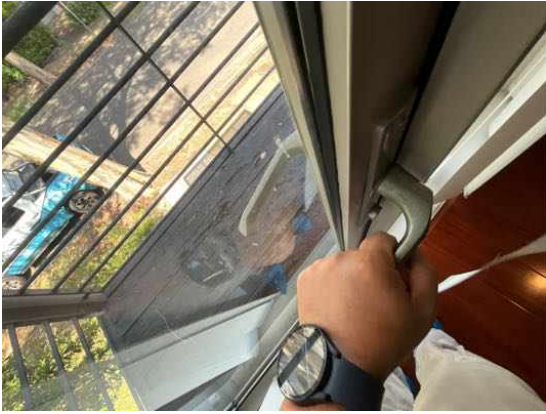
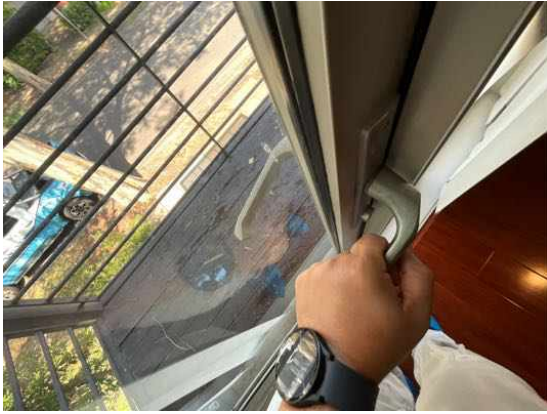
External timber structures are also constantly exposed to weather deteriorates in an exhilarate manner, ongoing assessments are required.

It is highly recommended that a structural engineer further, assess the external timber balcony or a deck to inform the client of its load capacity.

Regular maintenance inspections by competent practitioners is needed.

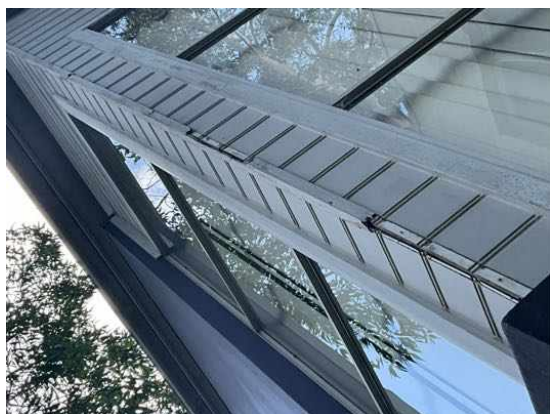
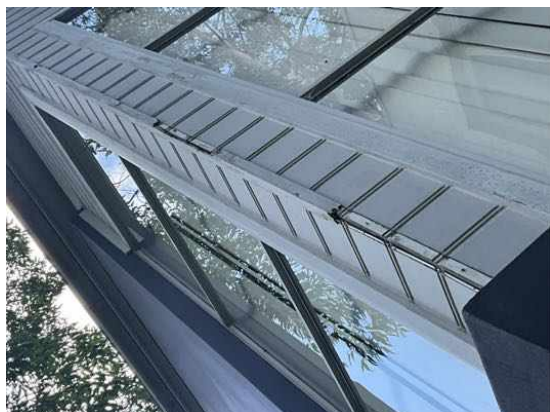
Building: Main Building  
Location: All Areas  
Finding: Rot - Timber Trim with Water Ingress Risk  
Information: The timber trim displays visible signs of deterioration, including delamination, paint peeling, cracking, and possible decay. The damaged section has opened up, exposing the internal substrate.

- Moisture ingress into the wall cavity, potentially leading to structural timber decay or concealed mould growth.
- Reduced durability of the cladding system.
- Potential pest entry point, especially if there's access to framing.
- Aesthetic deterioration impacting long-term maintenance costs.

Recommended Action:

- A licensed carpenter or building maintenance contractor should remove the damaged timber and inspect the substrate behind it for further decay.
- Replace or repair the affected section, apply appropriate flashing or sealant, and repaint using exterior-grade finishes.
- If moisture ingress has affected the internal framing or caused hidden mould or termite risk, further investigation by a building consultant or pest inspector is recommended.

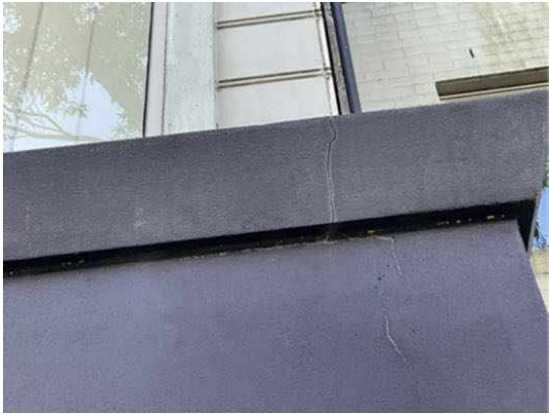
Building:	Main Building
Location:	All Areas
Finding:	Brickwork - Cracking noticeable
Information:	There were several cracks and or crack repairs evident to external brickwork.

Noticeable cracks are a common occurrence in external brickwork and are a likely result of age expected building movement, general expansion, and/or contraction of building materials in different weather conditions. Noticeable cracks in brickwork may develop if left unattended, with potential for necessitating major remedial works or replacement of the brickwork.

It is highly advised that a qualified bricklayer be appointed to provide necessary works to cracked brickwork to prevent any further damage. Such works should be conducted as soon as possible.

Always monitor these cracks and contact a building inspector should cracks widen, lengthen, or become more numerous.

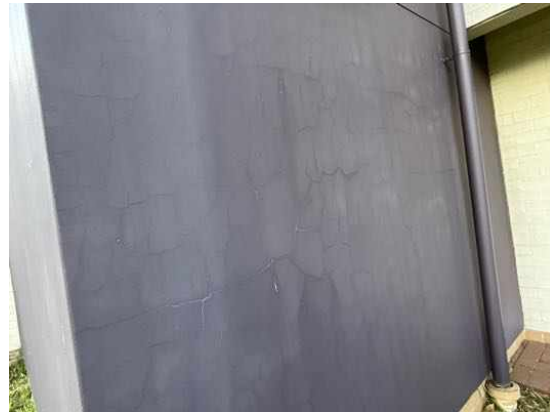
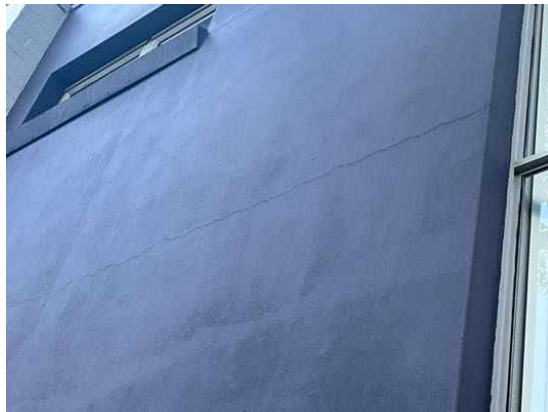
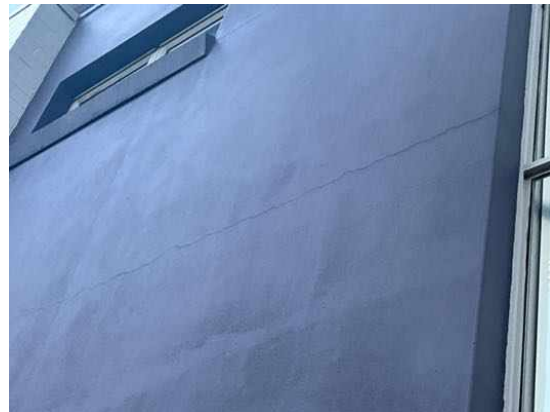
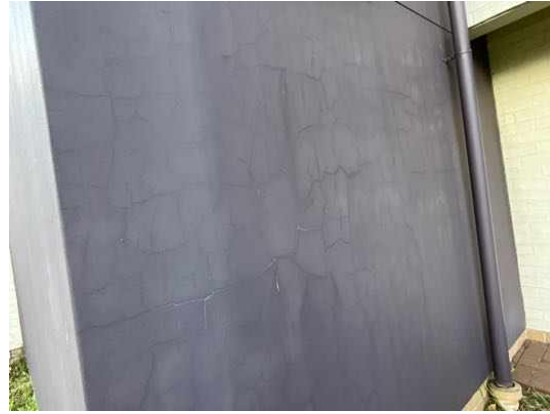
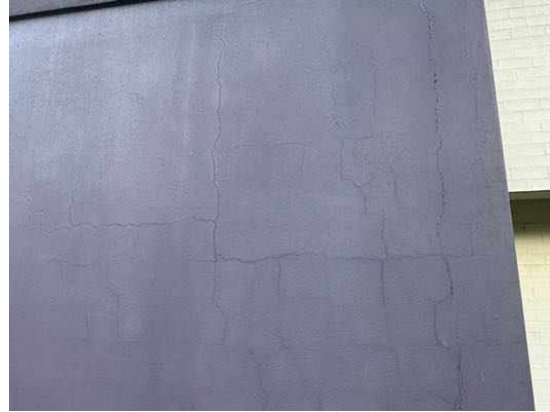
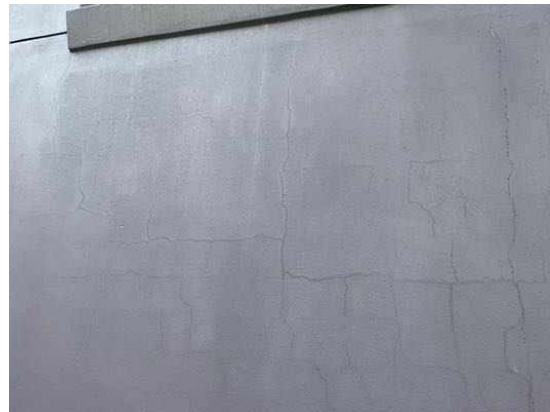
Finding 3.03

Building: Main Building  
Location: All Areas  
Finding: Cracking - rendered surface  
Information: Cracking observed along the vertical and diagonal plane of the rendered surface. The cracks appear as fine to moderate-width cracks, indicating potential shrinkage or movement within the substrate.

According to AS 4349.1-2007 Inspection of Buildings and the Guide to Standards and Tolerances 2017 cracks up to 1mm wide are considered an acceptable tolerable limit for plaster and render finishes in the absence of other symptoms (such as displacement or water ingress). Cracks between 1mm and 5mm wide may require repair depending on their cause and severity.

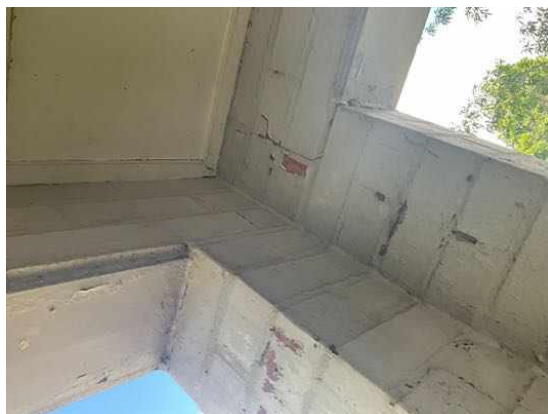
### Finding 3.04

Information: Sections of the paint in this area was found to have deteriorated. Paint deteriorating is generally an indication of excessive moisture in the area that is currently hidden by the painted surface.

The presence of excessive moisture can have major implications on associated building elements if left unattended. While only seemingly minor at this stage, the damage cannot be determined due to the paint, obstructing any further inspection of the damage.

It is highly advised that the affected paint to be cleaned to allow a further, more invasive inspection by a licensed builder/painter. Failure to act on this defect may necessitate major works in the future.

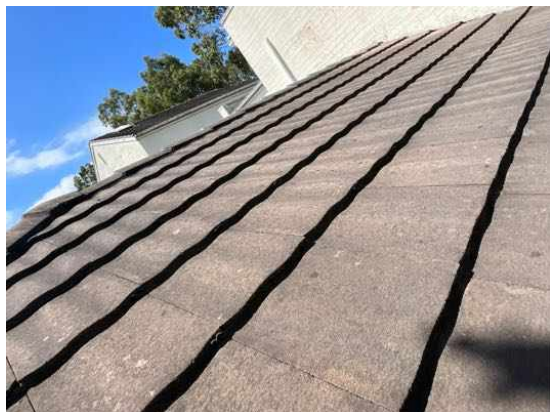
### Finding 3.05

Building:	Main Building
Location:	Roof Exterior
Finding:	Roof Weathered
Information:	Upon inspection of the exterior roofing, the majority of roof was not in a fair condition. While weathering of the roof is consistent with the age of the property, maintenance works are required.

Isolated areas of mortar have come loose in the valleys and minor cracking is also present. Re-pointing and re-sealing the may be considered as an interim solution by the client to help preserve and extend the life span of the tiles.

Where left unmanaged, deteriorating roof are likely to lead to a number of secondary defects, including minor water leaks and weather exposure to internal roofing structures.

Consultation with a roofing contractor is highly advised to gain advice on cost of remedial works that may be required in the short to medium term. Remedial works are likely to increase the longevity of the exterior roofing structure.

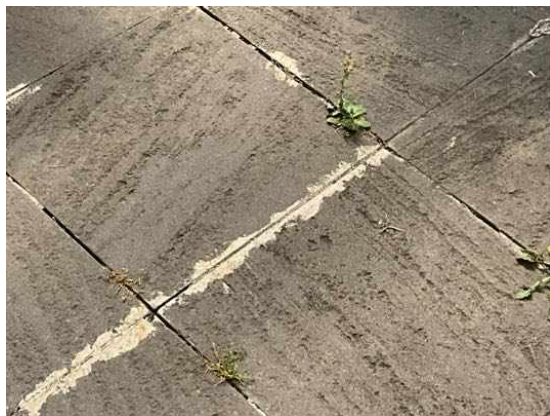
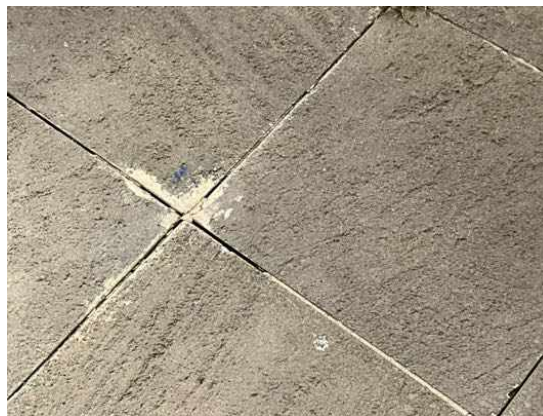
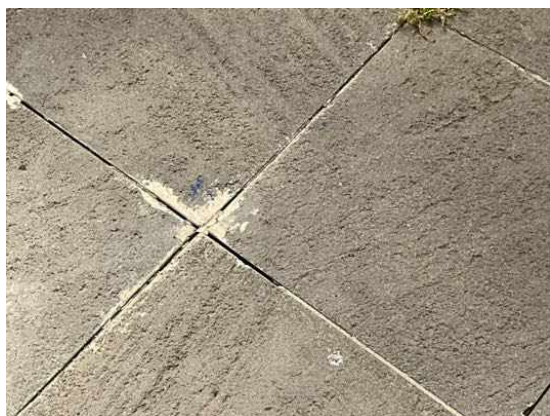
Building:	Main Building
Location:	Pergola
Finding:	Grouting - Missing or damaged
Information:	It was noted on inspection that sealant or grout is Missing or damaged. A flexible sealant is required to allow for expected expansion and contraction, while keeping the joint water tight and protective of all associated building materials.

Flexible and mould resistant materials should be applied to affected areas to prevent any subsequent water damage that is likely to occur. Regular maintenance and replacement of damage or missing or damaged sealant and grout is highly recommended , as this is a regular wear and tear defect.

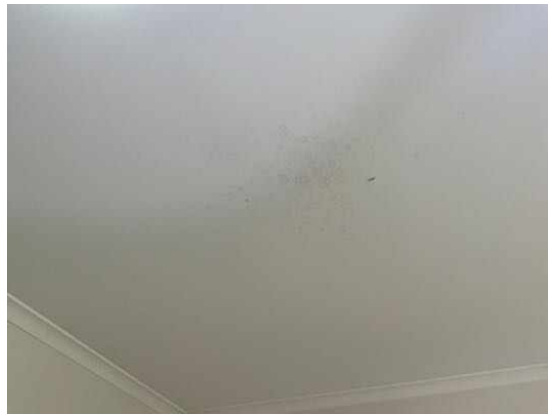
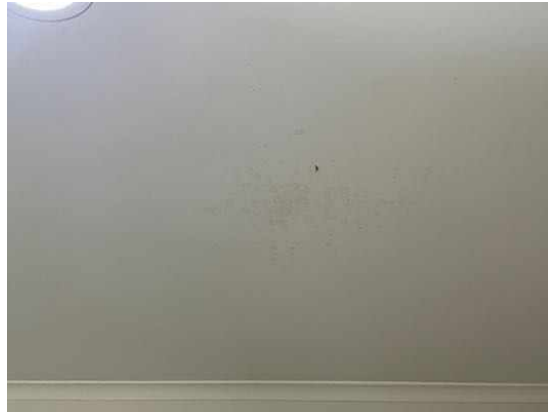
Finding: Water staining

Information: Water staining was evident in this area at the time of inspection. Water staining indicates that surfaces have been exposed to excessive moisture over time. The minerals and other elements in the water lead to staining, which may graduate to corrosion and deterioration if left unmanaged.

While mostly an appearance defect, water staining can be indicative of more serious defects, which may be currently concealed by other building elements.

Where water staining is active, a licensed plumber must be consulted to identify the cause of the staining and to provide advice on any reparation works that may be required. Replacement of any broken or damaged structures is advised.

Conversely, where water staining is old and inactive, affected building materials may be repaired or replaced at client discretion. A qualified carpenter or registered builder may be appointed to perform these works.

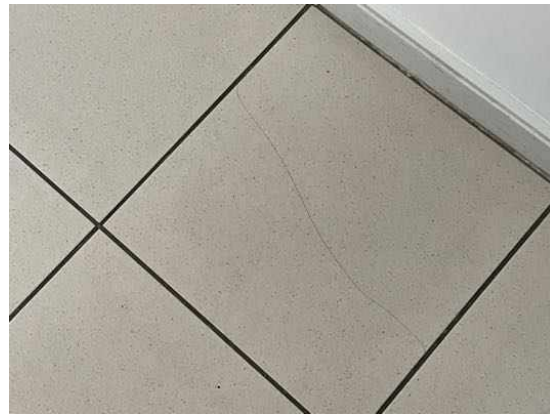
### Finding 3.13

Building: Main Building  
Location: Foyer  
Finding: Floor Tile crack  
Information: A floor tile has a visible crack on the surface.

The damaged tile presents a trip hazard, may lead to cuts if stepped on barefoot, and can allow moisture ingress into the substrate, which may cause further deterioration or loosening of adjacent tiles. It also affects the overall appearance of the floor.

A licensed tiler should be engaged to remove the damaged tile and install a matching replacement. If spare tiles are unavailable, additional remedial work may be required to blend the repair with surrounding finishes.

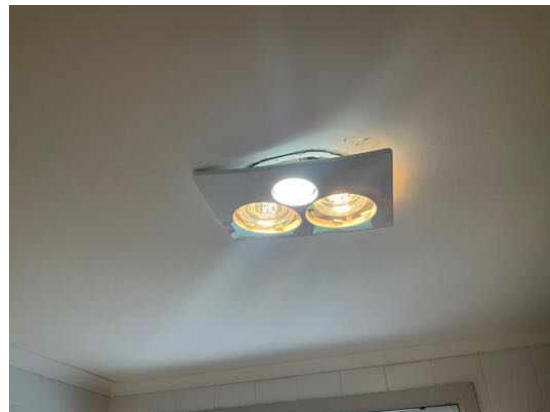
### Finding 3.14

Building: Main Building  
 Location: Bathroom  
 Finding: Poor workmanship  
 Information: The structure exhibits signs of poor workmanship, evident in various aspects of construction and finishing.

Risk: Poor workmanship poses a range of risks, including compromised structural integrity, potential safety hazards, and a decreased lifespan of the structure. It may also lead to aesthetic and functional issues.

Resolution: A qualified contractor or construction professional should be consulted to assess and address the poor workmanship. They can implement corrective measures to ensure structural soundness, safety, and overall quality of the construction.

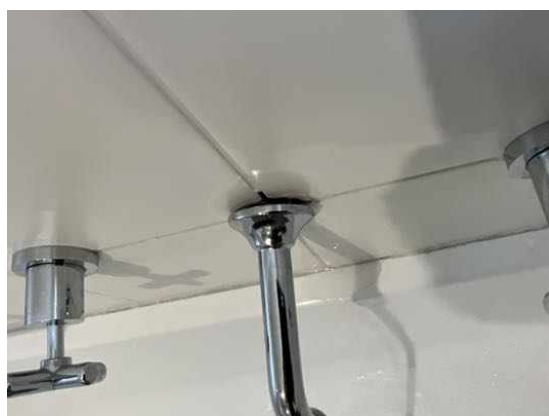
### Finding 3.15

Building: Main Building  
 Location: Bathroom  
 Finding: Leaking plumbing fitting  
 Information: Leaking plumbing fitting identified, posing the risk of water damage and increased water bills.

Potential structural damage, mold growth, and wastage of water resources.

Engage a licensed plumber to inspect and repair the leaking plumbing fitting, ensuring a proper seal and preventing any further water-related issues.

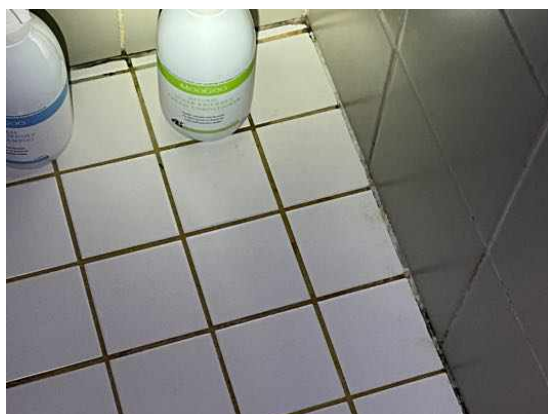
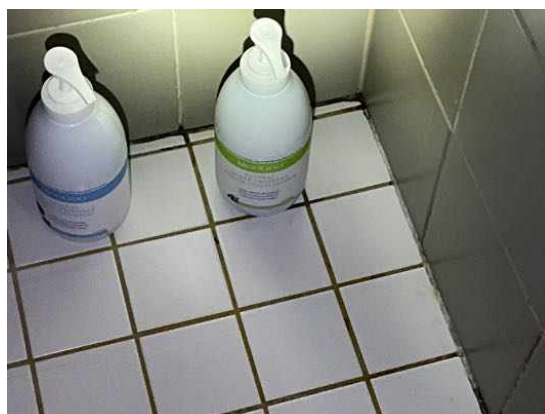
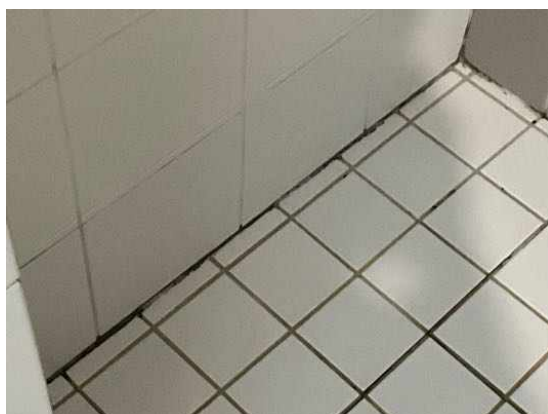
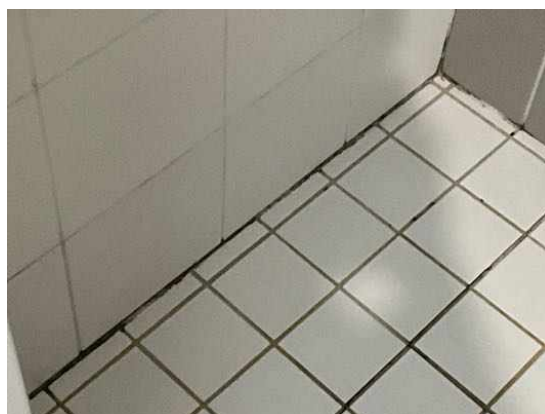
### Finding 3.16

Building:	Main Building
Location:	Bathroom
Finding:	Sealant and grouting - Missing or damaged
Information:	It was noted on inspection that sealant or grout is degraded to the tiled shower alcove and or other areas of the bathroom.

Different materials and floor areas move at different rates, generally causing cracking to grout or sealant at this point. A flexible sealant is required to allow for expected expansion and contraction, while keeping the joint water tight and protective of all associated building materials.

There appears to be excessive mould to the sealant and grout which will likely require scraping out and replacement.

Flexible and mould resistant materials should be applied to affected areas to prevent any subsequent water damage that is likely to occur. Regular maintenance and replacement of damage or missing or damaged sealant and grout is highly

recommended to the wet areas, as this is a regular wear and tear defect. Sealant and grouting in areas that come into regular contact with water should be maintained for the long term care of your property.

A sealant specialist or tiling contractor should be appointed to complete these works as soon as possible

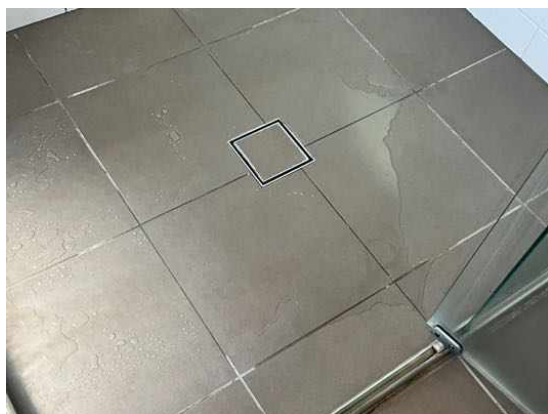
Information: Damp is evident to the lower 300mm of wall to the shower alcove. This defect is quite common, and is suspected to have been caused by moisture permeating through the grouting in this area, which shows evidence of deterioration. Leaking pipes within the adjoining wall is also a possible cause.

Remedial works may involve some sections of tiling and flooring repair and replacement. A tiling contractor or bathroom specialist should be appointed to provide further advice on reparation options and to perform works as necessary.
