Building and Timber Pest Inspection Report

Inspection Date: Wed, 1 Apr 2026

Property Address: 147 St Johns Rd, Glebe NSW 2037,
Australia

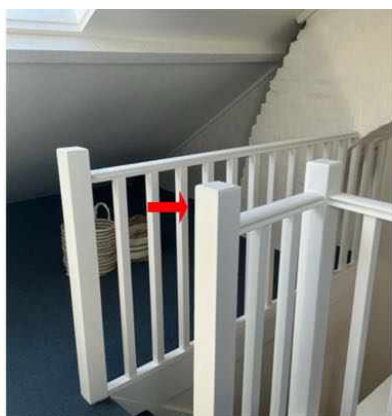
| Finding: | Handrail Stability & Safety Concern |
| Information: | Movement was noted in the stair balustrade/handrail assembly under light manual pressure at the loft level, indicating inadequate fixing or loosening of connections. Handrails and balustrades are critical safety elements designed to resist lateral loads, and any movement reduces their effectiveness and increases the risk of fall-related injury, particularly at stair openings. Although no immediate structural failure was observed, the condition is considered a safety concern and may worsen with use. It is recommended that a qualified carpenter secure and reinforce the balustrade to ensure compliance with safety expectations and adequate rigidity. |

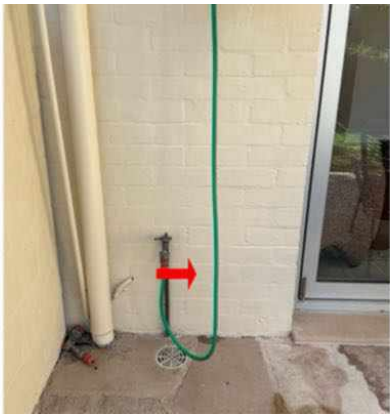
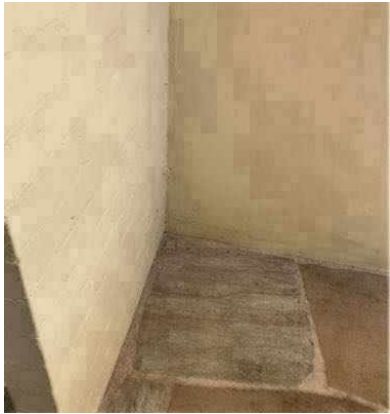
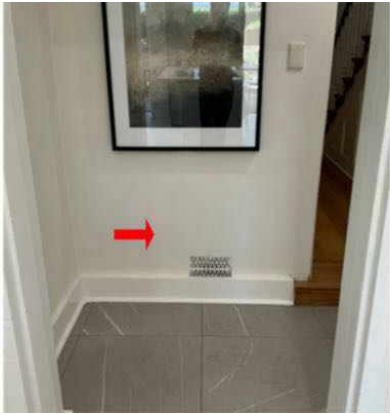
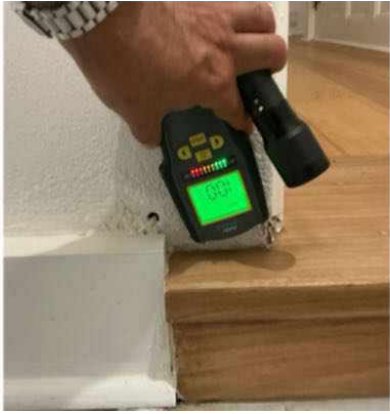
Finding 2.01

| Information: | Moisture ingress was observed affecting both internal and external building elements, with evidence including damp staining and/or elevated moisture readings. The distribution of moisture suggests a potential ongoing or systemic issue rather than isolated occurrence. If left unaddressed, this may lead to material deterioration, mould growth, and reduced durability of building elements. Further investigation by a qualified damp proofing specialist is recommended to determine the source and extent of moisture ingress. |

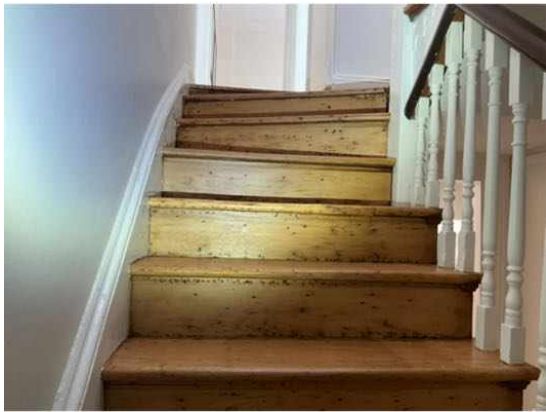
| Information: | unevenness was observed to the first floor, with gaps exceeding ~ 20mm between the flooring and skirting boards, as well as separation noted to sections of the staircase. The extent and irregular nature of these gaps are not consistent with normal material shrinkage and indicate movement or deformation within the floor structure, potentially associated with subfloor settlement or deflection of supporting elements. This condition represents a major defect due to its potential impact on structural performance and serviceability. Further assessment by a qualified builder or structural engineer is recommended to determine the cause, extent, and required rectification works. |

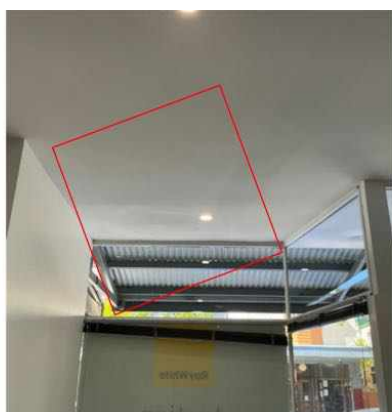
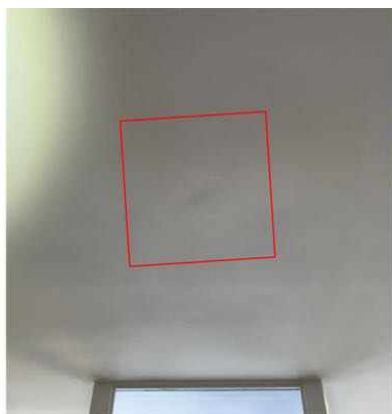
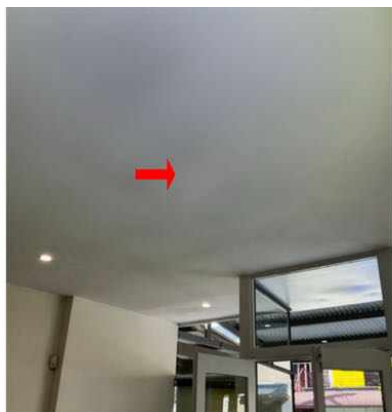
| Finding: | Ceiling - Water damaged (Repaired) |
| Information: | Water damage to the ceiling lining is generally an indication of excessive moisture being present in the roof void, usually via a leak to the roof covering. |

Where water damage is evident to the ceiling, the primary requirement is to identify and rectify the source of the leak. A roofing plumber should be appointed as soon as possible to identify the leak and perform rectification works as necessary, ensuring the water damage is restricted.

Once the leak is repaired, consultation with relevant tradespeople, including plasterers and painters, is advised. Rectification works may include replacement of ceiling lining or minor repainting, depending on the extent of the damage.

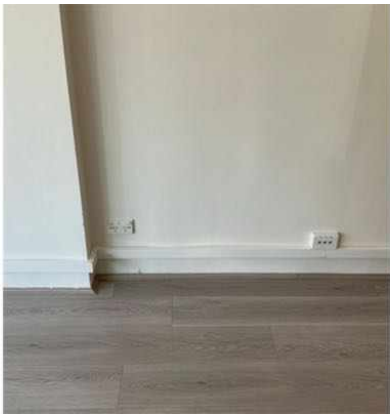
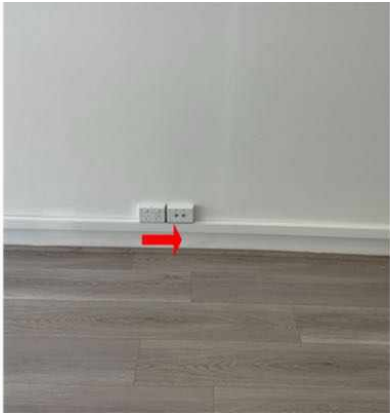
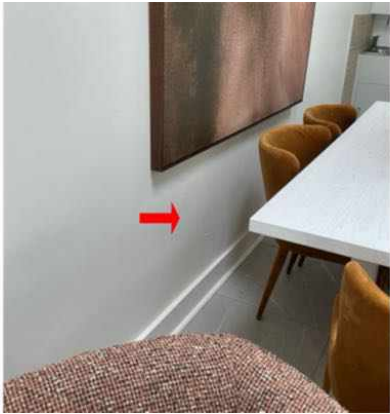
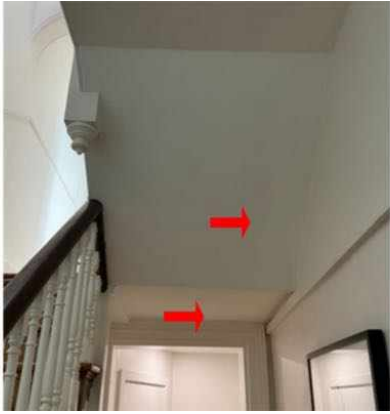
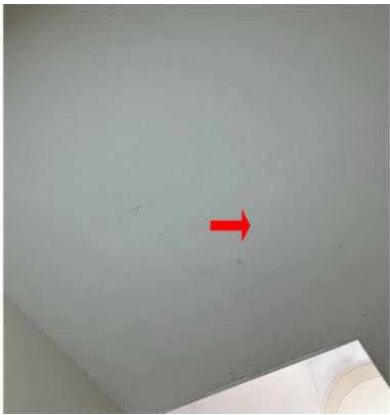
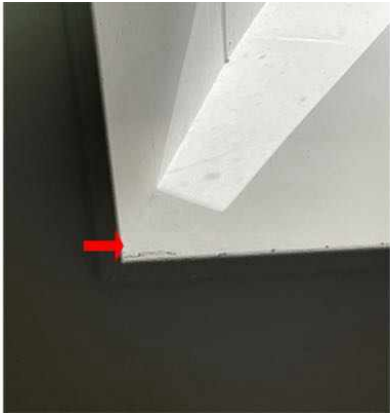
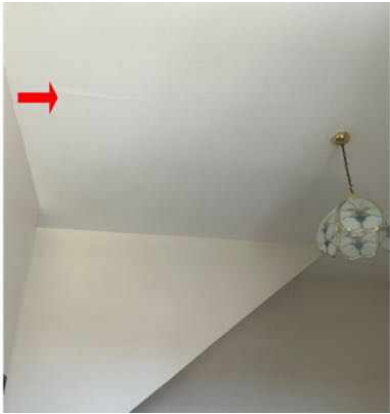
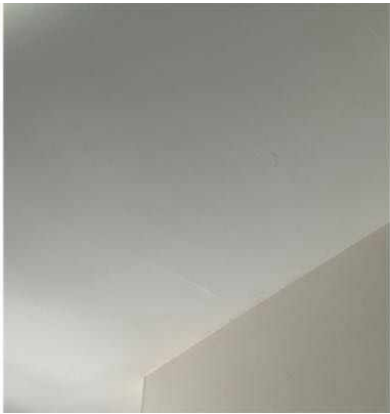
Finding 3.02

| Finding: | Painted surface - Bubbling or moisture related deterioration to some areas |
| Information: | Sections of paint in this area was found to have bubbled and deteriorated. Paint bubbling is generally an indication of excessive moisture in the area, that is currently hidden by the painted surface. |

The presence of excessive moisture can have major implications on associated building elements if left unattended. While only seemingly minor at this stage, the damage cannot be determined due to the paint obstructing any further inspection of the damage.

It is highly advised that the affected paint be cleaned to allow a further, more invasive inspection by a licensed plumber. Failure to act on this defect may necessitate major works in the future.

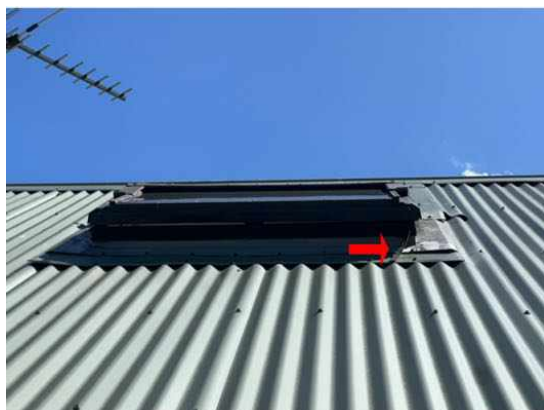
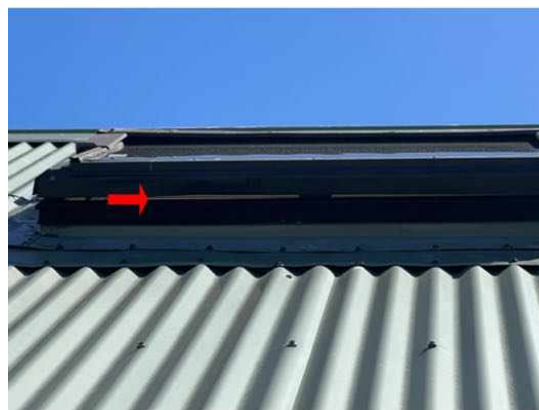
Finding 3.03

| Finding: | Flashing defective -poor installation |
| Information: | The metal flashing appears inadequately installed, with visible gaps and lifting and reliance on surface sealant rather than a properly chased and continuous detail. The junction does not appear fully weather-tight, increasing the risk of moisture ingress into the wall cavity or roof structure over time. Defective flashing installation can lead to concealed deterioration if not addressed. Recommend assessment and rectification by a qualified roofing contractor to ensure compliant and effective weatherproofing. |

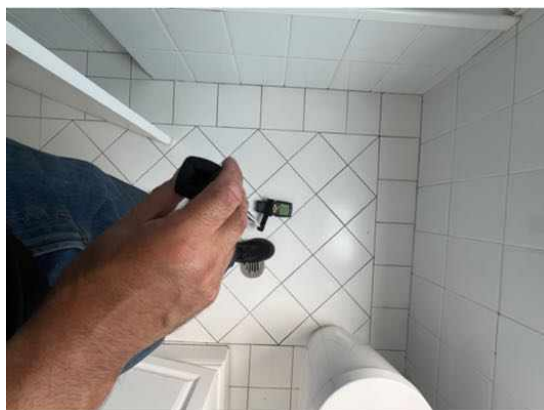
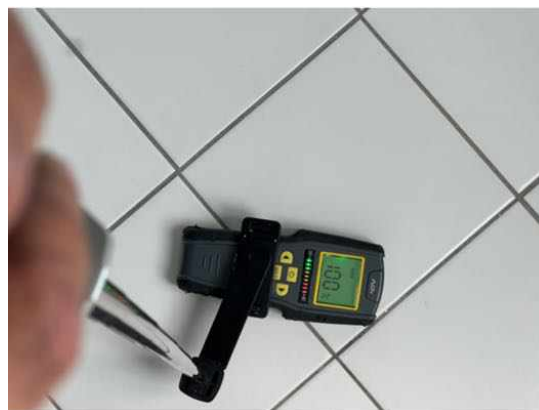
| Finding: | Elevated Moisture Bathroom |
| Information: | Elevated moisture levels were detected to tiled surfaces in bathroom/shower areas. Persistent moisture ingress can lead to concealed damage, including timber rot and mould growth. |

Elevated moisture readings in tiled wet areas can occur from normal shower use, age/deterioration of waterproofing membranes, plumbing leaks or moisture absorption through grout lines. While no damage was visible, elevated readings may indicate moisture retention behind tiles, which can be a conducive condition for future deterioration if not monitored.

Monitor the area over time for signs of drumming, efflorescence, tile movement, or grout deterioration. Further inspection by a licensed waterproofing is recommended (e.g., pressure testing, membrane assessment).

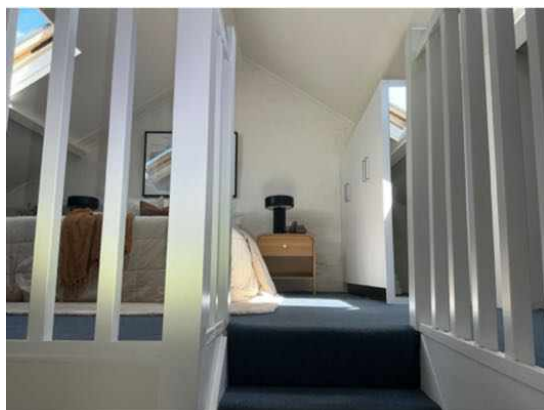
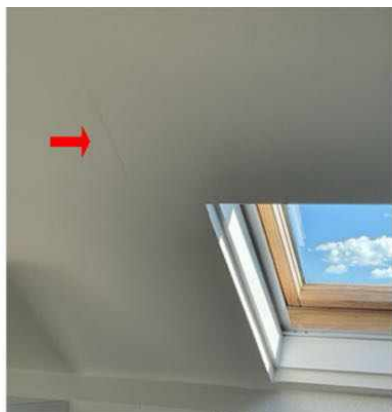
Finding 3.07

| Finding: | Renovations and/or repairs to some areas |
| Information: | Recent renovations, refurbishments or repairs were observed at the time of inspection. As this is a visual inspection only, the inspector is unable to determine the quality, compliance, or durability of such works where construction details are concealed. No comment can be made on whether these works were undertaken with the appropriate permits, approvals, or by licensed tradespersons. It is recommended that the purchaser seek clarification from the vendor or builder and request relevant documentation such as occupation certificates, warranties, or council approvals to confirm compliance and workmanship quality. |

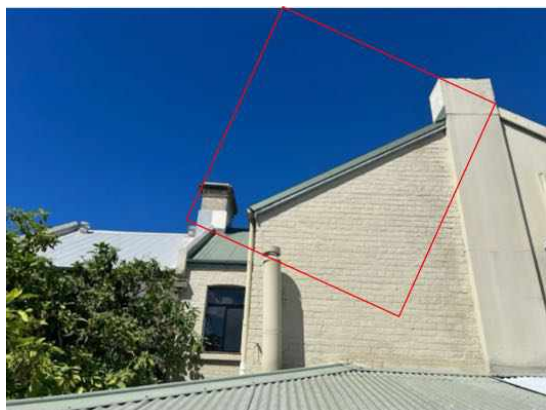
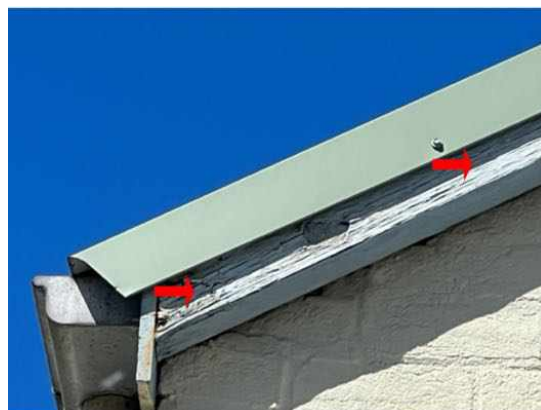
Finding 3.08

| Finding: | Fascias - Wood rot |
| Information: | Wood rot was found to be affecting fascias and barges in this area, evidenced by the presence of mould on the surface in some areas. Wood rot, also known as Fungal Decay, occurs when timbers and other cellulose building materials are exposed to damp conditions on an ongoing basis. |

It is likely that this wood rot has developed as a result of faults in the roof plumbing, creating excessive moisture in this areas. Frequent exposure to rain and other weather conditions also make fascias and barges susceptible to accelerated deterioration.

Early intervention and regular maintenance will prolong the useful life of these building elements. Prior to any works being performed, the cause of the moisture that has created the visible wood rot should be identified and addressed in a suitable manner.

It is advised that a roof plumber be appointed to inspect all roof plumbing and subsequently identify the cause of the wood rot. Replacement of affected fascias and barges may then be a necessary step in protecting surrounding building elements from such deterioration.

A qualified plumber may be appointed to assess the cause of excessive moisture and

to provide advice on any remedial works as required. A qualified carpenter or registered builder may also be required to replace affected building materials.

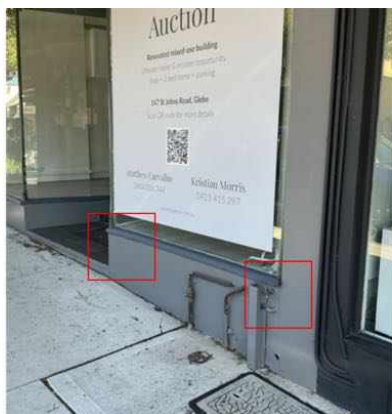
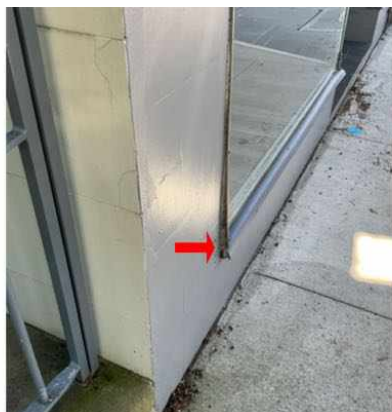
Finding 3.09

| Finding: | Wood rot to some areas |
| Information: | This building element shows evidence of wood rot. Wood rot, also known as Fungal Decay, occurs when timbers and other cellulose building materials are exposed to damp conditions on an ongoing basis. This could be the result of exposure to weathering over a prolonged period of time, or the attraction of excessive moisture from other abutting building materials. Contributing factors also include poor air ventilation in the area. |

Wood rot is often associated with general damp problems and is evidenced by a 'musty' smell or mould and mildew occurring on surfaces. If left unmanaged, damp conditions can lead to further health problems and the decay of timbers will continue.

Early intervention and regular maintenance, particularly of exterior timbers, will prolong the useful life of these building elements. Prior to any works being performed, the cause of the moisture that has created the visible wood rot should be identified and addressed in a suitable manner. Replacement of affected timbers may then be a necessary step in protecting surrounding building elements from such deterioration.

A qualified plumber may be appointed to assess the cause of excessive moisture and to provide advice on any remedial works as required. A qualified carpenter or registered builder may also be required to replace affected building materials.

Even though Liverpool termite activity was not visible. A further invasive inspection by a licensed termite technician its also highly recommended to eliminate possibility of potential termite activity.

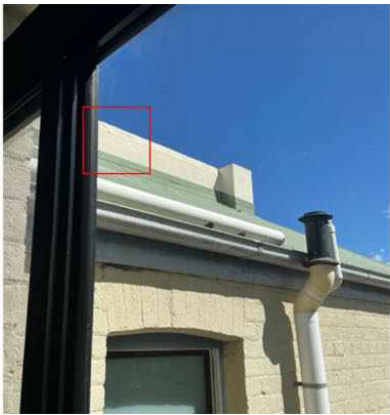
Finding 3.10

| Finding: | Brickwork - Cracking noticeable - Further closer inspection required |
| Information: | Noticeable cracks are a common occurrence in external brickwork and are a likely result of age expected building movement, general expansion, and/or contraction of building materials in different weather conditions. Noticeable cracks in brickwork may develop if left unattended, with potential for necessitating major remedial works or replacement of the brickwork. |

It is highly advised that a qualified bricklayer be appointed to provide necessary works to cracked brickwork to prevent any further damage. Such works should be conducted as soon as possible.

Always monitor these cracks and contact a building inspector should cracks widen, lengthen, or become more numerous.

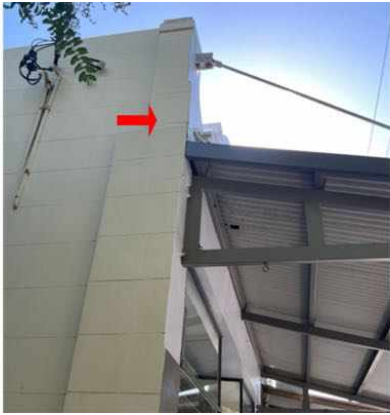
Finding 3.11

Building: Main Building
Location: All External Areas - Front , Side
Finding: Cracks to render - Category 1
Information: It has been observed that cracking to rendered surfaces has occurred. The degree of damage falls within Category 1 , described as fine cracks that do not need repair and which are less than 1.0mm in width limit.

Damage of this category is not considered a defect for rectification. Always contact your building inspector should cracks widen, lengthen, or become more numerous.

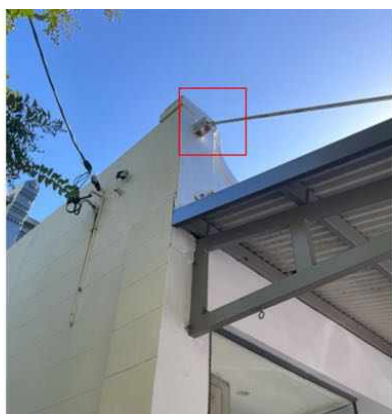
| Finding: | Building element - Rusted or corroded - Awning fixings rusted |
| Information: | This building element shows evidence of rusting and corrosion, which is likely to have |

developed as a result of excessive exposure to moisture and or inadequate coatings.

As surface rust provides no protection to the underlying iron, the deteriorating condition is likely to worsen if not addressed in the short-term future.

Where possible, the use of galvanized (treated) metals or aluminium coated metals aid in rust prevention, as does regular general maintenance. Rust formation can be controlled with coatings, such as paint, that isolate the iron from the environment.

Rusting and corrosion should be managed by ideally removing or limiting the affected surface from exposure to moisture. A registered builder may be appointed to replace any building elements that have been severely affected by rust or water damage.

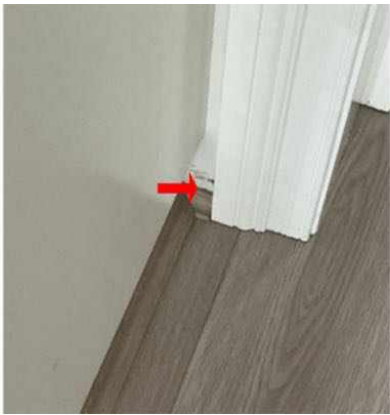
Finding 3.15

| Finding: | Paint Finish & Hairline Cracking - To some areas |
| Information: | The paint finish in this area was identified as being incomplete at the time of inspection including some hairline minor cracking. |

Whilst incomplete or missing paint and minor cracking and imperfections in finish is generally an appearance defect, it can also lead to the development of secondary building defects over time. Incomplete areas of paint finish expose the area to moisture, potentially accelerating the deterioration of underlying building materials.

A painting contractor should be appointed as soon as possible to perform necessary works to aid the appearance of the affected area and to ensure the area is protected against further deterioration. Alternatively, the homeowner following manufacturer instructions may perform these works.

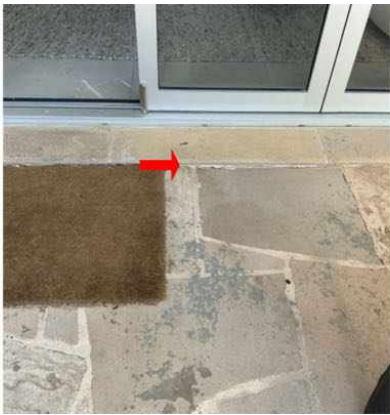
Finding 3.16

| Finding: | Sealant and grouting - Missing or degraded to some areas |
| Information: | It was noted on inspection that sealant or grout is degraded. |

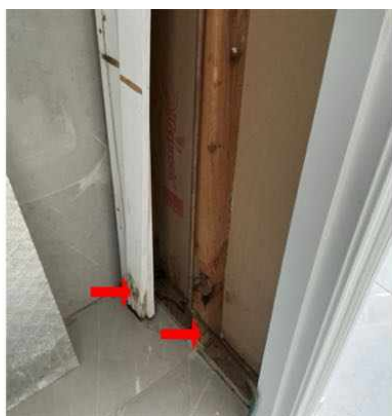
Works that have not been completed to a satisfactory level create potential for the development of building defects and may impede on the safety and integrity of the overall structure.

It is highly recommended that the relevant trades be appointed to complete these works and ensure the safety of the area and the longevity of all associated building elements.

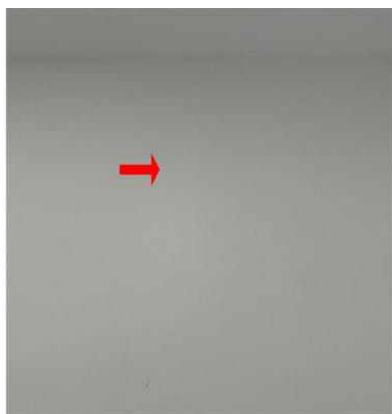
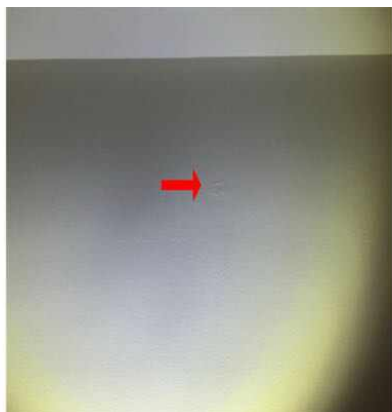
Finding 3.23

If left unmanaged, internal wall and ceiling sheeting may become loose and unstable, increasing the rate of deterioration of these building elements and creating potential for the development of secondary defects.

Re-fastening of popped nails will help to maintain the stability of these, and associated, building elements. Such minor works will also help to improve the appearance of the affected area and secure the linings. These works should be performed by a qualified carpenter or plasterer at client discretion.

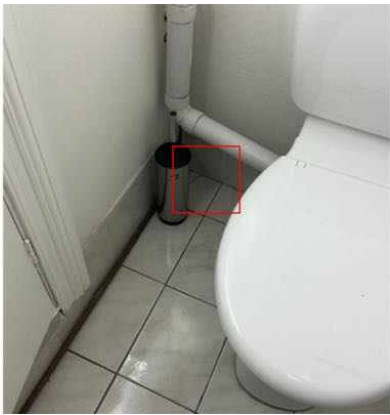
Finding 3.24

| Finding: | Tiles - Cracked or damaged |

A tiling contractor should be appointed to ensure that no further water damage occurs. The re-application of silicone and grouting throughout remaining tile work is also advised, to further protect the area against water penetration.

Where water penetration has led to water damage, appointment of a relevant tradesperson may be required to repair damaged building elements.

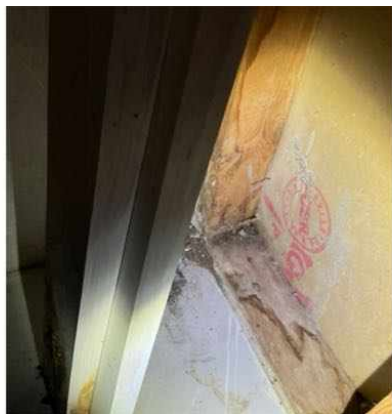
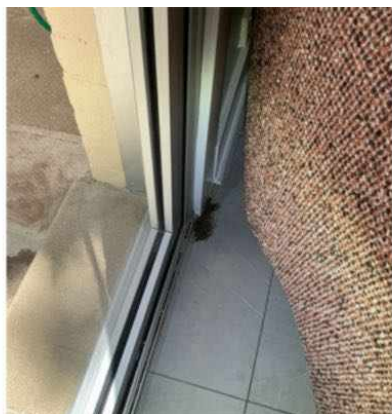
Finding 3.25

Building: Main Building
Location: All Internal Areas
Finding: Pest Activity

Information: The presence of pest-related material indicates possible concealed activity. As this inspection is non-invasive, the full extent of any infestation could not be determined at the time of inspection. The debris appeared consistent with insect e.g ant activity.

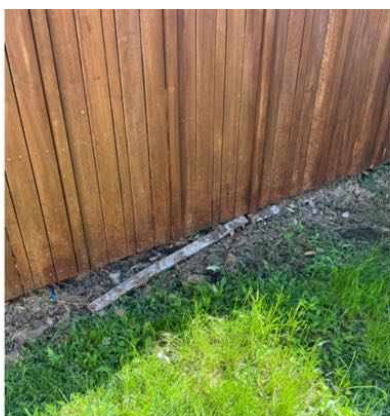
| Information: | Any timbers in direct ground contact provide opportunity for concealed termite entry and are likely to be subject to premature rot and decay as the soil retains moisture or damp conditions against the timbers. |

Remove untreated timber that is in direct contact with external grounds. Consider replacement with more durable materials i.e. treated timber or non timber elements. Frequent pest inspections are advised to readily identify any termite activity in these areas.

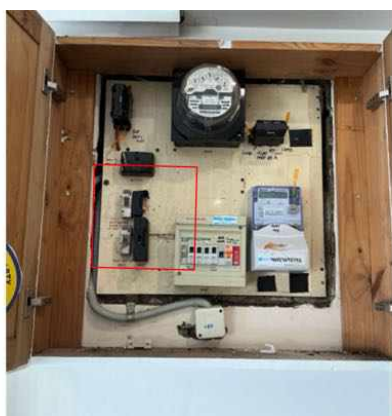
| Information: | The electrical switchboard while appearing to have adequate safety switches installed has old ceramic fuses in place. |

While this on its own on is not considered a defect it is noted for the clients consideration that a switchboard upgrade may be required in the short to mid term to improve the functionality of the electrical system. A licensed electrician could be appointed to provide quotation for the works at the client's discretion which may in turn expose other required works to bring the system up to a compliant state.
