Building and Timber Pest Inspection Report VR

Inspection Date: Tue, 3 Mar 2026

Property Address: 5 McFarlane St, South Grafton NSW 2460, Australia

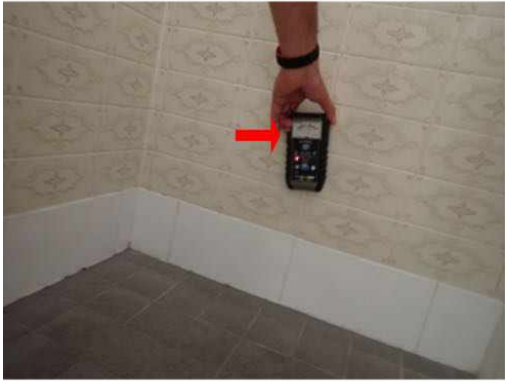
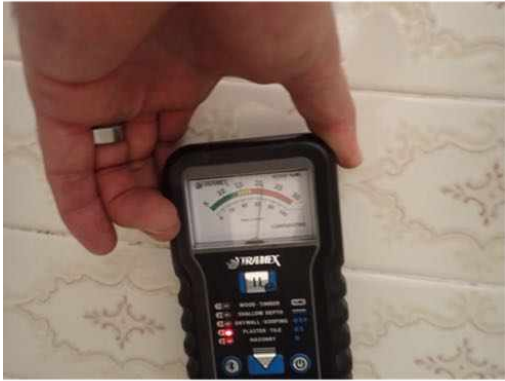
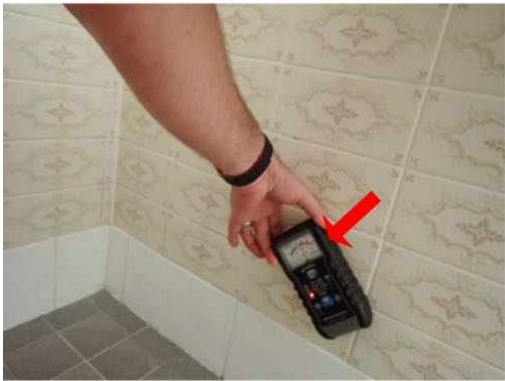
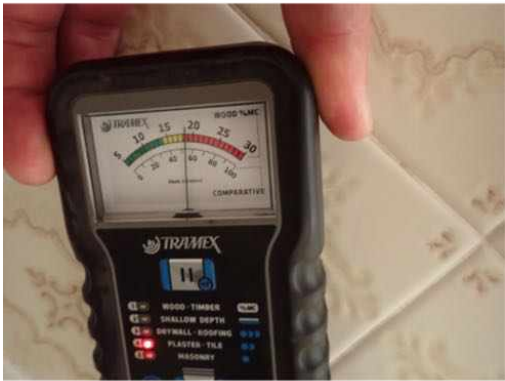
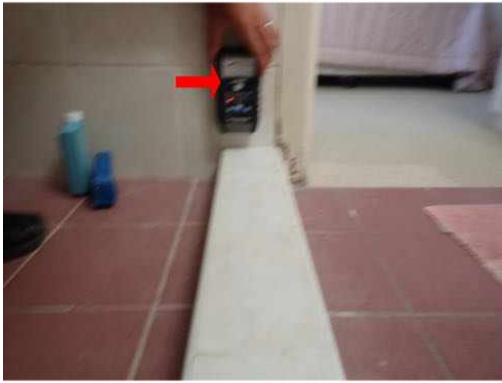
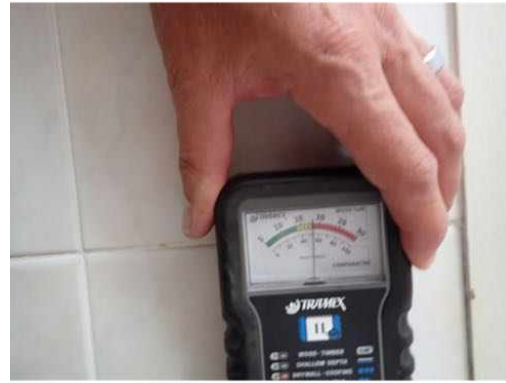
Finding 2.01

Building: Main Building
Location: Bathroom and ensuite
Finding: Elevated Moisture Meter Readings to Shower Areas – Bathroom and Ensuite
Information: Higher than normal moisture meter readings were obtained to the lower wall areas of the showers in the bathroom and ensuite at the time of inspection. Elevated moisture readings in these locations may indicate moisture penetration through grout, silicone seals, waterproofing membranes, or a possible plumbing issue within the wall. This condition can occur over time with regular use and is a common defect with a property of this age. Further investigation and maintenance may be required to prevent deterioration to surrounding building materials. Assessment and any necessary repairs should be carried out by a licensed plumber, tiler, waterproofing contractor, or suitably qualified tradesperson.

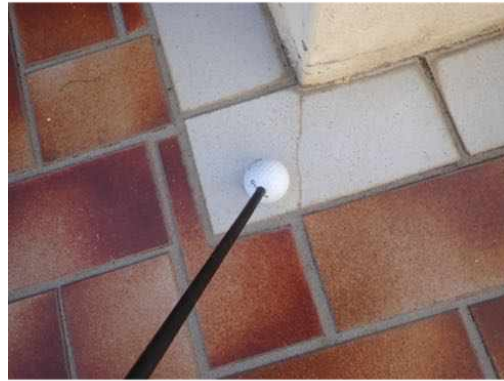
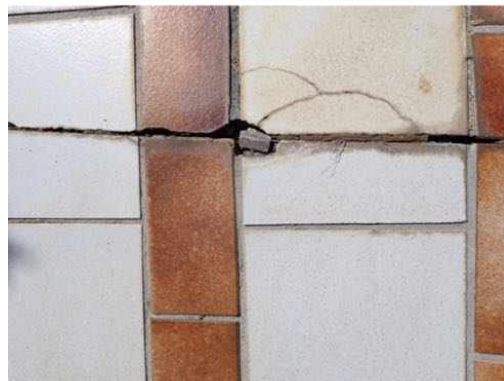
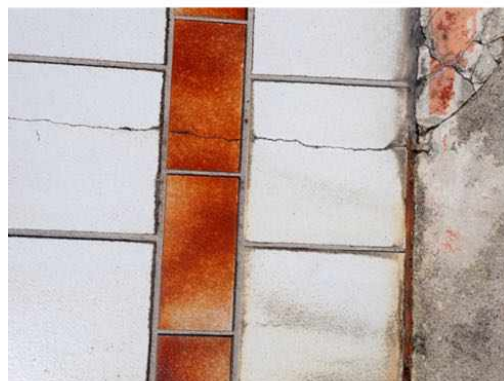
Finding 2.03

Building: Main Building
Location: Carport and driveway
Finding: Cracked Tiles to Carport and Driveway
Information: Cracked floor tiles were identified to areas of the carport and driveway. The cracking may be associated with movement of the underlying surface, impact damage, or general wear over time. If left unaddressed, the damage may worsen and may allow water to penetrate beneath the tiles. Replacement of the damaged tiles as required is recommended. Repairs should be carried out by a licensed tiler or suitably qualified tradesperson.

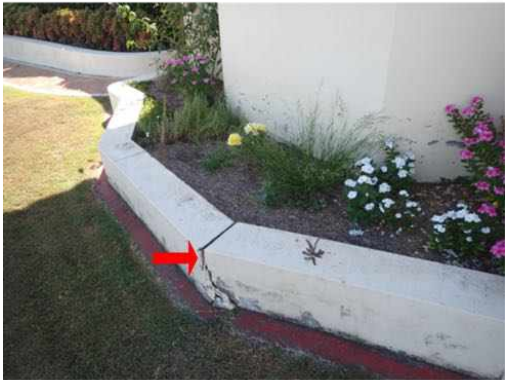
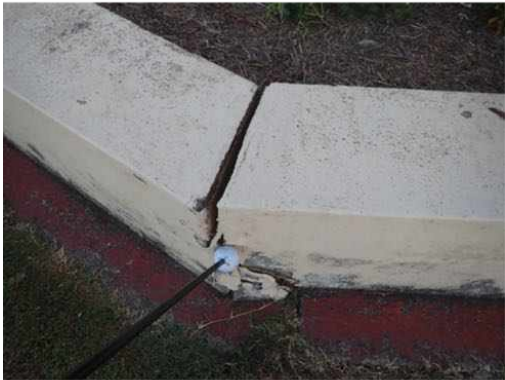
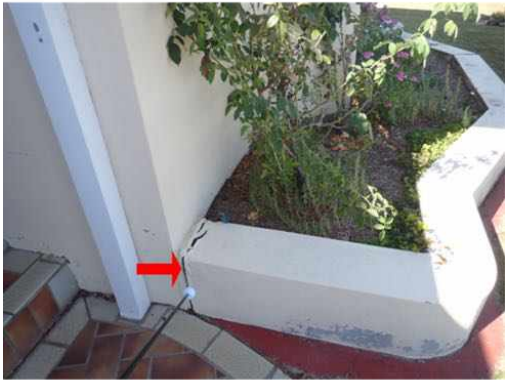
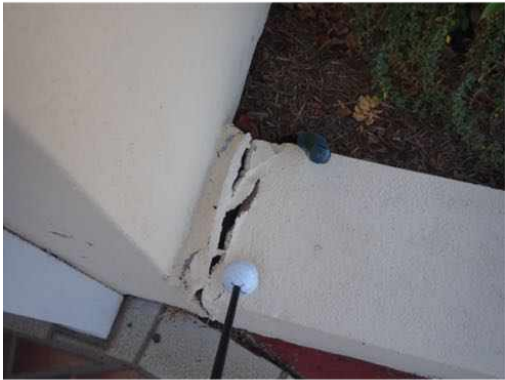
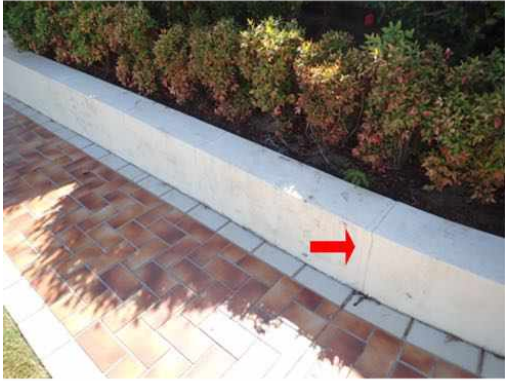
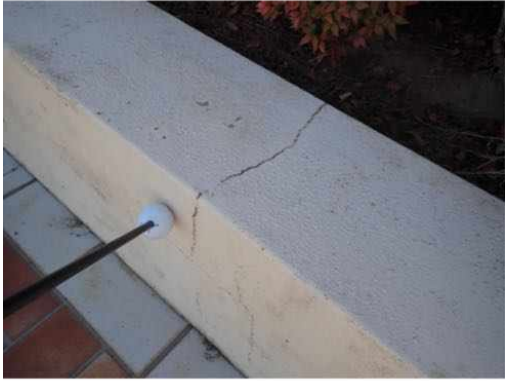
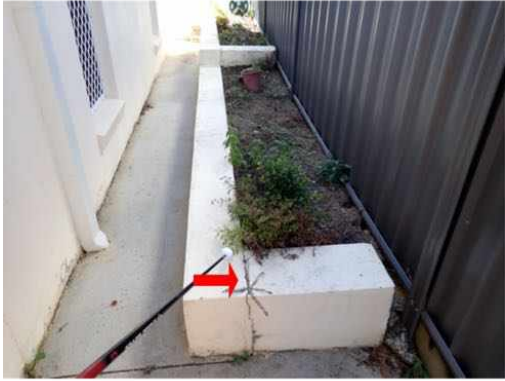
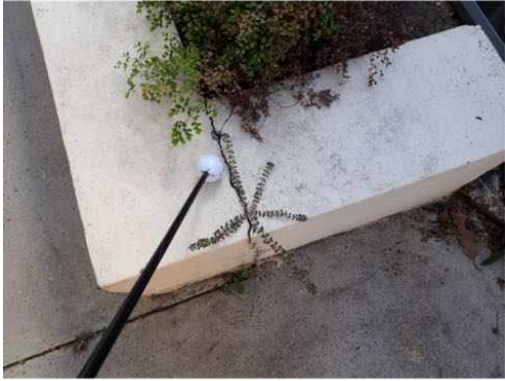
Finding 2.04

Building:	Yard
Location:	Carport
Finding:	Major and Minor Cracks to Brick Rendered Retaining Walls and Garden Beds
Information:	Major and minor cracks were identified to the low brick rendered retaining walls and garden beds around the property at multiple locations. Cracking to these types of structures can occur over time due to ground movement, soil pressure, and general weathering. Continued deterioration may occur if the cracking worsens or allows moisture penetration. Maintenance and repairs as required are recommended to prevent further deterioration. Repairs should be carried out by a licensed builder, bricklayer, or suitably qualified tradesperson.

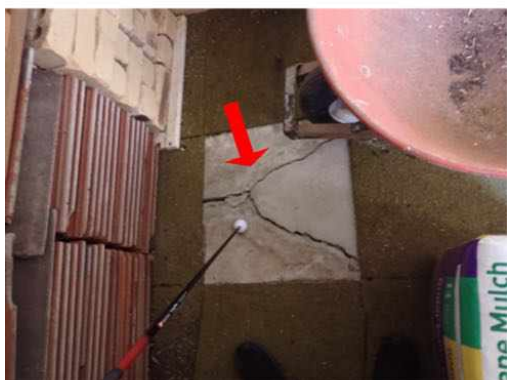
Finding 2.05

Building: Shed
Location: Shed concrete floor
Finding: Major Cracks to Shed Concrete Floor
Information: Major cracks were identified to the concrete floor within the shed. The cracking may be associated with ground movement, settlement, or deterioration of the concrete over time. Significant cracking may affect the serviceability and durability of the slab if left unaddressed. Further assessment and repairs as required are recommended to prevent further deterioration. Repairs should be carried out by a licensed builder, concreter, or suitably qualified tradesperson.

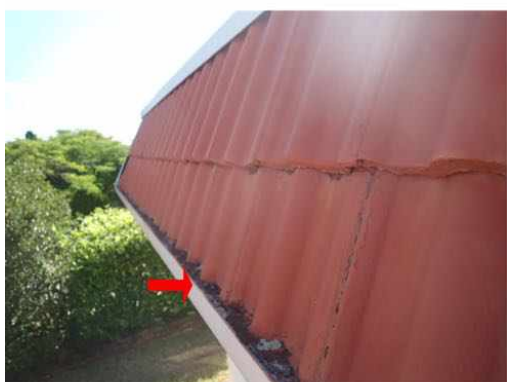
Finding 2.06

Building:	Carport
Location:	Carport roof
Finding:	Deterioration to Roof Tiles at Base of Carport Parapet
Information:	Deterioration was identified to the edges of the roof tiles around the base of the carport parapet. The deterioration may allow moisture ingress beneath the roof covering if left unaddressed and may worsen over time due to ongoing exposure to weather. Maintenance and repairs to the affected roof tiles and surrounding flashing as required are recommended to maintain the weatherproofing of the roof area. Repairs should be carried out by a licensed roofer or suitably qualified tradesperson.

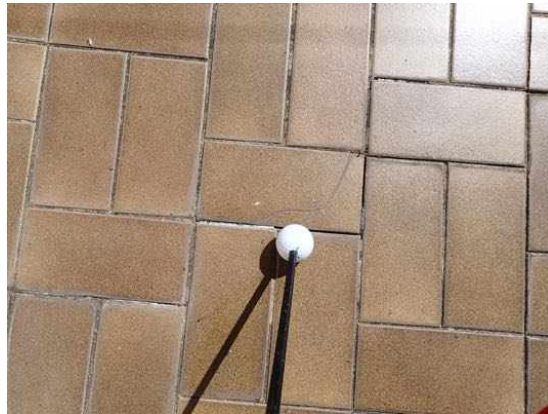
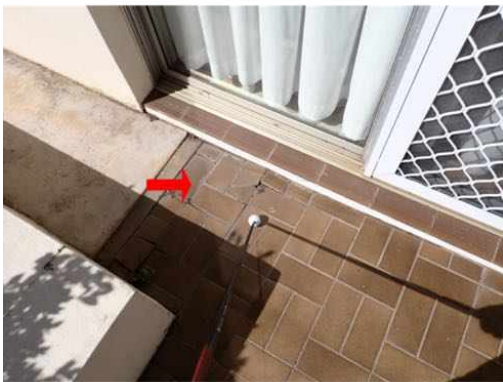
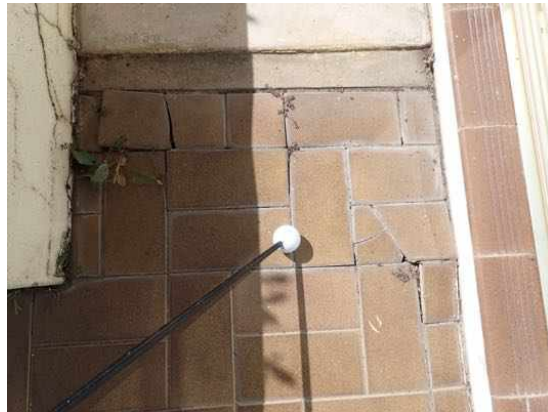
Finding 2.07

Building:	Yard
Location:	Rear tiled patio area
Finding:	Cracked, Drummy and Damaged Tiles to Rear Patio Area
Information:	Cracked, drummy and damaged tiles were identified to sections of the rear patio area. Drummy tiles indicate that the tiles have become debonded from the substrate and may loosen or crack further over time. The damage may be associated with movement of the underlying surface, deterioration of the adhesive, or general wear and this is a common defect. Replacement and re-fixing of the affected tiles as required is recommended to prevent further deterioration. Repairs should be carried

out by a licensed tiler or suitably qualified tradesperson.

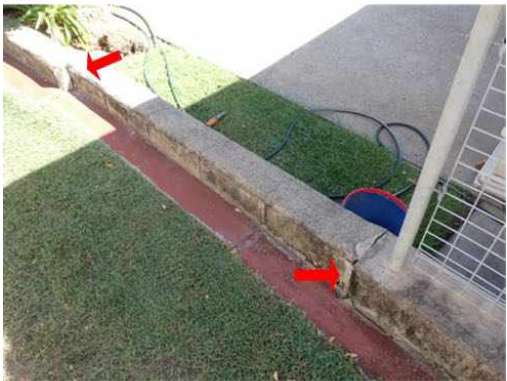
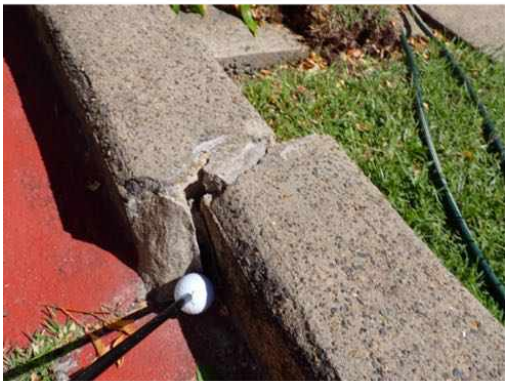
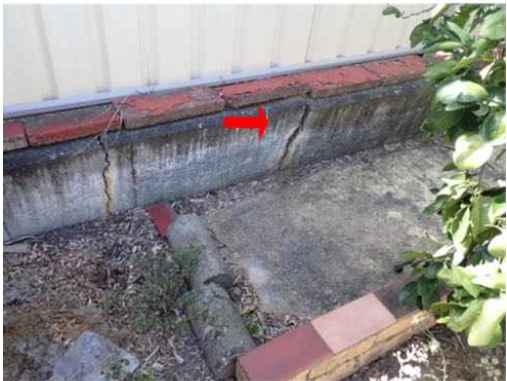
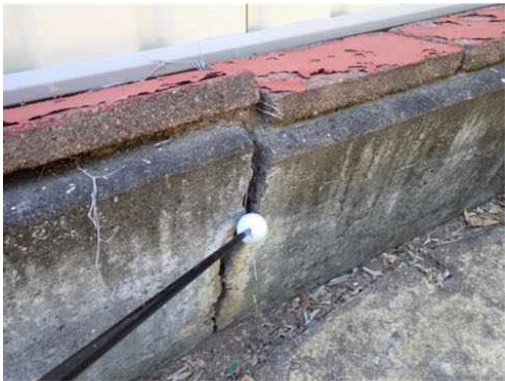
Finding 2.08

Building:	Yard
Location:	Back and left hand side boundary
Finding:	Large Cracks and Movement to Low Retaining Walls – Rear and Left Boundary
Information:	Large cracks and signs of movement were identified to the low retaining walls located at the rear and along the left-hand side boundary of the property. Movement and cracking in retaining walls may occur over time due to ground movement, soil pressure, and deterioration of materials. Significant movement may affect the stability and performance of the retaining walls if left unaddressed. Further assessment and repairs or rebuilding of affected sections as required is recommended. Works should be carried out by a licensed builder, structural landscaper, or suitably qualified tradesperson.

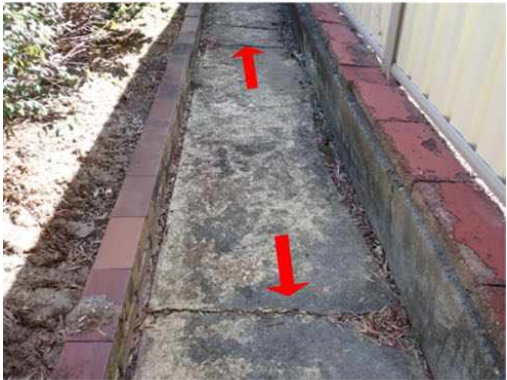
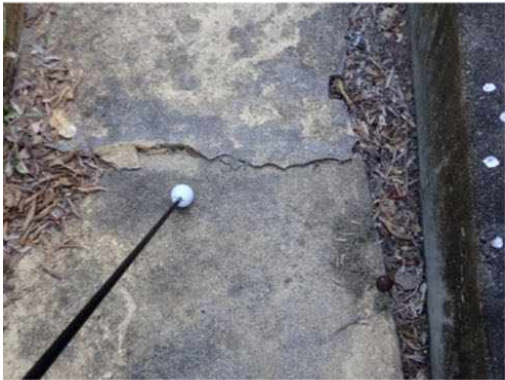
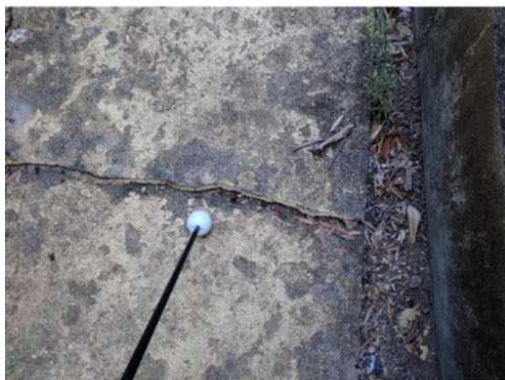
Finding 2.09

Building: Yard
Location: Rear left hand corner of property
Finding: Large Cracks to Concrete Path at Rear Left Side of Property
Information: Large cracks were identified in the old concrete path located at the rear left-hand side of the property. The cracking is likely associated with age, ground movement, or settlement of the underlying surface. Significant cracking may continue to deteriorate over time and may present a trip hazard if left unaddressed. Repairs or replacement of the affected sections of concrete as required is recommended. Works should be carried out by a licensed builder, concreter, or suitably qualified tradesperson.

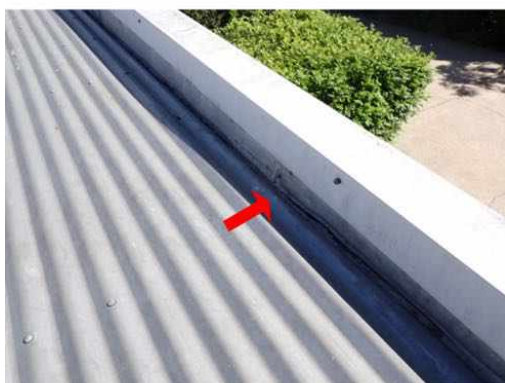
Finding 2.10

Building:	Main Building
Location:	Carport roof
Finding:	Poor and Deteriorated Silicone to Carport Parapet Roof
Information:	Poor and deteriorated silicone sealant was identified to the parapet roof area of the carport. The sealant appears aged and inadequately applied in areas, which may allow water ingress if left unmaintained. Deterioration of sealants in exposed roof areas is commonly associated with weathering and is a common defect with a property of this age. Removal of the deteriorated silicone and re-sealing of the affected areas with appropriate roofing sealant is recommended to maintain weatherproofing. Repairs should be carried out by a licensed roofer or suitably qualified tradesperson to prevent further damage to associated building materials.

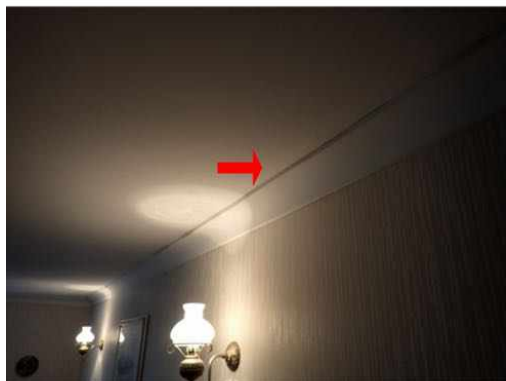
Finding 3.01

Building:	Main Building
Location:	Living Room
Finding:	Sagging Cornice to Living Room
Information:	Age-related sagging was identified to the cornice in the living room. The condition may

also be associated with previous water damage; however, no elevated moisture readings were detected to the ceiling in this area at the time of inspection. This type of movement and deterioration can occur over time and is a common defect with a home of this age. Repairs or refixing of the cornice as required is recommended. Works should be carried out by a licensed builder, plasterer, or suitably qualified tradesperson.

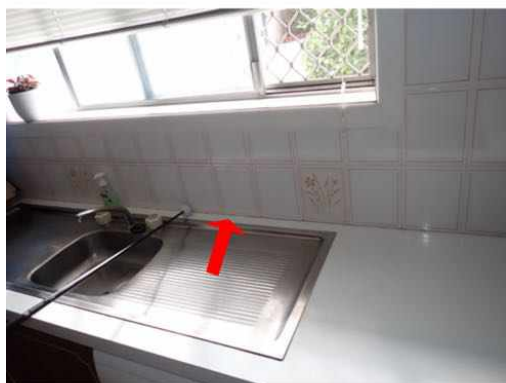
Finding 3.02

Building:	Main Building
Location:	Kitchen
Finding:	Deteriorated Silicone to Kitchen Benchtop and Tile Splashback Junction
Information:	Deteriorated silicone sealant was identified at the junction between the kitchen benchtop and the tiled splashback. The sealant has perished and is no longer providing an effective waterproof seal, which may allow moisture to penetrate behind the benchtop or wall lining and cause deterioration to adjacent materials over time. This condition is commonly associated with general wear and tear. Removal of the existing silicone and re-sealing with an appropriate sanitary grade sealant is recommended. Repairs should be carried out by a handyman or suitably qualified tradesperson.

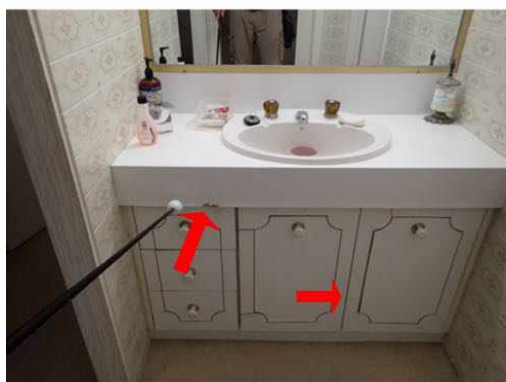
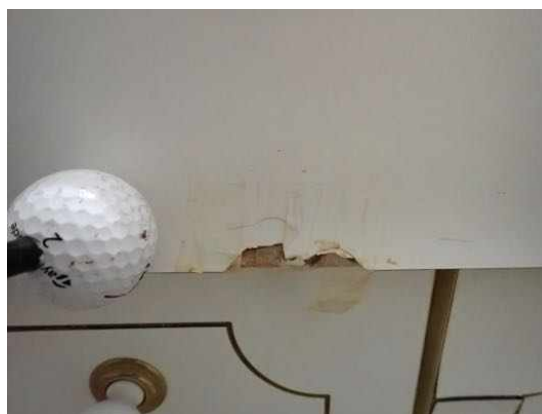
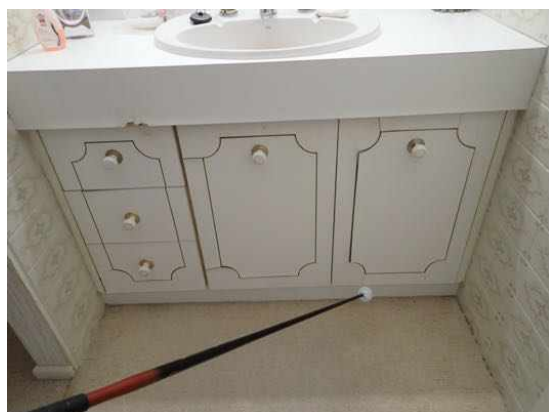
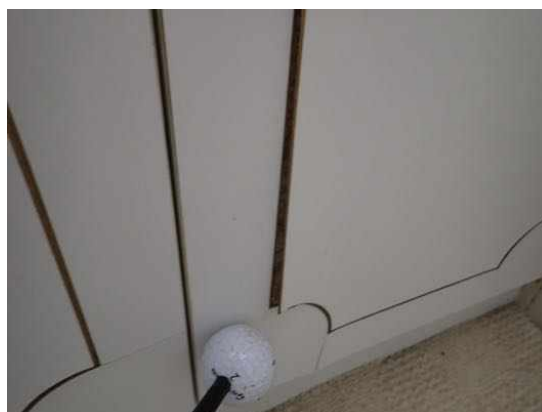
Finding 3.03

Building:	Main Building
Location:	Bedroom
Finding:	Delamination to Bathroom Vanity Cupboard Doors and Benchtop Laminat
Information:	Delamination was identified to the bathroom vanity cupboard doors and the laminate surface of the benchtop. The laminate finish is lifting and deteriorating, which is commonly associated with age, moisture exposure, and general wear and tear. If left unaddressed, the deterioration may worsen and affect the serviceability of the vanity unit. Repair or replacement of the affected components is recommended. Works should be carried out by a cabinet maker, carpenter, or suitably qualified tradesperson.

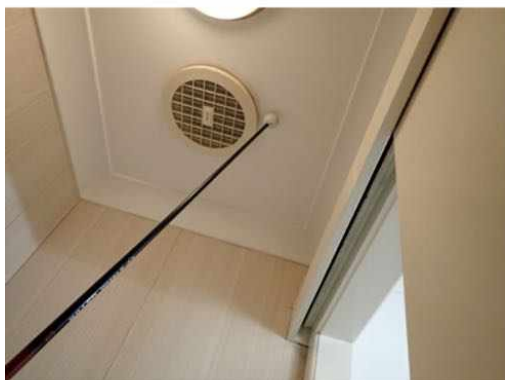
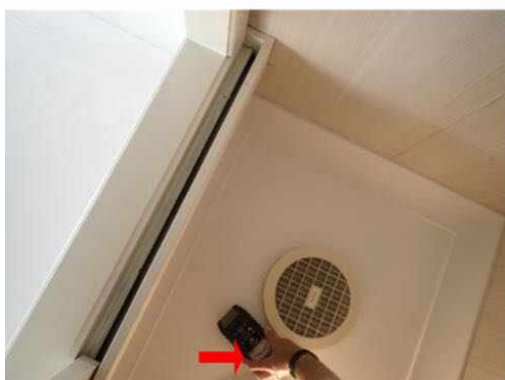
Finding 3.04

Building:	Main Building
Location:	Toilet (WC)
Finding:	Possible Old Water Stains to Plasterboard Around Ceiling Fan
Information:	Possible old water stains were identified to the plasterboard around the ceiling fan. The staining may be associated with previous moisture ingress; however, no elevated moisture readings were detected with the moisture meter at the time of inspection. This type of condition can occur over time and may relate to past roof leaks, condensation, or previous water ingress that has since dried. Continued monitoring and maintenance of the roof and ceiling areas is recommended. Repairs or further investigation, if required, should be carried out by a licensed roofer, builder, or suitably

qualified tradesperson.

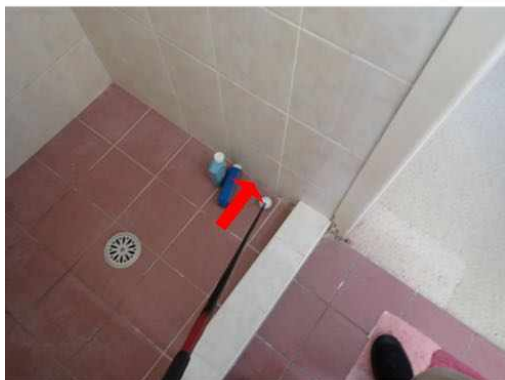
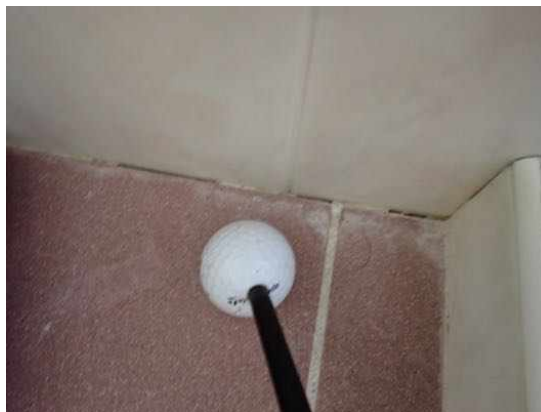
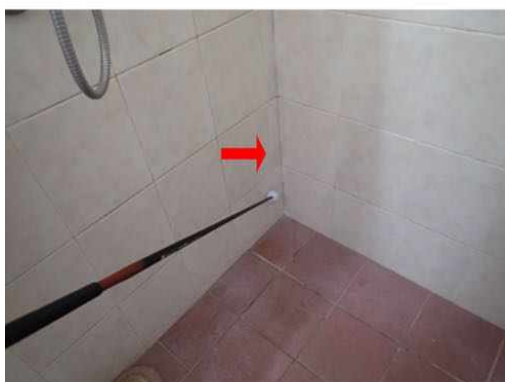
Finding 3.05

Building:	Main Building
Location:	Ensuite
Finding:	Deteriorated Grout and Silicone to Ensuite Shower
Information:	Deteriorated grout and silicone sealant were identified to the tiled areas of the ensuite shower. The deterioration may allow moisture to penetrate behind the tiles and surrounding materials over time. This condition is commonly associated with ongoing moisture exposure and is a common defect with a property of this age. Maintenance is recommended including regrouting and resealing the affected areas to maintain the waterproof integrity of the shower. Repairs should be carried out by a licensed tiler or suitably qualified tradesperson.

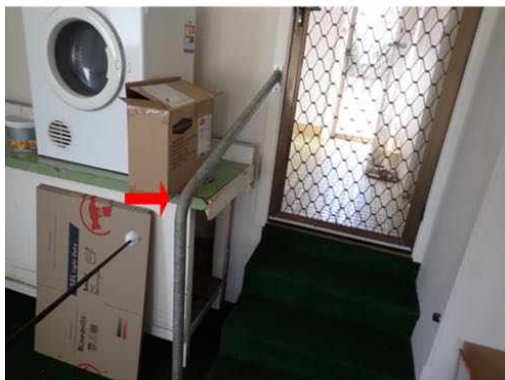
Finding 3.06

Building: Main Building
 Location: Garage
 Finding: Loose Handrail to Steps from Laundry to Garage
 Information: The handrail to the steps leading from the laundry to the garage was found to be loose at the time of inspection. Loose handrails may reduce stability and can present a potential safety hazard when using the steps. Re-fixing and securing of the handrail is recommended to ensure it is adequately supported and safe for use. Repairs should be carried out by a licensed builder, carpenter, or suitably qualified tradesperson.

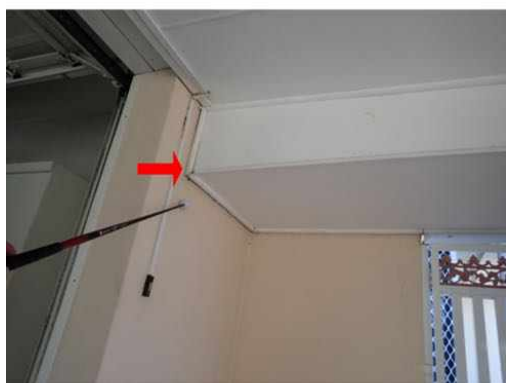
Finding 3.07

Building:	Main Building
Location:	Carport
Finding:	Movement Between Main Building and Carport Structure
Information:	Movement was identified at the junction between the main building and the carport structure. The carport appears to have been constructed at a later stage than the original dwelling, which may result in differential movement between the two structures over time. This type of movement is not uncommon where additions are connected to an existing structure. Continued monitoring is recommended and repairs or separation detailing may be required if movement continues. Assessment and any necessary repairs should be carried out by a licensed builder or suitably qualified tradesperson.

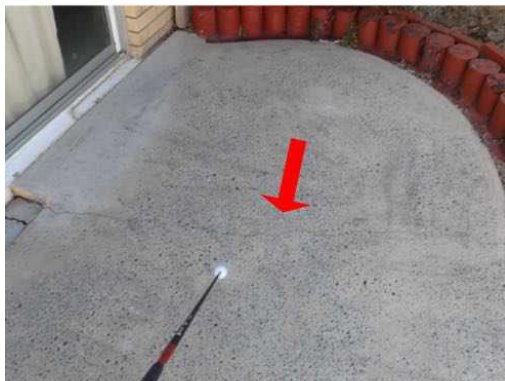
Finding 3.09

Building: Yard
 Location: Bbq area
 Finding: Minor Cracks to Concrete Path and Concrete Beside Garden Shed
 Information: Minor cracks were identified to the concrete path and the concrete area beside the garden shed. This type of cracking is commonly associated with minor settlement, shrinkage, or normal movement of concrete over time and is a common defect with a property of this age. The cracks appeared minor at the time of inspection; however, continued monitoring and maintenance is recommended to ensure the cracking does not worsen. Repairs, if required, should be carried out by a licensed builder, concreter, or suitably qualified tradesperson.

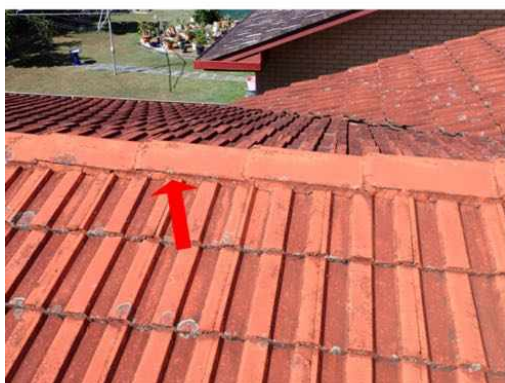
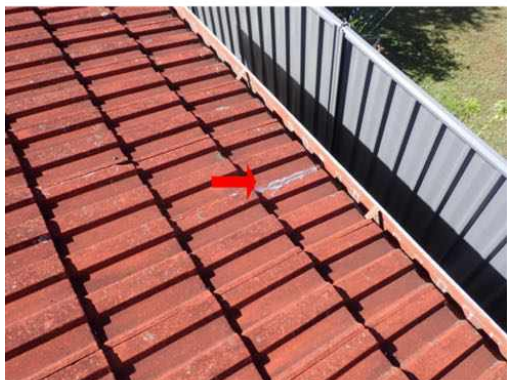
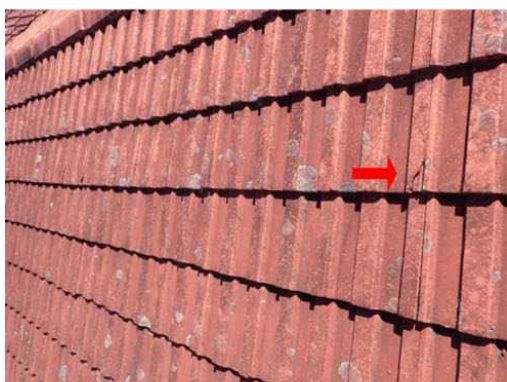
Finding 3.10

Building:	Main Building
Location:	Roof
Finding:	Roof Tiles Weathered with Cracked Tiles, Lichen Growth and Cracked Ridge Caps
Information:	The roof tiles were found to be generally in fair condition; however, they were noted to be weathered. Some cracked tiles were identified along with areas of lichen growth and cracking to the ridge capping. These conditions are commonly associated with age and prolonged exposure to weather and are common defects with a property of this age. Damaged tiles and cracked ridge capping may allow water ingress if left unmaintained. Maintenance including replacement of cracked tiles, cleaning of lichen growth and repairs to the ridge capping as required is recommended. Inspections and necessary repairs should be carried out by a licensed roofer or suitably qualified tradesperson to prevent further damage to associated building materials.

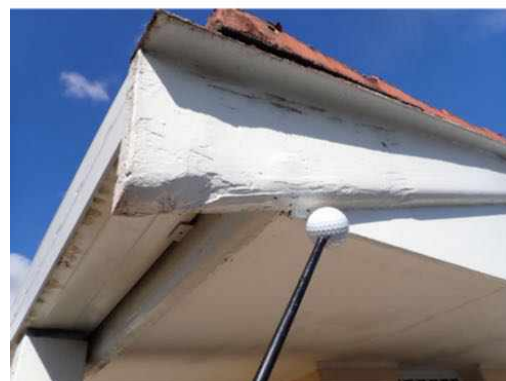
Finding 7.02

Finding: Possible Wood Rot to Ends of Fascia Boards

Information: The ends of several fascia boards were found to be soft behind the painted surface, indicating possible wood rot to these locations. Deterioration of timber fascia boards is commonly associated with prolonged exposure to moisture and weathering and is a common defect with a property of this age. If left unaddressed, the deterioration may worsen over time and affect the integrity of the affected sections. Further assessment and repairs including replacement of deteriorated timber as required are recommended. Repairs should be carried out by a licensed builder, carpenter, or suitably qualified tradesperson.

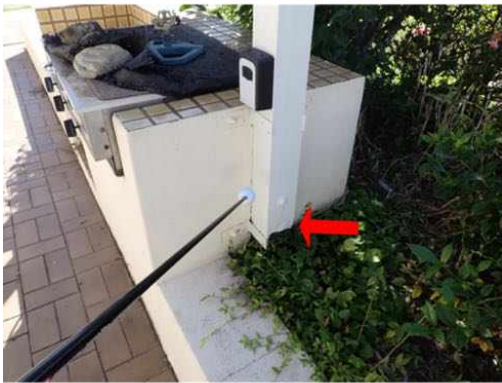
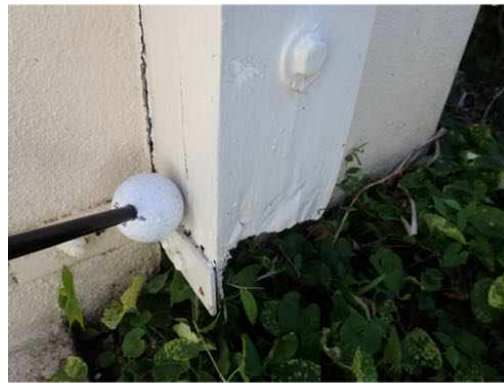
Finding 7.03

Finding: Wood Rot to Timber Posts Supporting BBQ Area Roof
Information: Wood rot was identified to the bottom sections of the timber posts supporting the roof over the BBQ area. The deterioration is likely associated with prolonged exposure to moisture and weathering at the base of the posts. Timber decay may continue to worsen over time and may affect the structural support of the roof if left unaddressed. Repair or replacement of the affected timber posts is recommended. Works should be carried out by a licensed builder, carpenter, or suitably qualified tradesperson.

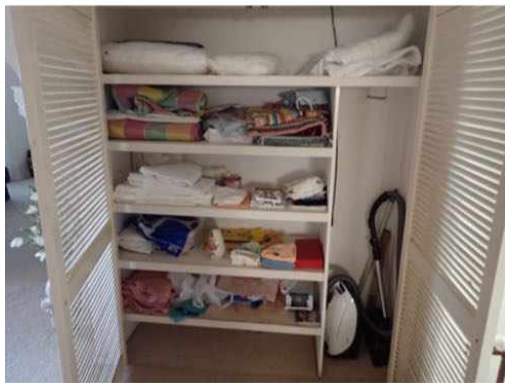
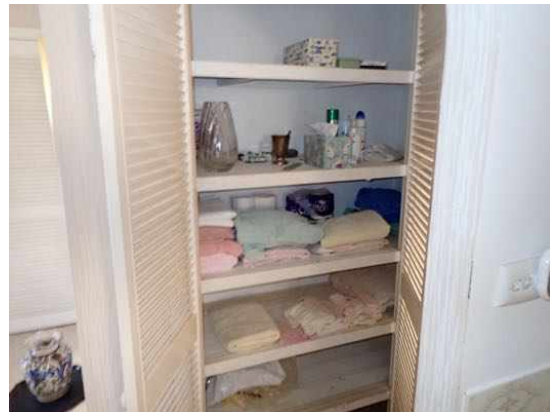
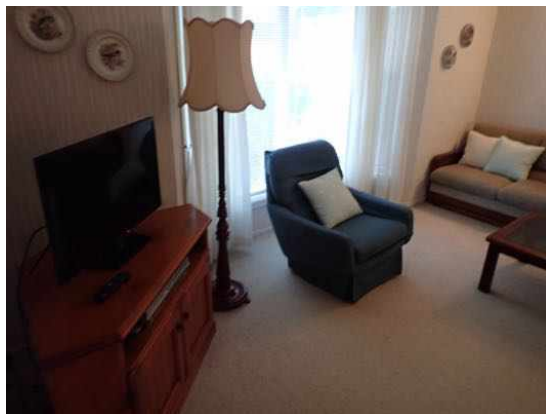
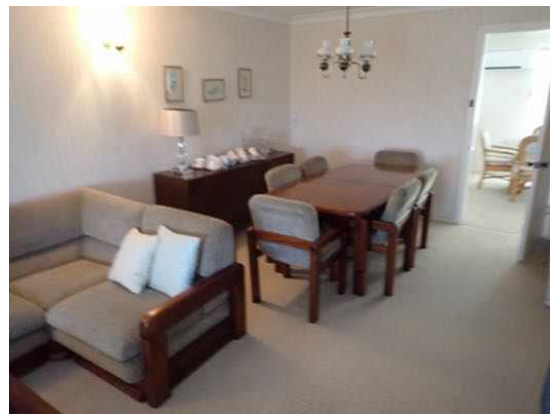
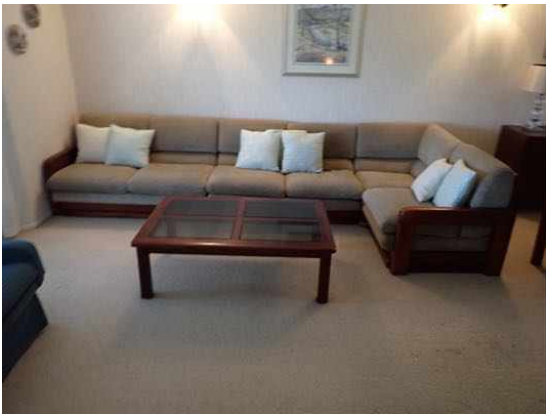
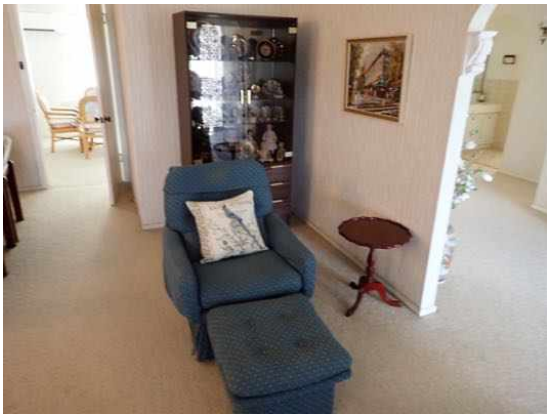
Noted Item

Building: Main Building
Location: All Areas
Finding: Additional Photos - Obstructions and Limitations
Information: These photographs are an indication of the obstructions and limitations which impeded full inspection of the area at the time of inspection. These obstructions can hide an array of defects and should be removed to allow full inspection to be carried out. A re-inspection is recommended once the areas are made accessible.
