Building and Timber Pest Inspection Report

Inspection Date: Tue, 27 Jan 2026

Property Address: 22/26 Ballantine St, Chermside QLD 4032,
Australia

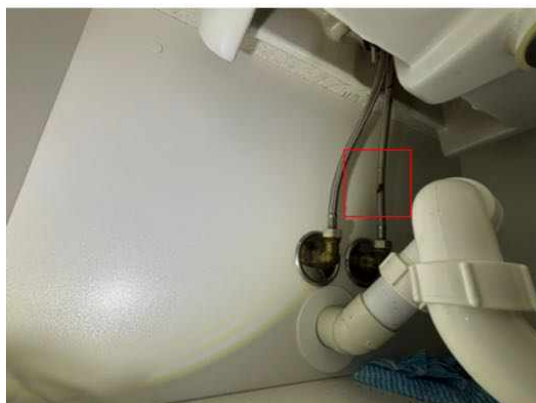
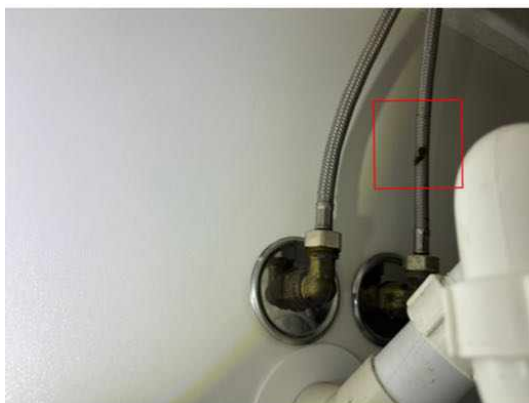
Finding 3.01

Building:	Main Building
Location:	Ensuite
Finding:	Ensuite - flexible hose has signs of rust
Information:	At the time of the inspection, it was noted that a flexible hose to the ensuite vanity mixer had signs of rusting. This may be due to the age of the hose. Flexible hoses typically have a 5 - 10 year lifespan. It is recommended that they be changed if they have signs of bulging, fraying, kinking or rust.

A licensed plumber should be engaged to replace both the flexible hoses to the vanity ensuite mixer. This should be done as a matter of urgency.

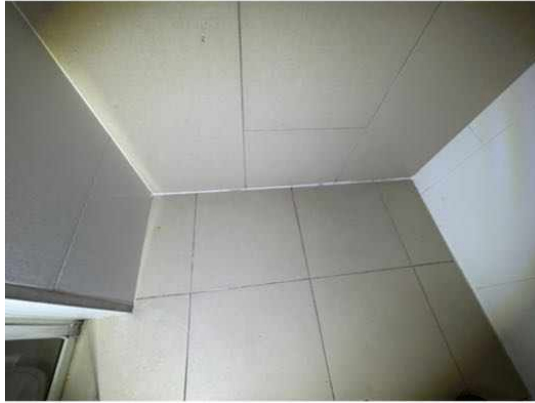
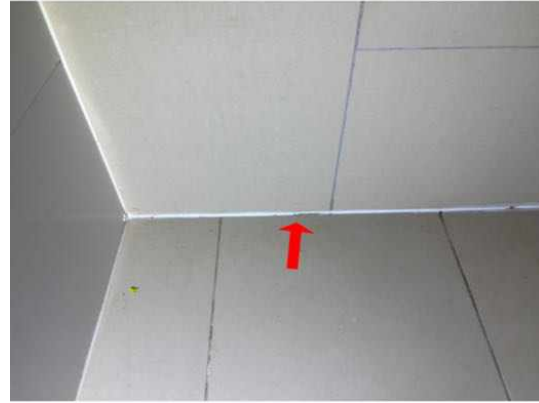
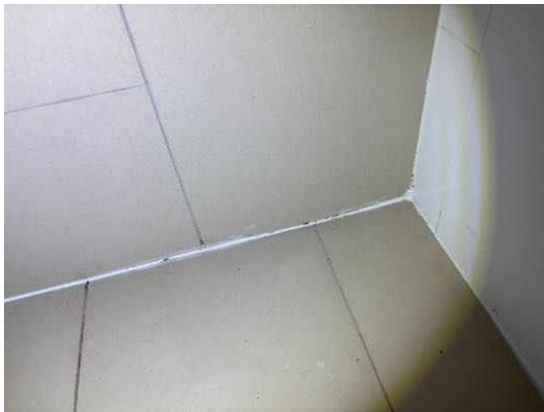
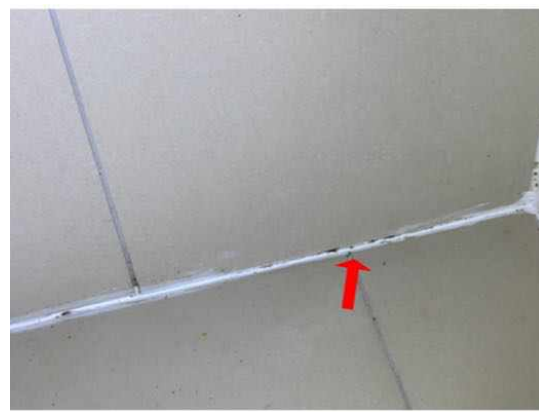
Finding 3.02

Building:	Main Building
Location:	Bathroom
Finding:	Bathroom - sealant deteriorating
Information:	At the time of the inspection it was noticed that the sealant in the bathroom shower cubicle was deteriorating. Sealant is used in tiled areas to prevent moisture from entering the wall cavity and causing damage to the building elements. A moist environment in the wall cavity may also be a conducive condition for termite activity.

If it is not addressed, damage to building elements will occur and would require invasive works to rectify any damage.

A building maintenance professional or sealant applicator should be appointed to replace all sealant as a matter of urgency.

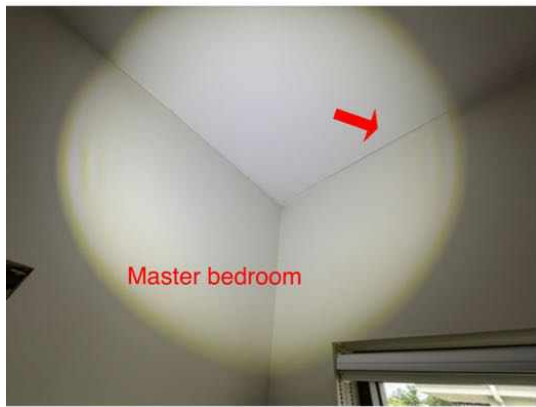
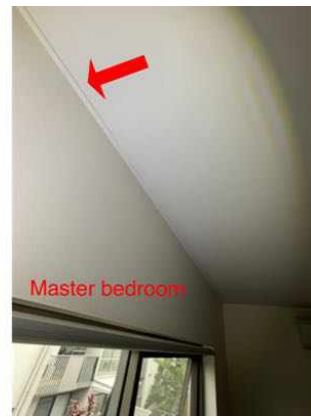
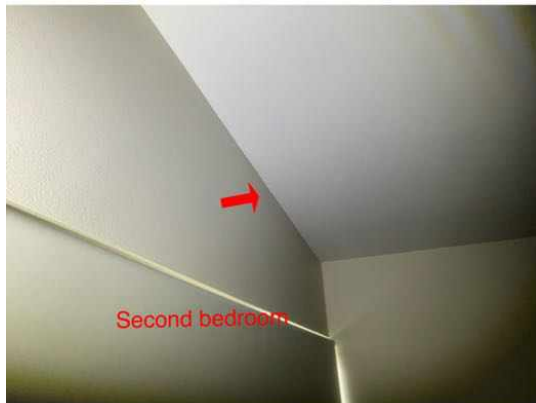
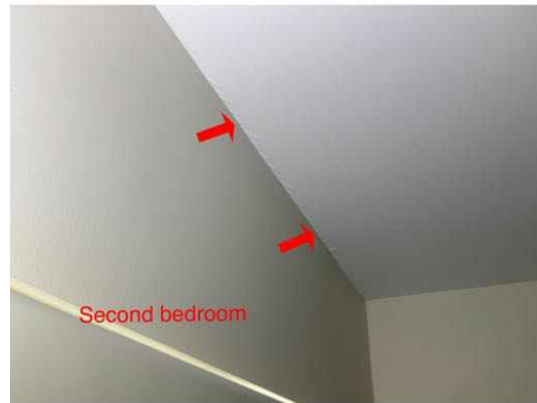
Finding 3.03

Building:	Main Building
Location:	Bedrooms
Finding:	Bedrooms - plaster tape peeling
Information:	At the time of the inspection, it was noted that a section of the plaster tape was peeling in the master bedroom and second bedroom. This may be due to general wear and tear. Normal moisture readings were recorded in these areas.

A paint contractor could be engaged to carry out the minor repairs to these areas. This can be done at the clients discretion.

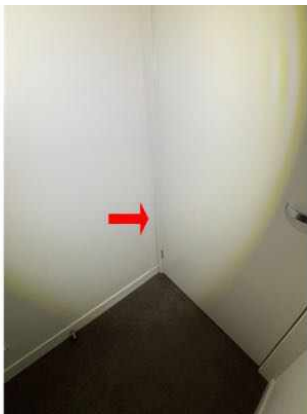
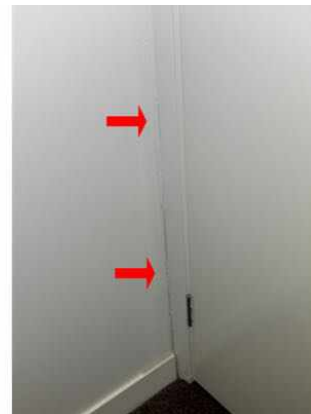
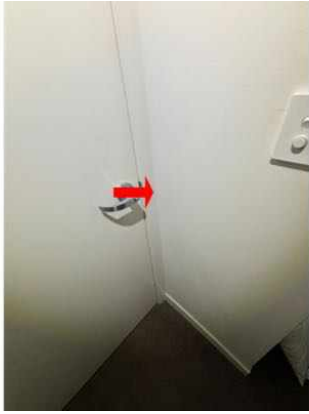
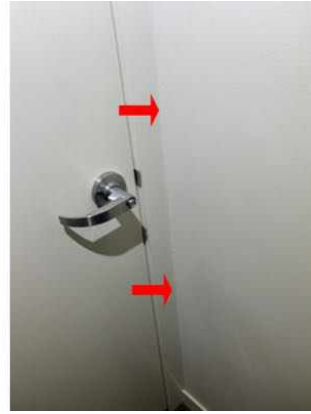
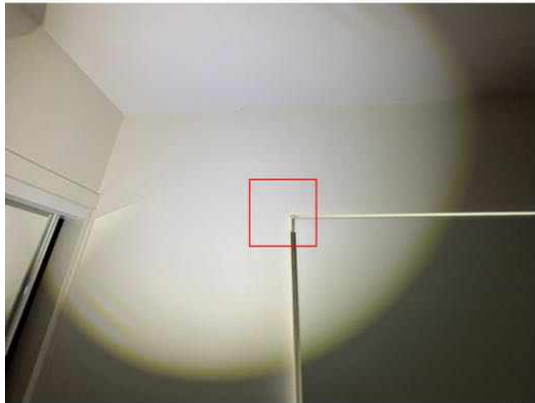
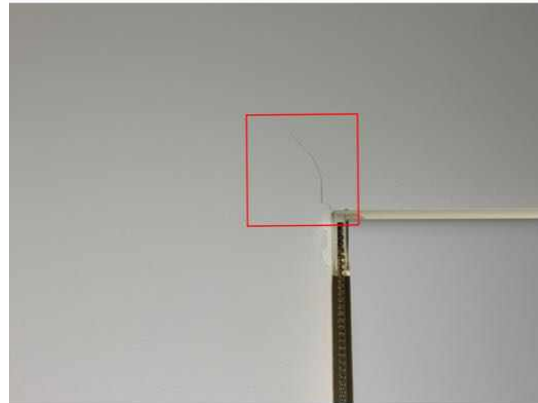
Finding 3.04

Building:	Main Building
Location:	Second bedroom
Finding:	Second bedroom - minor cracking
Information:	At the time of the inspection, it was noted that there was some minor cracking to sections of the wall linings in the second bedroom. This appears to be a general wear and tear issue due to normal movement of different building materials.

The functionality of this building element is not affected. A licensed painting contractor could be engaged to address this issue, this can be done at the clients discretion.

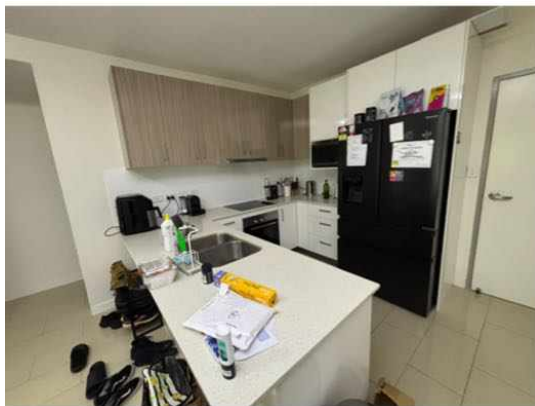
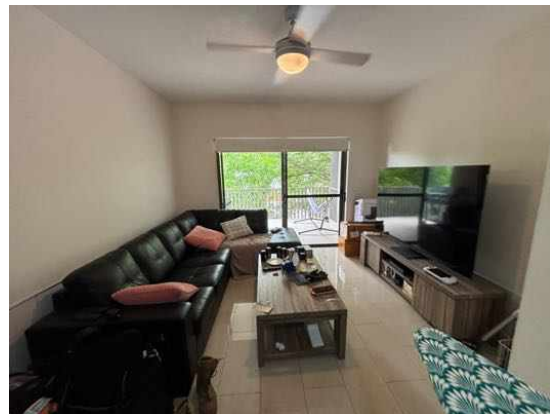
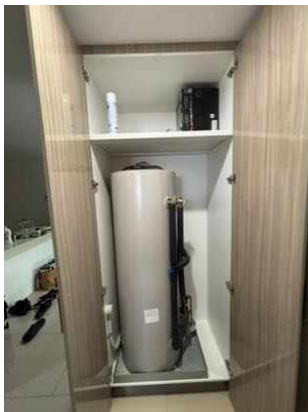
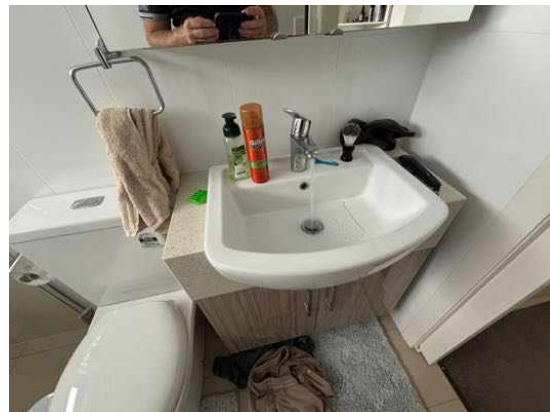
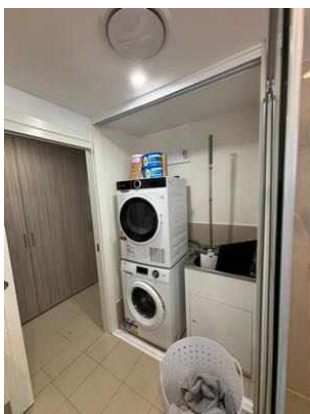
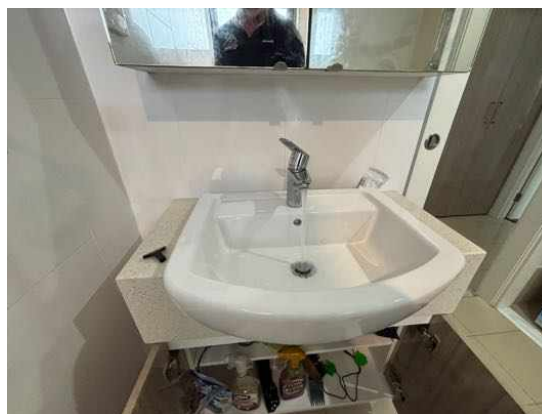
Building: Main Building
Location: All Internal Areas
Finding: Obstructions and Limitations - Internal areas
Information: These photographs are an indication of the obstructions and limitations which impeded full inspection of the property of the internal areas at the time of inspection. These obstructions can hide an array of defects and should be removed to allow full inspection to be carried out. A re-inspection is recommended once the areas are made accessible.

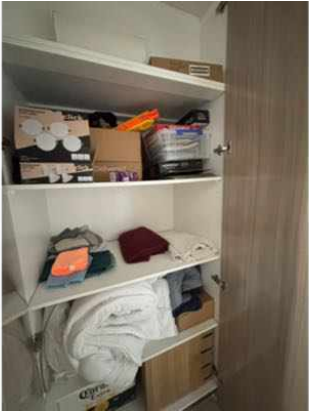
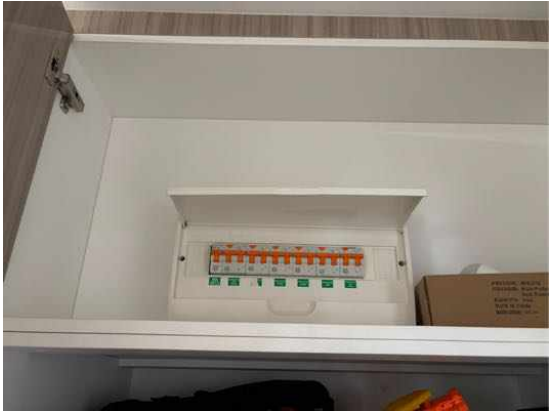
Building:	Main Building
Location:	All Internal Areas
Finding:	Evidence of a physical termite management system needs to be identified.
Information:	At the time of the inspection, no evidence of a physical termite management system was found. A durable notice is normally found in the electricity meter box or the kitchen sink cabinet.

A physical termite barrier is normally installed to the slab penetrations, perimeter and brick piers during construction. The client should enquire of the body corporate for any relevant information of the physical termite barrier.

The client should enquire of the body corporate as to the nature of the termite management plan for the building and the individual units. Also are annual termite inspections carried out and up to date.

A termite and timber pest technician should be engaged to carry out annual termite inspections as per AS 3660 in order to further protect the dwelling. Annual termite inspections must be carried out in partnership with any termite treatment system, physical or chemical, as no termite treatment system can be expected to be 100% effective.
