Building and Timber Pest Inspection Report

Inspection Date: Fri, 27 Feb 2026

Property Address: 1040 Barooga St, North Albury NSW 2640, Australia

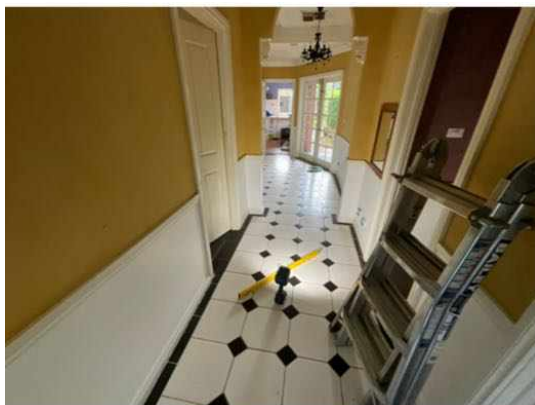
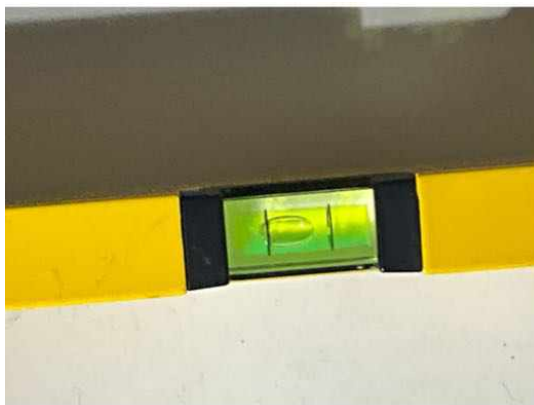
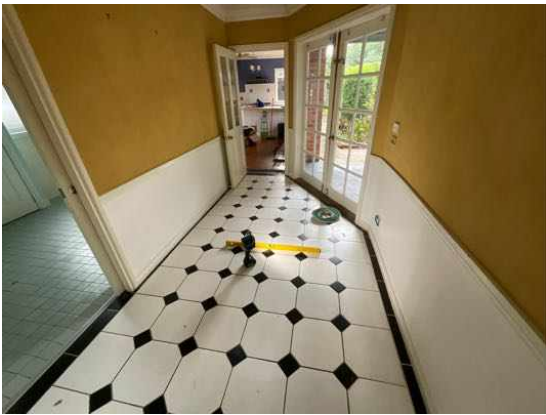
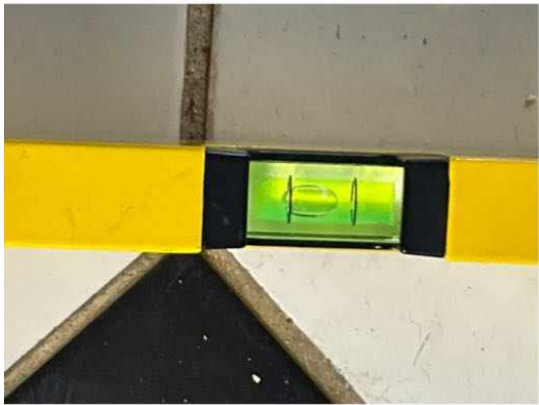
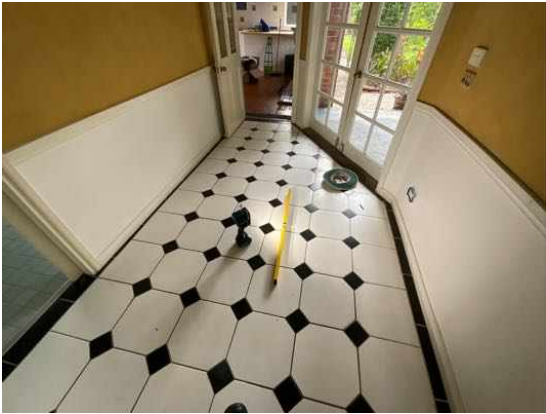
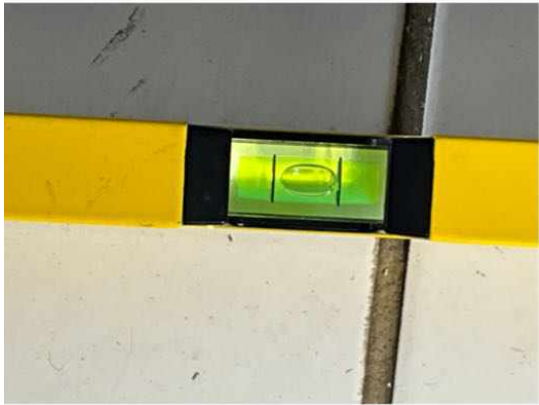
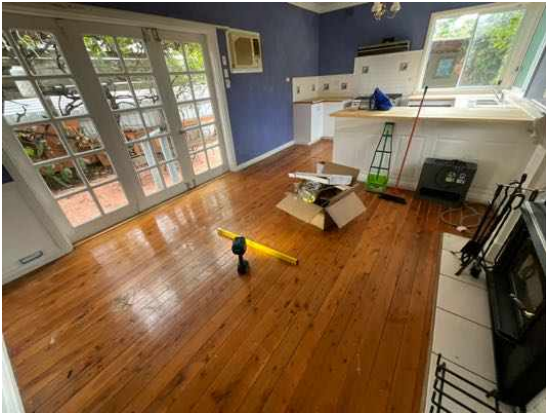
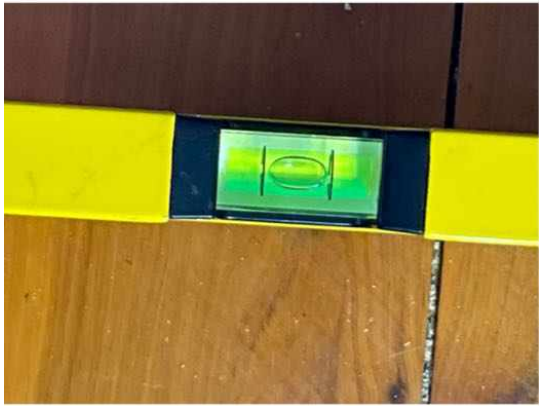
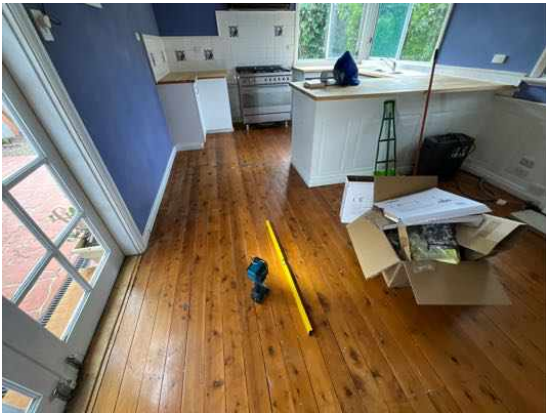
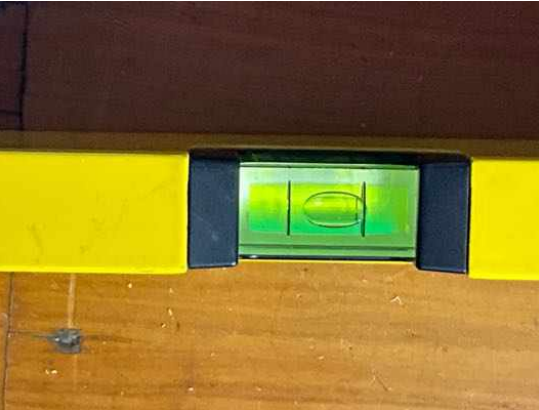
Finding 3.01

Building: Building 1
Location: All Internal Areas
Finding: Flooring - Uneven
Information: The internal flooring in this area is out of level and uneven. Uneven flooring is likely to indicate minor defects such as expected movement of the foundations of the property, but may also indicate subsidence of the associated subfloor stumps.

It is advised that the flooring be closely monitored to identify any further movement. Where flooring remains relatively unchanged for an extended period of time (i.e. several months), it is likely that this defect has been caused by expected movement of the foundations of the property.

However, where flooring is uneven further, potentially invasive inspection of the subfloor structures and stumps in this area is required. In this case, works to repair are likely to be required, and would be carried out by a registered builder specialising in re-stumping.

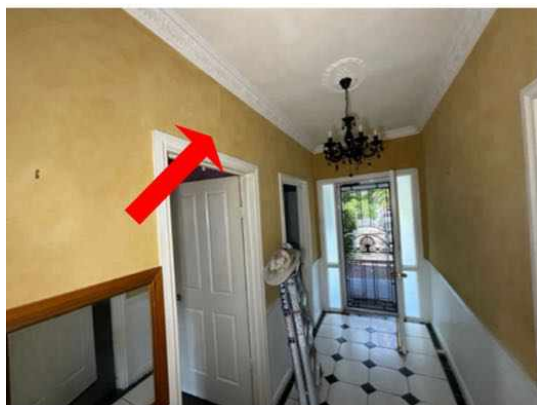
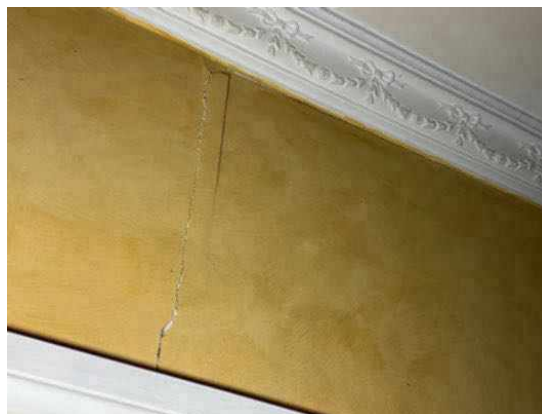
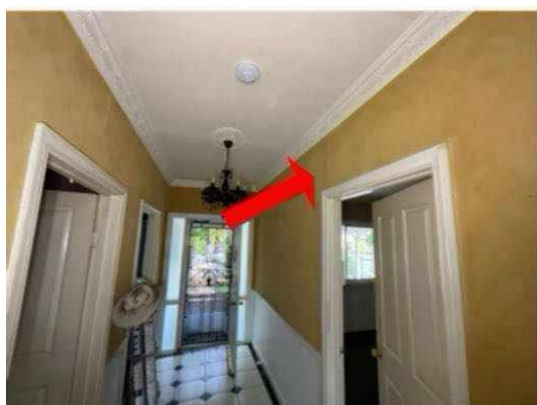
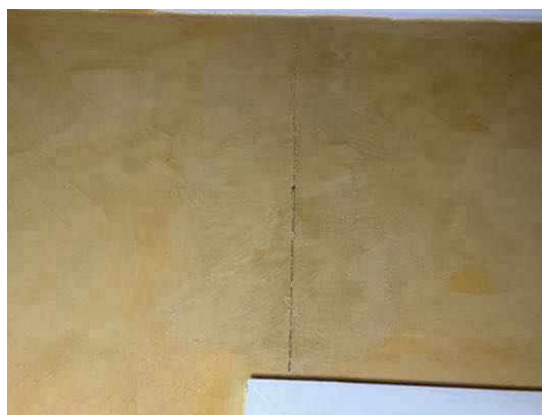
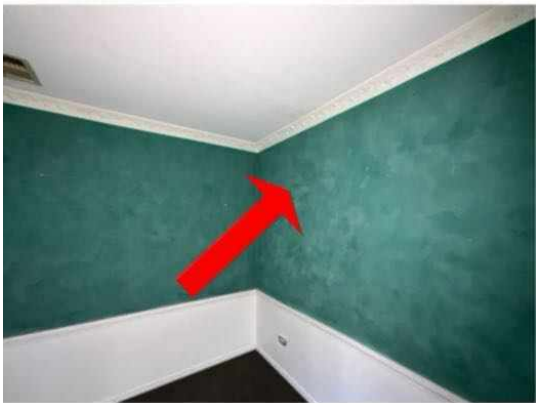
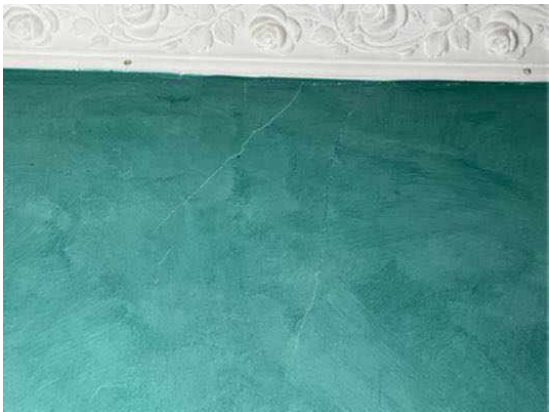
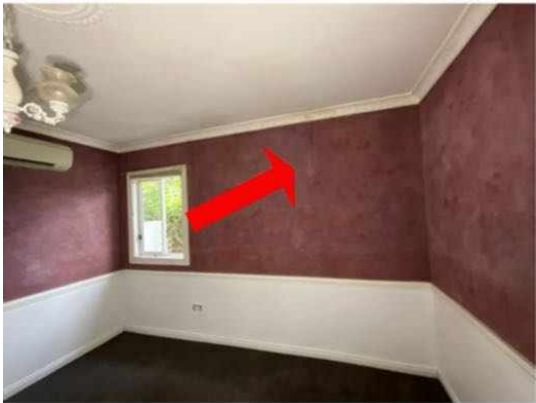
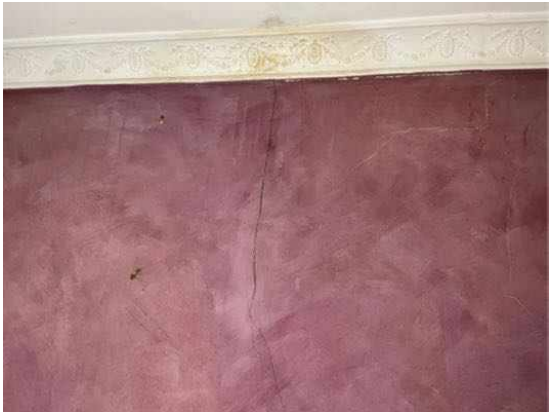
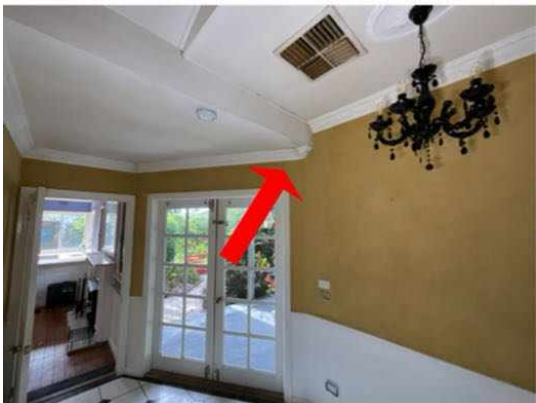
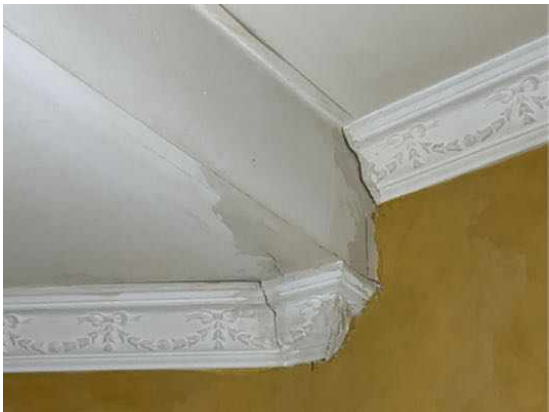
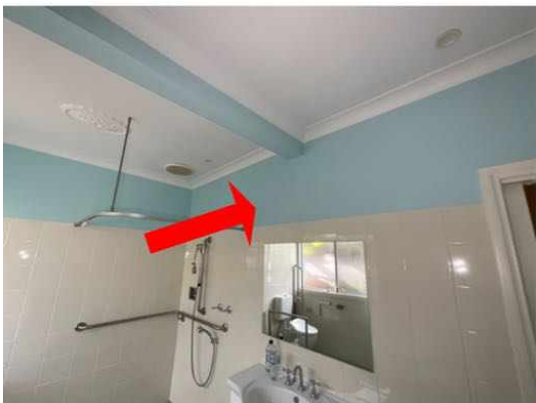
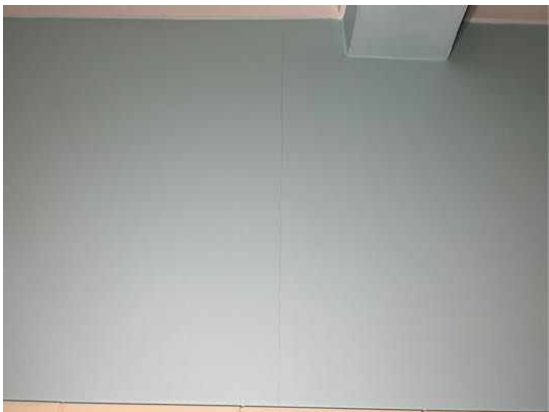
Finding 3.02

Building: Building 1
Location: Hall, bed 1, bathroom
Finding: Cracking - Damage Category 2 - Noticeable (up to 5mm)
Information: Noticeable cracks are a common occurrence as a result of many primary defects. Such causes may include age, general wear and tear, expected building movement, general expansion/contraction of building materials in different weather conditions, and/or minor failings in the installation or application of building materials.

Noticeable cracks may result in minor sticking or jamming of associated doors and windows, which require easement. However, noticeable cracks are easily filled and repaired. A plasterer can be consulted to install an expansion joint at this point to allow for this movement during different weather conditions.

Monitoring of all cracking should be conducted frequently. Always contact a building inspector should cracks widen, lengthen, or become more numerous. Additionally, your building inspector should also be contacted if associated building elements such as doors and windows become more difficult to operate over time.

Relevant tradespeople, such as carpenters, painters and plasterers, should be appointed to perform remedial works, as deemed necessary.

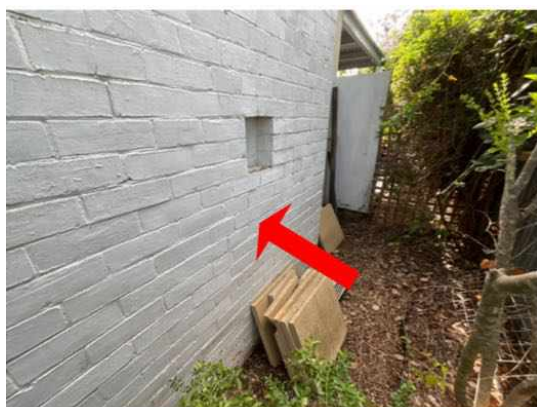
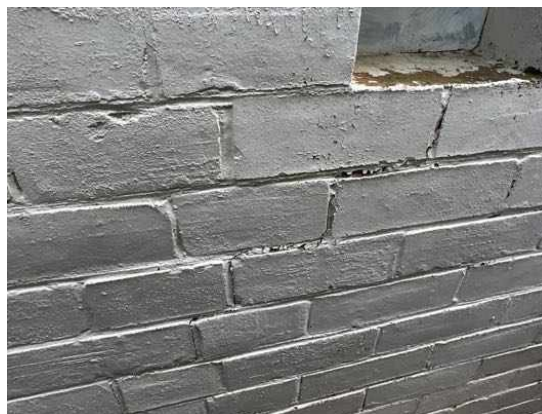
Finding 3.03

Building: Building 1
 Location: Chimney
 Finding: Brickwork- Step cracking
 Information: Step cracking was identified to the brickwork in this area at the time of inspection. Step cracking, which is similar to other forms of cracking, has a variety of possible causes. However, the most common is the subsidence of adjacent footings.

Step cracking is a relatively common defect, and is most likely to occur adjacent to windows, doors and other openings. Mortar failure in the gaps between affected bricks indicates the stresses and tensions affecting the wall.

Minor step cracking can be used as a warning sign to address factors causing stress to the wall, which can include the effect of surrounding trees, water leaks, soil erosion, or even the presence of reactive soils in the surrounding area.

If cracks increase in size or number contact a Licensed builder immediately to make all needed repairs.

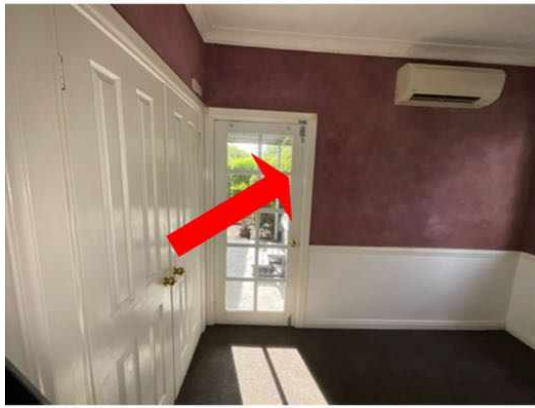
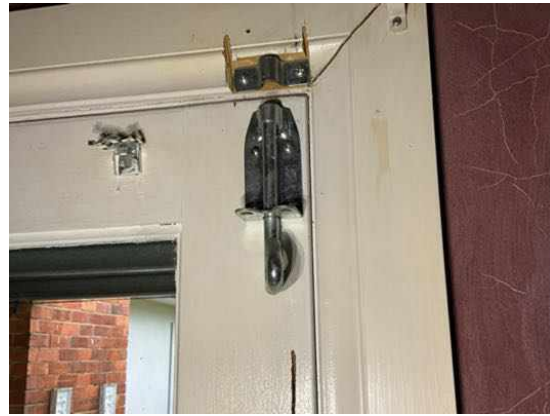
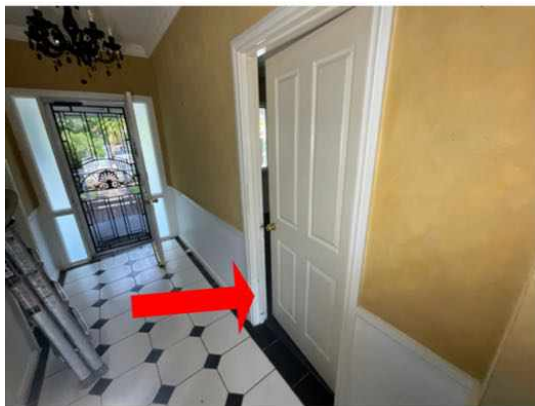
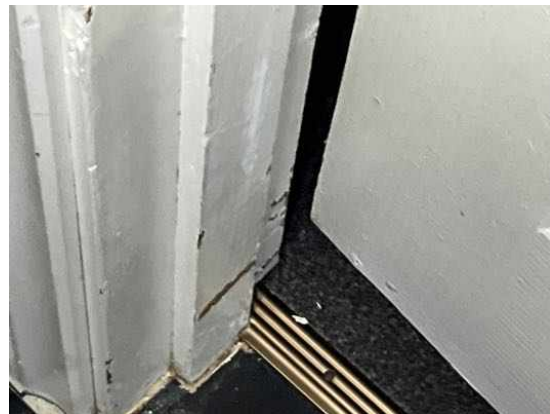
Finding 3.04

Building: Building 1
 Location: Bedroom 2,3
 Finding: Door- Binding/jamming
 Information: Binding and/or jamming of this door is evident during standard operation. This defect inhibits the functionality of the affected door as well as creating potential for secondary defects to associated building elements, such as damage to the floor covering.

A door that binds to flooring or to the associated door frame may have several causes, ranging from minor defects, such as poor installation of the door or deteriorated hinges, through to major structural issues, such as damage to subfloor structures.

A qualified carpenter or general handyperson should be appointed to perform minor rectification works at client discretion.

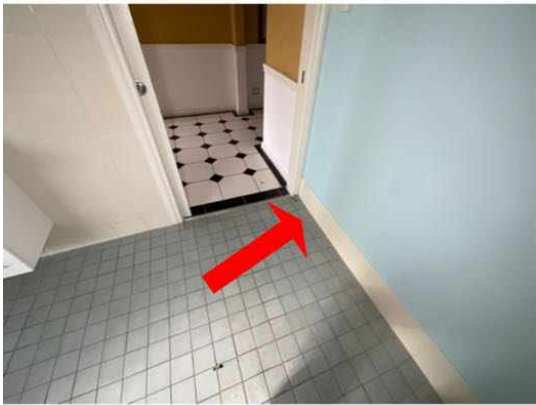
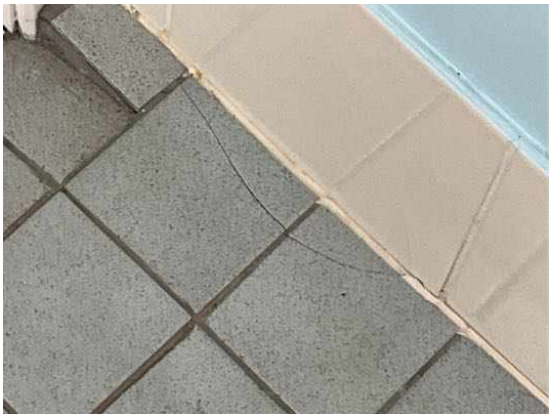
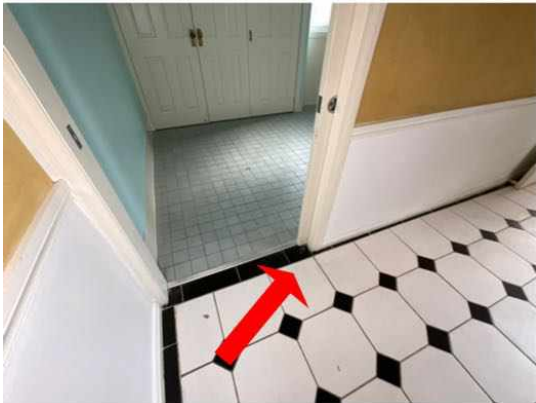
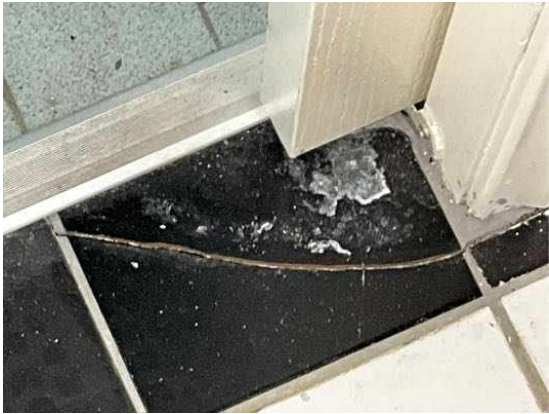
Finding 3.05

Building:	Building 1
Location:	Bathroom
Finding:	Cracked floor tiles
Information:	Cracking in the floor tiles was evident in this area at the time of inspection. It is suspected that this cracking has occurred as a result of minor settlement or impact damage.

Cracked tiles throughout the household detract from the overall appearance of the affected areas however it is unlikely to create or lead to any secondary defects.

While not considered a matter of urgency, replacement of cracked floor tiles is recommended at the clients discretion. A tiling contractor may be appointed to perform these works. Where cracks become more numerous, contact a licensed building inspector for further investigation.

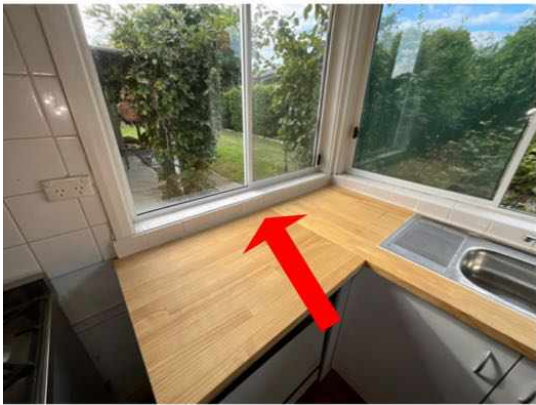
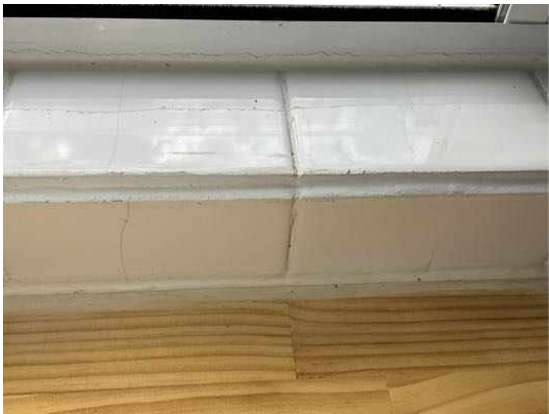
Finding 3.06

Building: Building 1
Location: Kitchen
Finding: Wall Tiles- Cracked
Information: Cracked tiles within the household detract from the overall appearance of the affected areas, as well as creating potential for water penetration to adjoining building elements. If left unmanaged, water damage may occur as a result of constant water penetration over a prolonged period of time.

While not considered a matter of urgency, replacement of tiles is advised as a solution. A Tiling Contractor may be appointed to perform these works at client discretion.

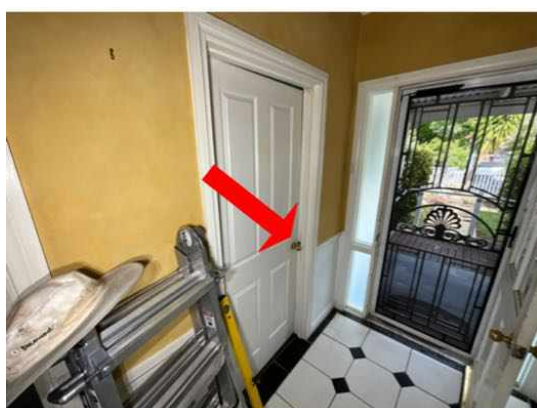
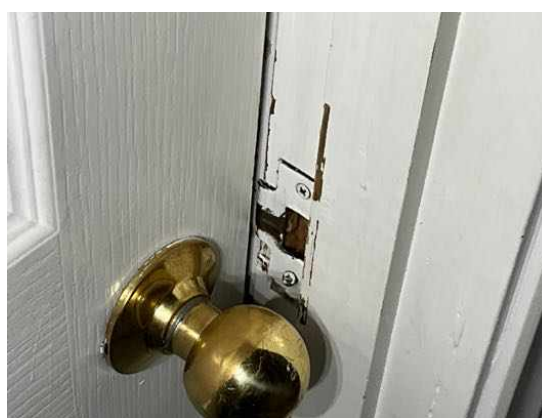
Finding 3.07

Building: Building 1
Location: Bedroom 1
Finding: Door - Striker plate misaligned
Information: The striker plate to this door appears to have become misaligned and has consequently resulted in the door's operation being compromised.

This is a common defect and is expected in a property of this age, whether being due to substandard installation or general deterioration of the door hardware.

Readjustment of the striker plate is recommended at client discretion. Works such as these can be completed by a general handyman or qualified carpenter.

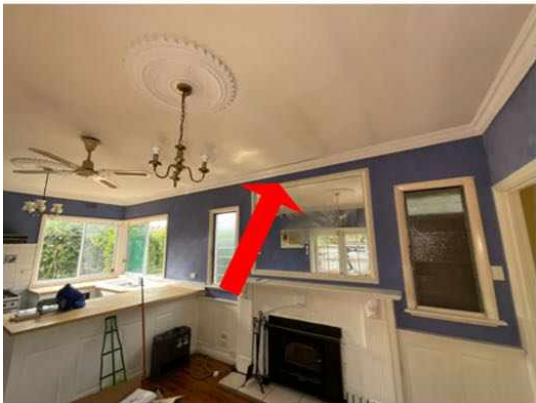
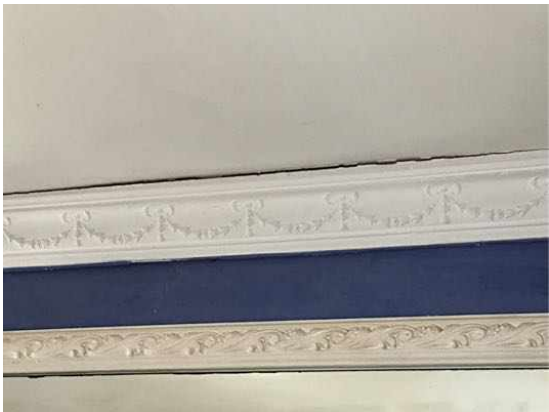
Finding 3.08

Building: Building 1
Location: Living Room
Finding: Cornice- sagging
Information: The cornice in this area is sagging. This may be due to age or poor initial installation.

A plasterer or handyman should be contacted soon to restore the area and prevent further deterioration.

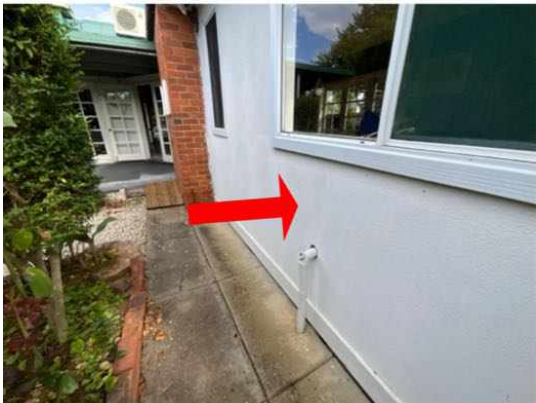
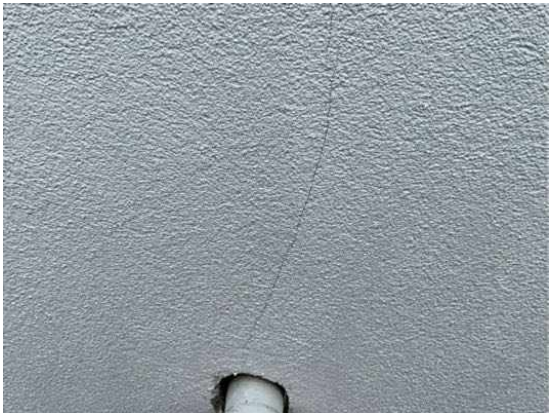
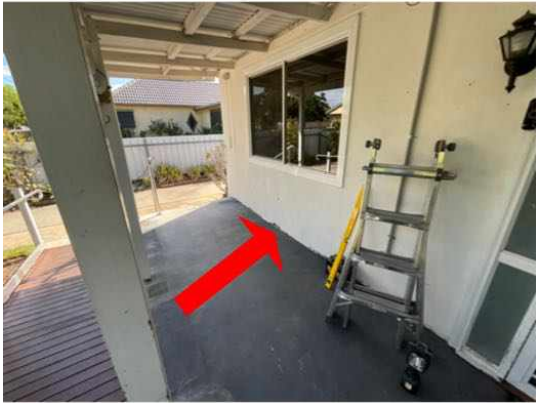
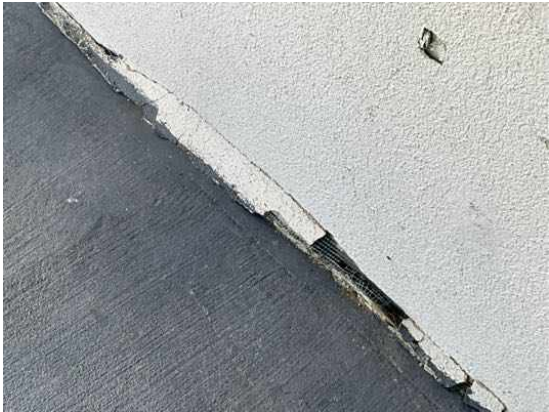
Finding 3.09

Building: Building 1
 Location: Yard - Back, front
 Finding: Render- Cracking
 Information: Cracking to the render in this area was identified at the time of inspection.

This type of cracking is often consistent with general dilapidation of the property, and may continue to develop if left unmaintained.

Frequent monitoring should be carried out to identify any further damage.

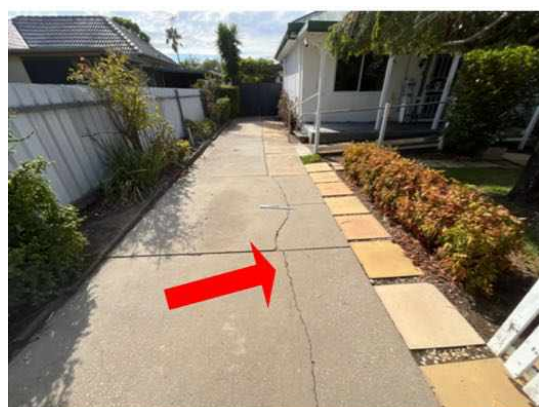
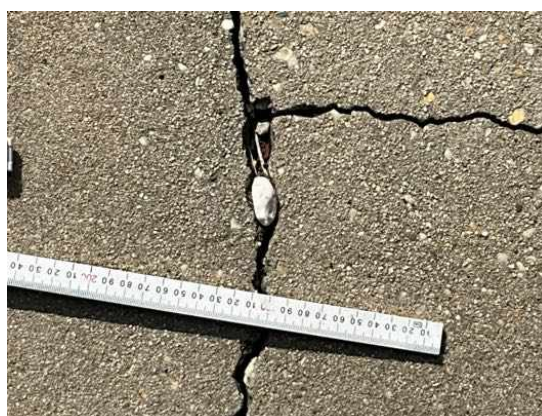
Finding 3.10

Building:	Building 1
Location:	Driveway
Finding:	Cracking - External Concrete Paving Damage Category 3 - Wide Cracks (2mm - 4mm)
Information:	Wide cracks were identified in external concrete paving Wide cracks are significant and are likely to lead to the development of safety hazards and secondary defects if left unmanaged.

General age and expected deterioration of the paved areas is a common cause of this type of cracking. However, expansion and contraction of the slab may also have occurred due to environmental factors. Such factors include variable moisture and weather conditions, the presence of trees and their roots having a settling or lifting affect on the soil, or the effect of load bearing, e.g. heavy vehicles over a sustained period of time.

Cracking to this degree may also be due to poor original installation of the concrete. Factors such as poor compaction of the sub surface and/or inadequate reinforcing of the slab may create cracking and other secondary defects. Wide cracks may also have a more significant structural cause, such as subsidence of soils.

Where the crack is located adjacent to structural elements of the building, the advice of a Structural Engineer is advisable before undertaking repairs. Significant repair and likely replacement of the concrete paving is probable.

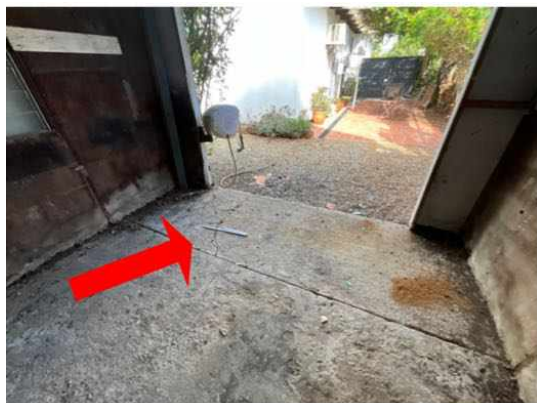
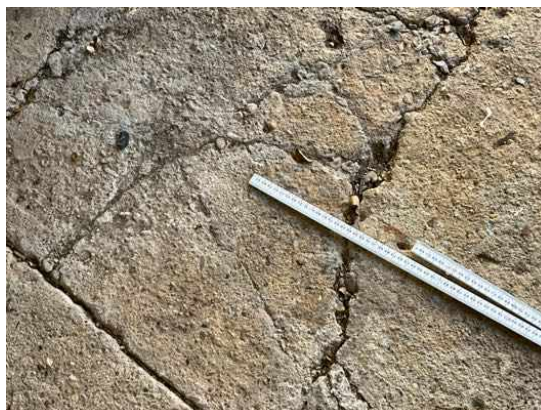
Finding 3.11

Building:	Building 1
Location:	Garage
Finding:	Crack in concrete slab - Category 2
Information:	A crack coded as Category 2 was identified in the slab. A Category 2 crack is described as a distinct crack, with the slab being noticeably curved or changed in level.

To be considered Category 2, the approximate width of the crack is less than 2.0mm, or a change in offset of less than 15mm when a 3m straight edge is placed over the defect.

Category 2 cracks to slabs should be monitored for a period of 12 months. At the end of the monitoring period, cracks rated greater than Category 2 are considered defects that require rectification.

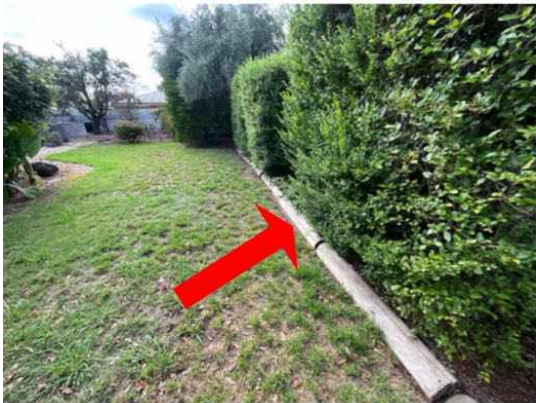
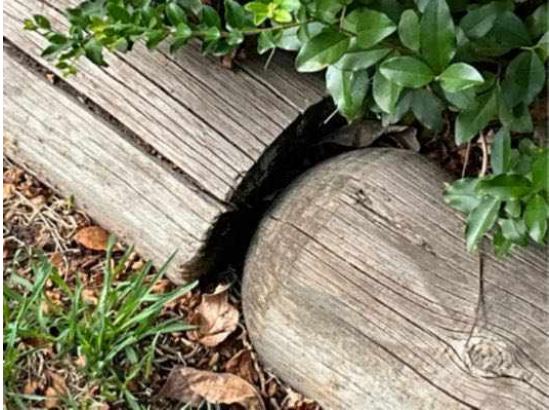
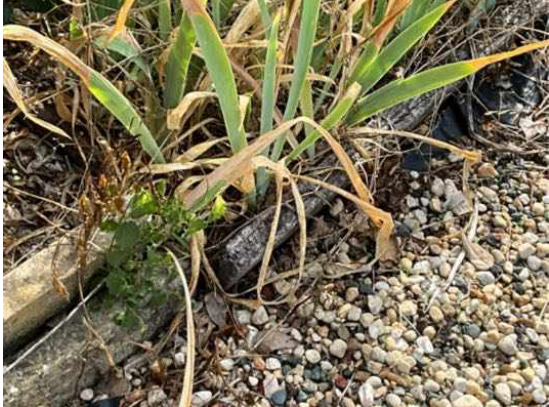
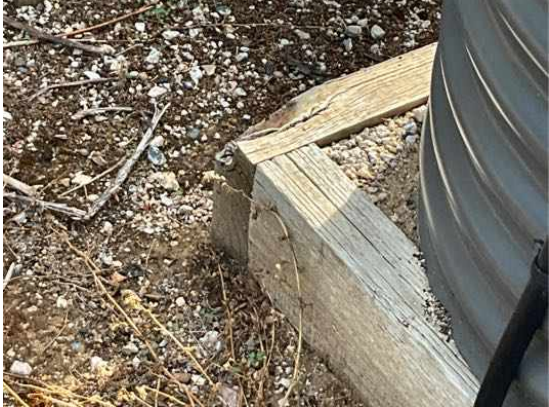
Building:	Building 1
Location:	Yard - Back
Finding:	Untreated or non-durable timbers in a hazardous environment
Information:	To reduce the risk of timber pest attack it is essential that timber used in a hazardous environment (e.g. in direct contact with the ground or frequently exposed to damp conditions) is of sufficient durability and/or is adequately preservative treated.

Untreated timbers in direct contact with the ground are likely to develop severe wood rot and/or fungal decay if left unattended creating attraction for subterranean termites to infest the timbers from surrounding areas.

If untreated or non-durable timbers are found to be in a hazardous environment it is highly advised that replacement of these building elements be performed as soon as

possible to aid the protection of the property against termite / timber pest attack.

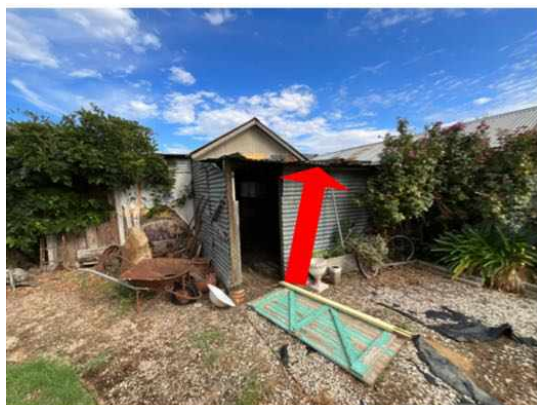
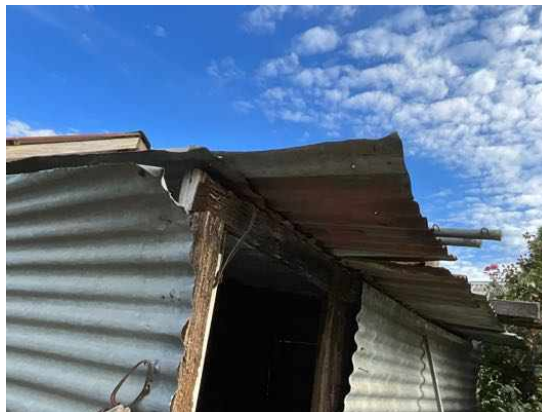
Finding 6.02

Building: Building 1
Location: Yard - Back
Finding: Guttering Missing
Information: The Guttering in this area was missing at the time of inspection. Guttering, Downpipes and Stormwater drainage are vital to protect the integrity of the structure and to prevent an environment conducive to Timber Pest attack.

A Plumber should be contacted as soon as possible to replace and connect to

drainage the missing Guttering.

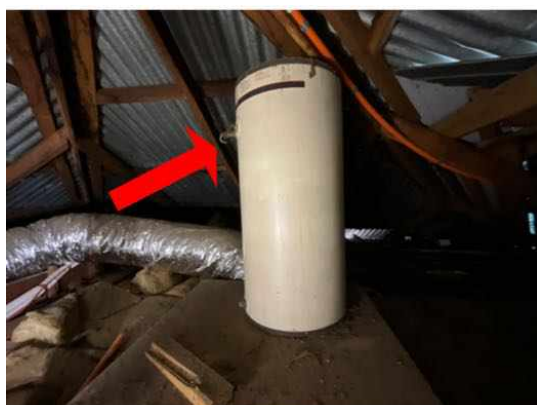
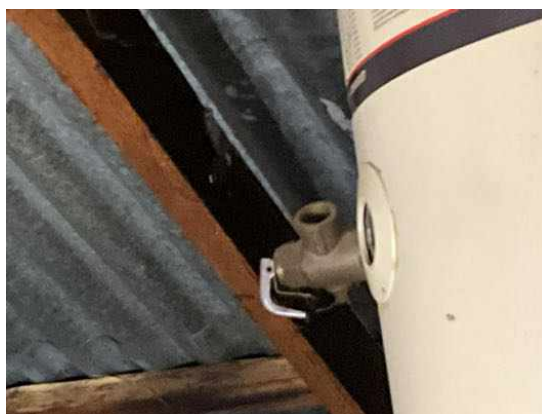
Finding 6.03

Building:	Building 1
Location:	Roof Void
Finding:	Gravity-Fed HWS - Disconnected
Information:	It was noted at the time of inspection that a disconnected gravity-fed hot water system (HWS) remains in this area.

Despite this plumbing structure being unused, it is likely to be storing residual water, and is therefore susceptible to rust and corrosion. If allowed to continue, rust and corrosion is likely to lead to damage to adjoining building elements, and may also make the area susceptible to termite or timber pest activity.

While it is a costly exercise to remove the disused gravity-fed HWS, it is advisable in the short-term future to prevent any further damage to the area. Further consultation with a licensed plumber is required to gain further advice on removal of the structure.

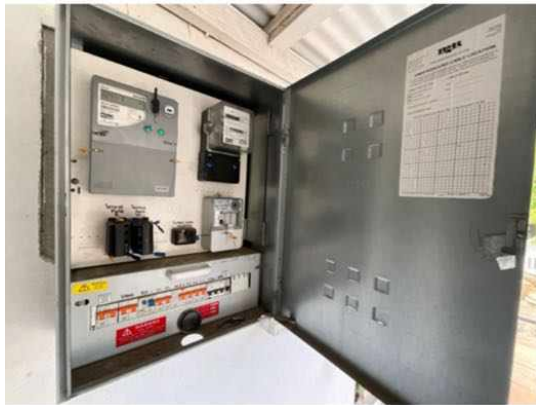
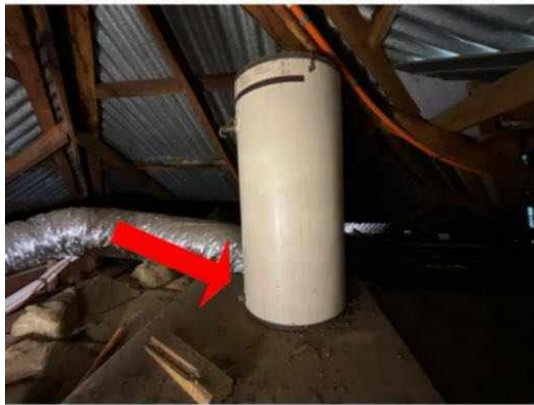
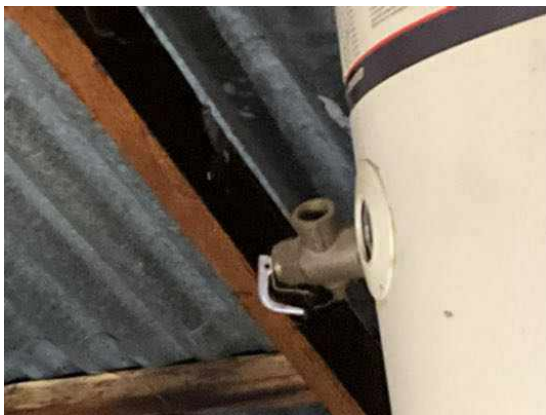
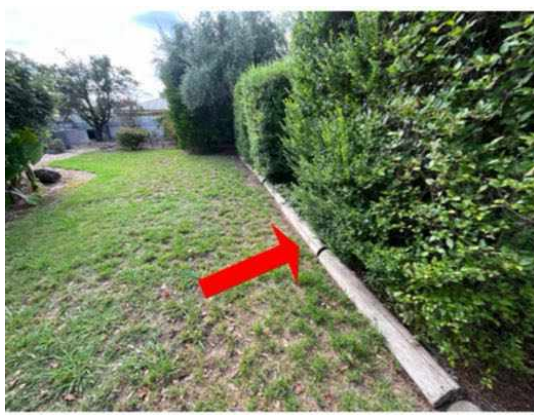
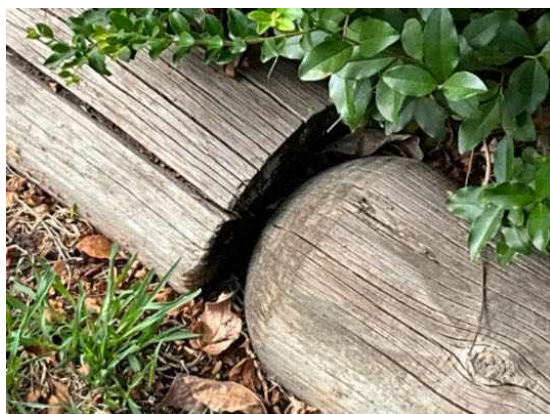
Finding 6.04

Building:	Building 1
Location:	All External Areas

Finding: Termite Management System - no evidence of a chemical installation
Information: The application of a post-construction chemical termite barrier is highly recommended for all properties, particularly if live termite activity has been found on the site previously. Such barriers are highly effective in preventing termite attack on any timber building elements throughout the property.

A durable notice should be placed in the switchboard unit to indicate current termite barriers. At the time of inspection, it appeared as though no termite management system has been installed, with no evidence to suggest preventative works taking place.

The client may consider gaining further advice from a pest controller as to the costs and procedures involved with this application. It is recommended that obtaining such advice be a short-term priority.

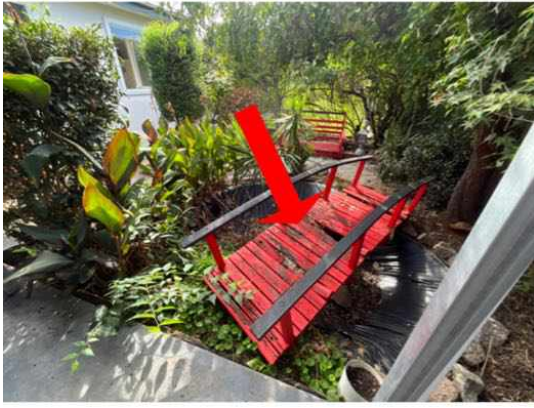
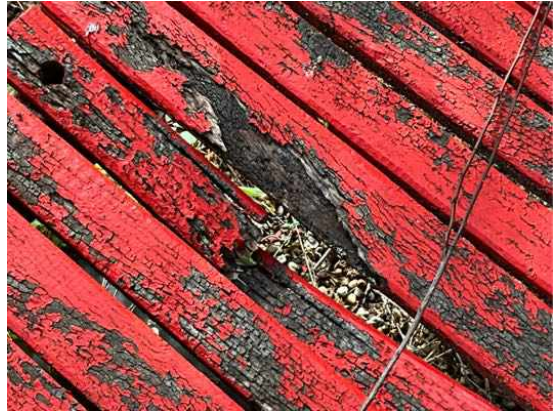
Finding 7.01

Building:	Building 1
Location:	Yard - Back
Finding:	Fungal decay - present (widespread)
Information:	Fungal decay is also known as wood decay or wood rot generally refers to the deterioration of timber elements when in contact with excessive levels of moisture for a prolonged period of time.

The development of fungal decay is accelerated by temperatures in the range of 5degreeC to 40degreeC as well as the presence of oxygen. Generally fungal decay develops on timber elements that are in use in an external environment which are exposed to rain penetration.

In this case, fungal decay appears to have become widespread and is likely to have affected any adjoining timber elements/structures. The widespread development of fungal decay is likely to have heavily impacted the structural integrity and tensile strength of the affected timber elements and the associated structure.

Timbers affected by widespread fungal decay should be replaced immediately. The cause of the moisture that has led to the development of such decay should also be identified and dealt with in an appropriate manner.

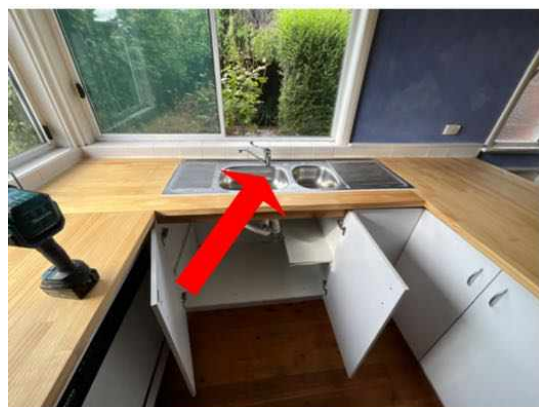
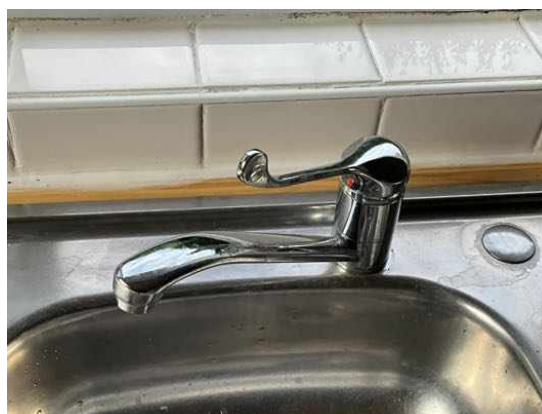
Building: Building 1
Location: Kitchen
Finding: Tap - Loose
Information: The tap in this area has not been installed correctly, or has deteriorated with age, and is consequently loose. This tap being loose creates potential for water leaks and subsequent water damage to the surrounding area.

Where taps or spouts are loose, a qualified plumber should be appointed to re-fix the plumbing fitting.

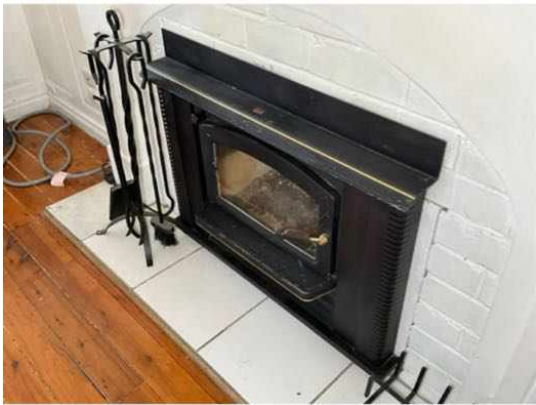
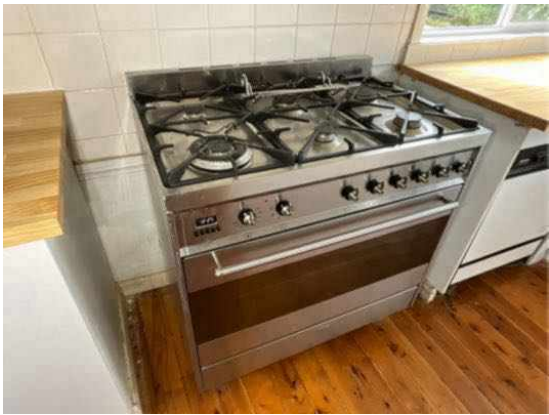
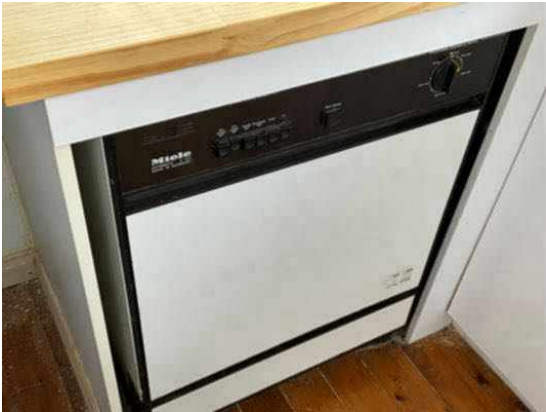
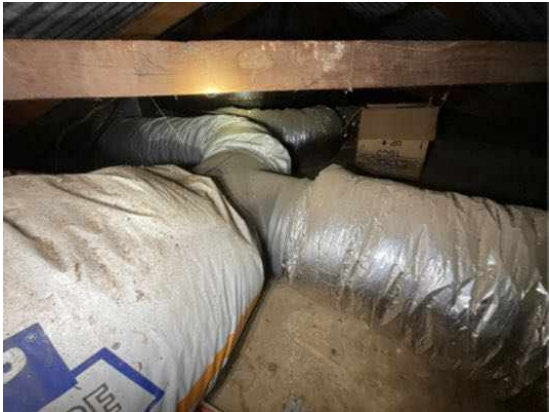
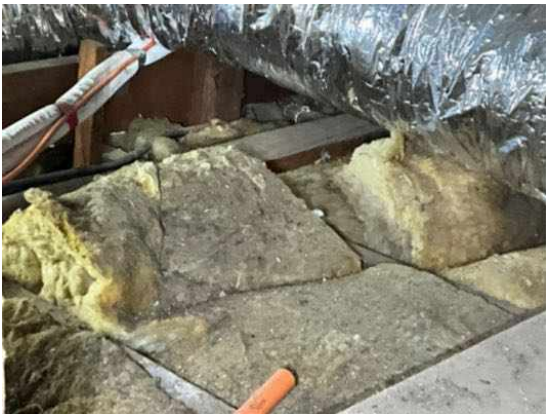
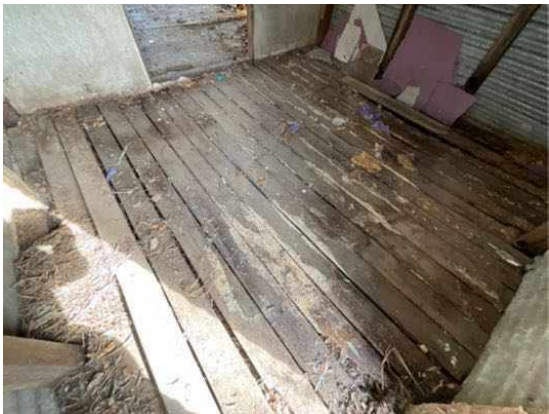
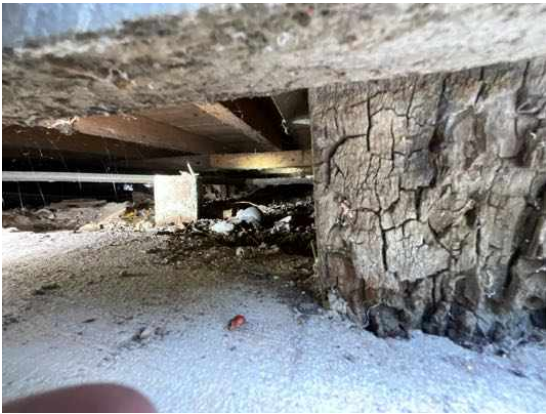
Building: Building 1
Location: All Areas
Finding: Additional Photos - Obstructions and Limitations
Information: These photographs are an indication of the obstructions and limitations which impeded full inspection of the property at the time of inspection. These obstructions can hide an array of defects and should be removed to allow full inspection to be carried out. A re-inspection is recommended once the areas are made accessible.
