# Building and Timber Pest Inspection Report

Inspection Date: Thu, 19 Mar 2026

Property Address: 10 Shaun St, Redbank Plains QLD 4301,  
Australia

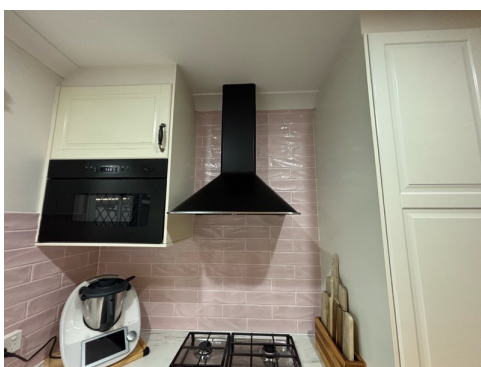
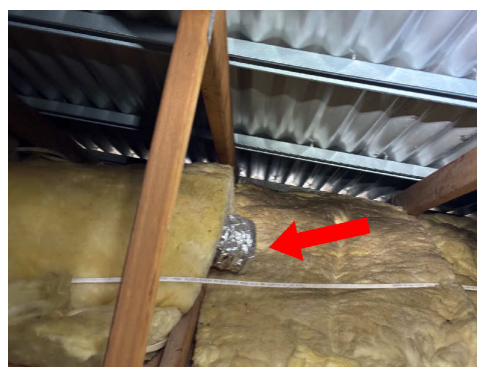
Information: At the time of the inspection, it was found that the range hood flue was found to lead directly into the roof space, rather than venting to the exterior of the building.

The positioning of this flue is likely to lead to a build-up of grease and grime in the surrounding area within the ceiling void, which can pose as a fire hazard in the roof void. The presence of insulation surrounding the flue adds to this fire safety risk.

Without re-direction to the exterior of the building, the Rangehood is not considered fully operational and is deemed a minor safety hazard.

It is therefore preferable that the flue be re-directed to vent into the external environment. A licensed plumber should be appointed as soon as possible to provide further consultation on the scope of these works and to provide quotations for any necessary works.

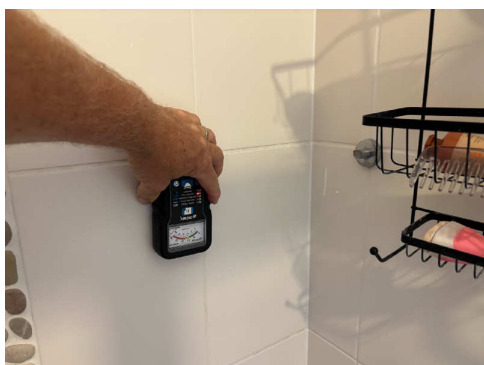
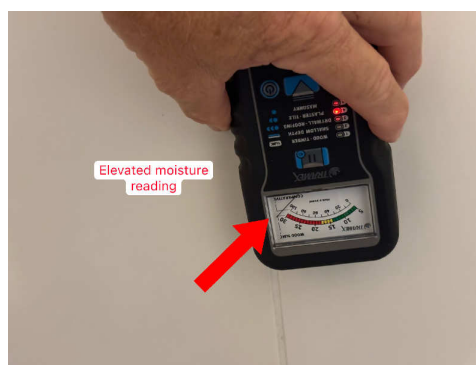
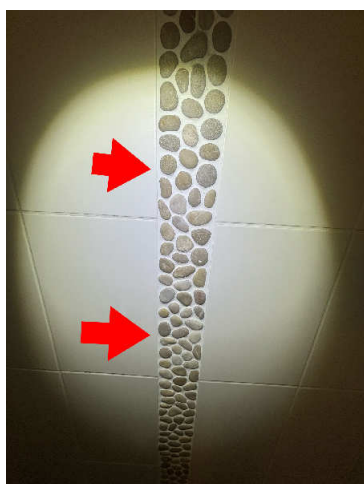
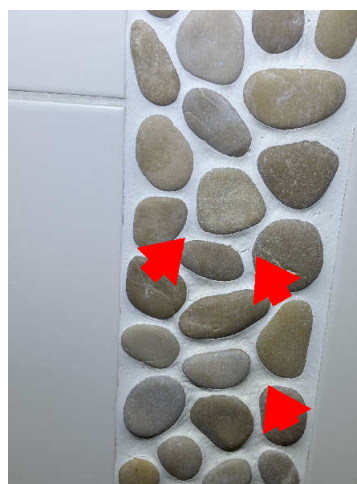
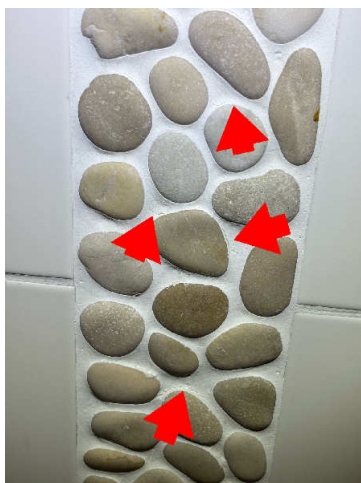
Finding: Ensuite - elevated moisture readings to shower wall

Information: At the time of the inspection, it was noted that there were elevated moisture readings recorded on the shower wall in the ensuite, where the decorative pebble feature is. This may be due to the age of the materials. It was found that there were several hairline cracks to the grout around the pebbles.

Grout and certain tiles can be porous. Moisture behind the wall tiles may have a negative affect on the wall tile glue. This could result in loose tiles.

A bathroom specialist could be engaged to replace the grout and seal the floor and wall tiles in the shower cubicle. This will give longevity to the bathroom. This can be done at the clients discretion.

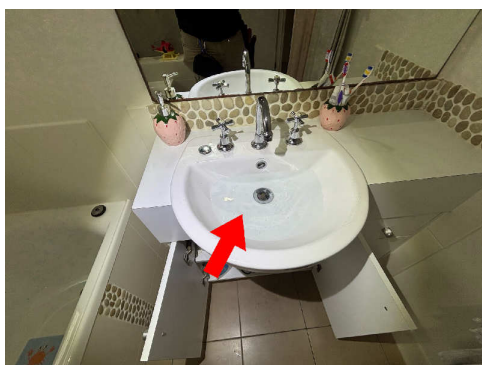
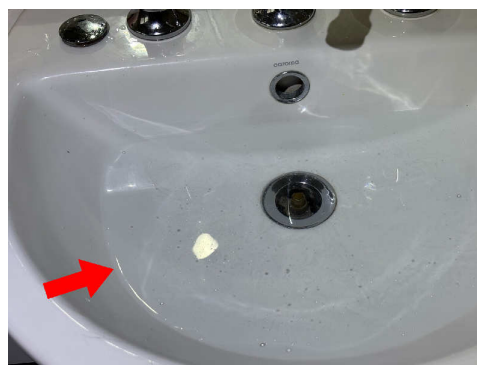
### Finding 3.02

Information: At the time of the inspection, it was noted that the hand basin in the family bathroom was slow draining. This appears to be caused by a partial blockage of the plumbing below the hand basin.

A licensed plumber could be engaged to check the associated plumbing and clear the blockage. This can be done at the clients discretion.

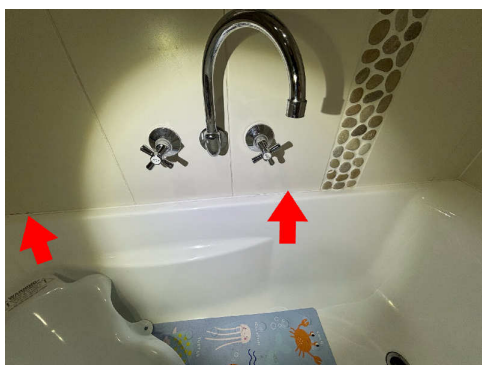
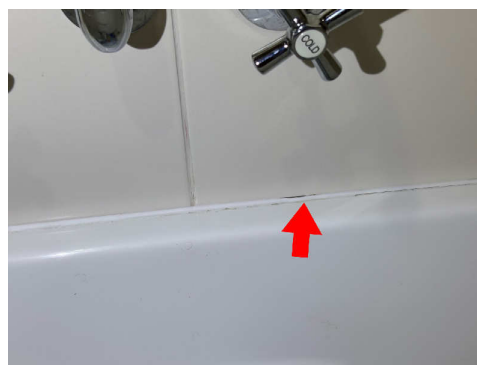
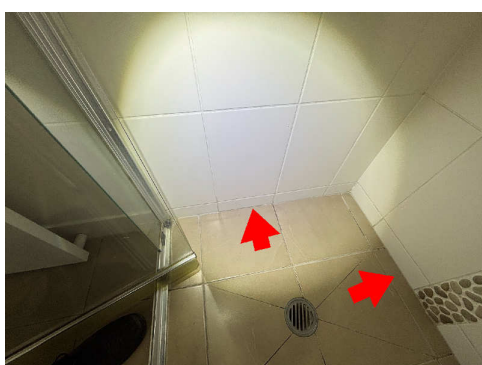
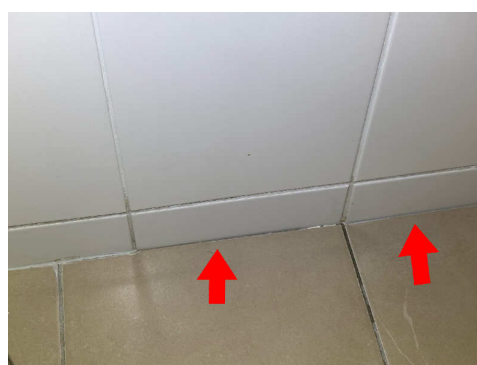
### Finding 3.03

Finding: Family bathroom - sealant deteriorating

Information: At the time of the inspection it was noticed that the sealant in the family bathroom was deteriorating. Sections of the sealant in the shower base is missing and sections of sealant around the bath tub is cracking.

Sealant is used in tiled areas to prevent moisture from entering the wall cavity and causing damage to the building elements. A moist environment in the wall cavity may also be a conducive condition for termite activity.

If it is not addressed, damage to building elements will occur and would require invasive works to rectify any damage.

A building maintenance professional or sealant applicator should be appointed to replace all sealant as a matter of urgency.

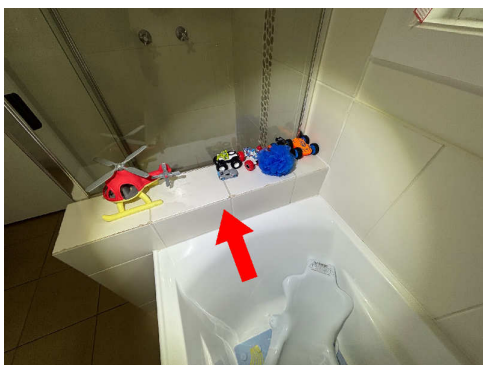
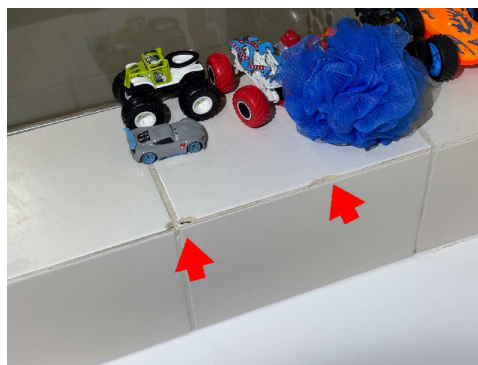
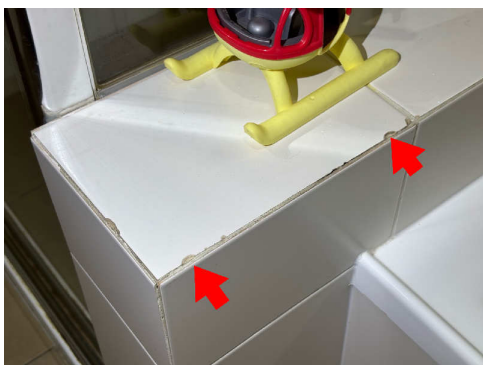
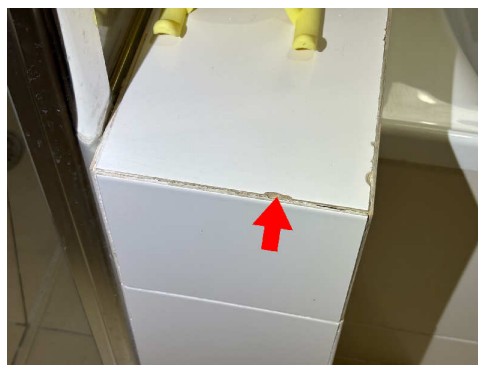
### Finding 3.04

Information: At the time of the inspection, it was noted that a few tiles were chipped on the ledge next to the bath tub in the family bathroom. These appear to be purely aesthetic issues and could be attended to at the clients discretion.

A tiler or building maintenance professional would be able to carry out the necessary works.

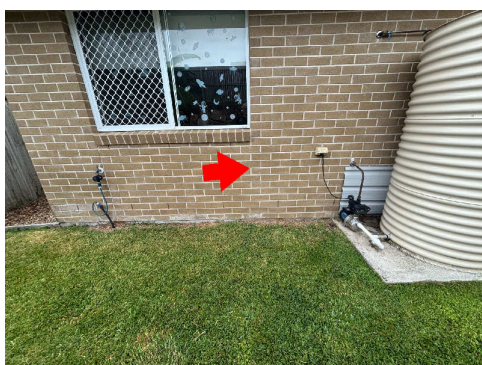
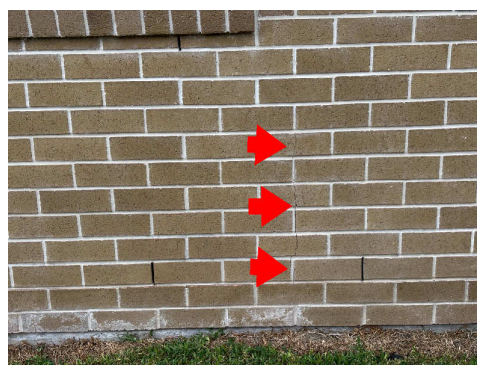
### Finding 3.05

Finding: Brickwork - Step cracking

Information: At the time of the inspection, it was noted that there was minor step cracking to the brickwork at the rear of the dwelling. This appears to be historic, the client should monitor these step cracks for any change in appearance.

Step cracking, which is similar to other forms of cracking, has a variety of possible causes. However, the most common is the subsidence of adjacent footings.

Step cracking is a relatively common defect, and is most likely to occur adjacent to windows, doors and other openings. Mortar failure in the gaps between affected bricks indicates the stresses and tensions affecting the wall.

Where step cracking is extensive or severe, the client is advised to consult a structural engineer. Minor step cracking can be used as a warning sign to address factors causing stress to the wall, which can include the effect of surrounding trees, water leaks, soil erosion, or even the presence of reactive soils in the surrounding area.

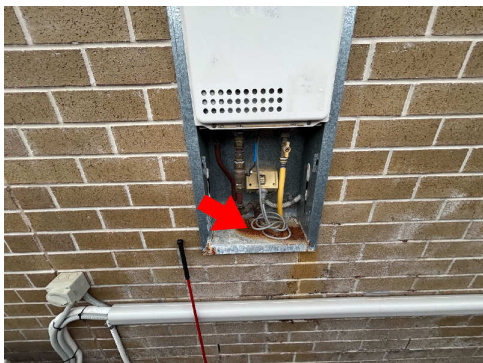
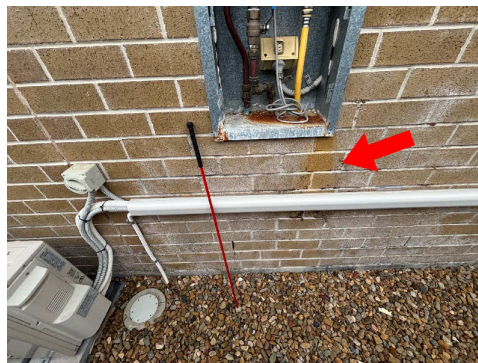
### Finding 3.06

Finding: How water unit - inactive water leak

Information: At the time of the inspection, it was noted that there was evidence of a past leak from the gas hot water unit mounted on the right hand side of the dwelling. Rust be seen on the metal shroud for the hot water unit and staining can be seen on the brickwork below the unit.

The unit was not leaking in the day of the inspection.

If a leak re-occured, a licensed plumber would be required to repair the leak.

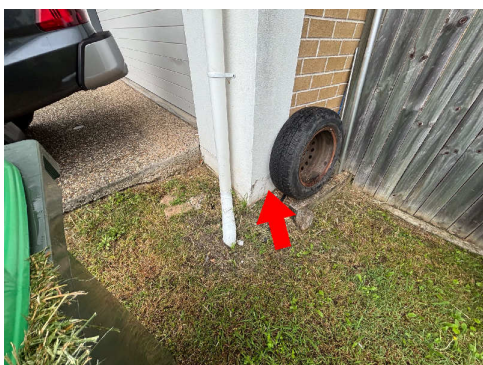
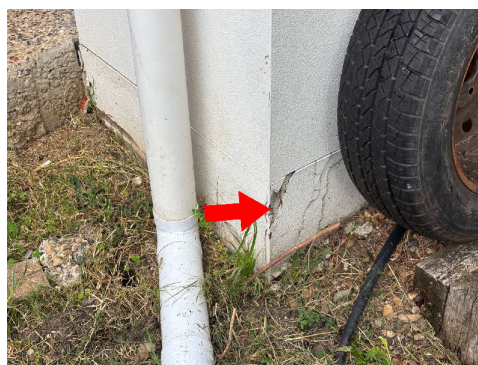
### Finding 3.07

Finding: Render - damaged

Information: At the time of the inspection, it was noted that there was minor damage to the render at the front of the dwelling. This may have been caused by impact from a lawn mower.

A solid plasterer could be engaged to repair the render. This can be done at the clients discretion.

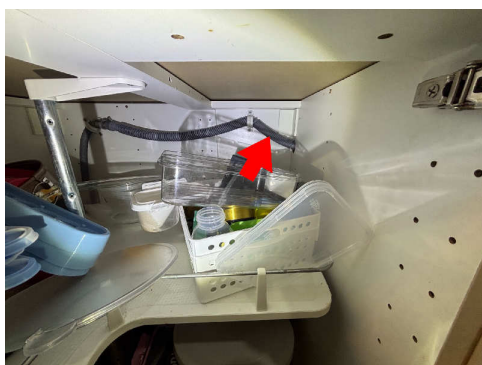
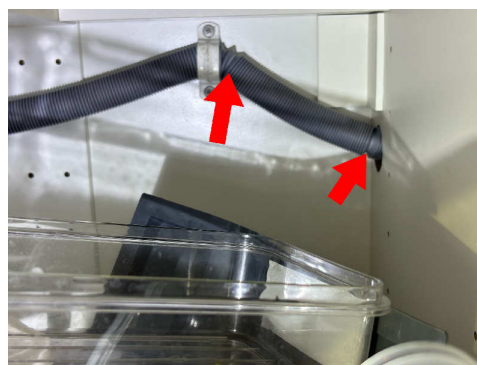
### Finding 3.08

Information: At the time of the inspection, it was noted that the flexible dishwasher drain hose appeared to have two stress points in it. It is recommended that this flexible drain hose be replaced to avoid potential leaks from this hose.

Due to the location of the hose, any leaks may remain undetected for a while.

A licensed plumber should be engaged to replace this flexible drain hose. This should be done as a short term priority.

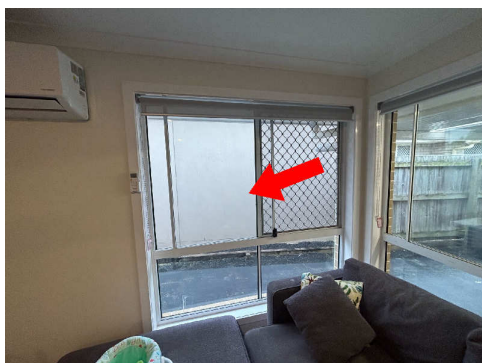
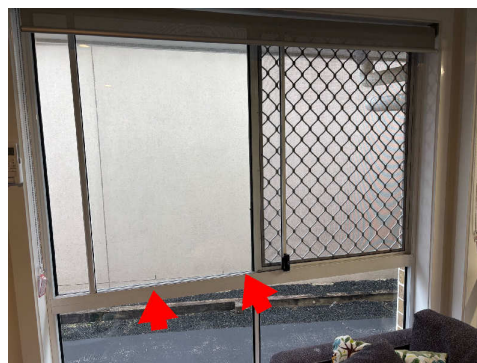
### Finding 3.09

Information: At the time of the inspection, it was noted that a sliding window in the lounge room was stiff to operate. This may be due to general wear and tear of the window runners.

A building maintenance professional could be engaged to assess the window and replace the affected runners. This can be done at the clients discretion.

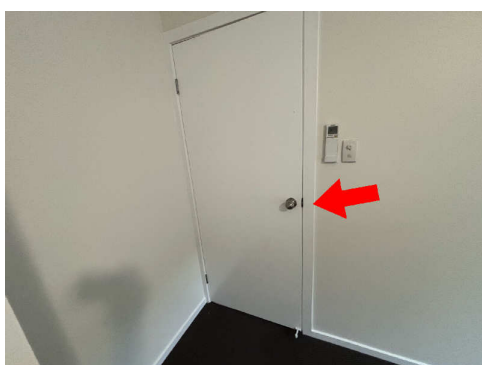
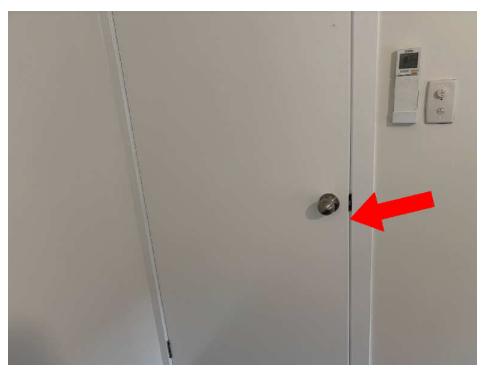
### Finding 3.10

Information: At the time of the inspection, it was noted that the hinged door to bedroom 2 was binding against the door jamb during normal operation. This appears to be general wear and tear.

For minor causes, a qualified carpenter or building maintenance professional should be appointed to perform minor rectification works at client discretion.

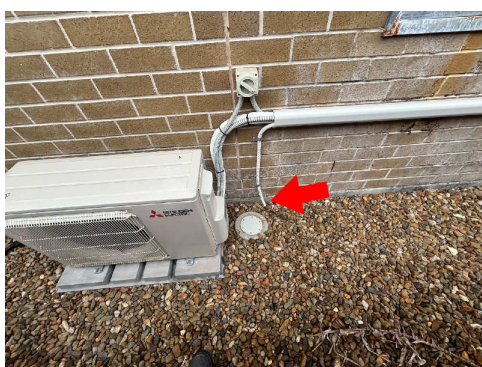
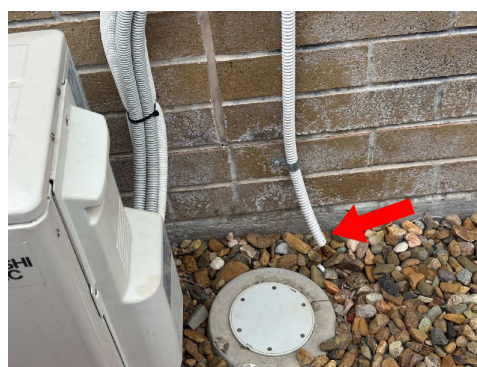
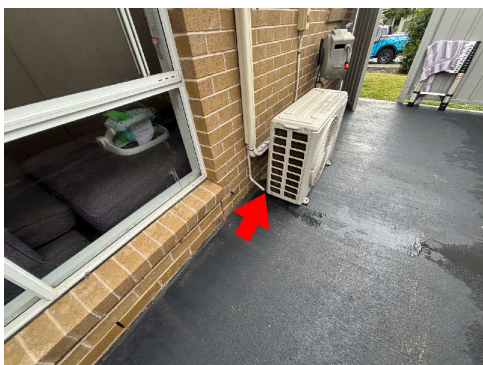
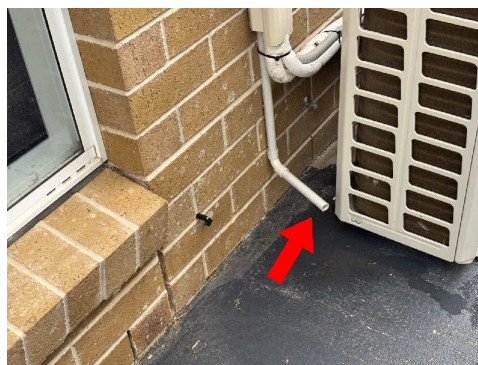
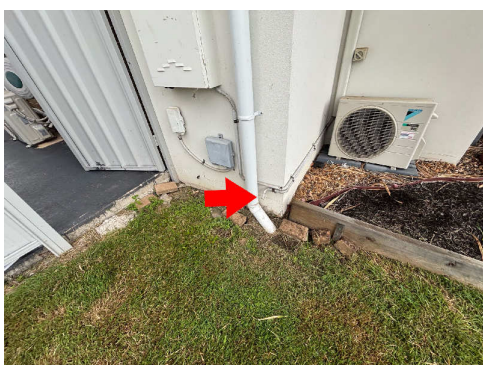
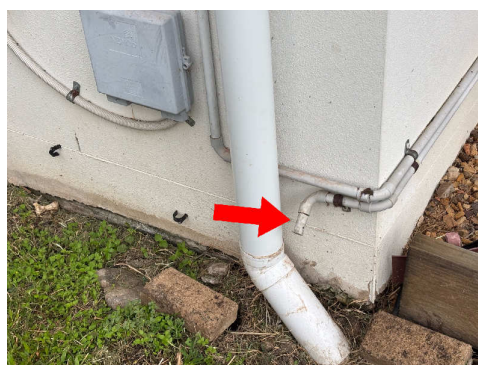
Finding: Air conditioner - Disconnected overflows

Information: At the time of the inspection, it was noted that the air conditioner drain overflows to all the units were not connected to the storm water drainage and as a result are draining next to the foundations of the dwelling.

Air conditioning overflows that are not connected to the storm water drainage and are draining near the foundation can create excessive moisture in the surrounding area.

Such leaking creates an environment which is conducive to an array of defects, including water damage to associated building elements and the attraction of termite or timber pest infestation.

It is highly recommended that a licensed plumber be appointed to connect the A/C overflow in order to prevent such an environment from being created. These minor works should be carried out as soon as possible.

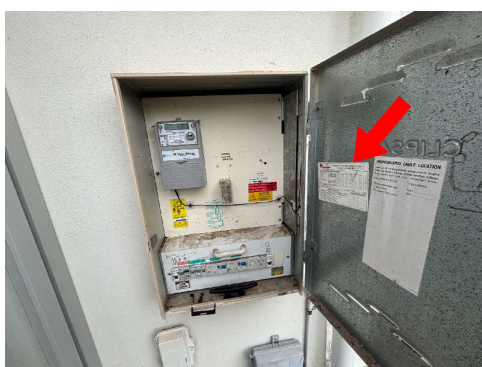
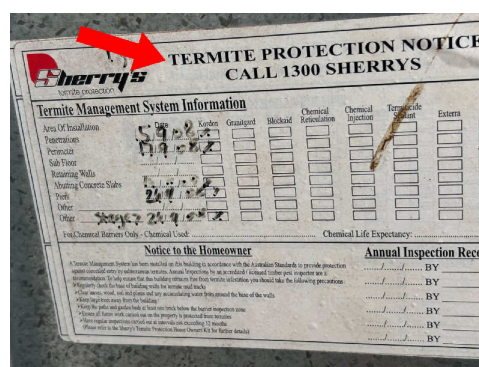
Information: At the time of the inspection, evidence of a physical termite management system was found by way of a durable notice in the electricity meter box.

A physical termite barrier does not stop or eliminate termites. A physical termite barrier is designed to expose concealed termite activity which will be found during a visual inspection.

A termite and timber pest technician should be engaged to carry out annual termite inspections as per AS 3660 in order to further protect the dwelling. Annual termite inspections must be carried out in partnership with any termite treatment system, physical or chemical, as no termite treatment system can be expected to be 100% effective.
