Building and Timber Pest Inspection Report

Inspection Date: Mon, 16 Feb 2026

Property Address: 2/204 Great Western Highway, St Marys
NSW 2760

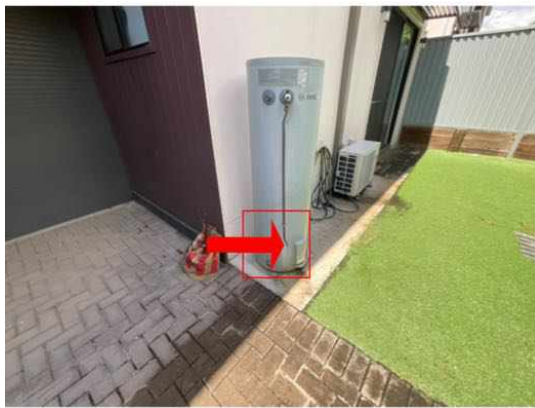
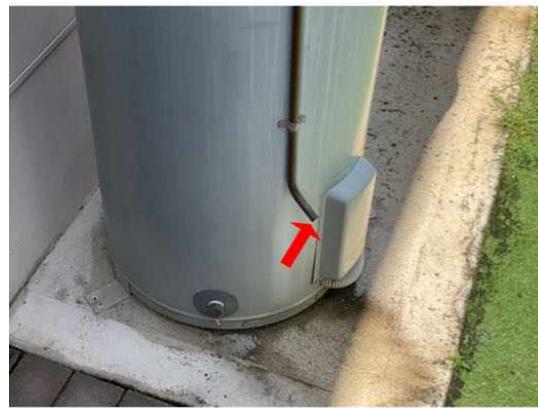
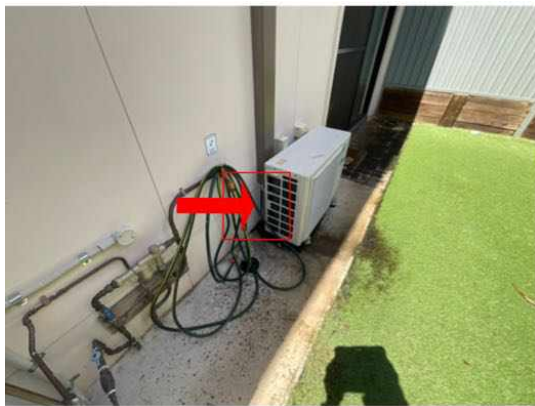
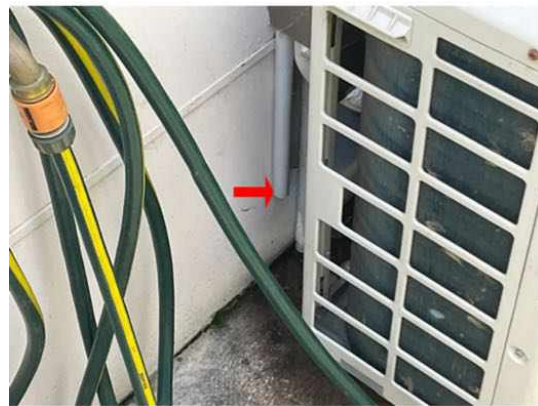
Building:	Main Building
Location:	All External Areas
Finding:	Overflow Management – Risk of Termite Activity..
Information:	Observation: Water Pooling from HWS and Air Conditioning Overflows

Water discharge from the Hot Water System (HWS) pressure relief valve and air conditioning unit overflows was observed discharging close to the base of the structure, contributing to water pooling around the building perimeter.

Persistent moisture near the foundation or subfloor area significantly increases the likelihood of termite activity. Termites are highly attracted to damp environments, and stagnant water near structural elements provides ideal conditions for foraging and infestation.

It is highly recommended that all overflows from the HWS and air conditioning units be redirected away from the building, preferably via fixed drainage or extension piping, to prevent water accumulation near the structure.

These minor corrective works should be undertaken promptly to minimise the risk of both termite ingress and potential structural damage due to ongoing moisture exposure.

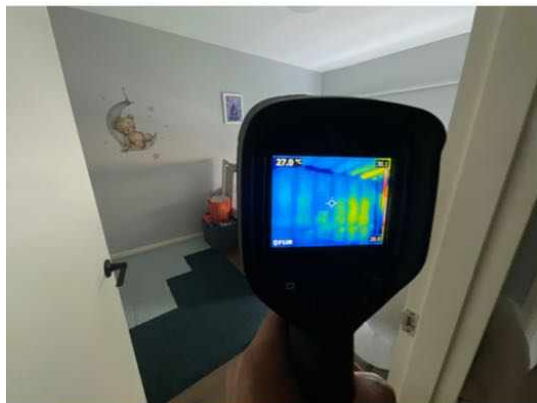
Termites release heat in the form of carbon dioxide and build mud tubes with high moisture content, which can create irregular heat patterns on surfaces such as walls, ceilings, and floors.

At the time of the inspection, no abnormalities indicating live termite activity were observed. However, it's important to note that various factors—such as obstructions, ambient temperature, and wall material/thickness—can impact the accuracy of thermal readings. In cases where surfaces are visually restricted or obstructed, a comprehensive thermal scan may not always be feasible.

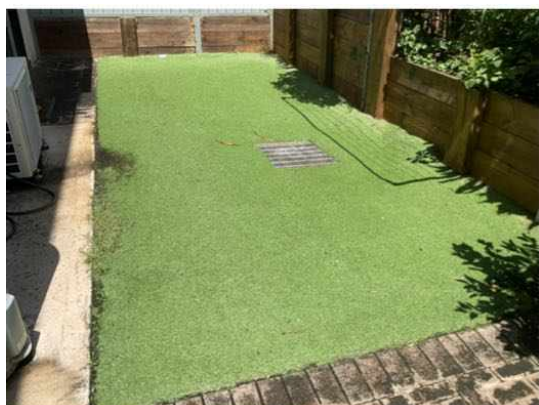
Building: Main Building
 Location: Yard - External Areas
 Finding: Site/Yard Drainage - Surface Water.
 Information: Site Drainage:

- Condition at the Time of Inspection: Site drainage appeared to be acceptable during the inspection, with no immediate concerns noted.

- Ongoing Monitoring: However, it is recommended that the site and yard be monitored during heavy rainfall to assess whether the existing drainage system can handle significant water flow. If the drains fail to cope with large volumes of water, it may be necessary to install additional drains to prevent water pooling around the structure.

- **Recommendation for Smoke Test:** A Smoke Test is recommended to detect illegal connections, blocked, or broken drains. This test will help identify any drainage issues that could cause water flow problems in the future.

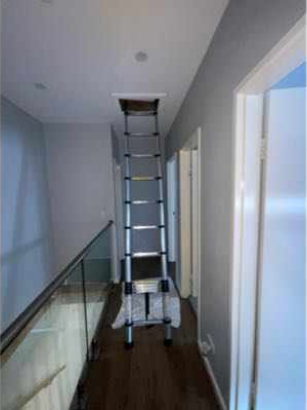
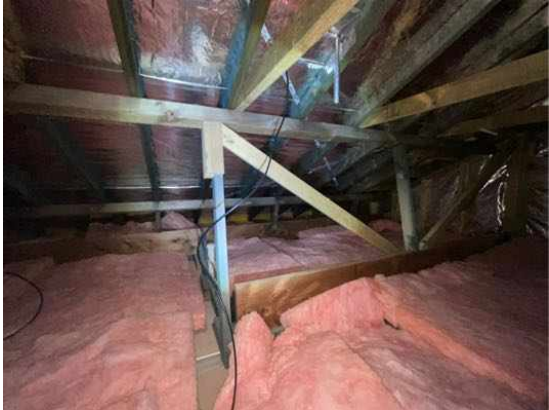
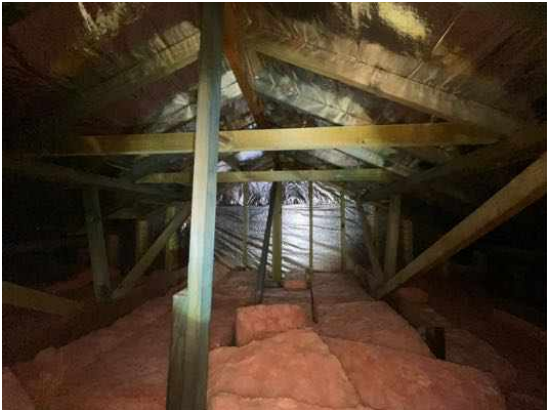
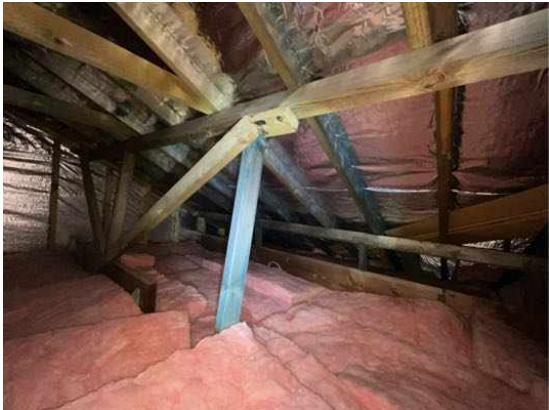
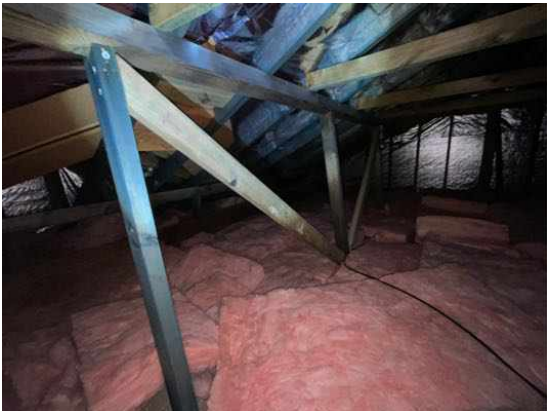
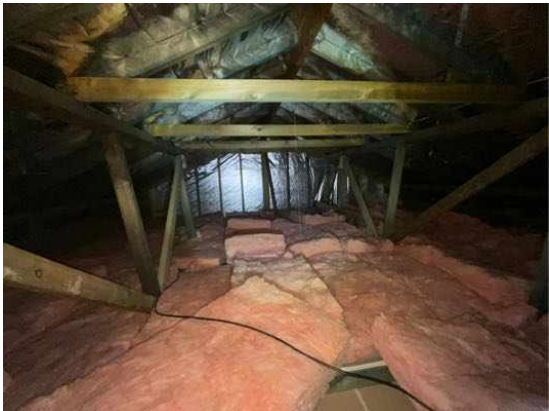
Building: Main Building
 Location: Roof Void
 Finding: Roof Void – Limited Accessibility..
 Information: Observation:

A full inspection of the roof space is not achievable unless all obstructions—including insulation and restricted access points—are removed, and full, safe access is provided. Termite activity or timber pest damage may go undetected in concealed or inaccessible areas.

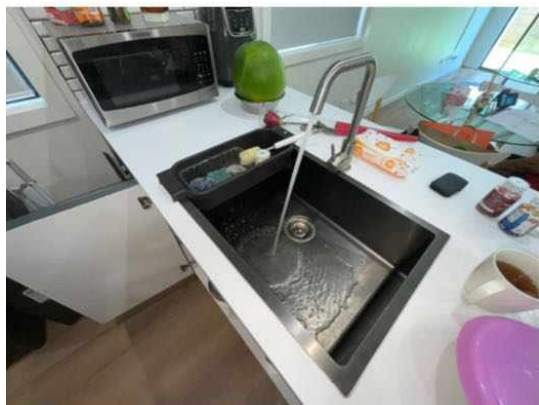
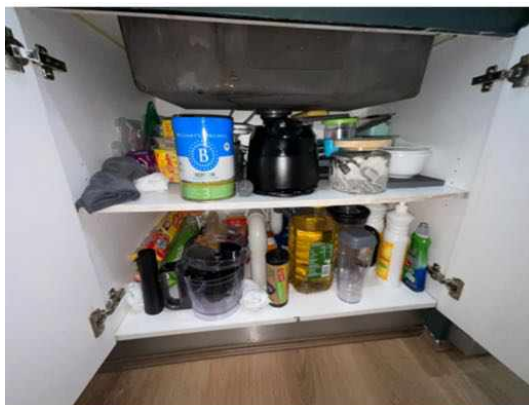
Building: Main Building
 Location: Kitchen
 Finding: Kitchen Sink – Overall Condition & Recommendations.
 Information: Observations:

- Further monitoring and testing are recommended once the tap(s) are in constant use, to identify any drainage issues or signs of slow leaks not evident during the limited inspection.
- It is recommended that the stored items beneath the sink be removed to allow for a full re-inspection of the plumbing and cabinetry, ensuring no concealed defects are present.

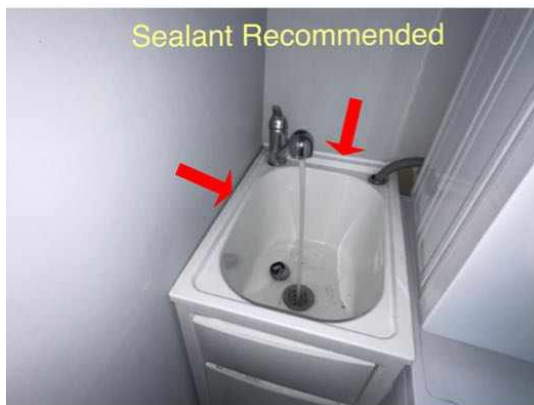
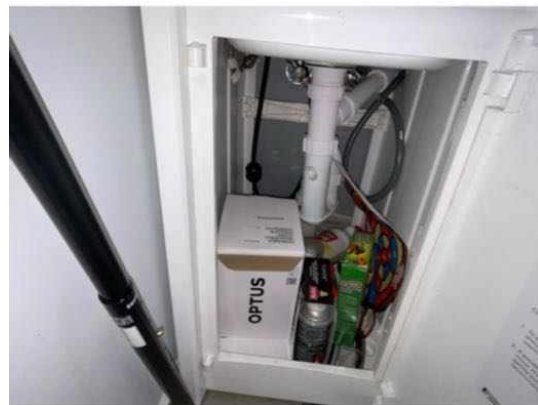
Building: Main Building
 Location: Laundry
 Finding: Laundry - Taps/Plumbing/Drainage.
 Information: Observation: Laundry Tub – Taps, Plumbing, and Cabinetry

plumbing or drainage leaks observed at the time of inspection.

- Further monitoring or testing is recommended once the taps are placed into regular use, to ensure no leaks develop over time and that the drainage system continues to perform adequately.
- Flexible and mould-resistant sealant should be applied to junctions between the basin and the wall to prevent water ingress that may lead to damage.
- Regular maintenance and prompt replacement of missing or deteriorated sealant is highly recommended, as this is a common wear-and-tear issue.
- Sealant and grouting in wet areas should be maintained as part of the long-term care and upkeep of the property.
- Where required, a sealant specialist or qualified tiling contractor should be appointed to carry out remedial sealing works.

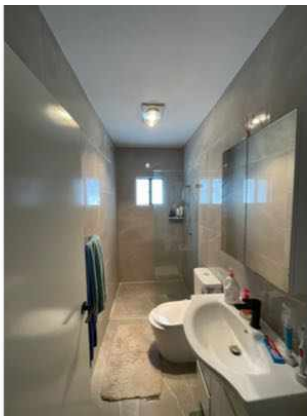
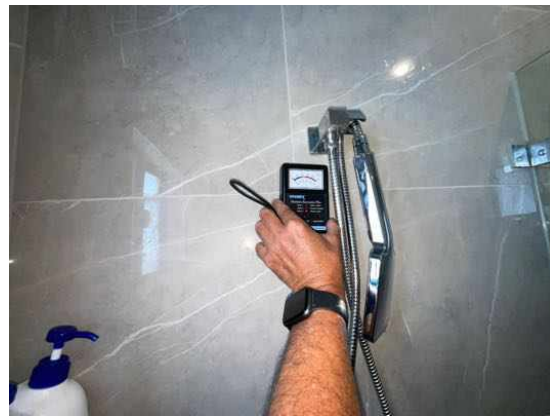
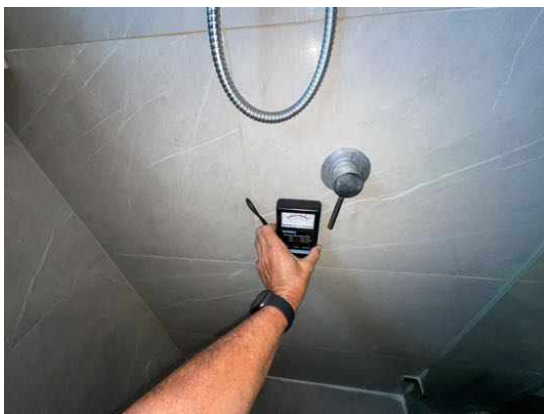
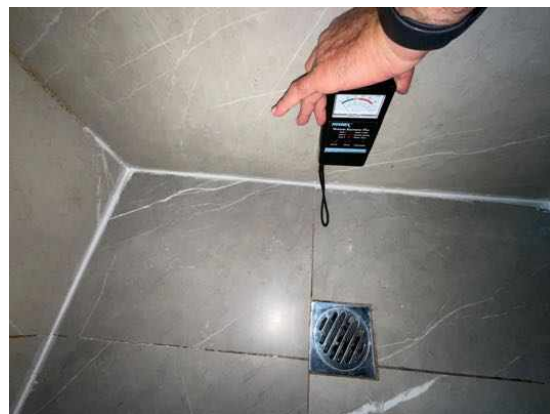
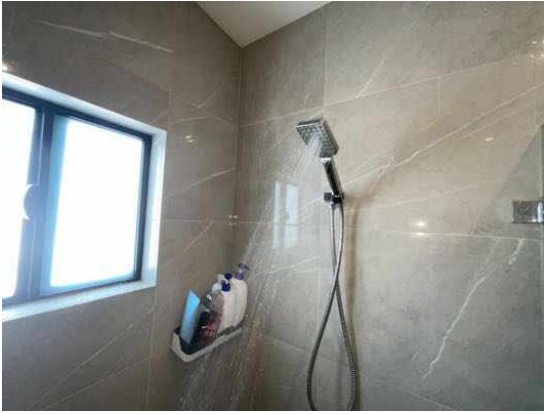
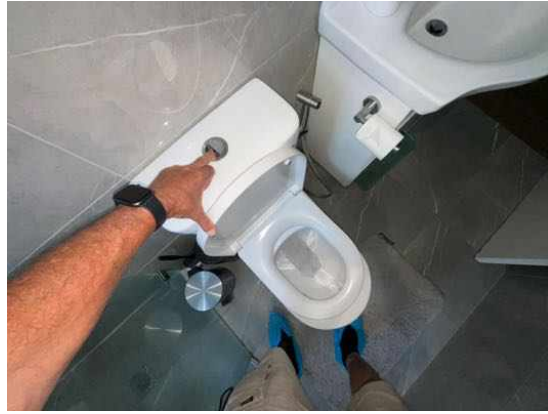
Building: Main Building
 Location: Bathroom
 Finding: Wet Areas - Bathroom(s) - Overall Condition & Recommendations.
 Information: Overall Condition & Recommendations

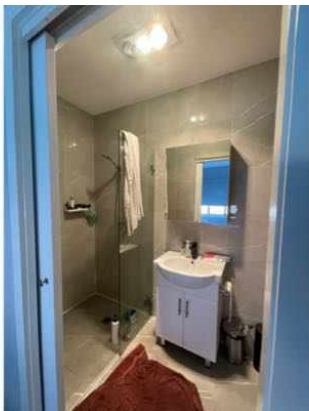
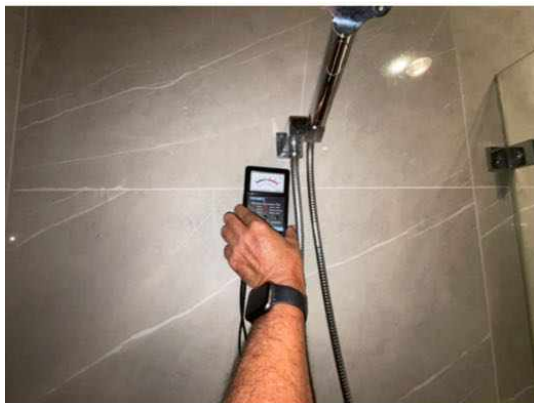
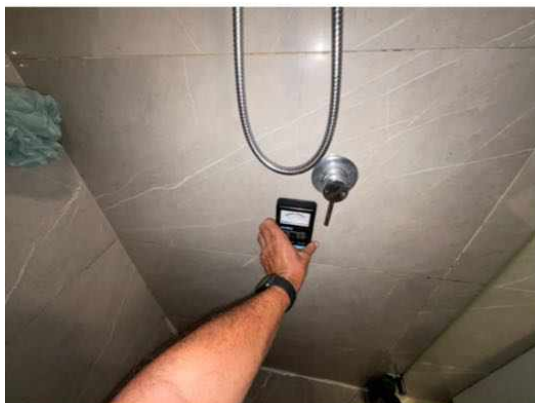
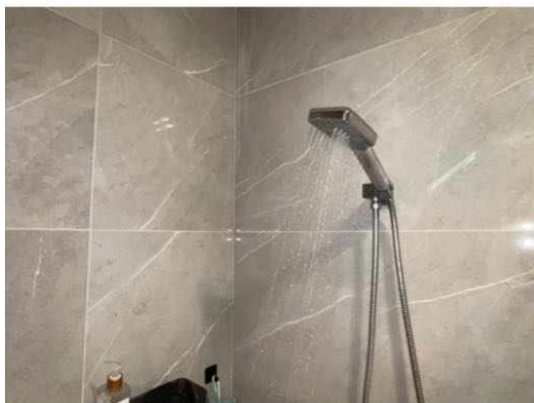
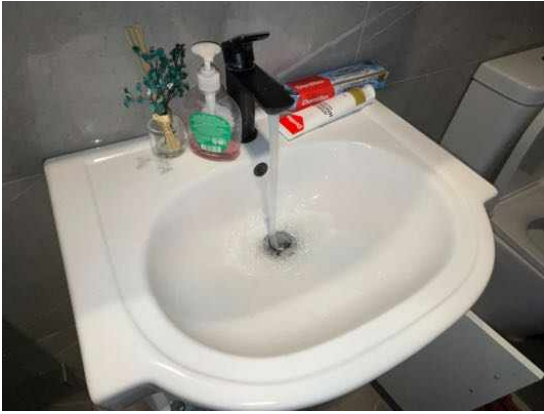
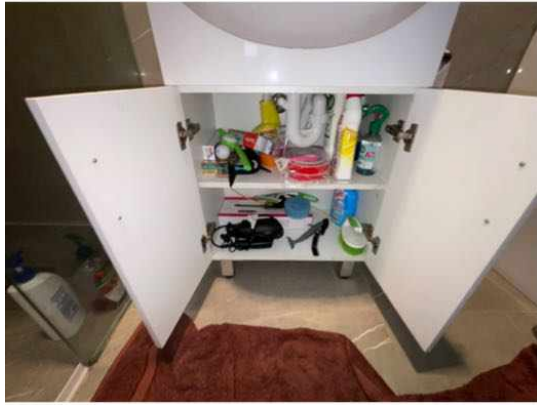
Building: Main Building
Location: Ensuite
Finding: Wet Areas - Bathroom(s) - Overall Condition & Recommendations.
Information: Overall Condition & Recommendations

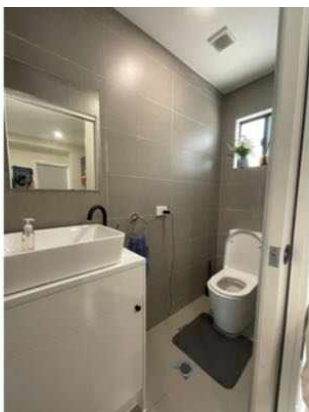
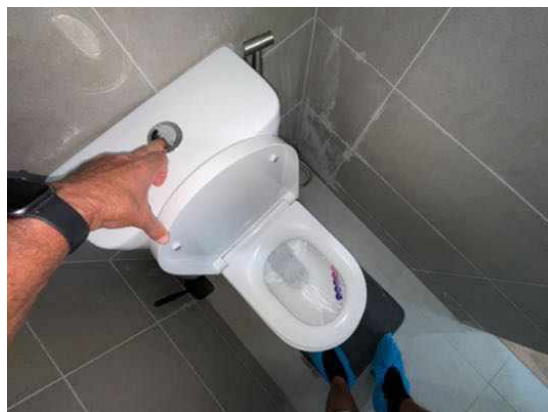
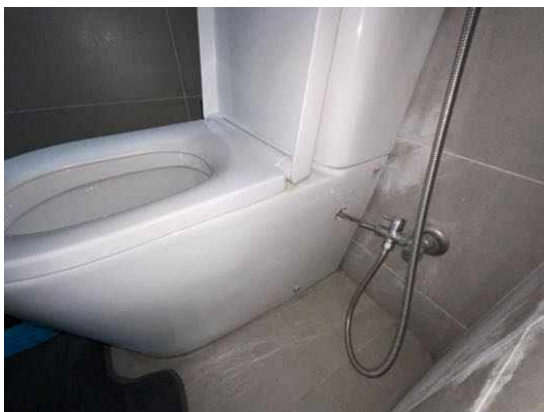
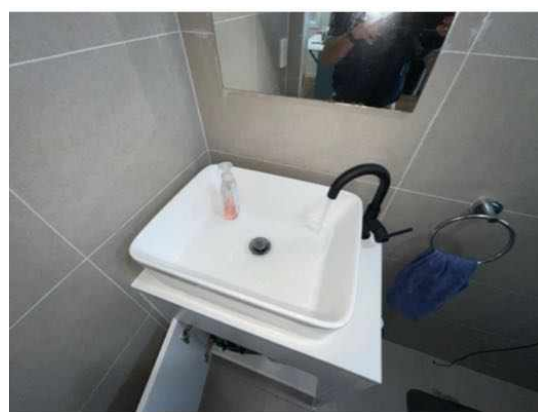
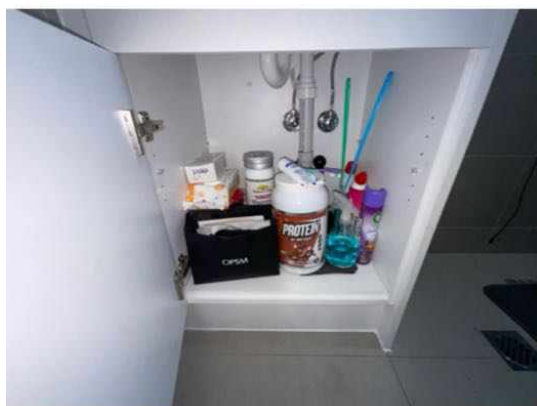
Building: Main Building
Location: Toilet (WC)
Finding: Overall Condition: Toilet & Basin.
Information: TOILET & BASIN ASSESSMENT

- Sealant around the basin and wall junctions appeared to be in serviceable condition.
- Regular maintenance of sealant and grouting in wet areas is essential to prolong the life of surrounding materials and reduce the risk of water damage.

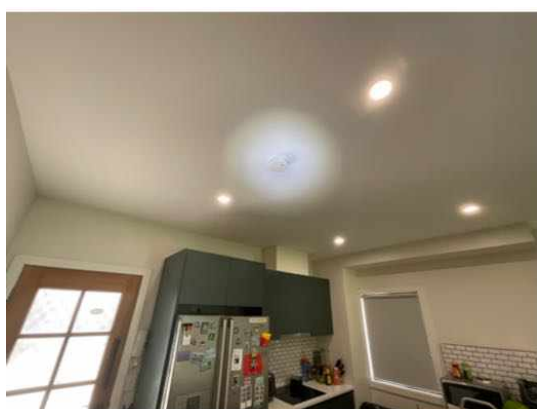
Building: Main Building
 Location: All Areas
 Finding: Smoke Detectors / Alarms.
 Information: Reporting on the presence, type, location, or compliance of smoke detectors or alarms, including hard-wired smoke detection systems and their legislative requirements, is outside the scope of this inspection report.

- All smoke detectors be tested monthly by the homeowner.
- All systems comply with the requirements of AS 3786 and any applicable state-based legislation.
