Building and Timber Pest Inspection Report

Inspection Date: Tue, 3 Mar 2026

Property Address: 100 Woorarra Ave, North Narrabeen NSW
2101, Australia

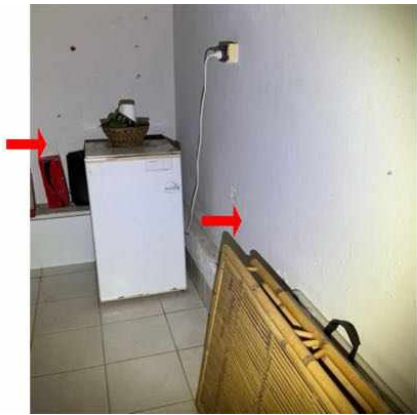
Building:	Main Building
Location:	All External Areas - Subfloor area
Finding:	Damp
Information:	Damp (or structural damp) refers to the presence of unwanted moisture in the structure of a building, either as the result of intrusion from outside, or condensation from within the structure. Generally, structural damp is caused by rain penetration, rising damp, and leaks from plumbing pipes.

Unmanaged damp facilitates the formation and development of mould, fungi growth and wood rot, decaying associated building materials and compromising their structural integrity. Damage to finishes is also likely to occur, including lifting, bubbling, peeling and staining of paint, plaster and wallpaper.

Consultation with a qualified plumber is advised immediately to identify the cause of damp and perform remedial works as required. Where excessive mould growth is present, further inspection by a specialist environmental health inspector should also be considered.

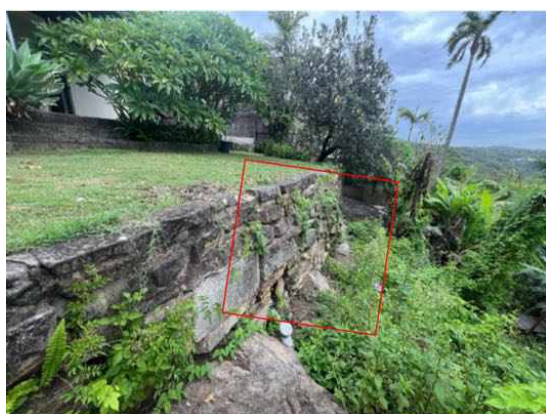
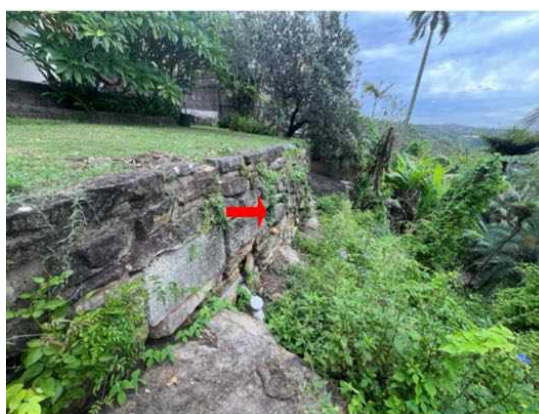
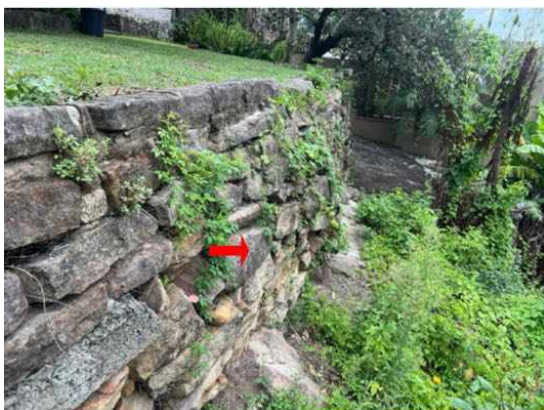
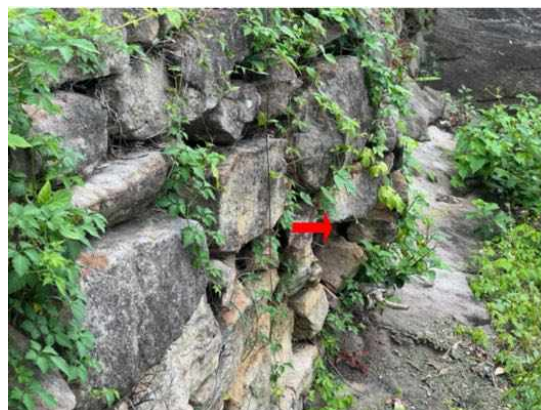
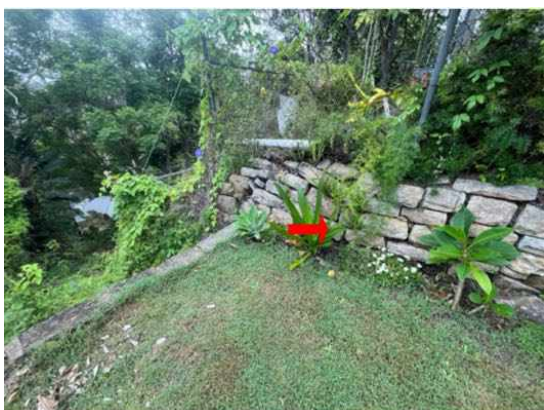
Finding 2.02

Building:	Main Building
Location:	All External Areas - Rear & Side
Finding:	Retaining wall - Defective (Rear and side) Bulging rear and collapsed side wall
Information:	The retaining wall in this area was found to be defective at the time of inspection. Generally, defective retaining walls are caused by poor original design or material use. However, deteriorated retaining walls may also be a result of substandard construction, poor site drainage or unmanaged stormwater flows.

If left unmanaged, the retaining wall may become a safety hazard if it continues to destabilise. Where retaining walls further rot and decay, an environment is created that is conducive to termite and pest infestation.

Significant repair and replacement should be expected. Where retaining walls are considered structural walls, a structural engineer / surveyor should be consulted regarding required remedial works. Otherwise, a landscaper or retaining wall installer may be appointed to repair or replace the wall, at the discretion of the client.

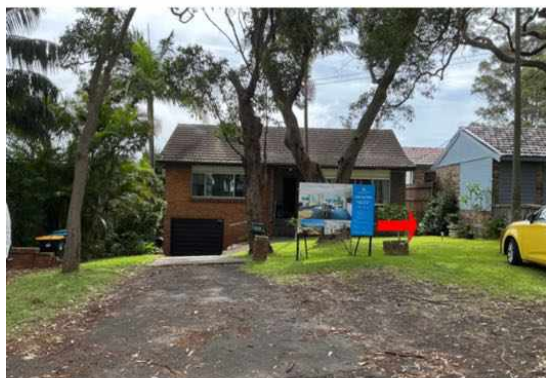
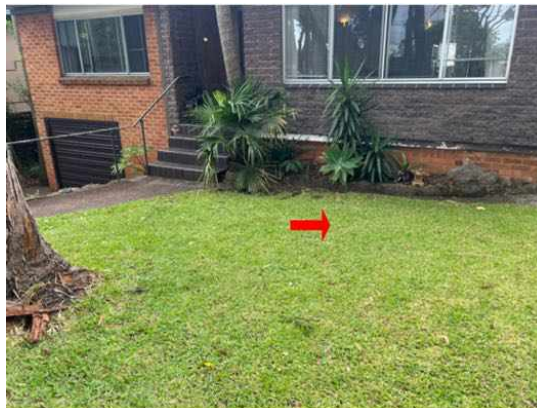
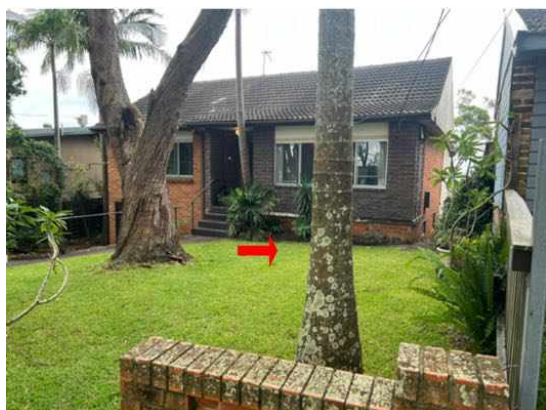
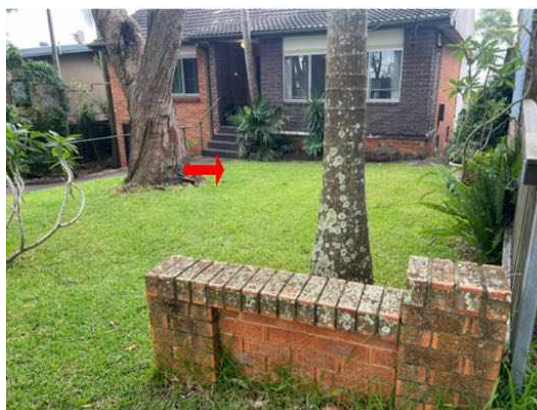
It is important that water does not lie against the base of walls; surrounding paths and ground levels should be sloped to drain water away from walls. Downpipes should not discharge stormwater onto lower walls or plinths. Stormwater should be carried away by large, regularly cleaned drains. Ground levels may need to be lowered to expose a buried DPC.

Where site drainage is inadequate, installation of an Agricultural (Aggie) Drain may be required. A qualified plumber should be appointed to further inspect the property and perform any remedial works as necessary. Water damage and secondary defects are likely to occur if left unmanaged.

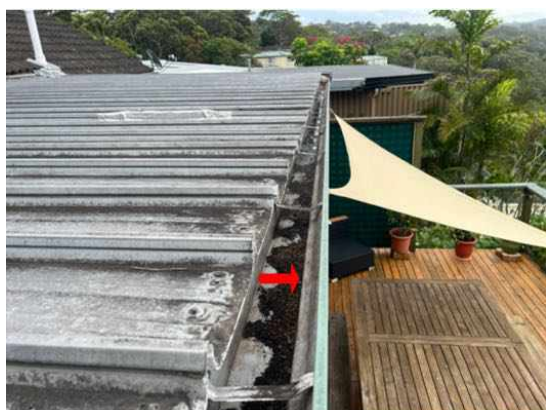
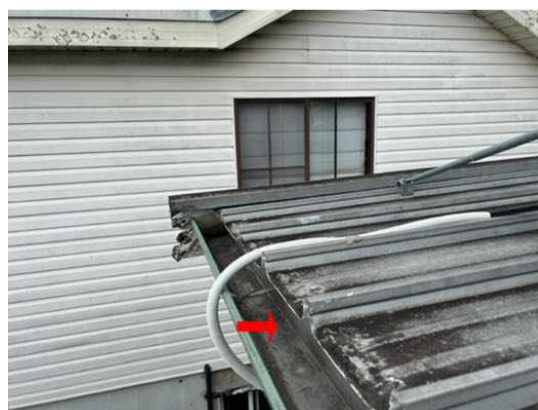
Blocked gutters are likely to lead to high levels of moisture in the affected areas. Such moisture will not only cause rust and decay of the associated building materials, but can also provide conditions that are conducive to termite and timber pest activity. Blockages in gutters should therefore be removed immediately to ensure dry conditions are maintained.

Consult a Licensed Plumber for further specific advice on remedial works that may be required. In the interim, it is highly advised that blocked gutters be removed by the homeowner or a general handyman as a matter of urgency.

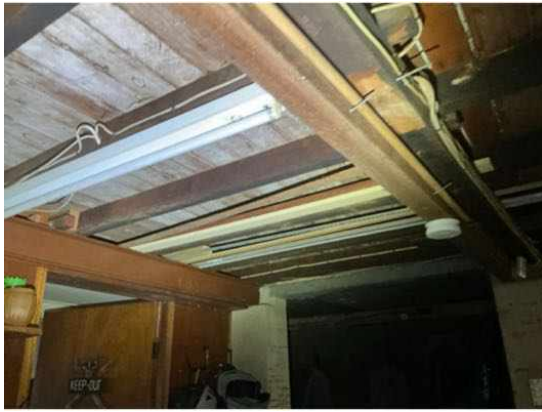
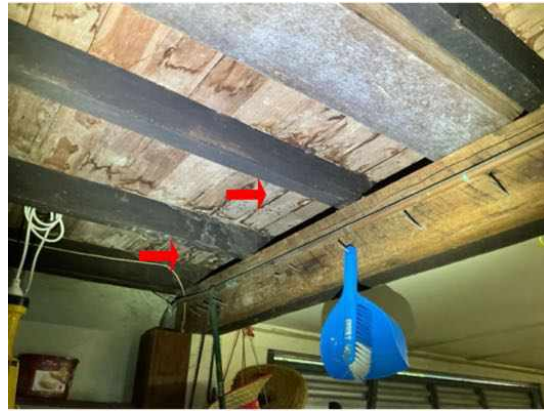
Finding: Aged Timber and moisture staining – Subfloor

Information: Visible decay was noted to some areas, consistent with age-related shrinkage and general weathering. The affected areas also exhibited localised surface darkening and moisture stains which may indicate past moisture exposure. No evidence of structural compromise was observed at the time of inspection. These conditions appear typical for a dwelling of this age and construction, but ongoing monitoring is recommended. A licensed builder or licensed carpenter should be consulted if there is further deterioration or leaks. It is also recommended for a licensed timber pest technician to perform invasive inspection for concealed timber pest activity.

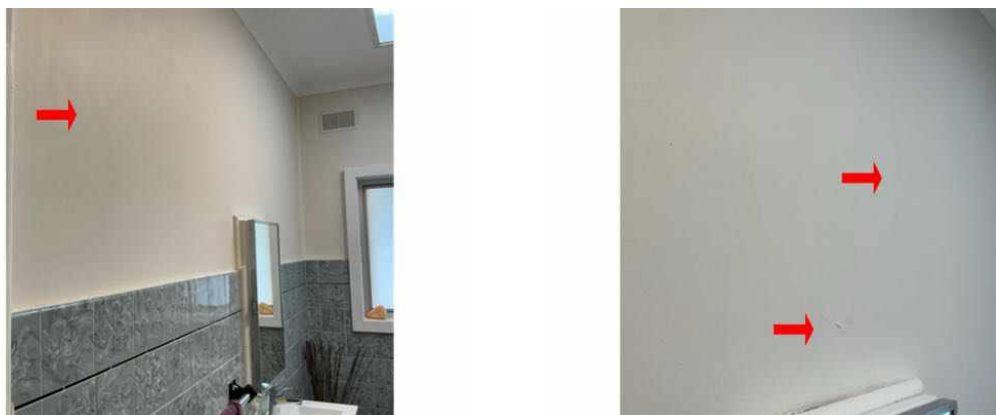
Information: The ceiling surface shows faint darkened spotting or shadowing, commonly consistent with surface mould or humidity-related staining, often found in bathroom or wet area ceilings with insufficient ventilation. While there is no visible sagging or major water damage, the pattern suggests prolonged moisture exposure, possibly due to steam accumulation or minor condensation issues. According to AS 4349.1-2007 (Appendix C), this would be classified as a minor defect unless further deterioration or active leaks are found. Recommend improving mechanical or natural ventilation, cleaning the

surface with mould treatment, and monitoring for recurrence.

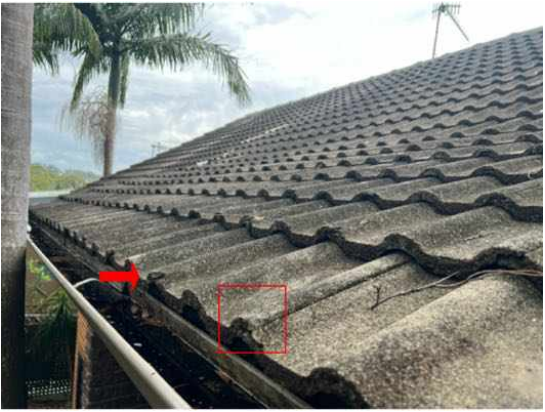
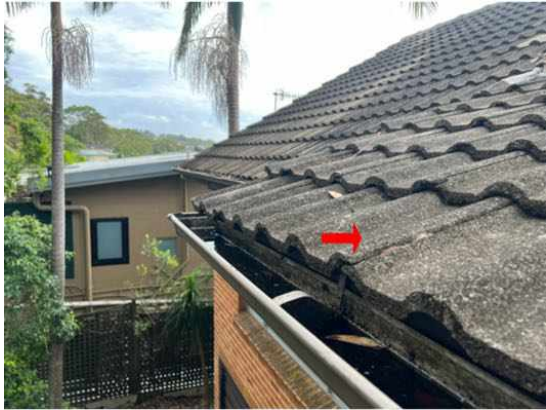
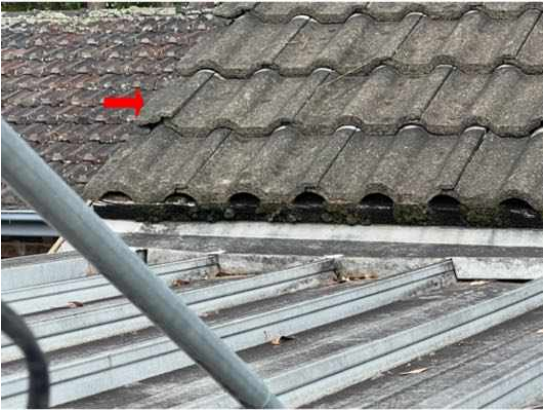
Finding 3.33

Building:	Main Building
Location:	Roof Exterior
Finding:	Roof tiles condition
Information:	The roof tiles display general surface weathering, minor edge erosion, consistent with age and environmental exposure. Some tiles appear slightly uneven, likely due to minor settlement or past foot traffic. Routine maintenance including cleaning of biological growth, clearing of valleys and checking that tiles are properly seated is recommended to maintain effective drainage and long-term weatherproof performance.

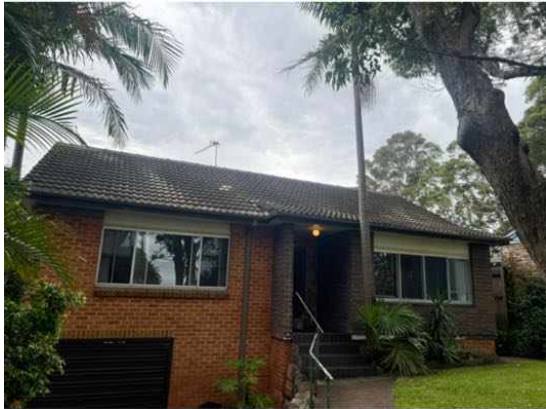
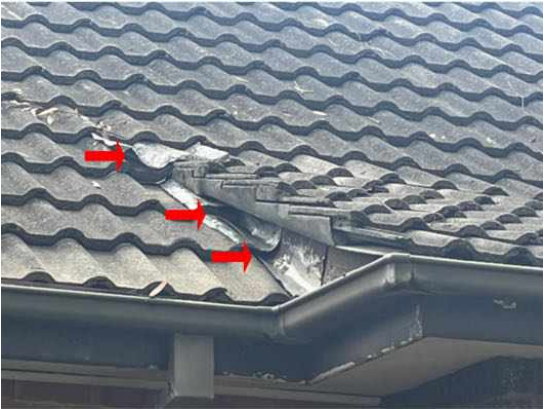
Finding 3.34

Building: Main Building
 Location: Roof Exterior
 Finding: Flashing defective -poor installation
 Information: Areas of flashing for walls and or step flashings have been identified which are missing weathering folds anti-capillary breaks and sealing were identified.

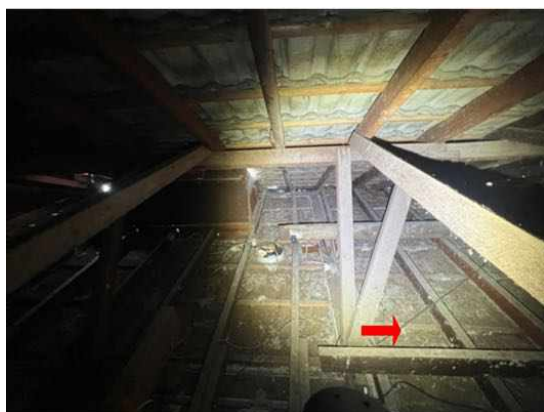
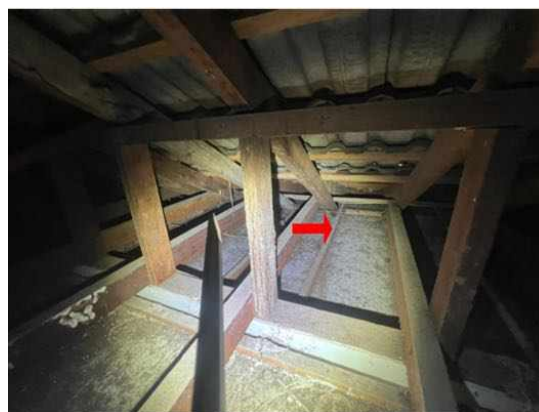
Finding 3.35

The level of insulation in the property does not meet current Australian Standards. Installation of adequate insulation is required and should be conducted as soon as possible.

Caution should be exercised when accessing the roof void. Do not attempt to stand on the framework to the underside of the trusses and be aware there is a potential for electric shock if contact is made with exposed or faulty electrical wiring.

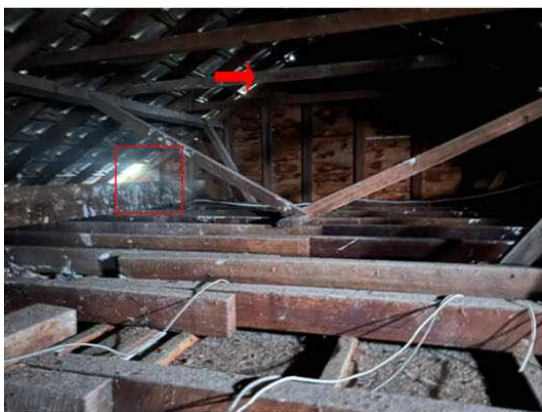
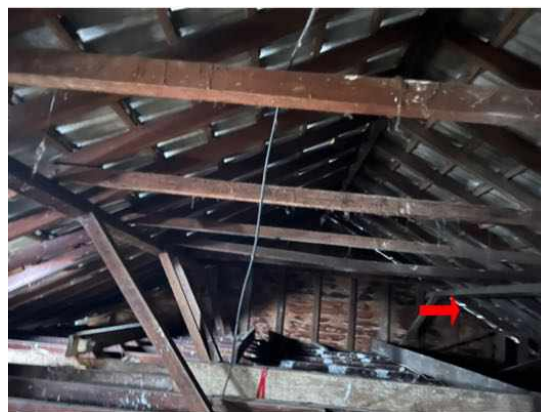
Finding 3.36

Building: Main Building
 Location: Roof Void
 Finding: Roof Void – No Sarking & Light Ingress
 Information: Light ingress is visible through multiple roof tile laps, which is typical of older tile roofs without sarking and may allow minor wind-driven moisture or dust into the space, though no active leaks were observed.

Consider retrofitting sarking or roof wrap in the future to improve thermal and moisture performance.

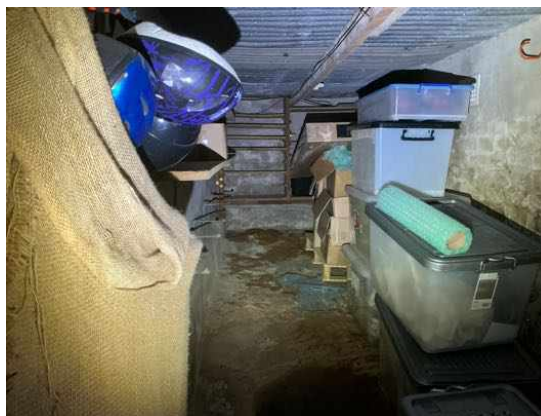
Finding 3.37

Building:	Main Building
Location:	Subfloor
Finding:	Subfloor ventilation - Inadequate
Information:	Adequate subfloor ventilation aids in preventing excessive moisture wood rot and termite activity by ensuring a dry subfloor environment.

A registered builder should be appointed as soon as possible to perform these works as necessary.

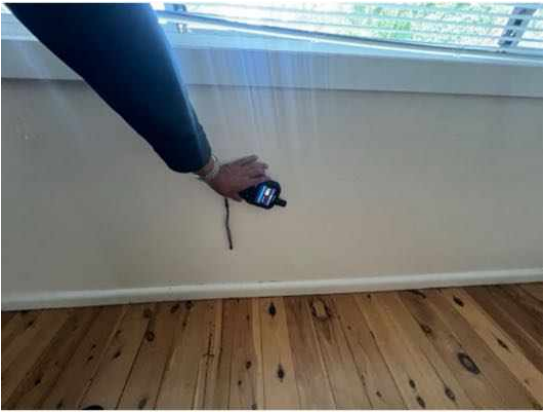
Finding 6.02

Building: Main Building
Location: Bedroom
Finding: Elevated moisture - identified (Possible timber pest activity requires invasive inspection)
Information: Elevated moisture can attract termites and produce conditions that promote fungal growth and wood decay.

Prior to any remedial works being performed a qualified plumber should be appointed to further inspect the property and to identify the cause of the excessive moisture. Works to remove affected building elements may then be necessary and should be performed by an appropriate tradesperson.

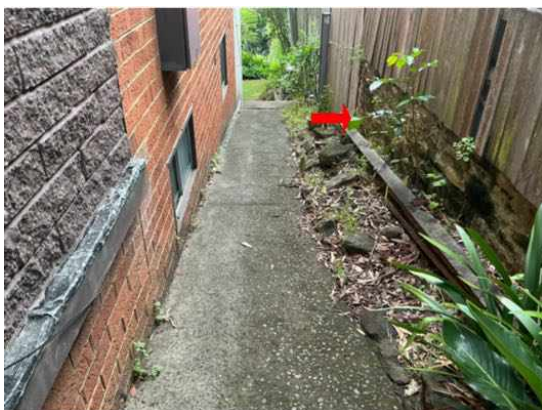
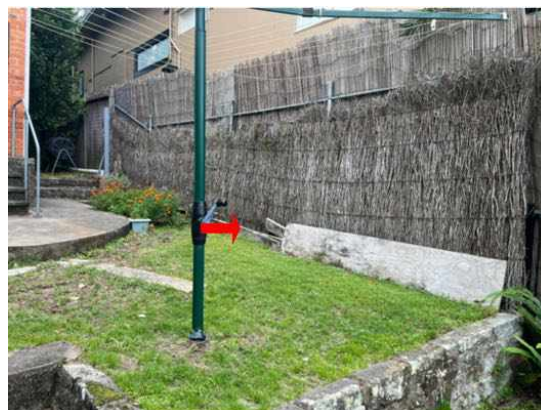
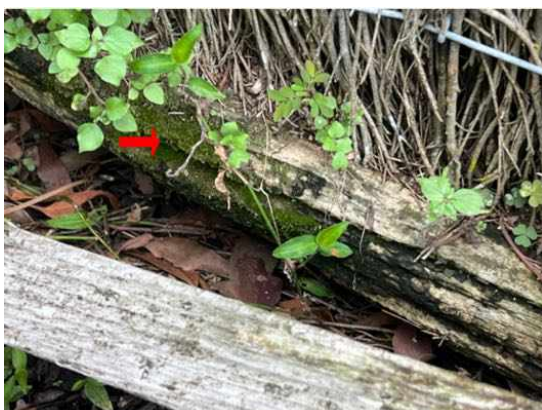
Finding 6.03

Building: Main Building
Location: All External Areas
Finding: Trees within 50m
Information: Trees within 50m of the property can be conducive to termite activity. It is recommended an invasive inspection of all trees with 50m to the property be carried out by a qualified pest control expert.

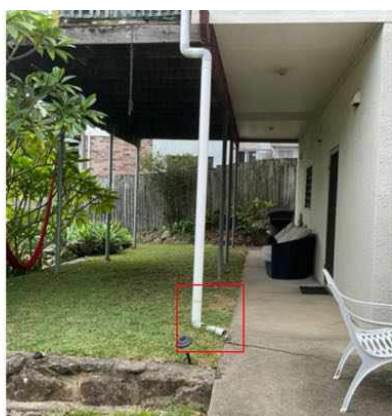
Building:	Main Building
Location:	All External Areas
Finding:	Air conditioner - Disconnected overflow
Information:	The Air Conditioner (A/C) overflow was found to be disconnected from storm water drainage and is creating excessive moisture in the surrounding area.

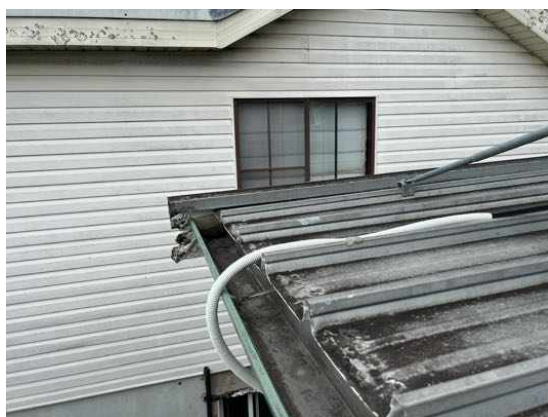
Finding 6.07

Building:	Main Building
Location:	All External Areas
Finding:	Gutters - Blocked/Pooling
Information:	Roof plumbing structures, such as guttering and downpipes, should be free of all debris to prevent blockages. Blockages of the guttering and downpipes will lead to pooling and accumulated water overflows, which is likely to subsequently flood eaves and exterior walls.

Consult a Licensed Plumber for further specific advice on remedial works that may be required. In the interim, it is highly advised that blocked gutters be removed by the homeowner or a general handyperson as a matter of urgency.

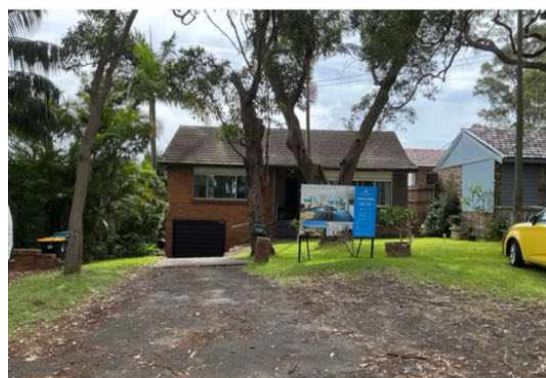
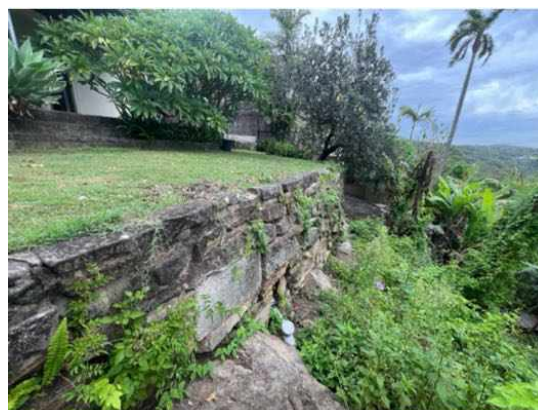
Building:	Main Building
Location:	All External Areas
Finding:	Structural adequacy on sloping sites
Information:	The dwelling is situated on a steeply sloping site, which inherently increases the risk of differential movement, subsidence and drainage-related issues compared with buildings on level ground. Evidence of damp, minor movement, cracking , step cracking were observed in external/internal areas. While no major structural failure was identified during this inspection, the adequacy of the structural system and footings cannot be confirmed within the scope of a standard AS 4349.1 inspection. It is strongly recommended that further assessment be carried out by a licensed structural engineer or geotechnical engineer, and that the current owners be requested to provide evidence (such as previous engineering reports, footing design documentation or certification) confirming the adequacy and stability of the structure given the site conditions.
