Building and Timber Pest Inspection Report

Inspection Date: Thu, 19 Mar 2026

Property Address: 173 Shellharbour Rd, Port Kembla NSW
2505, Australia

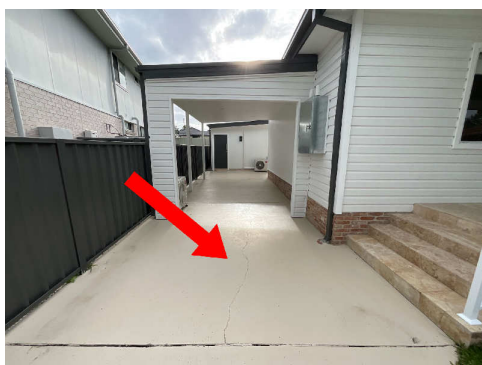
Finding: Crack in concrete slab - Category 0

Information: A crack coded as Category 0 was identified in the slab. A Category 0 crack is described as a hairline crack, representing insignificant movement of slab from level.

No rectification is required at this time. However, all cracking should be monitored over a 12 month period to identify any further damage in the area.

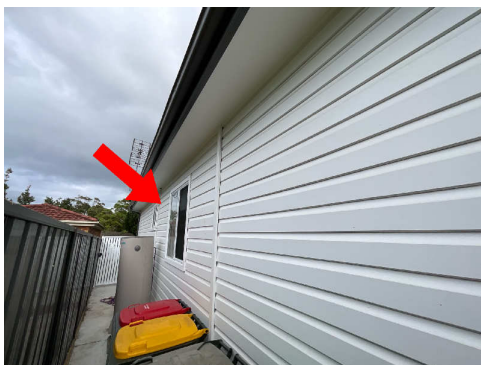
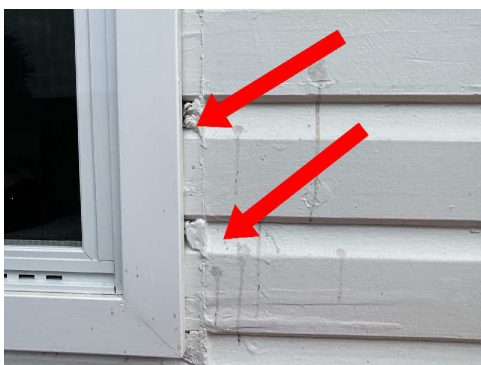
Finding 3.02

The window surround has been subject to previous modification works; however, the installation is incomplete and of substandard finish. The original-width architraves have not been reinstated, resulting in undersized replacement trims that do not adequately cover the junction between the window frame and external cladding.

Excessive sealant ("No More Gaps") has been applied in lieu of proper carpentry detailing. The sealant is poorly executed, visibly exposed, and uneven, detracting from the overall appearance and indicating an attempt to conceal gaps rather than correctly finish the installation. Evidence of previous architrave removal is apparent, with inadequate preparation and finishing of the substrate.

This condition is considered a cosmetic defect and indicative of poor workmanship, inconsistent with acceptable building standards and finish expected for residential construction.

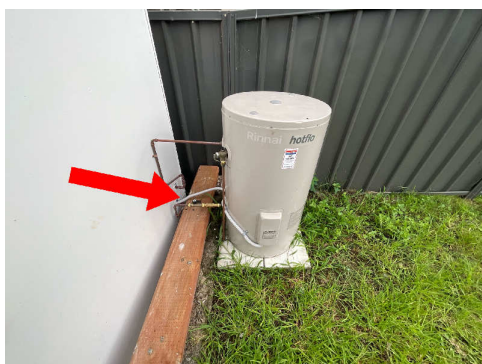
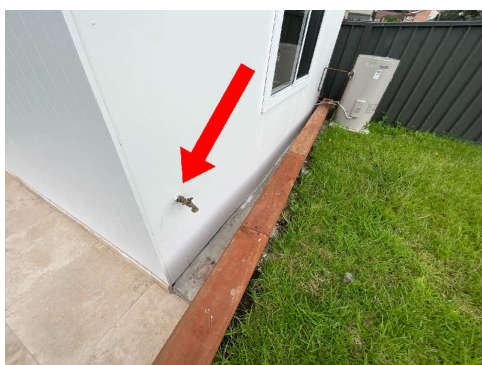
**Finding 3.03**

Gaps and holes around pipework makes the area susceptible to insect and vermin ingress, as well as allowing water penetration to the cavity wall. As such, associated building elements are likely to deteriorate at an accelerated rate, and major implications are expected if holes around the pipework are left unmanaged.

All excessive holes, gaps or cracks should be adequately filled by a suitable sealant or trimmings as soon as possible to prevent any further damage. Such works may be conducted by a general handyperson or licensed plumber.

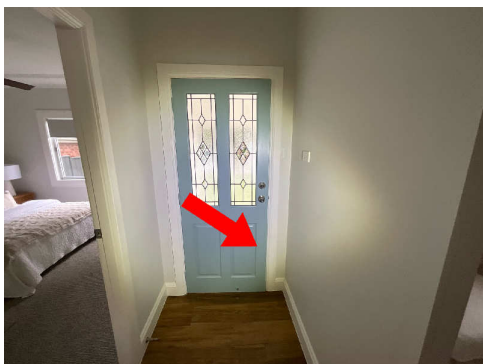
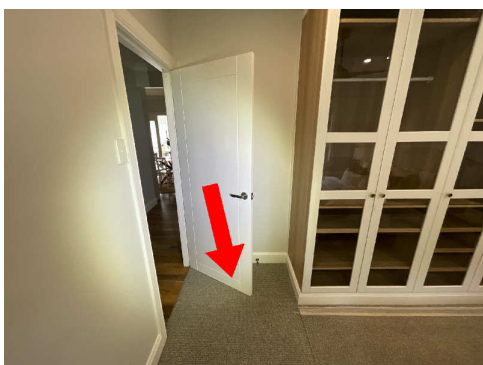
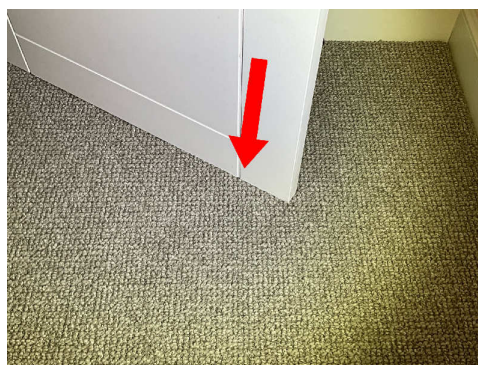
Finding 3.04

Information: Binding and/or jamming of this door is evident during standard operation. This defect inhibits the functionality of the affected door as well as creating potential for secondary defects to associated building elements, such as damage to the floor covering.

For minor causes, a qualified carpenter or general handyperson should be appointed to perform minor rectification works at client discretion.

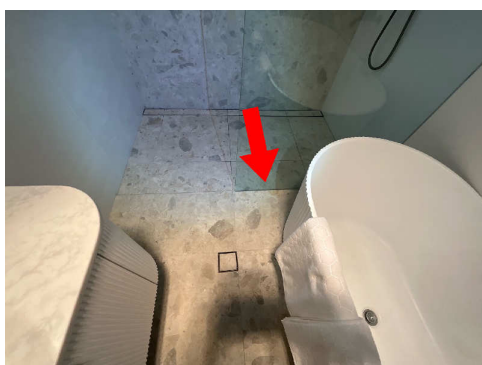
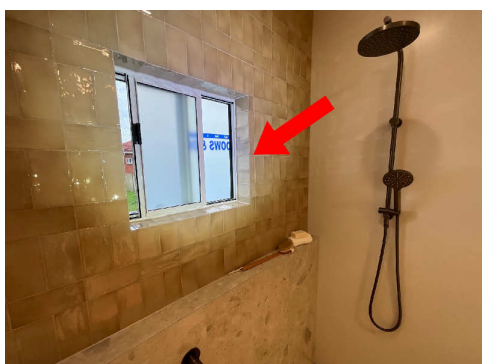
Finding 3.05

Finding: Sealant and grouting - Missing or damaged

It was noted on inspection that sealant or grout is degraded to the tiled shower alcove and or other areas of the bathroom.

Different materials and floor areas move at different rates, generally causing cracking to grout or sealant at this point. A flexible sealant is required to allow for expected expansion and contraction, while keeping the joint water tight and protective of all associated building materials.

Flexible and mould resistant materials should be applied to affected areas to prevent any subsequent water damage that is likely to occur. Regular maintenance and replacement of damage or missing or damaged sealant and grout is highly recommended to the wet areas, as this is a regular wear and tear defect. Sealant and grouting in areas that come into regular contact with water should be maintained for the long term care of your property.

A sealant specialist or tiling contractor should be appointed to complete these works as soon as possible

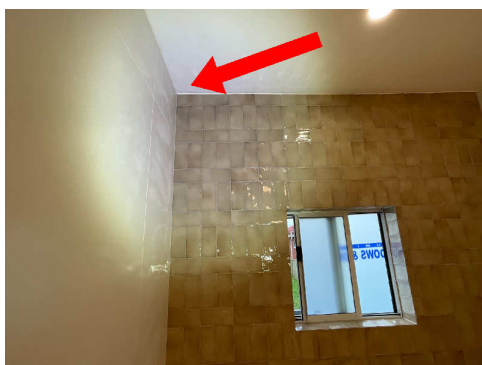
Finding 3.06

Information: A visible screw head (screw pop) was noted to the bathroom ceiling following recent renovation works. This indicates substandard plasterboard installation and/or inadequate setting and finishing, as fixings should be properly recessed, set, and finished to provide a smooth and uniform surface.

This condition is considered a defect in workmanship and does not meet acceptable finishing standards as outlined in the Guide to Standards and Tolerances.

The builder is to engage a qualified plasterer to re-fix (if required), set, sand, and repaint the affected area to achieve a consistent, flush finish in line with surrounding ceiling surfaces.

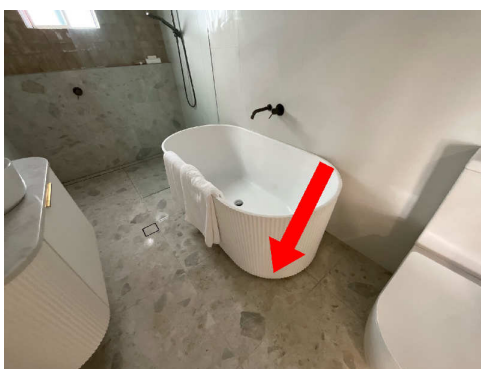
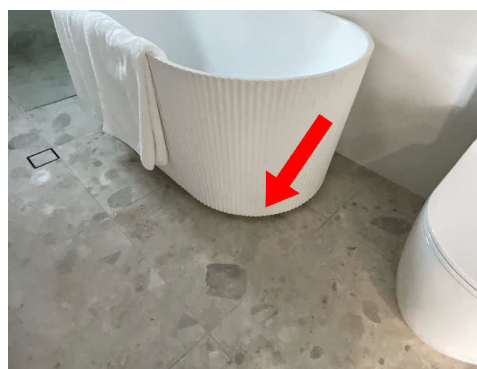
Finding 3.07

Information: The freestanding bath has not been sealed to the tiled floor, with no silicone bead provided at the base perimeter. This is considered incomplete installation, as sealing is required to prevent water ingress beneath the bath, which may lead to moisture accumulation, mould growth, and deterioration of surrounding materials.

This condition does not align with acceptable installation practice or manufacturer recommendations for sanitary fixtures.

A suitable sanitary-grade, mould-resistant silicone sealant is to be applied continuously around the base of the bath to provide a watertight seal and neat finish. Works should be carried out by a qualified tradesperson in accordance with manufacturer guidelines and relevant Australian Standards (e.g. AS 3740 – Waterproofing of Wet Areas).

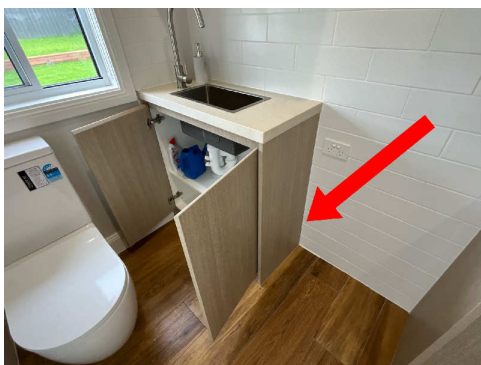
Finding 3.08

At the time of inspection, it was observed that the laundry joinery does not include the required provision holes or access openings to allow connection of washing machine pipework. In its current condition, the joinery restricts access for the installation of water supply hoses and the waste discharge pipe, rendering the washing machine unable to be connected without modification.

This is considered incomplete works and may result in damage to the joinery if ad-hoc alterations are required after handover.

It is recommended that the builder arrange for the laundry joinery to be modified by a suitably qualified tradesperson to provide appropriate access holes for washing machine water supply and waste connections. All works should be neatly finished and coordinated with the plumbing installation to ensure proper functionality and an acceptable appearance.

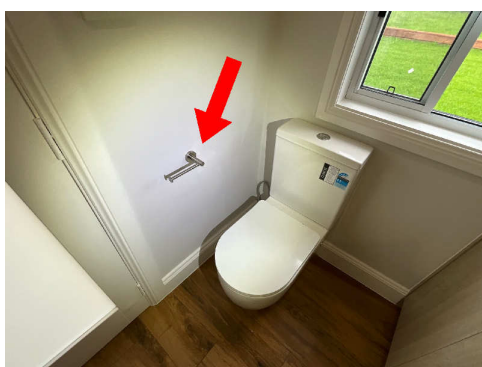
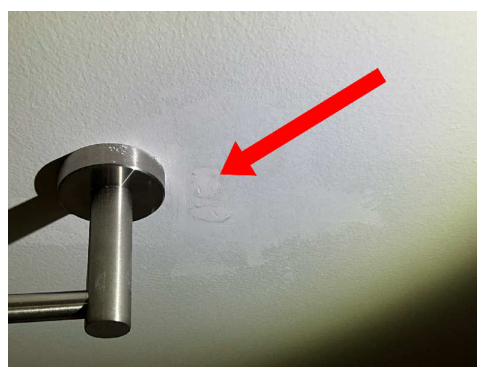
**Finding 3.09**

Location:	Laundry
Finding:	Minor Damage - Plasterboard Walls
Information:	<p>Minor damage was observed to plasterboard wall surfaces, including small indents and paint chips. These areas will require minor surface preparation, including filling, sanding, and repainting, to achieve a uniform finish.</p> <p>Engaging a licensed painter or plasterer can help with these repairs.</p>

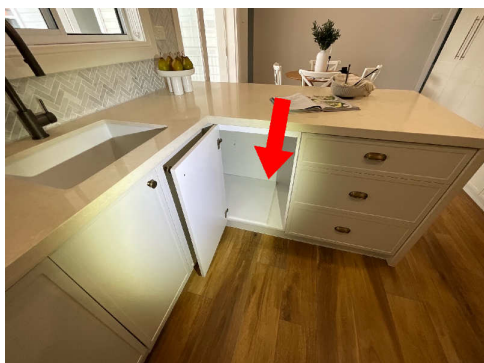
Finding 3.10

Building:	Main Building
Location:	Kitchen
Finding:	Joinery Shelf - Not Installed
Information:	<p>Although some building elements may seem irrelevant or unnecessary, all building elements play a key role in the operation and function of the overall structure and its performance.</p> <p>The appropriate tradesperson should be appointed as soon as possible to install the missing shelf.</p>

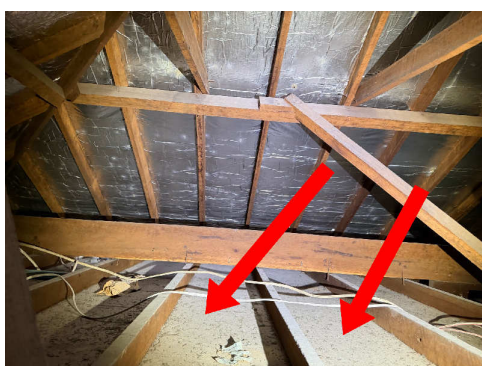
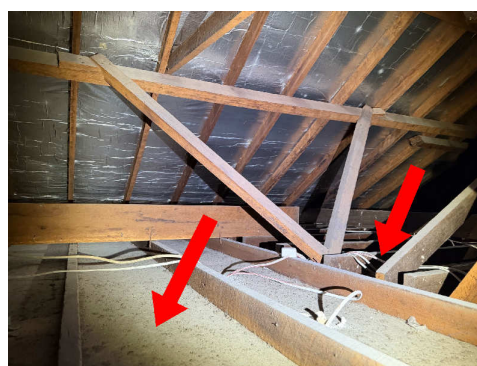
Finding: Insulation - Missing

Information: Upon inspection of the roof void it was noted that insulation is not present.

Insufficient insulation will result in a comparatively higher cost to heat and cool a property as there is a lack of Insulation (or uneven coverage of insulation) which works as a barrier to heat transfer. This helps to keep out unwanted heat in summer and preserves warmth inside your home in winter. It can also help soundproof your home from unwanted airborne noise transfer.

Where insulation is absent, the area does not meet current Australian Standards. Installation of adequate insulation is required and should be conducted as soon as possible.

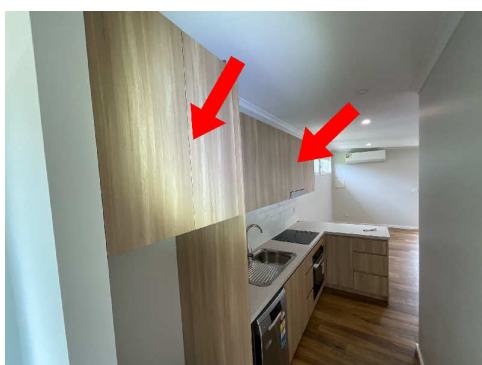
Finding 3.13

Building:	Granny-Flat
Location:	Kitchen
Finding:	Kitchen Joinery (Non-Functional Cupboard Doors)
Information:	Two sets of kitchen cupboard doors were found to be non-functional, as no opening mechanism has been installed. There are no push-to-open devices, pull handles, or underside finger pull rebates provided, preventing the doors from being operated as intended.

This constitutes substandard and incomplete joinery installation, as cupboard doors must be readily operable and fit for purpose. The current condition does not meet acceptable standards of workmanship or functionality as expected at completion.

The builder is to engage a qualified cabinet maker to install suitable opening mechanisms (e.g. push-to-open hardware, handles, or integrated finger pulls) and adjust the doors to ensure they are fully functional and operate smoothly in accordance with manufacturer specifications and acceptable trade practice.

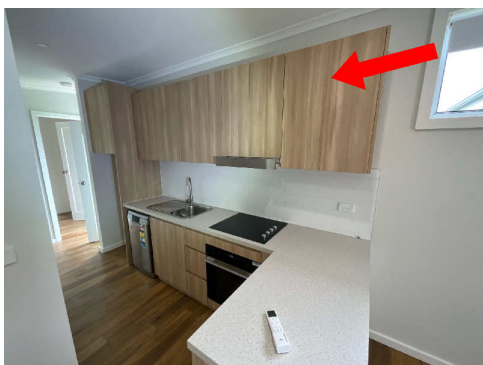
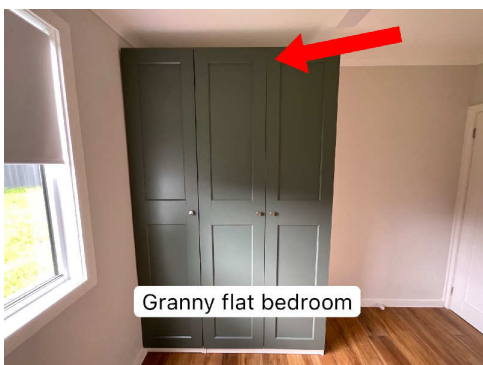
Finding 3.14

Binding and/or jamming of this door is evident during standard operation. This defect inhibits the functionality of the affected door as well as creating potential for secondary defects to associated building elements.

For minor causes, a qualified carpenter or general handyperson should be appointed to perform minor rectification works at client discretion.

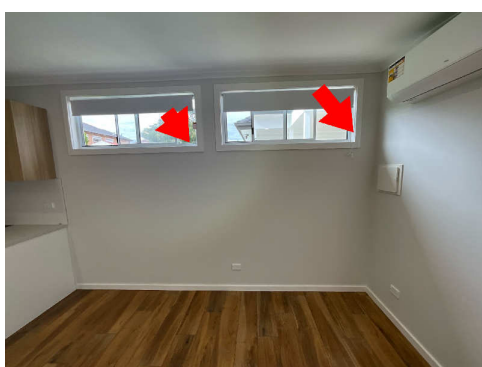
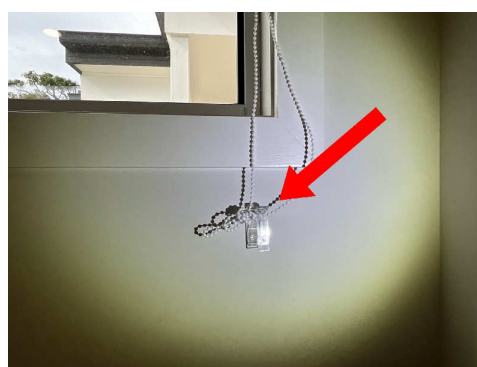
Finding 3.16

Building: Granny-Flat
 Location: Lounge Room
 Finding: Window Blind Safety Chain (Incomplete Fixing)

Information: The safety chain for the window blind has not been secured to the timber reveal. This represents incomplete installation and a potential safety hazard, as loose or unsecured blind cords/chains can pose a risk, particularly to young children.

The current condition does not comply with acceptable installation practice or safety requirements for corded internal window coverings.

The builder is to arrange for the blind installer to securely fix the safety chain tensioning device to the timber reveal (or adjacent structure) in accordance with manufacturer instructions and relevant safety requirements. The chain is to be tensioned and positioned to minimise slack and ensure safe operation.

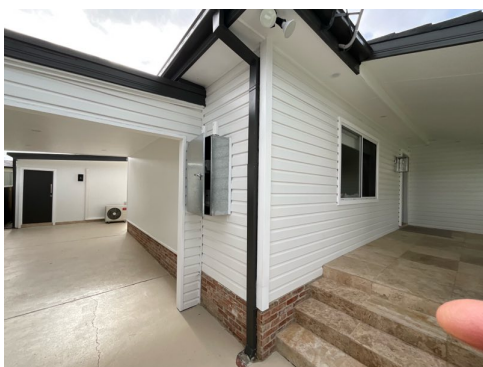
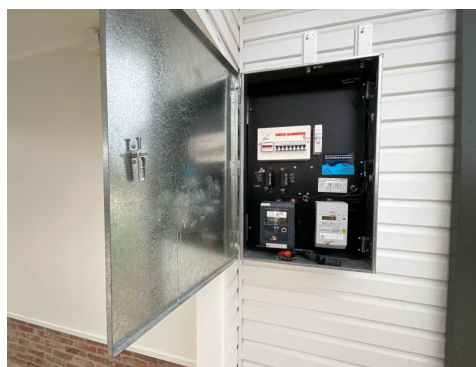
Information: The application of a post-construction chemical termite barrier is highly recommended for all properties, particularly if live termite activity has been found on the site previously. Such barriers are highly effective in preventing termite attack on any timber building elements throughout the property.

A durable notice should be placed in the switchboard unit to indicate current termite barriers. At the time of inspection, it appeared as though no termite management system has been installed, with no evidence to suggest preventative works taking place.

The client may consider gaining further advice from a pest controller as to the costs and procedures involved with this application. It is recommended that obtaining such advice be a short-term priority.

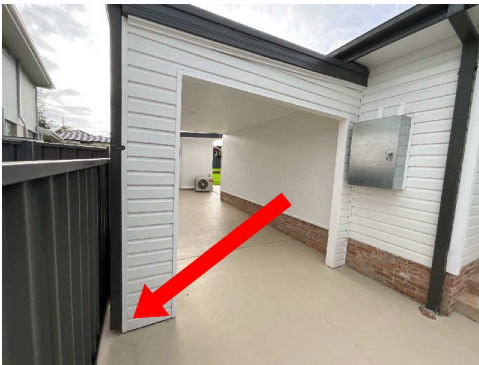
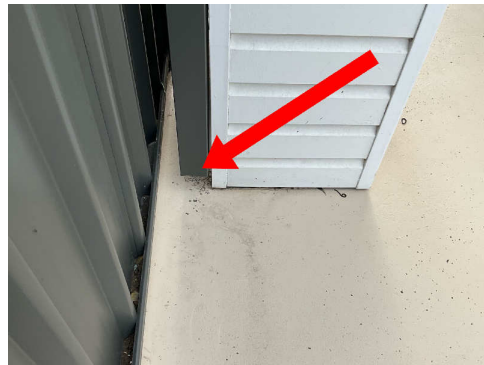
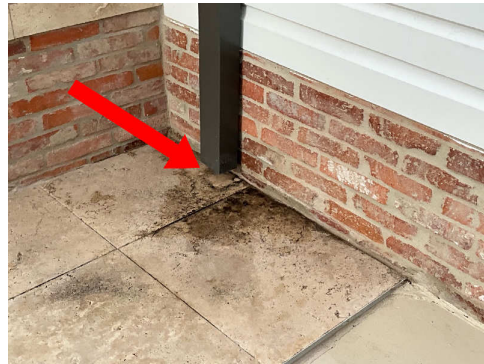
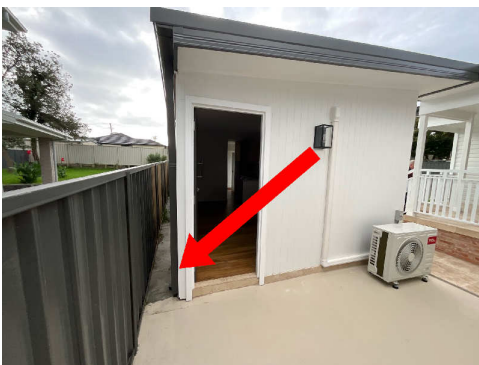
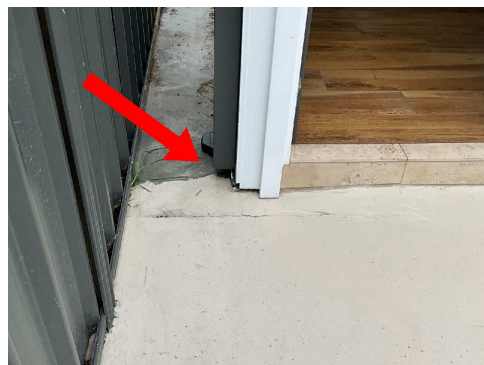
Finding 6.02

Where roof plumbing doesn't drain adequately, the area at the base perimeter can become excessively damp, potentially creating an environment that is susceptible to rust and corrosion of surrounding building elements, as well as attracting termites and other pests.

It is highly recommended that a plumber be appointed to further inspect the area and to install adequate drainage equipment where necessary.

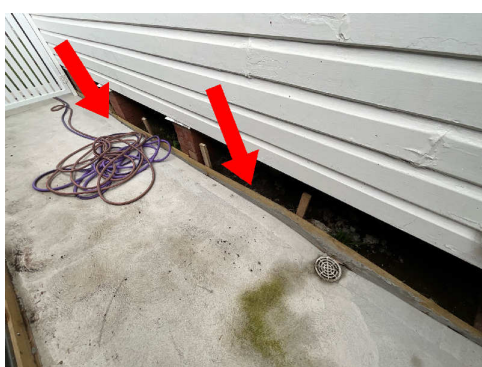
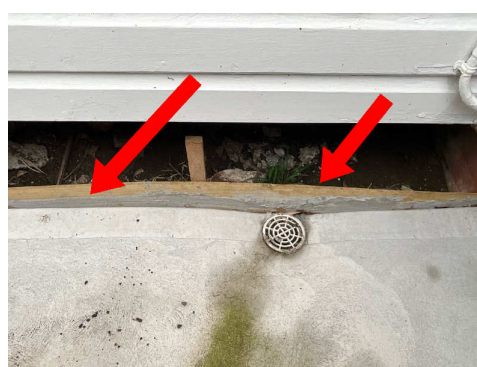
Finding 6.04

Finding: Formwork timbers - left in situ

Information: Formwork timber appears to have been left on site and in situ after concrete construction. Formwork timber is used to support and shape the concrete while pouring during the construction process. Leaving formwork timbers in the subfloor space or around the exterior of the property increases the risk of termite activity being present. As they are likely to come into contact with weather conditions or excessive moisture wood rot is likely to develop on timbers that are not treated. It is highly recommended that any formwork timbers be immediately removed from areas in which they may attract any termite/timber pest attack. Minimisation of risk/prevention of termite attack is far more adequate than dealing with the presence of termite activity.

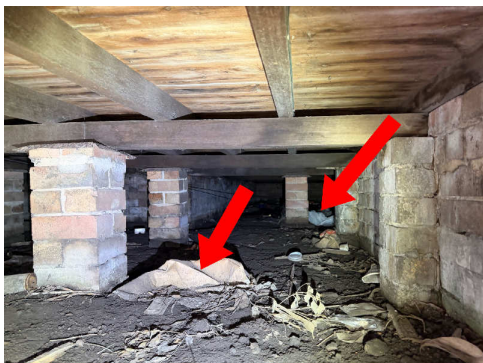
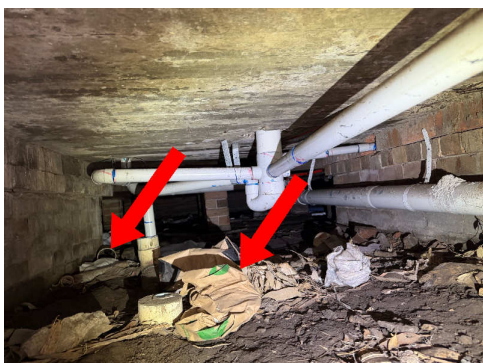
Finding 6.05

Information: An array of debris was found in the subfloor area at the time of inspection. Debris in this area restricts subfloor ventilation and creates potential for concealed pest entry. Stored timbers and other materials may also make the area susceptible to termite activity and wood rot.

A clear and empty subfloor will be better ventilated and easier to maintain in a dry condition. The removal of any timber debris is vital in minimising the risk of termite or wood borer activity.

Debris in the subfloor should be removed as soon as possible. Depending on the location and amount of debris and stored items, the homeowner may elect to undertake this task. Alternatively there are a large number of rubbish removal subcontractors that could undertake these works.
