## Building Inspection Report

Inspection Date: Thu, 19 Feb 2026

Property Address: 385 Station St, Box Hill South VIC 3128,  
Australia

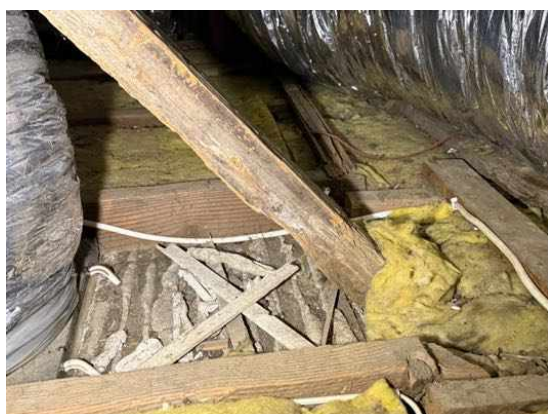
### Defects 3.01

Building:	Building 1
Location:	All Areas > All Areas
Finding:	Insulation - minor amount missing
Information:	Upon inspection of the roof void it was noted that some minor areas of the insulation was missing or removed. Insufficient insulation will result in a comparatively higher cost to heat and cool a property as there is a lack of Insulation (or uneven coverage of insulation) which works as a barrier to heat transfer. The roof insulation helps to keep

out unwanted heat in summer and preserves warmth inside your home in winter.

It can also help soundproof your home from unwanted airborne noise transfer. Installation of adequate insulation is required and should be conducted as soon as possible. Where insulation is absent, the area does not meet current Australian Standards.

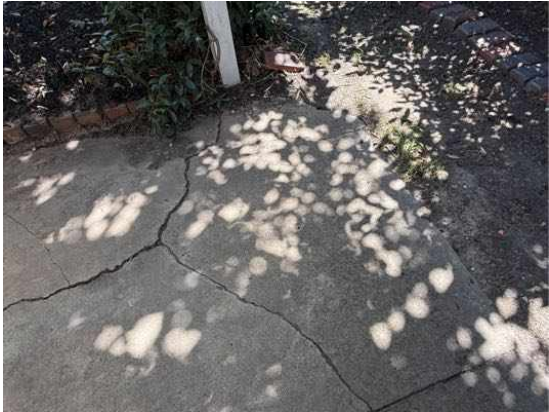
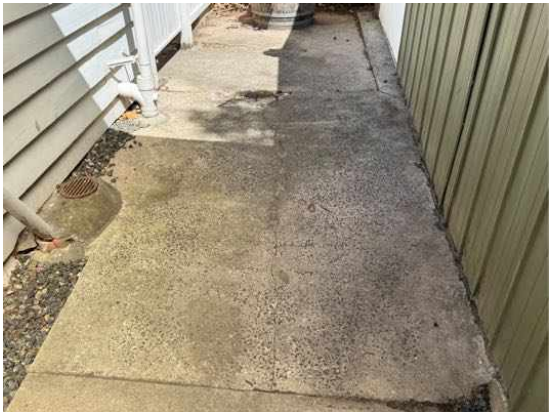
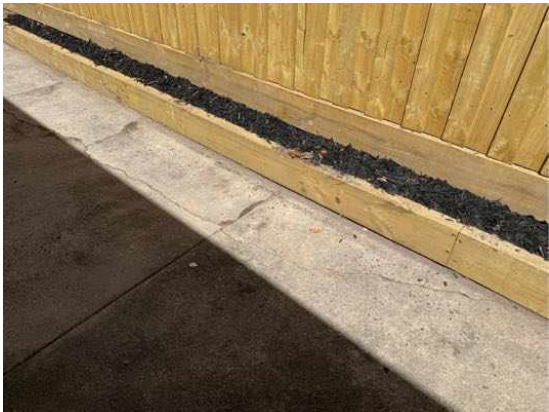
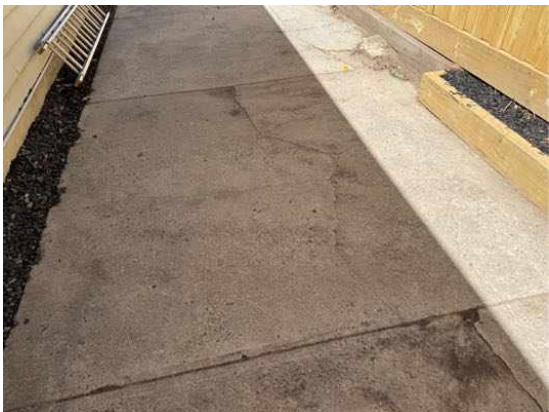
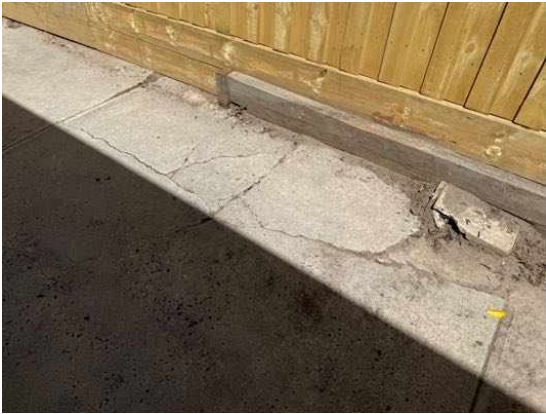
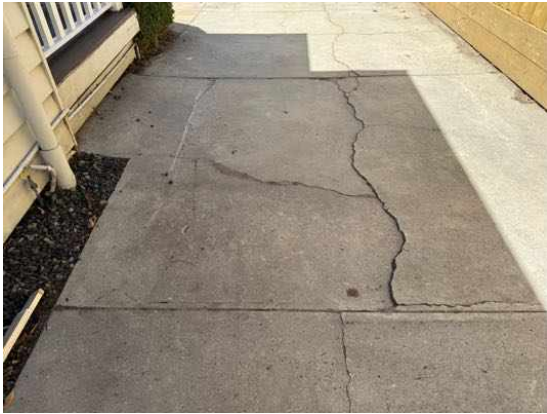
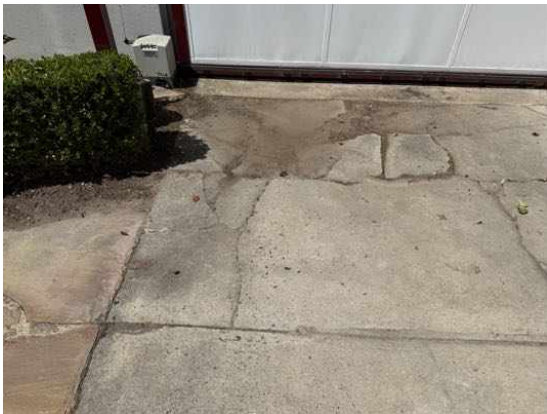
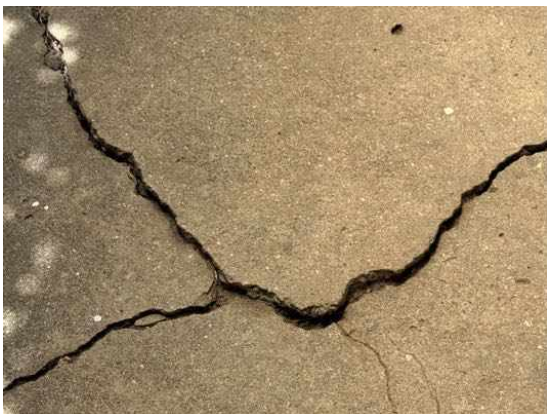
### Defects 3.02

Building:	Building 1
Location:	All Areas > All Areas
Finding:	Concrete driveway cracks
Information:	Numerous cracks on the driveway were observed at the time of the inspection. Also the rear pergola concrete showed concrete cracked and lifted, this area is considered to be a tripping hazard for occupants, especially young children and elderly. This area should be removed and re-instated to improve the overall appearance and aesthetics of the area.

Concrete cracks are a common occurrence as a result of many primary defects. Such causes may include age, general wear and tear, expected building movement, general expansion/contraction of building materials in different weather conditions, and/or minor failings in the installation or application of building materials. Monitoring of all cracking should be conducted periodically. Contact a relevant tradespersons,

especially where cracks have become trip hazards for occupants.

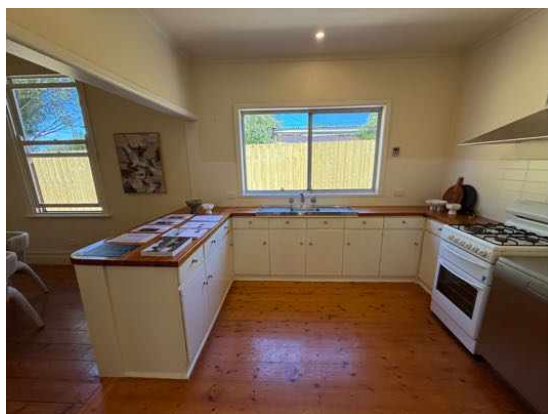
Defects 3.03

Building: Building 1  
Location: All Areas > All Areas  
Finding: Floor levels  
Information: The internal flooring throughout the home was observed to be showing signs of being out of level and uneven. At the time of the subfloor inspection it was observed that the home had been re-stumped with concrete stumps at some time. Uneven and out of level floors with a property of this age is considered in most cases to be normal however some areas were considered more than other areas. The uneven and out of level floors throughout the home is highly likely to indicate that at the time of the re-stumping of the home the stumps appeared to have been replaced at the original height and not has not been overly leveled. This could be due to the extensive plaster cracks that would have resulted in leveling the home.

Floor levels can have complex and varying causes, which will influence the required remedial works the client may wish to take. If client wishes to rectify these areas it is advised to begin by consulting a registered builder who has expertise in re-stumping to determine the required scope of works that may be deemed necessary. This may include some packing of stumps to some areas. Client may also consider consultation with a geotechnical engineer to understand what and how the surrounding soil is reacting to surrounding moisture.

A Registered Builder would generally carry out these types of works or can be guided and advised by an geotechnical or structural engineer where deemed to be required. The floors can be also monitored to identify any further movement even after floor have been rectified. Where flooring is uneven further, a potentially invasive inspection of the subfloor stumps and floor structures is required. If remedial work is carried out on the floors, it is likely that in some areas the floors would require the floors areas to be removed due to the close proximity to the ground.

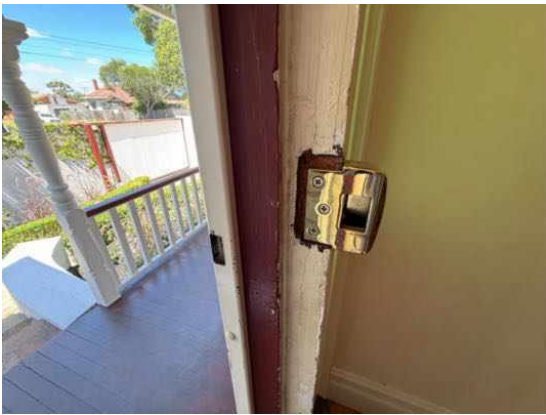
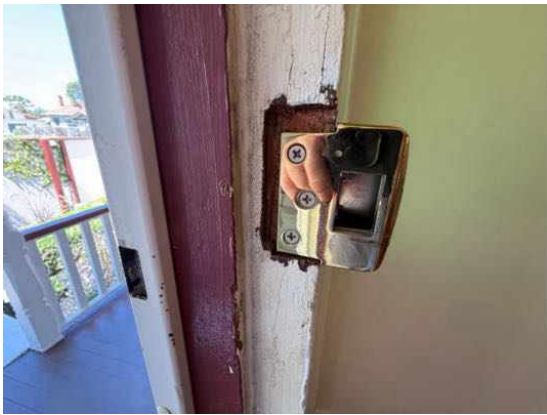
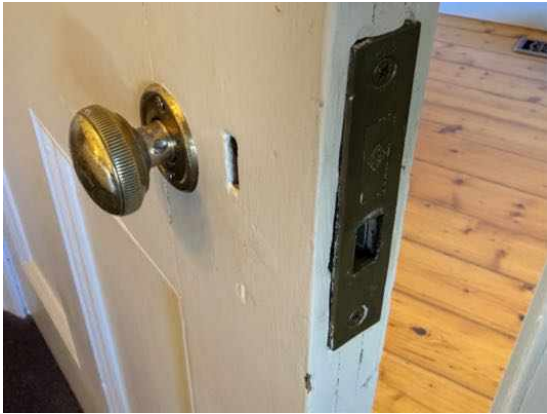
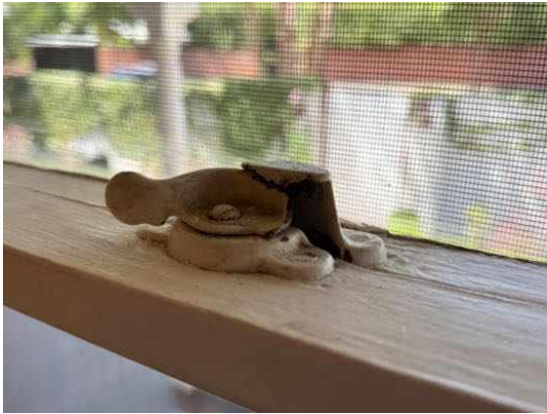
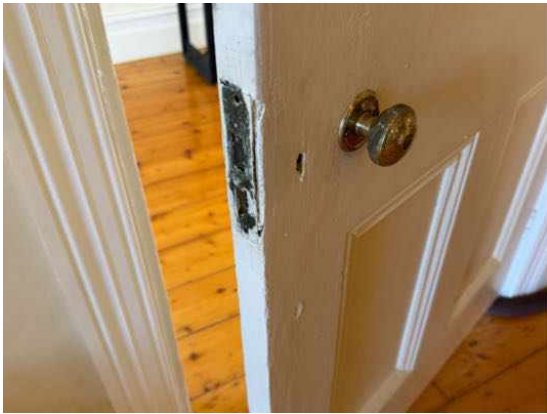
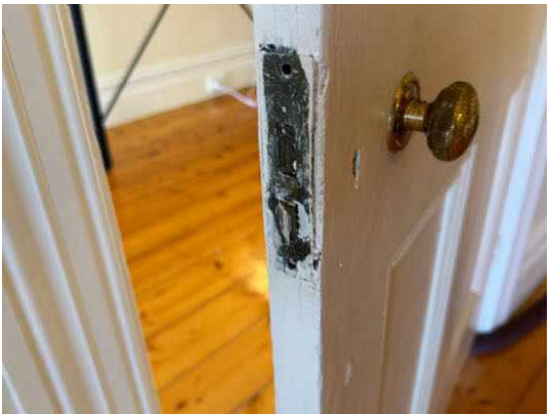
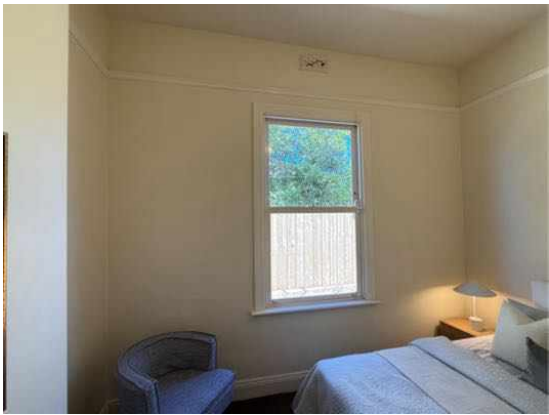
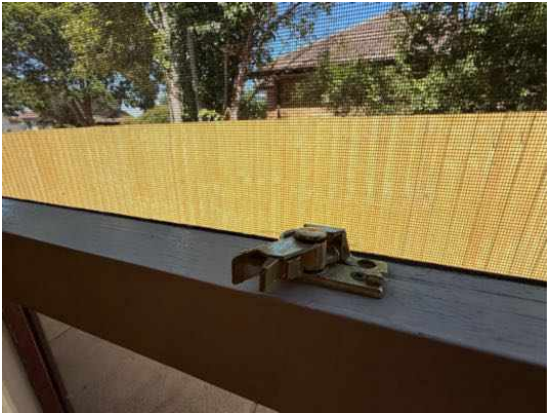
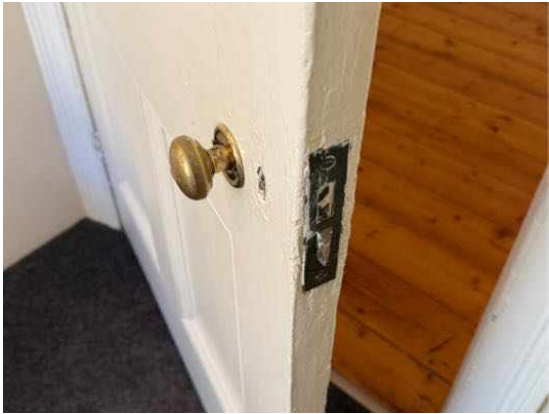
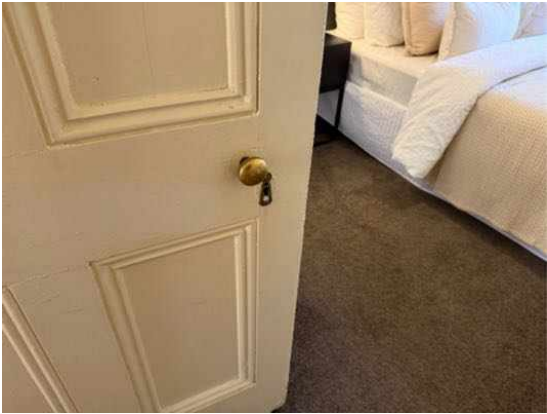
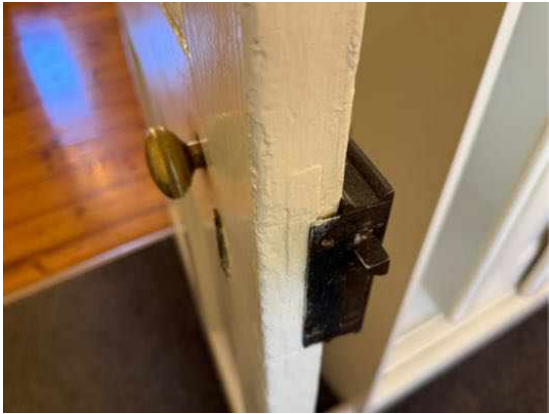
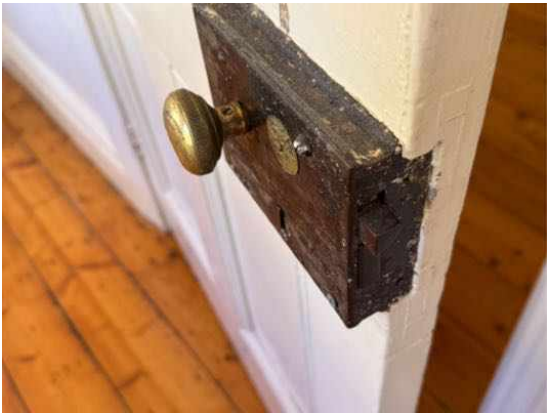
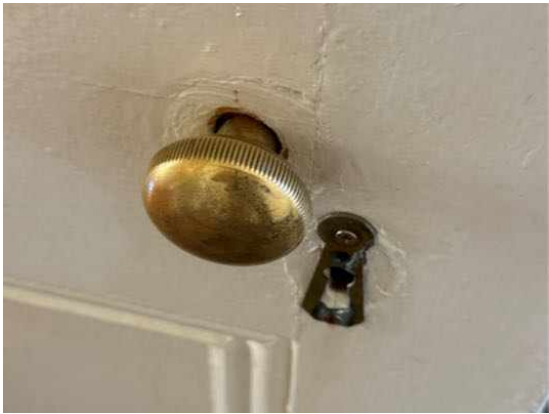
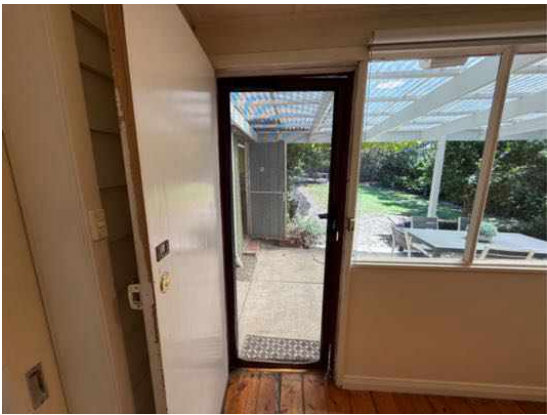
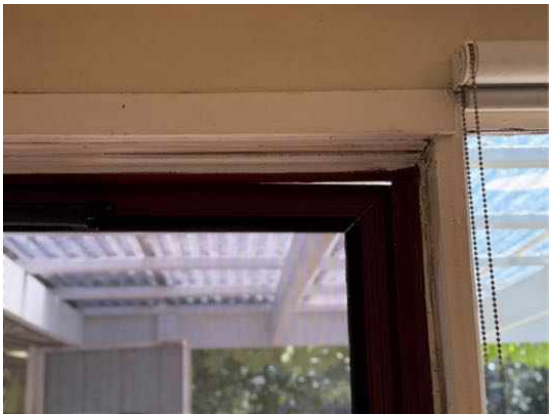
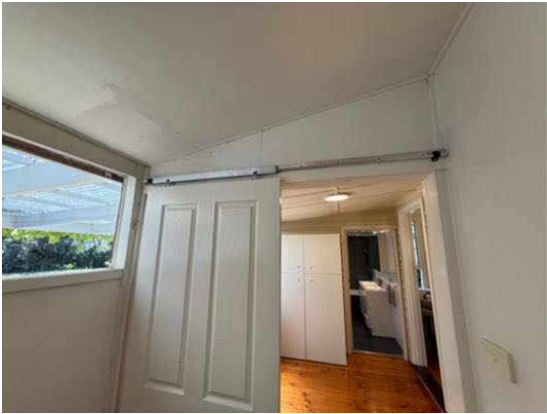
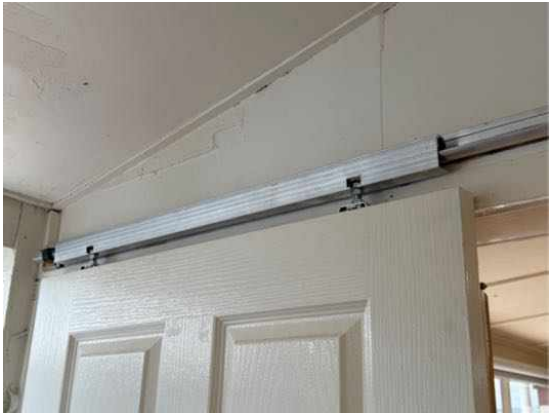
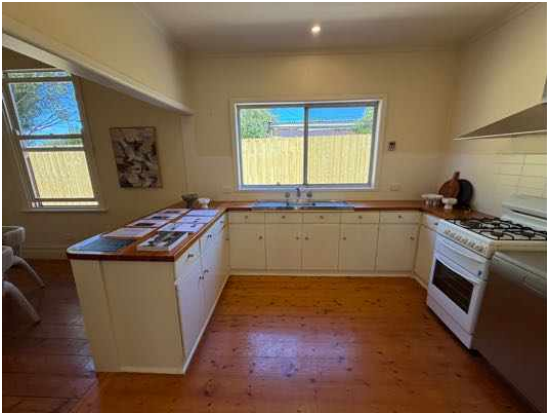
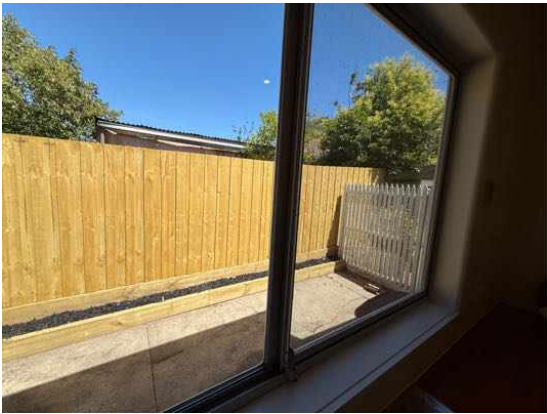
### Defects 3.04

Building:	Building 1
Location:	All Areas > All Areas
Finding:	Door handles and latches - door and window security
Information:	It was observed that doors still had the original door hardware, this door hardware has exceeded its useful life and is now considered to be a hazard for occupants. Numerous door handles and latches are not working as intended and in time occupants are highly likely to be stuck in a room unable to exit. The sliding doors throughout the home were also missing head pelmets and may also benefit by being renewed. Some handles and or door latches were observed to be sticking and handles spinning during normal operation.

Whilst detracting from the functionality of this building element, this minor defect may also be a safety hazard to all occupants, and may therefore have serious implications if occupants were not able to egress at the time of an emergency. It is suspected that this defect has occurred due to minor issues after painting, poor installation and or through general wear and tear, which is expected for building elements of this age. A qualified carpenter may be appointed to perform rectification works as necessary. If left unattended, further functional impairment is likely to occur.

Front exterior door and window security :- Numerous exterior doors and windows throughout the property were observed to require some maintenance. The exterior doors and windows may require new locks and other hardware to ensure the home has adequate security. Some door handles and keepers were observed to be poorly fitting. The exterior window locks were also considered to be an aged design and may not be providing adequate protection and security for occupants.

These remedial works will ensure that they offer adequate security and they operate correctly during standard operation. Doors and window hardware defects may inhibit the egress from the rooms and make it difficult for younger and other occupants to safely egress the interior areas if left unmanaged. The functionality of affected doors and windows may also be creating secondary defects to associated building elements, such as damage to the associated frames. Such defects may have several causes, ranging from, deteriorated door and window hardware or poor installation. A qualified carpenter should be appointed to perform remedial, rectification works to these doors and windows.

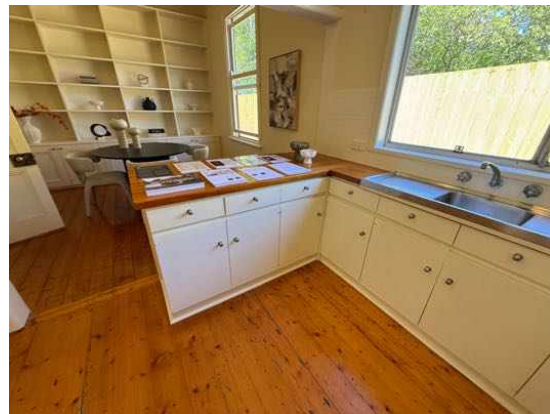
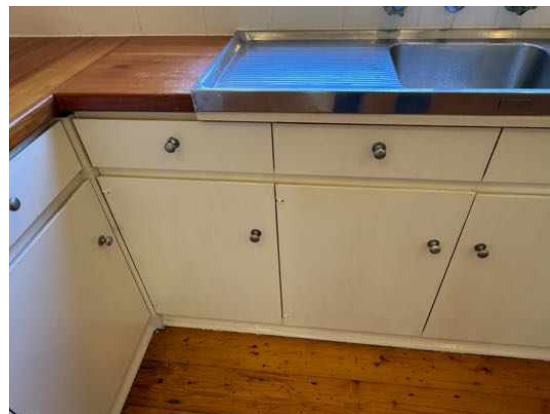
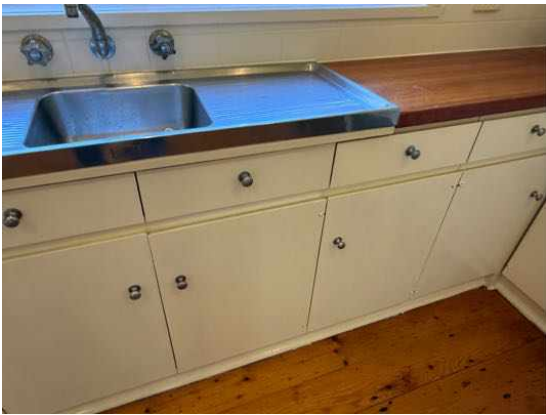
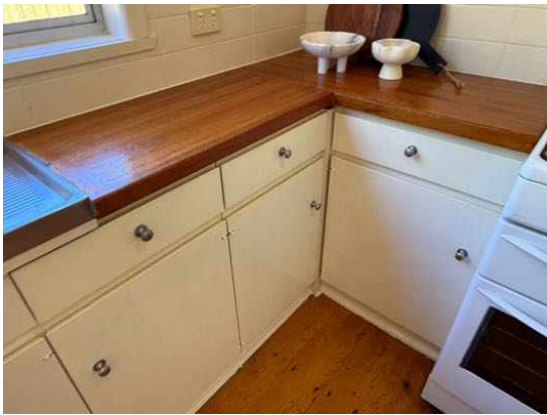
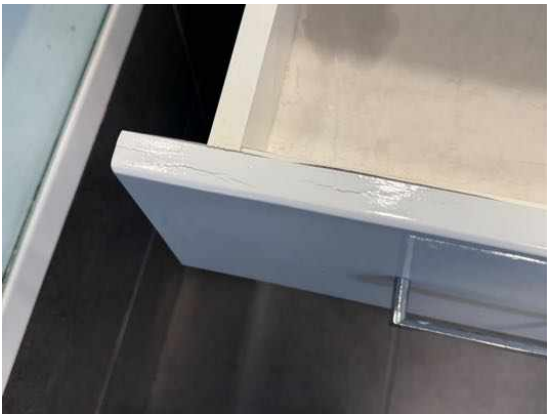
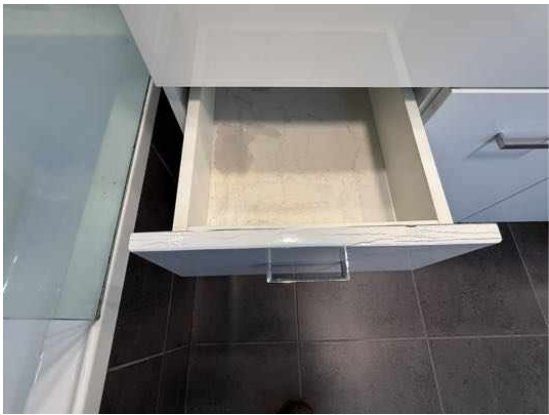
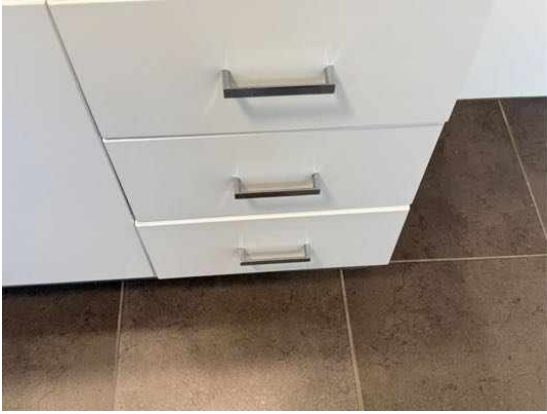
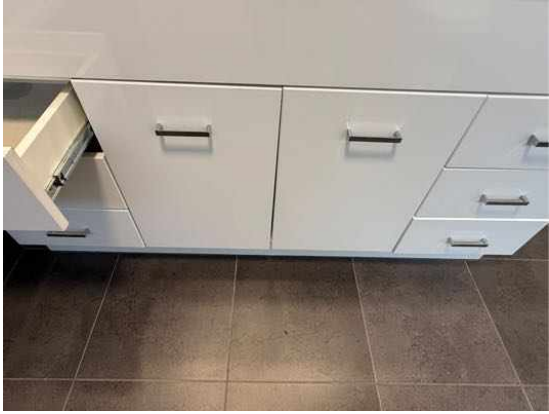
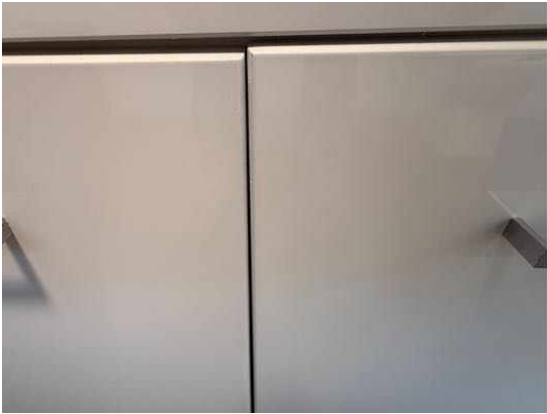
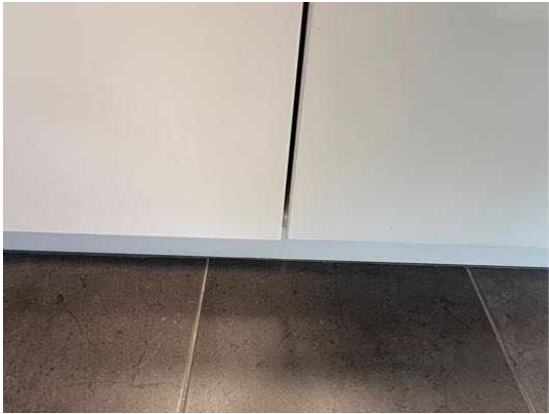
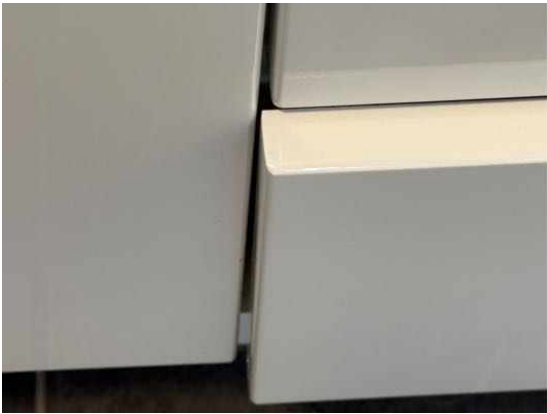
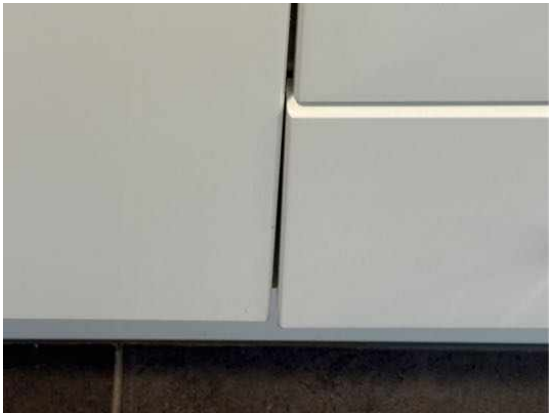
Defects 3.05

Building: Building 1  
Location: All Areas > All Areas  
Finding: Kitchen and bathroom cabinets  
Information: The kitchen and bathrooms cabinet doors showed that they were aged and deteriorated and signs of lack of maintenance over many years to the doors, drawers and cabinet carcasses. Many areas were observed to have some wear and may require some maintenance, remedial work or renewal to ensure further deterioration does not continue further. Although these defects may detract from the overall looks of the cabinetry, in most cases it does not necessarily affect the operational state of the cabinetry.

To improve the operation of these affected cabinets, cabinet doors or drawers, a qualified cabinet maker or carpenter may be appointed to renew, rejuvenate rectify or repair any cabinetry as deemed to be necessary. Such works should be completed at discretion of the client.

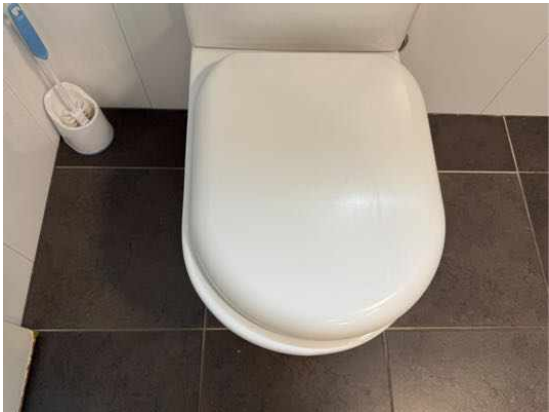
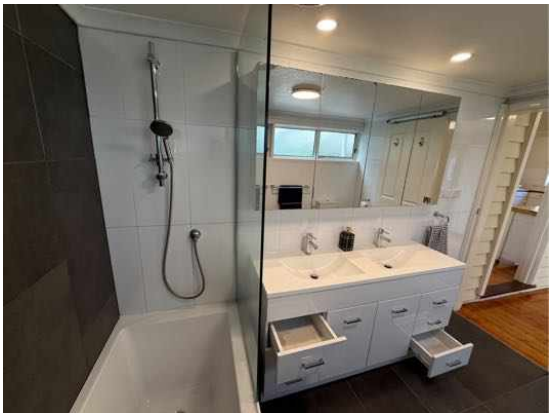
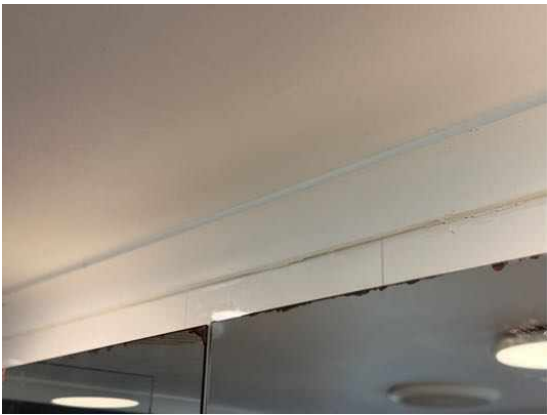
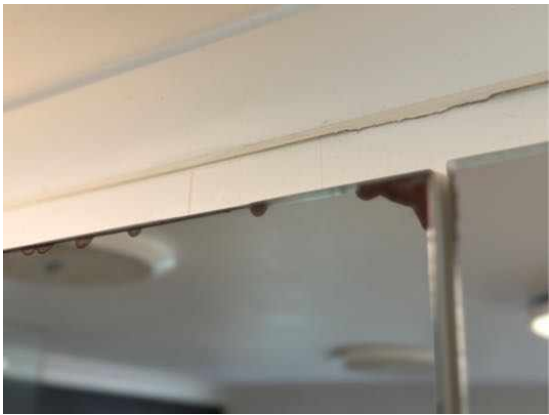
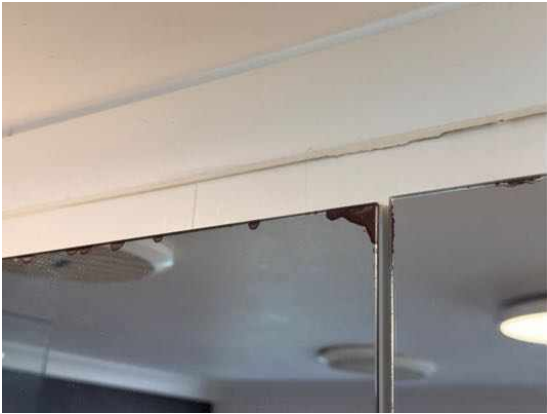
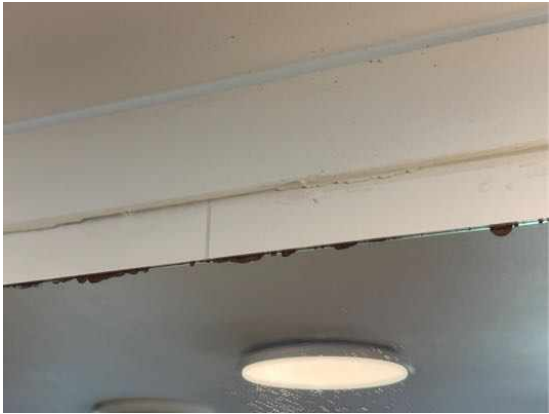
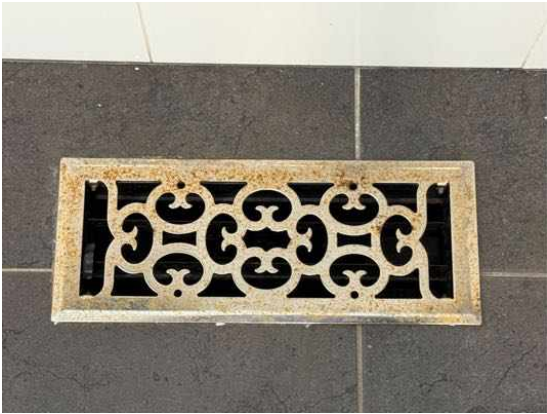
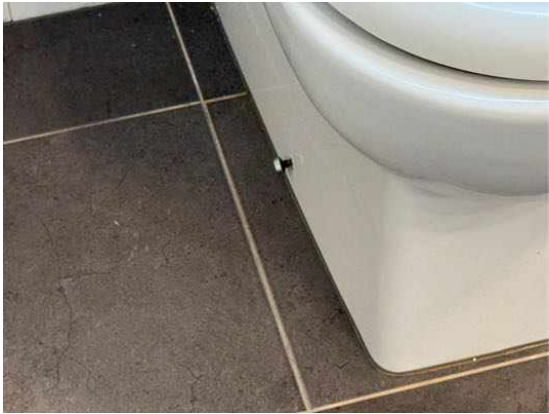
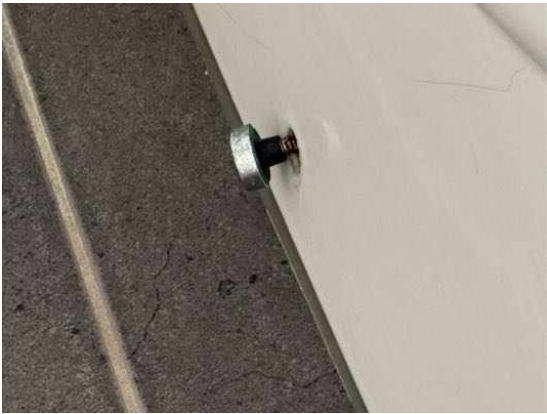
Defects 3.06

Building: Building 1  
Location: Bathroom > All Areas  
Finding: Toilet roll holders and towel rail - Loose  
Information: The toilet roll holders and towel rail were found to be loose at the time of inspection. While not a major operational defect, function can deteriorate if the problem is left unmanaged. It is recommended that some remedial works to rectify the loose toilet roll holders and towel rails to its original fixing. If these cannot be rectified to function as intended, client is recommended to renew. A qualified carpenter may be required to perform these works.

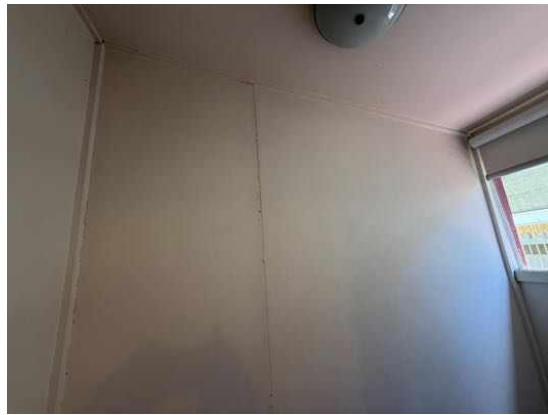
Building: Building 1  
Location: All Areas > All Areas  
Finding: Asbestos - Suspected ACM  
Information: Reporting on Asbestos is outside the Scope of this Report. This suspected defect is highlighted as a caution only. We suspect, based on our experience in the building industry, that there is a higher risk of the identified building element containing asbestos. As Asbestos Reporting is outside the scope of this report, we advise that you consider a separate Asbestos Inspection which can include the taking of samples for definitive confirmation of the presence of Asbestos when tested by a laboratory.

Asbestos sampling can only be taken upon ownership of the property only, due to being an invasive procedure. In the interim, the client is advised to act with caution, especially when considering any damage to building materials general wear and tear, renovations, extensions, demolition and general maintenance activities due to the suspected presence of Asbestos.

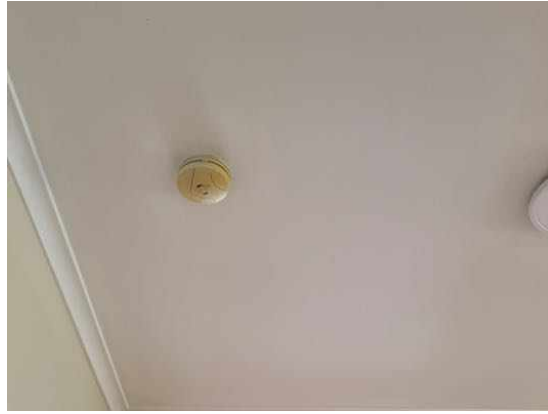
Building: Building 1  
 Location: All Areas > All Areas  
 Finding: Smoke detectors and alarms  
 Information: Reporting on Smoke Detectors or Alarms, including hard wired smoke detection systems and their legislative requirements, is outside the Scope of this Report. Please note that this defect is highlighted as a caution only. We suspect, based on our experience in the building industry, that smoke detectors are sometimes get overlooked, or they may be in a poor condition, so we recommend that they always should be addressed prior to occupation to improve occupant safety.

Always ensure sufficient working and suitable smoke detectors are installed prior and during to occupying any building. Additionally, it is advised that all smoke detectors be tested by the homeowner on a monthly basis.

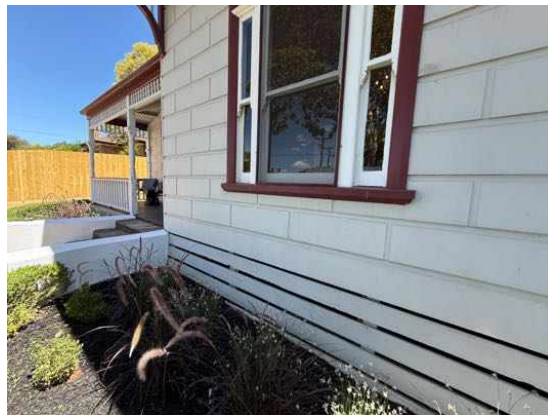
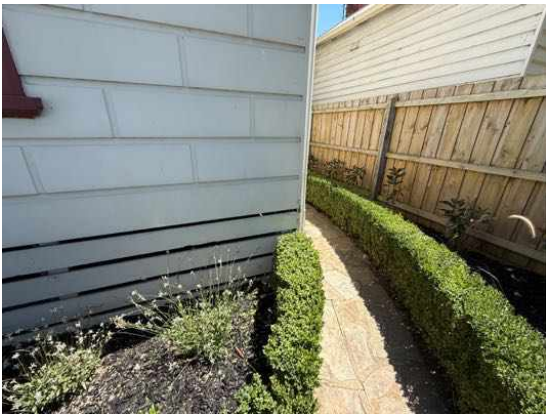
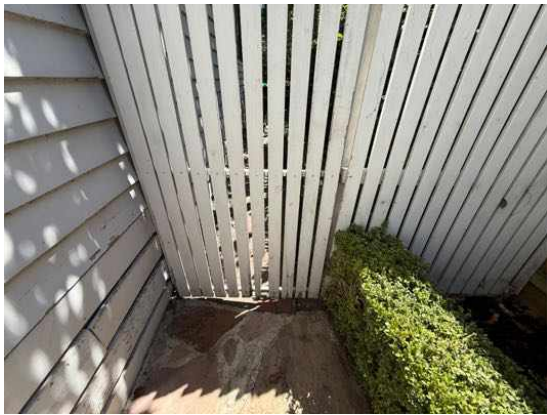
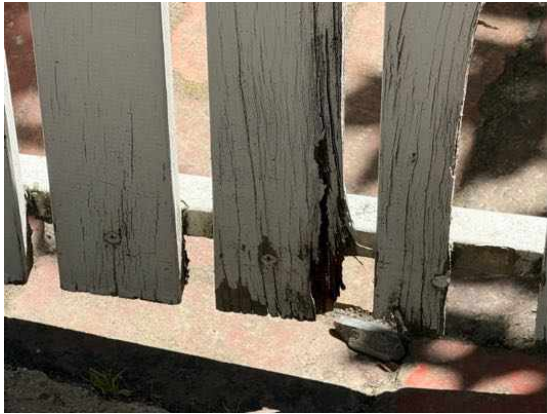
Building:	Building 1
Location:	All Areas > All Areas
Finding:	Timber in the ground and exposed to excessive weather conditions
Information:	External timbers in the ground and are frequently exposed to harsh and extreme weather conditions, will require adequate protection and maintenance in order to maintain their condition. Other timbers are exposed to moisture from ground contact which exposes these areas to accelerated wood rot and decay, damage and deterioration. Where timbers have not been painted properly or treated adequately, general deterioration is likely to occur at an accelerated rate.

If left unattended, replacement of these timbers is likely to be necessary in the future. Adequate treatment of these timbers is required to ensure excessive weathering does not occur, painting of these areas may be carried out by the client or by a painting contractor or general handyman.

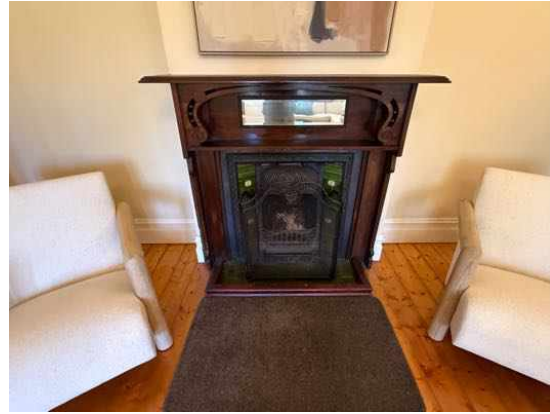
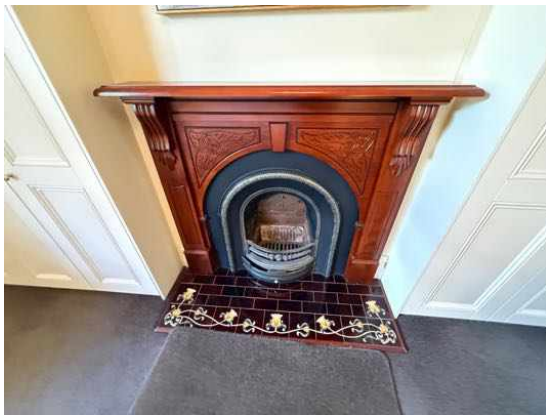
Building: Building 1  
 Location: All Areas > All Areas  
 Finding: Fireplace and chimney sweep  
 Information: Reporting on the fireplace and or the associated chimneys, including as to whether they are working or not and their legislative requirements, is outside the Scope of this Report. Please note that this is highlighted as a caution only. It is highly recommended the fireplaces and associated chimneys get checked periodically and even before use when they may not have been used in a while. If left unmaintained and not cleaned adequately a fireplace and chimneys may be or become a fire hazard.

We suspect, based on our experience in the building industry, that fireplaces and the

associated chimneys get over looked and do not get chimney swept or any maintenance for long periods of time. The chimney may therefore be in a poor condition, so we recommend that they always ensure that these areas be addressed prior to their use, this is to ensure home and occupant safety.

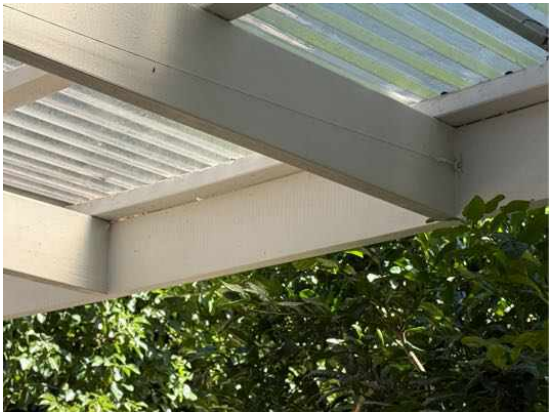
Building: Building 1  
 Location: All Areas > All Areas  
 Finding: Building elements missing  
 Information: Bolts and rafter brackets were observed to have been omitted or missing at the time of the inspection. The rear pergola areas have no bolts to the posts to perimeter beams and rafters brackets to beam missing, these types of building elements are an essential part of the building structure and will improve the longevity of the building structure as it becomes aged and deteriorated. Although some building elements may seem irrelevant or unnecessary, all building elements play a key role in the operation and function of the overall structure and its performance.

All cleaning, maintenance or replacement of any missing building elements should be conducted as soon as possible to ensure that no secondary damage or functional issues occur to associated building elements or materials not being installed. A qualified carpenter, builder or another appropriate tradesperson should be appointed to clean, maintain or replace the missing building elements or materials deemed necessary.
