Building and Timber Pest Inspection Report

Inspection Date: Tue, 31 Mar 2026

Property Address: 67 William St, Laidley QLD 4341, Australia

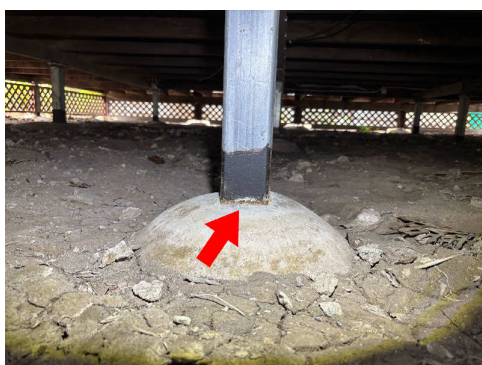
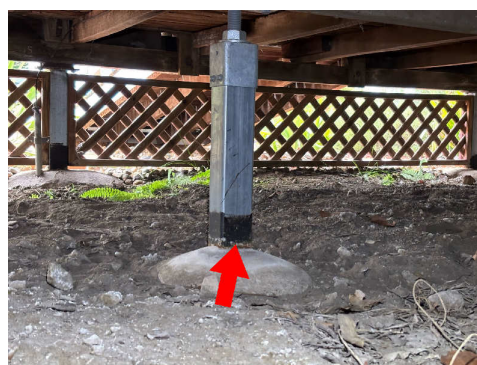
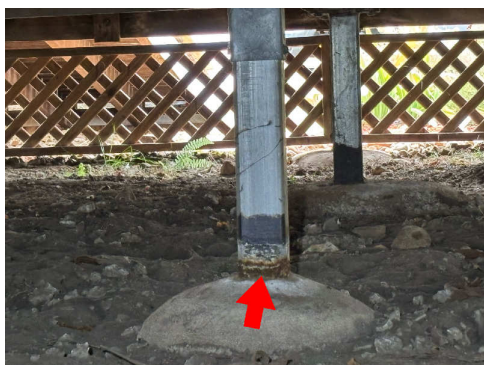
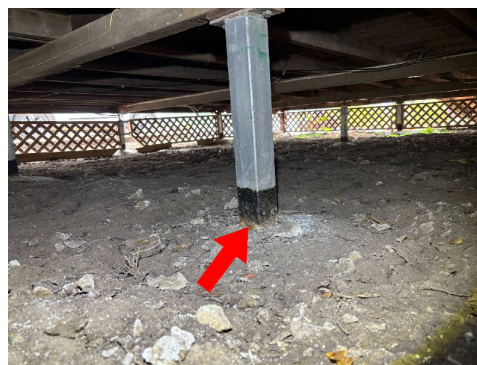
Finding 3.01

Finding: Evidence of surface rust - steel posts in subfloor area

Information: At the time of the inspection, it was noted that there was evidence of surface rust to several steel posts in the subfloor area.

The affected steel posts should be treated and coated to avoid the surface rust from progressing.

A building maintenance professional should be engaged to carry out this preventative maintenance to the steel posts in the subfloor area. This should be done as a short term priority.

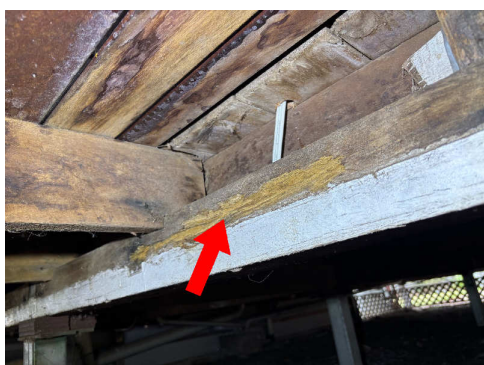
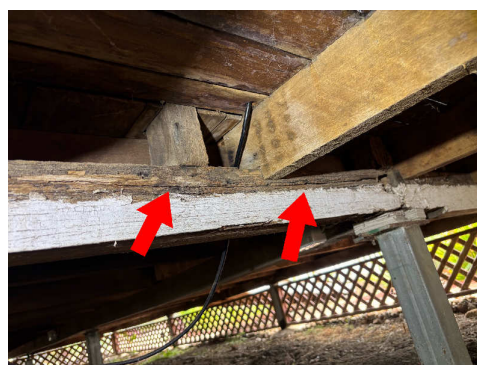
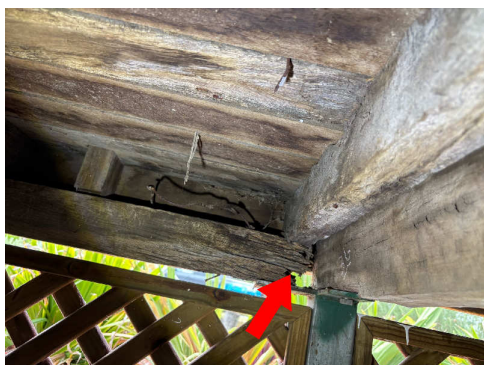
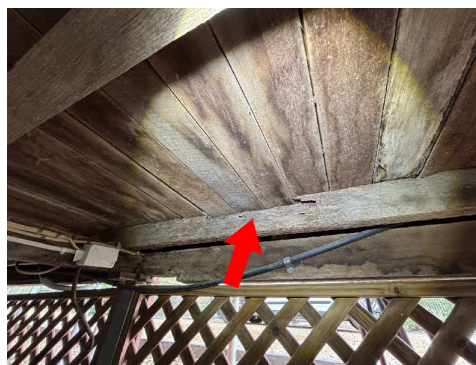
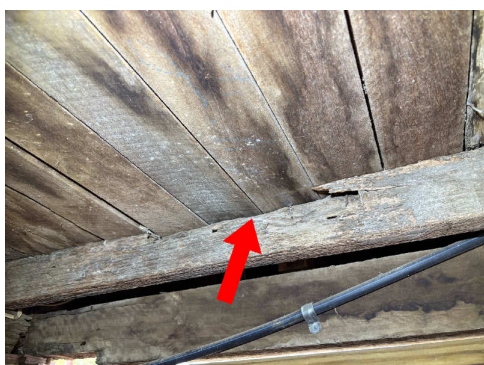
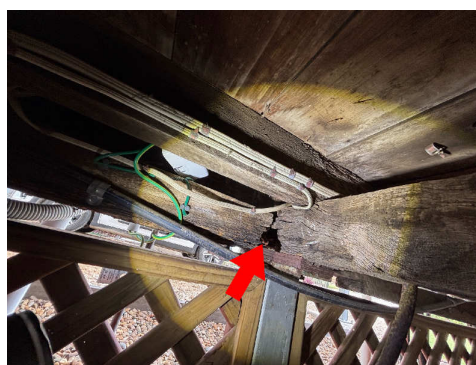
Finding 3.02

Finding: Subfloor - deteriorated bearers

Information: At the time of the inspection, it was noted that several timber bearers in the subfloor area have deteriorated due to fungal decay/wood rot.

Moisture does not appear to be affecting these timbers currently and they still retain some bearing capacity. However it is recommended that additional timbers be added to the affected areas. This is best practise to insure that these timber bearers do not fail which would be a structural defect.

A licensed carpenter should be engaged to add the additional timbers to the affected bearers. This should be done as a short term priority.

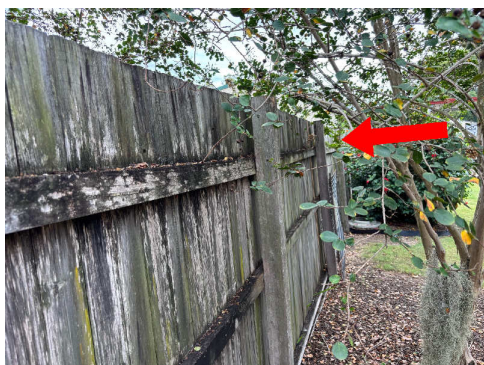
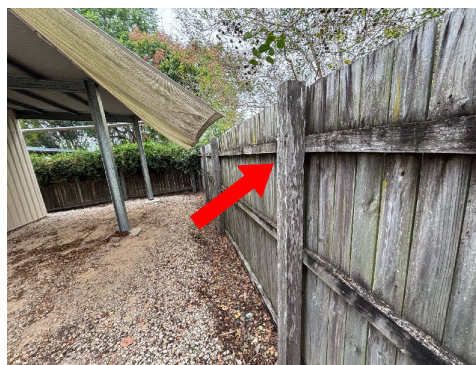
Finding 3.03

Finding: Boundary fence - deteriorating

Information: At the time of the inspection, it was noted that the timber boundary fence on the right hand of the property was deteriorating.

The timber fence is leaning towards the neighbours yard and there is some movement to sections of it when pressure is applied to it.

A fencing contractor should be engaged to assess the fences and provide a solution to rectify this issue. This can be done at the clients discretion.

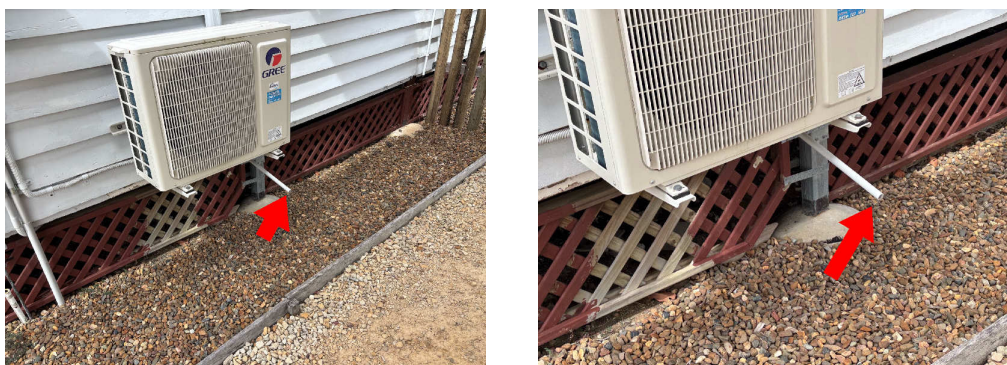
Finding 6.01

Finding: Air conditioner - Disconnected overflow

Information: At the time of the inspection, it was noted that the air conditioner drain overflow to the unit on the right hand side of the dwelling was not connected to the storm water drainage and as a result are draining next to the foundations of the dwelling.

Air conditioning overflows that are not connected to the storm water drainage and are draining near the foundation can create excessive moisture in the surrounding area.

Such leaking creates an environment which is conducive to an array of defects, including water damage to associated building elements and the attraction of termite or timber pest infestation.

It is highly recommended that a licensed plumber be appointed to connect the A/C overflow in order to prevent such an environment from being created. These minor works should be carried out as soon as possible.

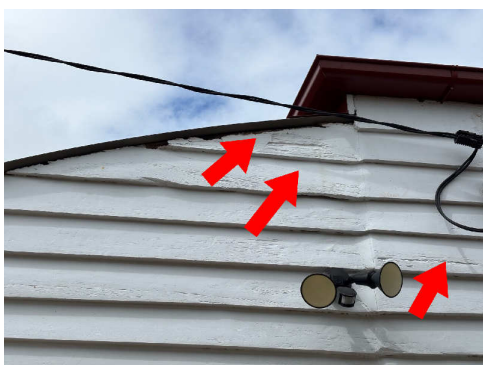
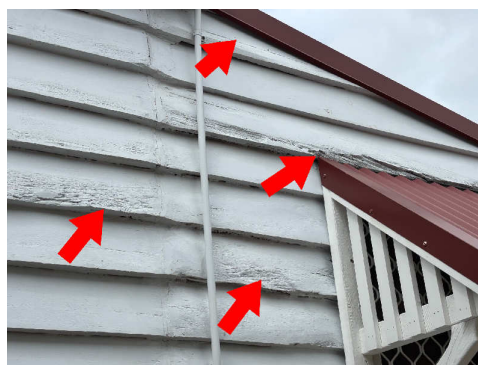
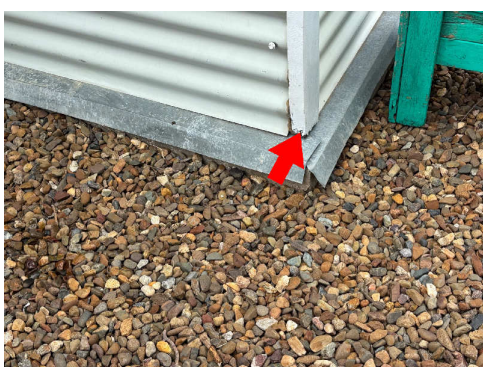
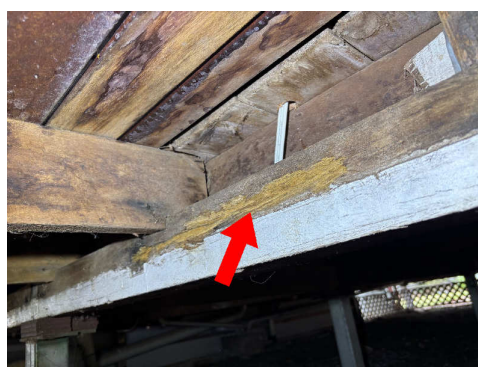
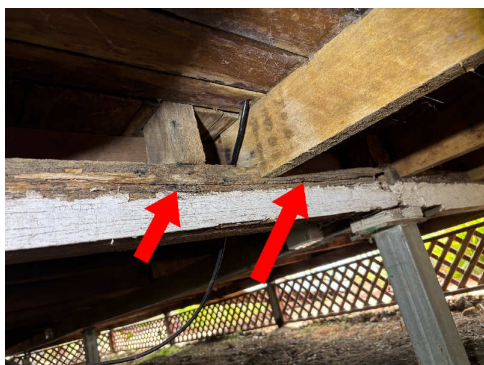
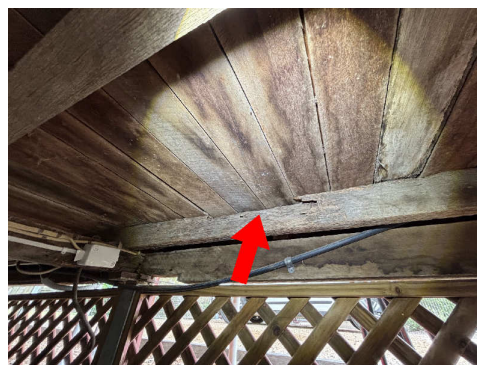
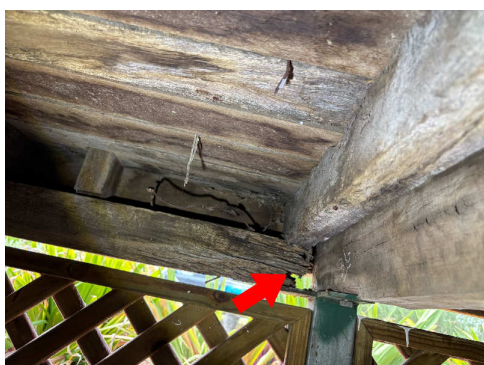
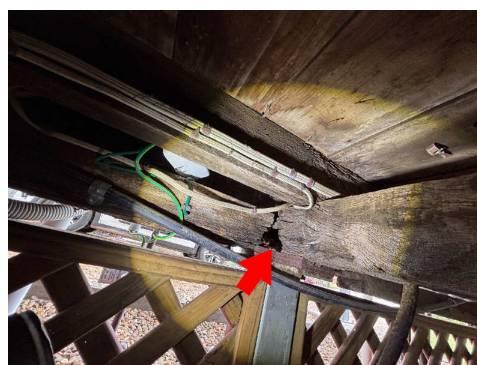
Finding 7.01

Finding: Wood rot

Information: At the time of the inspection, it was noted that there were examples of wood rot to timber building elements found around the dwelling. Examples were found to weather boards, timber mouldings on the exterior and timber bearers in the subfloor area. This may be due to the age of the timber building elements and general weathering.

This building element shows evidence of wood rot.

Wood rot, also known as Fungal Decay, occurs when timbers and other cellulose building materials are exposed to damp conditions on an ongoing basis.

Early intervention and regular maintenance, particularly of exterior timbers, will prolong the useful life of these building elements. Prior to any works being performed, the cause of the moisture that has created the visible wood rot should be identified and addressed in a suitable manner. Replacement of affected timbers may then be a necessary step in protecting surrounding building elements from such deterioration.

A qualified carpenter or registered builder may also be required to replace affected building materials.

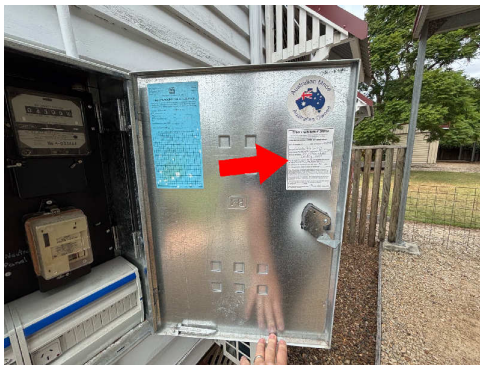
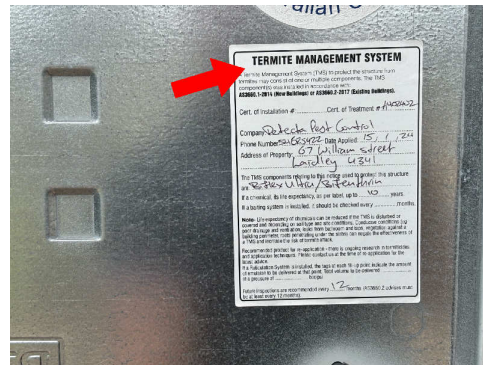
Finding 9.01

Finding: Evidence of a current chemical termite management system was identified.

At the time of the inspection, evidence of a current chemical termite management system was found by way of a durable notice in the electricity meter box.

A chemical soil treatment was carried out to the perimeter of the dwelling on the 15/01/2024 with an expected life span of 10 years in ideal conditions. This chemical treatment requires annual termite inspections. It is recommended that the client continue to use the company responsible for this installation to carry out the annual termite inspections.

The client should have annual termite inspections carried out as per AS 3660.2 to help protect the dwelling. Annual termite inspections should be carried out in partnership with any termite treatment system, chemical or physical, as no termite treatment system can be expected to be 100% effective.

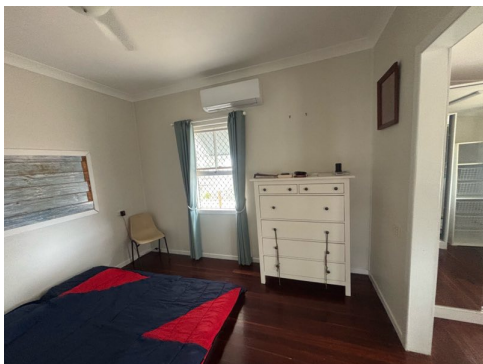
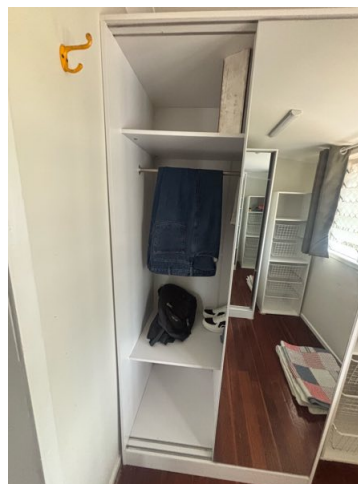
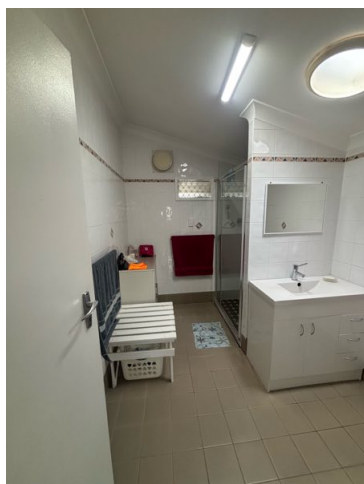
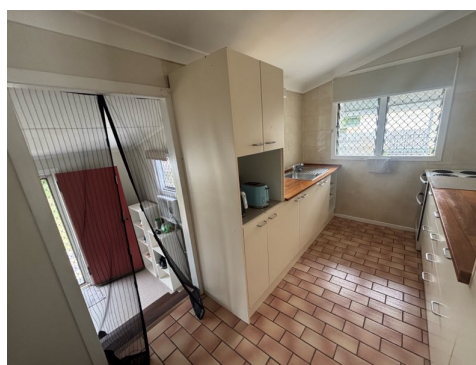
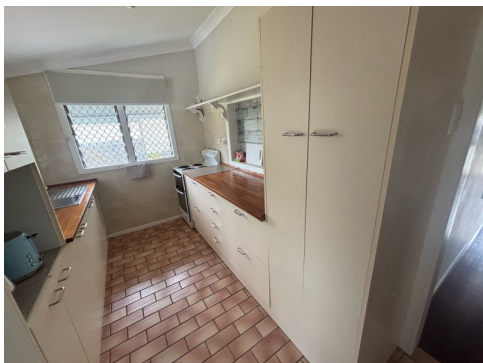
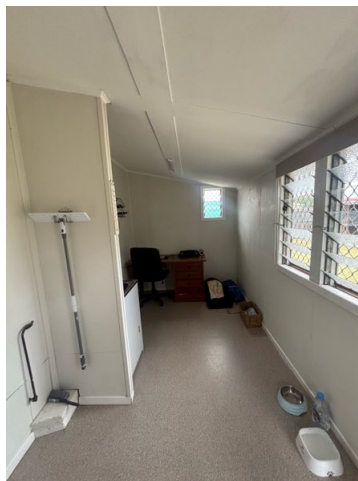
Finding: Obstructions and Limitations - Internal areas

Information: These photographs are an indication of the obstructions and limitations which impeded full inspection of the property of the internal areas at the time of inspection. These obstructions can hide an array of defects and should be removed to allow full inspection to be carried out. A re-inspection is recommended once the areas are made accessible.

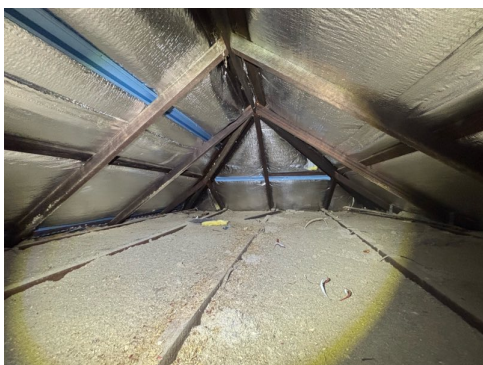
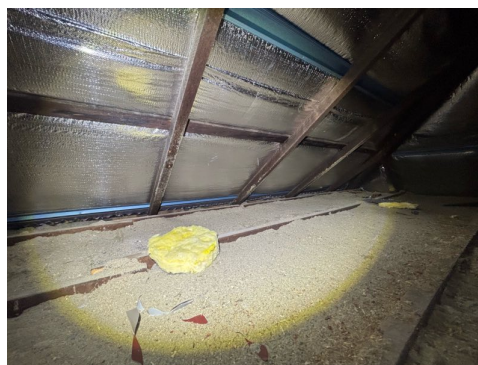
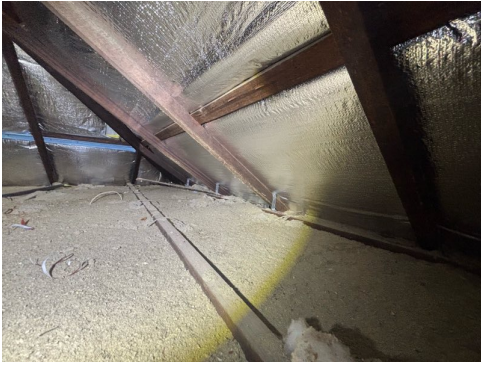
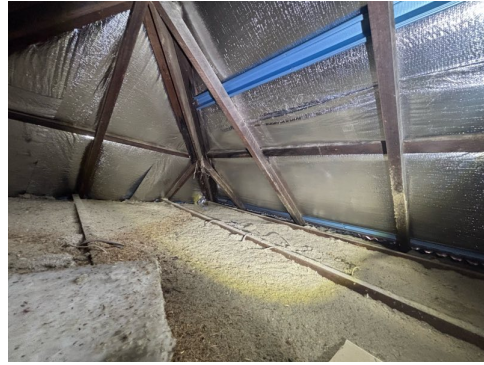
Finding: Obstructions and Limitations - Roof cavity

Information: These photographs are an indication of the obstructions and limitations which impeded full inspection of the property of the roof cavity at the time of inspection. These obstructions can hide an array of defects and should be removed to allow full inspection to be carried out. A re-inspection is recommended once the areas are made accessible.
