Building and Timber Pest Inspection Report

Inspection Date: Thu, 5 Feb 2026

Property Address: 36 Sheehan Cres, Shepparton VIC 3630,
Australia

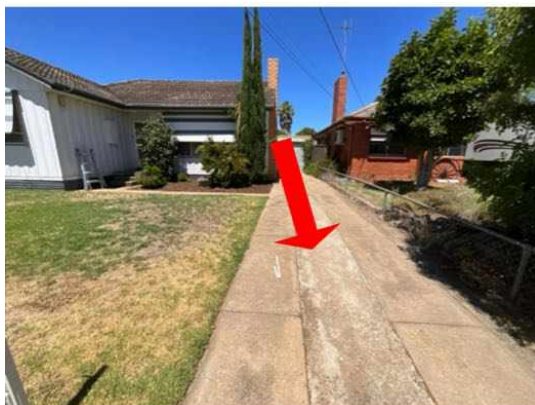
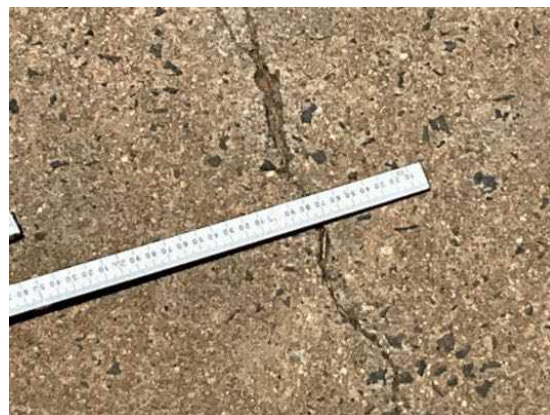
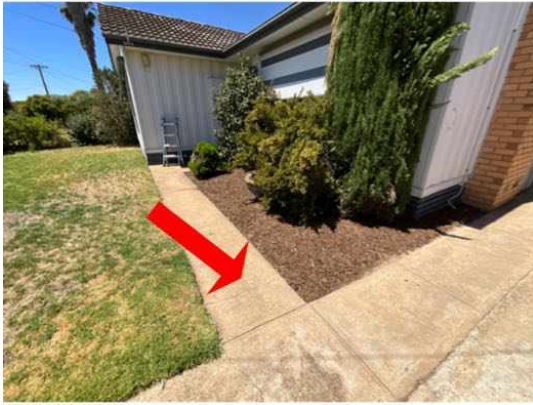
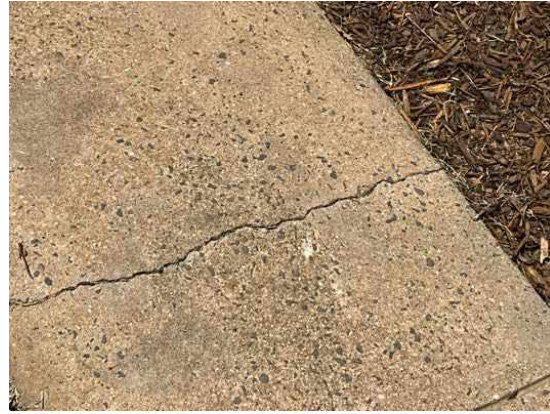
Finding 3.01

Building:	Building 1
Location:	Driveway area
Finding:	Cracking - External Concrete Paving Damage Category 1 - Fine (less than 2mm)
Information:	Fine cracks were identified in external concrete paving. Although fine cracks are quite noticeable, they are often only considered to be an appearance defect, and usually do not indicate any structural damage. To be considered a Category 1 or fine crack, the crack is found to be less than 2mm in width.

Generally the cause of a hairline crack in existing concrete paving such as driveways and pathways is indicative of the expansion and contraction of the concrete. Such causes are generally due to environmental factors, such as moisture levels, weather conditions, root systems of nearby trees or the soil types on which they are laid.

Fine cracks may also be due to poor original installation of the concrete. Factors such as poor compaction of the sub surface and/or inadequate reinforcing of the slab may create cracking and other secondary defects.

Monitoring of all cracking should be conducted frequently. Always contact a building inspector should cracks widen, lengthen, or become more numerous.

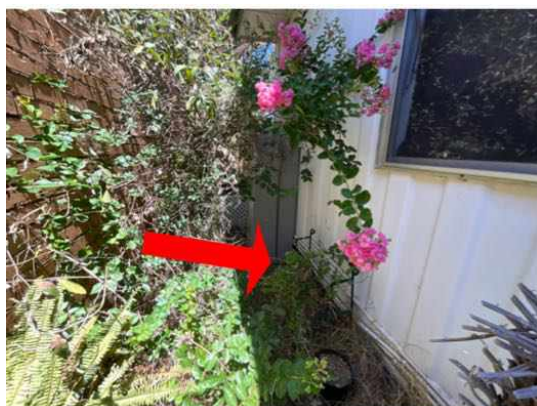
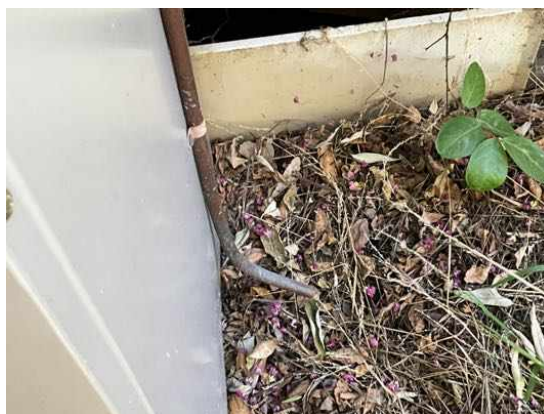
Finding 6.01

Building:	Building 1
Location:	Yard - Side
Finding:	HWS Overflow - Not Connected
Information:	The Hot Water System (HWS) overflow was found to be disconnected from storm water drainage and is creating excessive moisture in the surrounding area.

These damp conditions can lead to secondary defects such as rot, rust or corrosion of associated building elements, the formation of fungal decay, or even the creation of potential slip hazards. When coupled with poor site drainage, pooling of water may also attract termite activity to this area.

It is highly recommended that a licensed plumber be appointed to connect the HWS overflow in order to prevent such an environment from being created. These minor works should be carried out as soon as possible.

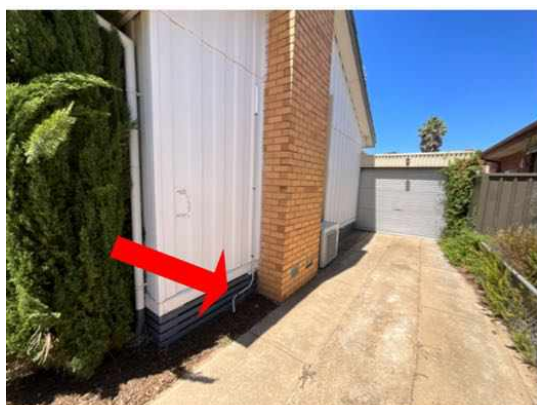
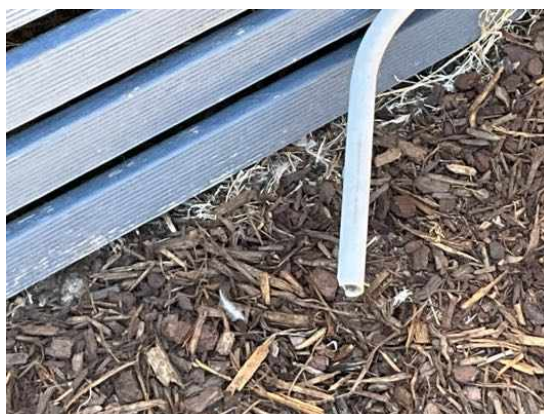
Finding 6.02

Building: Building 1
 Location: Driveway
 Finding: Air conditioner - Disconnected overflow
 Information: The Air Conditioner (A/C) overflow was found to be disconnected from storm water drainage and is creating excessive moisture in the surrounding area.

Such leaking creates an environment which is conducive to an array of defects, including water damage to associated building elements and the attraction of termite or timber pest infestation.

It is highly recommended that a licensed plumber be appointed to connect the A/C overflow in order to prevent such an environment from being created. These minor works should be carried out as soon as possible.

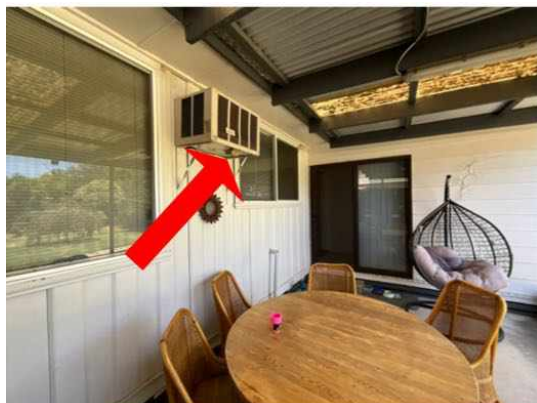
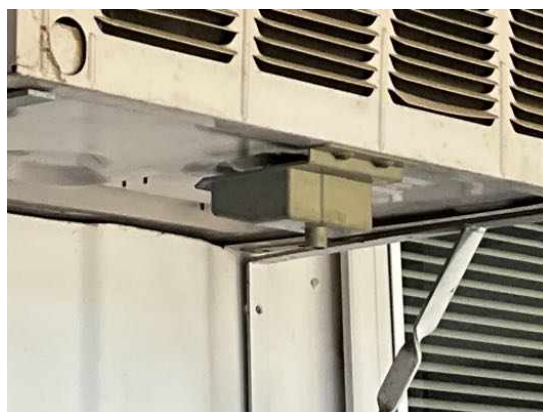
Finding 6.03

Building: Building 1
 Location: Alfresco
 Finding: Air conditioner - Disconnected overflow
 Information: The Air Conditioner (A/C) overflow was found to be disconnected from storm water drainage and is creating excessive moisture in the surrounding area.

Such leaking creates an environment which is conducive to an array of defects, including water damage to associated building elements and the attraction of termite or timber pest infestation.

It is highly recommended that a licensed plumber be appointed to connect the A/C overflow in order to prevent such an environment from being created. These minor works should be carried out as soon as possible.

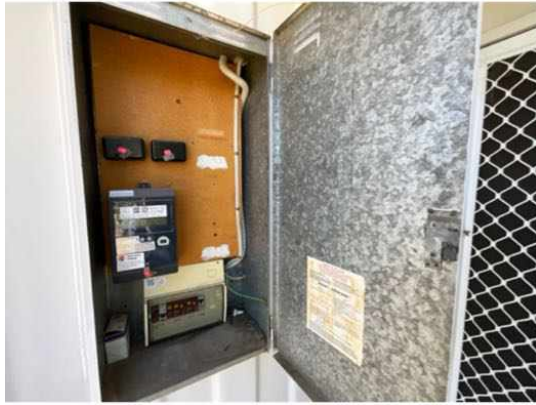
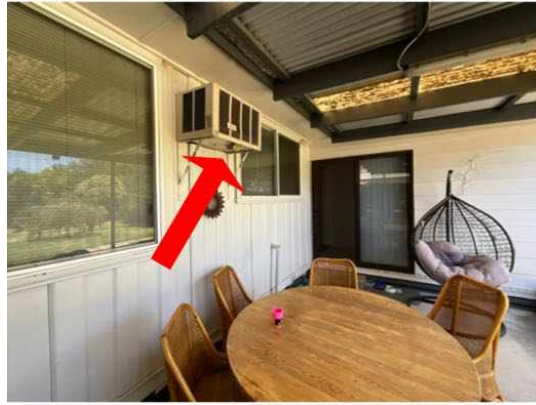
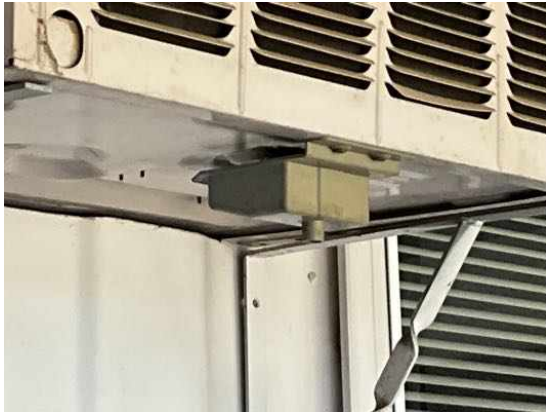
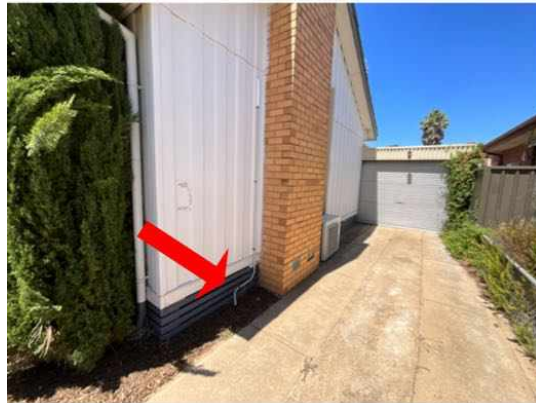
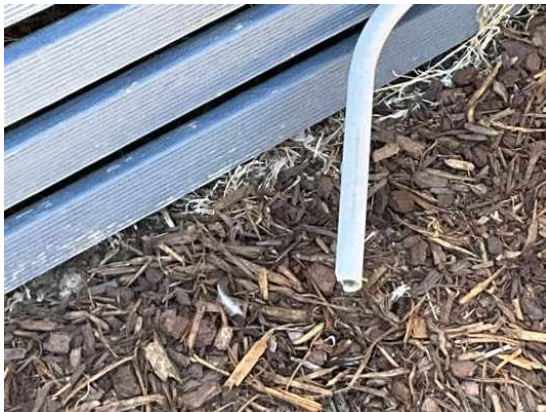
Finding 6.04

Building:	Building 1
Location:	All External Areas
Finding:	Termite Management System - no evidence of a chemical installation
Information:	The application of a post-construction chemical termite barrier is highly recommended for all properties, particularly if live termite activity has been found on the site previously. Such barriers are highly effective in preventing termite attack on any timber building elements throughout the property.

A durable notice should be placed in the switchboard unit to indicate current termite barriers. At the time of inspection, it appeared as though no termite management system has been installed, with no evidence to suggest preventative works taking place.

The client may consider gaining further advice from a pest controller as to the costs and procedures involved with this application. It is recommended that obtaining such advice be a short-term priority.

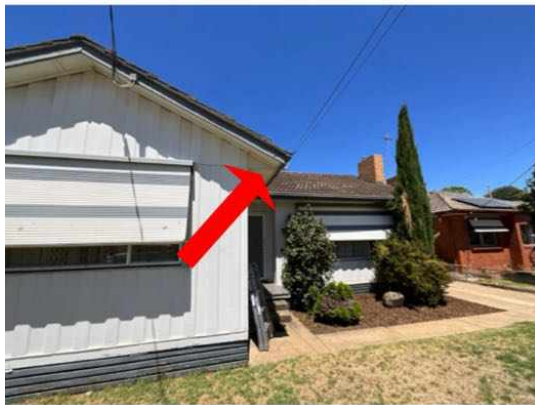
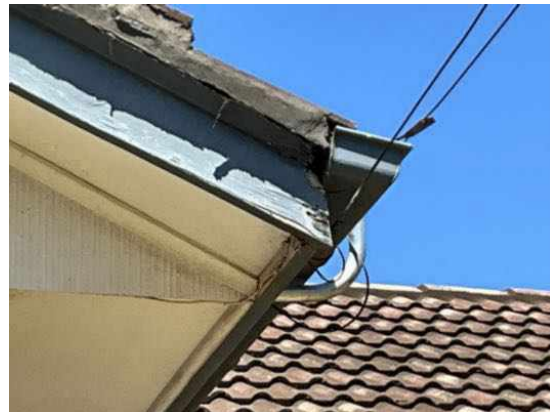
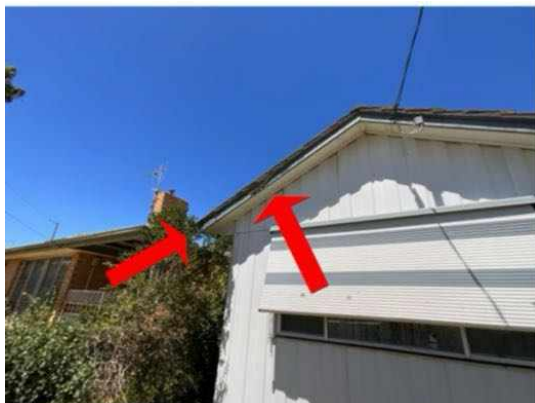
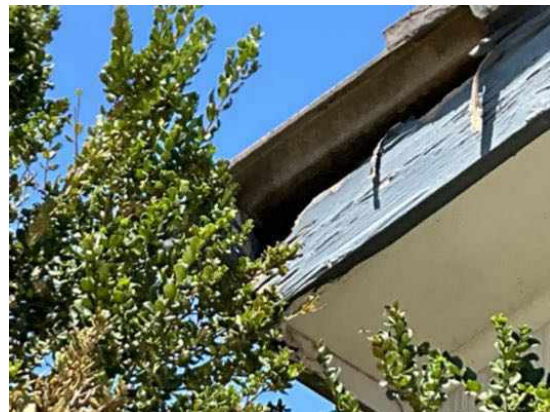
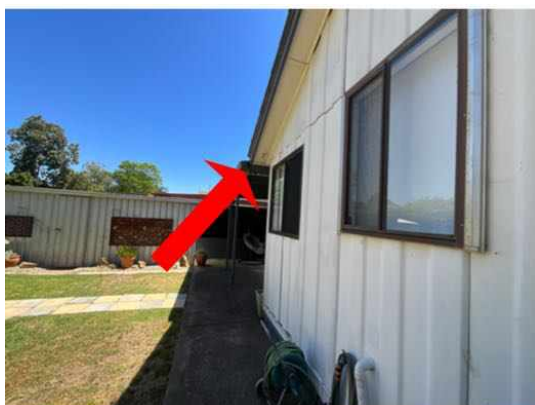
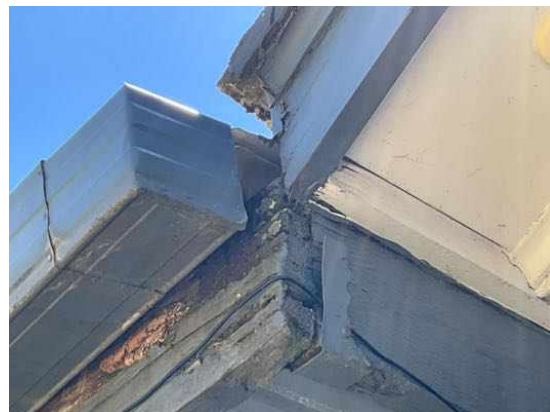
Finding 7.01

Location: Eaves

Finding: Fungal decay - present (localised)

In this case although the affected timber element is in a decaying state the extent of any visible damage appears to be localised to a specific area and is yet to spread to other parts of the building element or affect adjoining structures. The fungal decay is therefore likely to be of a relatively superficial nature with minimal impact on the structural integrity or tensile strength of the timber element.

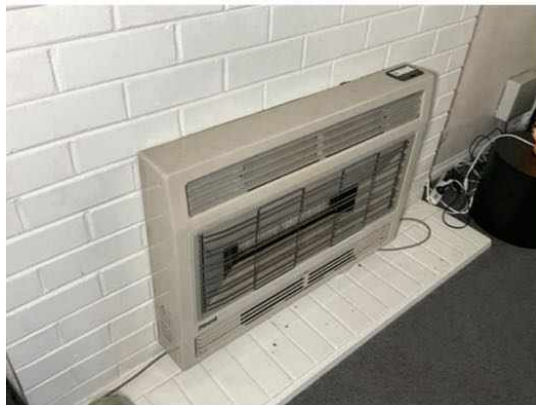
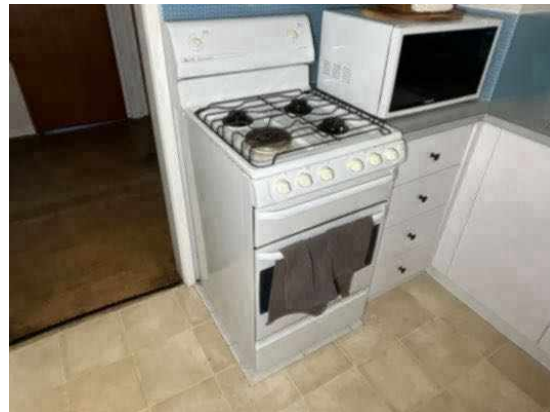
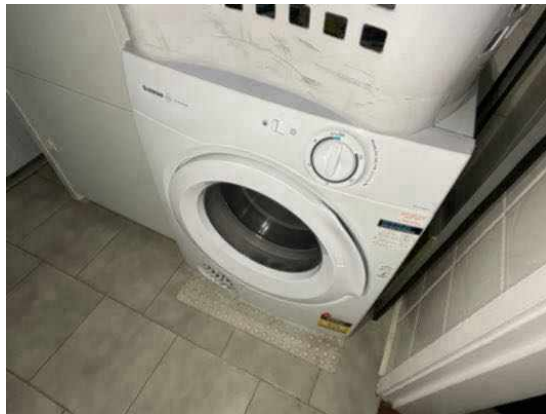
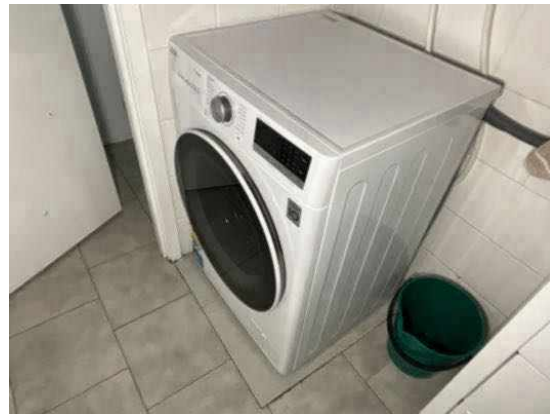
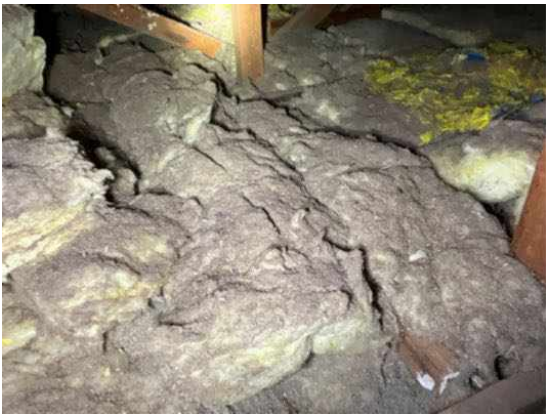
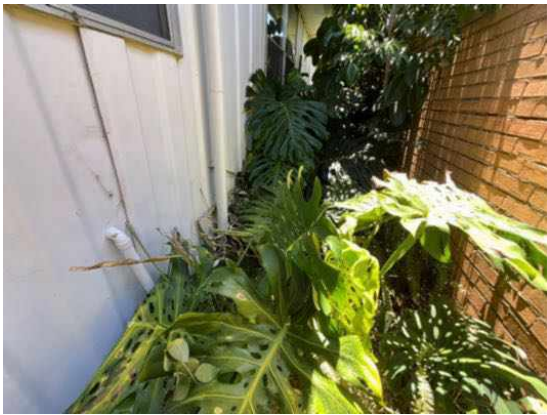
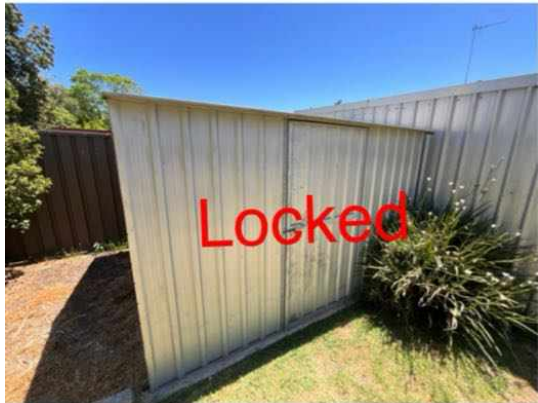
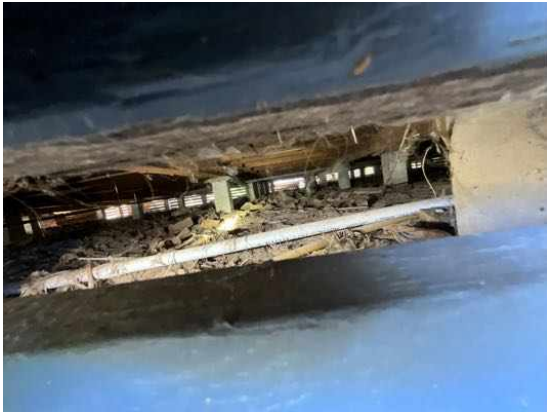
Noted Item

Building: Building 1
Location: All Areas
Finding: Additional Photos - Obstructions and Limitations
Information: These photographs are an indication of the obstructions and limitations which impeded full inspection of the property at the time of inspection. These obstructions can hide an array of defects and should be removed to allow full inspection to be carried out. A re-inspection is recommended once the areas are made accessible.
