Building and Timber Pest Inspection Report

Inspection Date: Tue, 13 Jan 2026

Property Address: 24 Don Mills Ave, Hebersham NSW 2770,
Australia

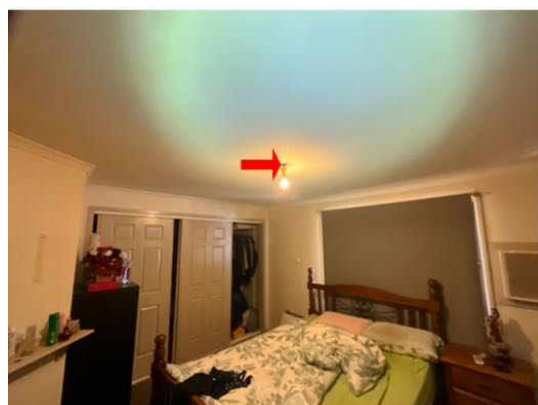
Building:	Main Building
Location:	Bedroom - Master
Finding:	Electrical fitting/light -- Broken/Loose
Information:	The electrical fitting or light in this area was found to be broken or loose at the time of inspection.

Breakage occurs generally when the building materials have aged and decayed, but may also be indicative of impact damage to the building element (accidental or deliberate).

Left unmanaged, the fitting is likely to further deteriorate, causing injuries or electrocution.

Repair and/or replacement of the broken fitting is advised urgently. A Licensed electrician should be appointed to repair/replace this element immediately.

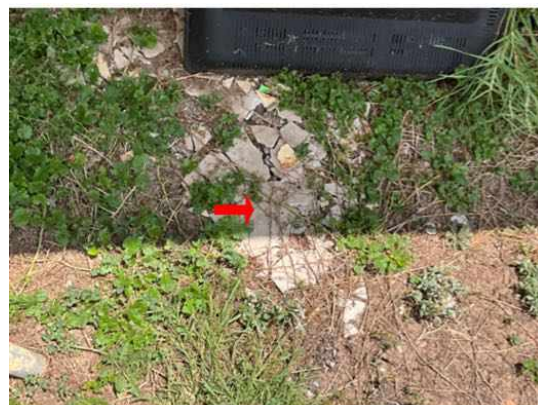
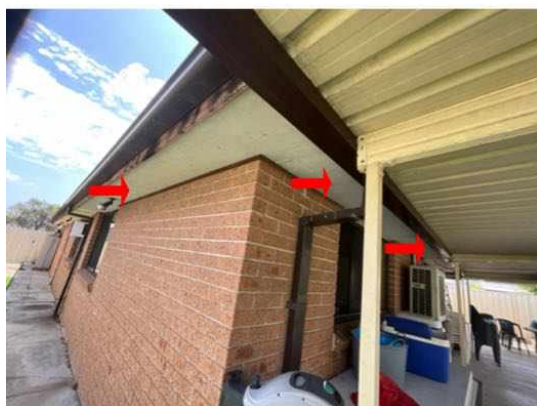
Information: Reporting on Asbestos is outside the Scope of this Report. This suspected defect is highlighted as a caution only. We suspect, based on our experience in the building industry, that there is a higher risk of the identified building element containing asbestos.

As Asbestos Reporting is outside the scope of this report, we advise that you consider a separate Asbestos Inspection and Condition Audit, which can include the taking of samples for definitive confirmation of the presence of Asbestos.

In the interim, the client is advised to act with caution, especially when considering any damage to building materials general wear and tear renovations extensions demolition and general maintenance activities due to the suspected presence of Asbestos.

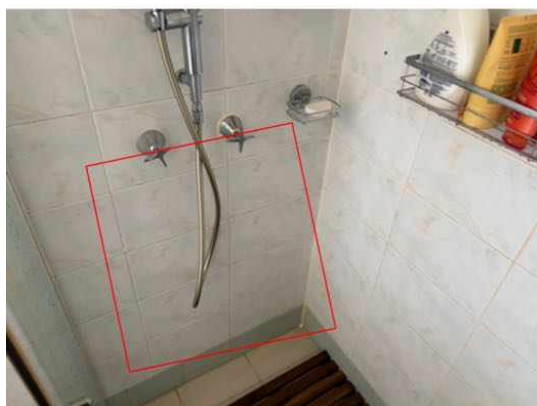
Finding 2.02

Building:	Main Building
Location:	Bathroom
Finding:	Water leak - Suspected
Information:	A water leak is suspected in this area as excessive moisture was detected at the time of inspection. Another potential cause maybe moisture ingress behind the tiles from around the wall fittings and penetrations.

Internal water leaks can be detrimental to surrounding building elements; their potential causes include damage to plumbing fittings and fixtures, through to water damage and deterioration of associated building elements.

Attracting termites, corrosion, mould, decay and water damage are potential outcomes where a minor water leak is left unattended. More serious defects may also result, such as electrical hazards, or water damage to structural building elements.

In extreme cases, structural damage may develop due to a prolonged water leak. It is highly advised that internal water leaks be addressed by a licensed plumber as a matter of relative urgency.

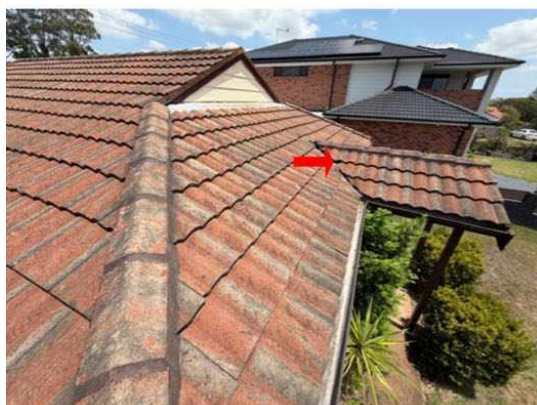
Location: Roof Exterior
 Finding: Roof tiles - Slippage
 Information: Upon inspection of the exterior roof covering, it was noted that numerous tiles have slipped from their original fixing. Tiles may slip over time due to a number of minor causes, including breakage of tiles, failings in the adjoining battens, or fixings that may have failed.

Roof tiles that have moved from their original position are very likely to allow water penetration into the roof void, exposing roofing structures to excessive moisture. This creates an environment that is conducive to water damage and accelerated deterioration of all associated building elements.

Replacement of loose or missing roofing tiles is recommended immediately to prevent the development of any secondary defects. A roofing restoration specialist should be appointed to complete such works as necessary.

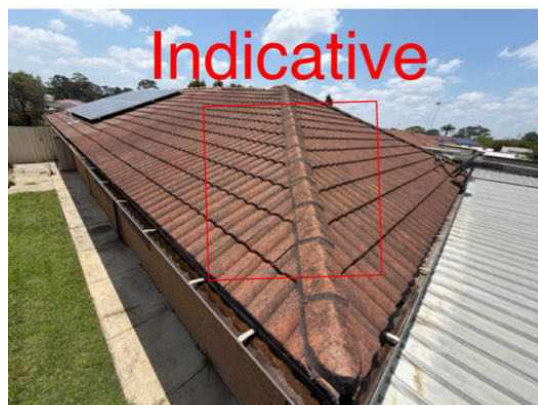
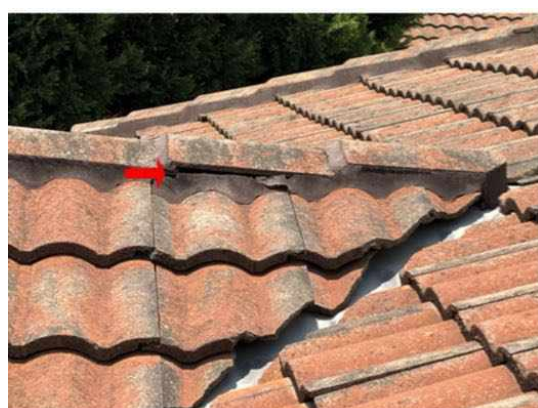
Finding 3.02

Building: Main Building
 Location: Roof Exterior
 Finding: Roof tiles - Weathered
 Information:

Upon inspection of the exterior roofing, the majority of roof tiles were considered to be in a fair condition. While weathering of the tiles is consistent with the age of the property, maintenance works are required.

Isolated areas of mortar have come loose and minor cracking is also present. Re-pointing and re-sealing the may be considered as an interim solution by the client to help preserve and extend the life span of the tiles.

Where left unmanaged, deteriorating roof tiles are likely to lead to a number of secondary defects, including minor water leaks and weather exposure to internal roofing structures.

Consultation with a licensed roofing contractor is highly advised to gain advice on cost

of remedial works that may be required in the short to medium term. Remedial works are likely to increase the longevity of the exterior roofing structure.

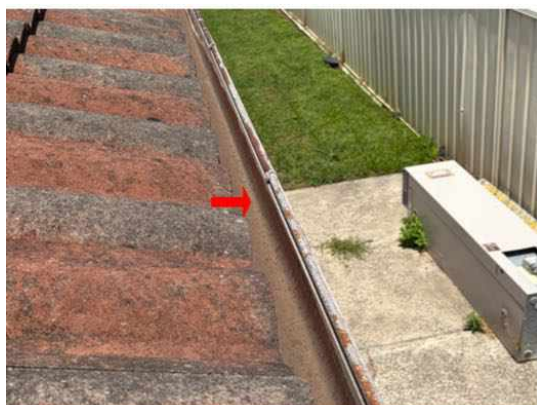
Finding 3.03

Building:	Main Building
Location:	Gutters
Finding:	Roof plumbing - Rusted or corroded
Information:	The roof plumbing has areas of rust and corrosion. It is suspected that this has been caused by blockages, resulting in pooling or standing water, that have prematurely rusted elements of the roof plumbing.

Rusted roof plumbing will generally develop holes and leaks that can affect other building elements with poor drainage of storm water. Poorly drained roof areas will also lead to damp conditions surrounding the base perimeter of the building which, if left unmanaged, can lead to a range of secondary building defects.

Repair and/or replacement of rusted roof plumbing is highly required in order to reinstate the roof drainage system to a fully operational level. To further maintain these areas, gutters should be cleaned frequently, allowing the avoidance of any partial blockages.

A licensed plumber or specialist roof restoration company should be appointed to undertake these works. It is advised that such works be completed as soon as

possible to prevent any further damage and deterioration.

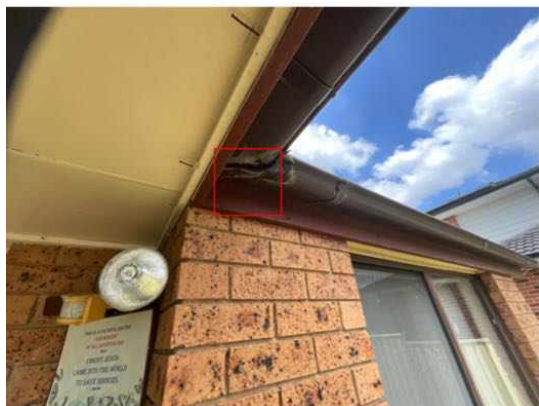
Building:	Main Building
Location:	Multiple areas of roof plumbing
Finding:	Water leak - External
Information:	Water leaks were found to be present to exterior plumbing work. Leaks are generally caused by deterioration of the plumbing elements over time, due to exposure to weather conditions, but may have also been caused by minor impact damage.

Such leaking creates damp conditions in the affected area, causing potential for water pooling and subsequent water damage if left unattended. These conditions may also attract termite attack, particularly if the area is subject to minimal levels of sun throughout daylight hours.

It is highly advised that a licensed plumber be appointed to rectify any water leaks that

may be present. Areas of repair and replacement of plumbing fittings and fixtures may be required and, as such, a quotation should be sought.

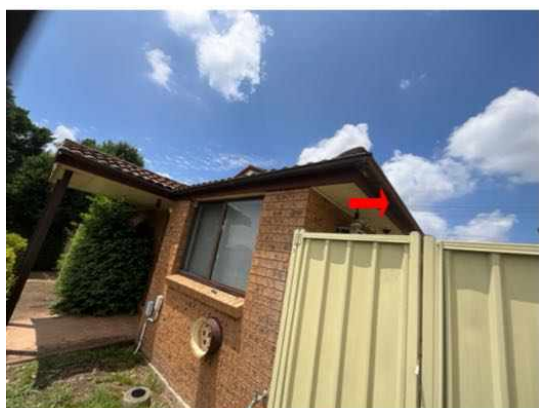
Finding 3.08

Building:	Main Building
Location:	Front left
Finding:	Stormwater drain - Not connected
Information:	The roof plumbing is not adequately connected to stormwater drainage on the site. This disconnection negatively impacts the functional capacity of the roof plumbing.

Where roof plumbing doesn't drain adequately, the area at the base perimeter can become excessively damp, potentially creating an environment that is susceptible to rust and corrosion of surrounding building elements, as well as attracting termites and other pests.

It is highly recommended that a plumber be appointed to further inspect the area and to install adequate drainage equipment where necessary.

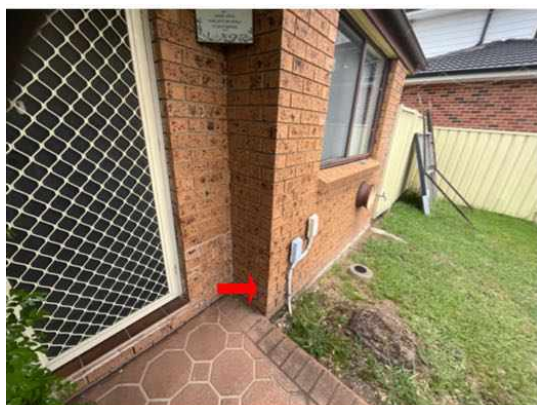
Finding 3.09

Building:	Main Building
Location:	Porch
Finding:	Damage to Masonry Walls (Cracks) - Category 1
Information:	It has been observed that damage to masonry walls caused by movement of slabs, footings, or other causes, has occurred. The degree of damage falls within Category 1, described as fine cracks, which are less than 1.0mm in width limit, and that do not need repair.

Damage of this category is not considered a defect for rectification. Always contact your building inspector should cracks widen, lengthen, or become more numerous.

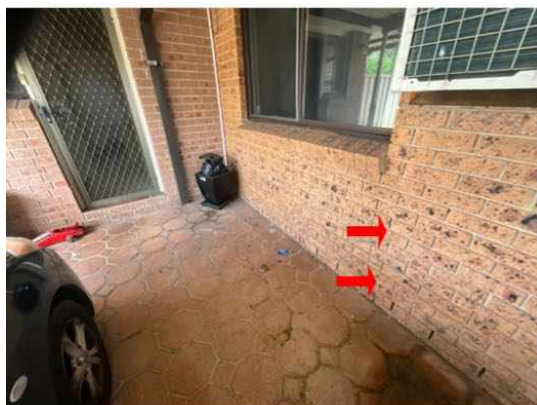
Finding 3.10

Building:	Main Building
Location:	Alfresco
Finding:	Damage to Masonry Walls (Cracks) - Category 0
Information:	It has been observed that damage to masonry walls caused by movement of slabs, footings, or other causes, has occurred. The degree of damage falls within Category 0, described as hairline cracks, which are less than 0.1mm in width limit.

Damage of this category is not considered a defect for rectification. Always contact

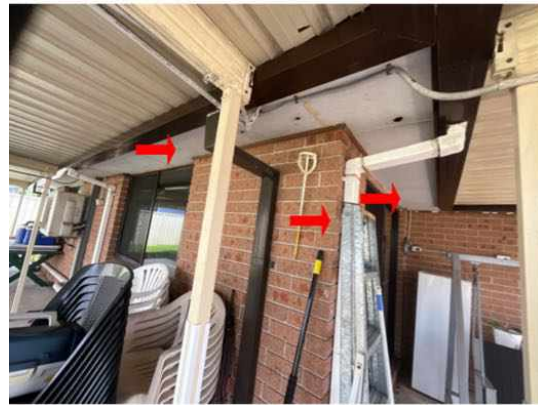
Finding 3.11

Building:	Main Building
Location:	Rear right corner
Finding:	Paint finish - Incomplete
Information:	The paint finish in this area was identified as being incomplete at the time of inspection.

Whilst incomplete or missing paint finish is generally an appearance defect, it can also lead to the development of secondary building defects over time. Incomplete areas of paint finish expose the area to moisture, potentially accelerating the deterioration of underlying building materials.

Incomplete paint finishes should be sanded back, filled, leveled and painted, as applicable. Where inadequate or missing paint protection has led to the deterioration of the associated building element, repair and/or replacement of this building element may be required.

A painting contractor should be appointed as soon as possible to perform necessary works to aid the appearance of the affected area and to ensure the area is protected against further deterioration. Alternatively, the homeowner following manufacturer instructions may perform these works.

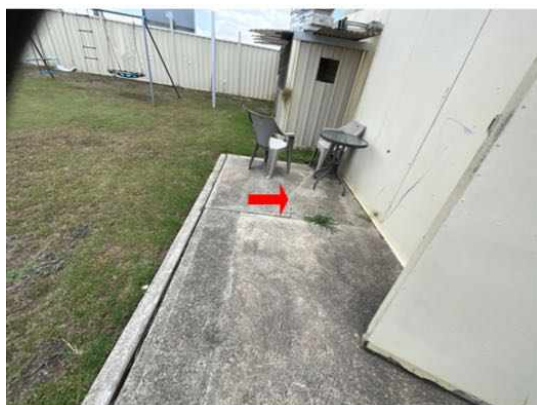
Finding 3.14

Building:	Main Building
Location:	Shed
Finding:	Cracking - External Concrete Paving Damage Category 3 - Wide Cracks (2mm - 4mm)
Information:	Wide cracks were identified in external concrete paving Wide cracks are significant and are likely to lead to the development of safety hazards and secondary defects if left unmanaged.

Significant repair and likely replacement of the concrete paving is probable.

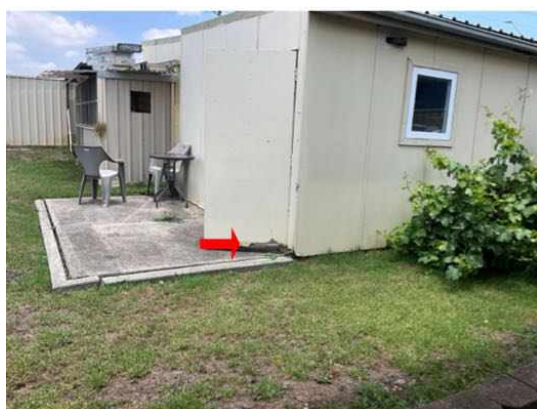
Finding 3.15

Building:	Main Building
Location:	Shed
Finding:	Building element - Damaged
Information:	Breakage occurs generally when the building materials have either aged and decayed, or as a result of damage (accidental or deliberate).

A relevant tradesperson should be appointed to repair or replace the affected building element prior to any subsequent damage being caused.

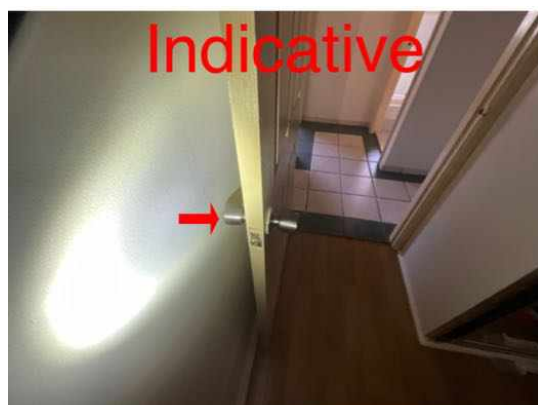
Building: Main Building
 Location: All Areas
 Finding: Door stop - Missing
 Information:

Re-installation or replacement of the door stop is advised as soon as possible to prevent any subsequent damage to the door or associated structures. A registered builder may be appointed to perform these works at client discretion.

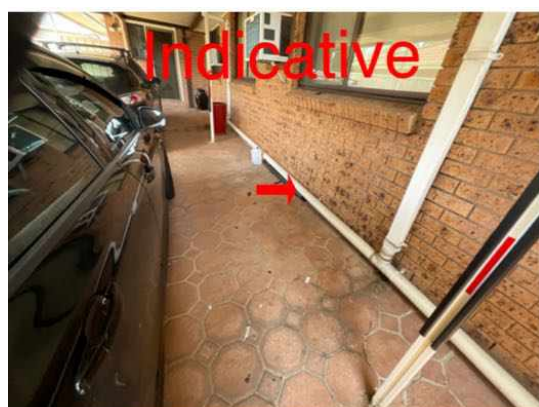
Finding 6.04

Building:	Main Building
Location:	Perimeter
Finding:	Slab Edge - Exposure
Information:	Slab Edge Exposure: Where external concrete slab edges are not exposed there is a high risk of concealed termite entry. In some buildings built since July 1995 the edge of the slab forms part of the termite shield system. In these buildings an inspection zone of at least 75mm should be maintained to permit detection of termite entry. The concrete edge should not be concealed by render, tiles, cladding, flashings, adjoining structures, paving, soil, turf or landscaping etc. Where this is the case you should arrange to have the slab edge exposed for inspection. Concealed termite entry may already be taking place but could not be detected at the time of the inspection. This may have resulted in concealed timber damage. Does the slab edge inspection zone fully comply?

Not able to comment. A very high proportion of termite attacks are over the edge of both Infill and other concrete slabs types. Covering the edge of a concrete slab makes concealed termite entry easy. Infill slab type construction has an even higher risk of concealed termite ingress as the slab edge is concealed due to the construction design and cannot be exposed. The type of slab may only be determined by assessment of the construction plans by a qualified person e.g. Builder, Architect. Construction Plans may be obtainable by your local Council or Builder. Termite activity and or damage may be present in concealed timbers of the building. We strongly recommend frequent regular inspections in accordance with AS 3660.2. Where the slab edge is not fully exposed or the slab is an infill slab or the slab type cannot be determined then we strongly recommend inspections every 3 to 6 months in accordance with AS 3660.2 or AS 4349.3.

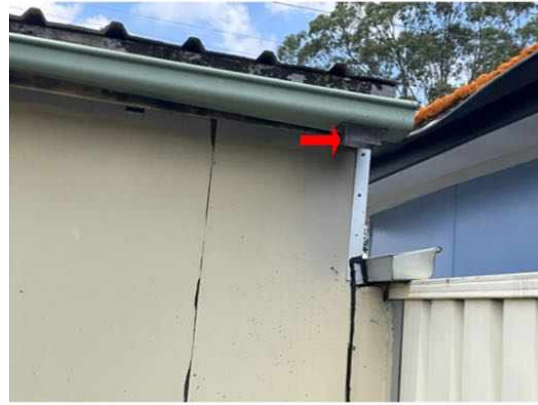
Finding 6.09

Building:	Main Building
Location:	Front left
Finding:	Stormwater drain - Not connected
Information:	The roof plumbing is not adequately connected to stormwater drainage on the site. This disconnection negatively impacts the functional capacity of the roof plumbing.
