## Building Inspection Report

Inspection Date: Mon, 23 Mar 2026

Property Address: 449 Lake Albert Rd, Lake Albert NSW 2650,  
Australia

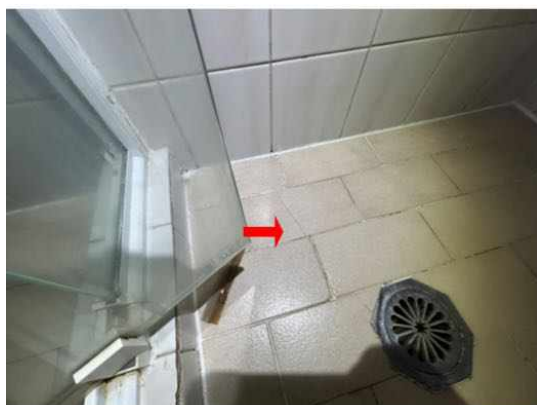
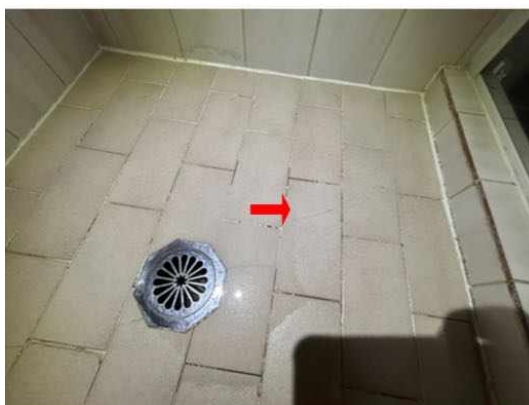
#### Defects 3.01

Building: Main Building  
 Location: Bathroom  
 Finding: Tiles Cracked or damaged  
 Information: There appears to be cracked tiles to, but not limited to, the bathroom shower floor.

If left unaddressed, cracks can allow water ingress, leading to further deterioration.

Recommend client contact a licensed builder or tiler for further evaluation as soon as possible.

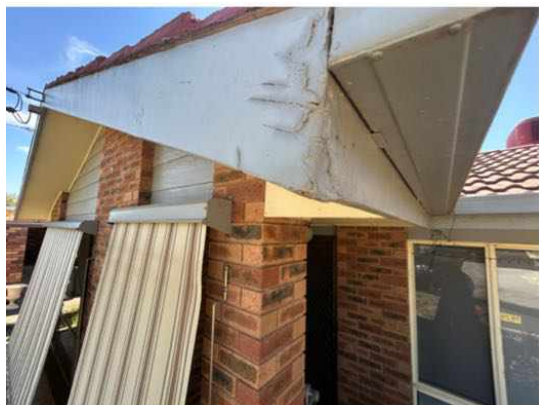
#### Defects 3.02

Building: Main Building  
 Location: External  
 Finding: Wood decay  
 Information: There appears to be wood decay to, but not limited to, the front fascia corner of the house which has been patched up and painted. Wood decay, also known as Fungal Decay, occurs when timbers and other cellulose building materials are exposed to damp conditions on an ongoing basis. This may lead to further decay of the materials

Recommend contacting a licenced builder for further evaluation as soon as possible.

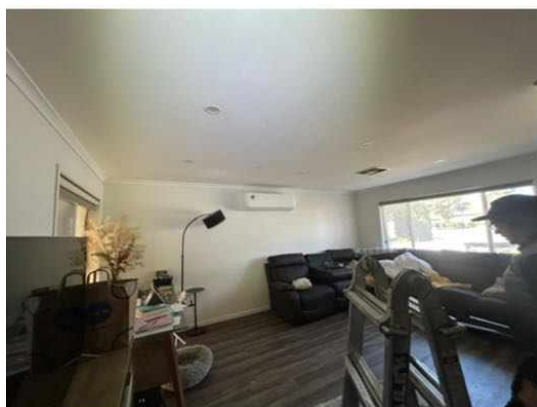
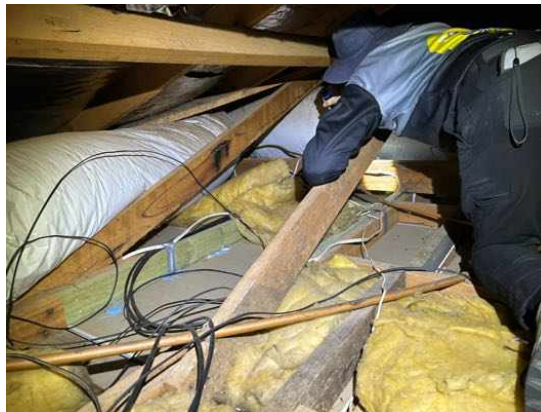
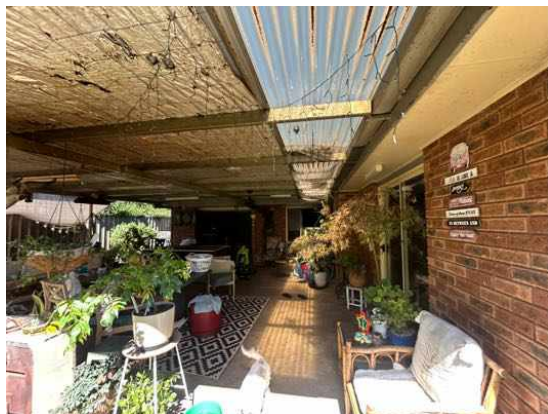
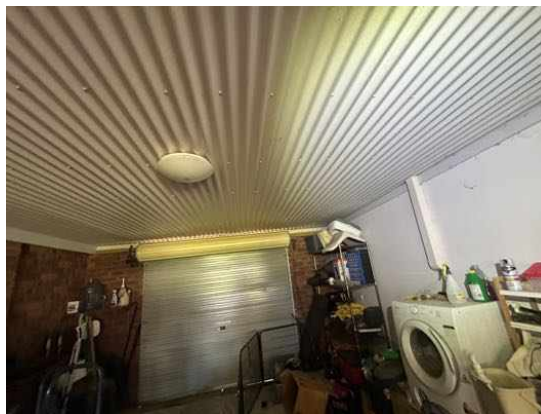
Building: Main Building  
 Location: All Areas  
 Finding: Additional Photos - Obstructions and Limitations  
 Information: These photographs are an indication of the obstructions and limitations which impeded full inspection of the property at the time of inspection. These obstructions can hide an array of defects and should be removed to allow full inspection to be carried out. A re-inspection is recommended once the areas are made accessible.

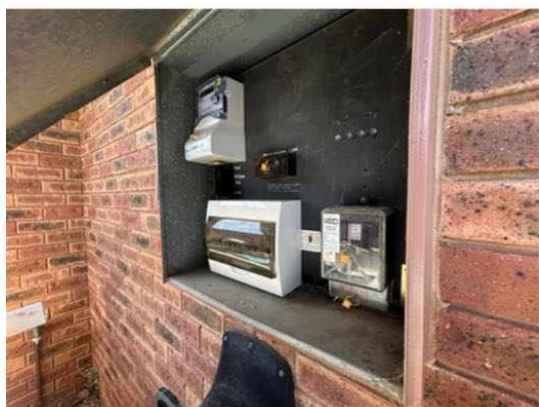
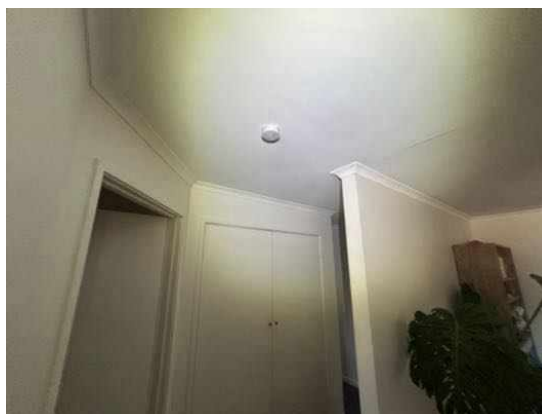
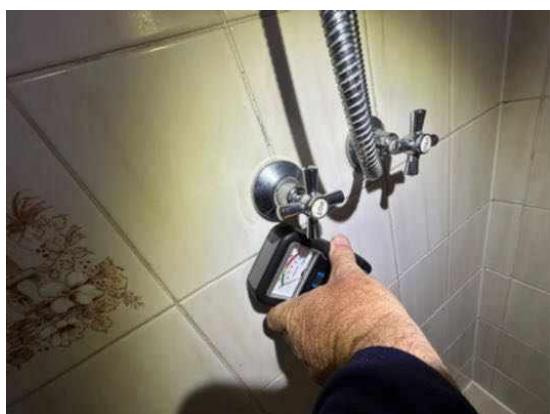
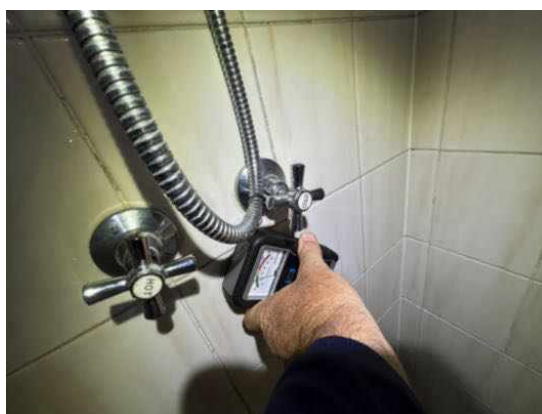
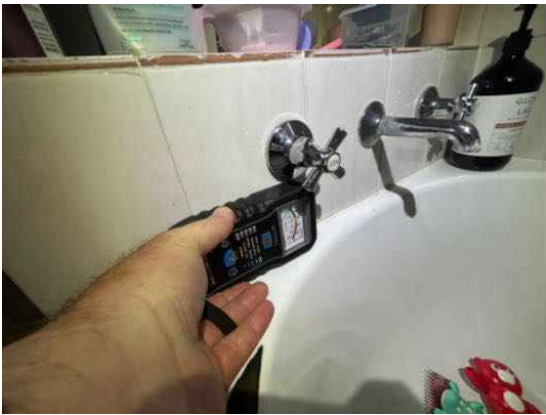
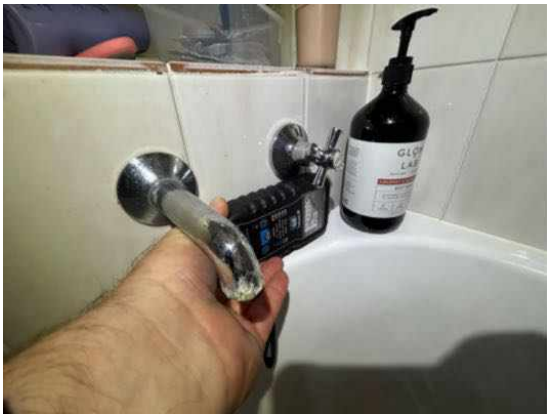
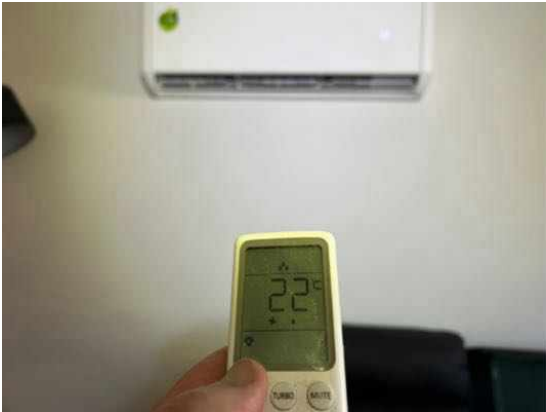
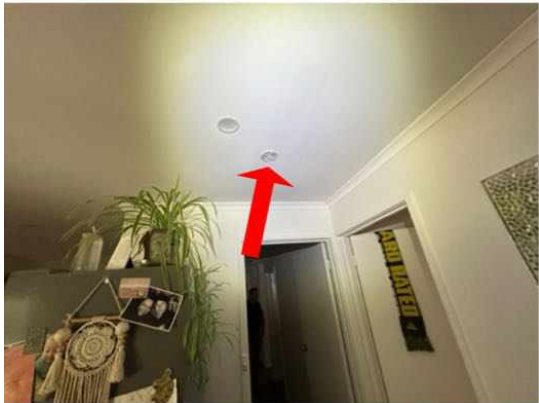
A photo of the switchboard and RCDs has been included for reference. This

inspection does not assess electrical compliance and we are not licensed electricians. We recommend engaging a qualified electrician to confirm that the installation meets current safety standards, whether the property is to be rented out or occupied by the purchaser.

A photo of the smoke alarms has been included for reference. There appeared to be one smoke alarm mixing outside the rear bedroom. We have not assessed their location, condition, or operation. We recommend engaging a qualified person to confirm that the smoke alarms meet current safety standards, whether the property is to be rented out or occupied by the purchaser.

Moisture readings below taps where possible and walls adjacent to showers where possible. Where there didn't appear to be any high moisture readings at the time of the inspection

The air conditioning system was operated via the wall-mounted control panel at the time of inspection. The control appeared to respond to input and air was discharged from the associated ceiling vents. The overall cooling or heating performance, efficiency, and internal mechanical condition of the unit could not be fully assessed during a brief visual inspection.

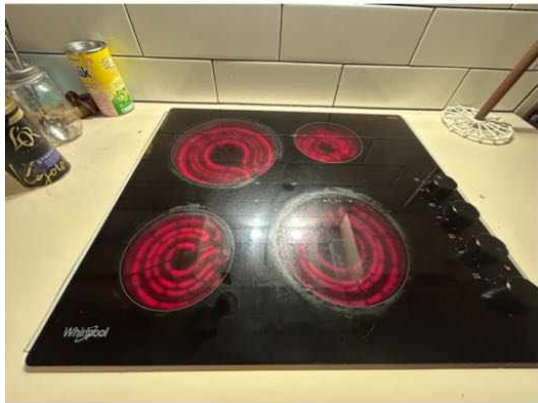
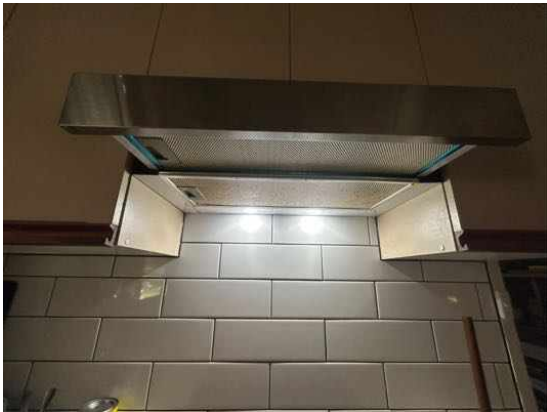
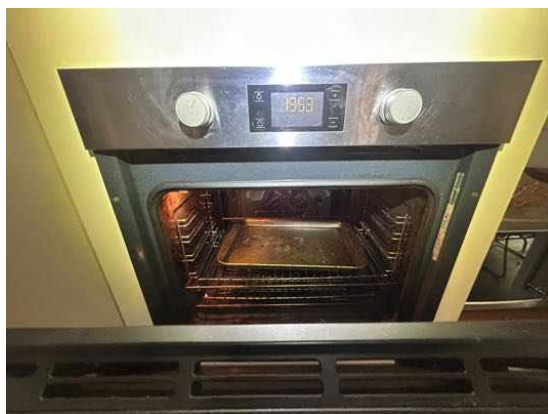
Building: Main Building  
Location: Kitchen  
Finding: Oven, Cooktop & Rangehood  
Information: Oven appeared to be working

Cooktops appeared to be working

Rangehood appeared to be working

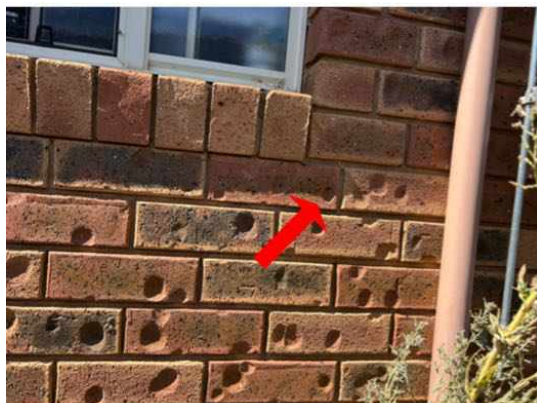
Building:	Main Building
Location:	External
Finding:	Cracking (small) to External brickwork
Information:	There appears to be small cracking to the external brickwork to, but not limited to the western elevation to the boot might of the window. These cracks are classed as number 2 below which is typically not structural but should be monitored

2. Small Cracks (1mm – 5mm) – Minor

- Slight cracks that may require cosmetic repairs (e.g., repointing). Typically not structural but should be monitored.

Client may wish to contact a licensed builder for further assessment if desired.

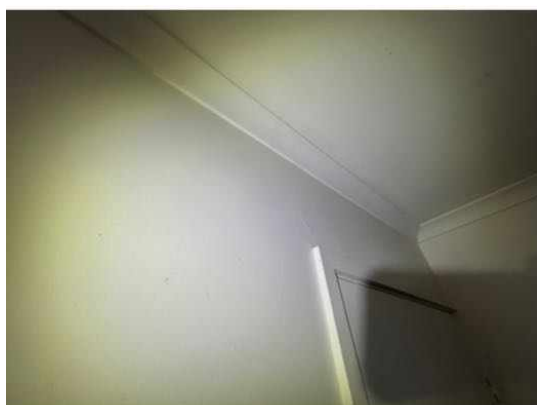
Building: Main Building  
 Location: Interior  
 Finding: Cracking to interior wall  
 Information: There appears to be minor cracking to, but not limited to, the bathroom. Although cracks are noticeable, they are often only considered to be an appearance defect.

If desired, a painter or home maintenance professional could be contacted to repair the cracks when desired.

Monitoring of all cracking should be conducted frequently. Always contact a building inspector or licensed builder should cracks widen, lengthen, or become more numerous.

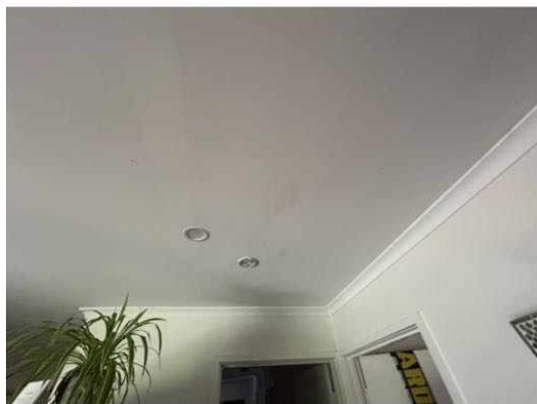
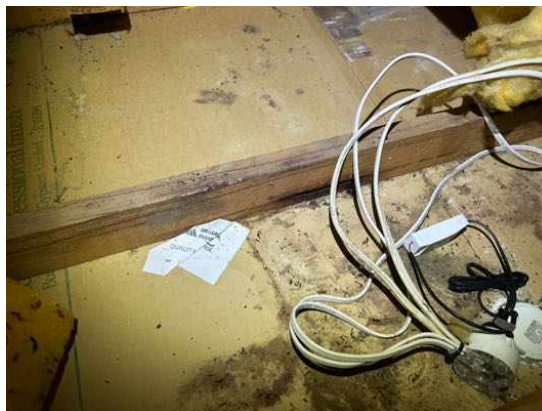
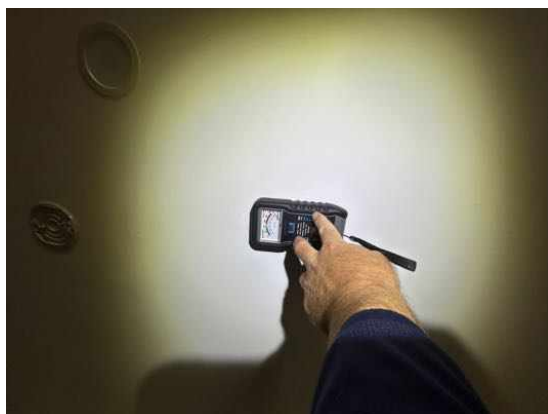
Building: Main Building  
 Location: Interior  
 Finding: Moisture to Ceiling  
 Information: There appears to be moisture to, but not limited to, the ceiling near the missing smoke alarm. Inspection of the roof void showed a possible past water stain, which is

possible the ceiling may be drying out

Recommend contacting a roof plumber or licensed builder for further evaluation if the mark in the ceiling remains.

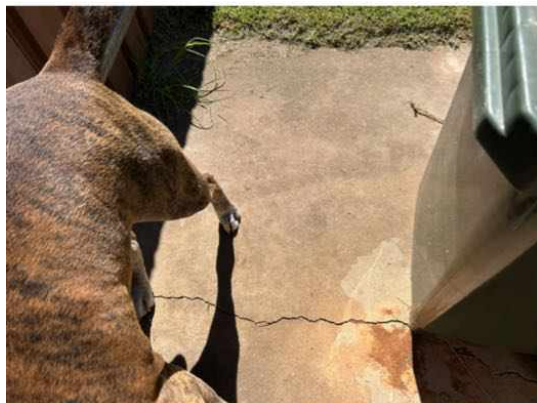
Building: Main Building  
 Location: External  
 Finding: Footpath Cracking  
 Information: There is minor cracking to footpaths in various locations.

This is not uncommon in buildings of similar age and can be caused by a number of different factors including ground movement in clay soils

Suggest homeowners keep an eye on this crack for further movement, should the crack widen, we suggest the homeowner contacts a builder for further evaluation.

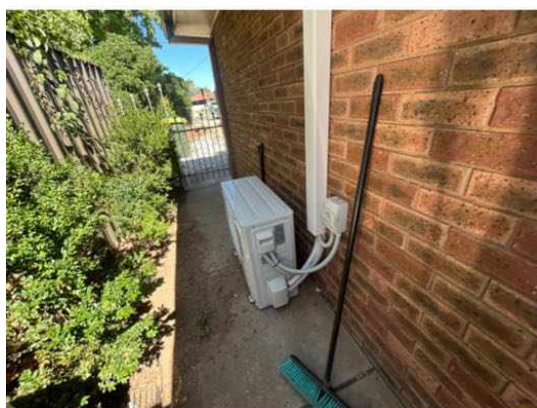
Building:	Main Building
Location:	External
Finding:	Air conditioner condensation drains
Information:	The air conditioner condensate drains didn't appear connected to the stormwater system and currently discharge to the ground, which can lead to damp soil conditions that may attract termites or cause minor surface pooling. While there is no specific requirement for these drains to be connected, it is recommended they be directed to suitable drainage or the stormwater system where practical to reduce ongoing moisture near the structure.

Client may wish to contact a plumber for further evaluation at clients discretion

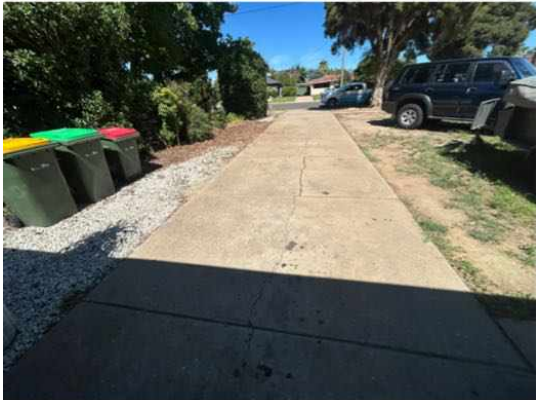
Building:	Main Building
Location:	External
Finding:	Driveway Cracking
Information:	There is cracking to the driveway.

This is not uncommon in buildings of similar age and can be caused by a number of different factors including tree roots, water pooling and vehicle traffic

Suggest homeowners keep an eye on this crack for further movement, should the crack widen, we suggest the homeowner contacts a structural engineer or licensed builder for further evaluation.

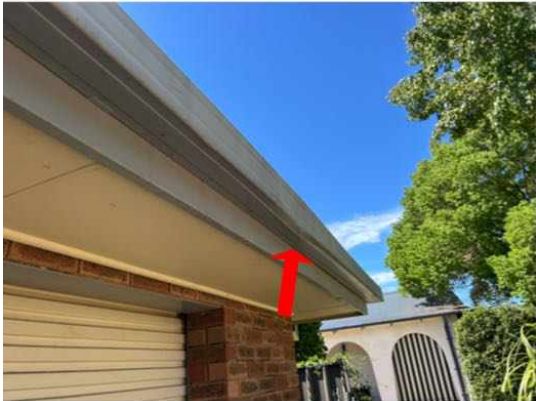
Building: Main Building  
Location: External  
Finding: Gutter  
Information: The guttering to the front elevation above the garage appears to have some localised impact damage at the time of inspection.

Client may wish to contact a roof plumber for further evaluation at clients discretion
