## Building and Timber Pest Inspection Report

Inspection Date: Tue, 13 Jan 2026

Property Address: The Avenue, 42/13-17 Brown St, Labrador  
QLD 4215, Australia

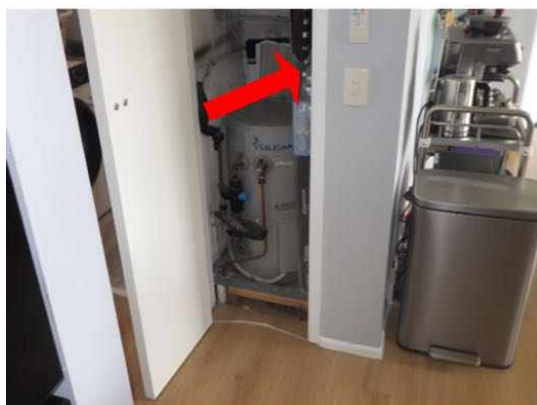
Exposed electrical cabling and/or connections represent a potential safety hazard including for fire and personal contact.

A licensed electrician should be engaged to undertake rectification work as a matter of priority.

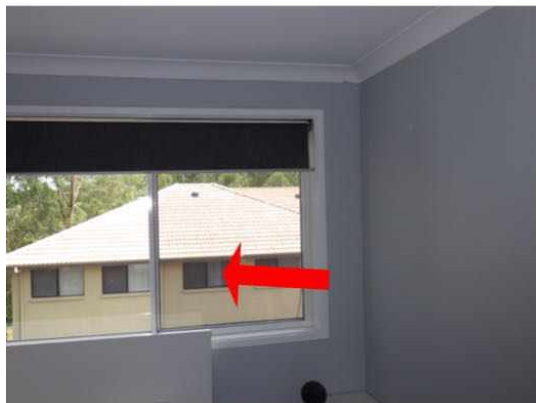
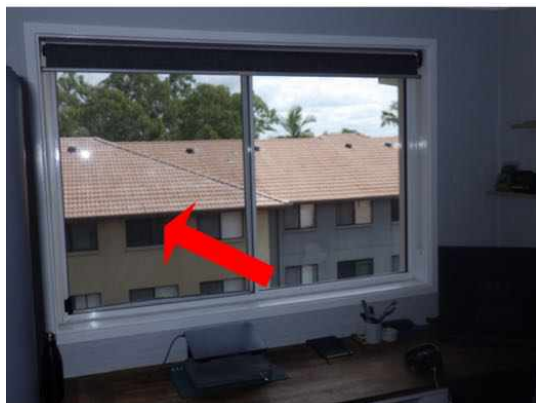
#### Finding 1.02

Building:	Main Building
Location:	Bedrooms > Existing
Finding:	Window safety
Information:	It was noted that the windows of the upper level bedrooms are less than 1.7m from the floor and have a fall greater than 2m on the exterior from the sill and as such are required to only open upto 125mm or have security grills fitted.

This is noted as a safety concern and this regulation may not have been in place at the time of construction.

Windows are defective if they do not comply with provision 3.9.2.5 of Volume 2 of the BCA that requires that a window opening must have protection if the floor below the window in a bedroom is 2 m or more above the ground surface beneath.

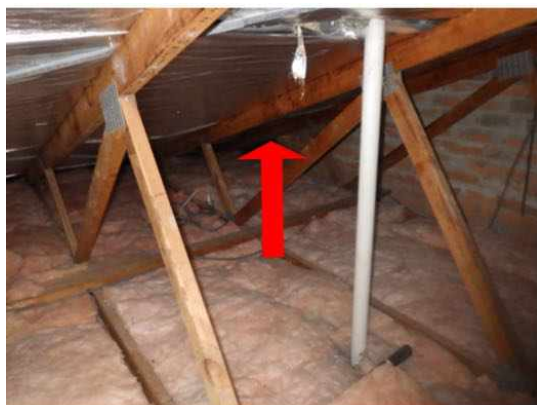
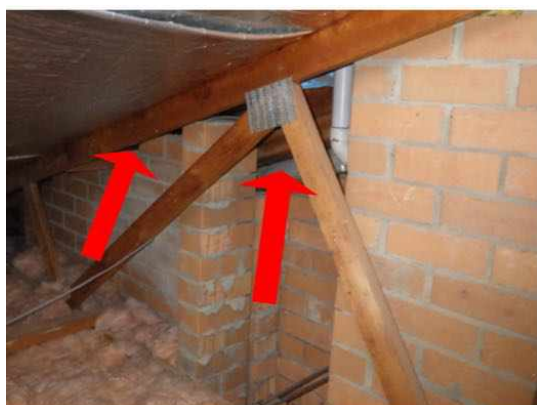
Information: At the time of inspection it was noted there were gaps in the brick, fire or party wall in the ceiling space area. The party wall has noticeable holes, gaps and unsealed penetrations which may compromise the fire rating integrity of the wall.

It is recommended a licensed builder registered for firewall construction is consulted regarding current party wall regulations and or rectification work and repairs.

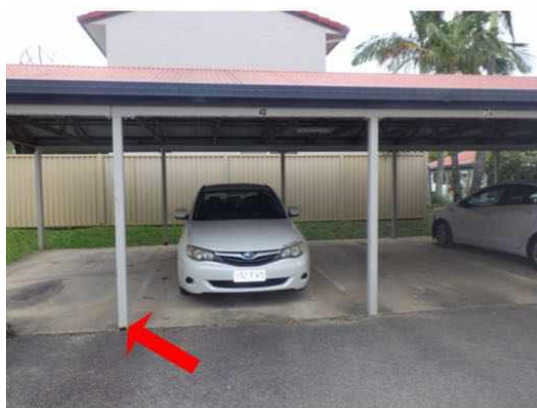
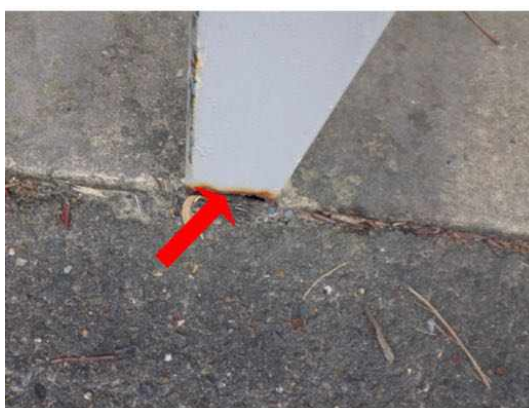
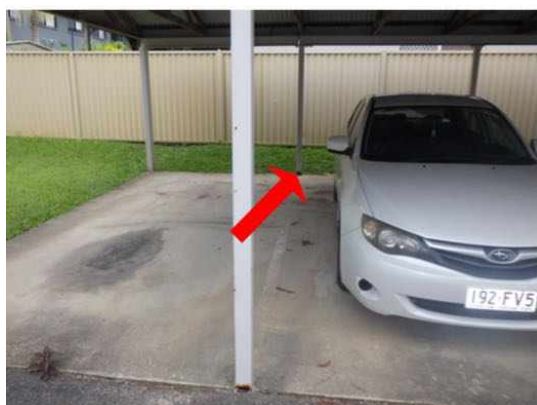
Building: Carport  
 Location: Carpark > Ground Level  
 Finding: Steel posts- Rusted or corroded  
 Information: The steel support posts to the carport area roof show evidence of rusting and corrosion, which is likely to have developed as a result of excessive exposure to moisture and or inadequate coatings.

As surface rust provides no protection to the underlying iron, the deteriorating condition is likely to worsen if not addressed in the short-term future.

Rusting and corrosion should be managed by ideally removing or limiting the affected surface from exposure to moisture. A licensed metal fabricator should be appointed to replace or repair any metal support posts that have been severely affected by rust.

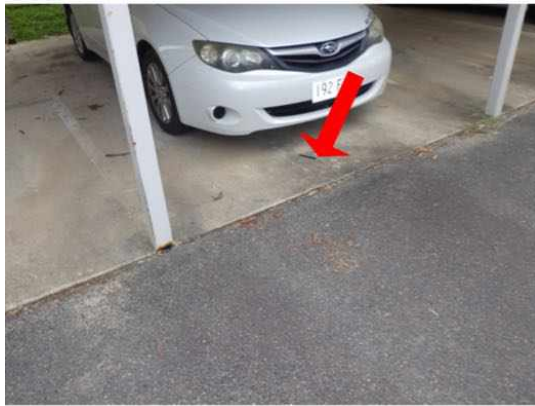
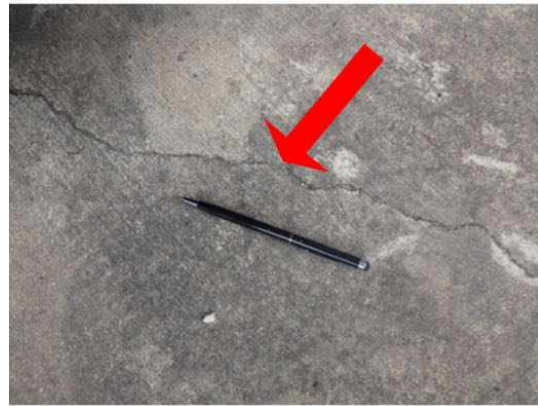
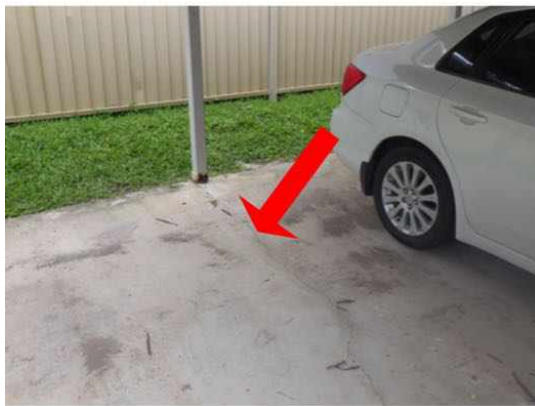
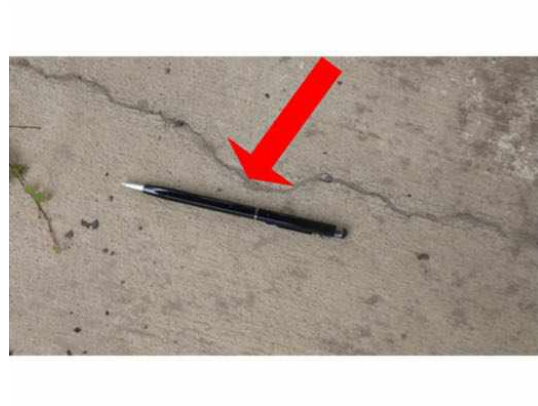
### Finding 3.02

Building:	Carport
Location:	Carpark > Ground Level
Finding:	Cracking in concrete slab - Category 1
Information:	Cracking coded as Category 1 was identified in the carport area concrete slab. A Category 1 crack is described as a fine but noticeable crack, with the slab at an otherwise reasonable level.

To be considered Category 1, the approximate width of the crack is less than 1.0mm, or a less than 10mm change in offset when a 3m straight edge is placed over the defect.

Category 1 cracks should be monitored for a period of 12 months. At the end of the monitoring period, identified cracks that are rated greater than Category 2 are

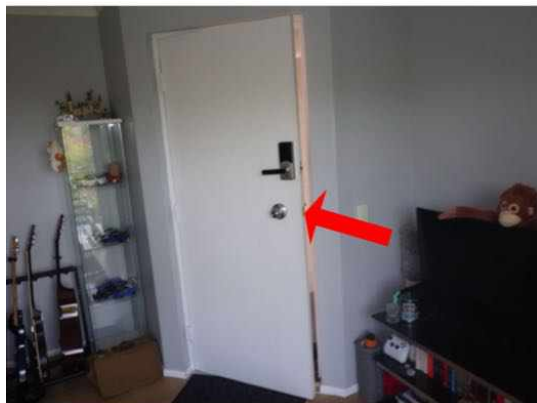
### Finding 3.03

Finding: Door Latch - Missing

Information: It was noted that the door handle latch set to the entry door was missing at the time of inspection. Whilst detracting from the functionality of this building element, this minor defect may also compromise the required fire rating of the entry door.

A licensed fire door installer should be consulted for further advice and/ or to perform rectification works as necessary.

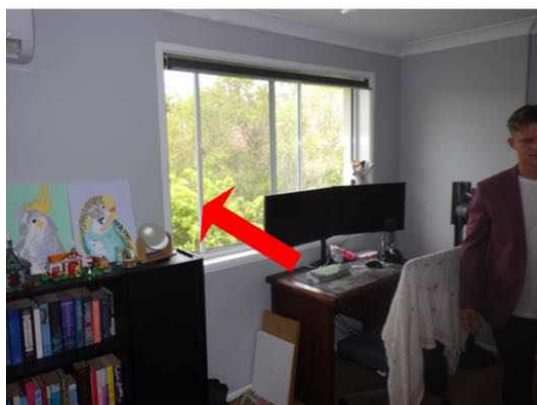
### Finding 3.04

Building: Main Building  
 Location: Dining Room > Centre Left  
 Finding: Window Catch - Latch missing  
 Information: It was noted that the window catch to the dining room area sliding window was missing at the time of inspection. Whilst detracting from the functionality of the window, this minor defect may also be a security risk.

It is suspected that this defect has occurred due general wear and tear, which is expected for building elements of this age.

An aluminium sliding window service agent or general handyperson may be appointed to perform rectification works as necessary, at client discretion.

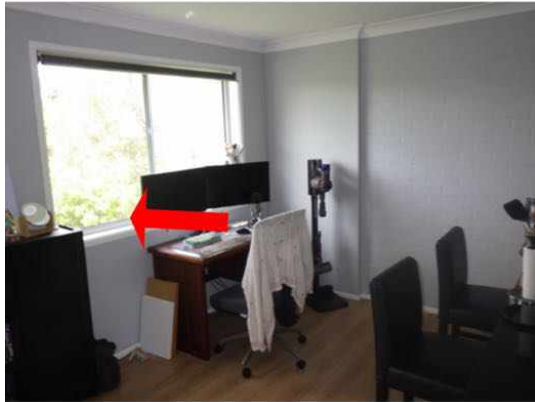
### Finding 3.05

Building: Main Building  
 Location: Dining Room > Centre Left  
 Finding: Window - Stiff to Slide  
 Information: The aluminium sliding window in the dining area was stiff to operate at the time of the inspection. Windows provide ventilation to the adjoining area and should be at a fully operational level to ensure user comfort.

Generally, factors such as general age of the building element and a lack of maintenance are the usual causes for this type of defect.

An aluminium window service agent will be required to repair the affected window.

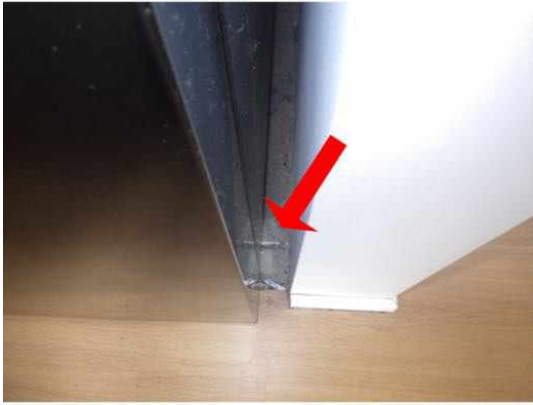
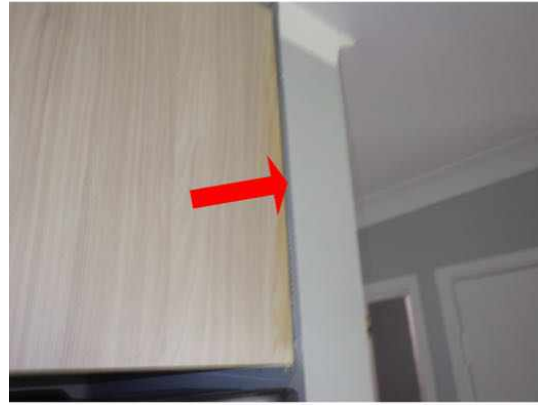
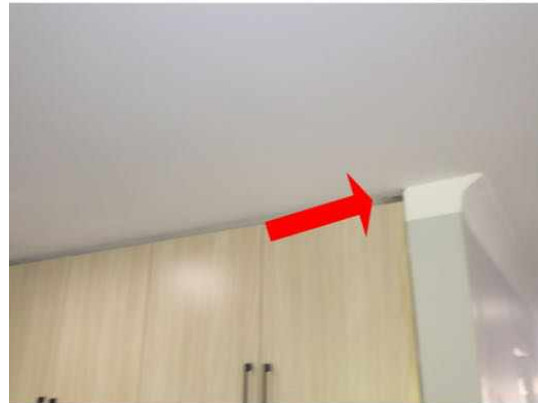
### Finding 3.06

Building: Main Building  
 Location: Kitchen > Centre Right  
 Finding: Incomplete works.  
 Information: At the time of inspection it appeared there were areas of incomplete renovation or alterations work to the floor and wall linings in the kitchen area fridge space and overhead cabinetry (as per example photos).

A qualified carpenter or general handyman could be engaged to complete the work, at the clients discretion.

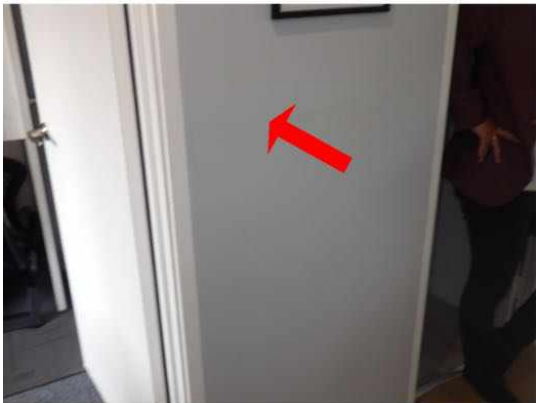
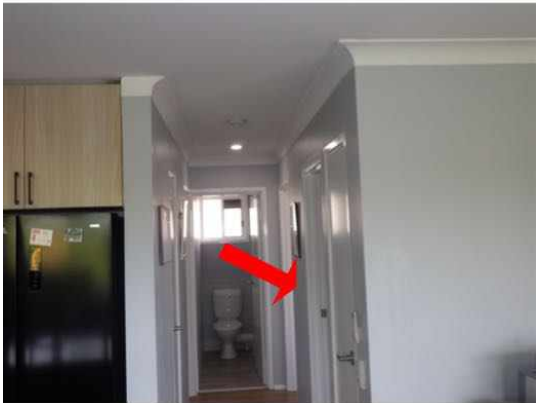
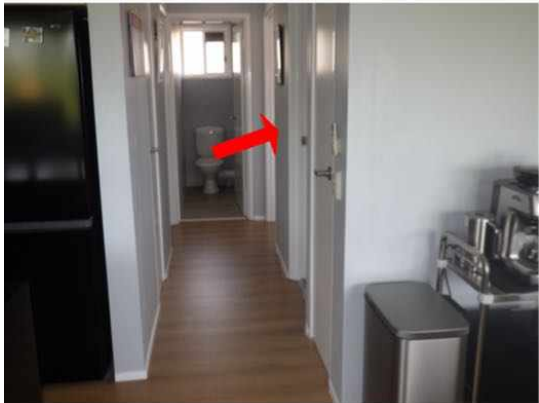
### Finding 3.07

Building:	Main Building
Location:	Hallway > Centre Right
Finding:	Cracking - Wall
Information:	There is cracking to an area of the wall lining in the hallway.

The cracking appears minor in nature and is generally only ever an appearance defect. While such cracking may be noticeable in some cases, it is quite common and does not indicate any structural damage.

Cracking of this nature can generally be repaired with minor sanding, filling and/or repainting. Such works should be performed by a qualified painter or a general handyman.

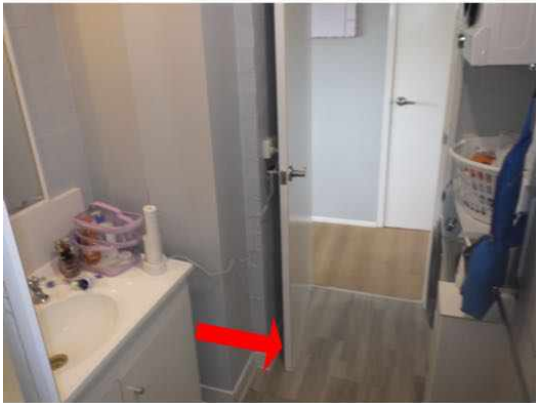
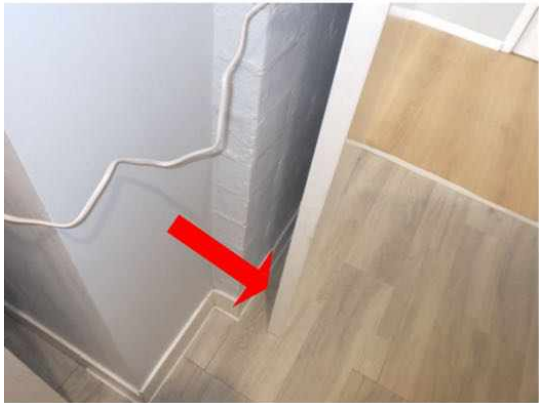
**Finding 3.08**

Building: Main Building  
Location: Bathroom/Laundry > Front  
Finding: Door stop - Missing  
Information: The bathroom door stop is missing or is inadequate to stop the door handle from impacting the wall.

Re-installation or replacement of the door stop is advised to prevent any subsequent damage to the wall linings or associated structures.

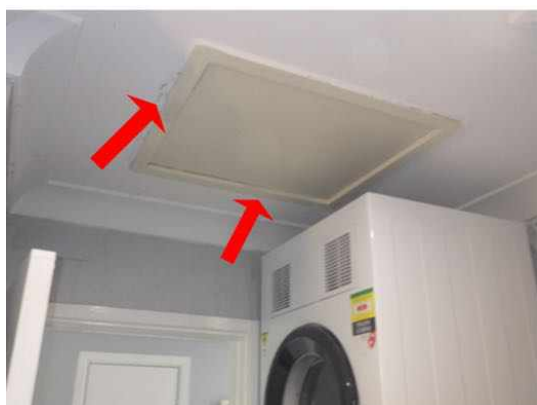
### Finding 3.09

Building:	Main Building
Location:	Bathroom/Laundry > Centre
Finding:	Cracking - Ceiling
Information:	There is cracking or damage to an area of the bathroom/laundry area ceiling.

The cracking or damage appears minor in nature and is generally only ever an appearance defect. While such cracking may be noticeable in some cases, it is quite common and does not indicate any structural damage.

Cracking or damage of this nature can generally be repaired with minor sanding, filling and/or repainting. Such works should be performed by a qualified painter or a general handyman.

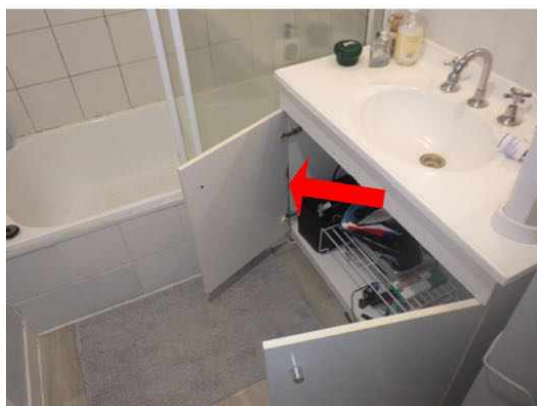
### Finding 3.10

Building:	Main Building
Location:	Bathroom/Laundry > Centre Right
Finding:	Cabinetry - Deterioration
Information:	At the time of inspection the bathroom cabinetry showed signs of minor deterioration. The level of damage appears consistent with exposure to moisture or general wear and tear.

A qualified cabinet maker or general handyman could be engaged to undertake repair works at the clients discretion.

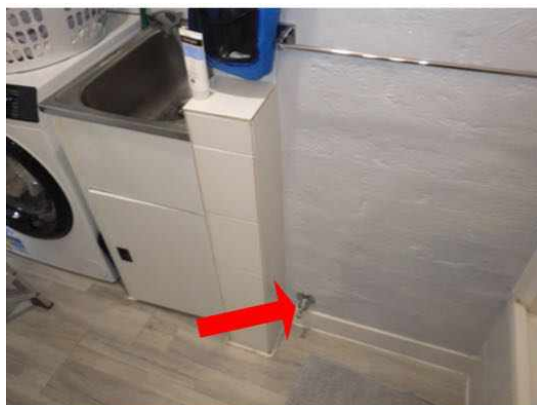
### Finding 3.11

Building: Main Building  
 Location: Bathroom/Laundry > Centre Left  
 Finding: Tap Missing  
 Information: At the time of inspection there was a tap handle fitting missing from the bathroom/laundry area wall.

A licensed plumber should be engaged to replace the missing tap.

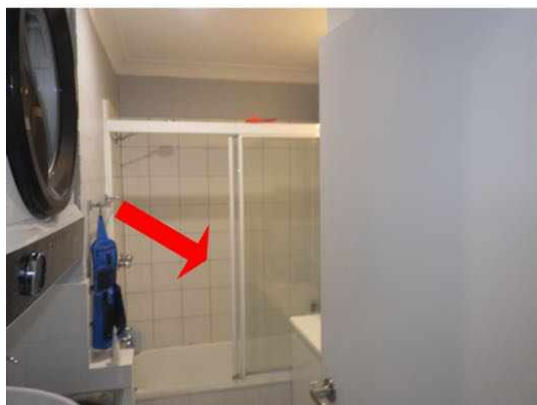
### Finding 3.12

Building: Main Building  
 Location: Bathroom/Laundry > Centre,Rear  
 Finding: Shower - Cracked tile  
 Information: Cracking was evident to a wall tile in the bathroom shower cubicle at the time of inspection. The cracking is more than likely due to impact damage, but may have also been caused by general ageing and deterioration of associated building elements. While the cracking appears to be minor, any additional impact may lead to further cracking.

As this area is frequently exposed to water, any cracking is likely to allow water penetration if left unmanaged.

Appointment of a tiling contractor is required to repair the cracked shower wall tile, so as to ensure no water damage occurs.

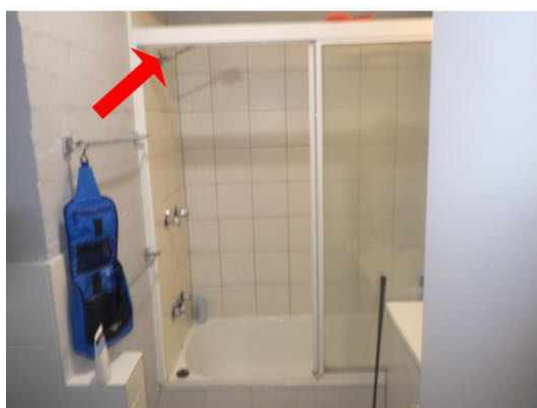
### Finding 3.13

Building: Main Building  
 Location: Bathroom/Laundry > Rear Left  
 Finding: Tiles - Gaps  
 Information: At the time of inspection there was a gap between the bathroom shower area shower rose back plate or shroud and the wall tiles. It is important this area is sealed to prevent moisture or liquids penetration and/or vermin from accessing and/or nesting in these areas.

A qualified tiler or general handyman could be engaged to undertake rectification work.

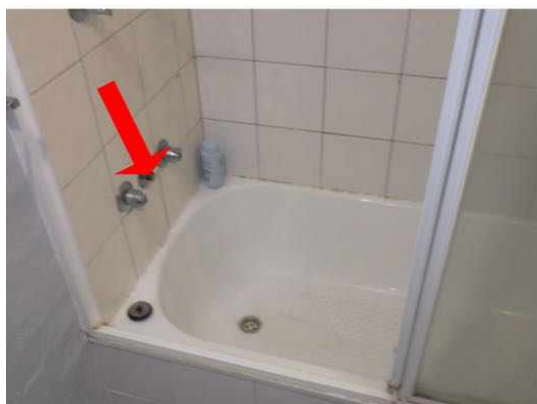
### Finding 3.14

Building: Main Building  
 Location: Bathroom/Laundry > Rear Left  
 Finding: Fitting Missing  
 Information: At the time of inspection there was a bath spout fitting missing from the bathroom area shower cubicle. It appears the bath spout has been purposely removed and the

pipework capped off (reason unknown).

A licensed plumber should be engaged to check the plumbing pipework and replace the missing bath spout.

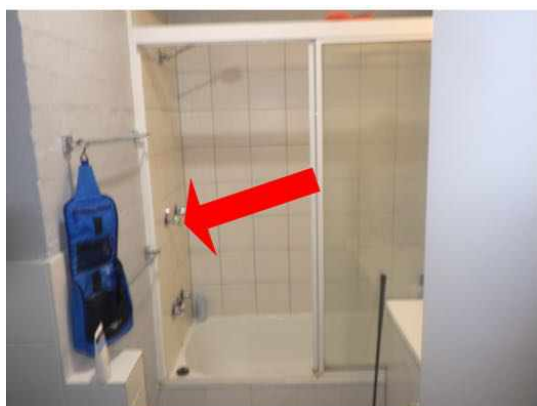
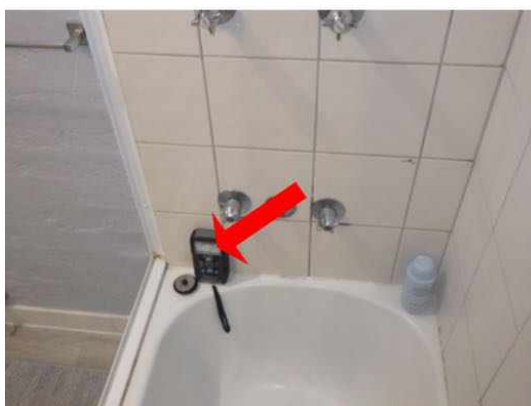
### Finding 3.15

Building: Main Building  
 Location: Bathroom/Laundry > Rear Left  
 Finding: Shower - Moisture  
 Information: Elevated moisture level readings were recorded on the south side wall to the bathroom shower alcove at the time of inspection. No moisture level readings were able to be obtained on the opposite side of the wall. Both sealant and grout appear in fair condition at present.

This defect is suspected to have been caused by a leaking water pipe or moisture permeating or leaching through the grouting and perhaps gaps in the sealant.

Consultation with a qualified plumber or bathroom specialist would be advised to identify the cause of damp and to perform remedial works as required.

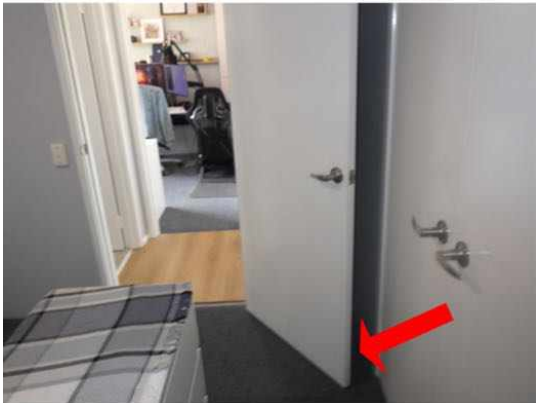
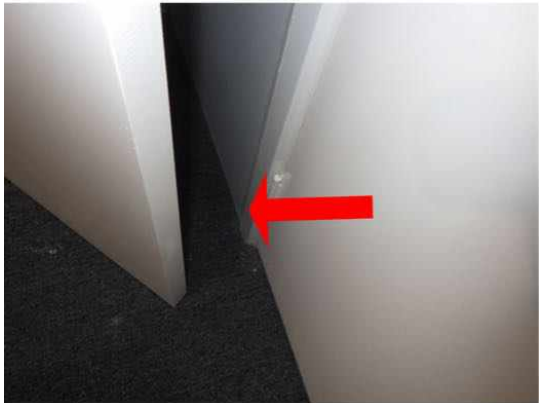
**Finding 3.16**

Building: Main Building  
Location: Bedroom > Front  
Finding: Door stop - Missing  
Information: The bedroom door stop is missing or is inadequate to stop the door handle from impacting the wall.

Re-installation or replacement of the door stop is advised to prevent any subsequent damage to the wall surface or associated structures.

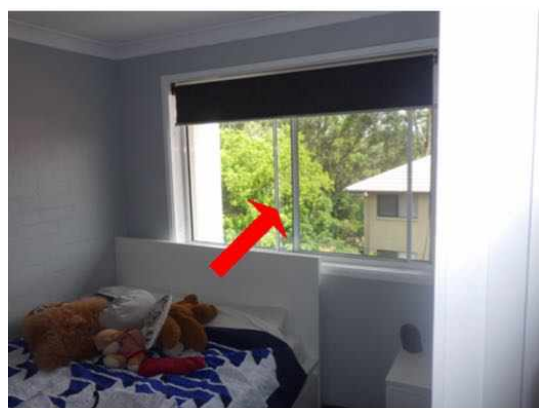
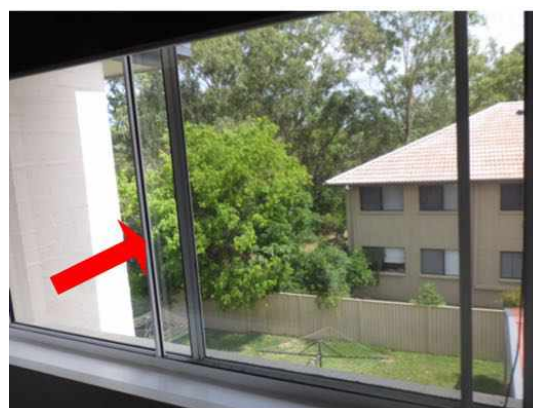
### Finding 3.17

Building:	Main Building
Location:	Bedroom > Centre Right
Finding:	Window Catch - Latch missing
Information:	It was noted that the window catch to the bedroom area sliding window was missing at the time of inspection. Whilst detracting from the functionality of the window, this minor defect may also be a security risk.

It is suspected that this defect has occurred due general wear and tear, which is expected for building elements of this age.

An aluminium sliding window service agent or general handyperson may be appointed to perform rectification works as necessary, at client discretion.

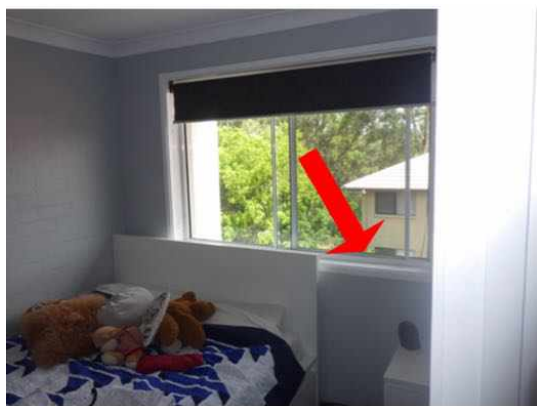
### Finding 3.18

Building:	Main Building
Location:	Bedroom > Centre Right
Finding:	Window - Stiff to Slide
Information:	The aluminium sliding window in the bedroom area was stiff to operate at the time of the inspection. Windows provide ventilation to the adjoining area and should be at a fully operational level to ensure user comfort.

Generally, factors such as general age of the building element and a lack of maintenance are the usual causes for this type of defect.

An aluminium window service agent will be required to repair the affected windows.

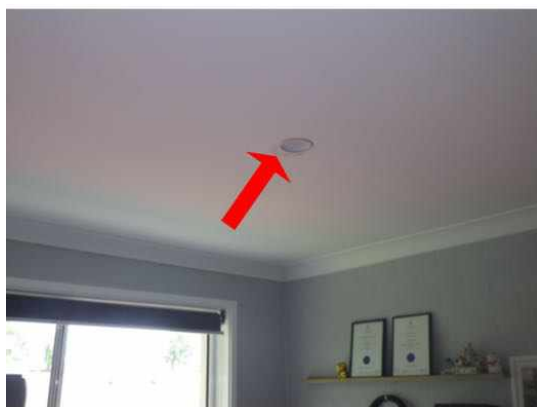
### Finding 3.19

Building:	Main Building
Location:	Bedroom 2 > Centre
Finding:	Ceiling - Scuffed
Information:	Superficial scuff marks were noted to the bedroom 2 ceiling at the time of inspection. Marked and scuffed surfaces, while detracting from the overall appearance of the affected building element, do not indicate any operational or structural damage. This degree of surface damage is consistent with previous alterations.

A qualified painter or general handyman may be appointed to rectify marked or scuffed surfaces at the client's discretion.

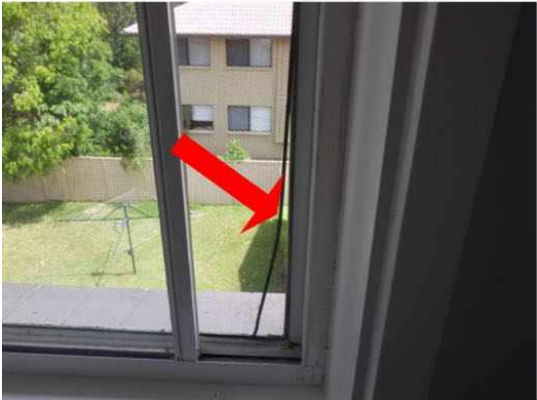
### Finding 3.20

Building:	Main Building
Location:	Bedrooms > Existing
Finding:	Insect Screens
Information:	At the time of inspection a number of insect screens showed signs of damage or general wear and tear (as per example photos).

A insect screen service agent or supplier could be consulted regarding repair or replacement of the damaged screens.

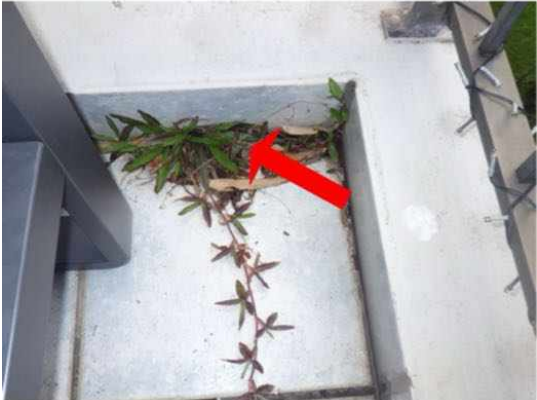
**Finding 3.21**

Building: Main Building  
Location: Balcony > Front Left  
Finding: Blocked Drain  
Information: At the time of inspection it was noted the external balcony area nib wall drain pipe was blocked with vegetation type debris.

A general handyman could be engaged to remove the debris and unblock the drain at the clients discretion.

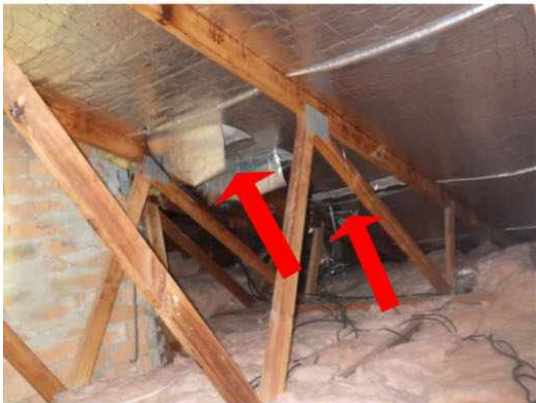
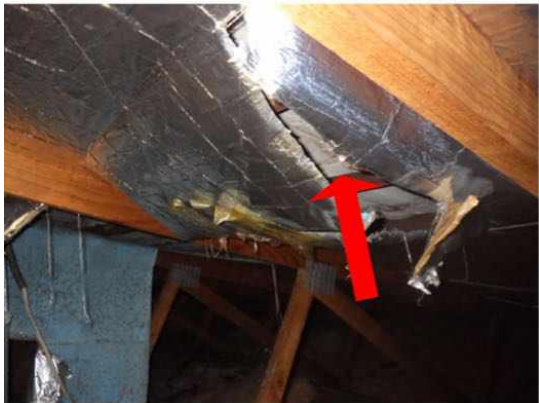
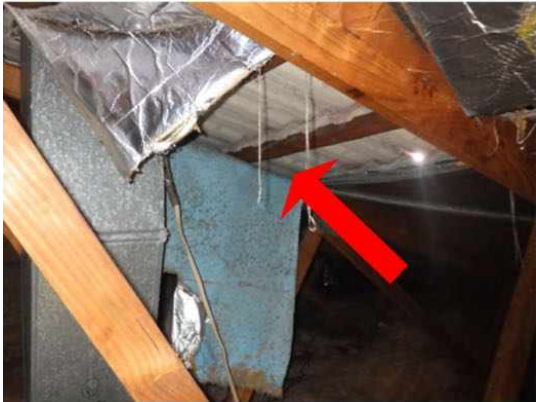
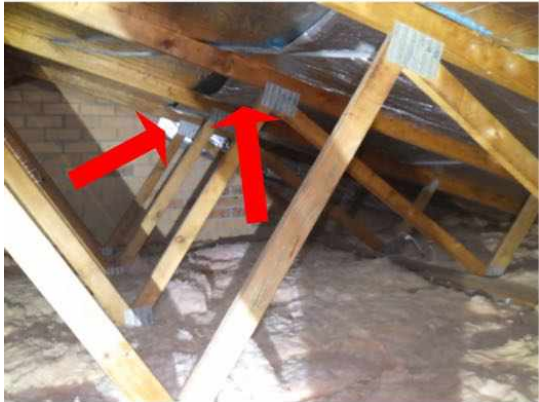
**Finding 3.22**

Building: Main Building  
Location: Attic > Existing  
Finding: Sarking - Damaged  
Information: At the time of inspection it was noted, there was loose or damaged sarking in the roof space area.

Where sarking is damaged, both insulation and moisture protection of the property are inhibited. This creates a loss of energy and thus negatively impacts the energy efficiency of the property, allowing potential for moisture ingress from condensation or leaking roof tiles.

It is important to repair any holes or damaged sections of sarking to ensure that the building material is fully functional. A registered builder or qualified carpenter should be consulted to provide further advice on this defect and to perform rectification works at client discretion.

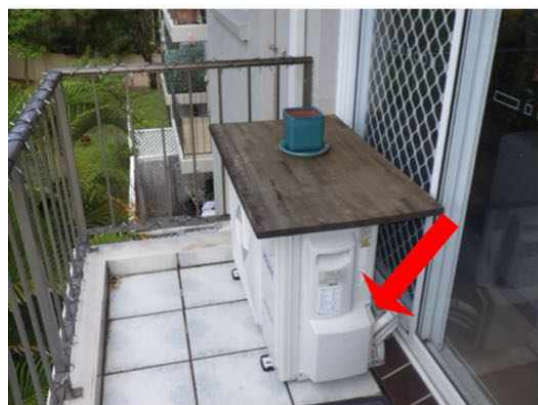
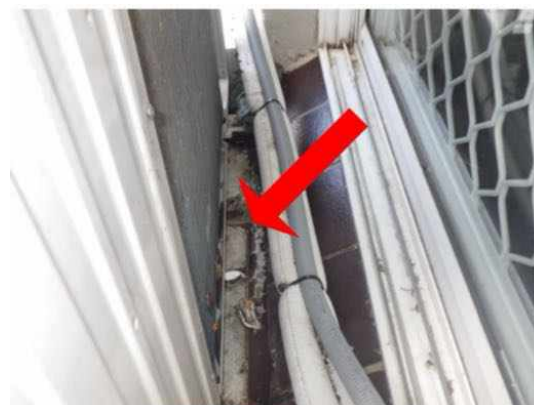
Building:	Main Building
Location:	Balcony > Front Right
Finding:	Overflow - Not plumbed for drainage
Information:	The air conditioning unit overflow is not plumbed or connected to suitable drainage, which can result in the surrounding area becoming excessively damp. These damp conditions can lead to secondary defects such as rot, rust or corrosion of associated building elements, the formation of fungal decay, or even the creation of potential slip hazards. When coupled with poor site drainage, pooling of water may also attract termite activity to this area. It is highly recommended that a qualified air conditioning unit service agent be appointed to check the operational condition of the unit and to install adequate drainage to the overflow. These works will ensure that the area remains dry and free of any secondary defects.

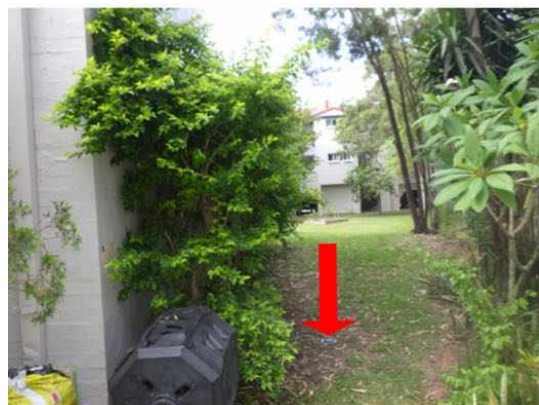
In this instance evidence of a previously installed baiting stations was observed. This system requires regular inspections and replenishment.

No evidence of regular or annual inspections was found.

Where a Termite Management System has been identified you should refer to the type of barrier date of installation warranty conditions and any documentation provided by a past owner or body corporate managers.
