## Building Inspection Report

Inspection Date: Thu, 26 Feb 2026

Property Address: unit 6/15 Beafield Rd, Para Hills West SA  
5096, Australia

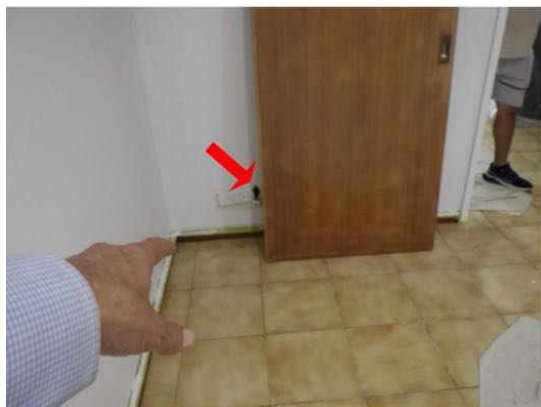
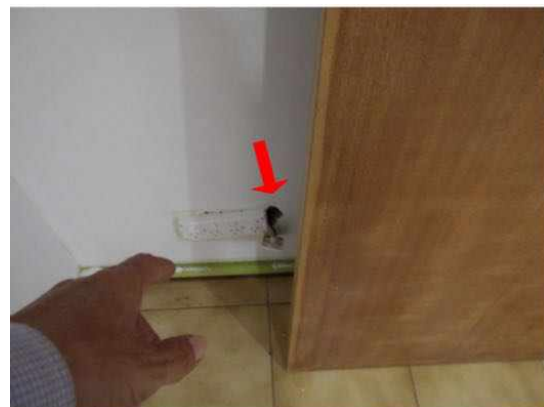
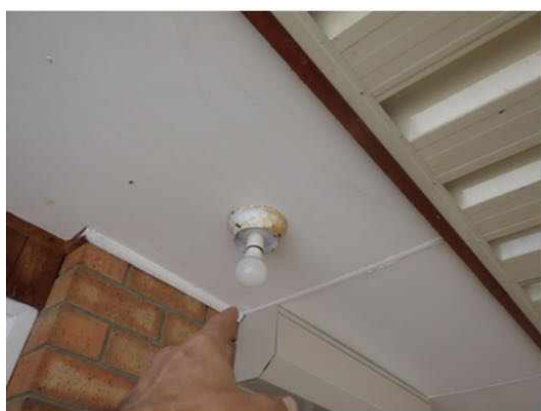
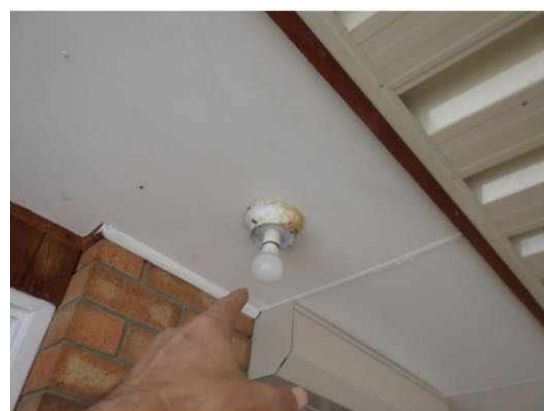
#### Defects 1.01

Building: Building 1  
Location: All Areas  
Finding: Electrical fitting - Broken/ Loose from its original fixing  
Information: The electrical fitting in this area was found to be broken/ loose from its original fixing at the time of inspection. Breakage occurs generally when the building materials have aged and decayed, but may also be indicative of impact damage to the building element (accidental or deliberate).

Left unmanaged, the fitting is unlikely to cause further damage to surrounding building elements. However, the broken fitting does expose electrical works, and may create a safety hazard if there is potential contact with persons in the area.

Repair and/or replacement of the broken fitting is advised. A Licensed electrician should be appointed to repair/replace the fitting immediately.

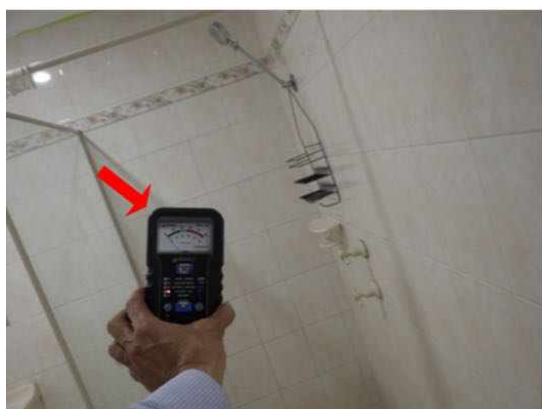
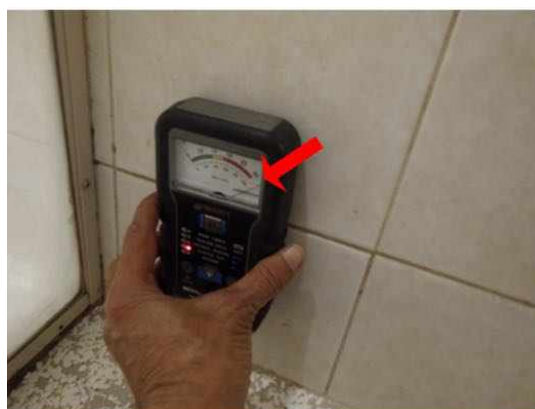
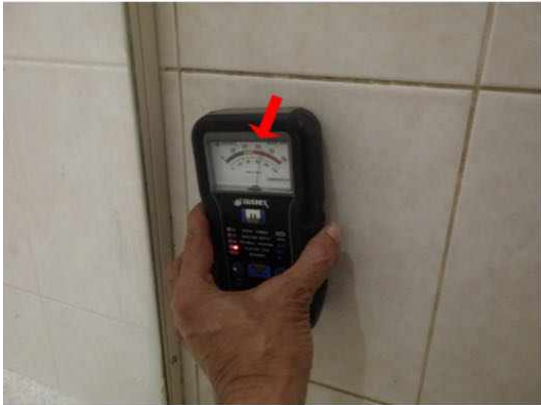
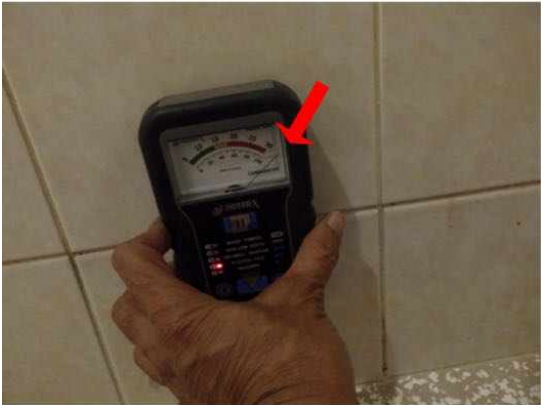
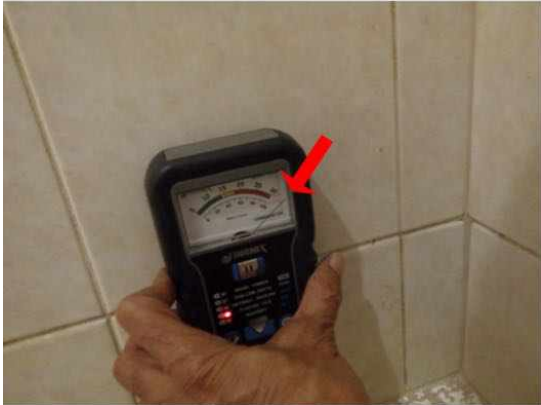
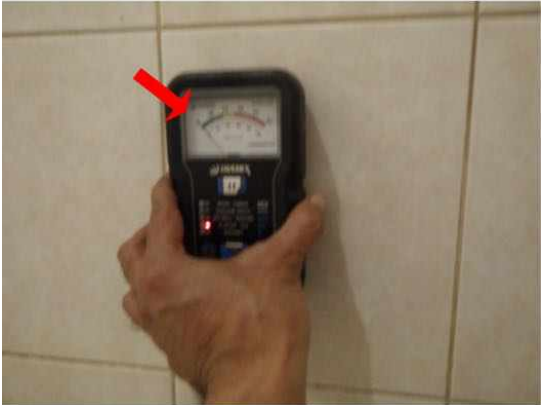
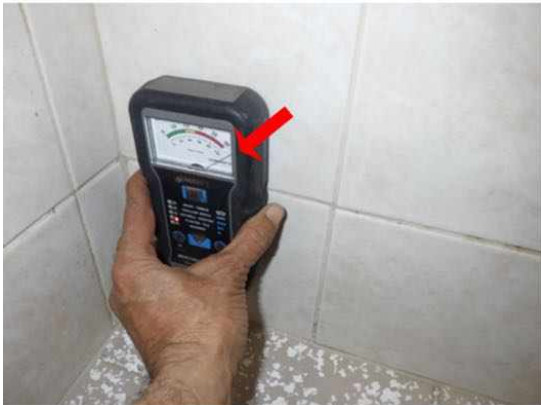
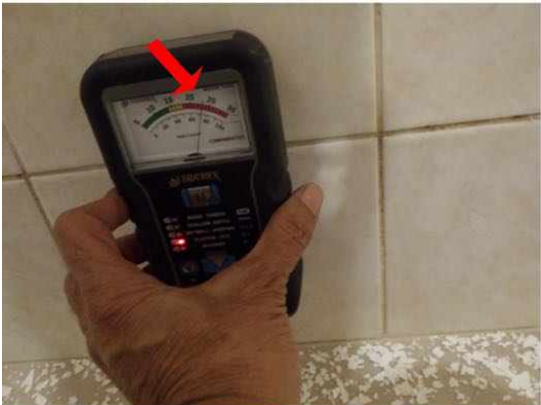
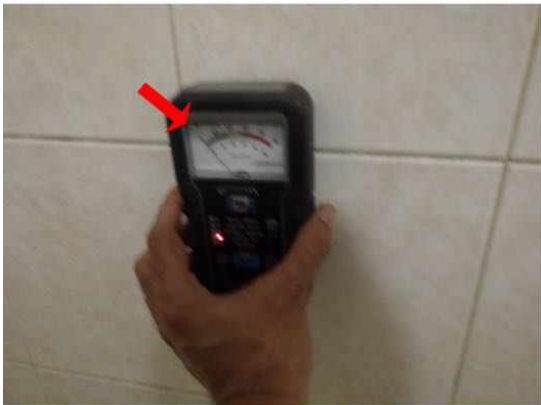
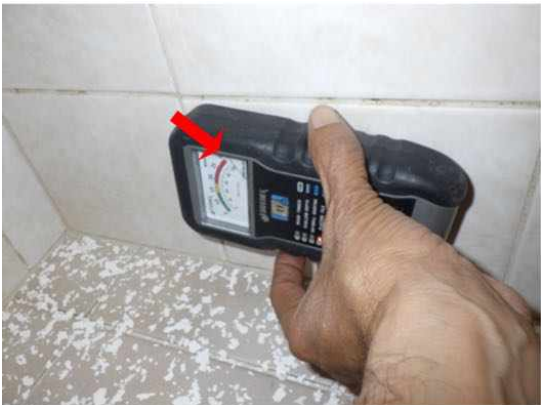
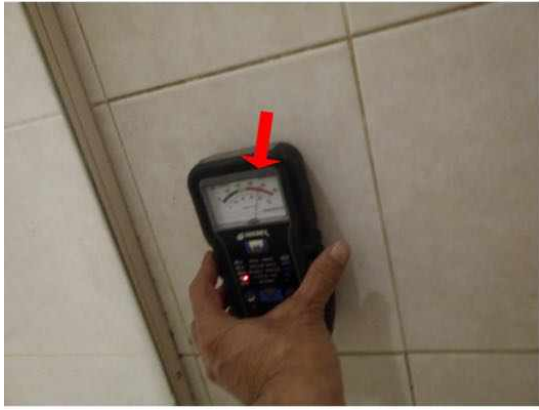
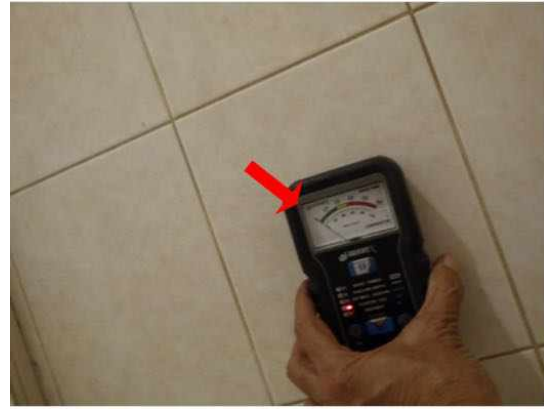
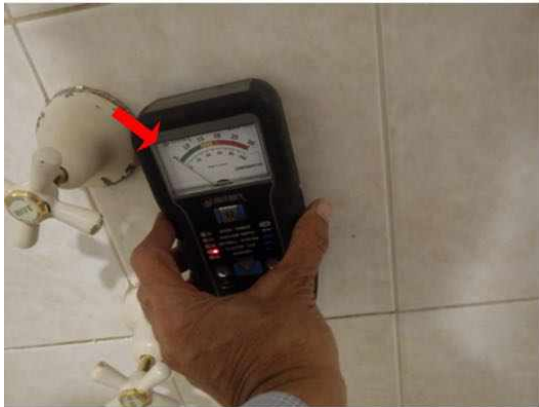
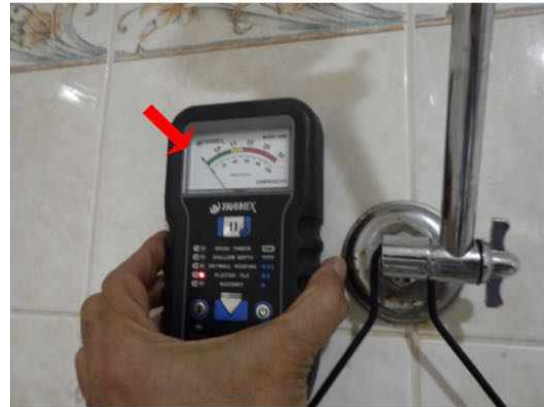
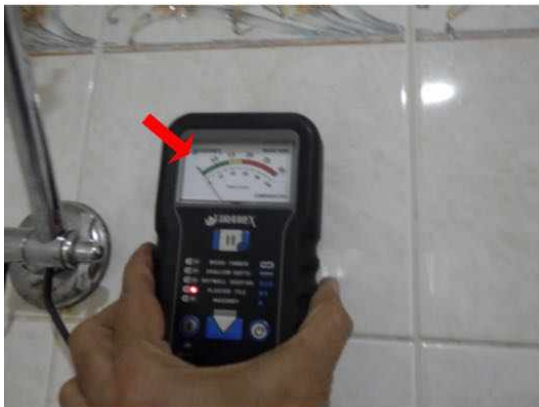
## Defects 2.01

Building:	Building 1
Location:	Bathroom
Finding:	Shower Alcove - Damp
Information:	Damp is evident to the lower 400mm approximately of wall to the shower alcove. This defect is quite common, and is suspected to have been caused by moisture permeating through the grouting in this area, which shows evidence of deterioration. Leaking pipes within the adjoining wall is also a possible cause.

Damp (or structural damp) refers to the presence of unwanted moisture in the structure of a building, either as the result of intrusion from outside, or condensation from within the structure. In the shower area, internal water leaks or other sources of excessive moisture are generally the cause of damp.

Unmanaged damp in the shower recess is likely to facilitate the formation and development of mould and fungi growth, decaying associated building materials and compromising their structural integrity. Exposure to these contaminants is associated with a wide range of respiratory and other health-related problems.

Consultation with a qualified plumber or bathroom specialist is advised immediately to identify the cause of damp and to perform remedial works as required. Where excessive mould growth is present, further inspection by a specialist environmental health inspector should also be considered.

Always ensure that sealant and grout is in good condition to prevent any moisture issues occurring in the future.

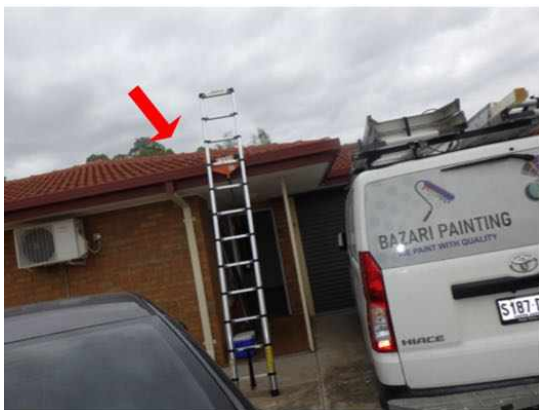
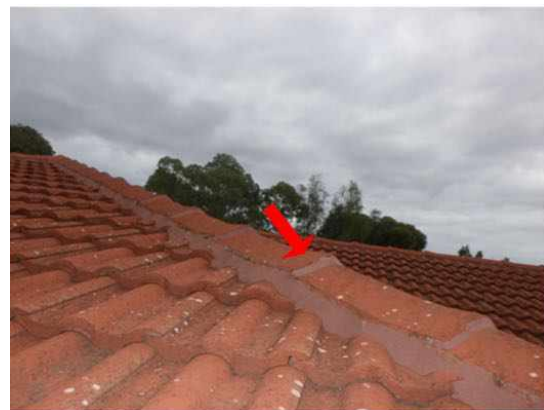
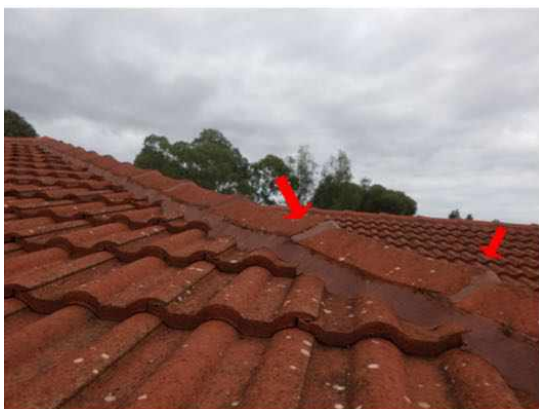
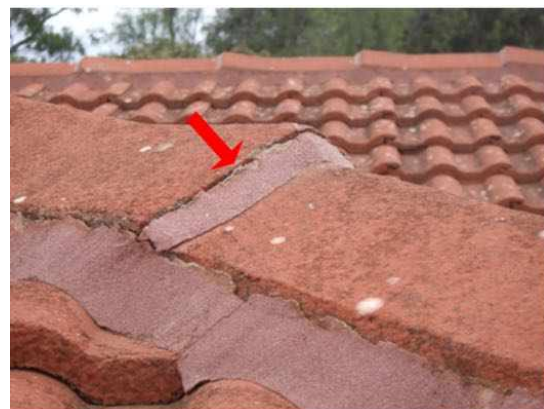
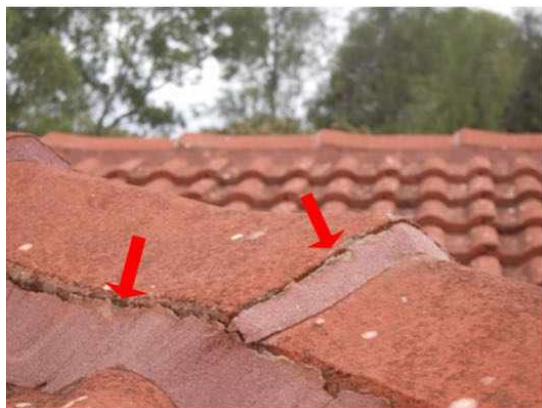
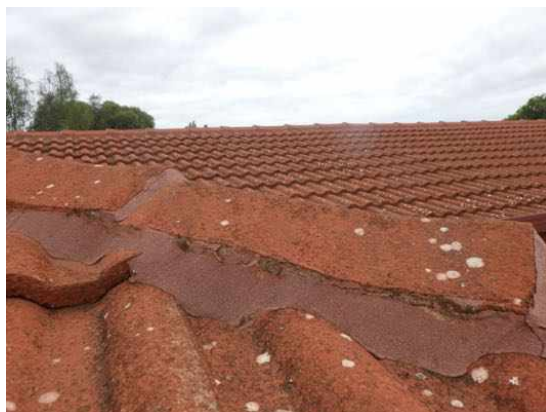
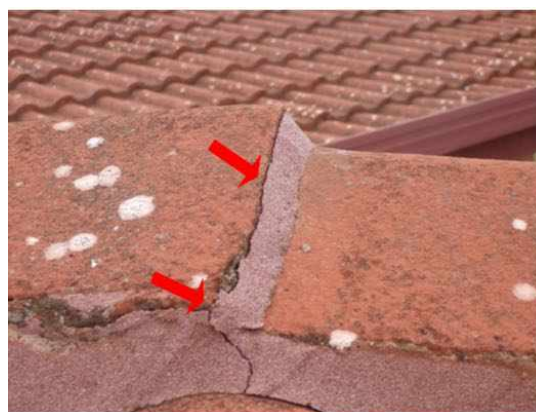
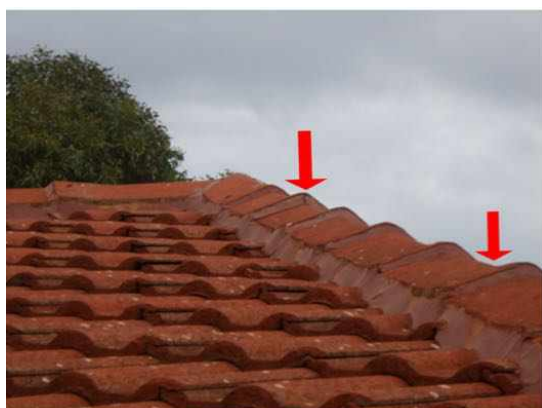
### Defects 3.01

Building:	Building 1
Location:	All External Areas
Finding:	Mortar - Deterioration
Information:	At the time of inspection it was noticed that evidence of mortar deterioration to few roof tiles around the property.

other building elements on the exterior roof covering, such as gable ends, hip capping and valleys. Upon inspection of the exterior roof, it was noted that sections of the mortar show varying levels of deterioration.

Mortar generally deteriorates as a result of frequent exposure to weather conditions over a prolonged period of time. Mortar that is deteriorating may allow water ingress into the roof void, putting associated building elements and roofing structures at risk of water damage. Deteriorated mortar also detracts from the functionality of roof tiles and other roofing elements, potentially decreasing weather tightness and roof drainage.

Mortar deterioration can be attended to by a handyperson where areas of deterioration are localised and easily accessible. Otherwise, consultation with a roofing contractor is advised where greater works are required.

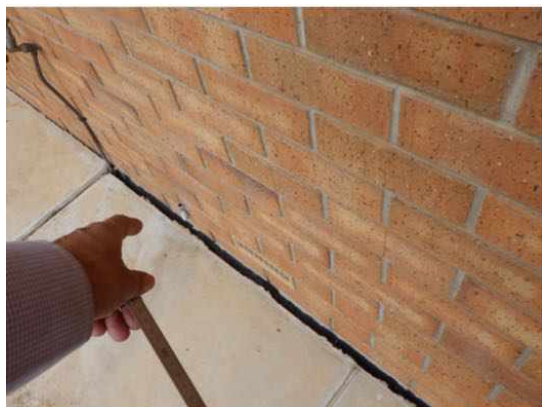
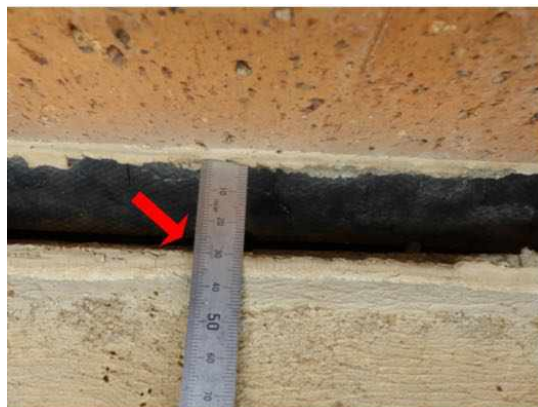
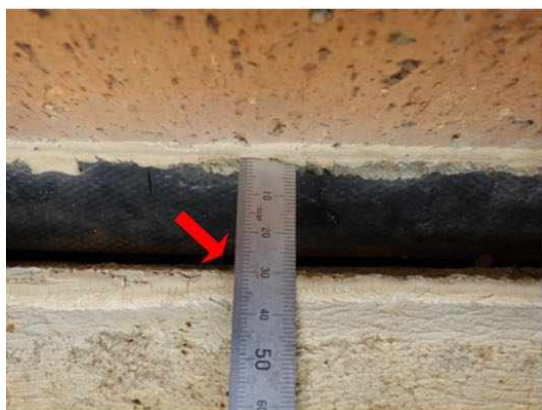
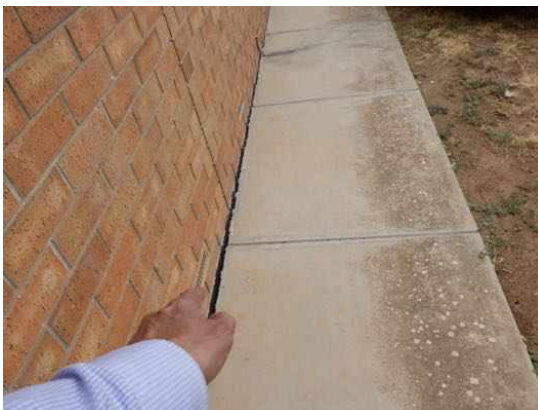
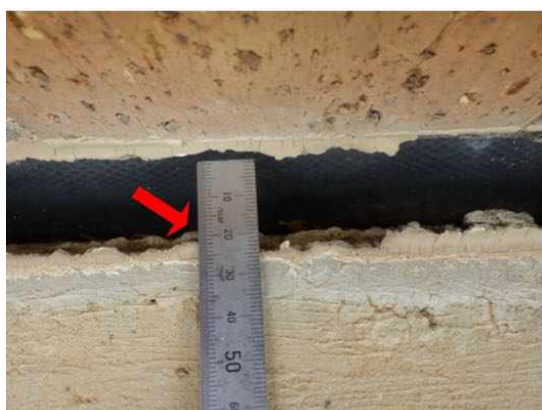
### Defects 3.02

Building:	Building 1
Location:	All External Areas
Finding:	Gaps in perimeter pavement
Information:	Gaps in the external concrete paving were identified at the time of inspection. Gaps in the slab are significant and are likely to lead to the development of secondary defects if left unmanaged, such as the creation of a trip hazard and water entry points.

It is likely that this movement has occurred for several reasons. These could include substandard installation, reactive clay soils and stormwater issues.

including roof and ground flows, contained and continually maintained. High moisture also creates an environment that is conducive to termite attack.

A licensed Plumber should be appointed immediately to ensure that the stormwater pipework is intact and adequate, and all gaps to concrete, driveways and paths should be sealed by a licensed builder or a general handy person to keep moisture from entering.

A licensed concretor may be required to replace pavements that are beyond repair.

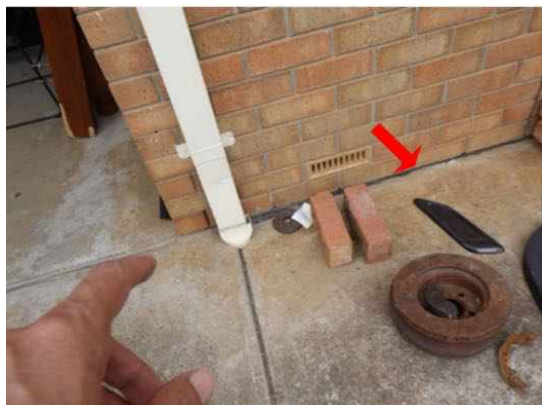
### Defects 3.03

Location: All External Areas  
 Finding: Slab Edge - Exposure compromised  
 Information: At the time of inspection it was noticed that slab edge exposure has been compromised in few sections around the property.

If the slab edge is not properly exposed there is a high risk of termite attack. Sometimes, in order to determine the type of slab, a suitably qualified person such as an architect or builder may be required to consult the construction plans.

Where the slab edge cannot be properly inspected, it is highly recommended that termite or timber pest inspections be carried out every 6-12 months to aid protection of the property against infestation.

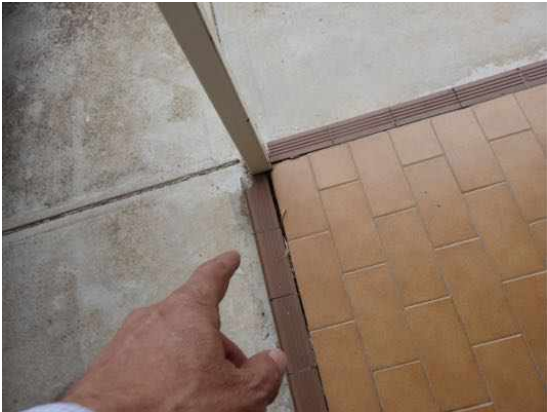
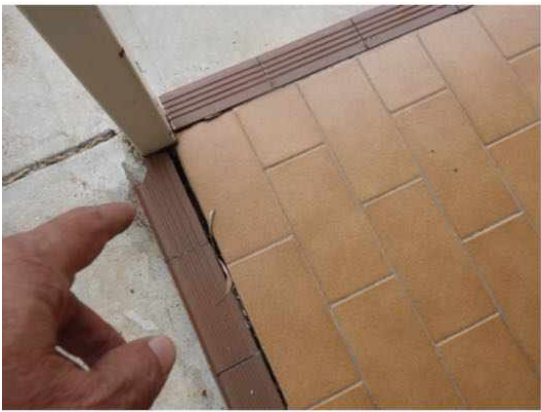
### Defects 3.04

Building: Building 1  
 Location: All External Areas  
 Finding: Floor tiles - Cracked/ Damaged  
 Information: Cracking / damage in the floor tiles was evident in this entry area at the time of inspection. It is suspected that this cracking has occurred as a result of the floor being uneven and lacking a solid or suitable foundation for the tiles to be laid on. Settlement in the floor foundations may also have caused movement and resulted in the cracking of tiles in this area.

Cracked tiles throughout the household detract from the overall appearance of the affected areas, as well as creating potential for water penetration to adjoining building elements. If left unmanaged, water damage may occur as a result of constant water

While not considered a matter of urgency, replacement of cracked floor tiles is advised as a solution. A tiling contractor or general handyperson may be appointed to perform these works at client discretion.

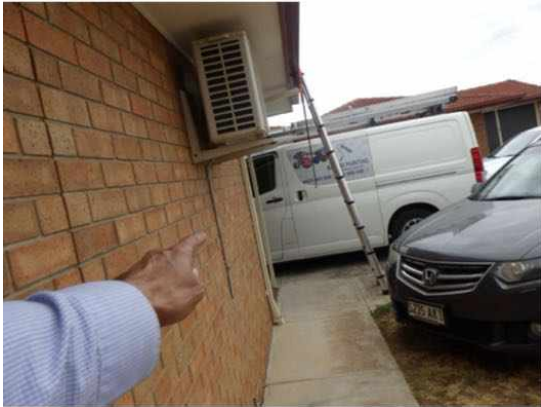
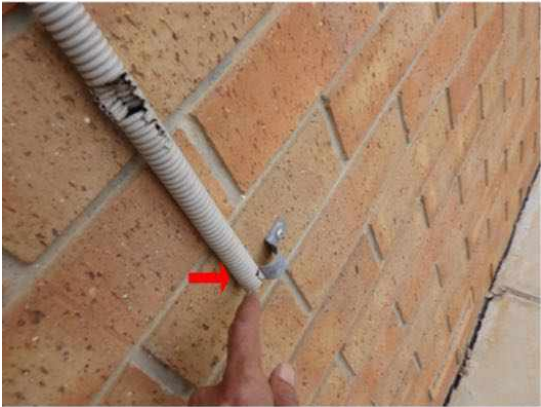
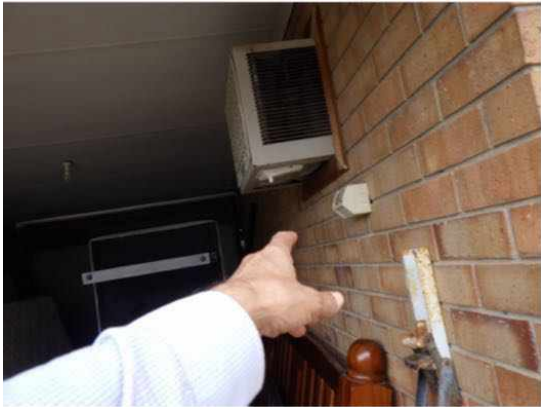
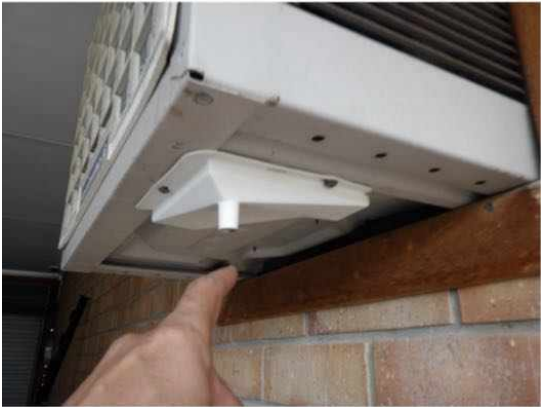
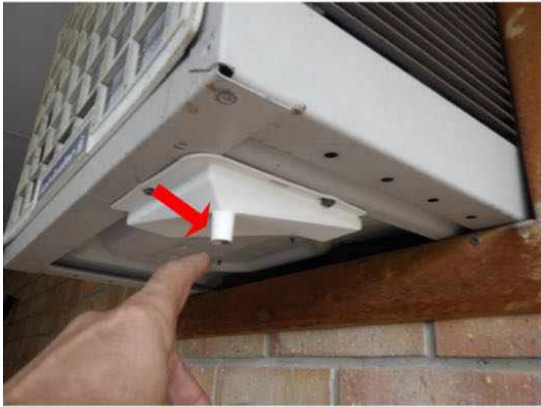
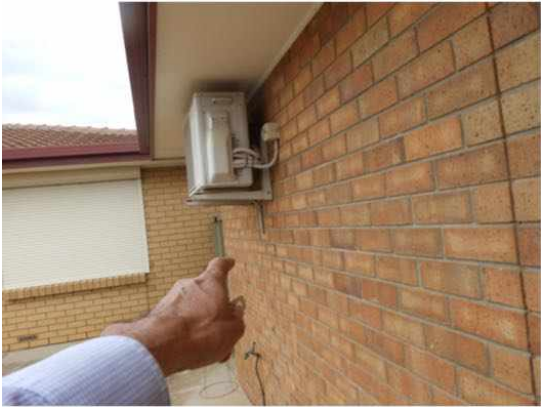
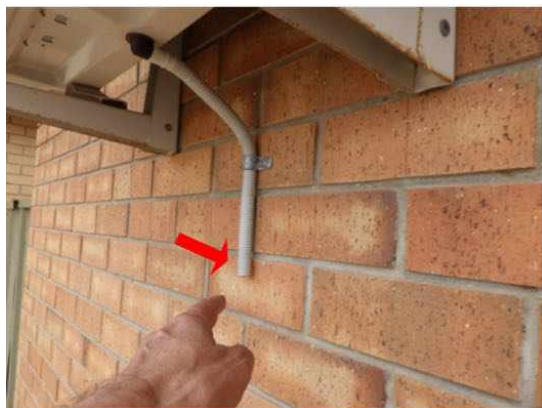
**Defects 3.05**

Building:	Building 1
Location:	All External Areas
Finding:	Air conditioner - Disconnected overflow
Information:	The Air Conditioner (A/C) overflow was found to be disconnected from storm water

drainage and is creating excessive moisture in the surrounding area.

Such leaking creates an environment which is conducive to an array of defects, including water damage to associated building elements and the attraction of termite or timber pest infestation.

It is highly recommended that a licensed plumber be appointed to connect the A/C overflow in order to prevent such an environment from being created. These minor works should be carried out as soon as possible.

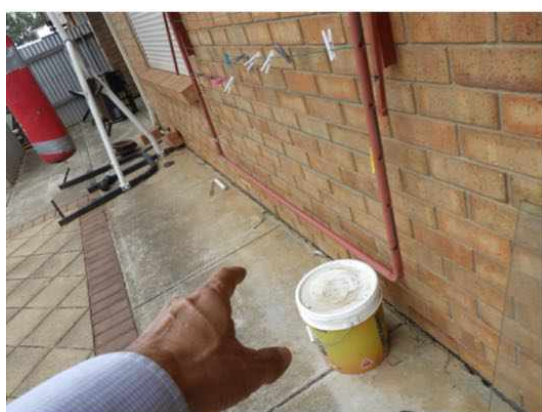
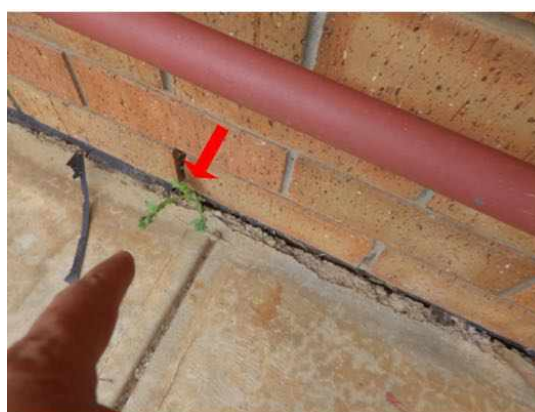
### Defects 3.06

Building:	Building 1
Location:	All External Areas
Finding:	Bridging - Vegetation
Information:	Where vegetation obstructs inspection of building elements, also known as bridging as it provides a bridging point for the access of termites, full inspection can not be achieved. Consequently moisture or dampness may be present and the areas becomes conducive to termite activity. Plants against or very close to buildings provide cover, shade and can provide an environment that is attractive to termite infestation.

The removal and replanting of species that do not provide "cover" or cutting back of existing vegetation will assist greatly in preventing Bridging from occurring.

The removal of any such materials that may be conducive to termite activity should be carried out as soon as possible and arrange re inspection to minimize the risk of termite attack.

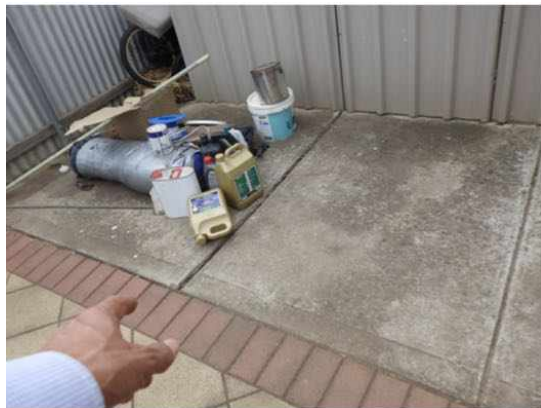
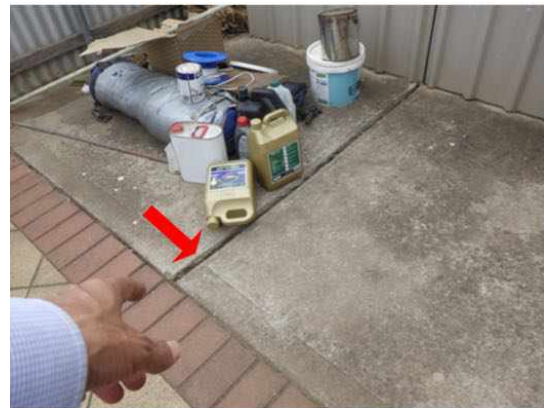
### Defects 3.07

Finding: Paving - Uneven

Information: Sections of the external paved area are uneven, creating a potential trip hazard. It appears as though the area has been subject to rough installation, or that paving sections have lifted due to movements in the foundation of the property.

Where paving creates a trip hazard, personal injury may ensue if due caution is not taken by all persons within this area.

Re-paving of the area is required as soon as possible to remedy this situation. Further consultation with a specialist concreter is advised.

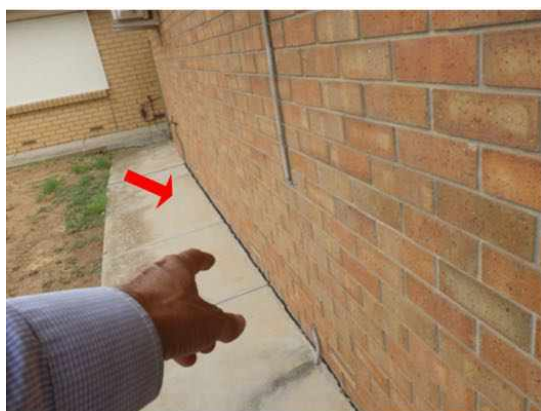
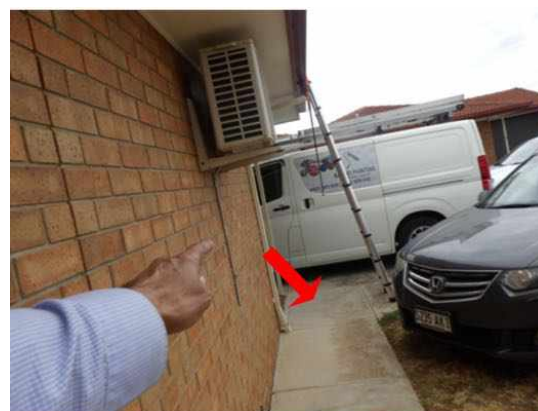
Building: Building 1  
 Location: All External Areas >  
 Finding: Termite Management System - No evidence of a chemical installation  
 Information: The application of a post-construction chemical termite barrier is highly recommended for all properties, particularly if live termite activity has been found on the site previously. Such barriers are highly effective in preventing termite attack on any timber building elements throughout the property.

A durable notice should be placed in the switchboard unit to indicate current termite barriers. At the time of inspection, it appeared as though no termite management system has been installed, with no evidence to suggest preventative works taking place.

The client may consider gaining further advice from a pest controller as to the costs and procedures involved with this application. It is recommended that obtaining such advice be a short-term priority.

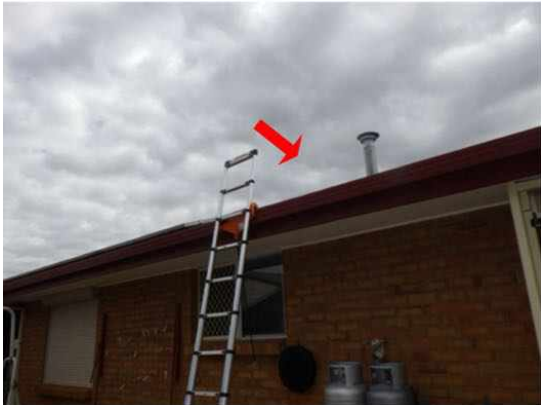
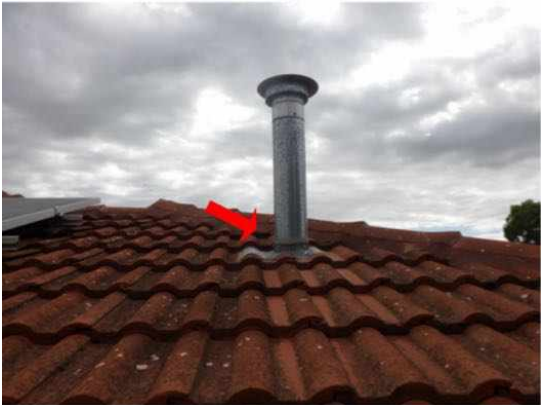
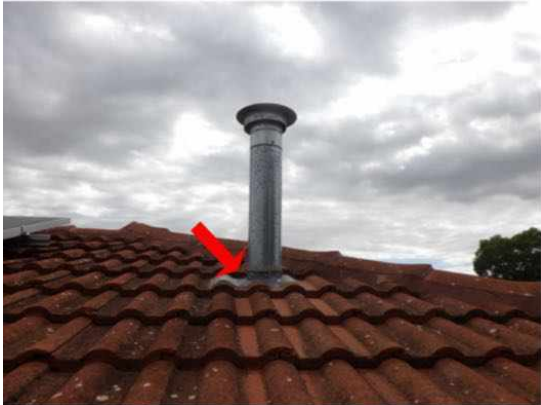
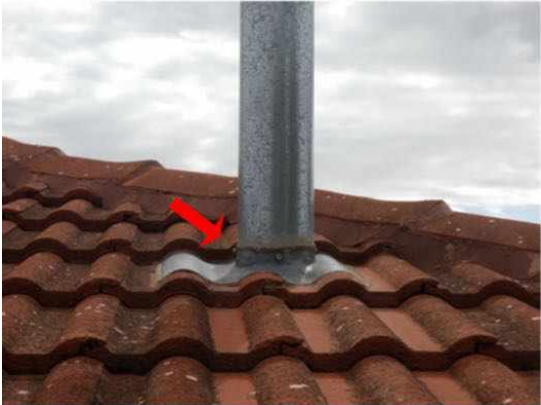
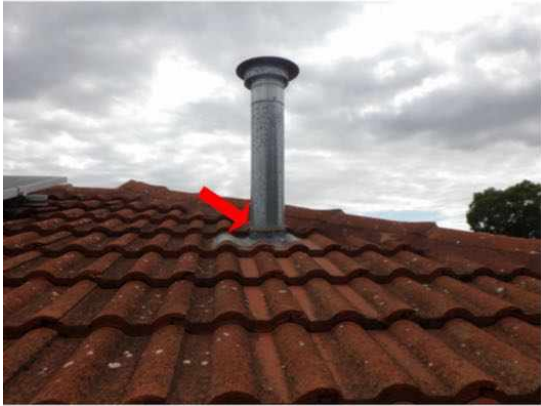
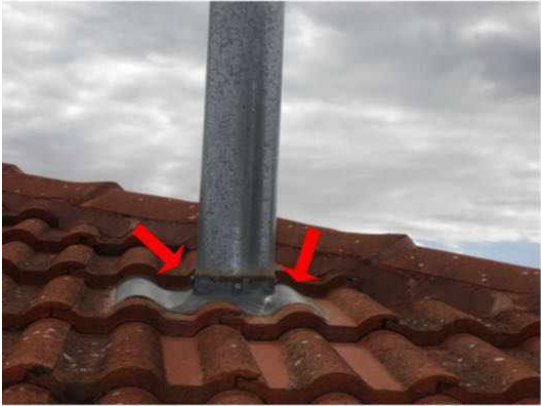
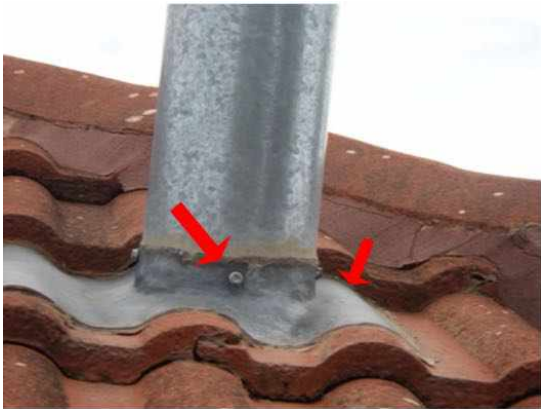
Building: Building 1  
 Location: All External Areas  
 Finding: Roof Exterior / Roof Space – Exhaust Flue Pipe & Flashing  
 Information: At the time of inspection of the roof space area, it was observed that the range hood exhaust flue pipe had been installed through the roof covering. Flashing was noted to be installed around the flue penetration at the roof tiles, and power-driven screws were observed fixing the exhaust flue pipe.

Apart from the above, at the time of inspection, we were advised by the current owners that they had previously noticed evidence of water damage to the ceiling linings in the kitchen area. No invasive testing was carried out as part of this inspection.

Further investigation by an appropriately qualified tradesperson is recommended to confirm the effectiveness of the roof flashing and to determine whether any ongoing or concealed moisture ingress is present.

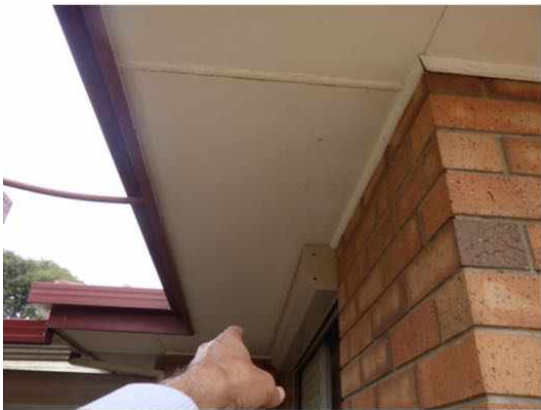
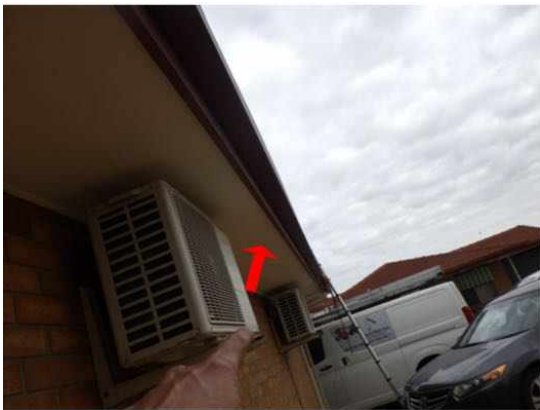
Building: Building 1  
 Location: All External Areas  
 Finding: Asbestos - Suspected ACM Identified on Site  
 Information: Reporting on Asbestos is outside the Scope of this Report. This suspected defect is highlighted as a caution only. We suspect, based on our experience in the building industry, that there is a higher risk of the identified building element containing asbestos.

As Asbestos Reporting is outside the scope of this report, we advise that you consider a separate Asbestos Inspection and Condition Audit, which can include the taking of samples for definitive confirmation of the presence of Asbestos.

In the interim, the client is advised to act with caution, especially when considering any damage to building materials general wear and tear renovations extensions demolition and general maintenance activities due to the suspected presence of Asbestos.

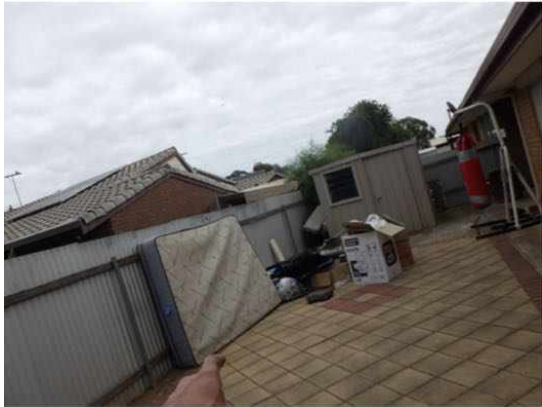
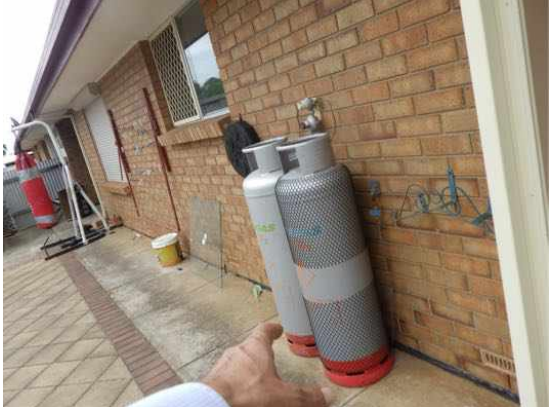
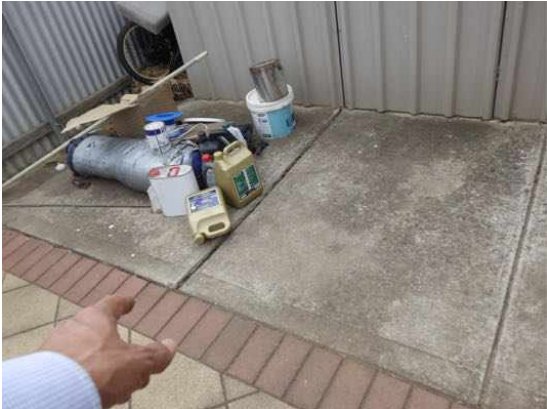
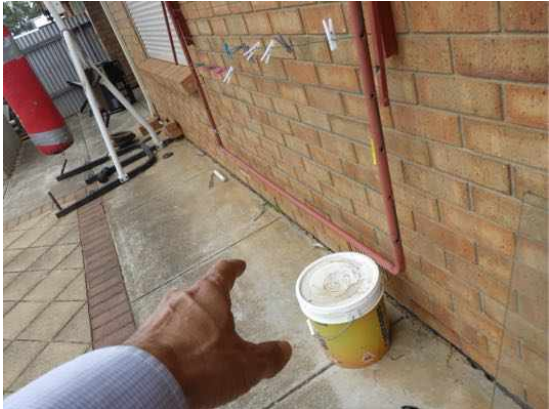
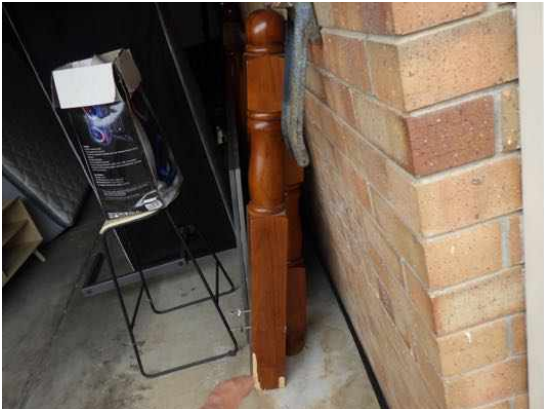
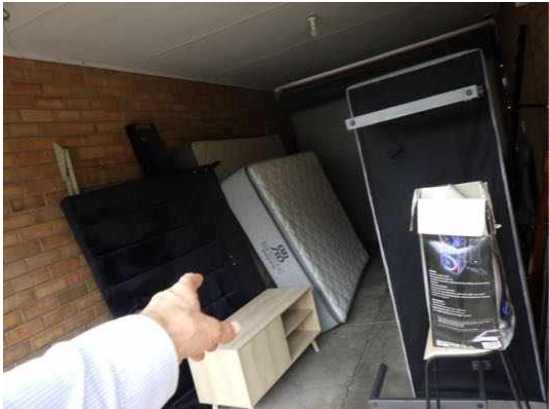
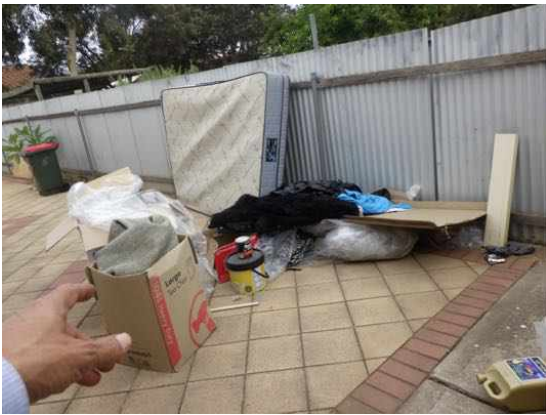
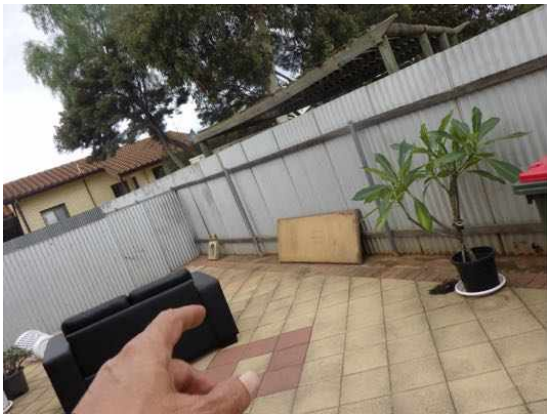
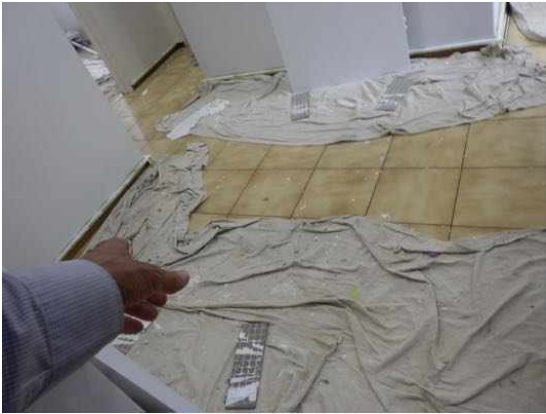
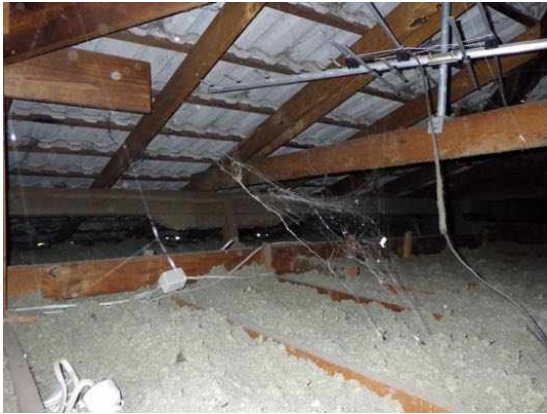
Building: Building 1  
 Location: All Areas  
 Finding: Additional Photos - Obstructions and Limitations

Information: These photographs are an indication of the obstructions and limitations which impeded full inspection of the property at the time of inspection. These obstructions can hide an array of defects and should be removed to allow full inspection to be carried out. A re-inspection is recommended once the areas are made accessible.
