Building and Timber Pest Inspection Report

Inspection Date: Fri, 23 Jan 2026

Property Address: 53 Air League Ave, Leppington NSW 2179,
Australia

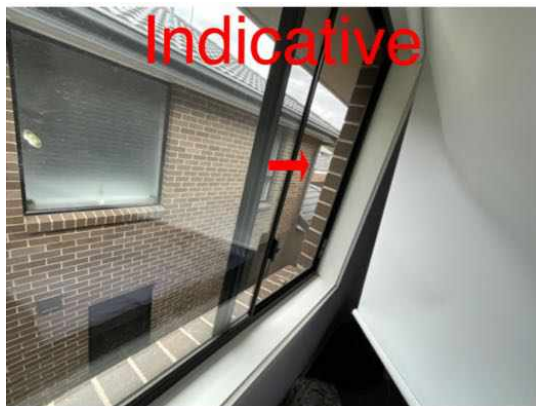
Finding 1.01

Building:	Main Building
Location:	Upstairs Windows
Finding:	Window restrictions - Missing
Information:	Window restrictors were found to be missing.

The National Construction Code (NCC) requirements apply to all openable bedroom windows in residential buildings, including hotels, motels and for all windows in early childhood centres.

Windows need to be locked at 12.5cm when the devices are engaged. The safety devices must be robust and child proof. The alternative is security screens such as bars or grills on the windows so long as they have gaps no bigger than 12.5cm. Flyscreens do not comply unless they are the reinforced security type and capable of resisting the very strong outward pressure which would prevent a child falling through. The laws apply to openable windows in a building within 1700mm of the internal floor and if the internal floor is more than 2m above the ground floor outside.

Windows upstairs lack appropriate child locks, creating a safety hazard. Window restrictors must be installed on these Windows immediately for added safety.

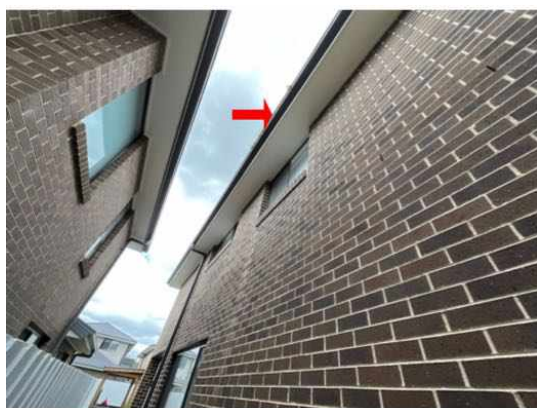
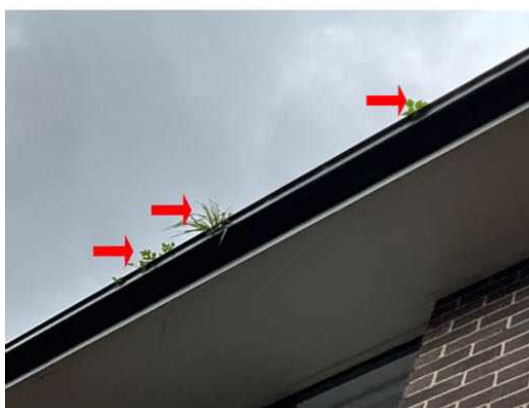
Finding 3.01

Building:	Main Building
Location:	Gutters >

Finding: Gutters - Debris
Information: Roof plumbing structures, such as guttering and downpipes, should be free of all debris to prevent blockages. Blockages of the guttering and downpipes will lead to pooling and accumulated water overflows, which is likely to subsequently flood eaves and exterior walls.

Blocked gutters are likely to lead to high levels of moisture in the affected areas. Such moisture will not only cause rust and decay of the associated building materials, but can also provide conditions that are conducive to termite and timber pest activity. Blockages in gutters should therefore be removed immediately to ensure dry conditions are maintained.

Where gutter guard is installed regular maintenance should include cleaning out any debris which may rest on top of or filter through the gutter guard.

Consult a Licensed Plumber for further specific advice on remedial works that may be required. In the interim, it is highly advised that blocked gutters be removed by the homeowner or a general handyperson as a matter of urgency.

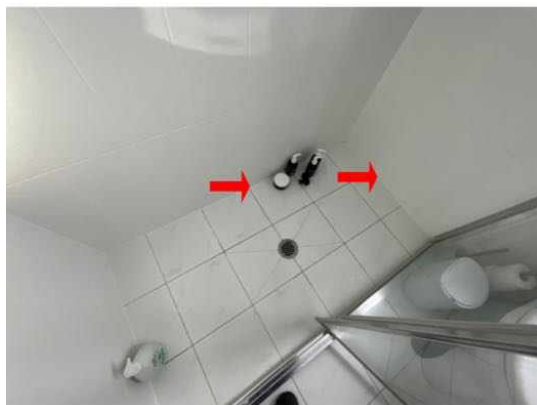
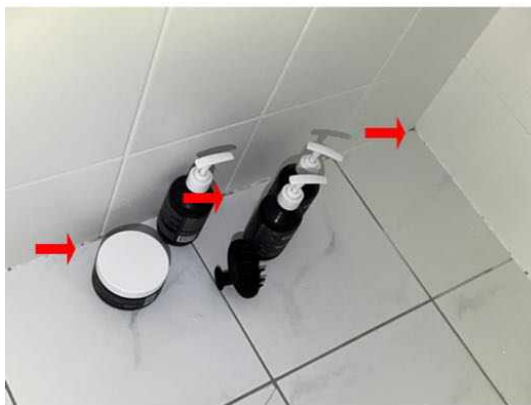
Finding 3.02

Building: Main Building
Location: Ensuite
Finding: Sealant and grouting - Missing or damaged
Information:

It was noted on inspection that sealant or grout is degraded to this area.

Different materials and floor areas move at different rates, generally causing cracking to grout or sealant at this point. A flexible sealant is required to allow for expected expansion and contraction, while keeping the joint water tight and protective of all associated building materials.

Flexible and mould resistant materials should be applied to affected areas to prevent any subsequent water damage that is likely to occur. Regular maintenance and replacement of damage or missing or damaged sealant and grout is highly

recommended to the wet areas, as this is a regular wear and tear defect. Sealant and grouting in areas that come into regular contact with water should be maintained for the long term care of your property.

A sealant specialist should be appointed to complete these works as soon as possible.

- Ensure wet area sealant and grouting is in serviceable condition

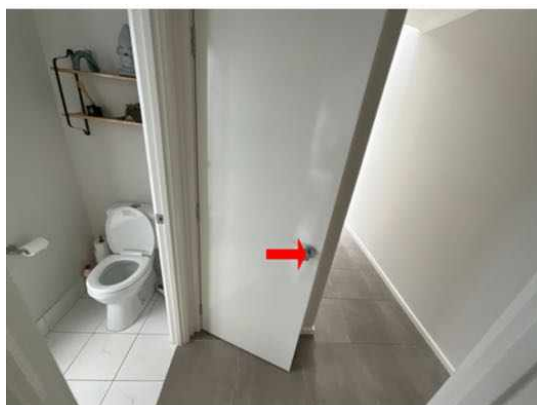
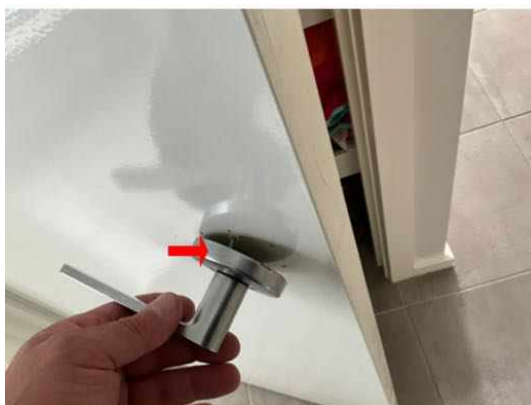
Finding 3.03

Building:	Main Building
Location:	Cupboard
Finding:	Fitting or fixture - Loose
Information:	The fitting in this area is loose and requires adjustment to tighten.

If left unmanaged, the fitting may further deteriorate, causing potential for the development of other minor secondary defects.

A relevant tradesperson should be appointed to perform these rectification works at discretion of the client.

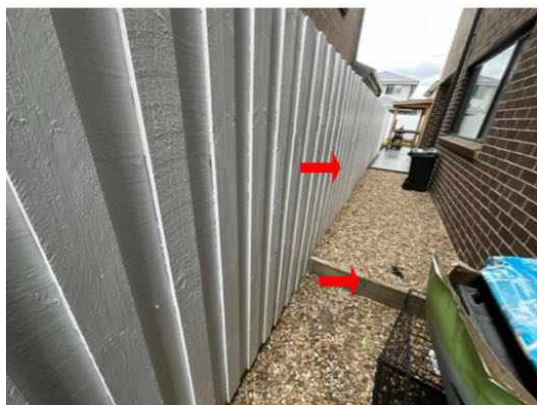
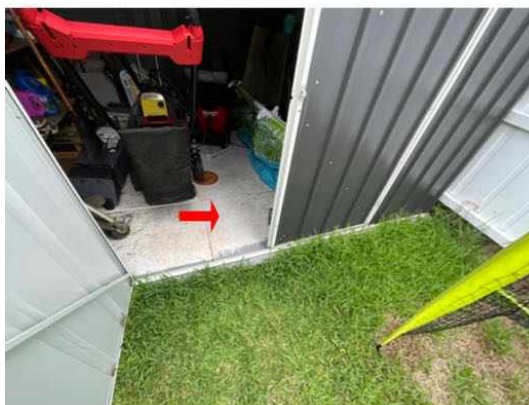
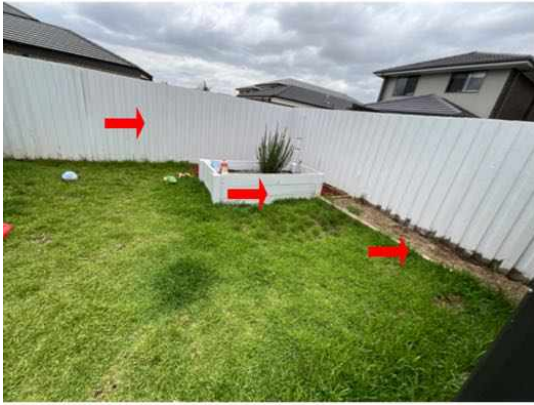
Finding 6.01

Building: Main Building
Location: Fencing & Landscaping
Finding: Building materials in direct ground contact - conducive to termites
Information: Where timber elements are in direct contact with the ground and consequently moisture or dampness they become conducive to termite activity. Whether timber is used as a building element part of a fencing structure or stored as an unused item they can provide an environment that is attractive to termite infestation.

When met with excessive moisture timber begins to decay and develop wood rot. Any timbers that are in direct contact with external grounds especially if left untreated or non-durable also provide ingress for subterranean termites into that particular element.

The removal of any such materials that may be conducive to termite activity should be removed as soon as possible to minimise the risk of termite attack.

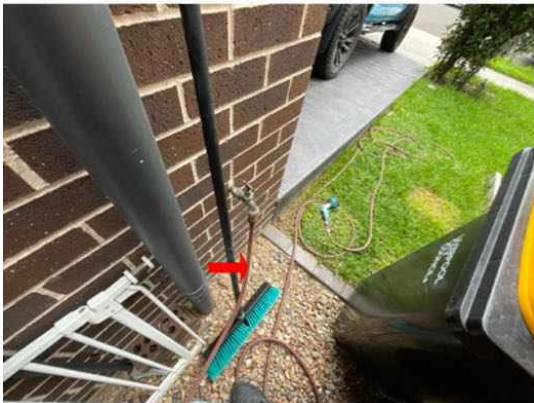
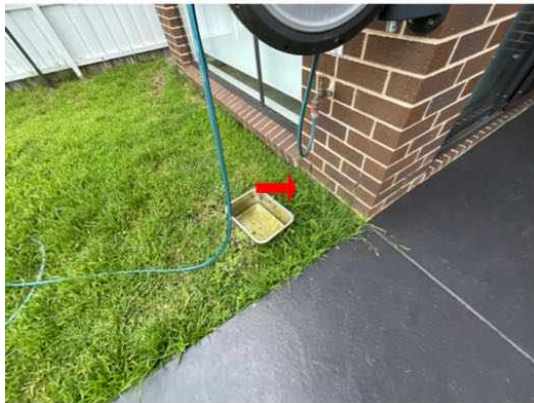
Finding 6.02

Building: Main Building
 Location: External tap
 Finding: Tap - No drain
 Information: The external tap in this area was noted to have no drain at the time of inspection.

This keeps the surrounding surfaces damp while using the tap, which becomes conducive to termite activity.

A licensed plumber must be appointed to ensure an appropriate drain is installed.

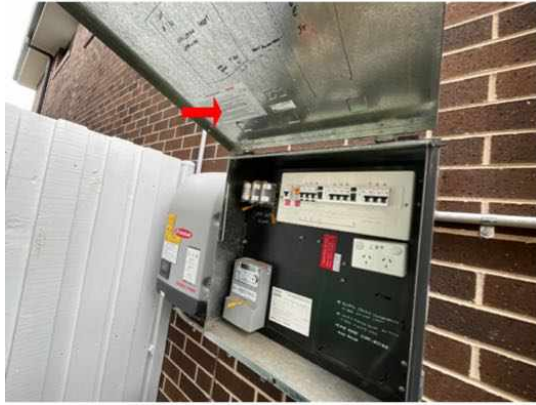
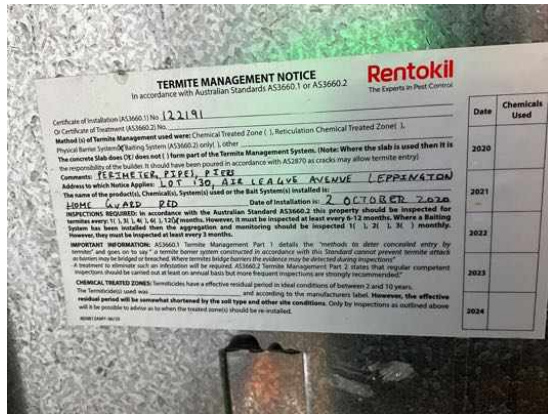
Building:	Main Building
Location:	Meterbox
Finding:	Evidence of a previous termite management system was identified
Information:	There are a number of factors which indicate the presence of a previously installed or applied termite barrier. The most common are a durable notice (to the inside of your meter box) observable physical barriers installed to building perimeter and in ground reticulation systems.

Where a Termite Management System has been identified you should refer to the type of barrier date of installation warranty conditions and any documentation provided by a builder or past owner. Consult the company who installed the barrier to confirm whether the system is still under warranty.
