# Building Inspection Report

Inspection Date: Mon, 2 Mar 2026

Property Address: 1 Jelica Pl, Esk QLD 4312, Australia

This building inspection is of the colourbond roofing only. No other areas of this house form any part of this report.

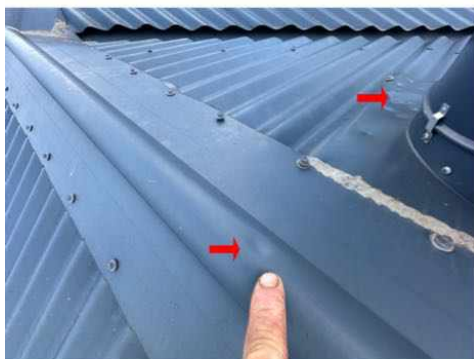
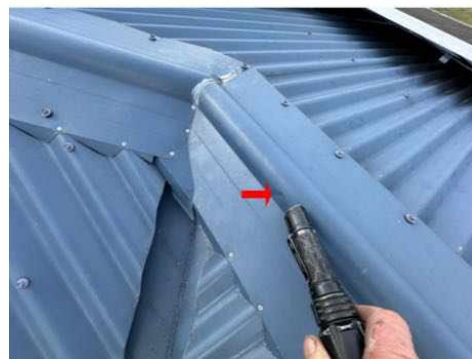
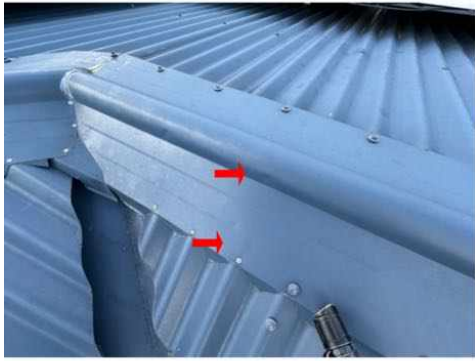
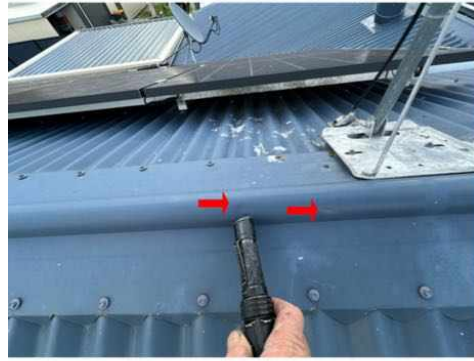
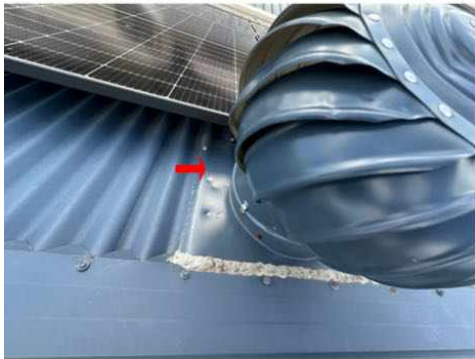
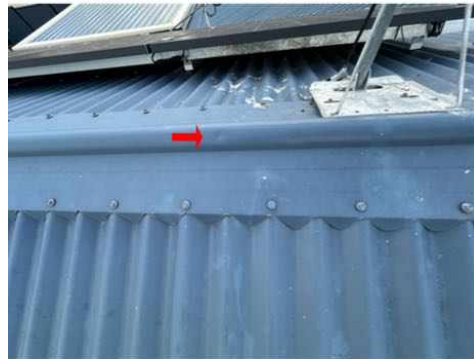
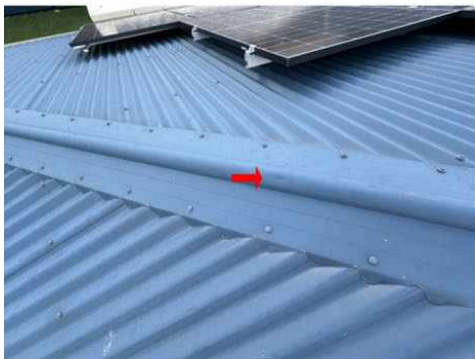
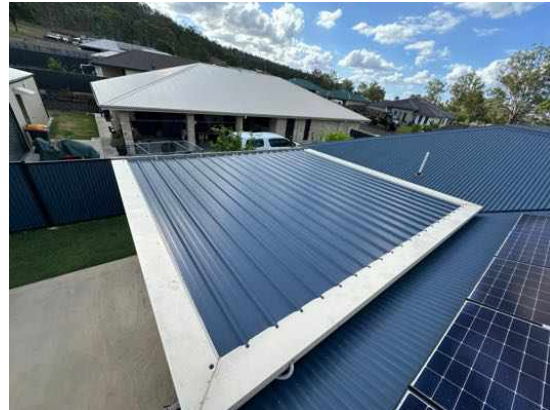
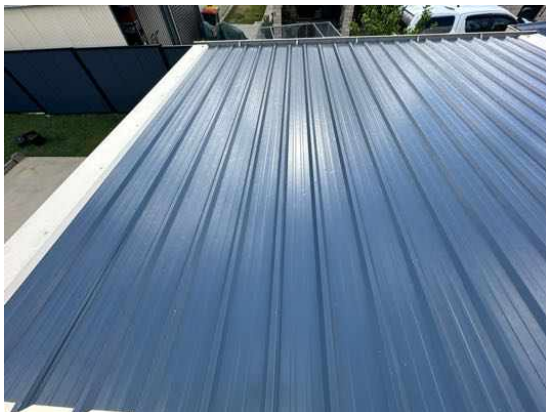
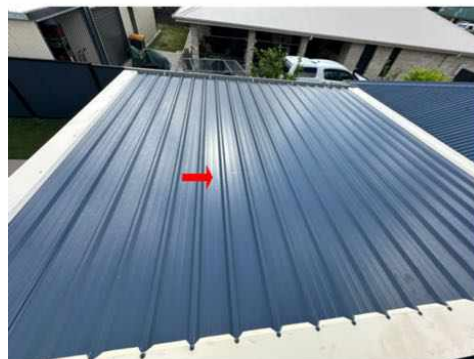
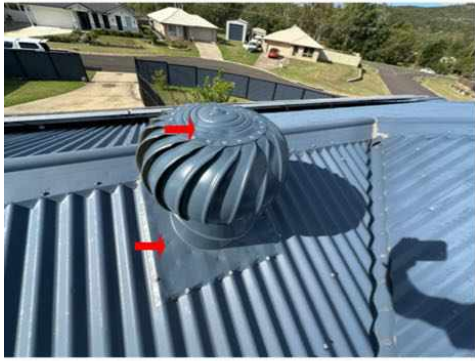
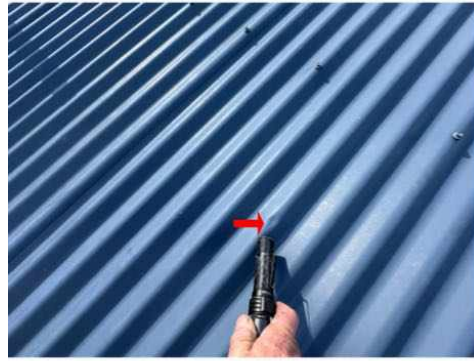
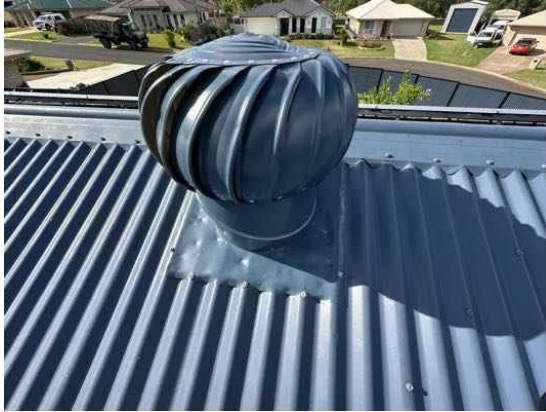
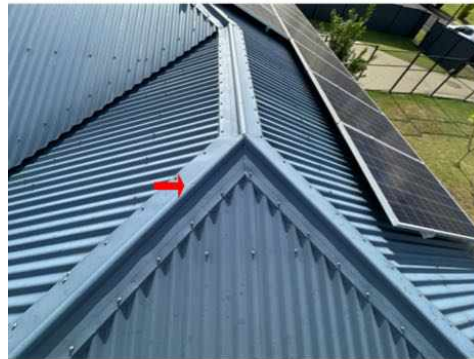
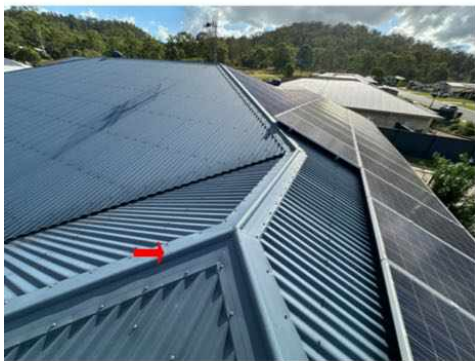
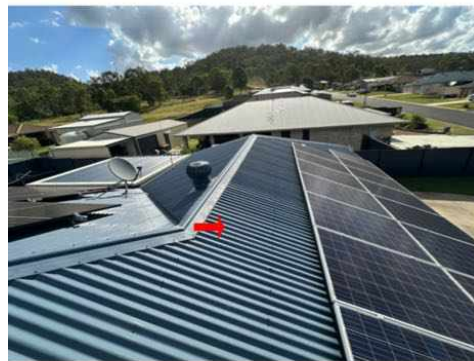
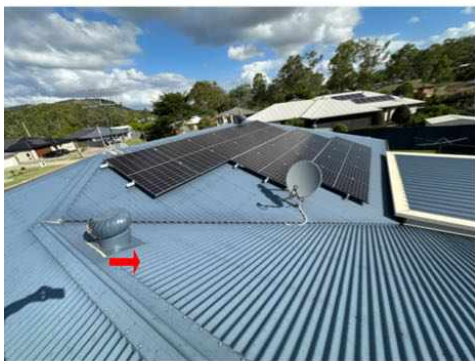
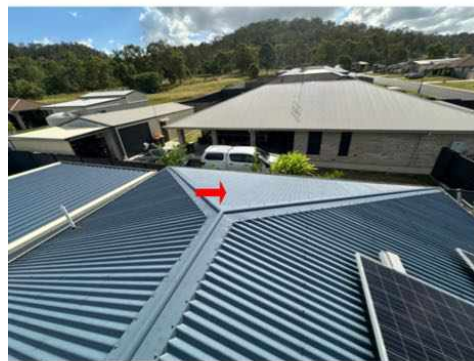
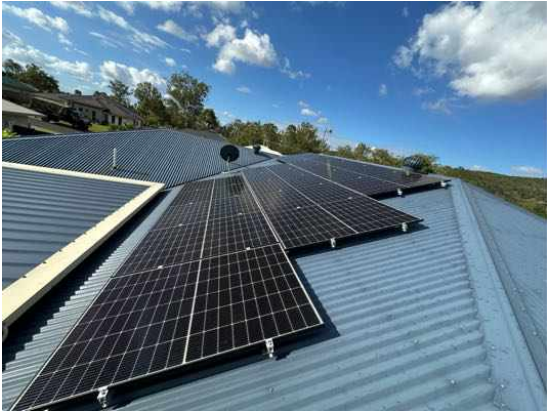
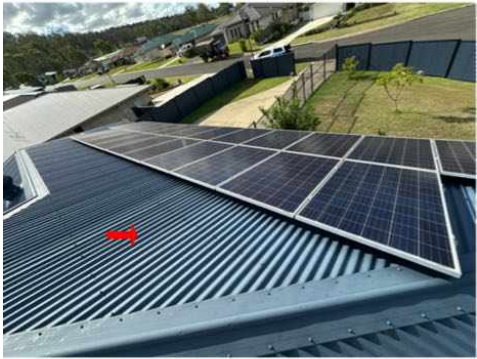
#### Defects 3.01

Finding: Roof sheets ,flashings and whirly birds -Hail damage

Information: Upon inspection of the exterior roofing, it was found that the roofing show signs of minor hail damage .There are small hail dents to the roof sheets and hip and ridge caps .

There is more visible damage to the flat section of the pergola roof and the whirly birds .

- The roof was found to be in fair condition compared with properties of similar age and construction methods. There was minor hail damage found to the roof sheets and hip and ridge caps throughout the roof, there was also damage to the whirly birds. There was no visible evidence of damage to the solar panels on the day of inspection.

Further investigation and advise from an independent roofing contractor is advised on further remedial solutions.

Recommend an independent roofing contractor be engaged to further investigate and advise on remedial solutions.
