Building and Timber Pest Inspection Report

Inspection Date: Thu, 8 Jan 2026

Property Address: 18 Townview Ave, Walla Walla NSW 2659,
Australia

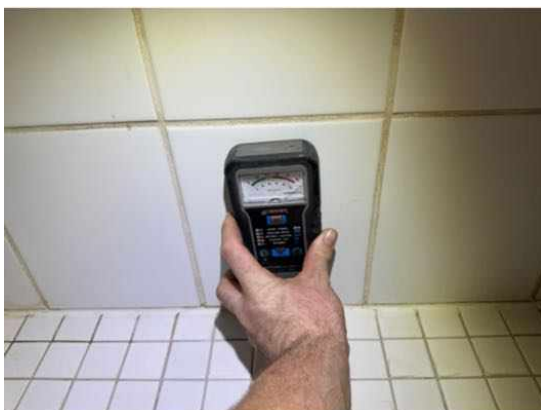
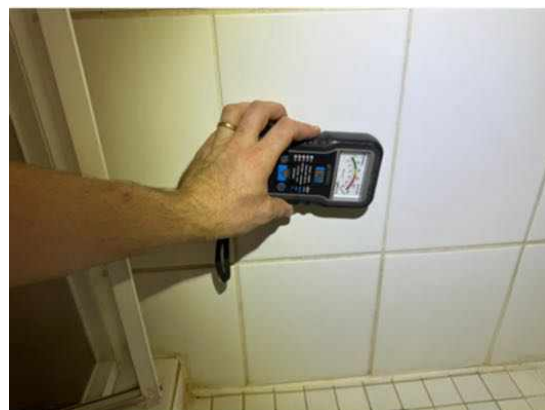
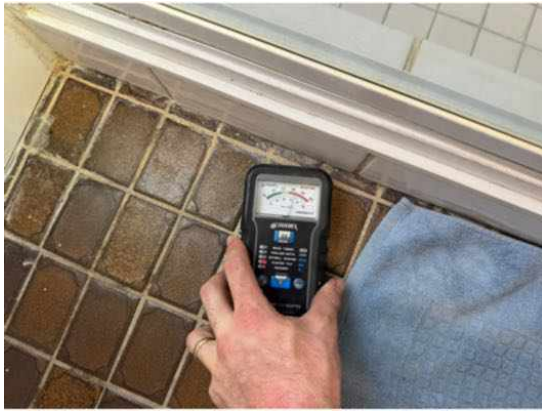
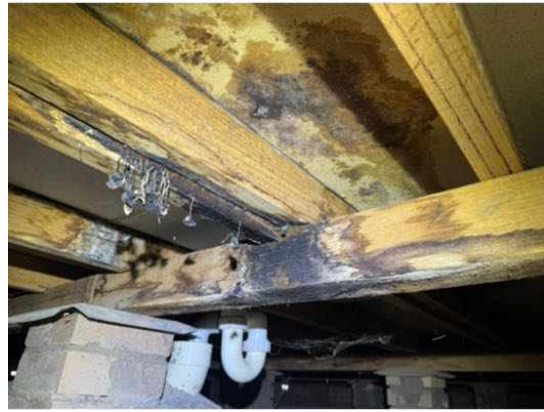
Finding 3.01

Building: Main Building
Location: Shower
Finding: Shower & Bathroom Floor - High Moisture
Information: It appears that high moisture is present to the base of the shower walls and bathroom floor. Fungal decay was also identified in the subfloor, beneath the area. Potential causes of leaking include but are not limited to loose or damaged plumbing fittings and fixtures, and/or deteriorated / missing seals.

Areas of leaking and high moisture create an environment conducive to termite activity.

Recommend engaging a licensed plumber and/or tiling contractor promptly, to provide remedial works where necessary, to avoid the development of secondary building defects.

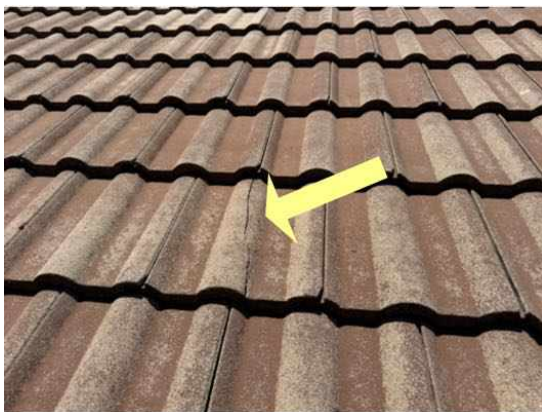
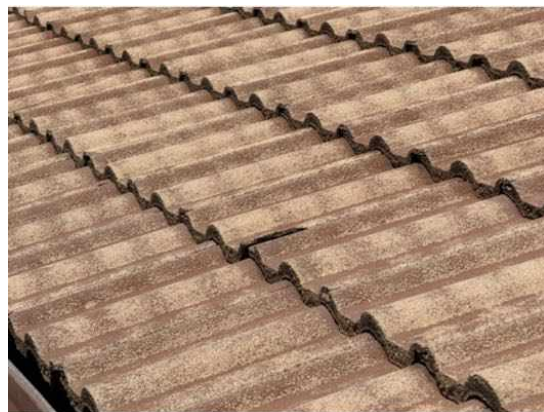
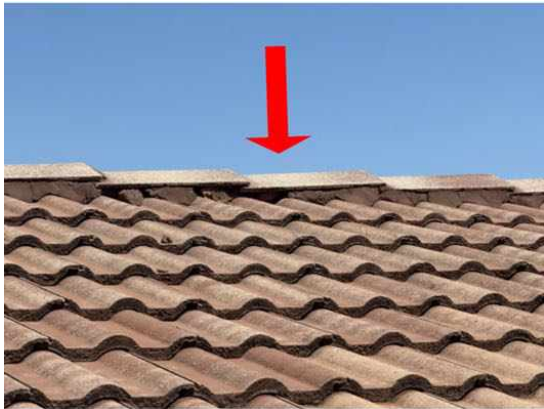
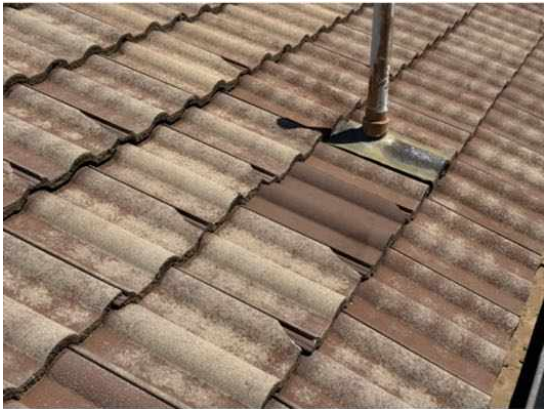
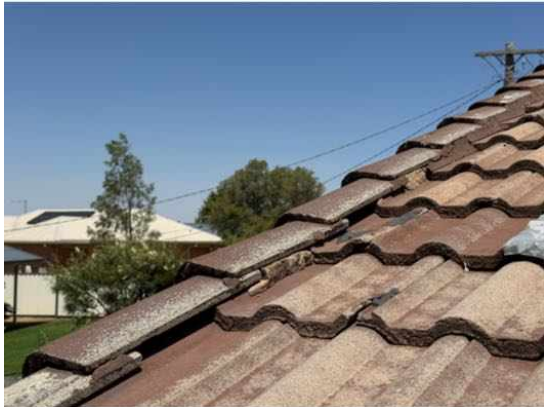
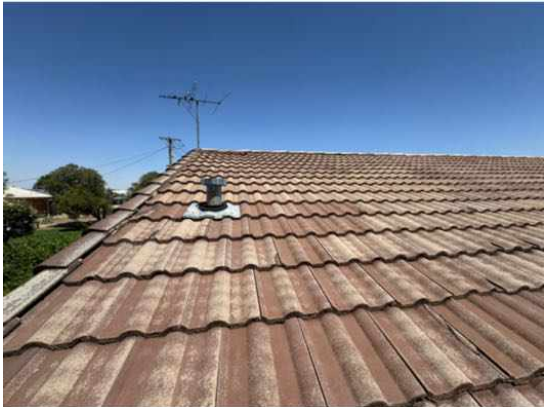
Finding 3.02

Finding: Roof Exterior - Weathered, Cracking

Information: The roof exterior was found to be in a weathered condition evidenced by some broken roof tiles, and cracking in the tile pointing. While weathering of the tiles is consistent with the age of the property, maintenance works are required.

Where left unmanaged, deteriorating and damaged roof tiles are likely to lead to secondary defects, including water leaks. Recommend consulting with a licensed roofing contractor in the short term, to provide further advice & maintenance works where required.

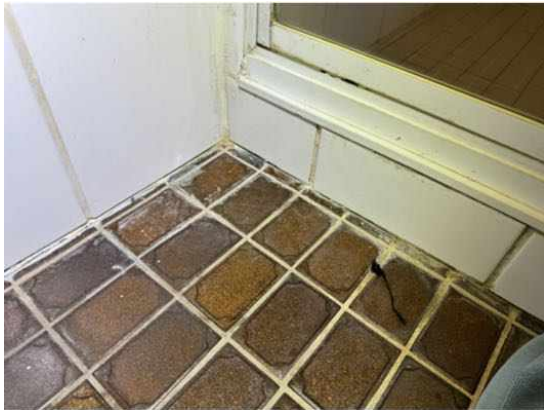
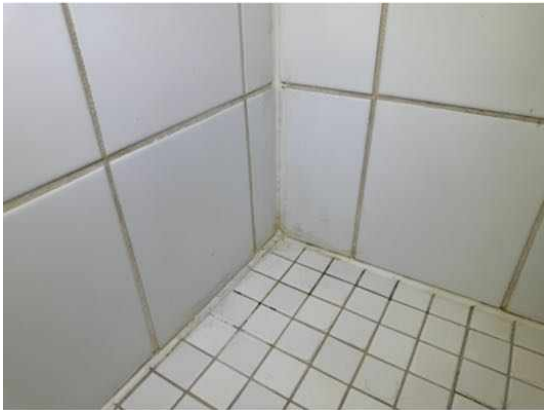
Finding 3.03

Building: Main Building
Location: Tiled Areas
Finding: Sealant and grouting - deteriorated or missing
Information: It appears that the sealant and grout is weathered and deteriorated, in some tiled areas. Sealant and grouting in areas that come into regular contact with water should be maintained for the long term care of your property.

A sealant specialist or tiling contractor should be appointed to complete these minor works, to prevent the potential development of secondary building defects overtime.

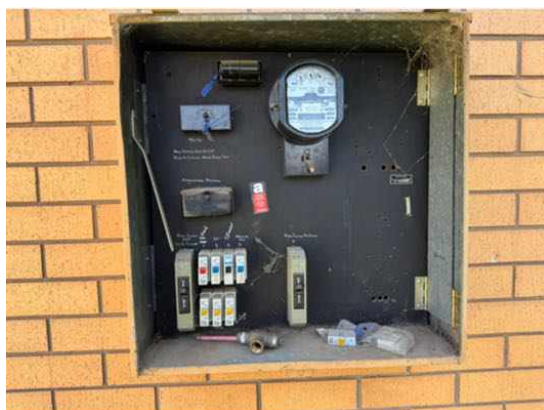
Finding 6.01

Building: Main Building
 Location: Switchboard
 Finding: Termite Management System - no evidence of a chemical installation
 Information: The application of a termite barrier is recommended, as it appears no termite management system has been installed, with no evidence or durable notice to suggest works taking place. Generally, a durable notice is placed in the meter box to indicate current termite barriers.

Such barriers are highly effective in preventing termite attack on the building and therefore should be installed. Recommend seeking further advice from a licensed pest controller.

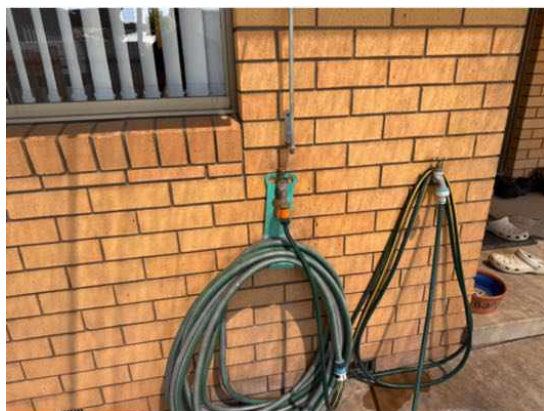
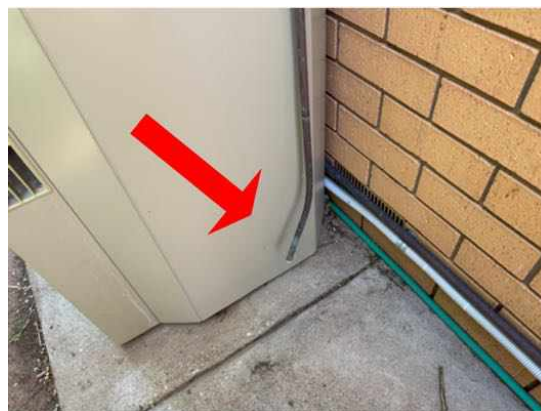
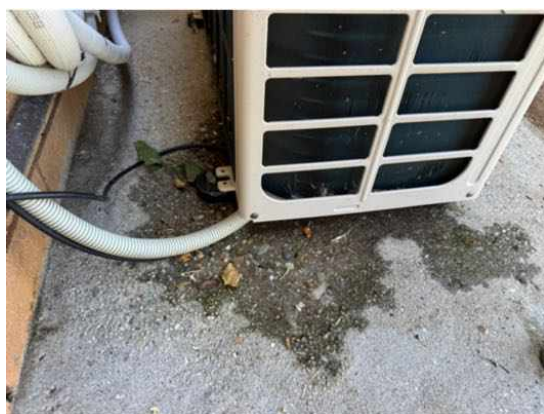
Finding 6.02

Building: Main Building
 Location: All external areas
 Finding: Potential Water pooling - against property
 Information: It appears that there are potential areas around the perimeter of the property that could be susceptible to water pooling.

Where insufficient drainage of taps, hot water system & aircon overflows are present, water pooling is likely to occur, and can create areas conducive to timber pests and

potential damage to the subfloor structure overtime, if neglected.

Recommend consulting with a licensed plumber in the short term to further assess and provide remedial advice.

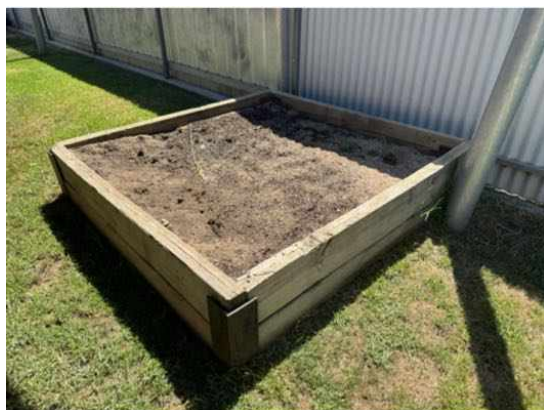
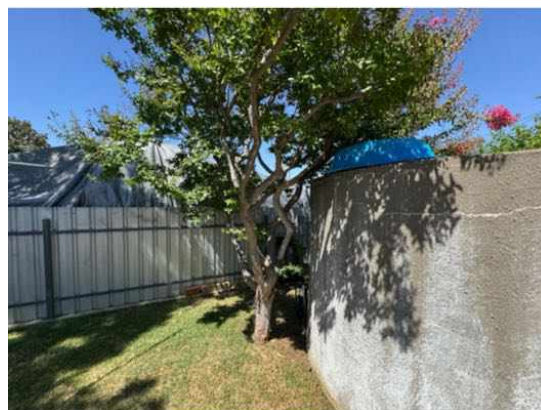
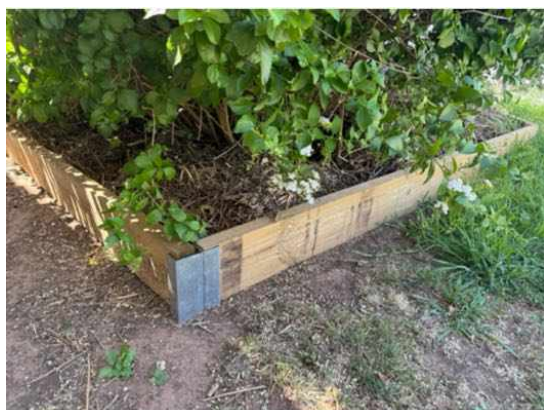
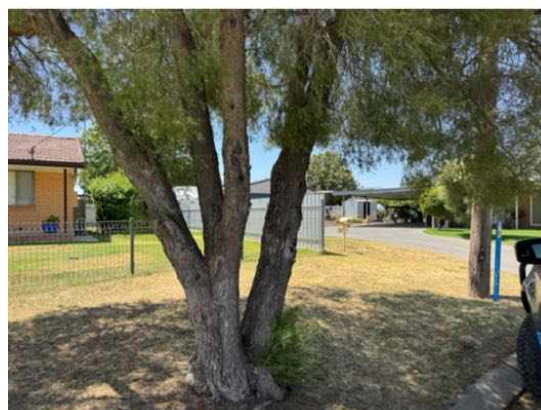
Finding 6.03

Building:	Main Building
Location:	All External Areas
Finding:	Timber in direct ground contact & trees - conducive to termites
Information:	Where timber materials are in direct contact with the ground and consequently moisture, they become conducive to termite activity. The landscaping timbers, and trees surrounding the building create an environment conducive to termite infestation.

Where feasible, any timbers in direct contact with the ground should be removed and any trees in close proximity to the building should be removed or test drilled (inspected) at least annually to reduce the risk of termite infestation & detect any early signs of termite activity.

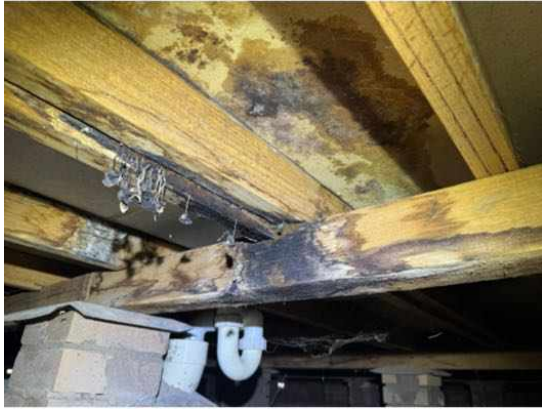
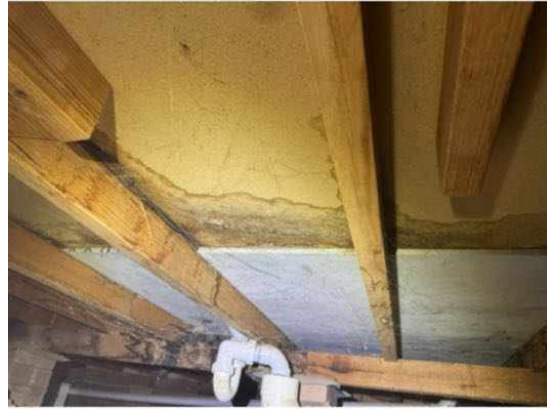
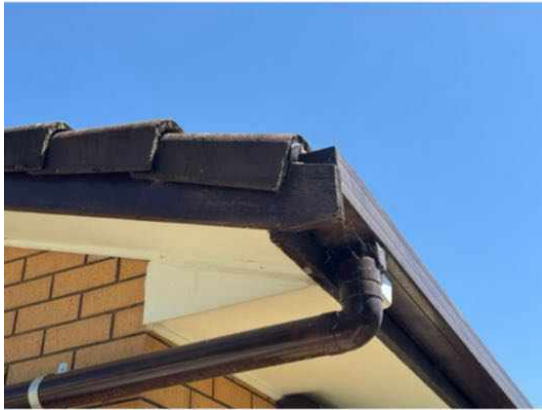
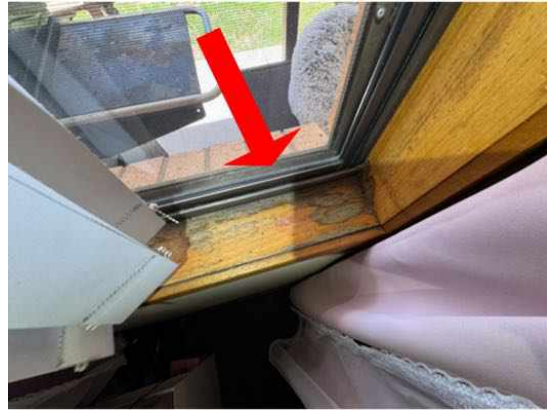
Finding 7.01

Building:	Main Building
Location:	Subfloor beneath bathroom, fascia's, window frames
Finding:	Fungal decay & weathering
Information:	Areas of fungal decay (wood rot) were identified at but not limited to beneath the bathroom area in the subfloor, and to areas of the fascias. General weathering was identified to some window frames.

For areas of fungal decay, the client can engage a licensed carpenter at their discretion to replace affected materials. For areas of general weathering, it is advised the client engage a licensed painter to apply protective sealant or coating to areas of weathered external timbers.

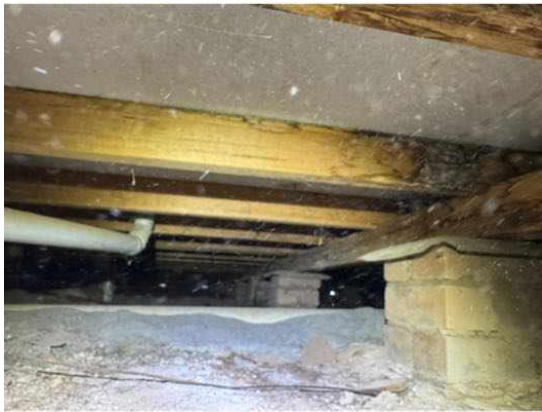
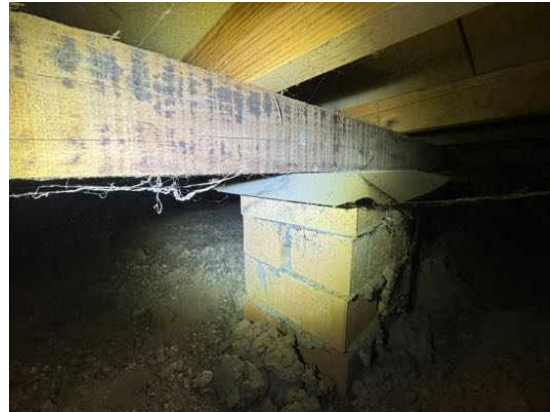
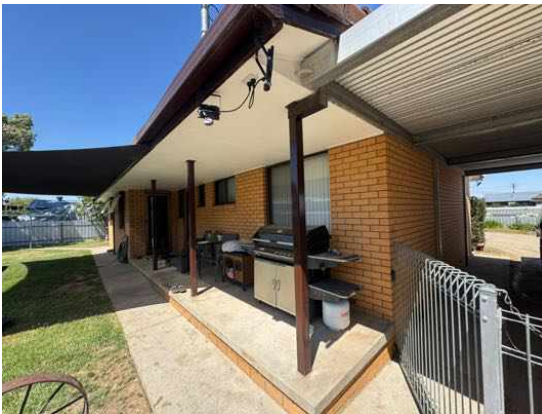
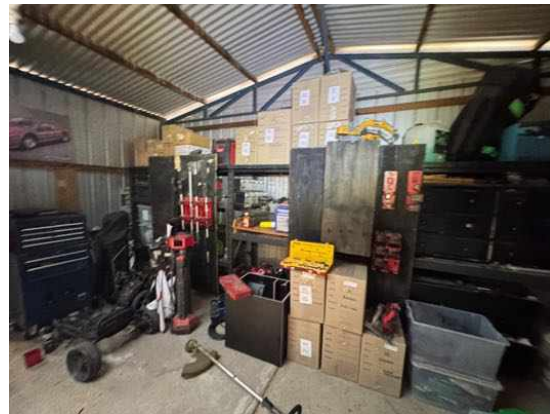
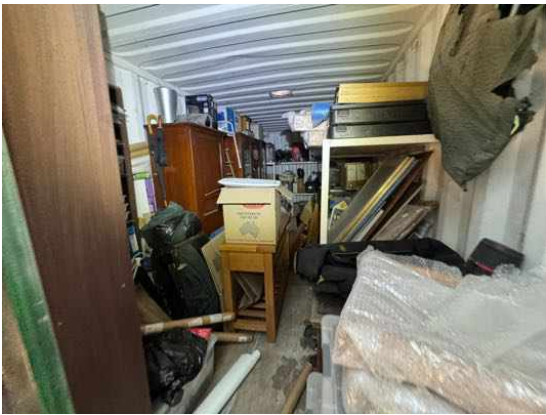
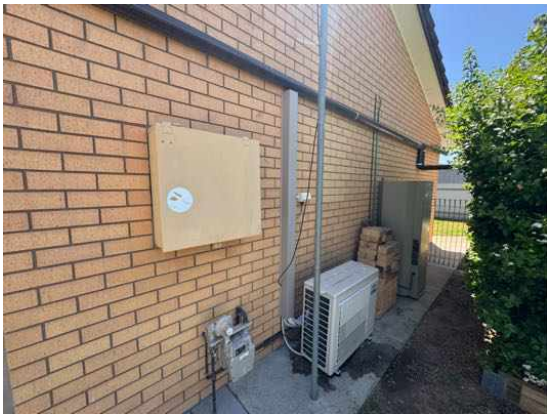
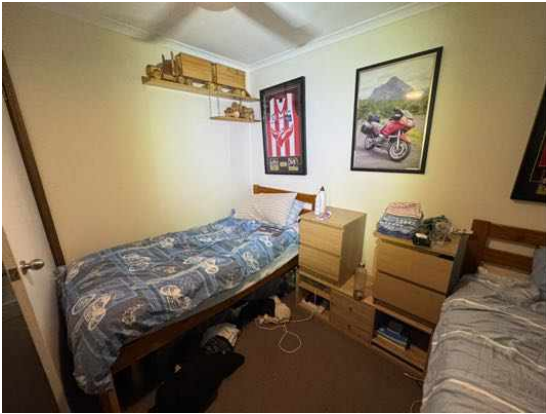
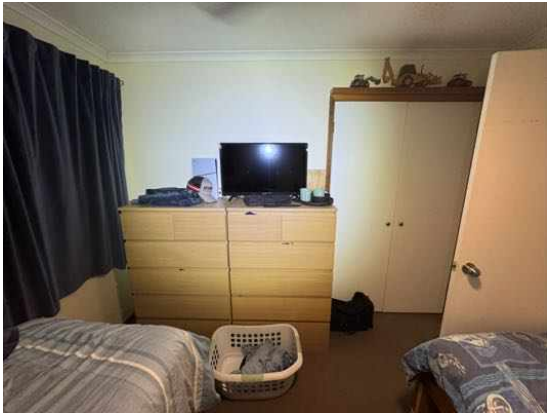
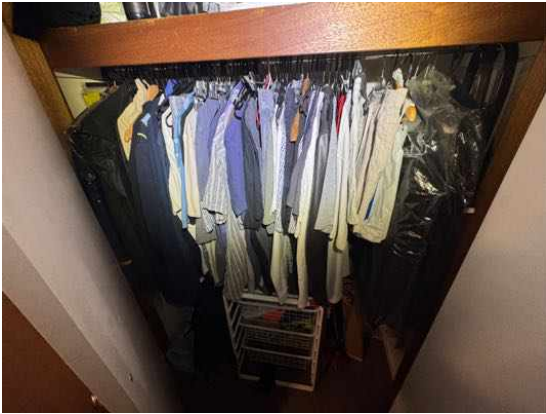
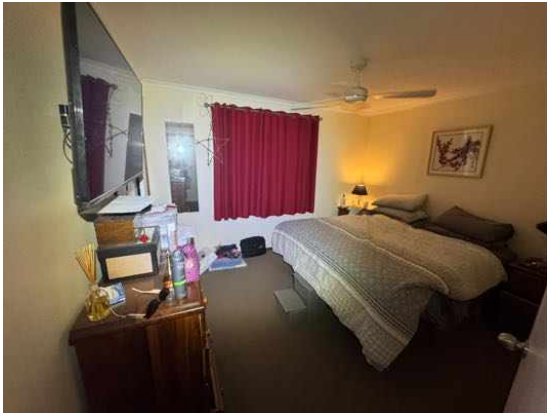
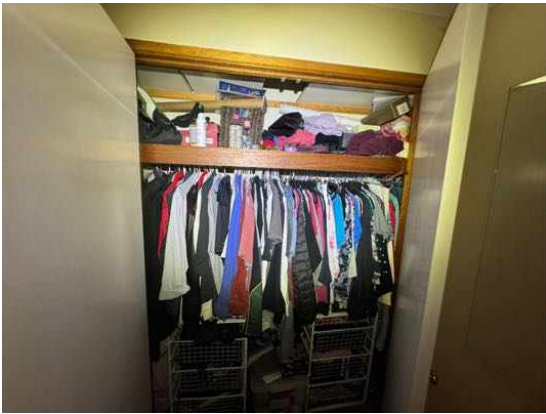
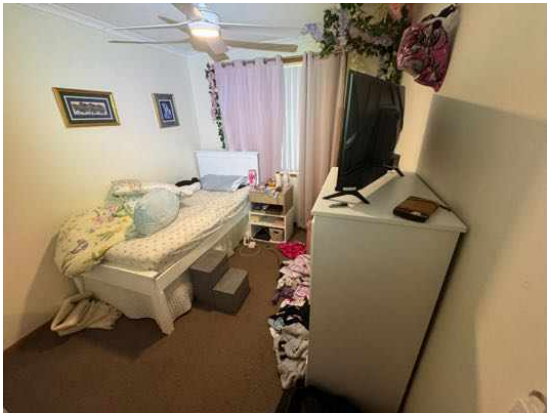
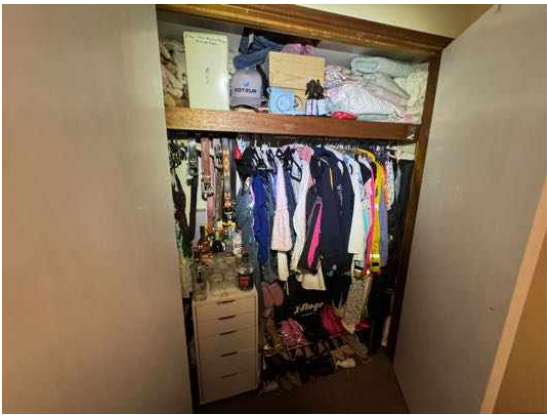
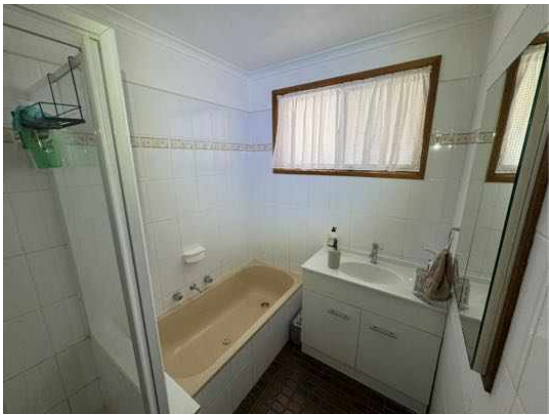
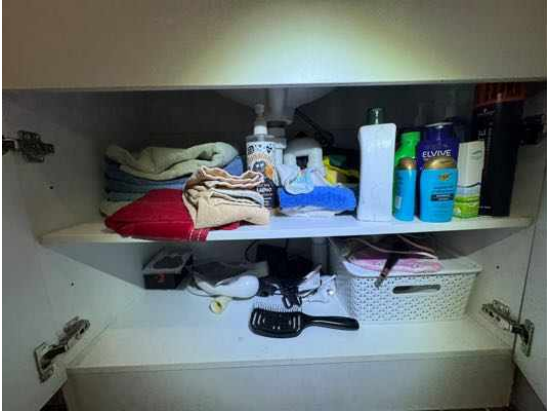
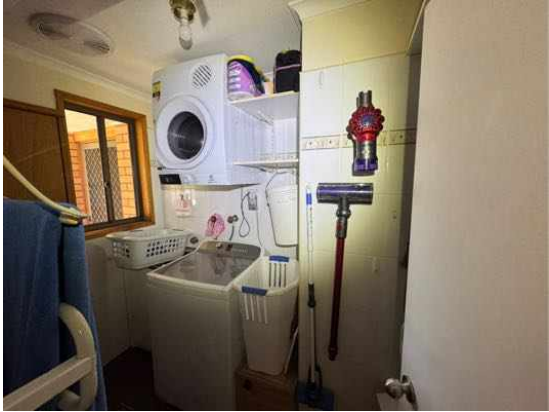
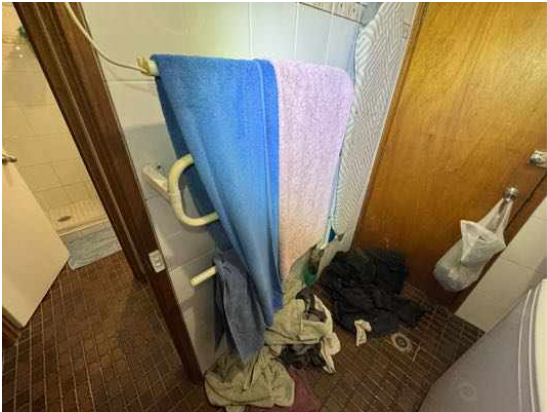
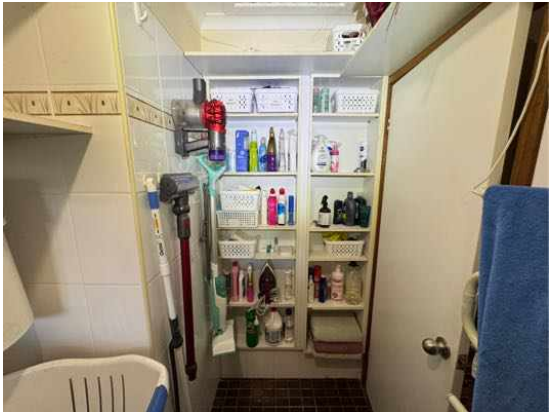
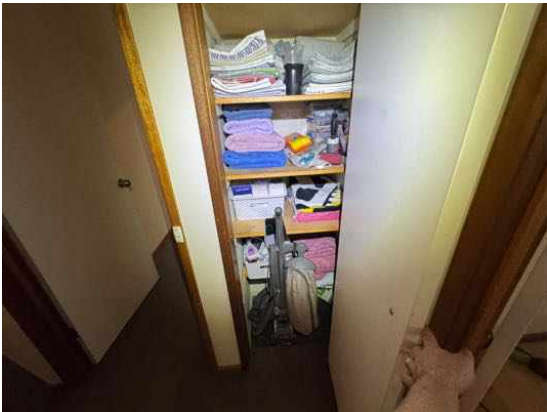
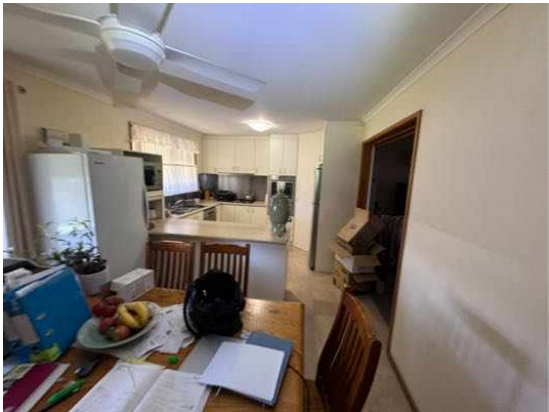
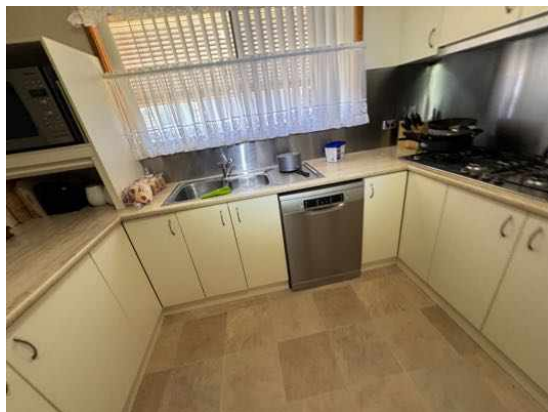
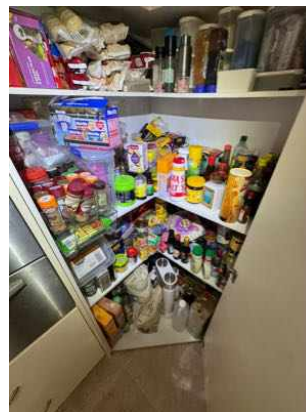
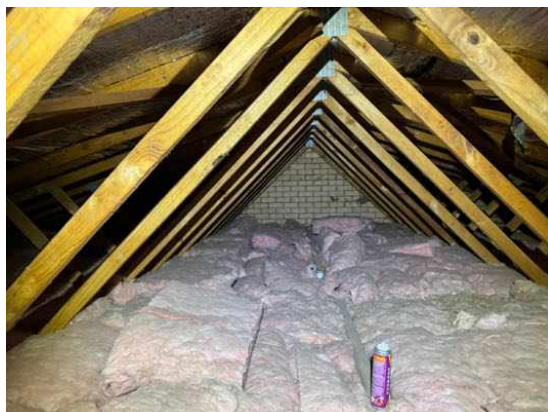
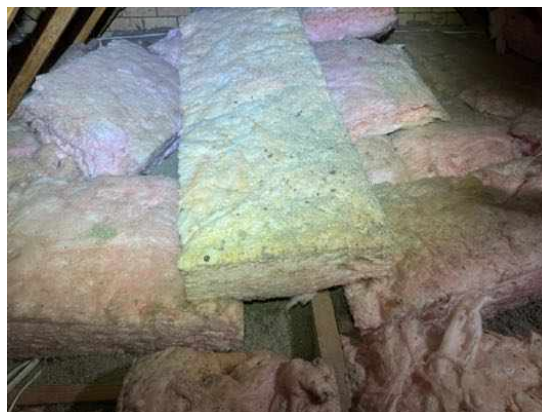
Building: Main Building
Location: All Areas
Finding: Additional Photos - Obstructions and Limitations
Information: These photographs are an indication of the obstructions and limitations which impeded full inspection of the property at the time of inspection. These obstructions can hide an array of defects and should be removed to allow full inspection to be carried out. A re-inspection is recommended once the areas are made accessible.

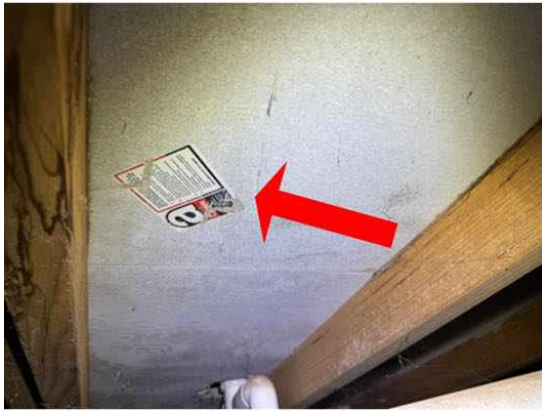
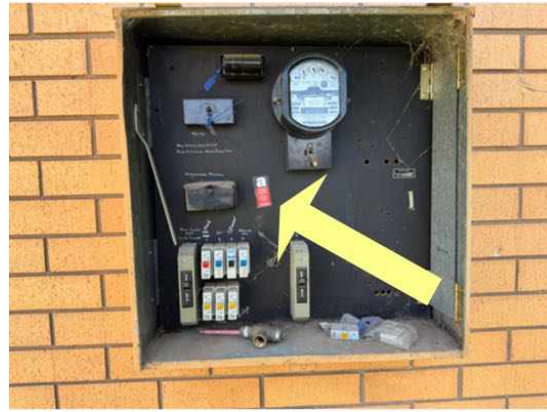
Building:	Main Building
Location:	Switchboard, Bathroom Floor Sheeting
Finding:	Asbestos - Suspected ACM Identified on Site
Information:	This finding is highlighted as a caution only as reporting on asbestos is outside the scope of this report. It is suspected that the materials including but not limited to the switchboard lining and bathroom floor sheeting are ACM's (Asbestos containing materials) as there were asbestos warning stickers on the materials.

Therefore, no works should be conducted to these areas without further specialist advice. It is also advised that the client consider a separate Asbestos Inspection and Condition Audit, which can include the taking of samples to identify & confirm any other potential ACM's on site.

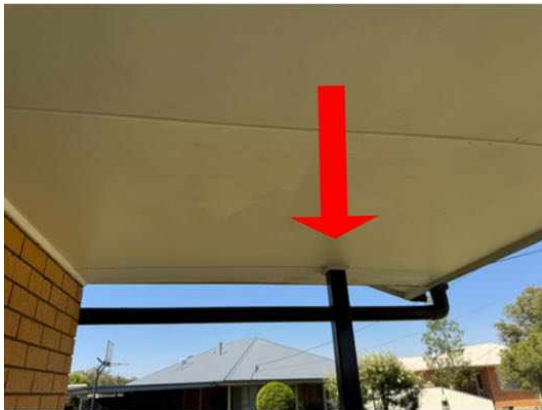
Building: Main Building
 Location: Front Eave
 Finding: Soffit Lining - Sagging
 Information: It appears that minor sagging was present at, but not limited to the front soffit lining. Recommend that the client should monitor the area. Should further sagging occur, a licensed carpenter should be engaged at clients discretion to provide maintenance works.

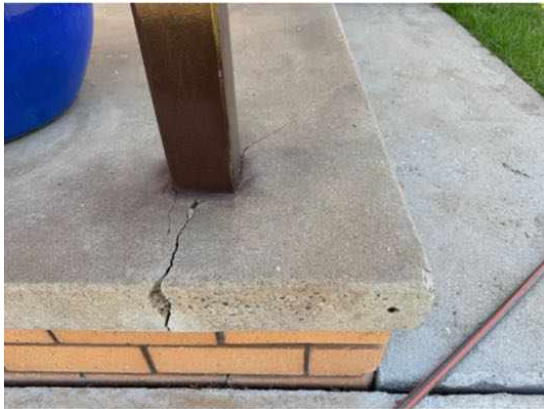
Building: Main Building
 Location: Porch
 Finding: Minor Cracking - Porch Slab
 Information: Minor cracking was identified at, but not limited to the front porch. Recommend that the client monitor the cracking.

Should further cracking of the slab occur, the client should engage their building inspector to provide further advice.

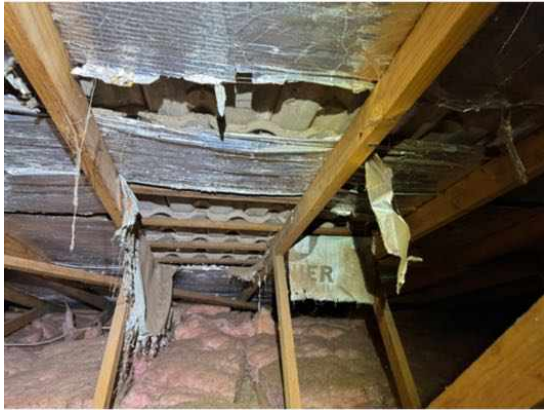
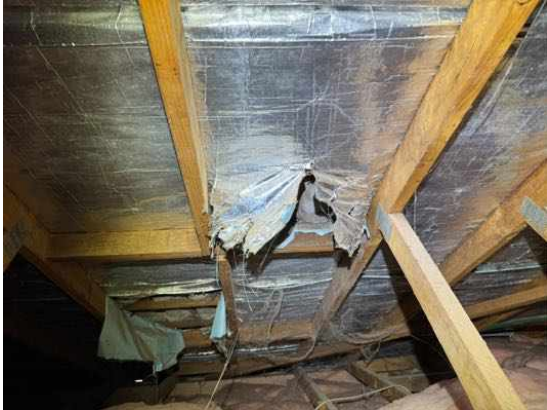
Building: Main Building
Location: Roof Void
Finding: Sarking - Damaged
Information: The sarking appears to be damaged/deteriorated in areas of the roof void. Sarking is a laminated aluminium foil applied to the interior of the roof covering, which assists in insulating the property and acts as a vapour-barrier to the roof void.

Where sarking is damaged, there is potential for moisture ingress from condensation or leaking roof tiles. Recommend engaging a roofing contractor at clients discretion, to provide further advice.
