# Building and Timber Pest Inspection Report

Inspection Date: Fri, 13 Mar 2026

Property Address: 2/59 Marsden St, Parramatta NSW 2150,  
Australia

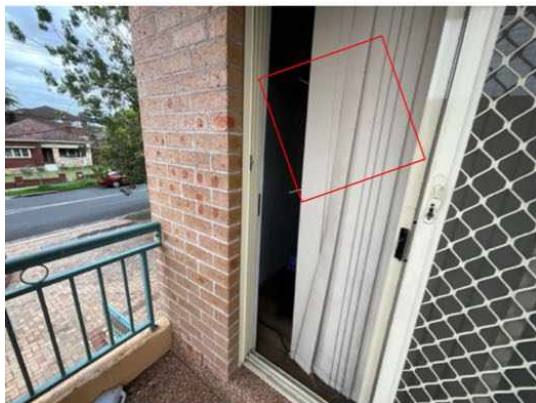
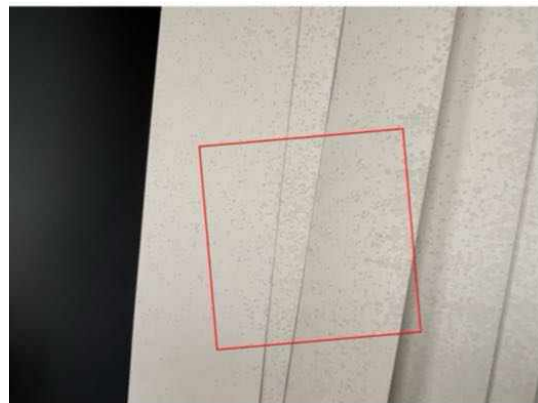
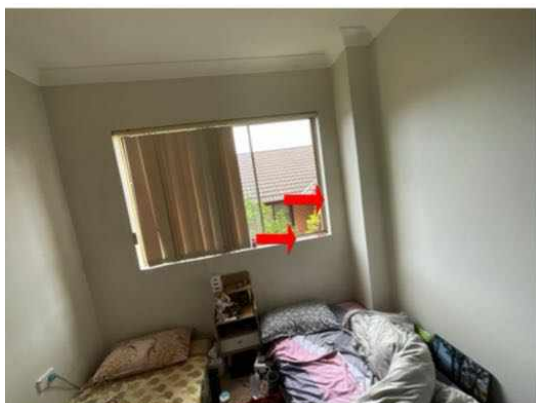
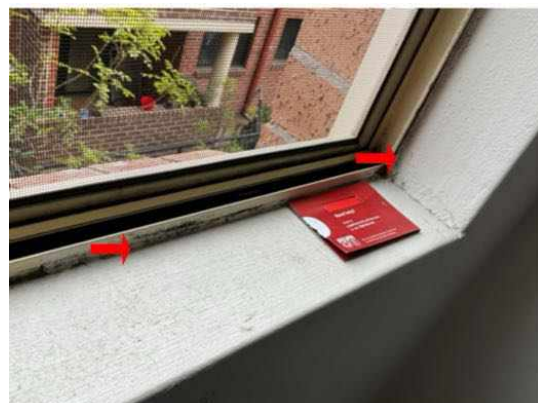
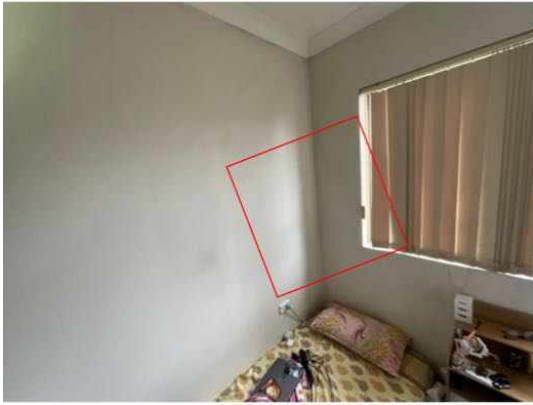
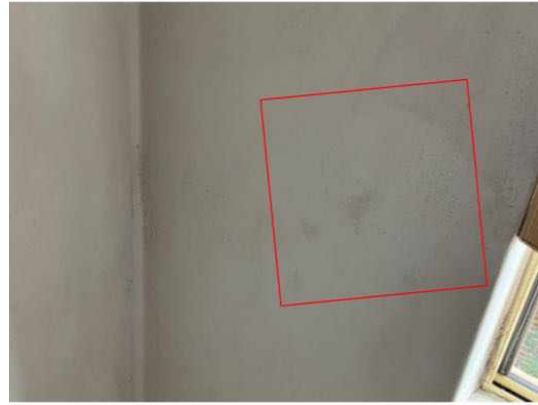
Building: Main Building  
Location: Both bedrooms  
Finding: Mould - Present  
Information: Evidence of mould growth was noted, which is believed to have grown due to lack of ventilation to the area. Where evidence of mould growth was noted, there may be environmental, biological or health issues associated with the report. A specialist inspection by a suitably qualified environmental health inspector is warranted, where mould is extensive or where any queries regarding air quality spores or other related issues apply.

Generally, the client is advised to ensure that the general environment is free of moisture and humidity to aid in the prevention of mould formation and development. Any mould found during the inspection should be cleaned immediately by a cleaning contractor or the homeowner as applicable.

A safety hazard is due to mould. A mould remediation contractor is required to treat this mould urgently.

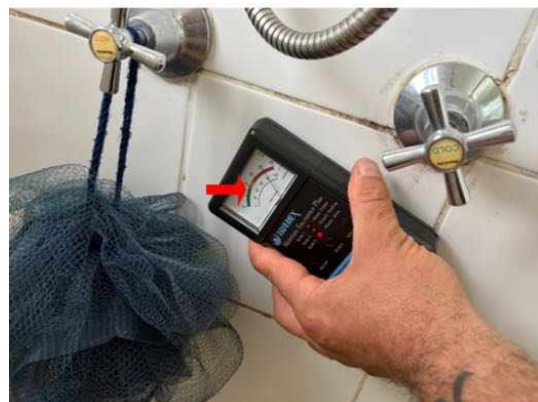
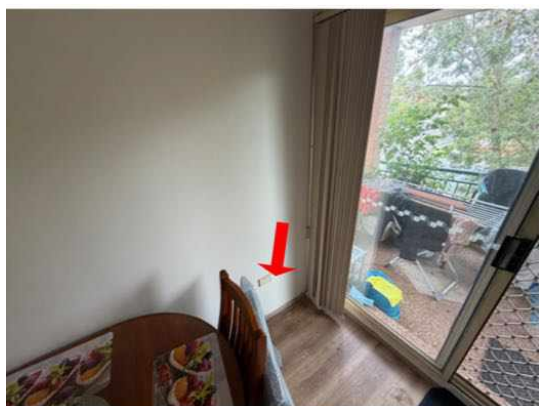
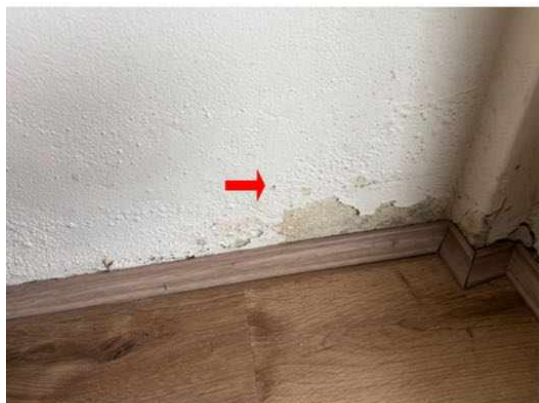
### Finding 2.01

Finding: Water leak suspected - Internal

Information: A water leak is suspected in this area at the time of inspection. Internal water leaks can be detrimental to surrounding building elements; their potential causes include damage to plumbing fittings and fixtures, through to water damage and deterioration of associated building elements.

Rust, corrosion, decay and water damage are potential outcomes where a minor water leak is left unattended. More serious defects may also result, such as electrical hazards, or water damage to structural building elements.

In extreme cases, structural damage may develop due to a prolonged water leak. It is highly advised that internal water leaks be addressed by a licensed plumber as a matter of relative urgency.

Excess moisture was also identified to the ensuite shower, but also to the surfaces behind the shower. Water damages were also evident, indicative of an internal water leak. A bathroom specialist must be appointed urgently for further assessment and rectifications.

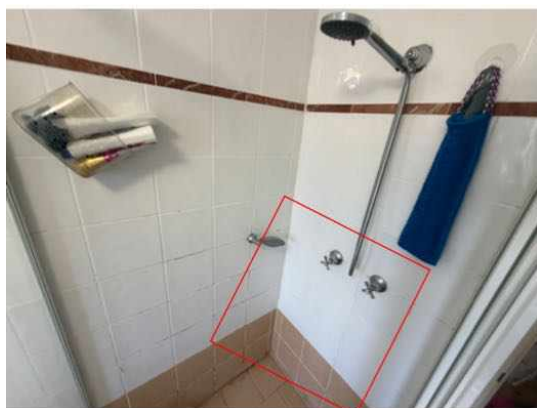
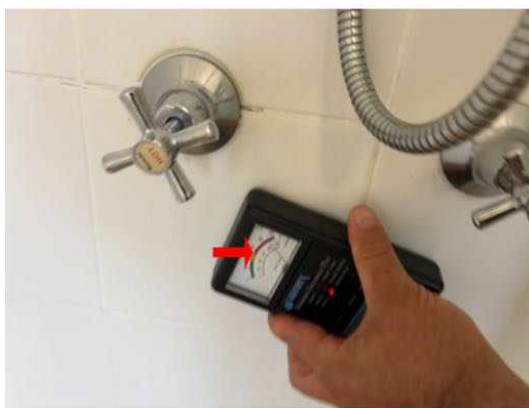
## Finding 2.02

Building:	Main Building
Location:	Bathroom
Finding:	Water leak - Suspected
Information:	A water leak is suspected in this area as excessive moisture was detected at the time of inspection. Another potential cause maybe moisture ingress behind the tiles from around the wall fittings and penetrations.

Internal water leaks can be detrimental to surrounding building elements; their potential causes include damage to plumbing fittings and fixtures, through to water damage and deterioration of associated building elements.

Attracting termites, corrosion, mould, decay and water damage are potential outcomes where a minor water leak is left unattended. More serious defects may also result, such as electrical hazards, or water damage to structural building elements.

In extreme cases, structural damage may develop due to a prolonged water leak. It is highly advised that internal water leaks be addressed by a licensed plumber as a matter of relative urgency.

Excessive moisture was identified to the walls in the bathroom shower. There maybe a water leak OR otherwise moisture maybe penetrating around the fittings. A licensed plumber must be appointed urgently for further assessment and repairs.

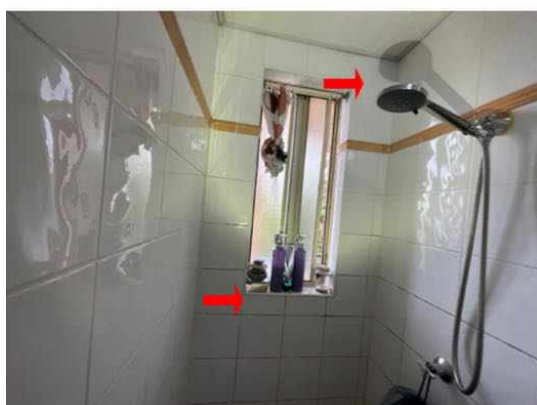
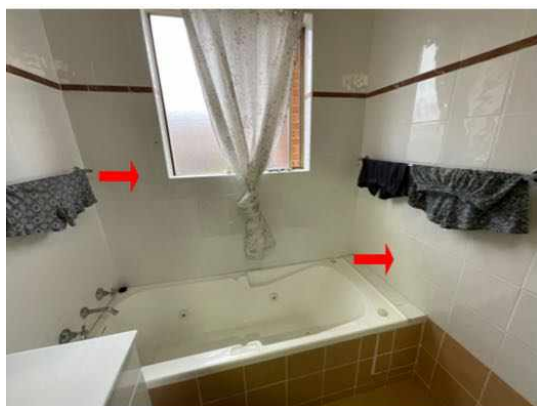
### Finding 3.01

Building:	Main Building
Location:	Ensuite
Finding:	Wet area tiles - Cracked or damaged
Information:	Cracking was evident to the tiling in this area at the time of inspection. While the cracking appears to be minor, this area is frequently exposed to water, allowing potential for water penetration into adjoining sections of walls or flooring.

If left unmanaged, water penetration to these areas may lead to subsequent water damage, which is likely necessitate repair work to affected building elements.

A bathroom specialist should be appointed to determine the integrity of the bathroom waterproofing membrane. If the membrane was found to be intact then relatively minor works to replace the cracked tiles should be carried out to ensure no further damage occurs. The re-application of silicone and grouting throughout remaining tile work is also advised, to further protect the area against water penetration.

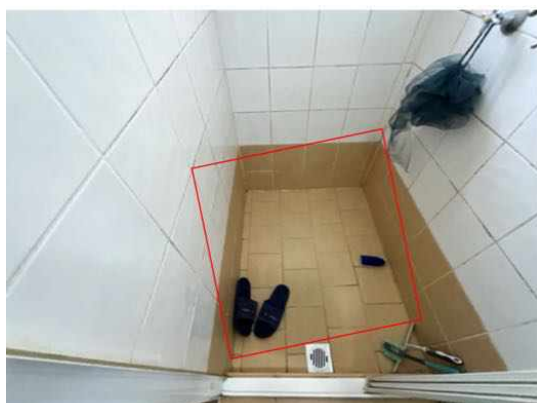
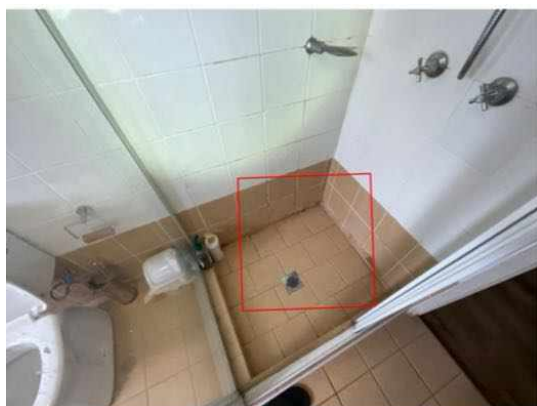
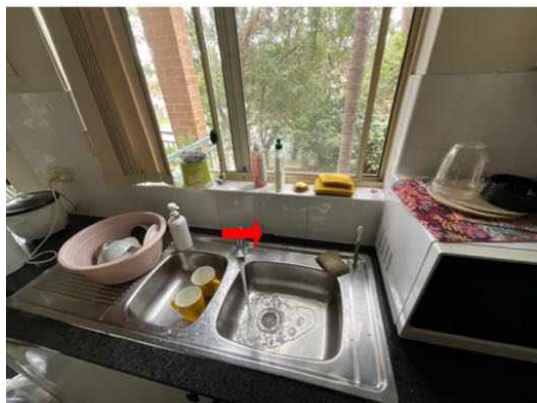
### Finding 3.02

Building: Main Building  
 Location: All Wet Areas  
 Finding: Sealant and grouting - Missing or damaged  
 Information:

It was noted on inspection that sealant or grout is degraded to this area.

Different materials and floor areas move at different rates, generally causing cracking to grout or sealant at this point. A flexible sealant is required to allow for expected expansion and contraction, while keeping the joint water tight and protective of all associated building materials.

Flexible and mould resistant materials should be applied to affected areas to prevent any subsequent water damage that is likely to occur. Regular maintenance and replacement of damage or missing or damaged sealant and grout is highly recommended to the wet areas, as this is a regular wear and tear defect. Sealant and grouting in areas that come into regular contact with water should be maintained for the long term care of your property.

A sealant specialist should be appointed to complete these works as soon as possible.

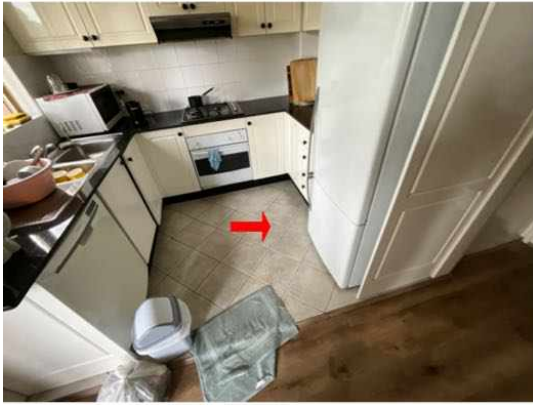
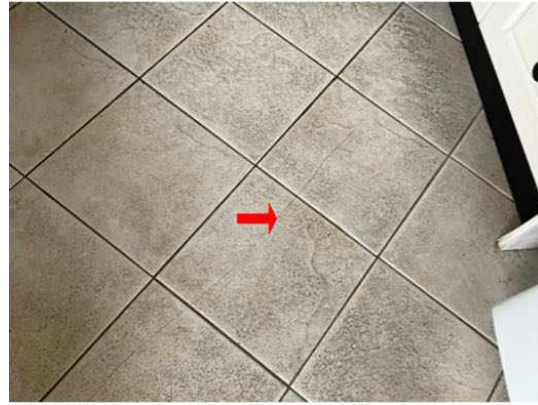
### Finding 3.03

Building: Main Building  
 Location: Kitchen  
 Finding: Cracked floor tiles  
 Information:

Cracking in the floor tiles was evident in this area at the time of inspection. It is suspected that this cracking has occurred as a result of minor settlement or shrinkage.

Cracked tiles throughout the household detract from the overall appearance of the affected areas however it is unlikely to create or lead to any secondary defects.

While not considered a matter of urgency, replacement of cracked floor tiles is recommended at the clients discretion. A licensed tiling contractor may be appointed to perform these works. Where cracks become more numerous, contact a licensed building inspector for further investigation.

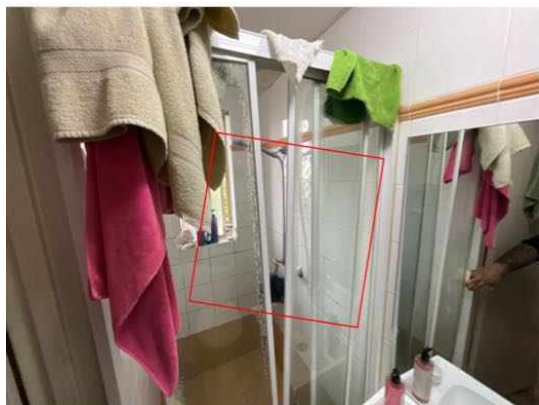
### Finding 3.05

Building: Main Building  
 Location: Ensuite  
 Finding: Shower door - Defective  
 Information:

Shower door has been removed from its position and/or defective and not operating as per expected at the time of inspection.

The normal operation of the shower is currently affected, causing the exterior of the shower becoming excessively wet and slippery while usage.

A bathroom specialist is required to repair the shower door as soon as possible.

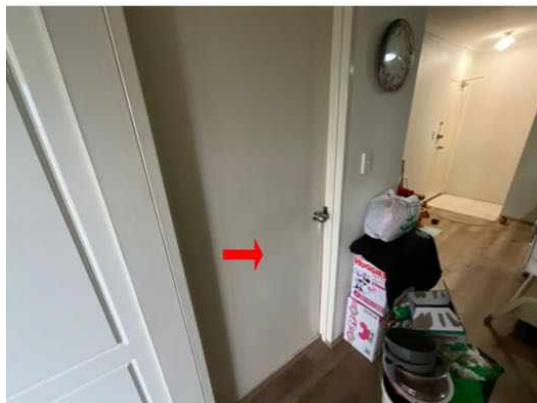
### Finding 3.06

Building:	Main Building
Location:	Laundry
Finding:	Building element - Damaged
Information:	The door in this area is twisted and won't latch. Breakage occurs generally when the building materials have either aged and decayed, or as a result of damage (accidental or deliberate).

Repair and/or replacement of broken elements is advised to ensure that additional secondary defects do not arise as a consequence. Such works are necessary, as all building elements play a key role in the operation and function of the overall structure and its performance.

A relevant tradesperson should be appointed to repair or replace the affected building element prior to any subsequent damage being caused.

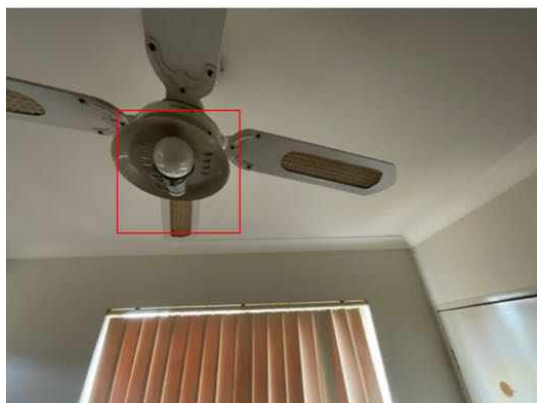
### Finding 3.07

Building:	Main Building
Location:	Both bedrooms
Finding:	Light cover - Missing (Cosmetic)
Information:	The light cover in this area was found to be missing at the time of inspection. Breakage occurs generally when the building materials have aged and decayed, but may also be indicative of impact damage to the building element (accidental or deliberate). This is mainly a cosmetic defect which can be replaced by the home owner.

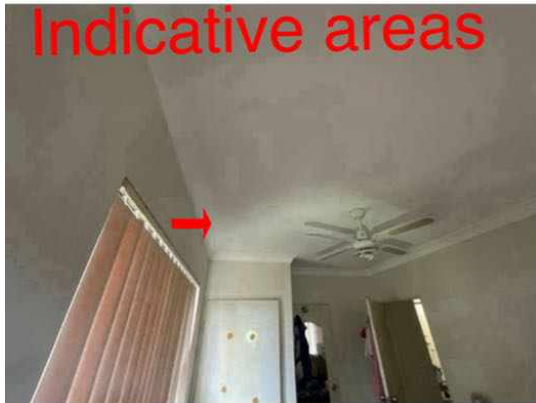
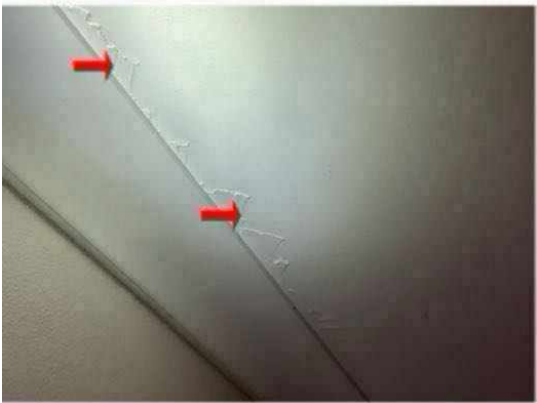
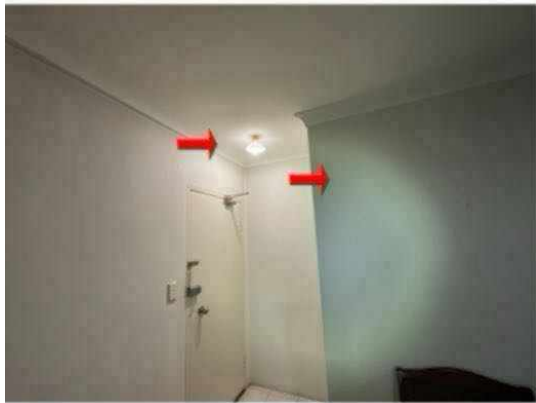
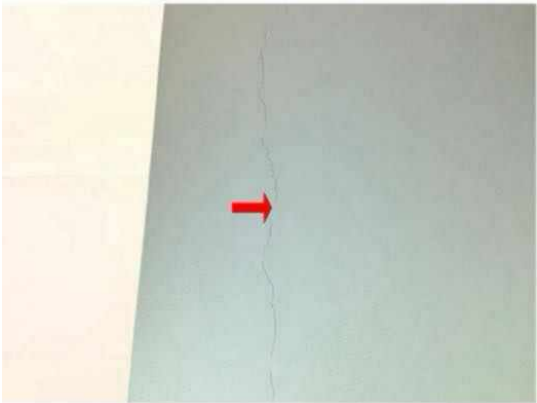
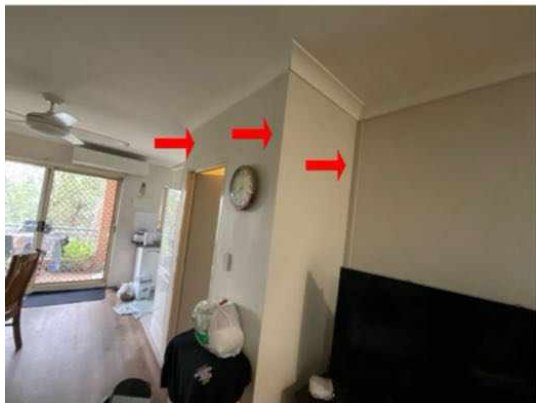
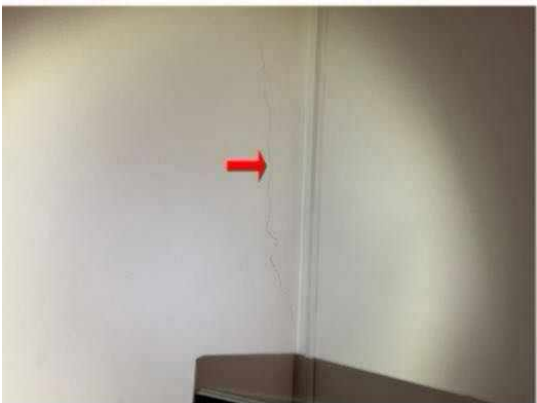
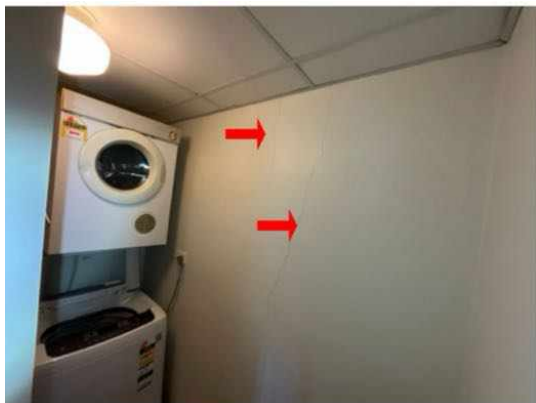
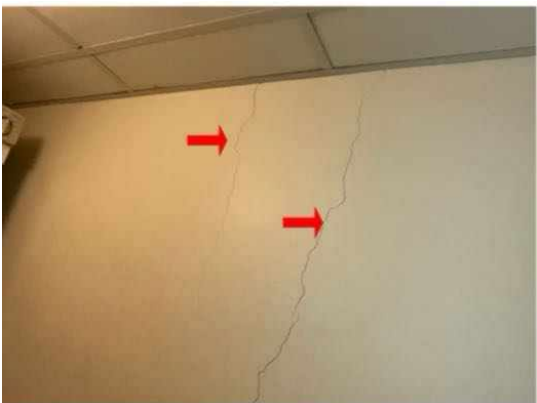
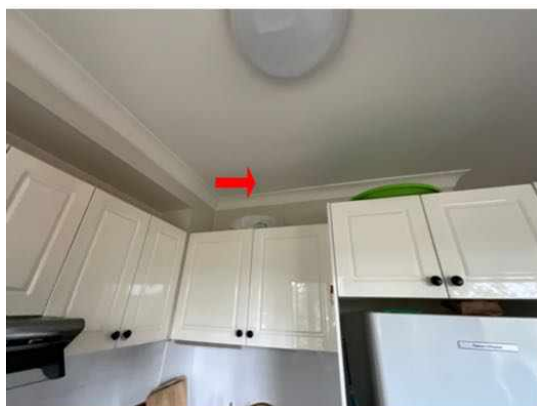
### Finding 3.08

Building:	Main Building
Location:	Multiple areas
Finding:	Cracks to internal render - Category 1
Information:	It has been observed that cracking to internal rendered surfaces has occurred. The degree of damage falls within Category 1, described as fine cracks that do not need repair and which are less than 1.0mm in width limit.

Damage of this category is not considered a defect for rectification. Always contact your building inspector should cracks widen, lengthen, or become more numerous.

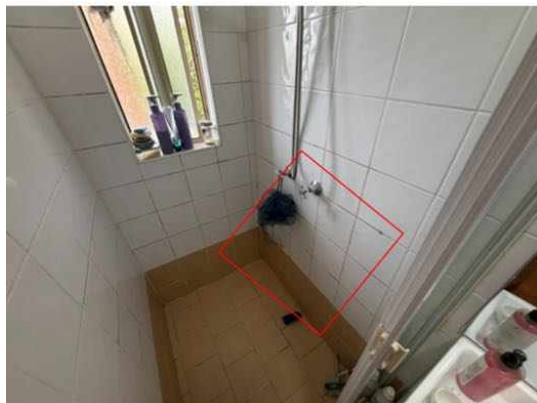
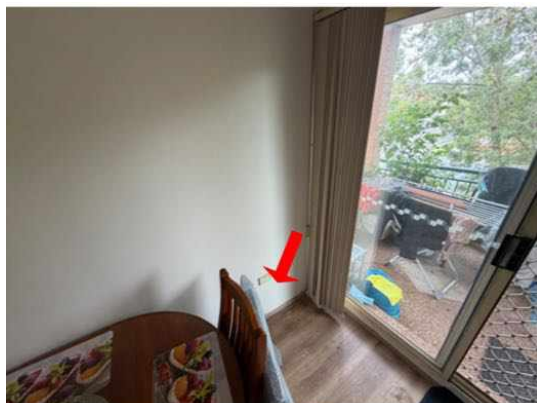
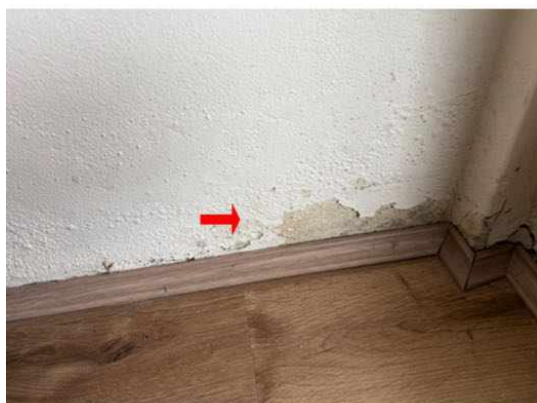
Building:	Main Building
Location:	Ensuite - Master
Finding:	Water leak suspected - Internal
Information:	A water leak is suspected in this area at the time of inspection. Internal water leaks can be detrimental to surrounding building elements; their potential causes include damage to plumbing fittings and fixtures, through to water damage and deterioration of associated building elements.

Rust, corrosion, decay and water damage are potential outcomes where a minor water leak is left unattended. More serious defects may also result, such as electrical hazards, or water damage to structural building elements.

In extreme cases, structural damage may develop due to a prolonged water leak. It is highly advised that internal water leaks be addressed by a licensed plumber as a matter of relative urgency.

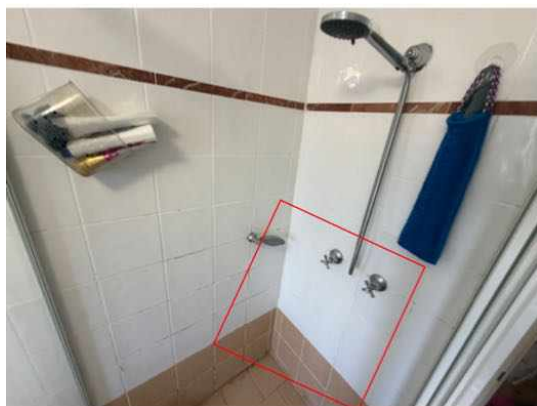
### Finding 6.02

Finding: Water leak - Suspected

Information: A water leak is suspected in this area as excessive moisture was detected at the time of inspection. Another potential cause maybe moisture ingress behind the tiles from around the wall fittings and penetrations.

Internal water leaks can be detrimental to surrounding building elements; their potential causes include damage to plumbing fittings and fixtures, through to water damage and deterioration of associated building elements.

Attracting termites, corrosion, mould, decay and water damage are potential outcomes where a minor water leak is left unattended. More serious defects may also result, such as electrical hazards, or water damage to structural building elements.

In extreme cases, structural damage may develop due to a prolonged water leak. It is highly advised that internal water leaks be addressed by a licensed plumber as a matter of relative urgency.

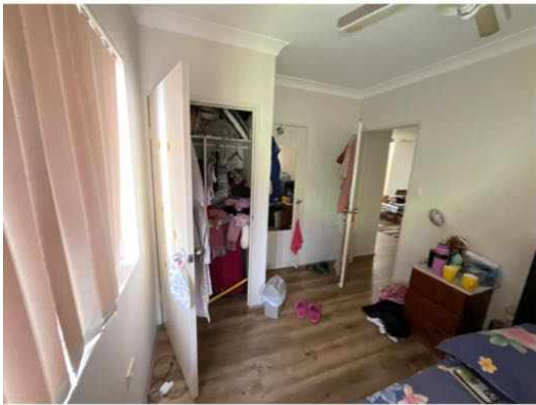
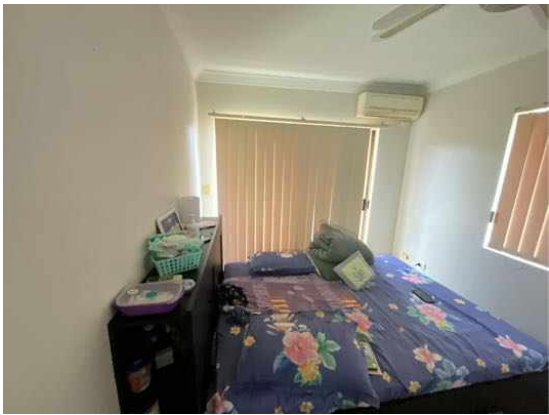
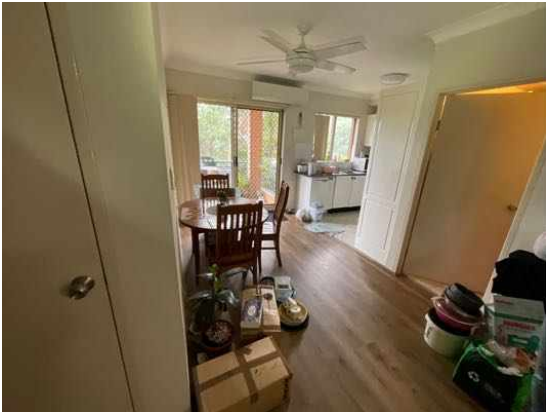
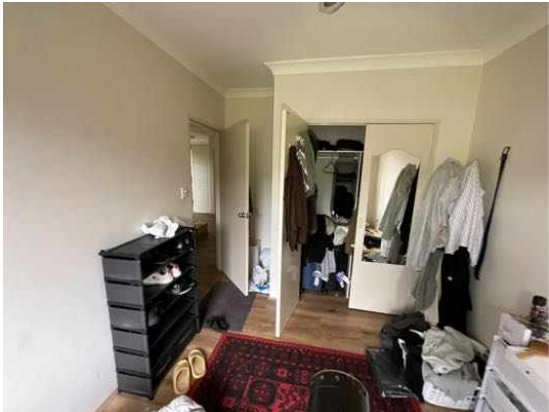
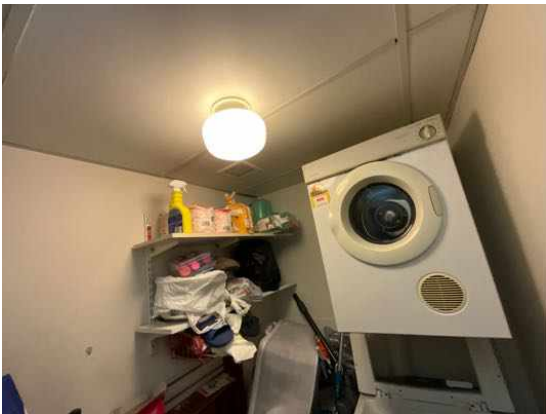
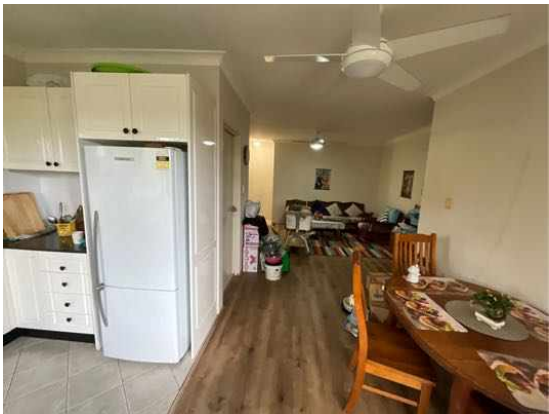
Building: Main Building  
 Location: All Areas  
 Finding: Additional Photos - Obstructions and Limitations  
 Information:

These photographs are an indication of the obstructions and limitations which impeded full inspection of the property at the time of inspection. These obstructions can hide an array of defects and should be removed to allow full inspection to be carried out. A re-inspection is recommended once the areas are made accessible.
