Building and Timber Pest Inspection Report

Inspection Date: Mon, 2 Feb 2026

Property Address: 3 Reidy St, Benalla VIC 3672, Australia

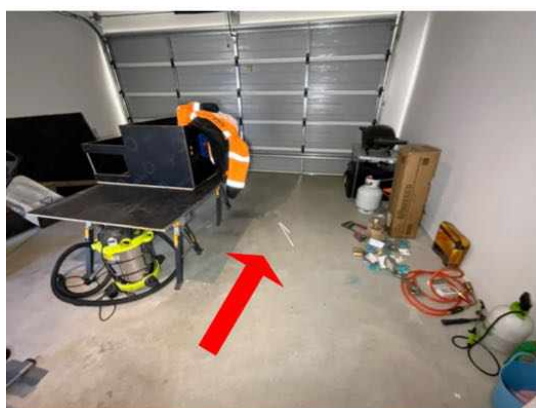
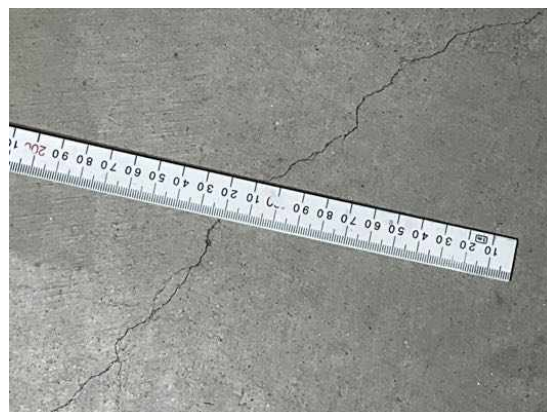
Finding 3.01

Building: Building 1
Location: Garage
Finding: Crack in concrete slab - Category 1
Information: A crack coded as Category 1 was identified in the slab. A Category 1 crack is described as a fine but noticeable crack, with the slab at an otherwise reasonable level.

To be considered Category 1, the approximate width of the crack is less than 1.0mm, or a less than 10mm change in offset when a 3m straight edge is placed over the defect.

Category 1 cracks should be monitored for a period of 12 months. At the end of the monitoring period, identified cracks that are rated greater than Category 2 are considered defects, and require rectification.

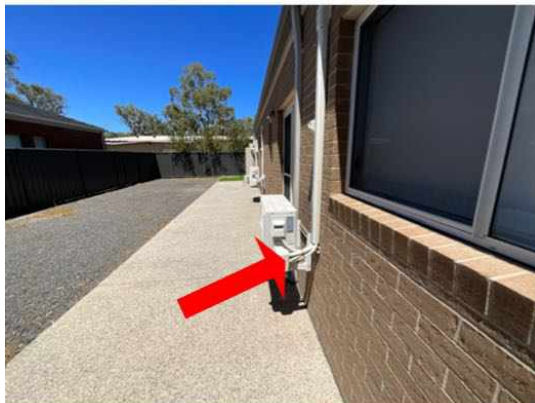
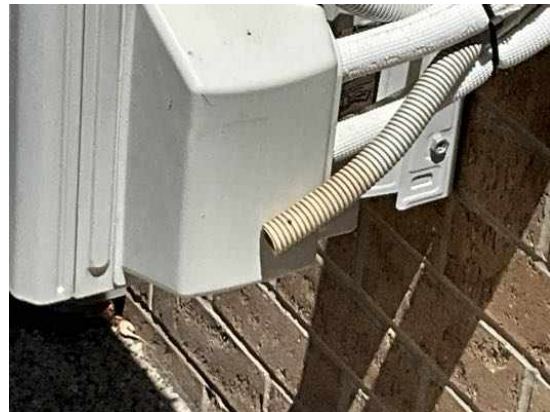
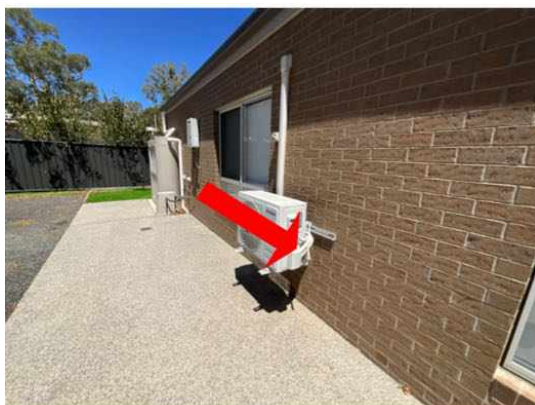
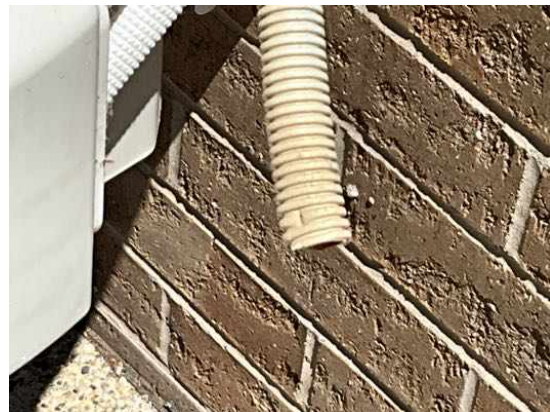
Finding 6.01

Building: Building 1
 Location: Yard - Side
 Finding: Air conditioner - Disconnected overflow
 Information: The Air Conditioner (A/C) overflow was found to be disconnected from storm water drainage and is creating excessive moisture in the surrounding area.

Such leaking creates an environment which is conducive to an array of defects, including water damage to associated building elements and the attraction of termite or timber pest infestation.

It is highly recommended that a licensed plumber be appointed to connect the A/C overflow in order to prevent such an environment from being created. These minor works should be carried out as soon as possible.

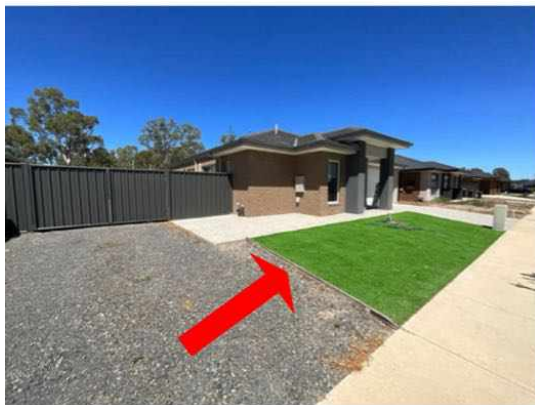
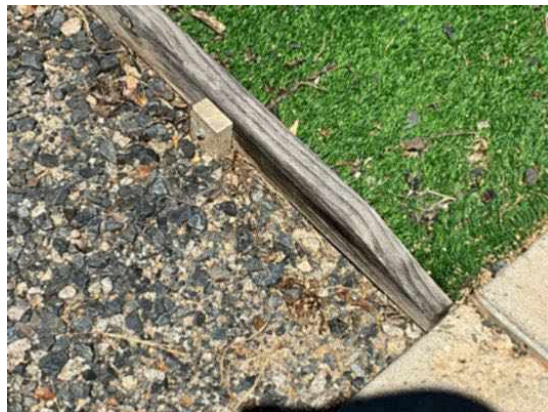
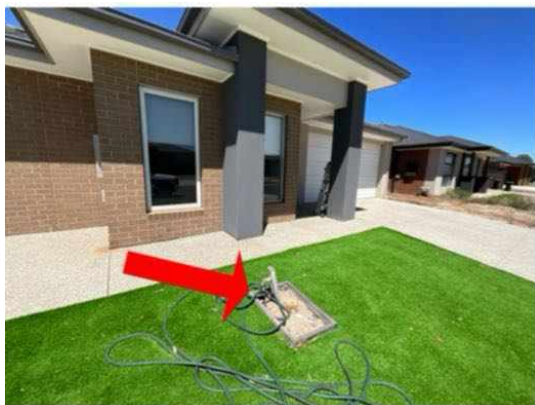
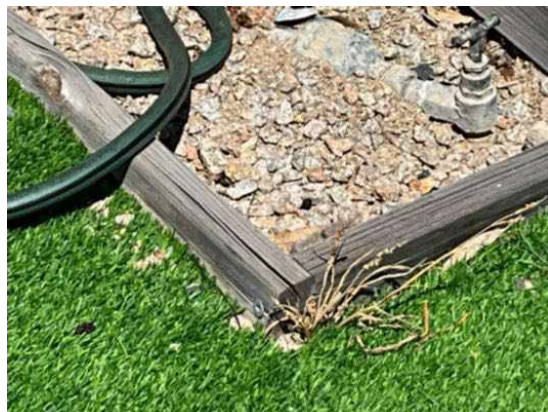
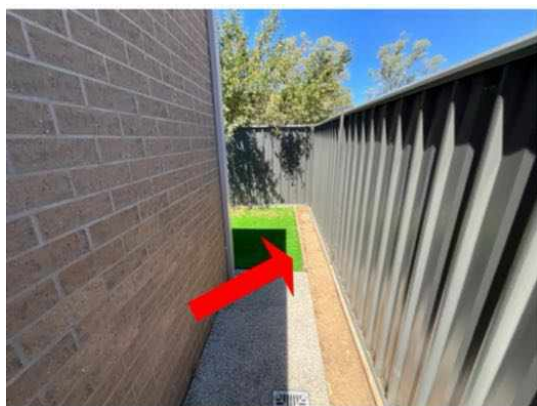
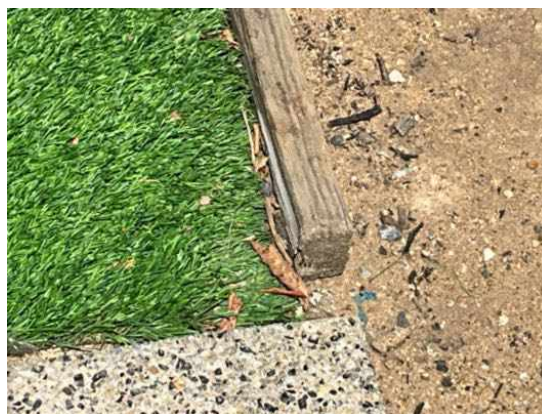
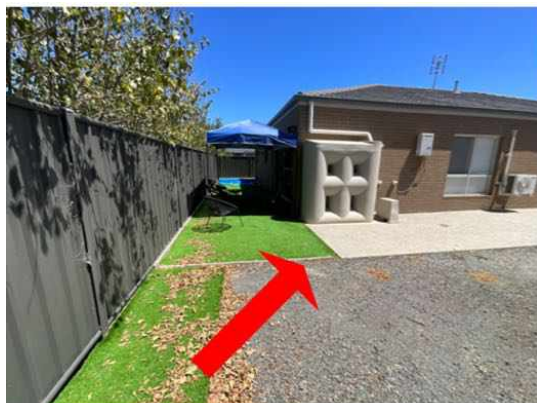
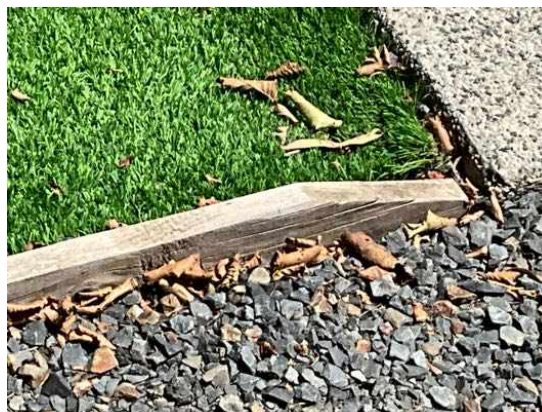
Finding 6.02

Building: Building 1
Location: Yard - Front, back
Finding: Untreated or non-durable timbers in a hazardous environment
Information: To reduce the risk of timber pest attack it is essential that timber used in a hazardous environment (e.g. in direct contact with the ground or frequently exposed to damp conditions) is of sufficient durability and/or is adequately preservative treated.

Untreated timbers in direct contact with the ground are likely to develop severe wood rot and/or fungal decay if left unattended creating attraction for subterranean termites to infest the timbers from surrounding areas.

If untreated or non-durable timbers are found to be in a hazardous environment it is highly advised that replacement of these building elements be performed as soon as possible to aid the protection of the property against termite / timber pest attack.

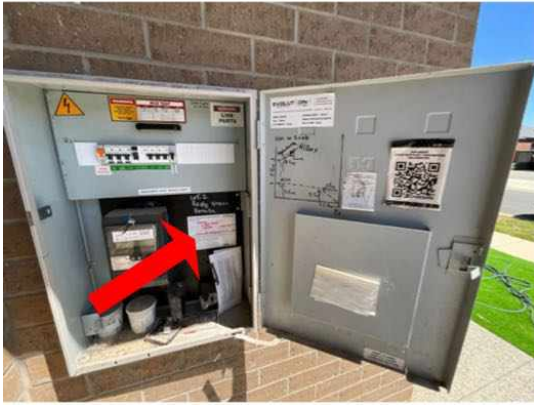
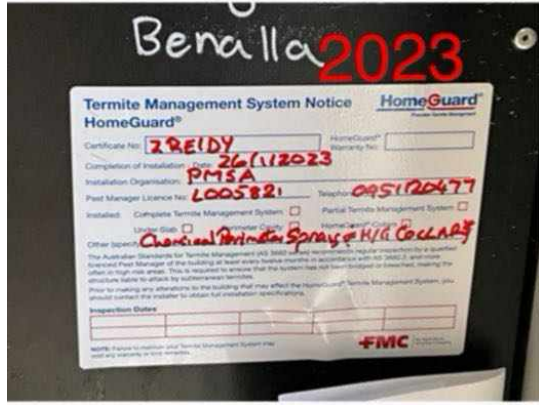
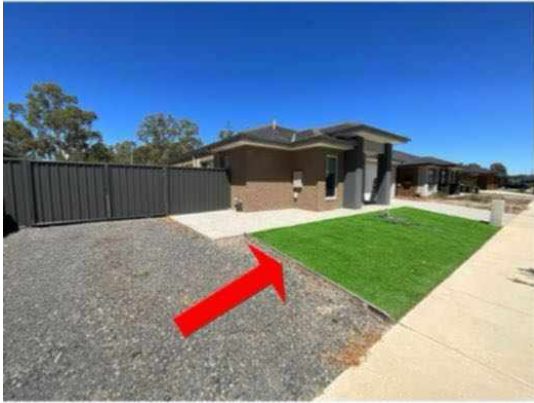
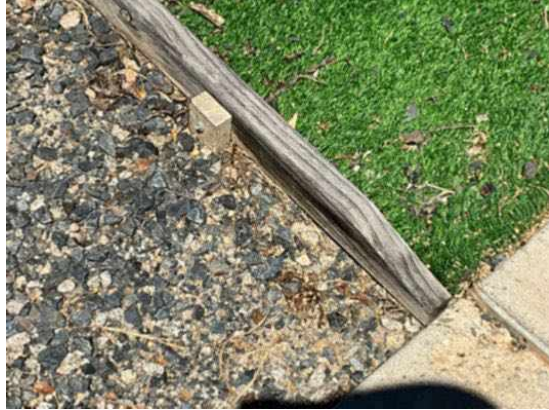
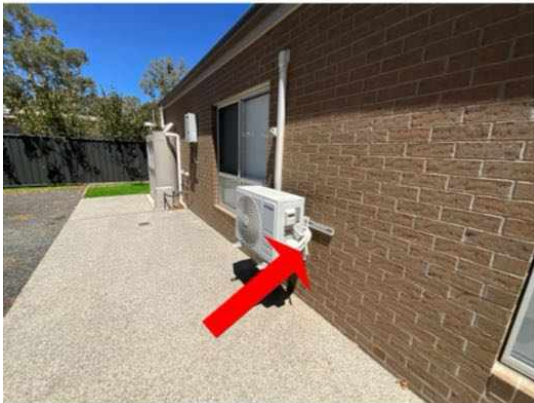
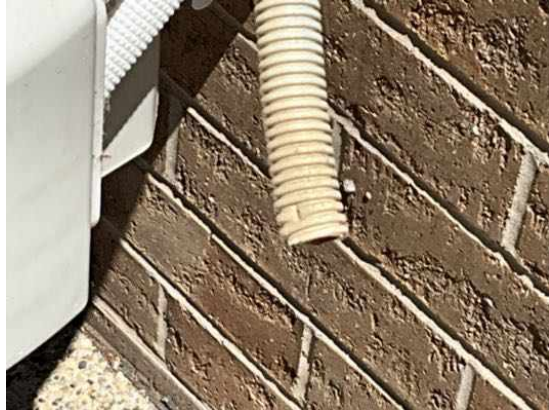
Finding 6.03

Building:	Building 1
Location:	All External Areas
Finding:	Termite Management System- evidence of a chemical installation
Information:	The application of a post-construction chemical termite barrier is highly recommended for all properties, particularly if live termite activity has been found on the site previously. Such barriers are highly effective in preventing termite attack on any timber building elements throughout the property.

A durable notice has been placed in the switchboard unit to indicate current termite barriers. At the time of inspection, it appeared as though a termite management system has been installed. The recency of any treatment cannot be determined.

The client may consider gaining further advice from a pest controller as to the costs and procedures involved with this application. It is recommended that obtaining such advice be a short-term priority.

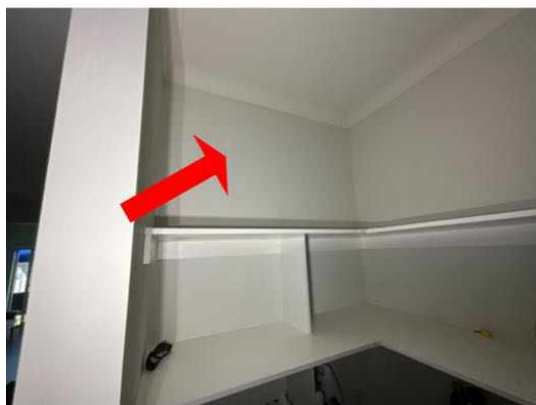
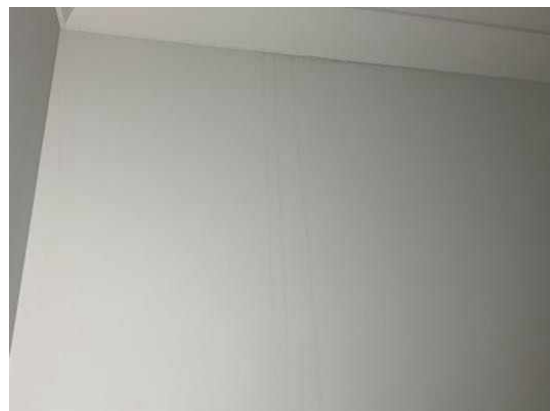
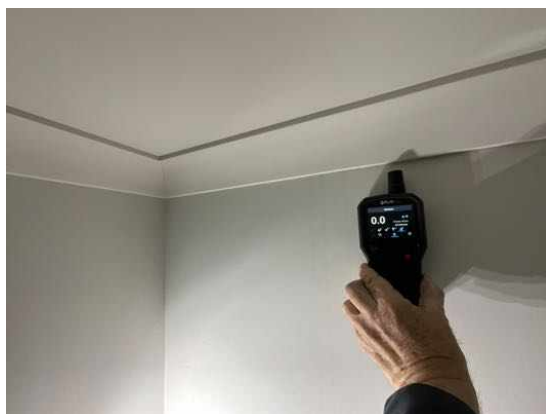
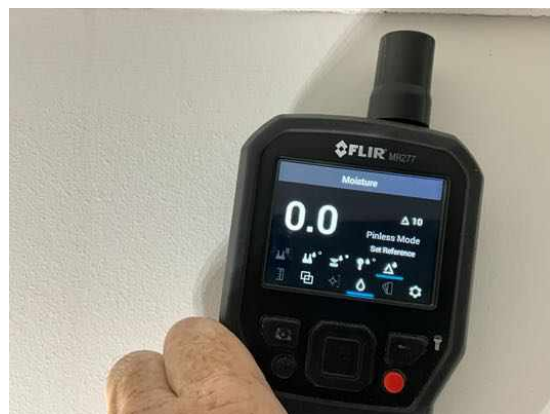
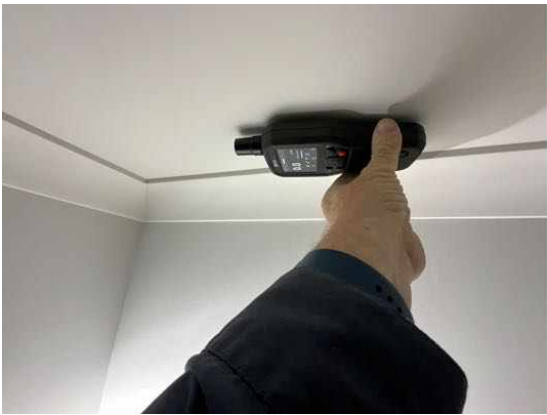
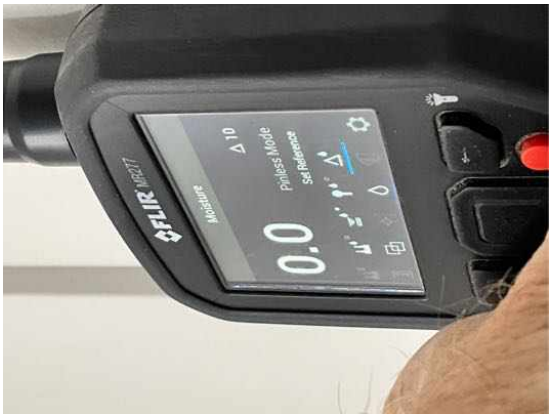
Building: Building 1
Location: Pantry - Walk In
Finding: Wall- Water stained
Information: Water staining to this section of the wall was evident at the time of inspection. Water staining indicates that surfaces have been exposed to excessive moisture over time. The minerals and other elements in the water lead to staining, which may graduate to corrosion and deterioration if left unmanaged.

While mostly an appearance defect, water staining can be indicative of more serious defects, which may be currently concealed by wall linings.

The water staining is old and inactive, no action is needed at this time.

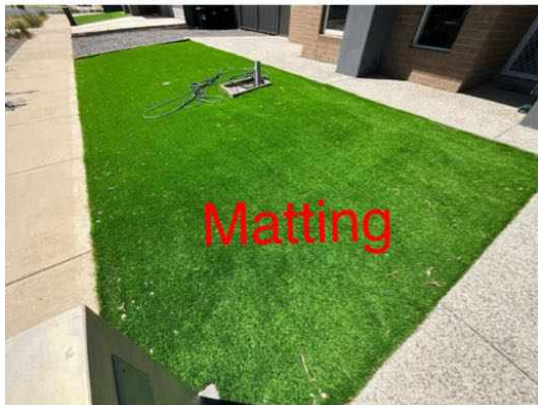
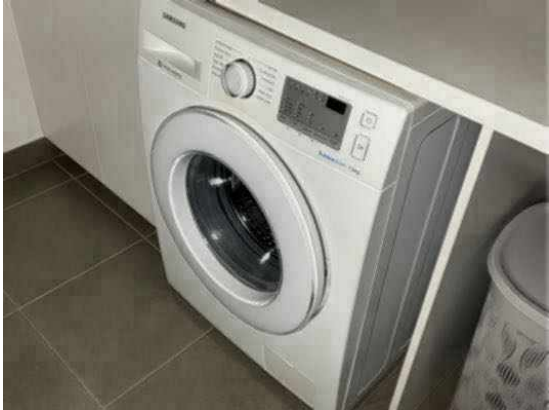
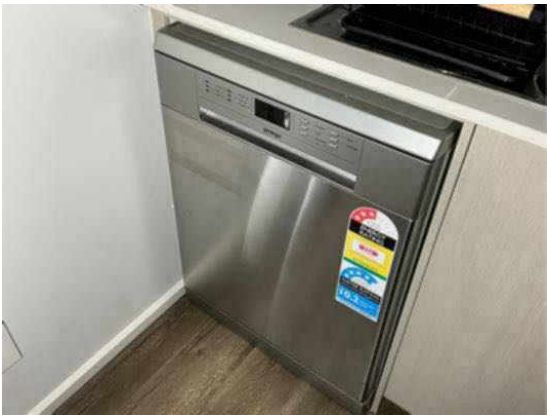
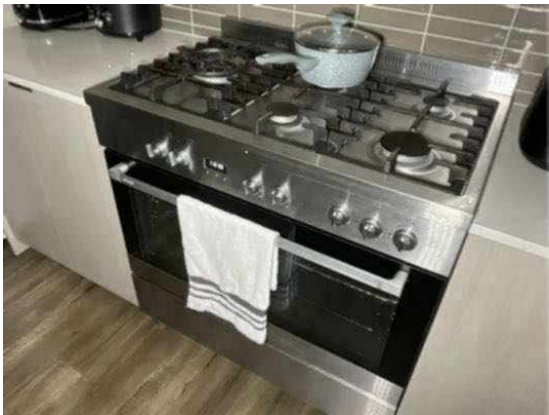
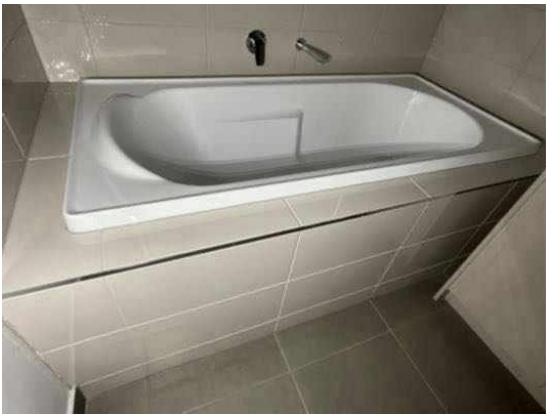
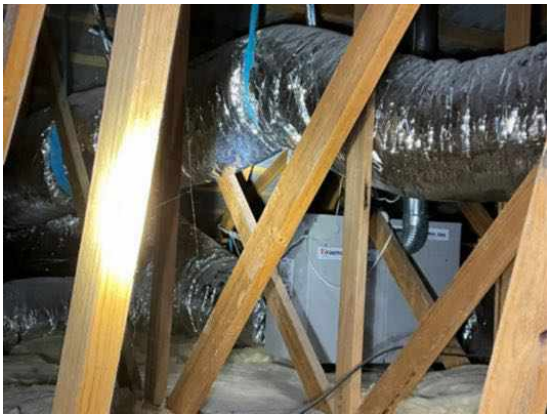
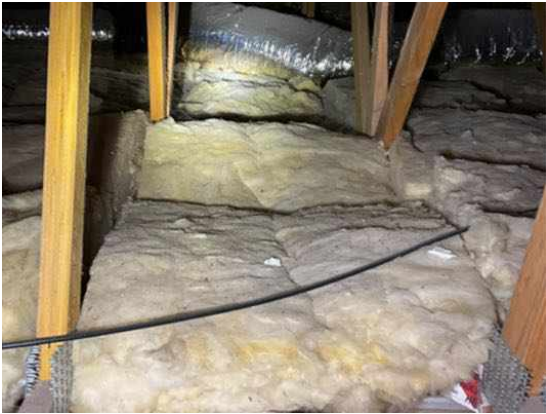
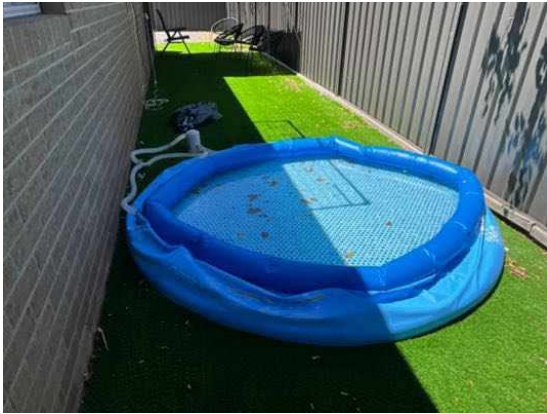
Building: Building 1
Location: All Areas
Finding: Additional Photos - Obstructions and Limitations
Information: These photographs are an indication of the obstructions and limitations which impeded full inspection of the property at the time of inspection. These obstructions can hide an array of defects and should be removed to allow full inspection to be carried out. A re-inspection is recommended once the areas are made accessible.
