## Building Inspection Report

Inspection Date: Fri, 20 Feb 2026

Property Address: 401/85 Nicholson St, Brunswick East VIC  
3057, Australia

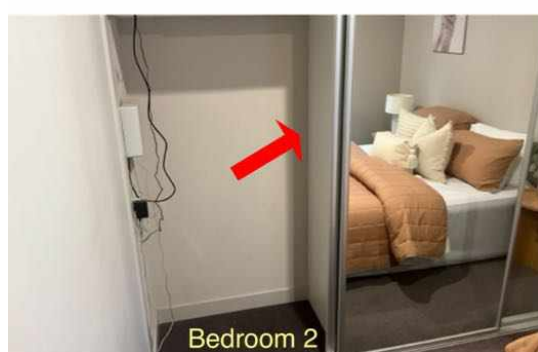
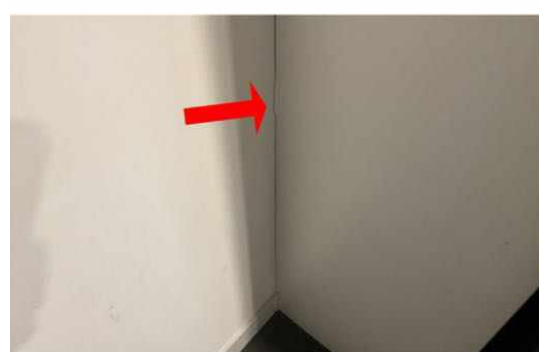
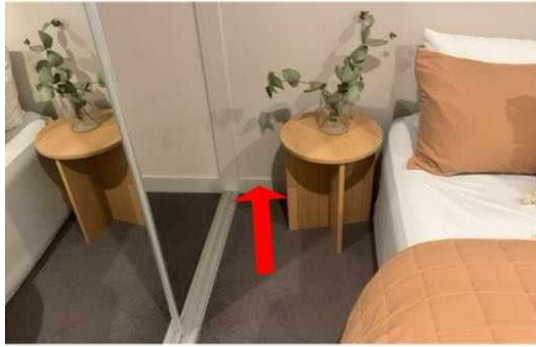
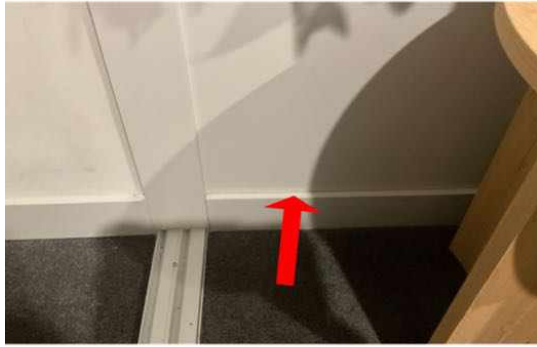
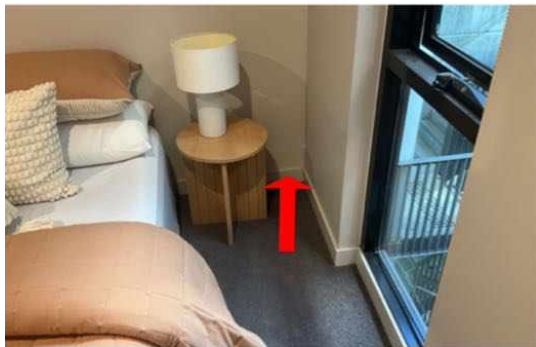
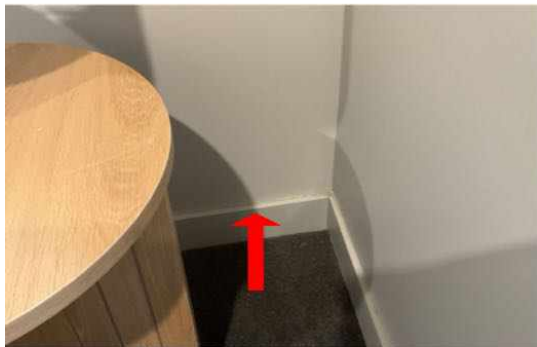
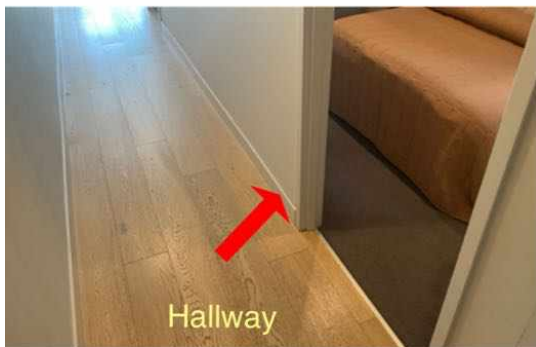
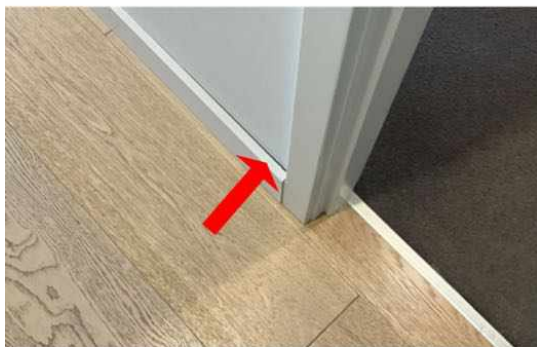
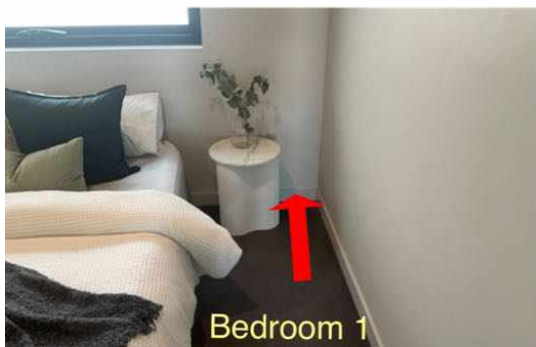
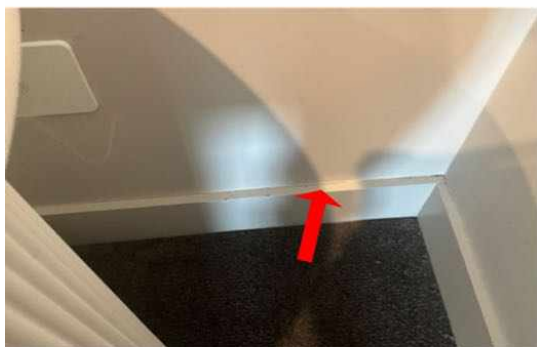
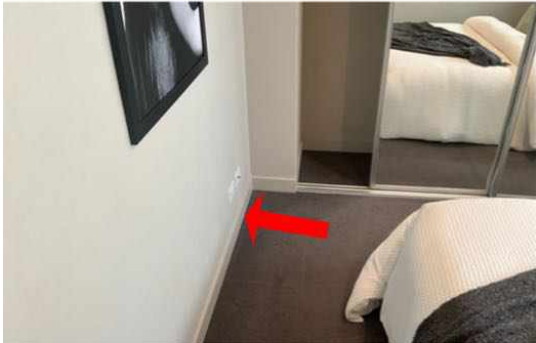
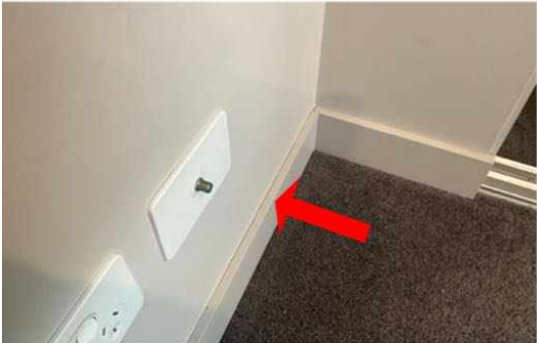
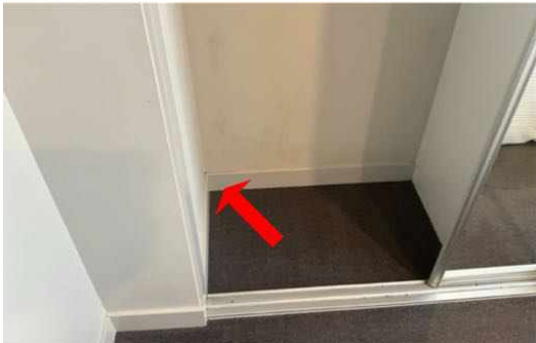
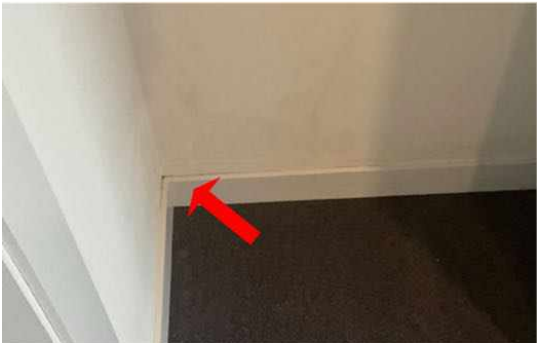
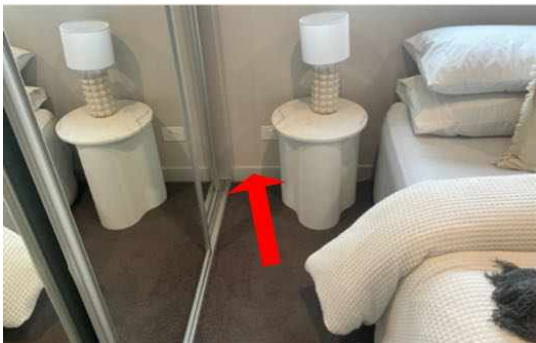
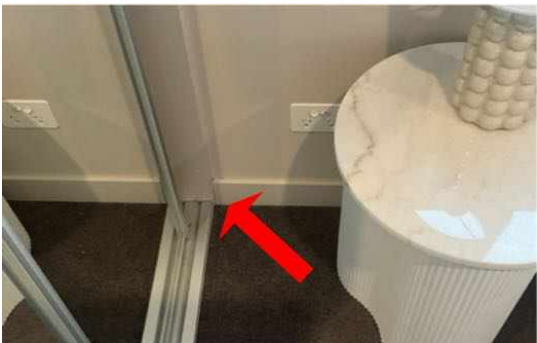
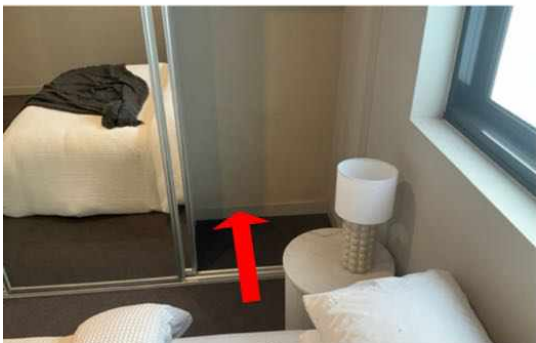
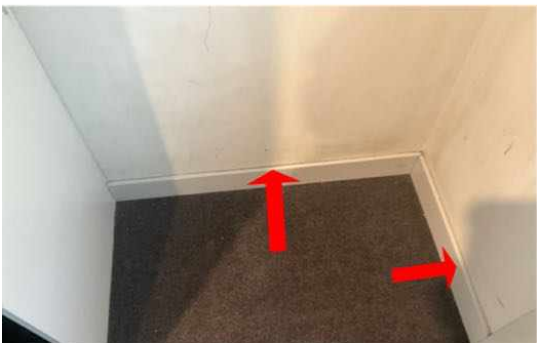
#### Defects 3.01

Finding: Cracking - fine

Information: Some fine cracking was noted throughout the property.

Although fine cracks are quite noticeable, they are often only considered to be an appearance defect, and usually do not indicate any structural damage. Generally, the cause of a fine crack is indicative of a separation between building materials and finishes (e.g. paint, plaster, etc.) along joins.

Cracking of this nature can generally be repaired with minor sanding, filling and/or repainting. Such works should be performed by a qualified painter or a general handyman.

Monitoring of all cracking should be conducted frequently. Always contact a building inspector should cracks widen, lengthen, or become more numerous.

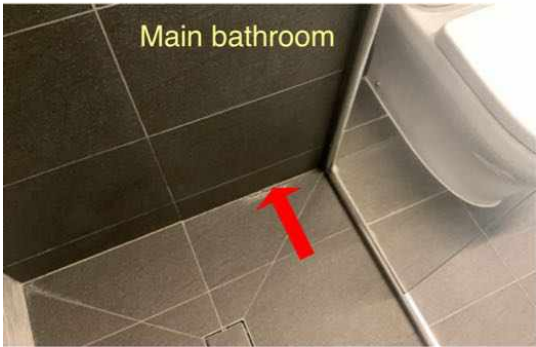
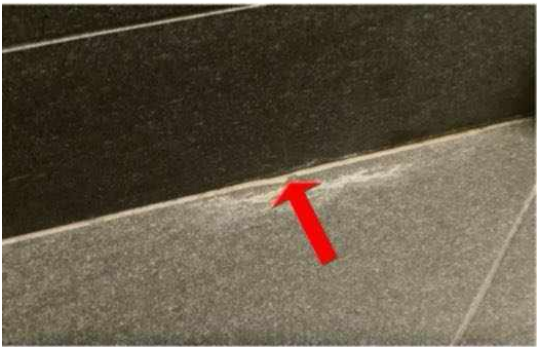
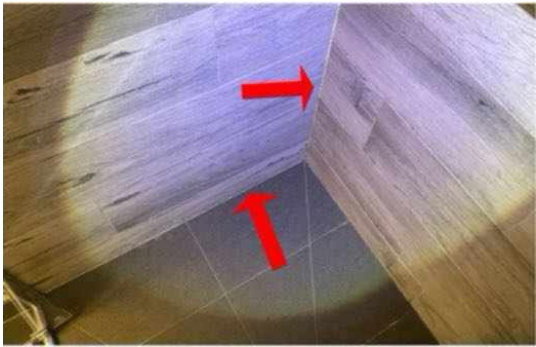
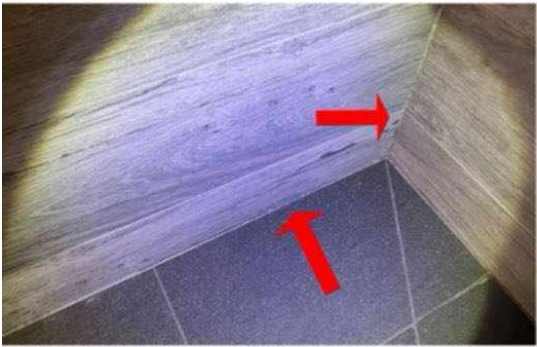
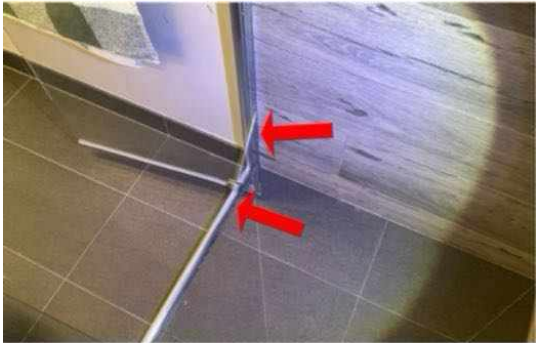
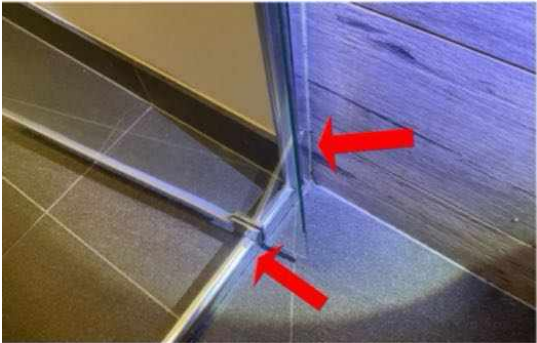
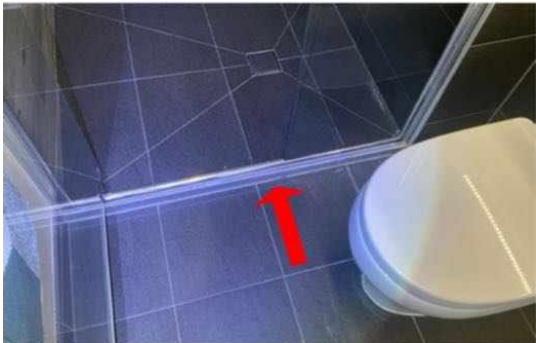
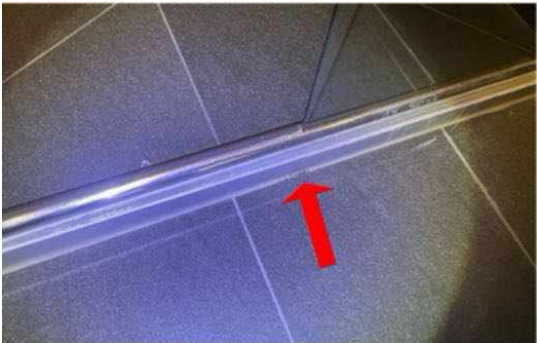
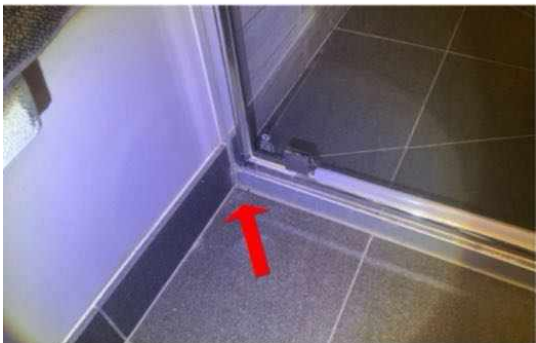
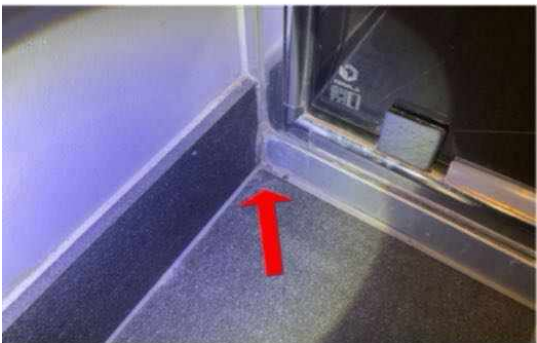
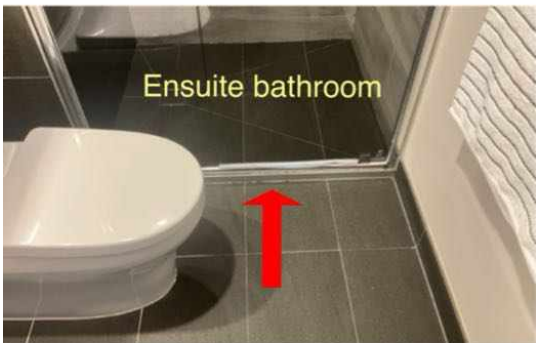
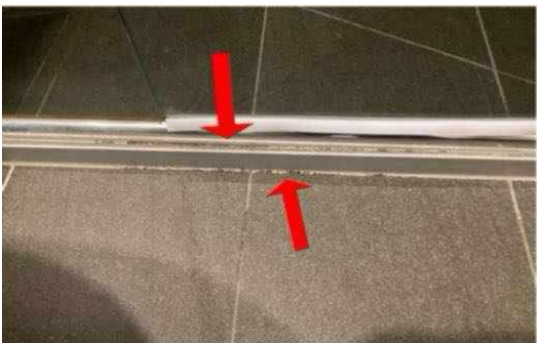
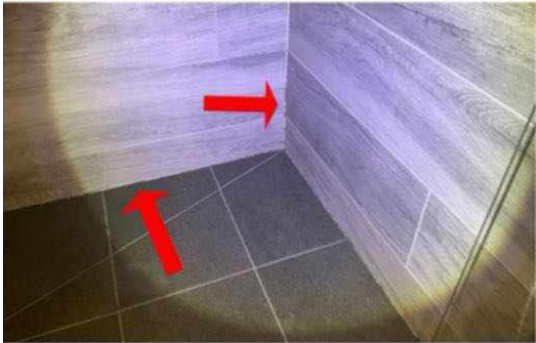
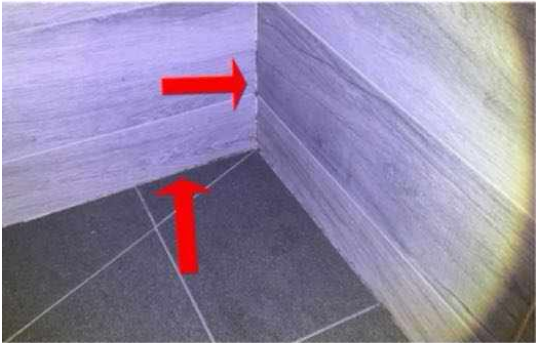
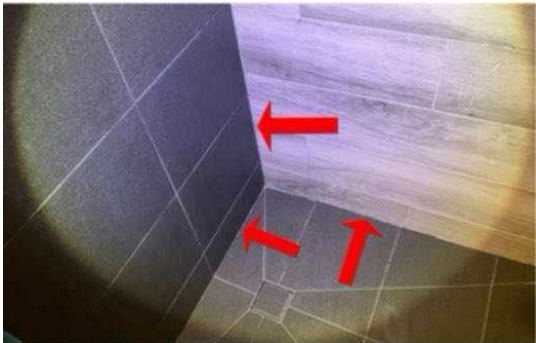
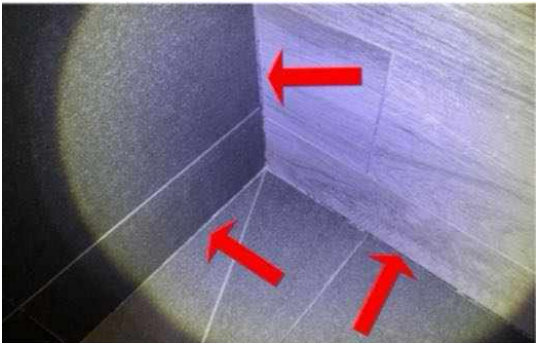
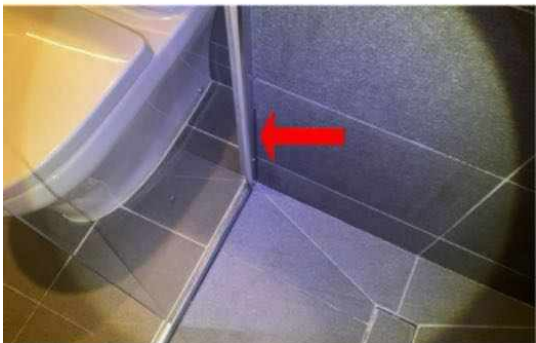
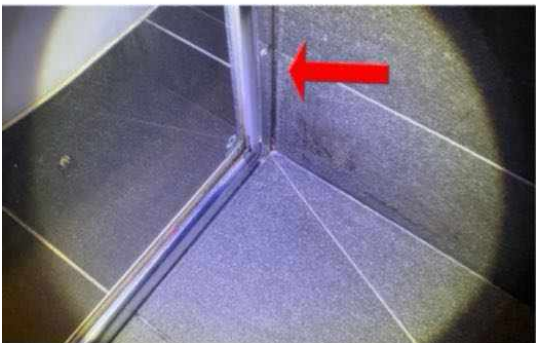
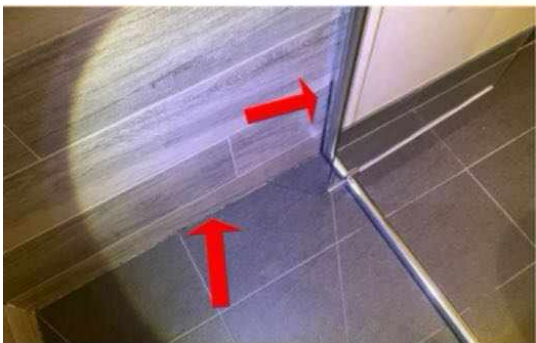
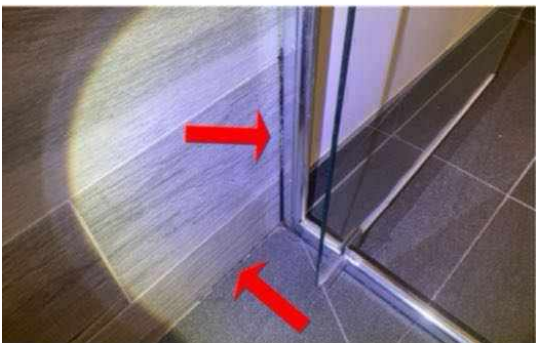
Defects 3.02

Building:  
Location: Bathroom  
Finding: Sealant / Grout - Degraded and mouldy within the shower  
Information: Sealant / Grout is degraded in this area. Sealant and grout is used to protect gaps and crevices in building materials to ensure that they are water-tight and prevent water penetration to the associated structures.

Failure to do so is likely to lead to further deterioration of the sealant and grout which in turn can lead to water damage to the surrounding area.

Excessive mould can also lead to respiratory issues .

Where sealant or grout is damaged or mouldy , a tiling contractor should be appointed immediately to scrape out and re-apply where necessary.

Grout and sealant is deteriorated in some areas within both showers. It is recommended that both showers be freshened up with new grout and sealant.

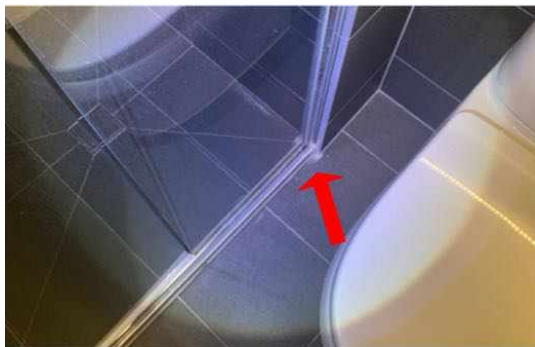
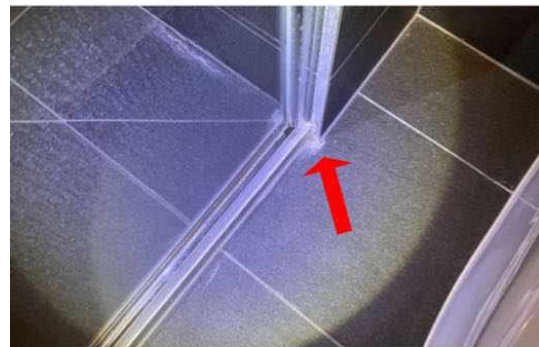
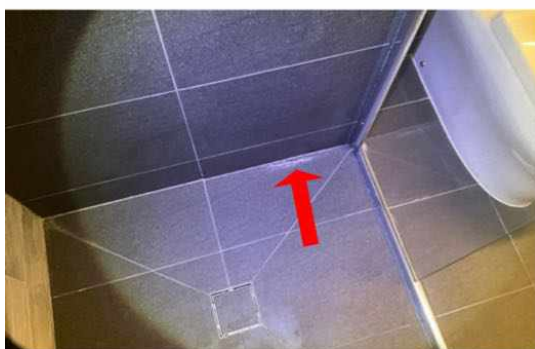
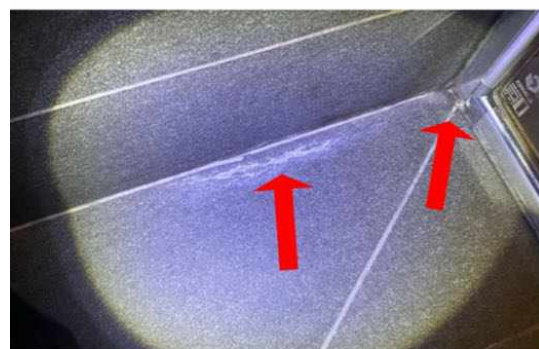
Defects 3.03

Building:  
 Location: Bathroom  
 Finding: Shower tiles - Efflorescence  
 Information: Slight Efflorescence appears to be affecting the tiles in this area. Efflorescence typically occurs when excess salts within the concrete or cement mortar is leached to the surface due to water transfer.

It is typically seen as white salt deposits between and around the tiles. While detracting from the overall appearance of the affected area, efflorescence is not likely to develop into secondary damage if left unmanaged.

Generally, soluble salt deposits can be removed by dry brushing with a stiff-bristled brush. Repeated dry brushing is an ideal treatment for eliminating this forming of efflorescence.

A cleaning contractor or general handyperson may be appointed to perform these works at the discretion of the client.

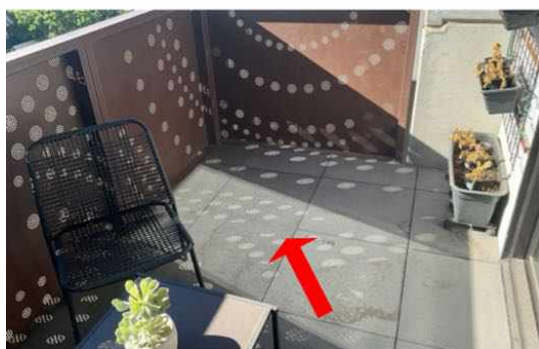
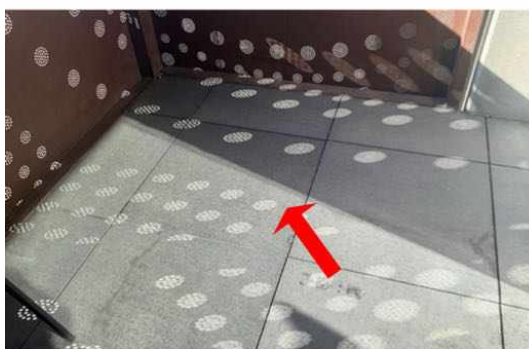
### Defects 3.04

Building:  
 Location: Balcony  
 Finding: Balcony tiles loose and uneven

Information: At the time of inspection, some of the tiles on the balcony were loose, and slightly uneven when walked upon. These tiles are raised off the concrete base and sit on “feet” underneath and can become loose and slightly uneven / wobbly if debris gets trapped underneath.

The tiles may be lifted, checked and cleaned of any debris underneath. Once the area underneath the pavers has been cleaned, the pavers should be replaced. Should the pavers still be uneven , a new base may need to be put in place to ensure the paver is even and not loose.

A tiler or paving specialist may be engaged to perform this task.

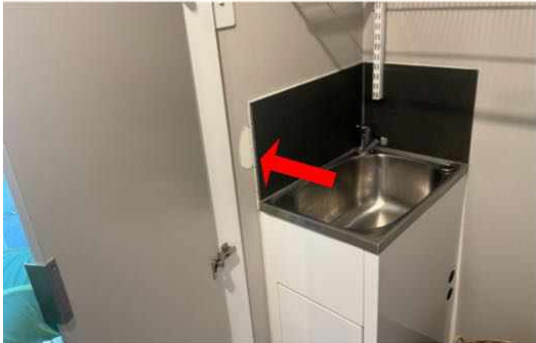
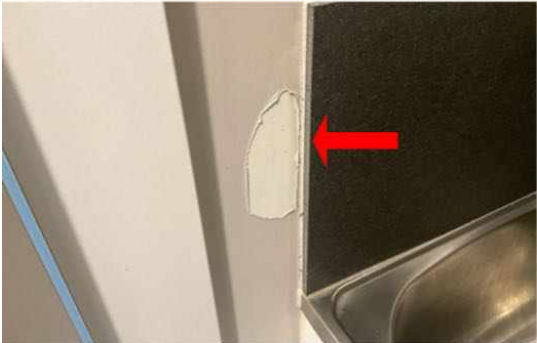
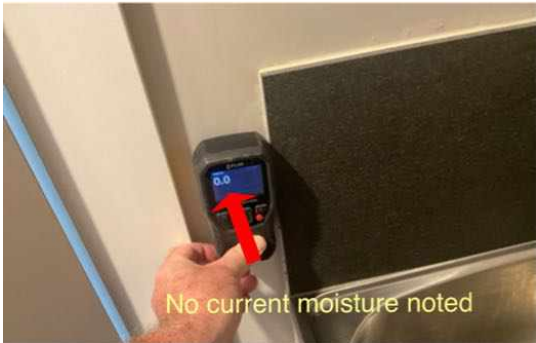
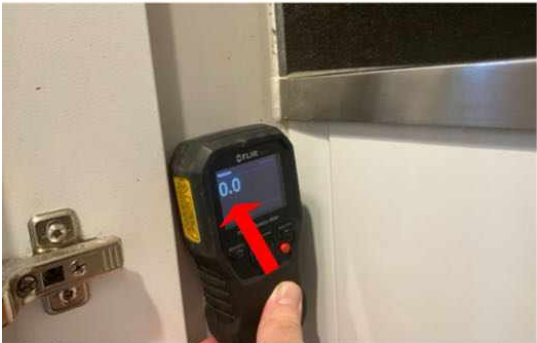
### Defects 3.05

Building: Laundry  
 Location: Laundry  
 Finding: Additional Photos - minor defects  
 Information: Additional photos are provided for your general reference.

Paint was peeling on the side wall next to the laundry tub. It is suspected this may have occurred from internal spills. No current moisture was noted within the wall when tested with a moisture meter.

The wall may be sanded and repainted at the discretion of the homeowner. A competent, handyman or painter can be used to perform this task.

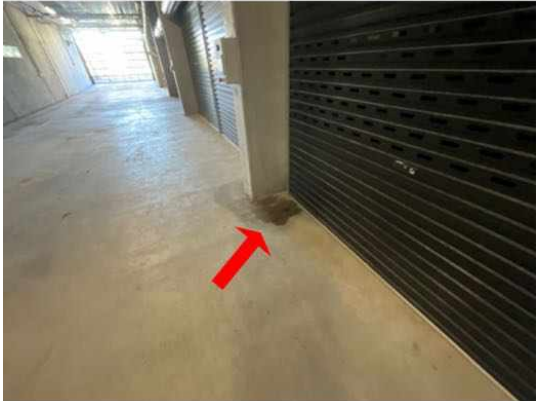
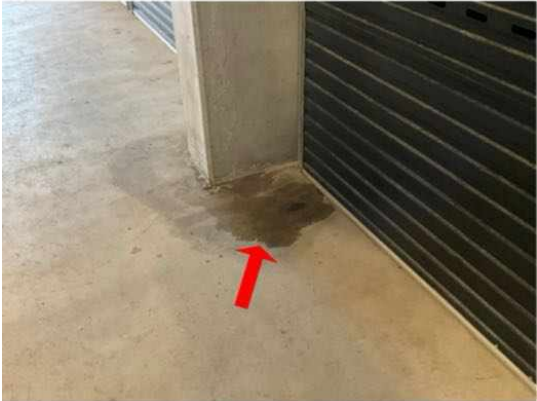
**Defects 3.06**

Building:  
Location: Garage  
Finding: Additional photos - suspected owners corporation minor defects  
Information: - slight moisture on the ground in the garage. Suspected drips from pipes above. Doesn't appear to be anything major.

Please note: it is suspected that these items would be covered by the owners corporation.

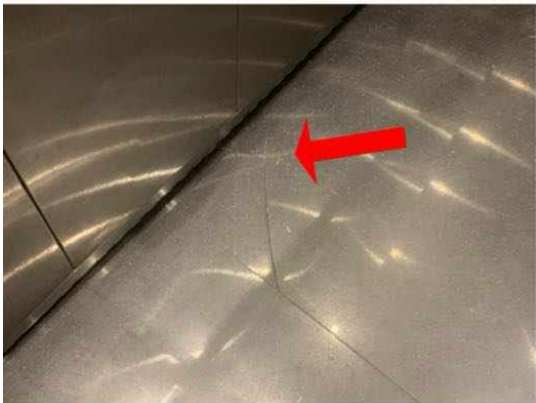
Cracked tiles in lift
